Final Reclamation Inspection

Operator: Simcoe LLC - 10749

Location ID: 333703

Inspection Photos
Location Name: Ralph Downing A2, A4
Location ID: 333703

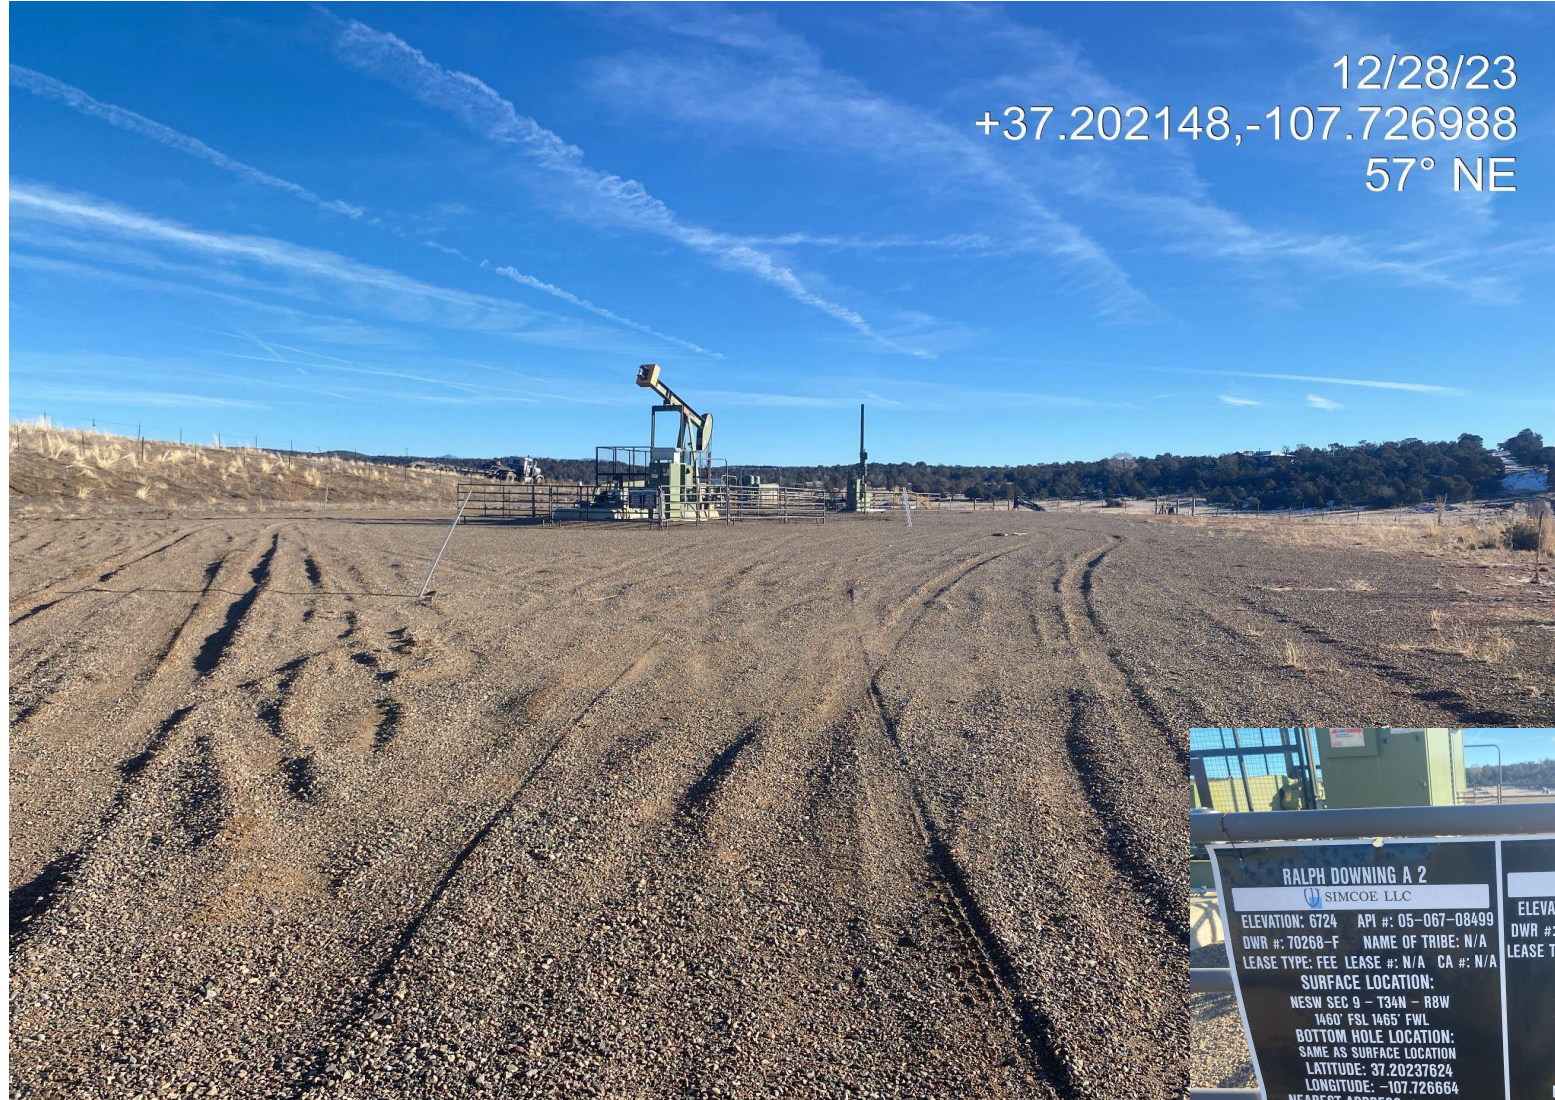
Photo 1. View of the well disturbance from the entrance facing center.

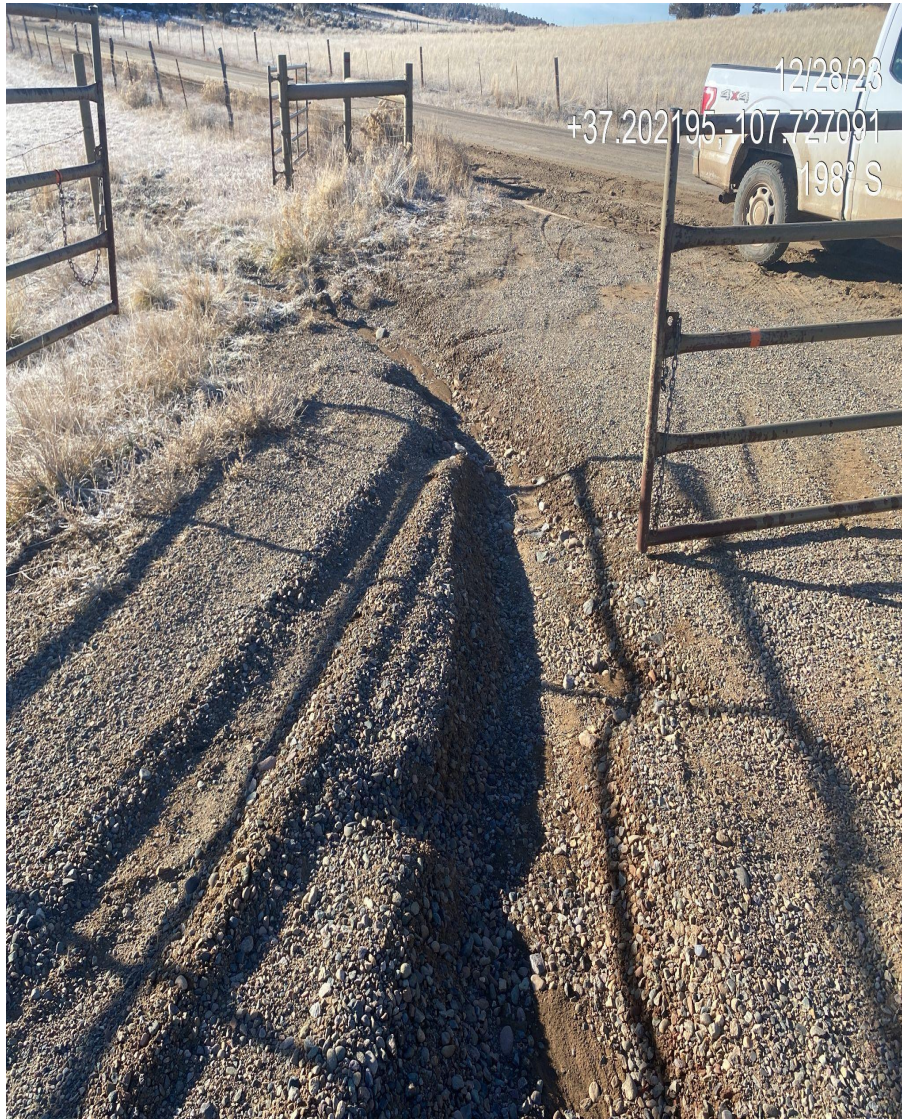
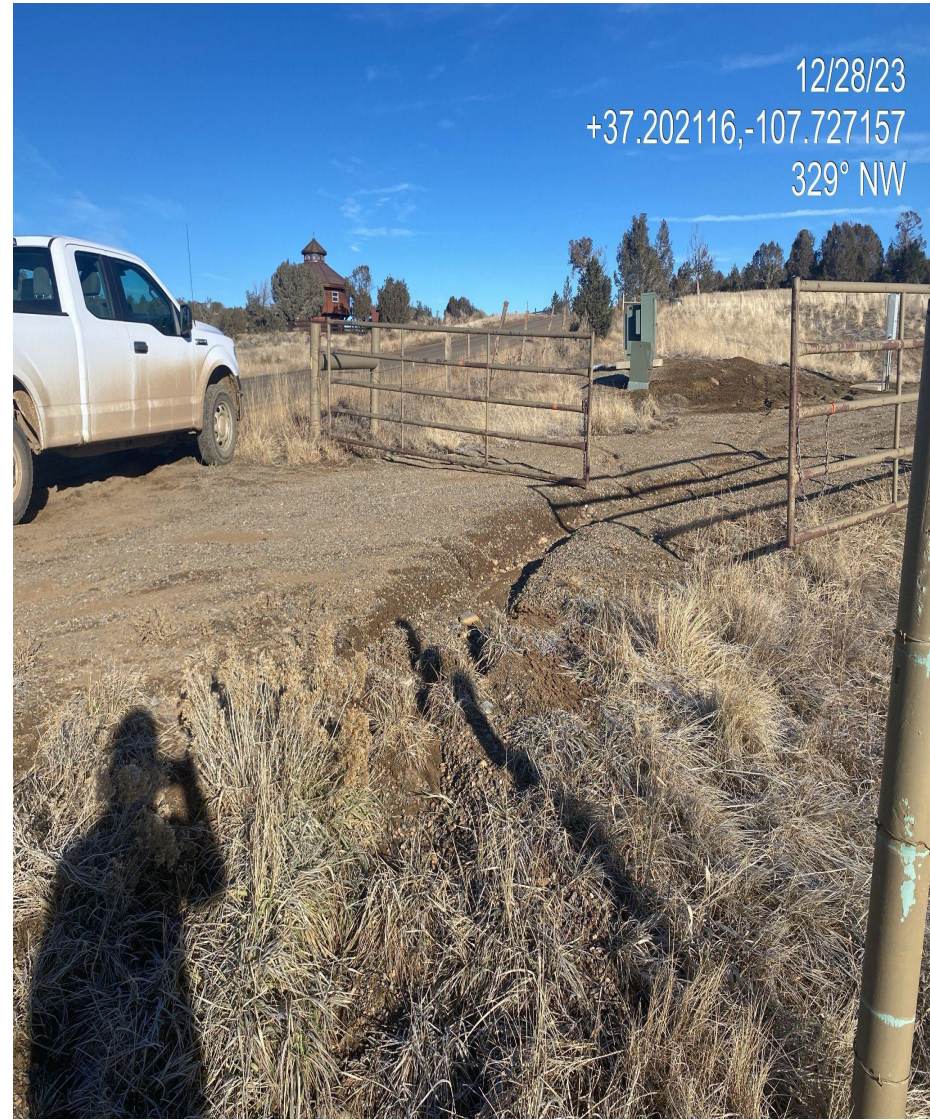
Photo 2. View of rill/gully erosion forming at the access point.

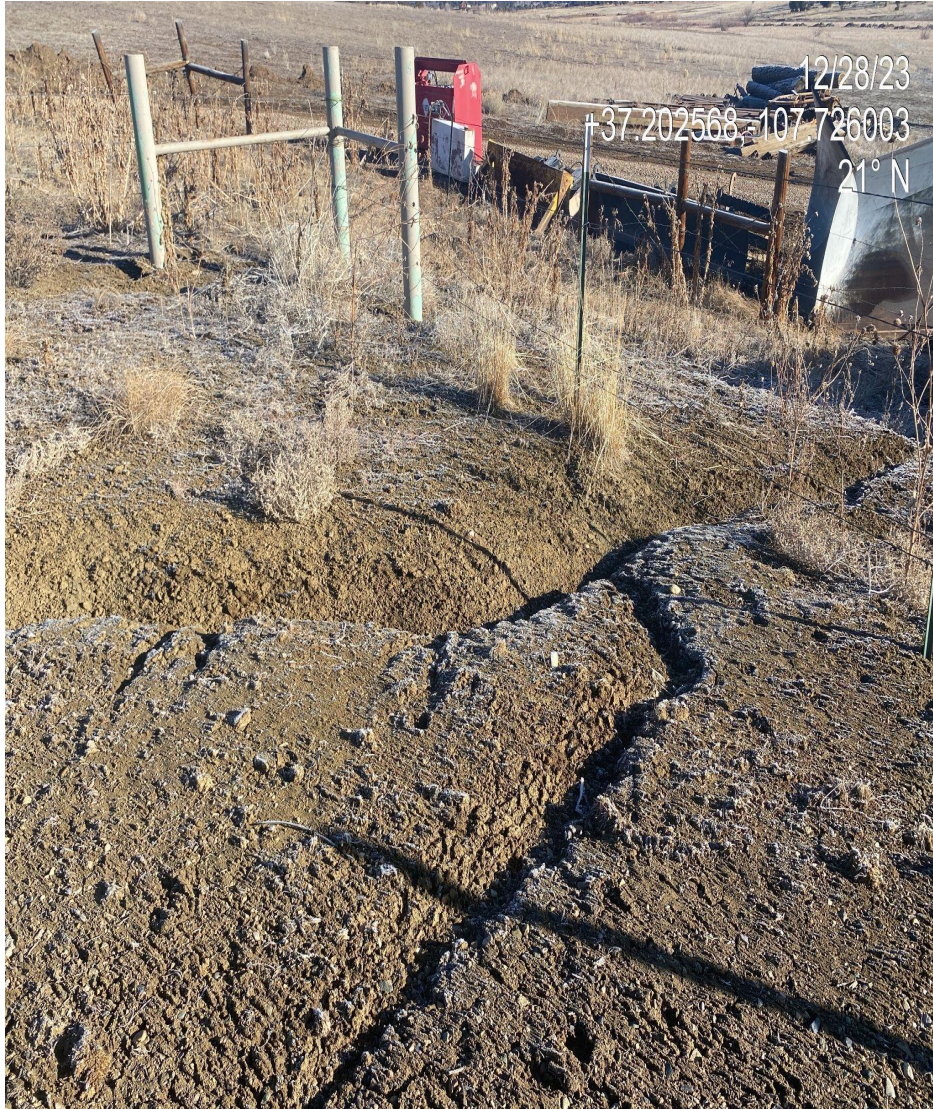
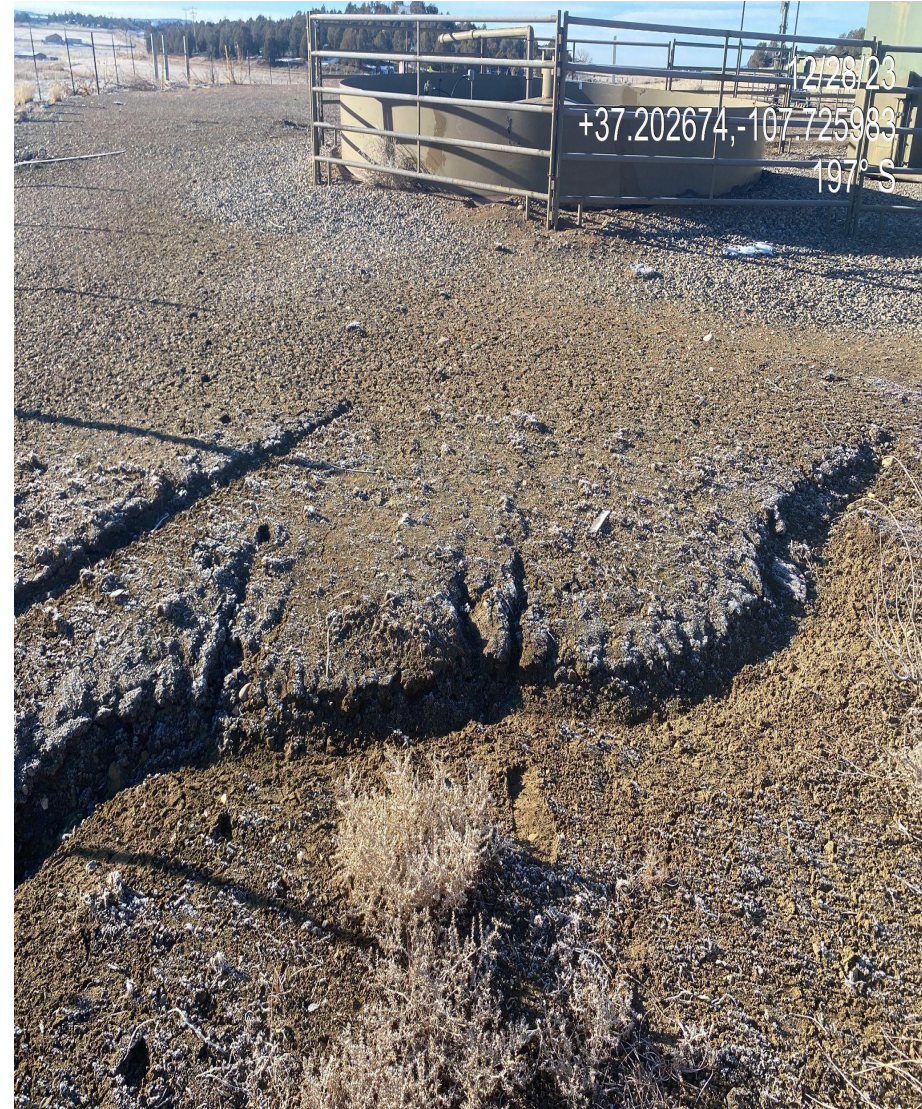
Photo 3. View of additional rill/gully erosion forming on the eastern edge of the disturbance.

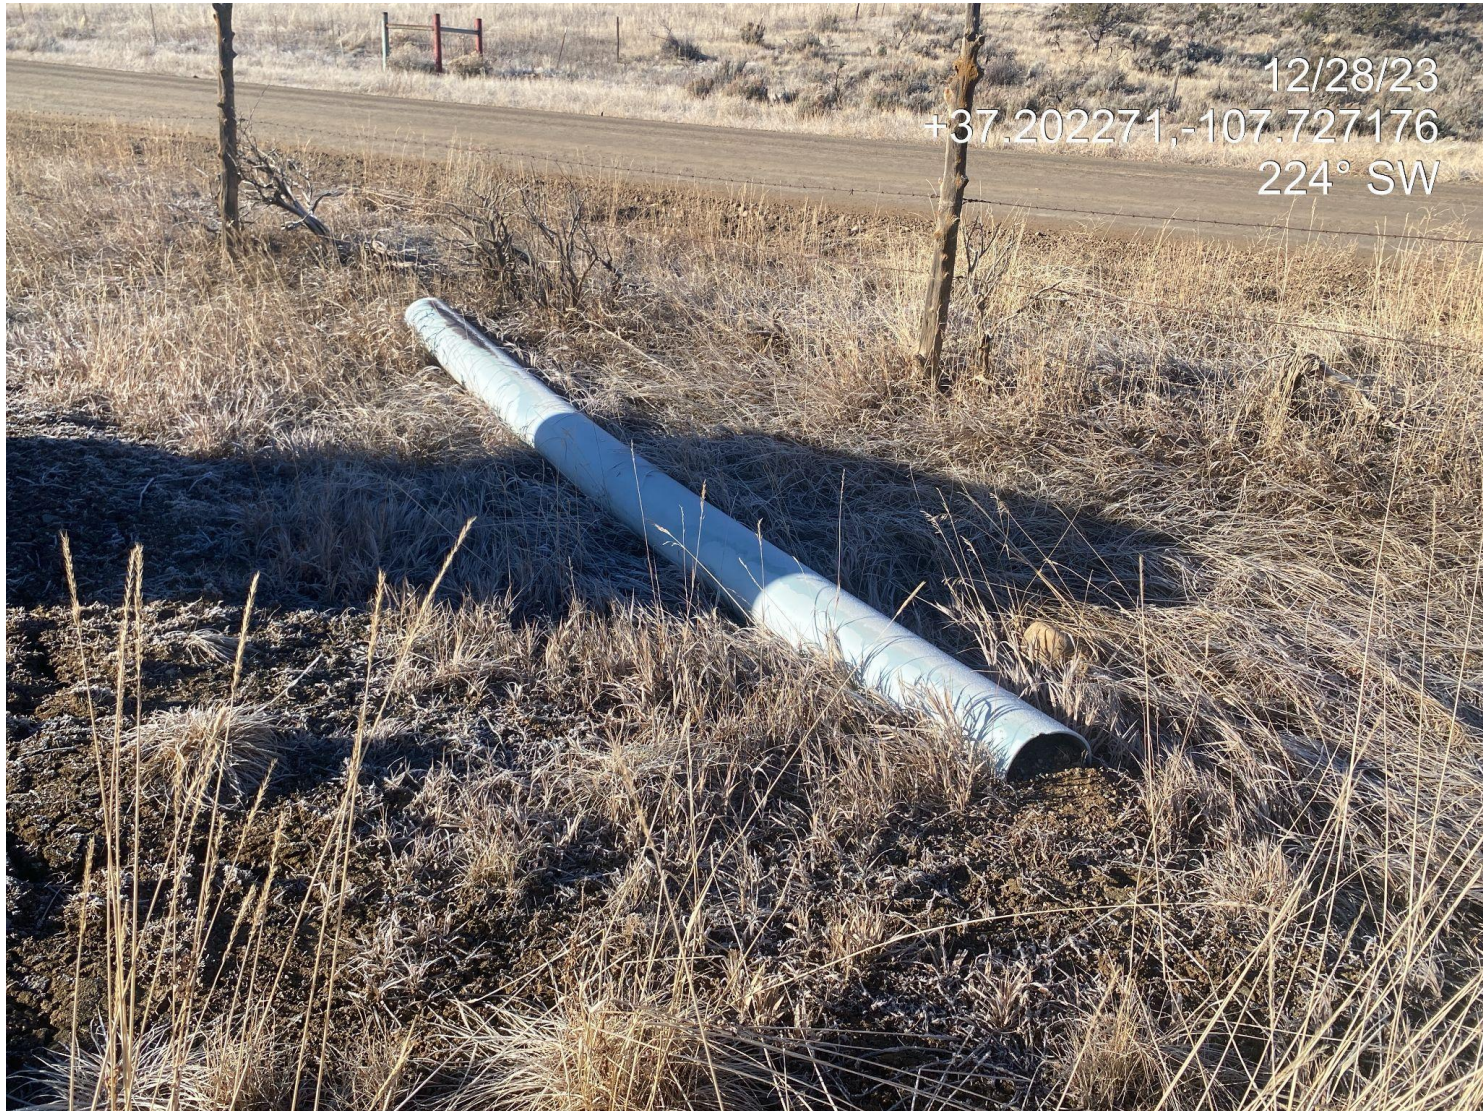
Photo 4. View of unused equipment/debris observed in the western interim reclamation area.

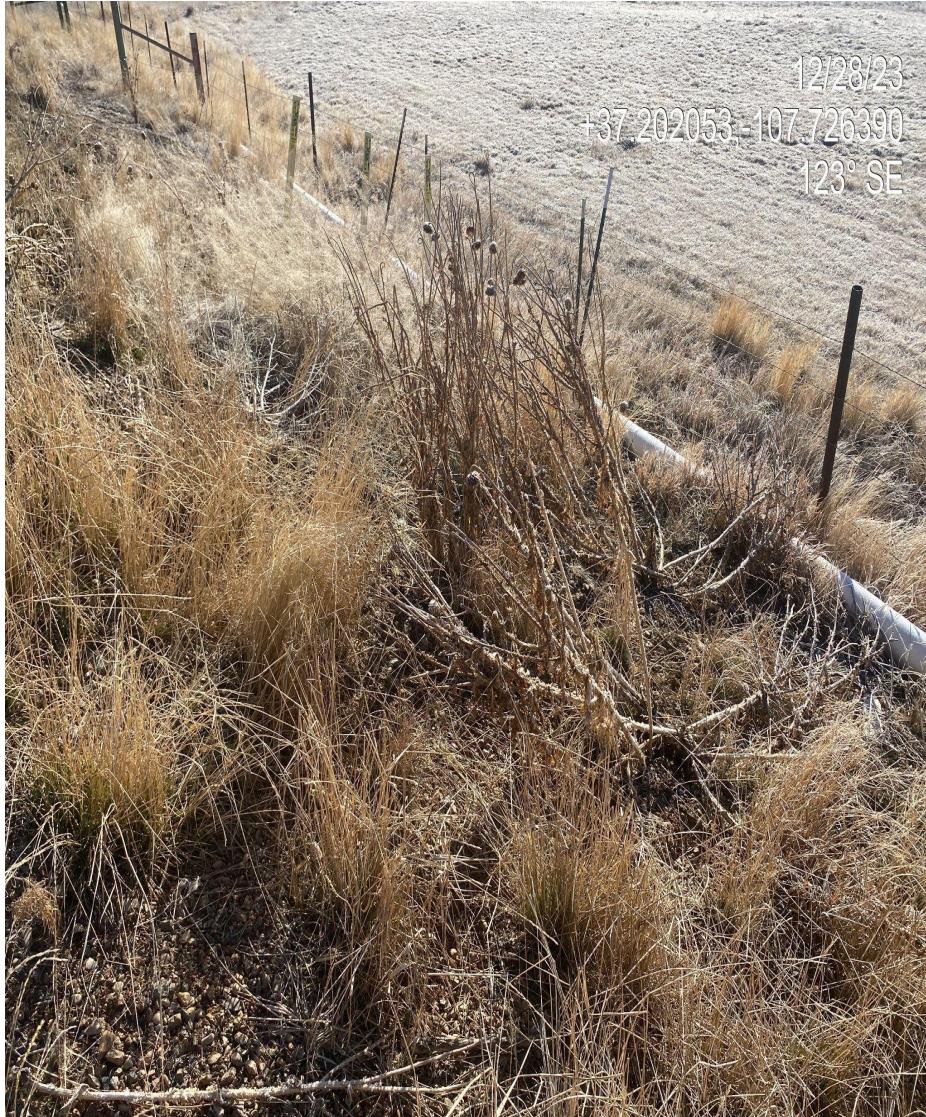
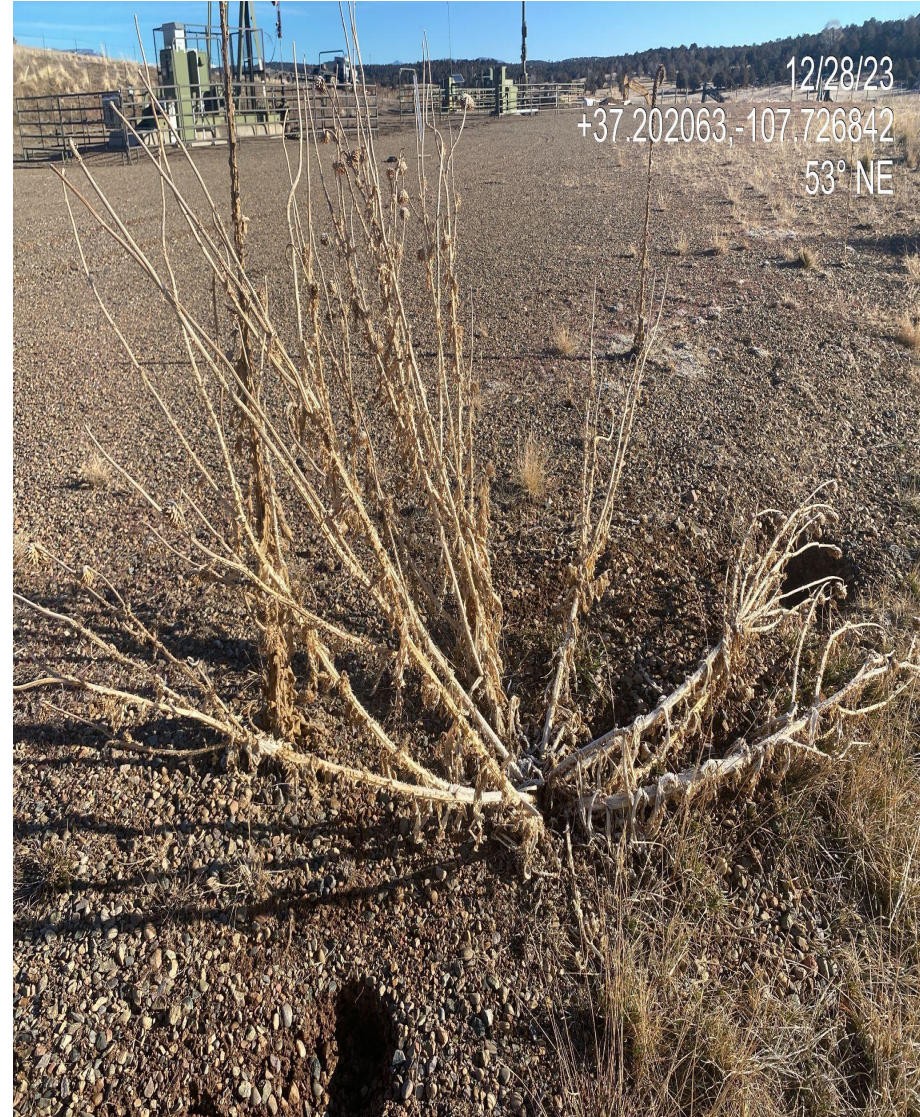
Photo 5. View of musk thistles observed in various locations throughout the disturbance.

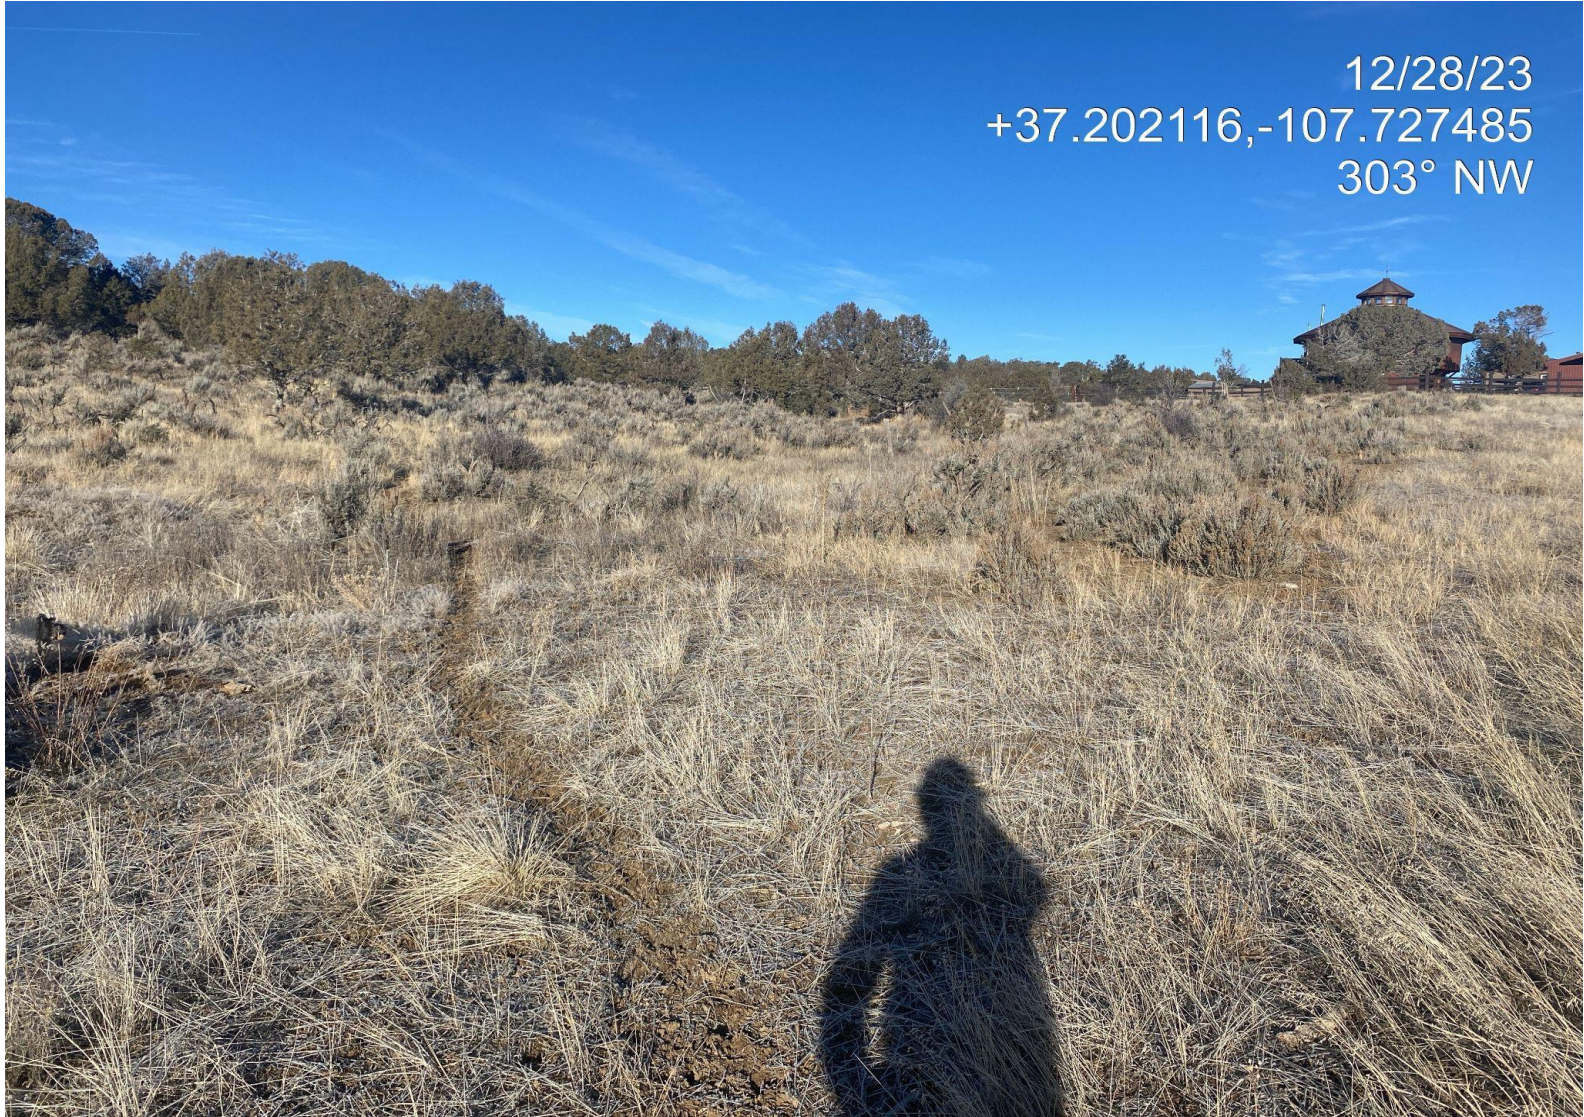
Photo 6. Reference area comprised of western wheatgrass, sagebrush and juniper.
