Inspection Photos

Location Name: CAERUS PICEANCE LLC DAYBREAK FEDERAL 30-6 (PG30) Pad

Location #: 334657

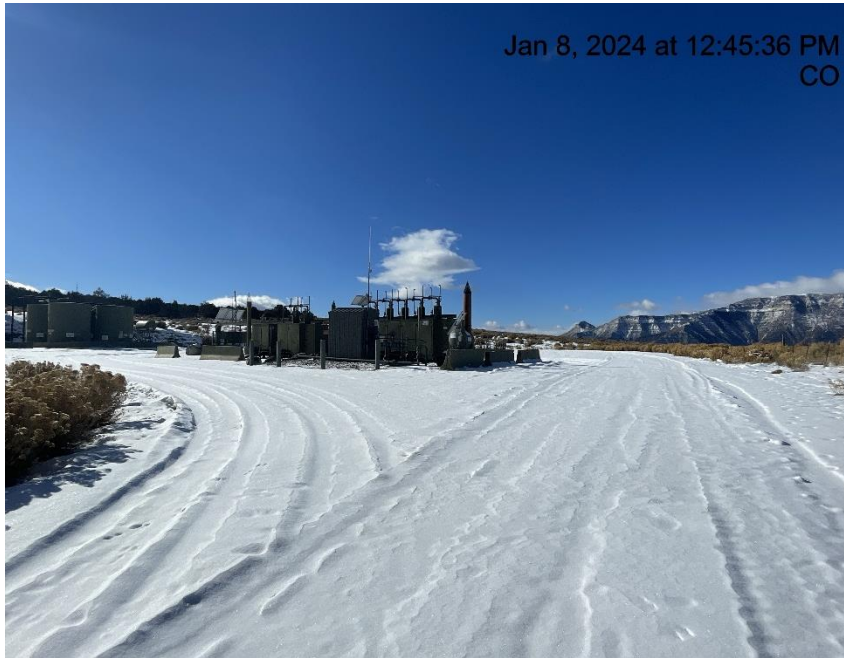
Photo # 2030 From entrance to location

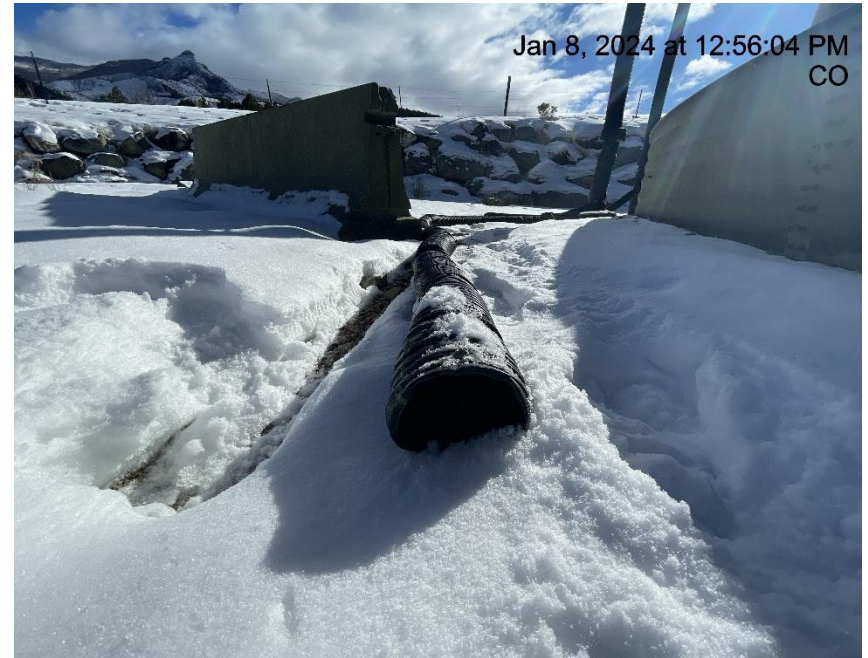
Photo # 2037 Flowline heating insulation open ended

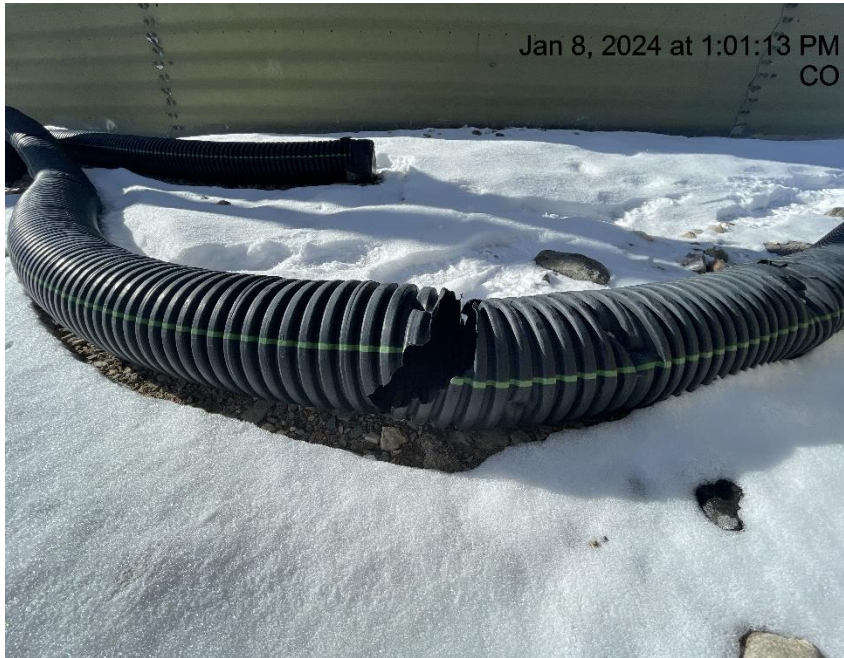
Photo # 2038 Hole in flowline heating insulation/wildlife hazard
