Final Reclamation and Stormwater Inspection

Operator: WESTERN OPERATING COMPANY - 95620

Location ID: 313646

Inspection Photos
Location Name: Sand River #16
Location ID: 313646

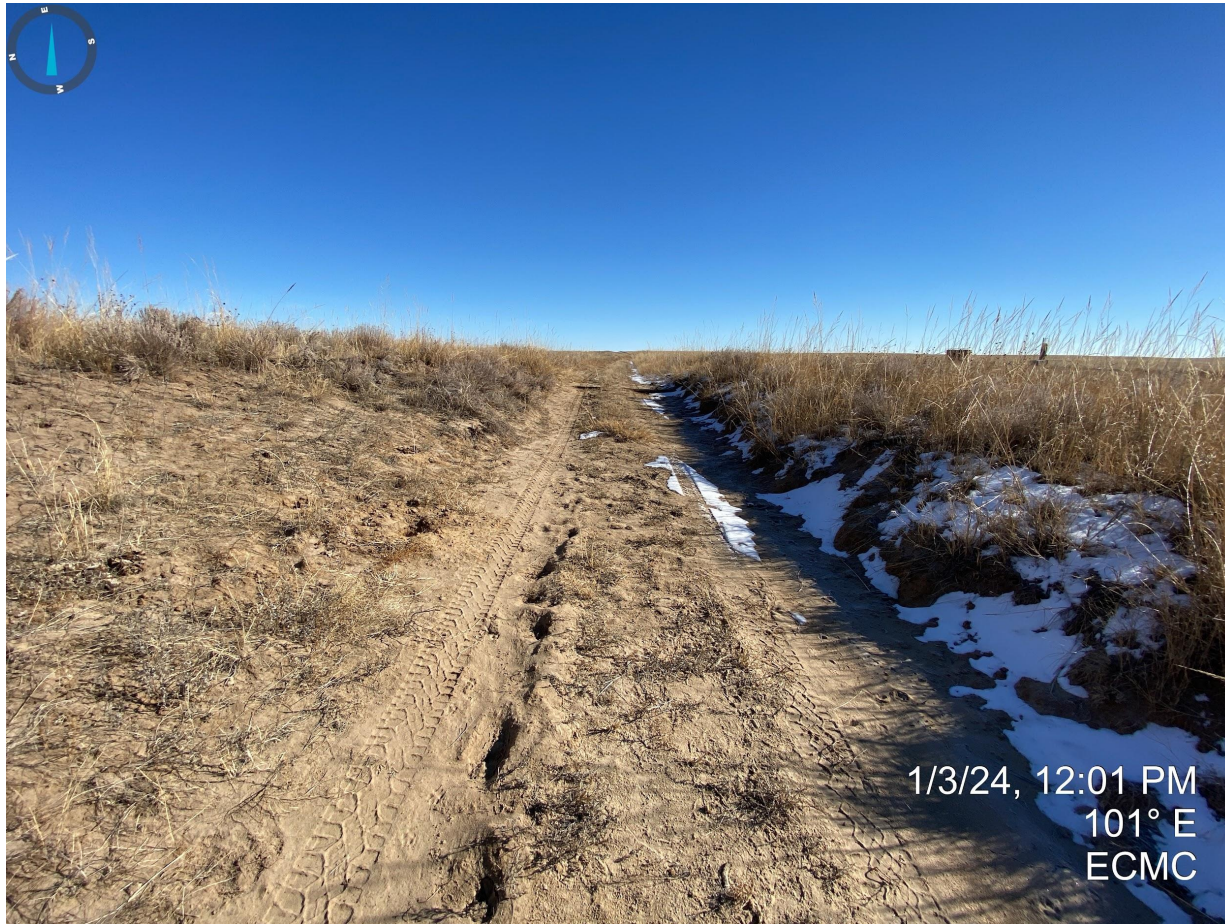
Photo 1. Taken from the eastern portion of the access road, facing east. The access roads do not appear to have been reclaimed as they are not contoured/graded to reflect pre-disturbance/reference area topography. Additional reclamation activities are required.

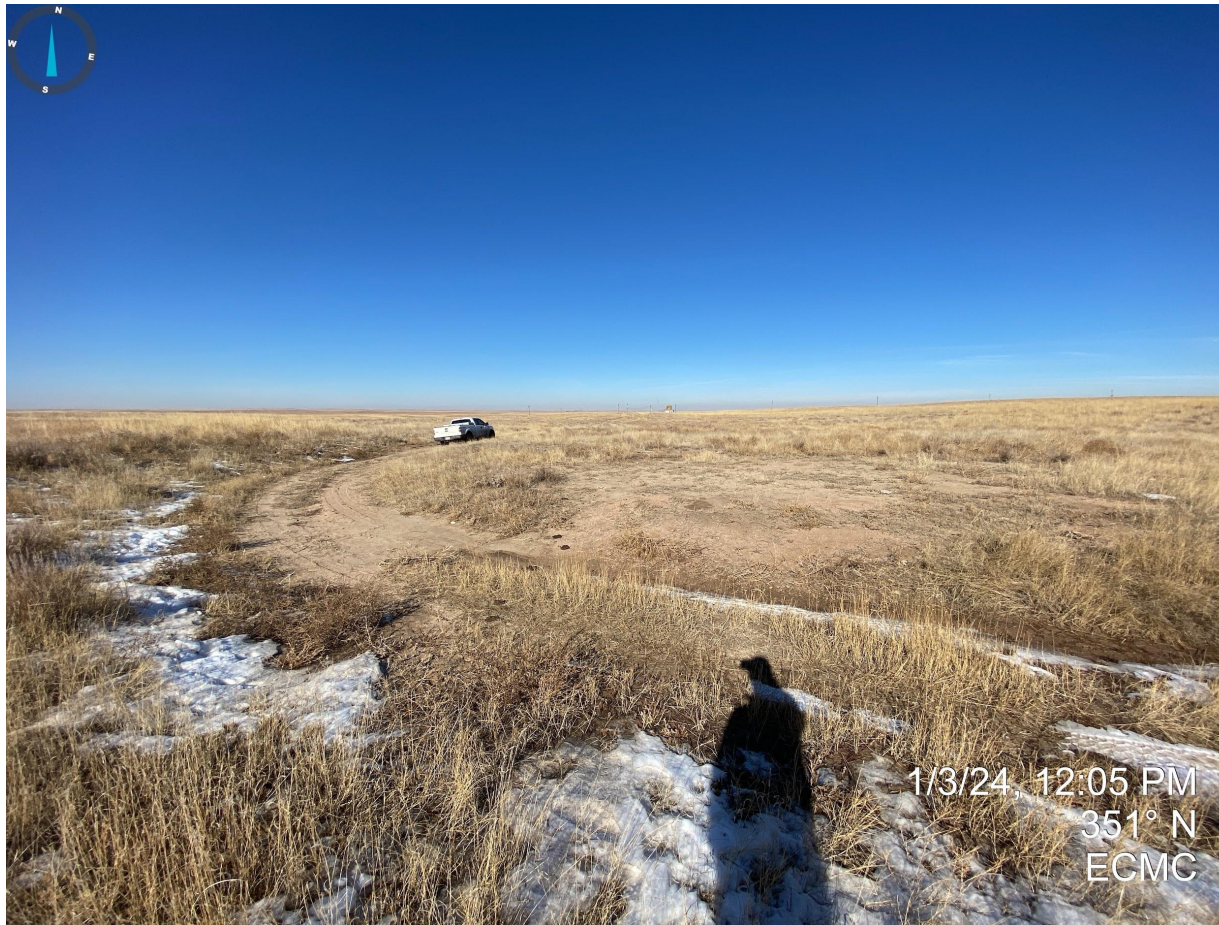
Photo 2. Taken south of the location, facing north. Photo illustrates that the access road and former location have not been regraded or contoured to reflect pre-disturbance conditions.

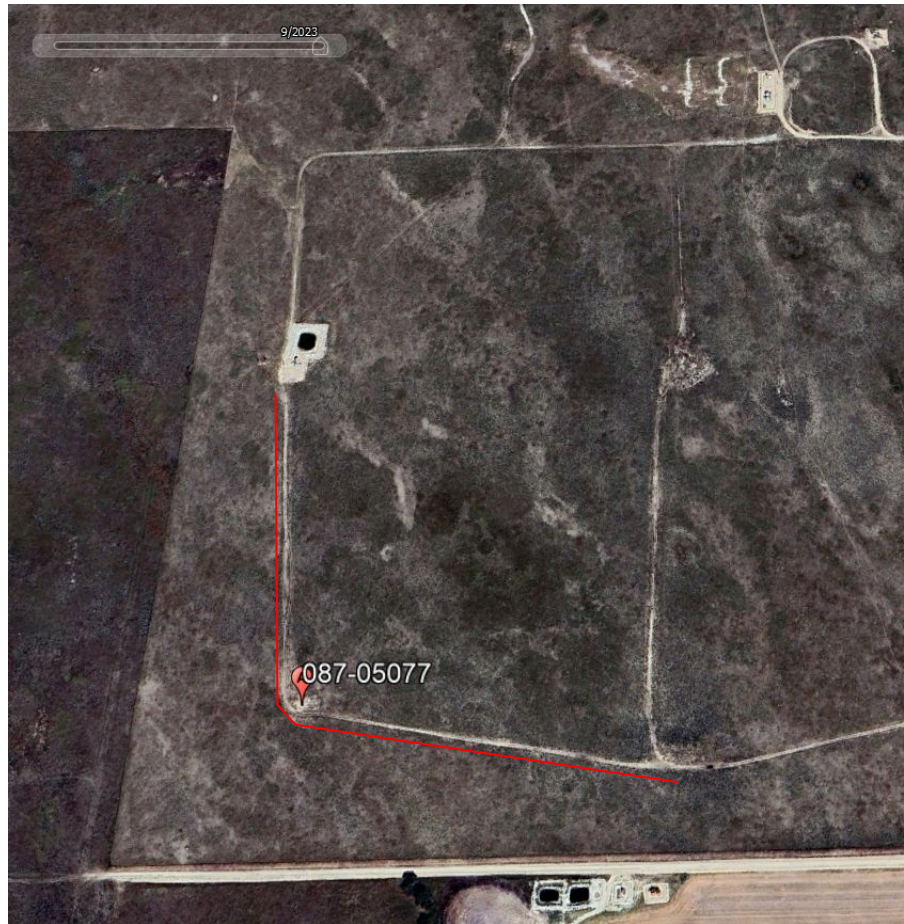
Photo 3. Google Earth aerial imagery taken circa 09/2023. Photo illustrates access roads, highlighted in red, that have not been reclaimed and will require such activities per Rule 1004.

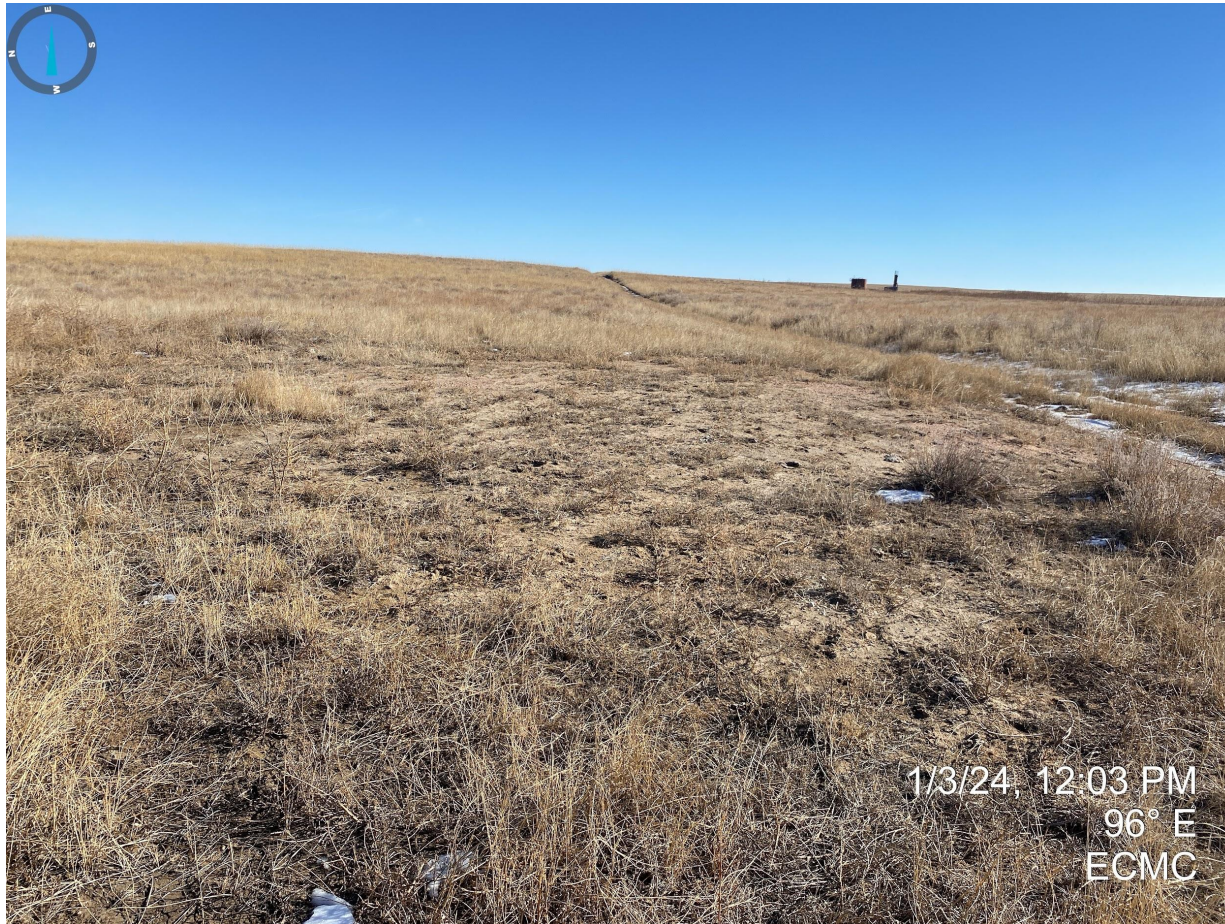
Photo 4. Taken west of the location. The former well location is not progressing towards Rule 1004 standards and regulations as the location is predominantly bare/exposed soils and the access road which has not been reclaimed.

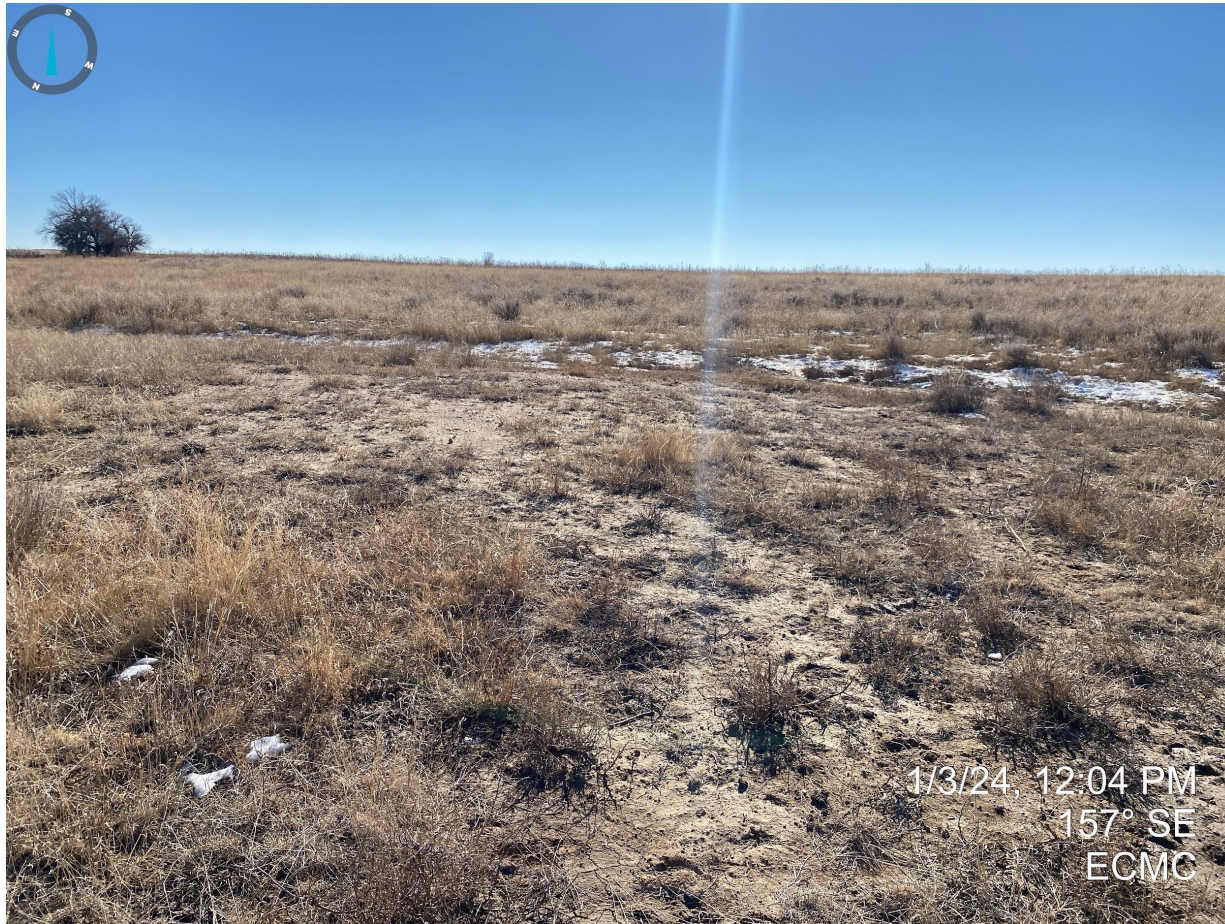
Photo 5. Taken from the northern portion of the former well location; see comments in Photo 4.

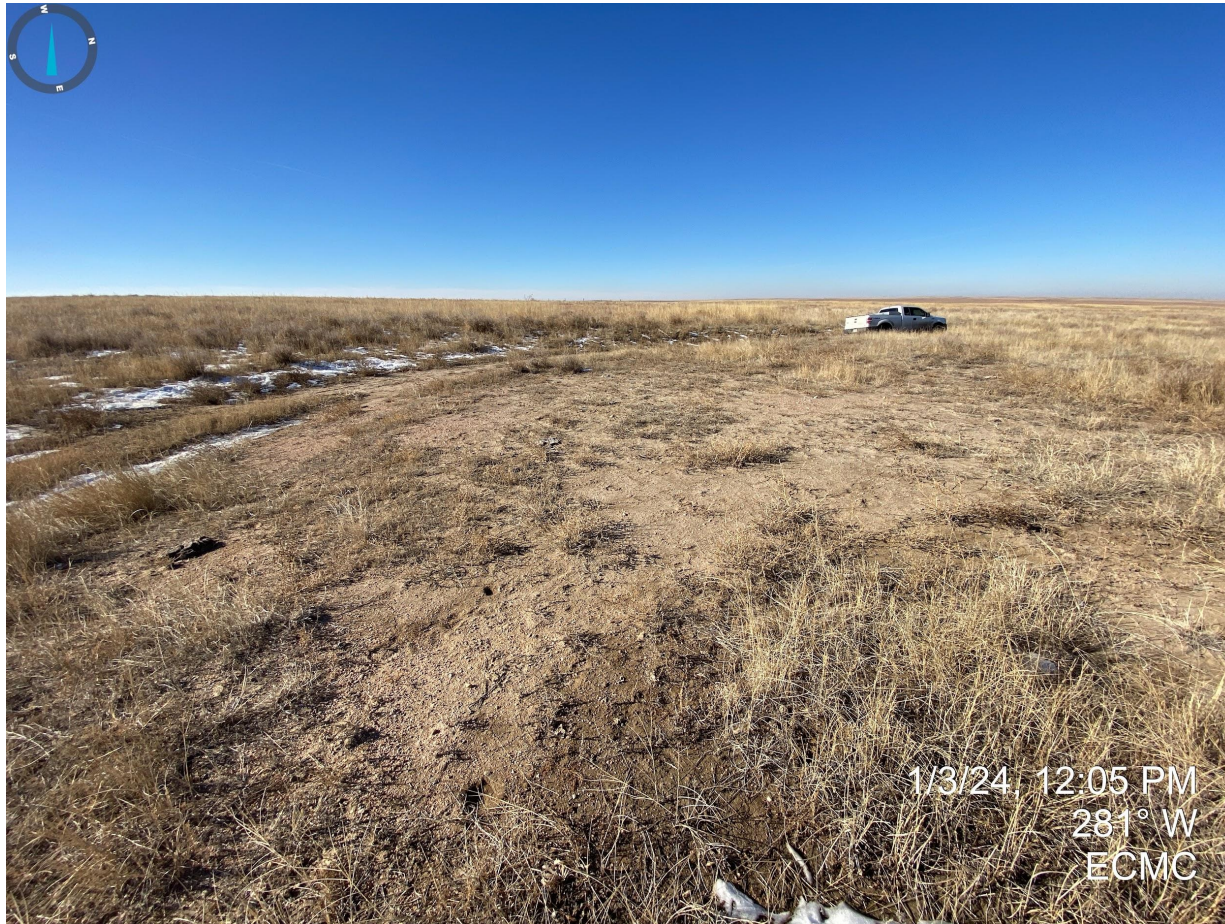
Photo 6. Taken from the eastern portion of the former well location; see comments in Photo 4.
