Interim Reclamation and Stormwater Inspection

Operator: WESTERN OPERATING COMPANY - 95620

Location ID: 393493

Inspection Photos
Location Name: Sand River 61N56W
Location ID: 393493

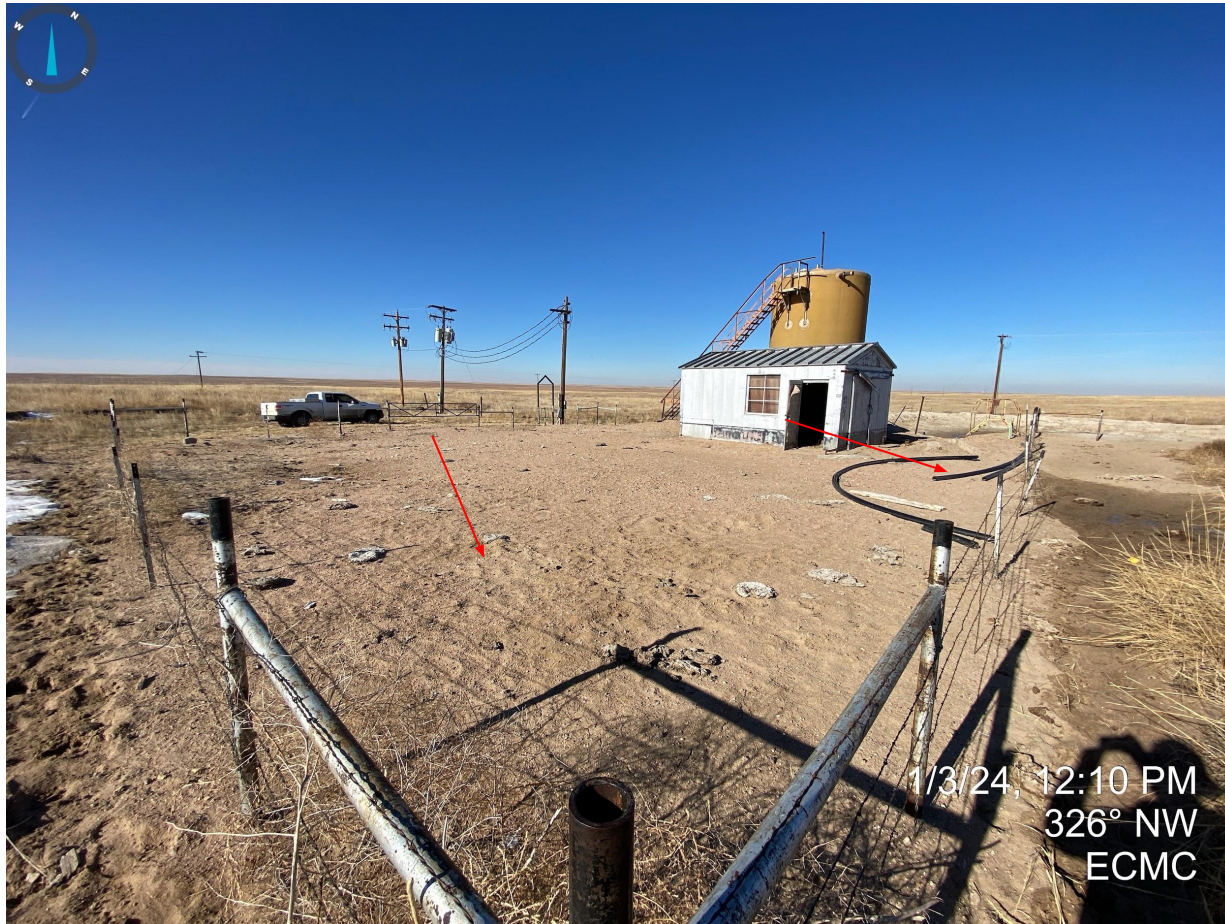
Photo 1. Taken from the southeast corner of the location. Unused equipment and unstabilized production areas pictured.

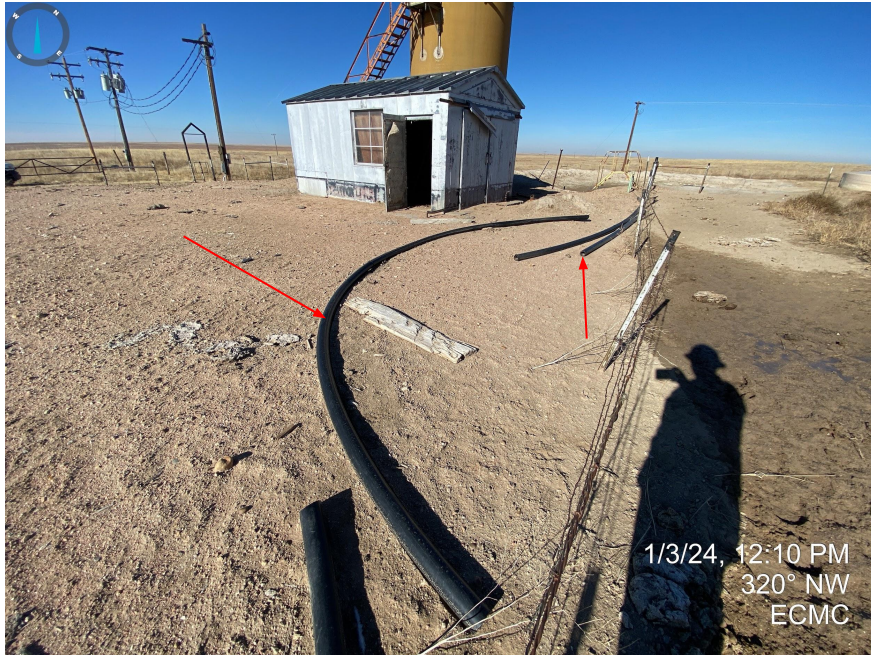
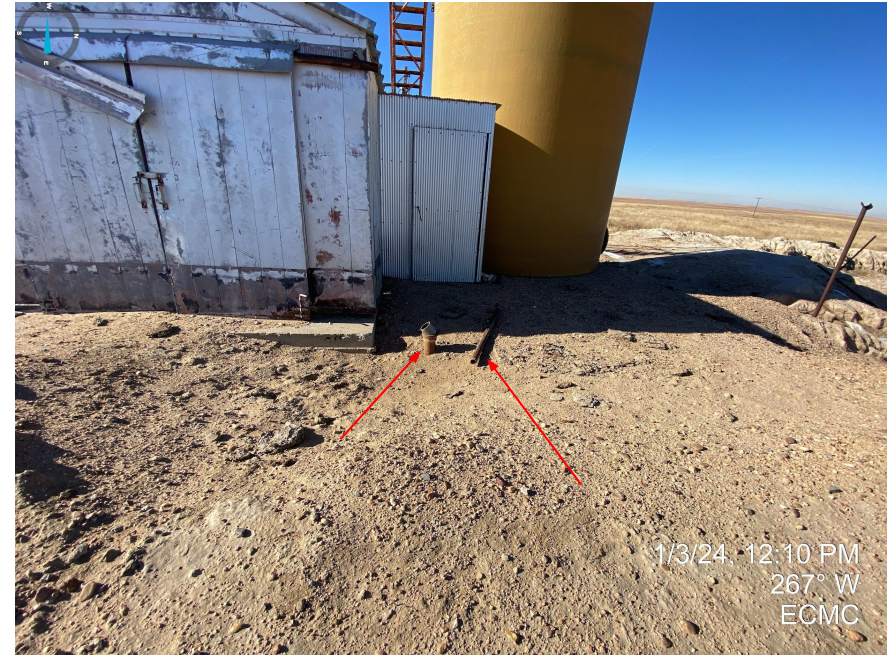
Photos 2 & 3. Unused equipment and debris located next to facility.

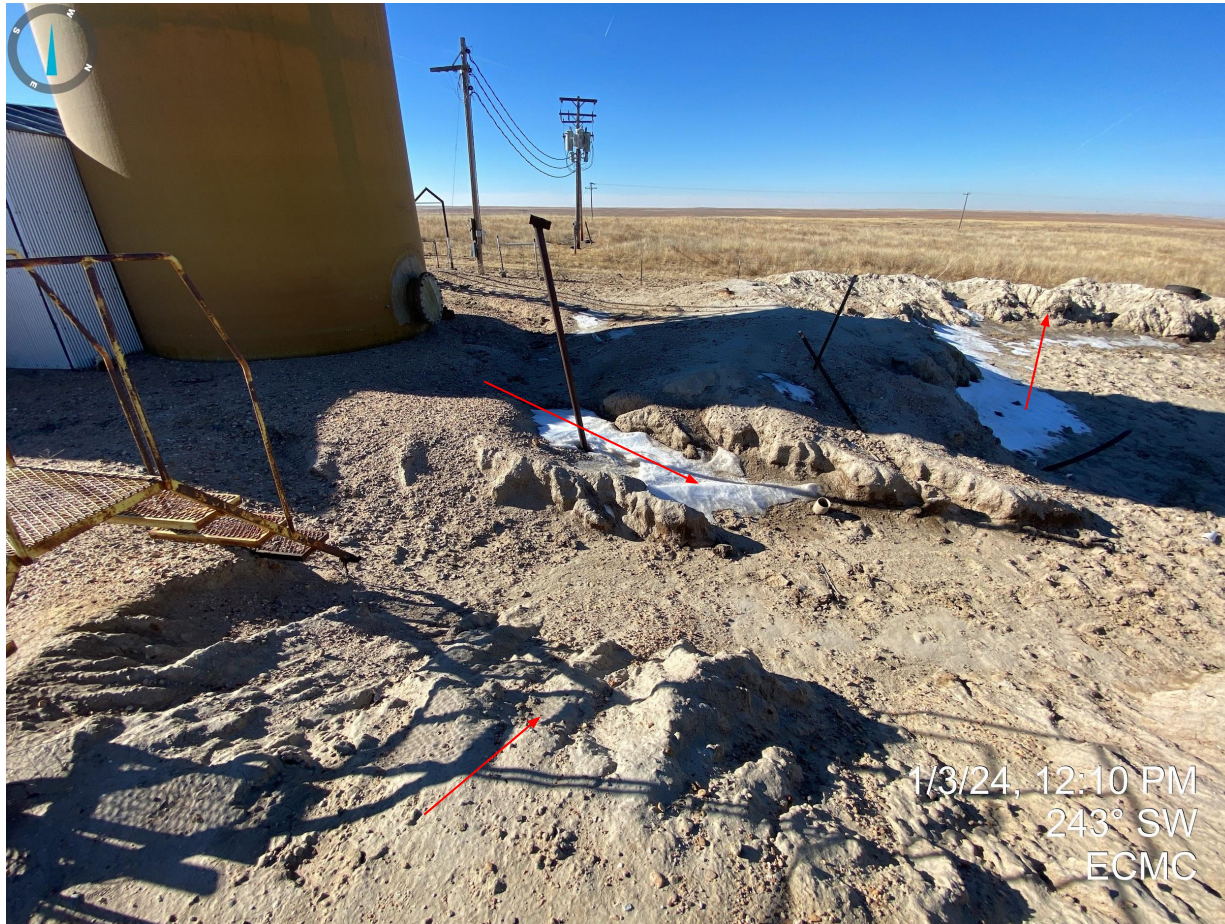
Photo 4. Erosion degradation occurring on pit berms.

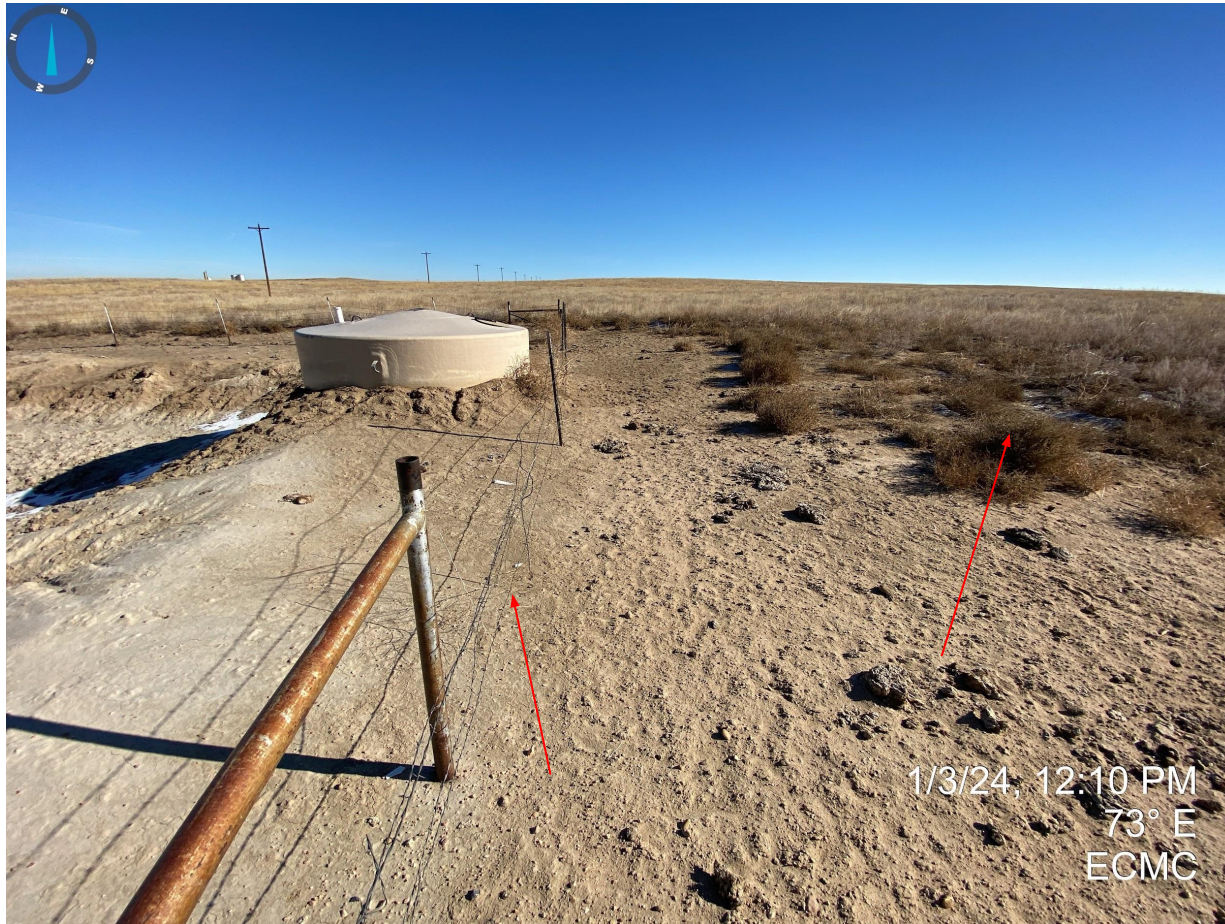
Photo 5. Taken near the southeast corner of the pit. Photo illustrates that there are no apparent stormwater control measures around the perimeter of the location and pit. Also pictured, undesirable vegetation (e.g. russian thistle) that does not appear to have been managed for.

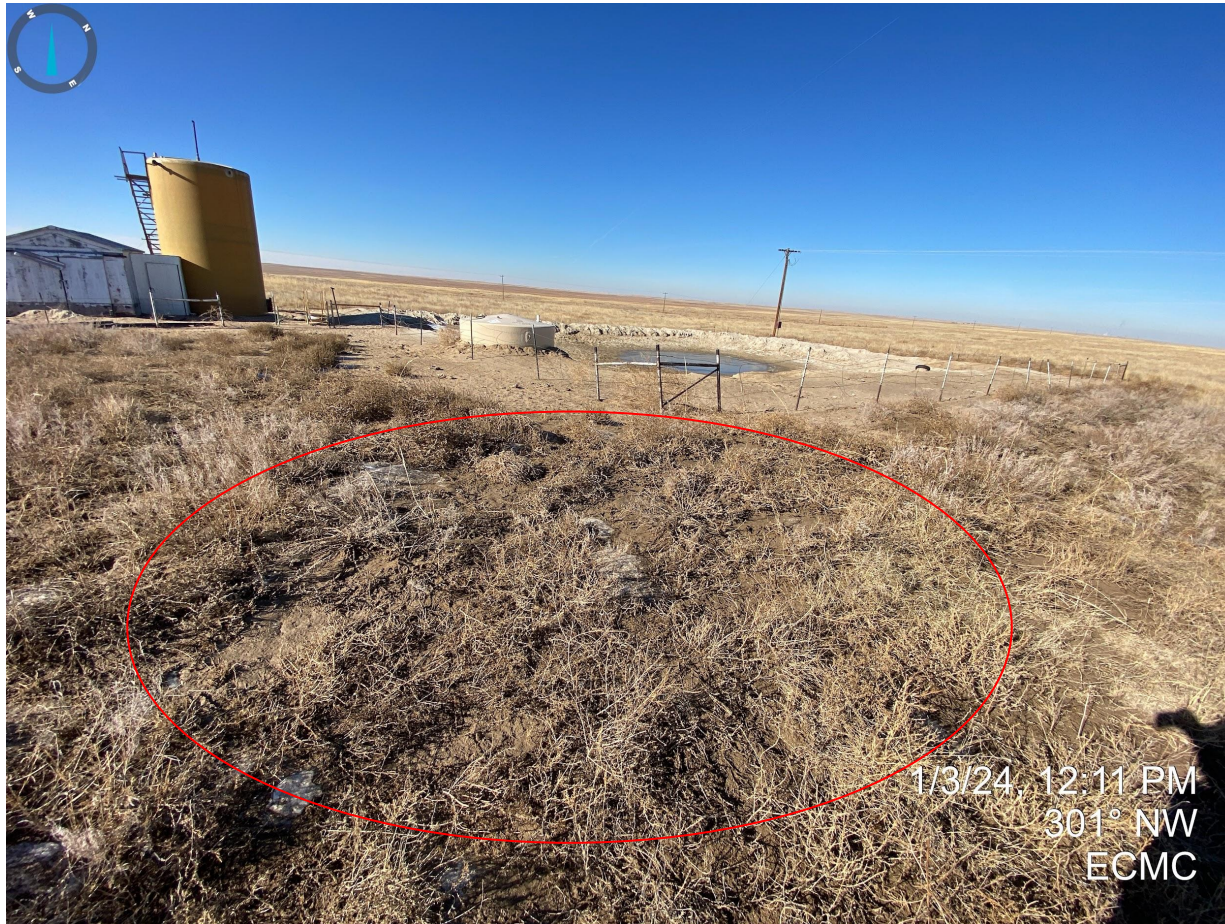
Photo 6. Taken southeast from the pit. Blow sand accumulations were observed southeast of the pit, indicating wind erosion from unstabilized production areas.

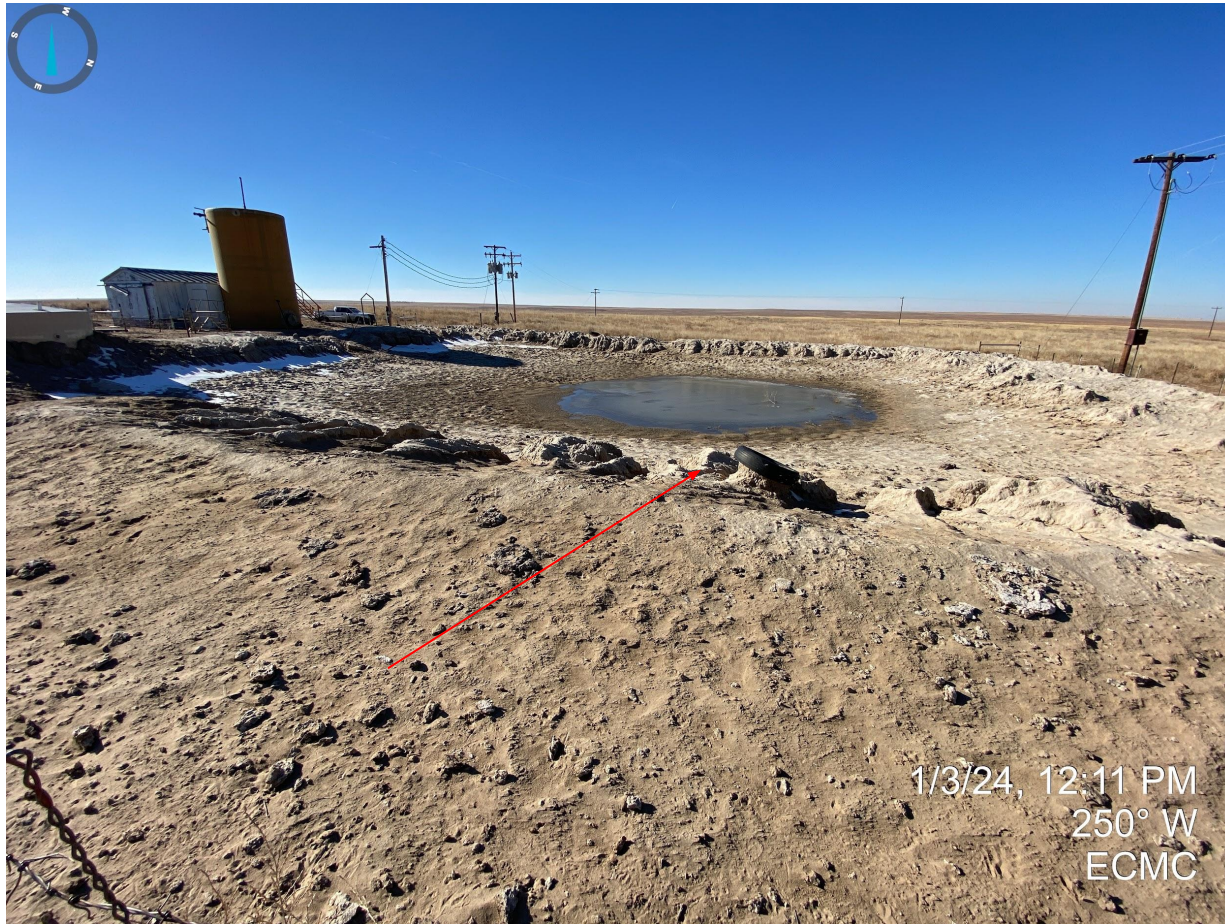
Photo 7. Taken from the east side of the pit. Photo illustrates that pit berms are eroding and the production areas are not properly stabilized.

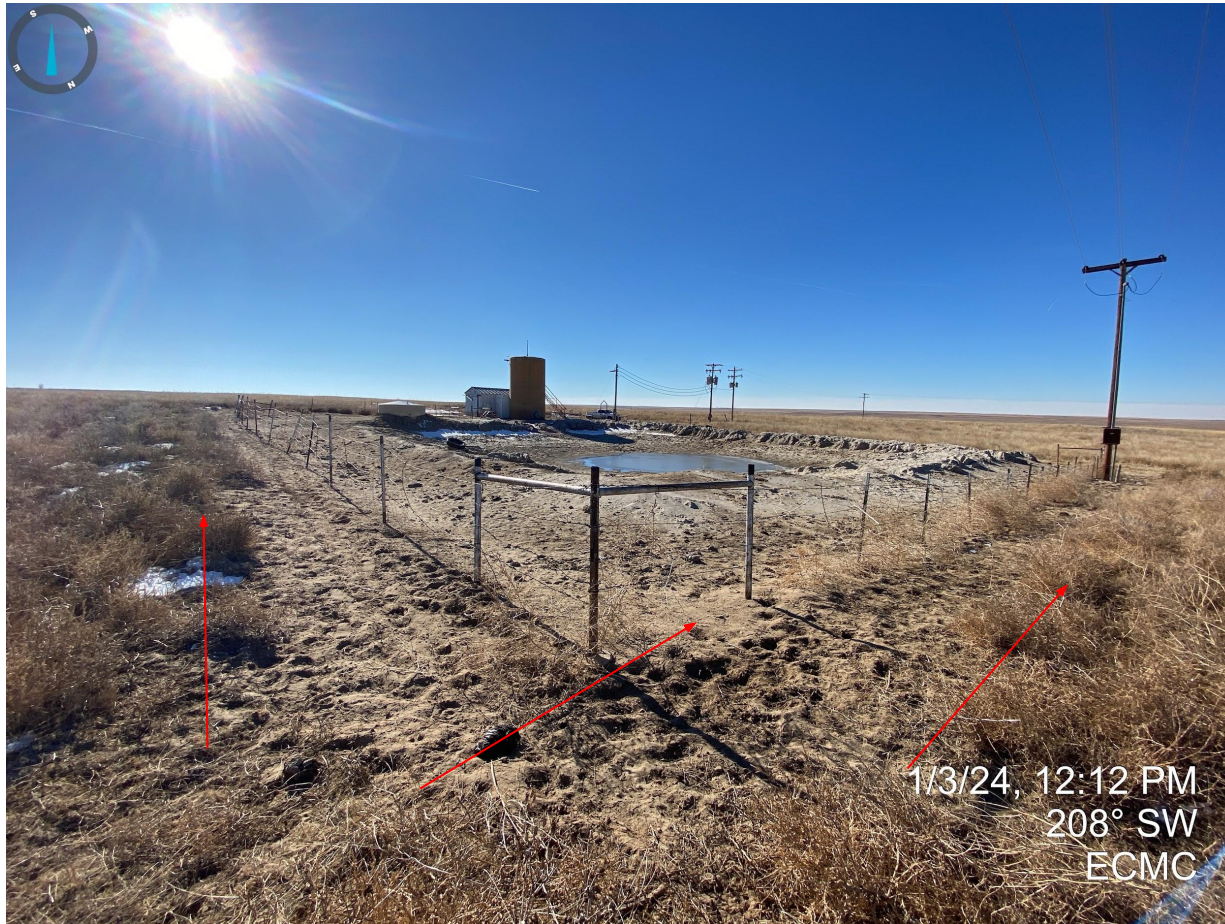
Photo 8. Northeast corner of the pit. No apparent perimeter stormwater controls and undesirable vegetation (e.g. russian thistle) observed.

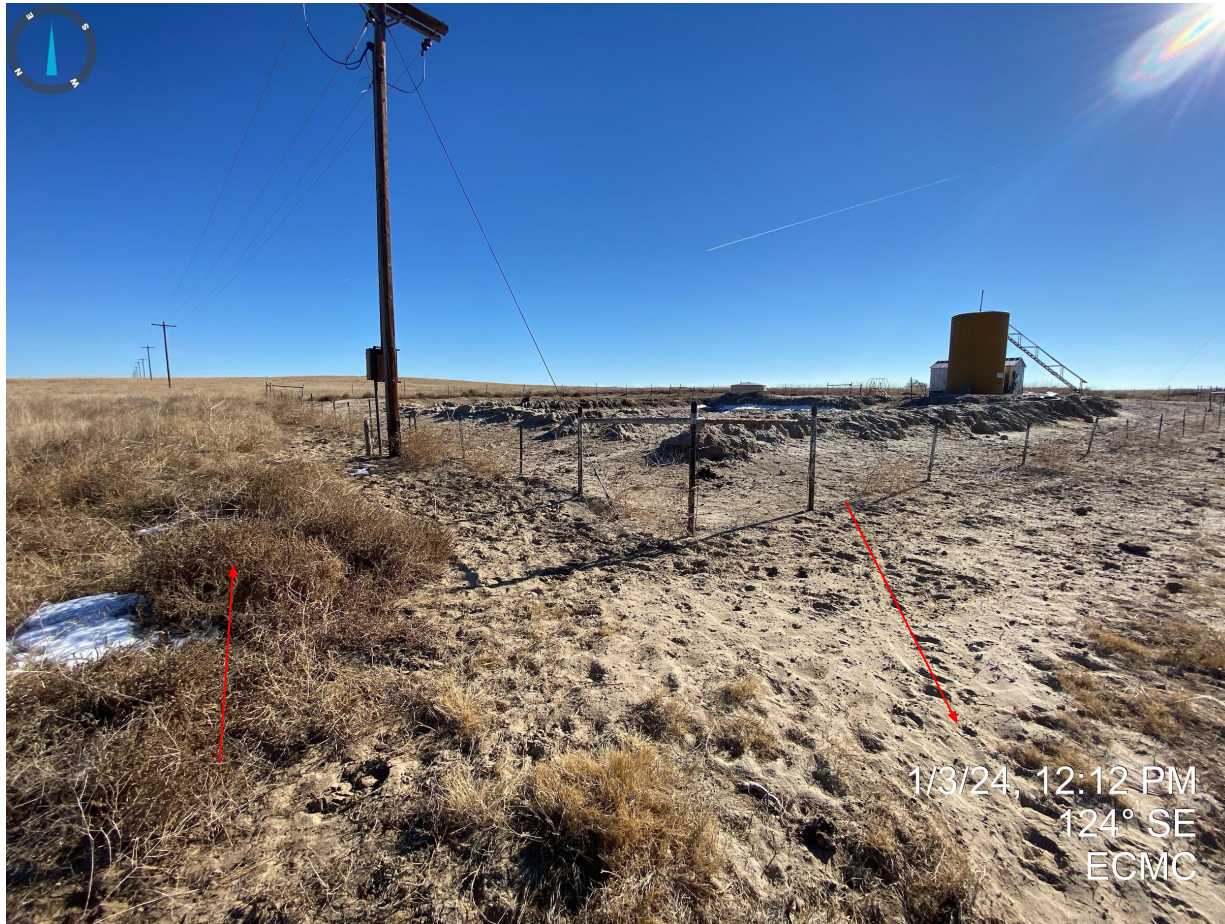
Photo 9. Taken from the northwest corner of the pit. Photo illustrates no apparent stormwater controls that would prevent the sediment transport (pictured by red arrow) from leaving the location. Additional stormwater controls are needed for the location. Also pictured, undesirable vegetation (russian thistle).

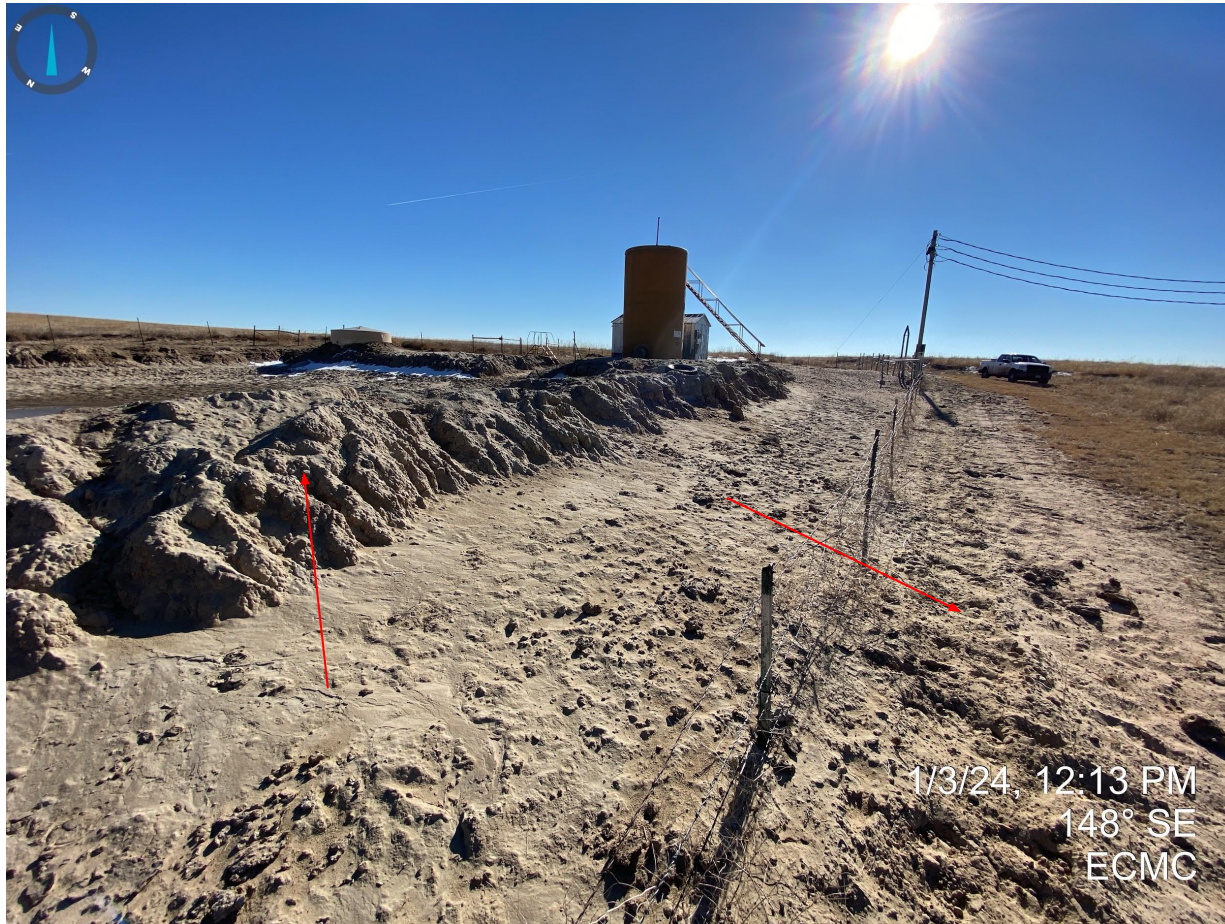
Photo 10. Western side of pit. Pit berms are severely eroded and require maintenance and additional stormwater controls to prevent sediment transport outside of the fenced areas.

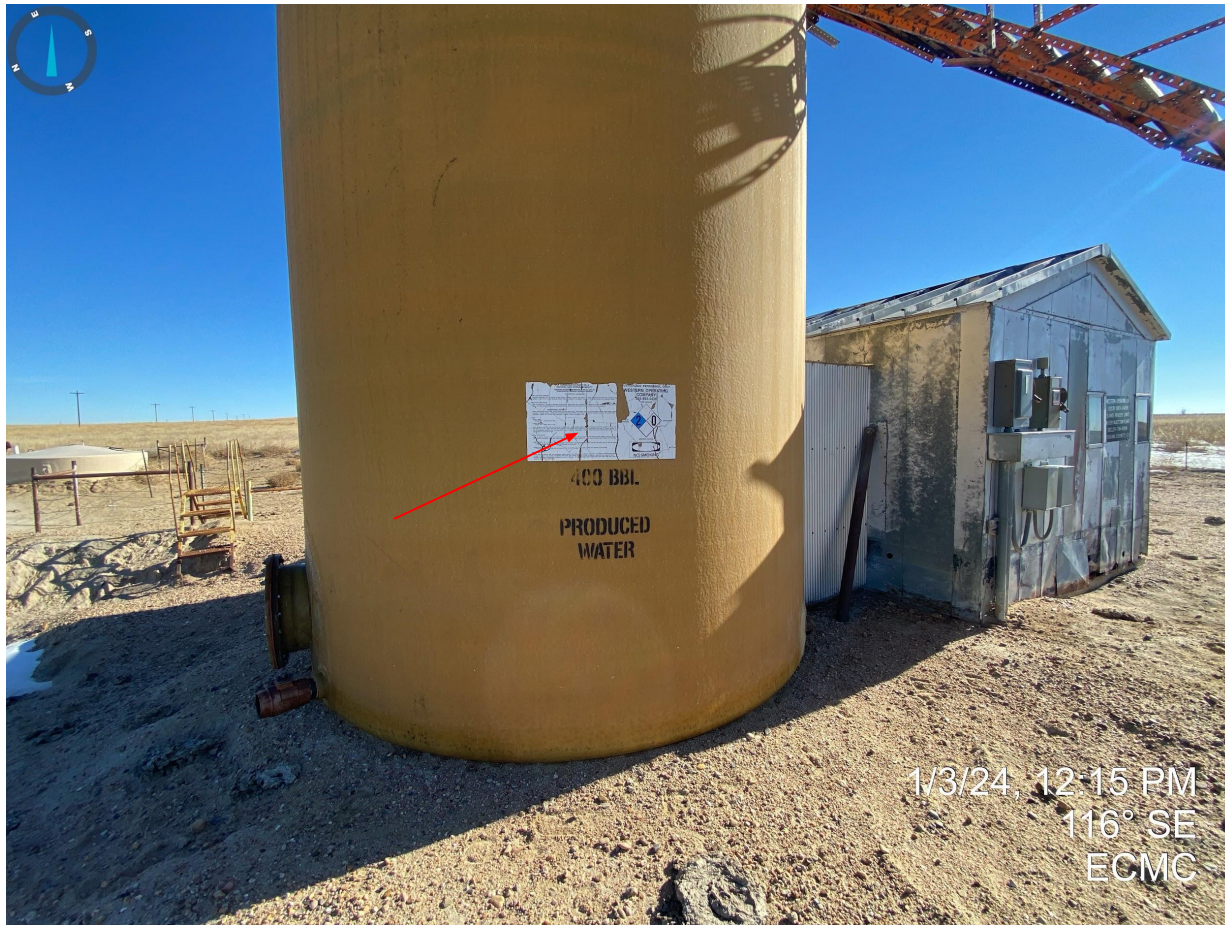
Photo 11. Tank label at produced water tank is not legible.

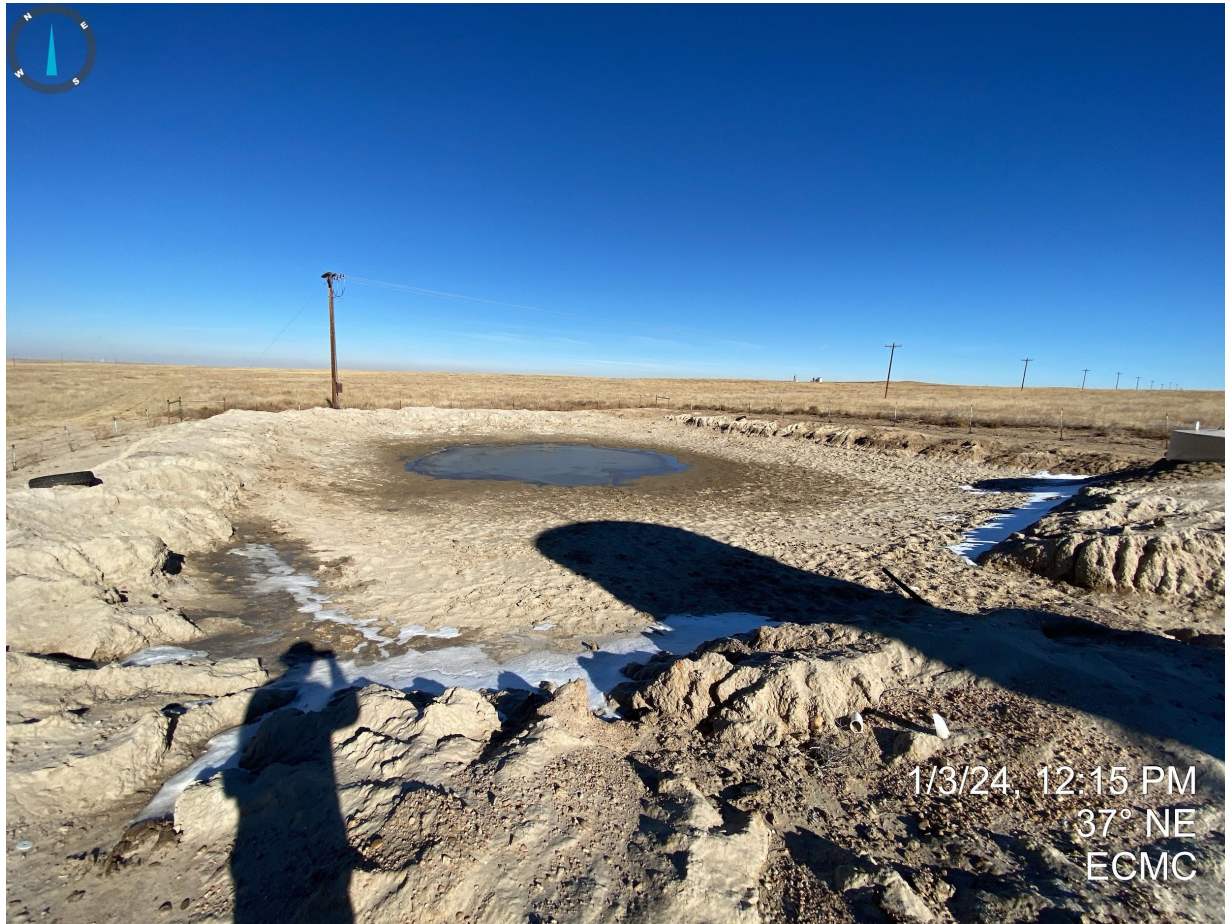
Photo 12. Overview of pit from the southwest corner. The pit is experiencing severe erosion degradation.
