Interim Reclamation and Stormwater Inspection

Date: 01/03/2024

Operator: WESTERN OPERATING COMPANY - 95620

Location ID: 313654

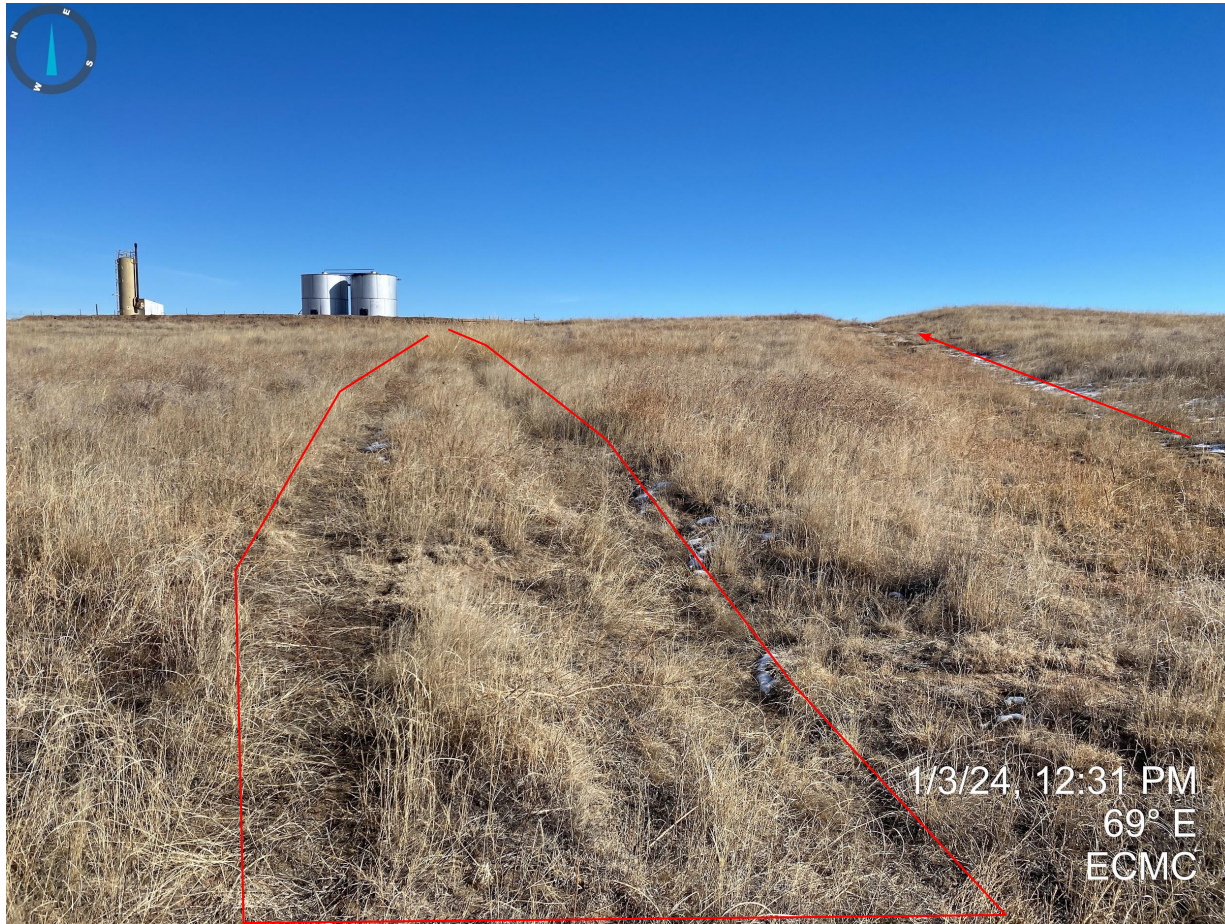
Photo 1. Taken southwest of the tank battery. Photo illustrates vehicle traffic (red polygon) occurring outside of the designated lease road (red arrow).

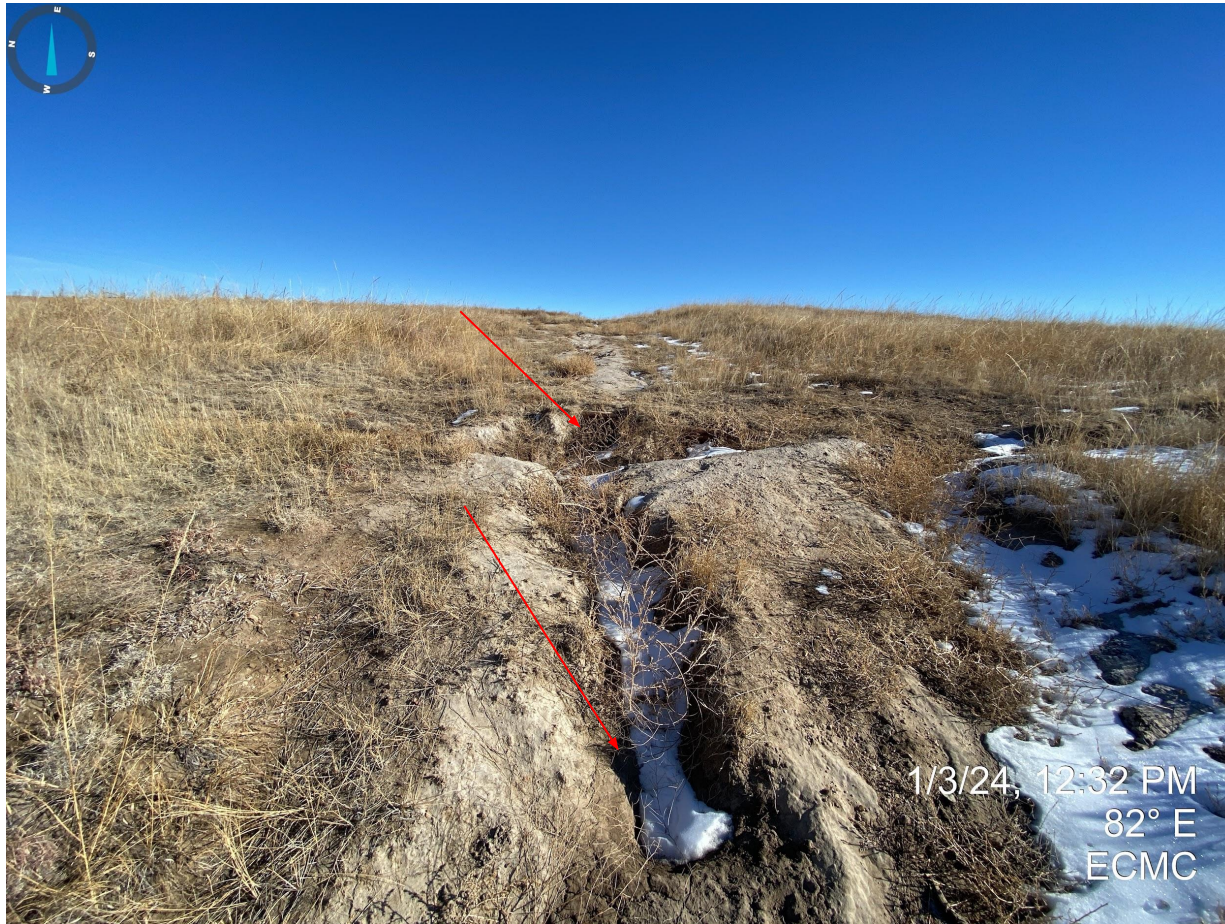
Photo 2. Taken from the access road, south of the tank battery. Erosion degradation (e.g. gullying) is occurring on the road and no apparent stormwater control measures were observed that might otherwise prevent further site degradation.

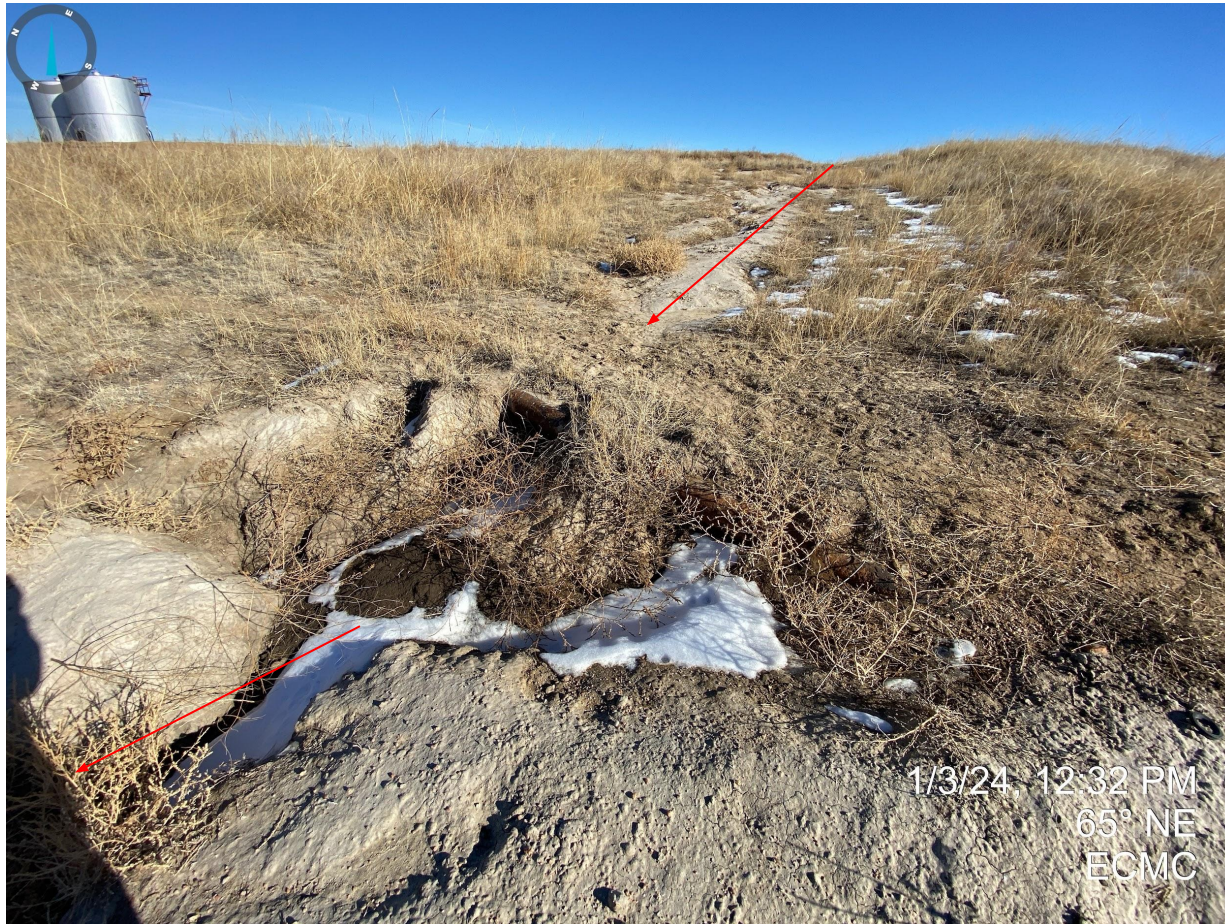
Photo 3. Close up of gully erosion; See comments in Photo 2.

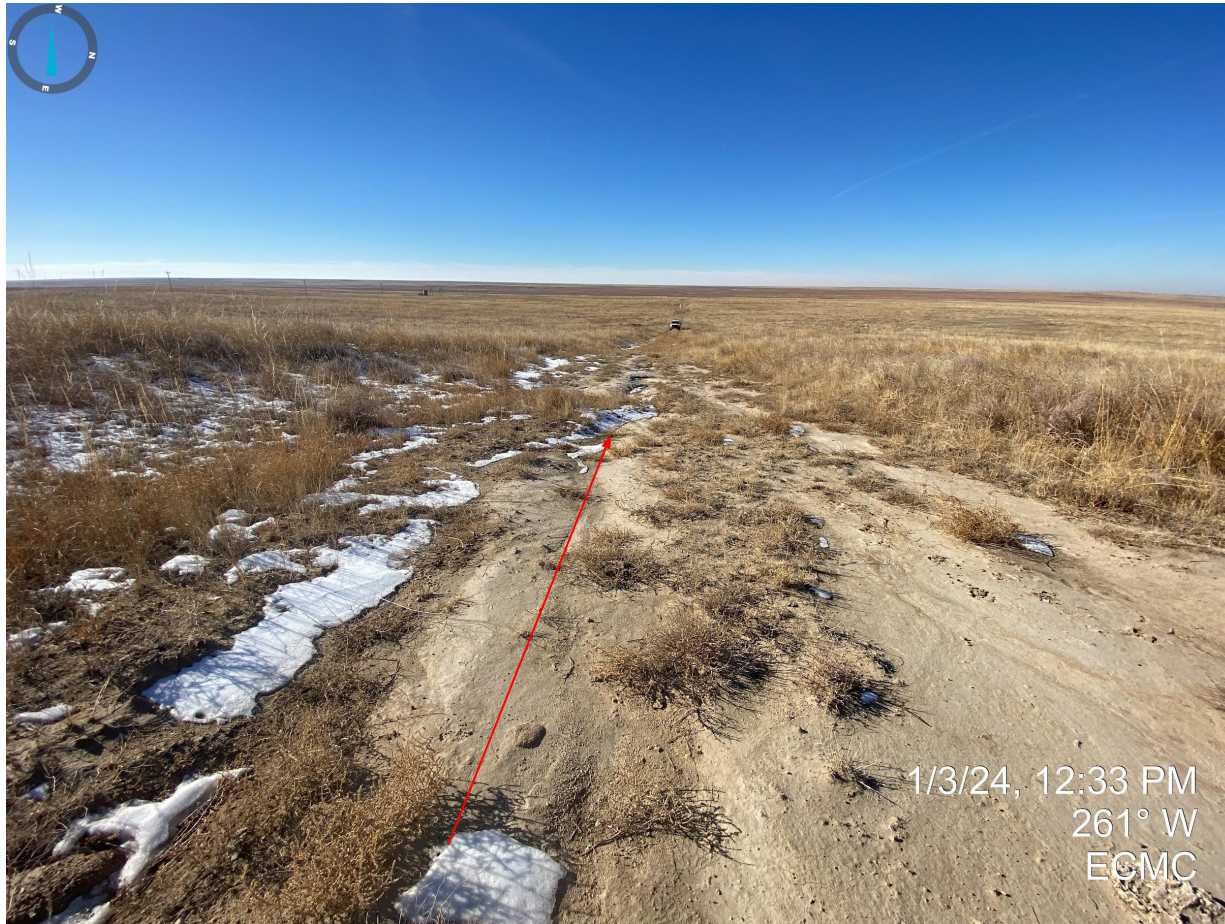
Photo 4. Taken from the access road, directly south of the tank battery. See comments in Photo 2.

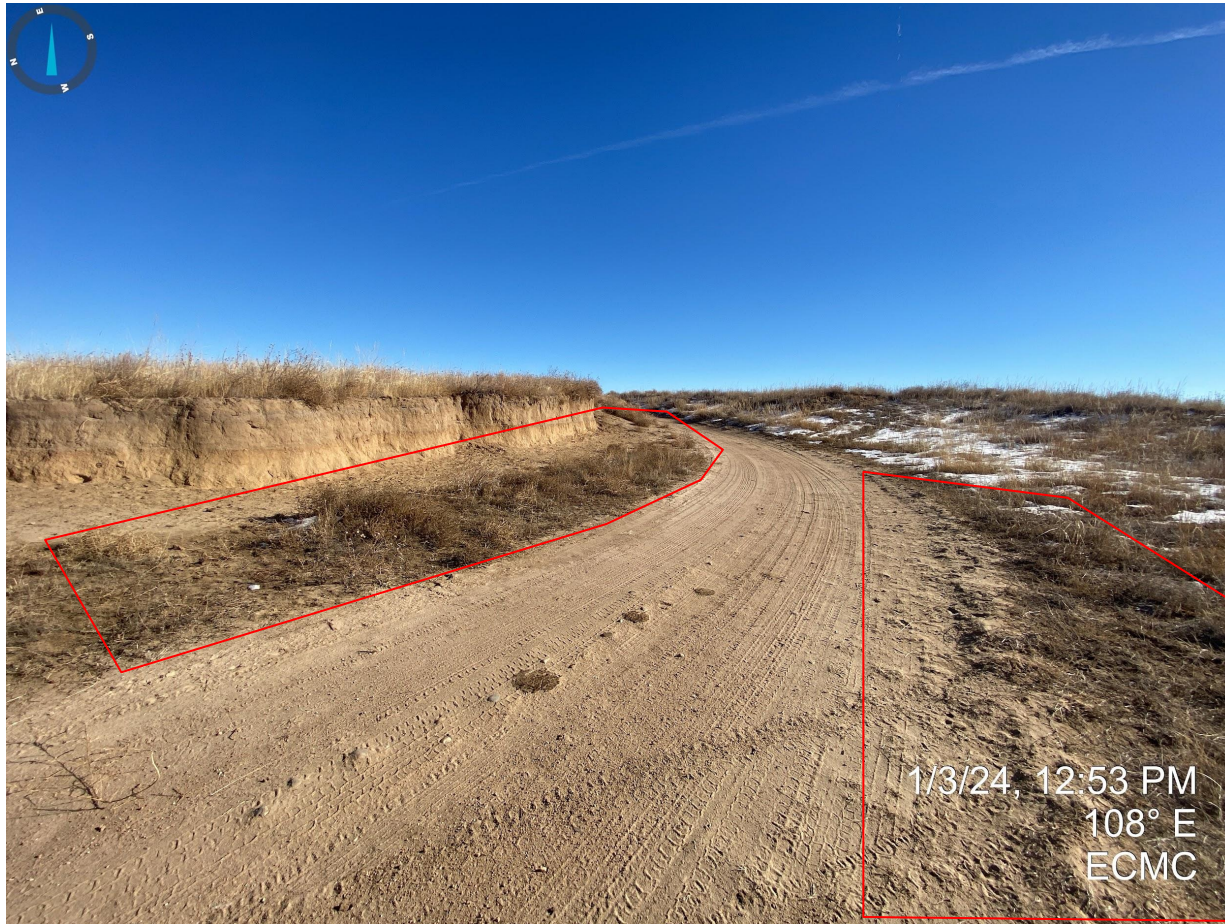
Photo 5. Undesirable vegetation (e.g. russian thistle) observed along the access road.

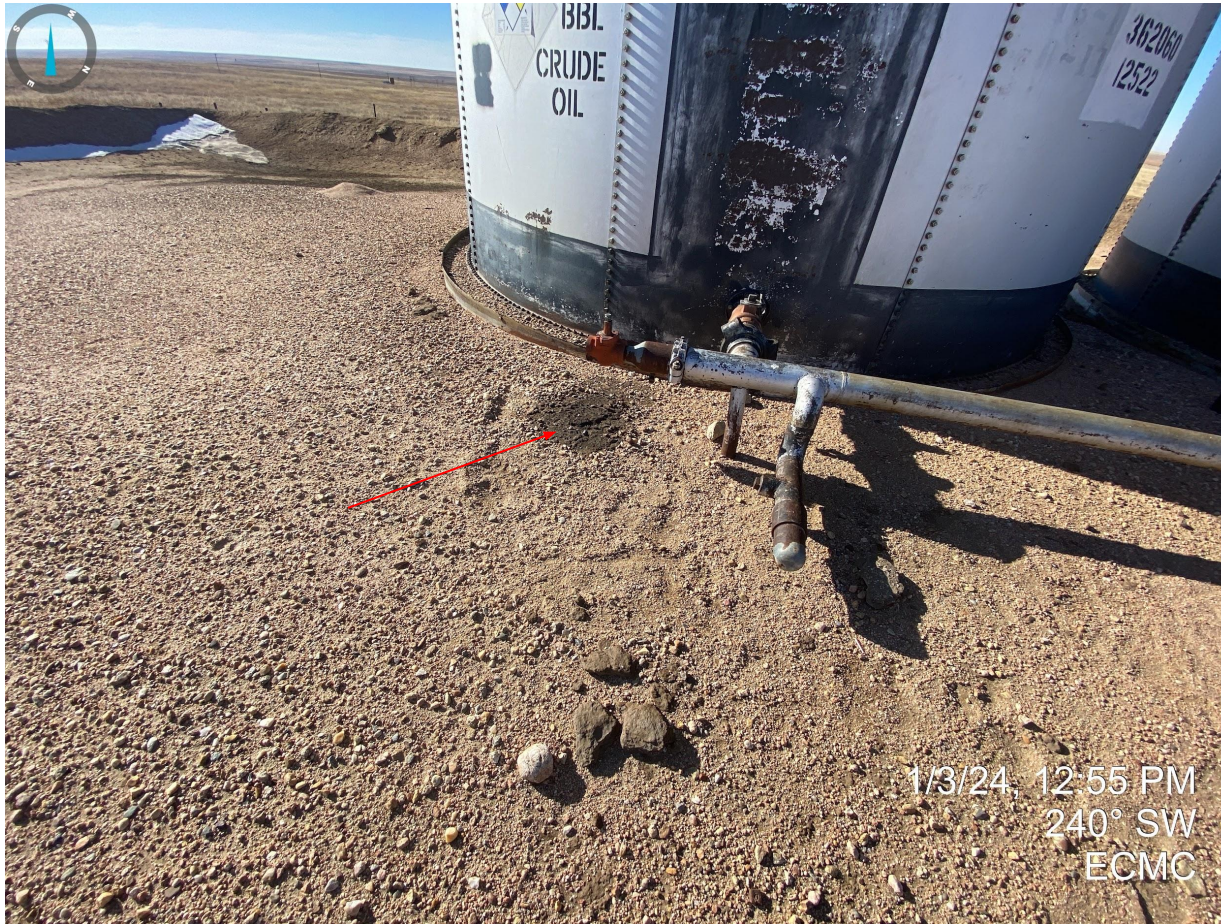
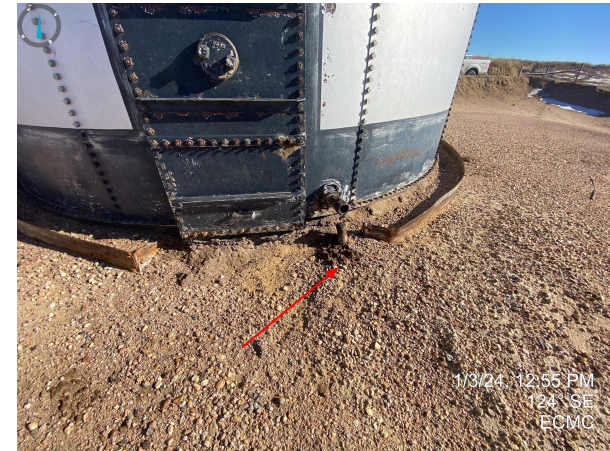
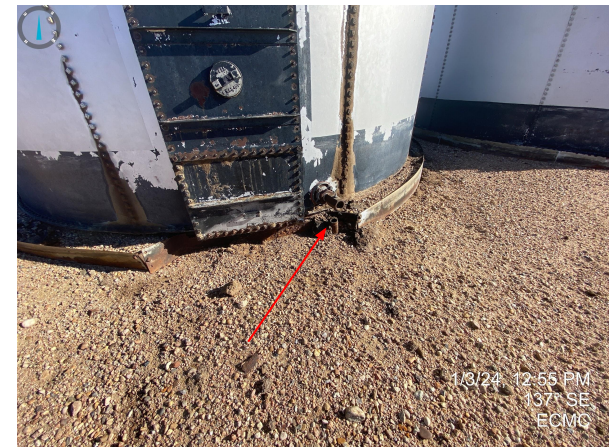
Photo 6. Stained soil observed near the connection/loadout lines at the tank battery.

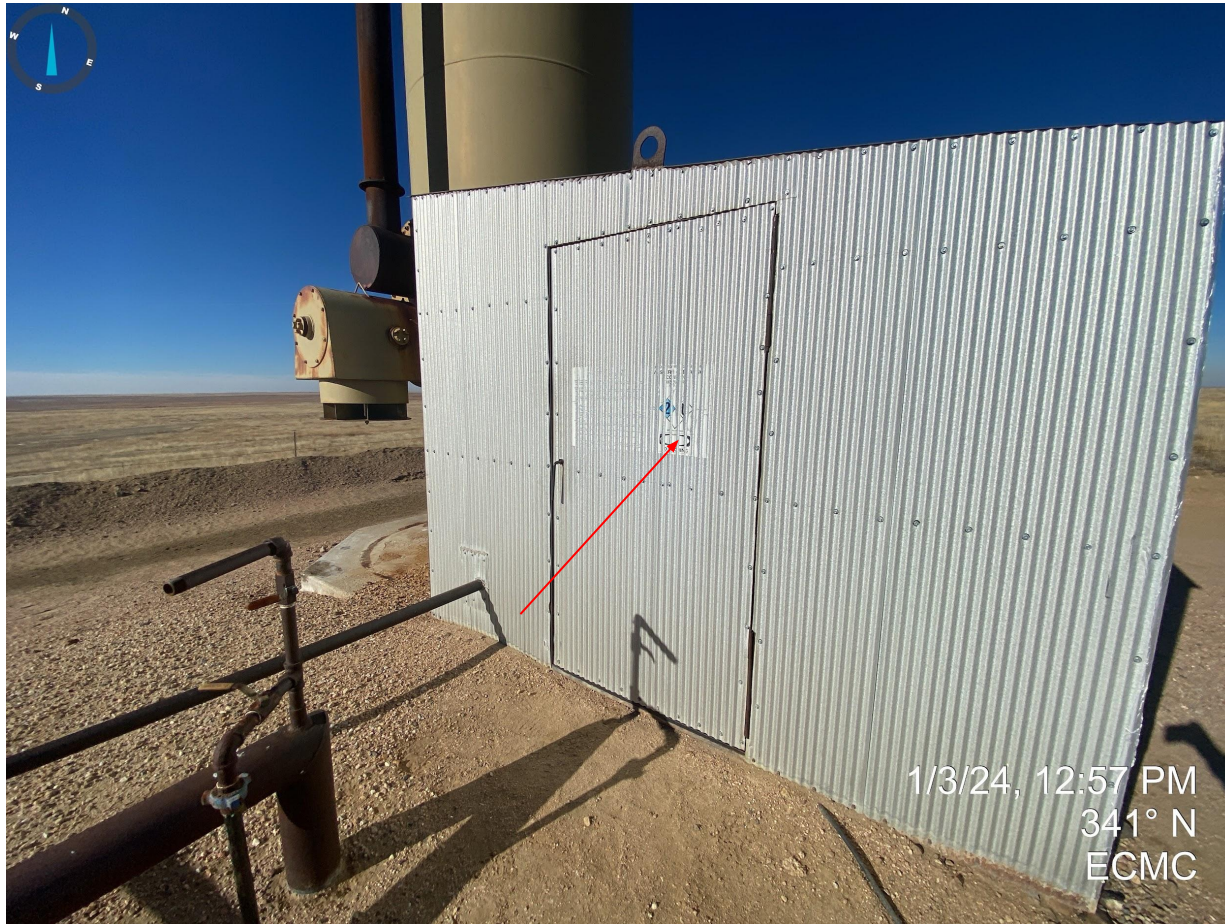
Photo 7. NFPA placard at shed is not legible.

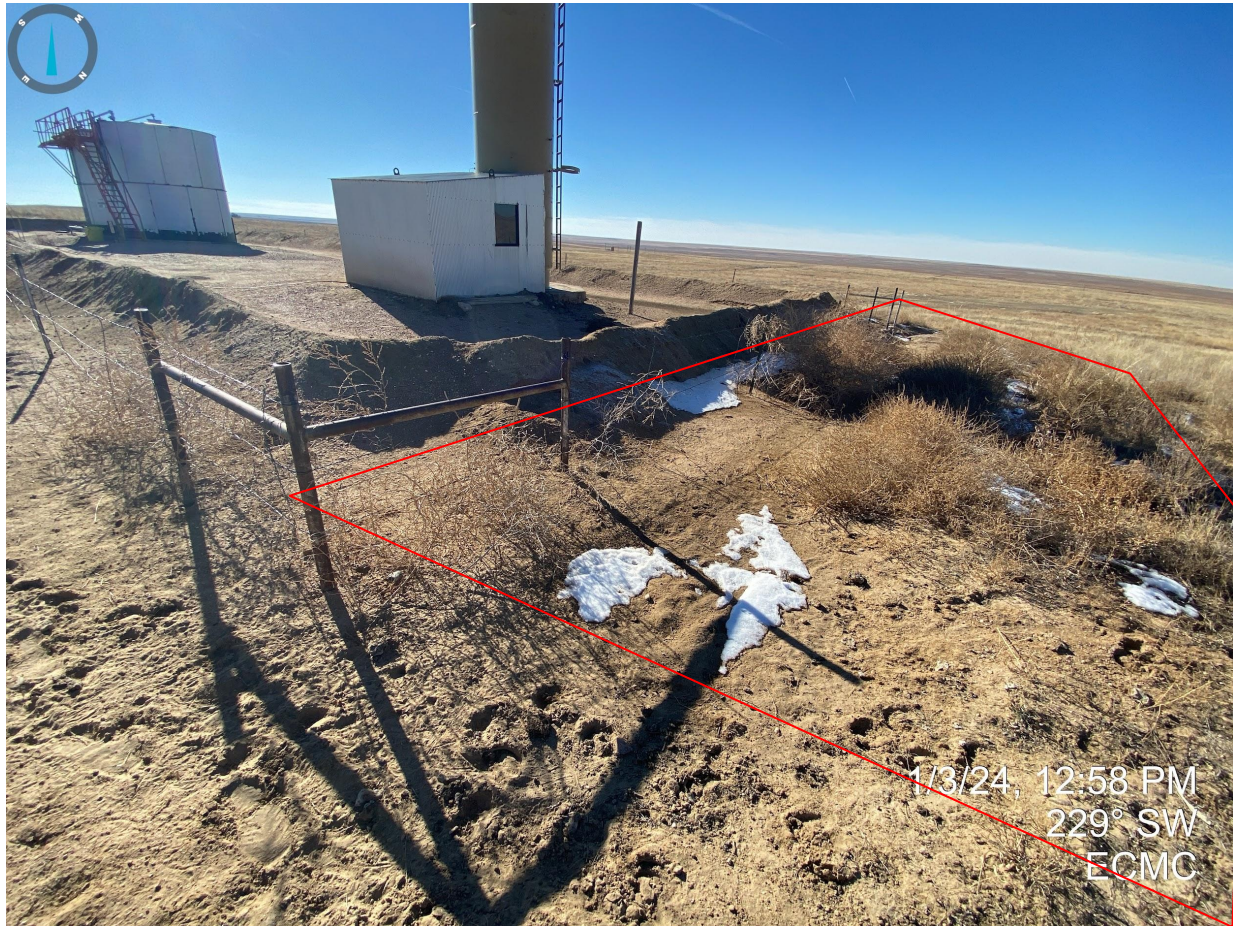
Photo 8. Northern portion of the tank battery. Undesirable vegetation observed within the interim areas.

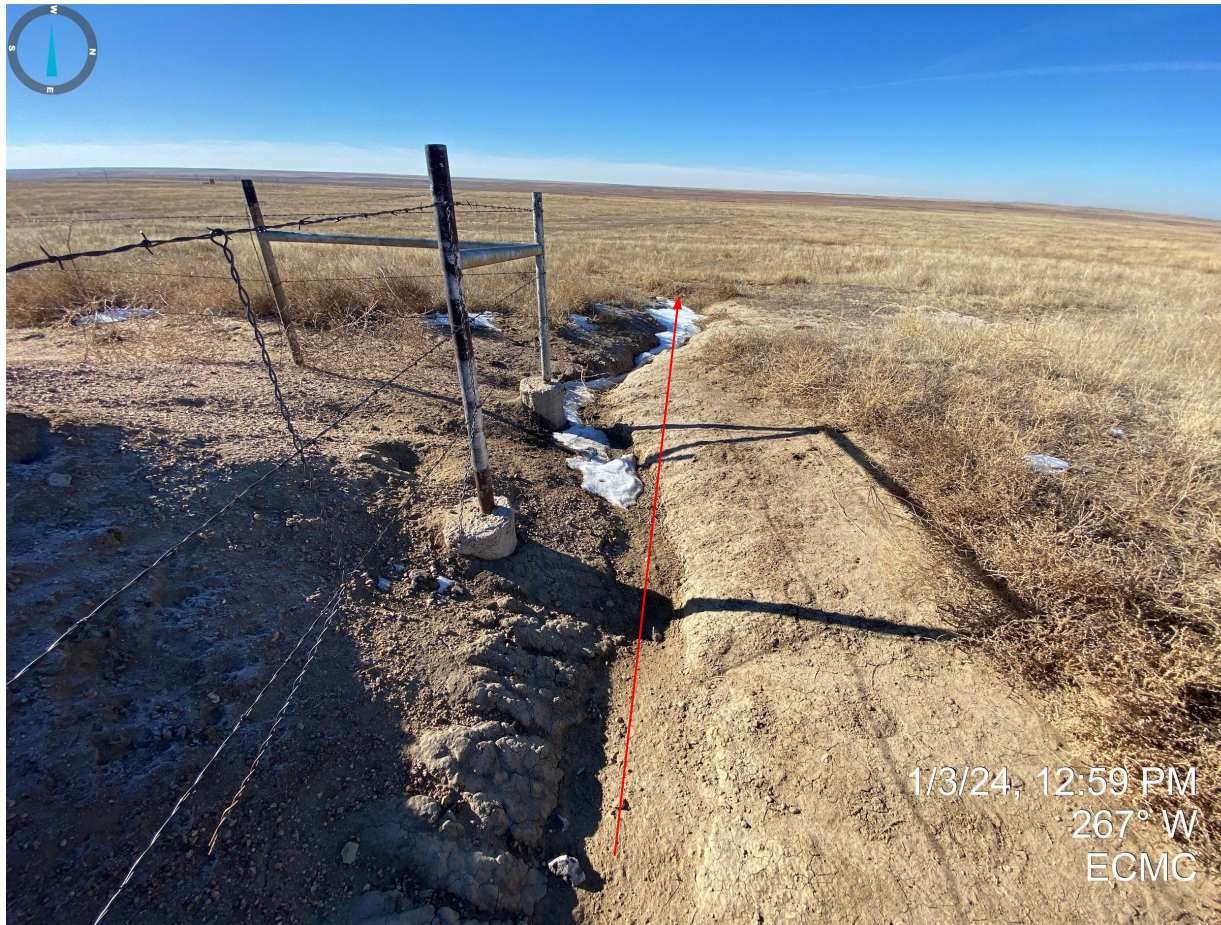
Photo 9. Erosion degradation (e.g. gully) occurring on the northwestern portion of the tank battery. No apparent stormwater control measures observed during this inspection.

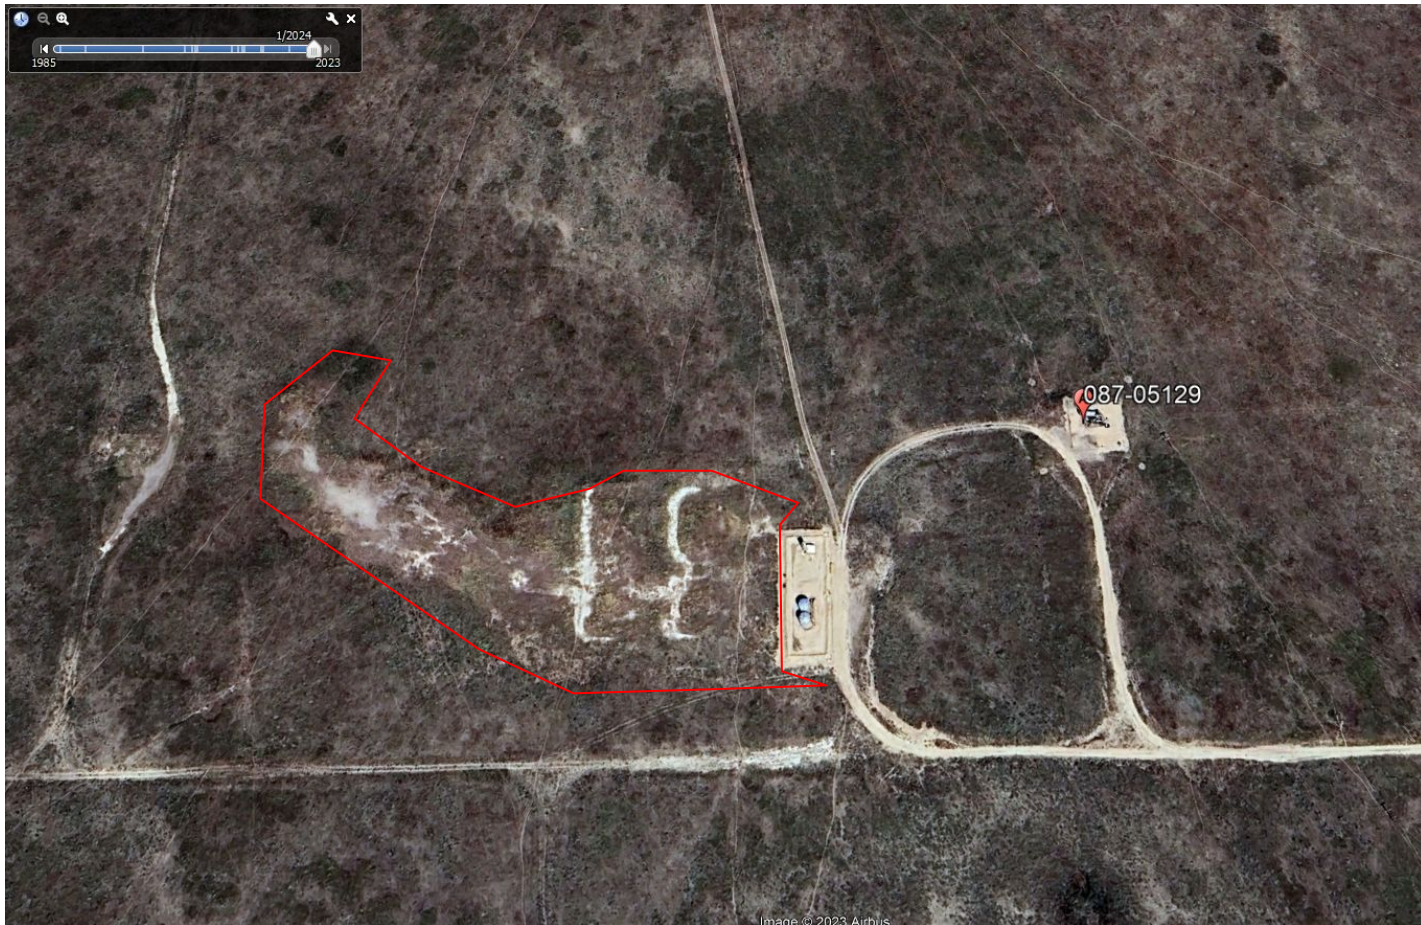
Photo 10. Google Earth aerial imagery (circa 09/2023) illustrating the suspected salt kill area, west and down gradient of the former produced water pits. Red polygon is an approximate outline of the salt kill impacted area; the Operator is being required to investigate the impacted area on a Form 19I.

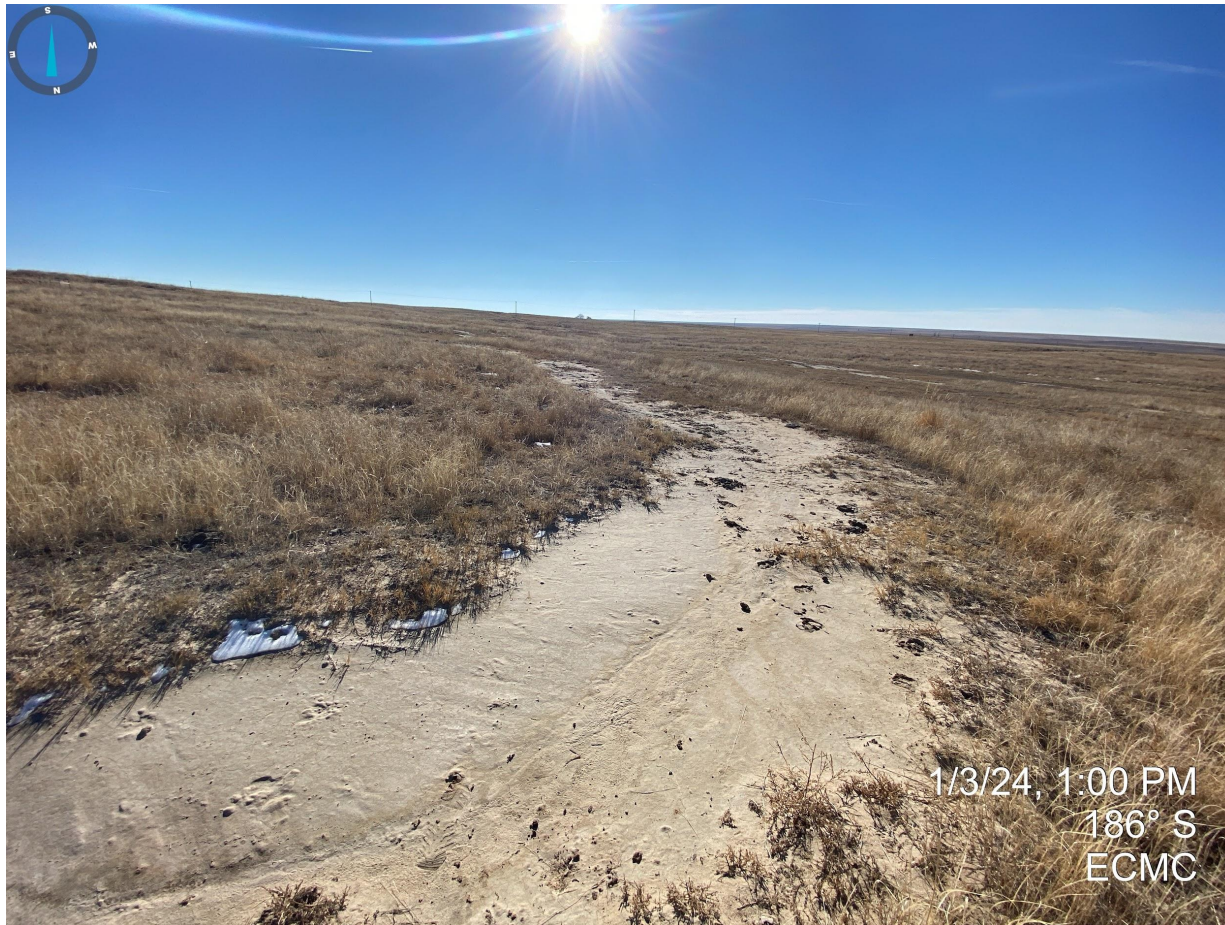
Photo 11. Taken north and west of the tank battery facility, looking south into the salt kill impacted area.

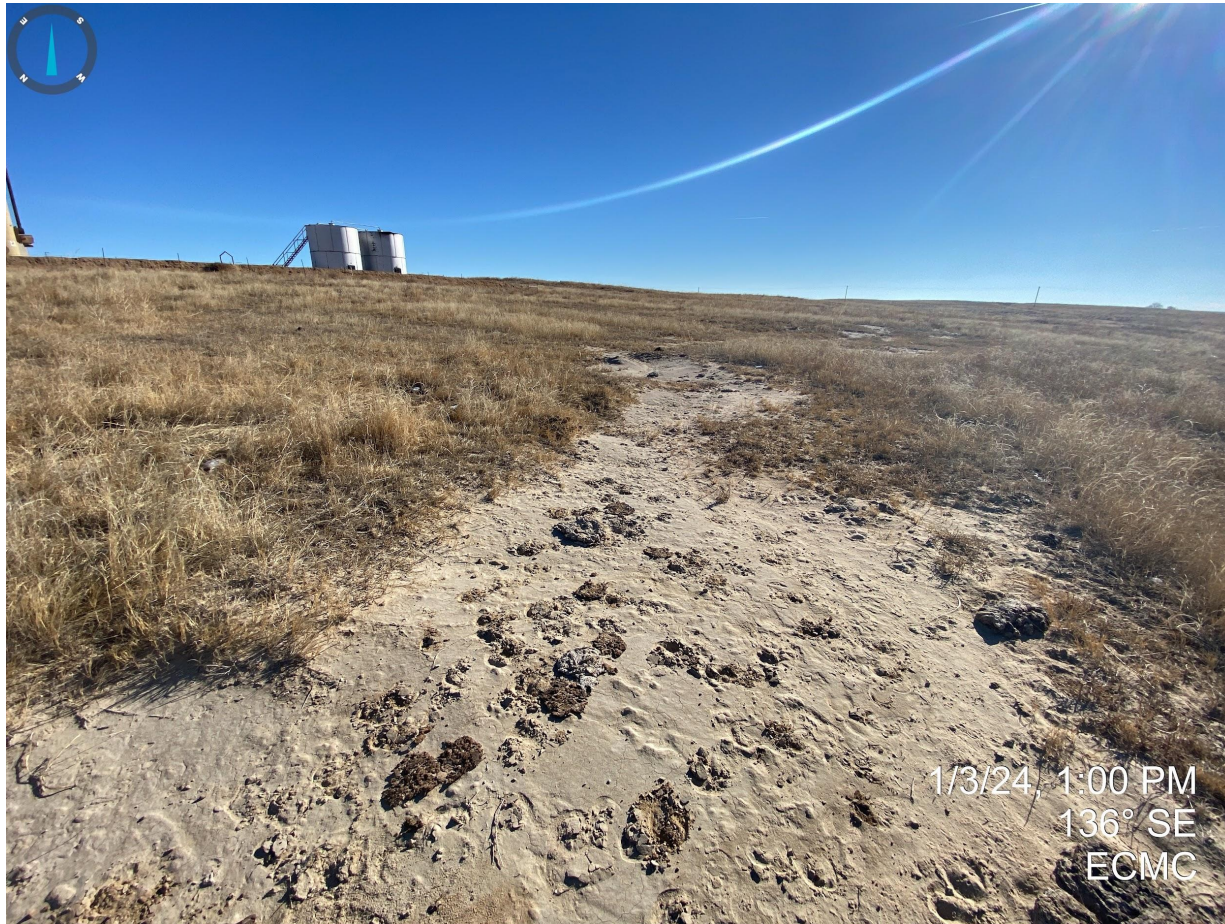
Photo 12. Taken west of the tank battery facility, looking southeast into the salt kill impacted area.

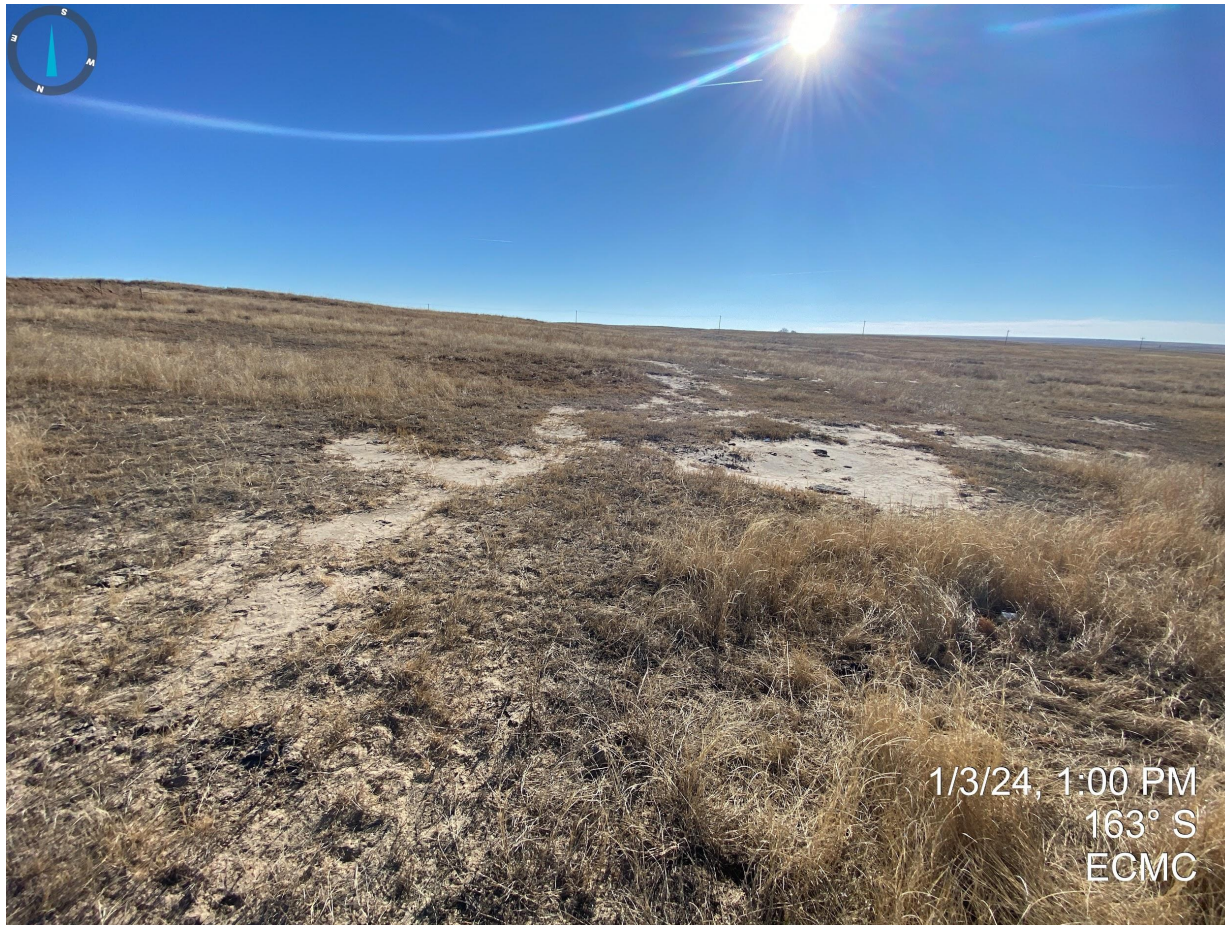
Photo 13. Taken west of the tank battery facility, looking south into the salt kill impacted area.

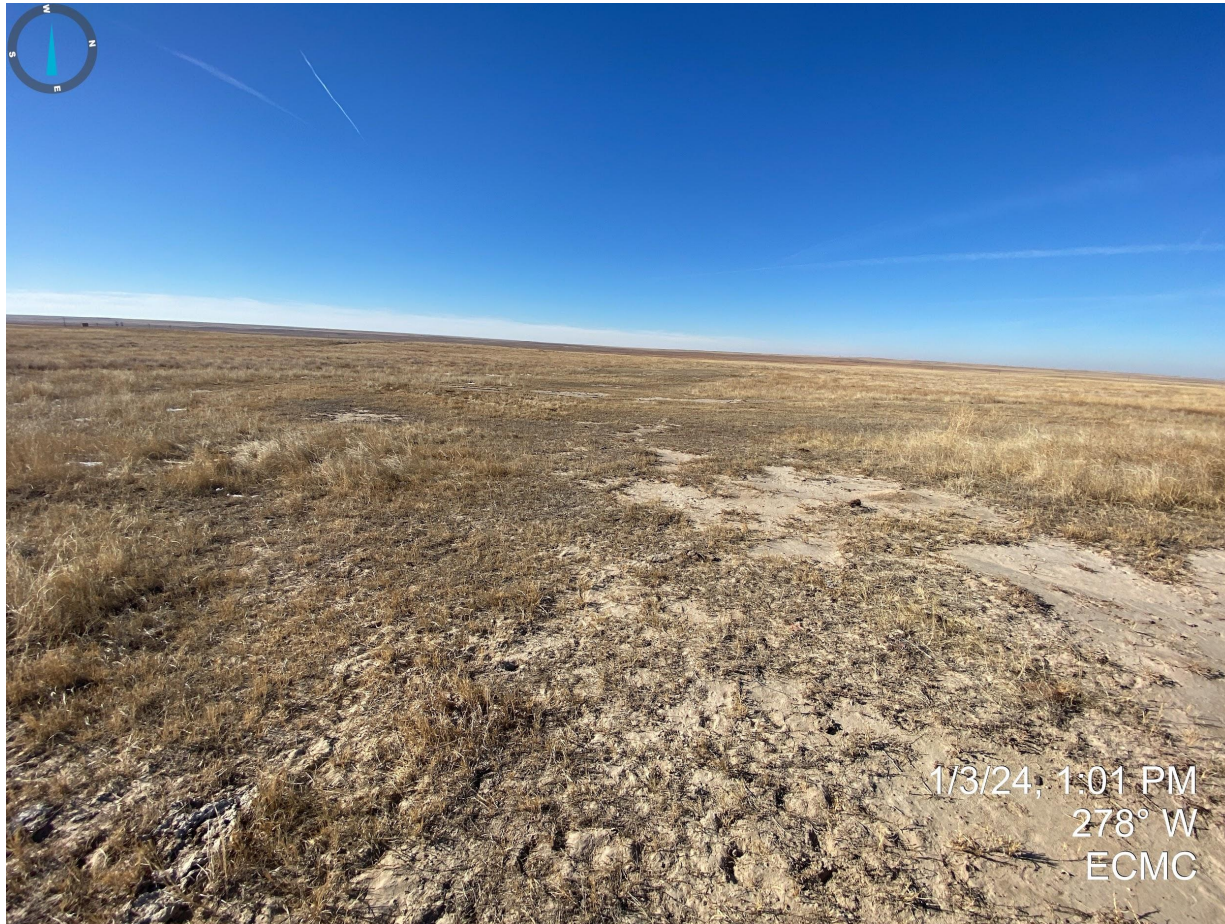
Photo 14. Taken south and west of the tank battery facility, looking west into the salt kill impacted area.

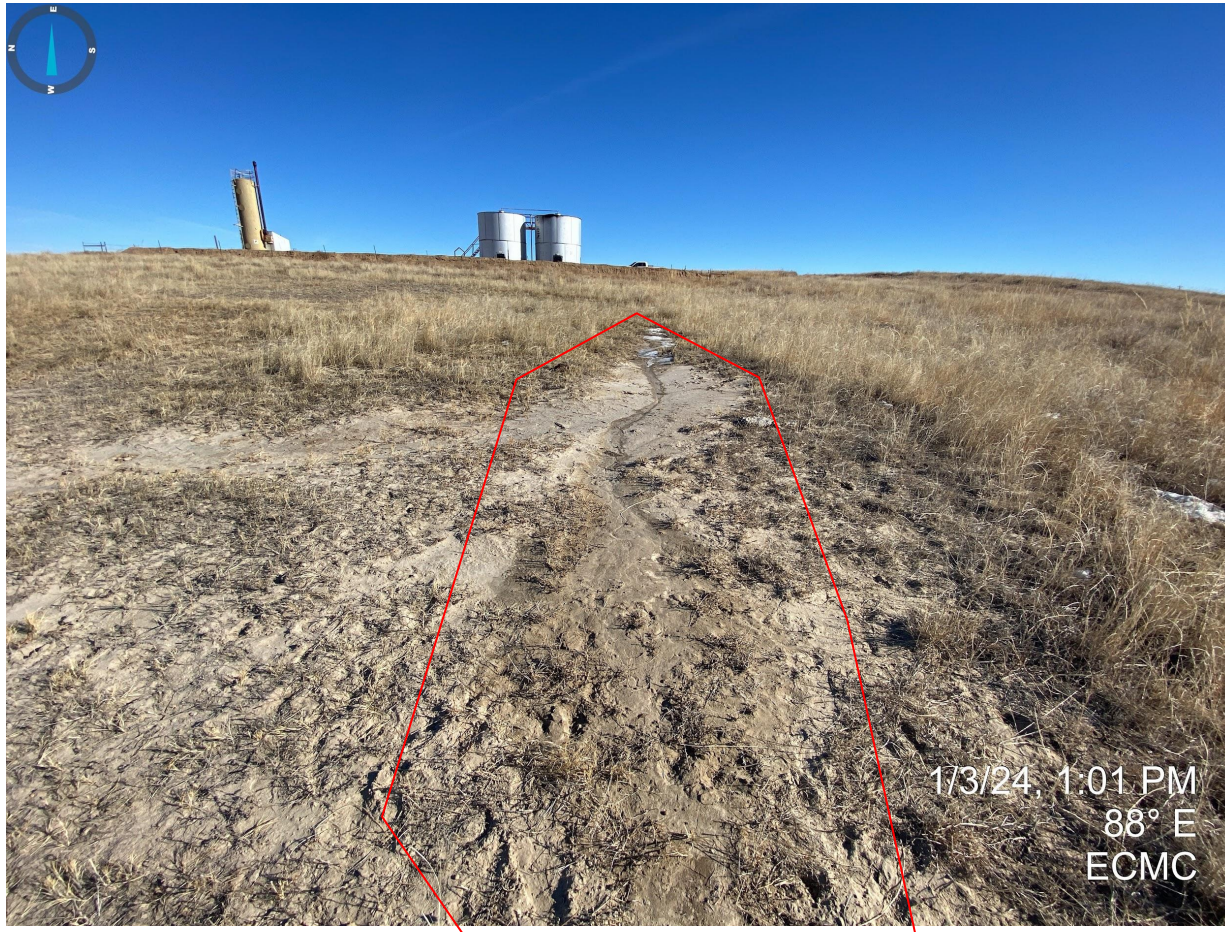
Photo 15. Taken west of the tank battery facility, looking east into the salt kill impacted area. Red polygon illustrates erosion degradation (e.g. rilling) occurring within the salt kill area.

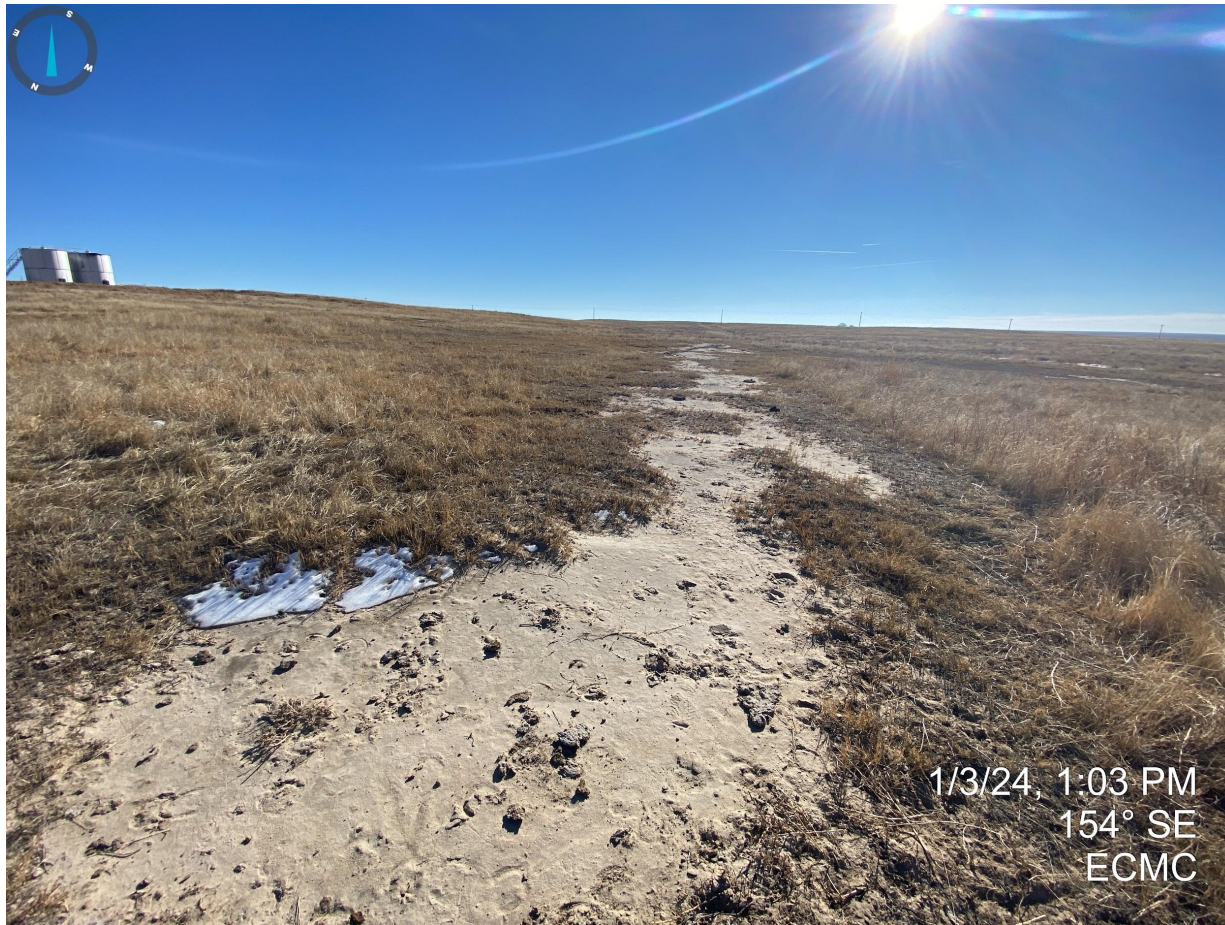
Photo 16. Taken west of the tank battery facility, looking southeast into the salt kill impacted area.

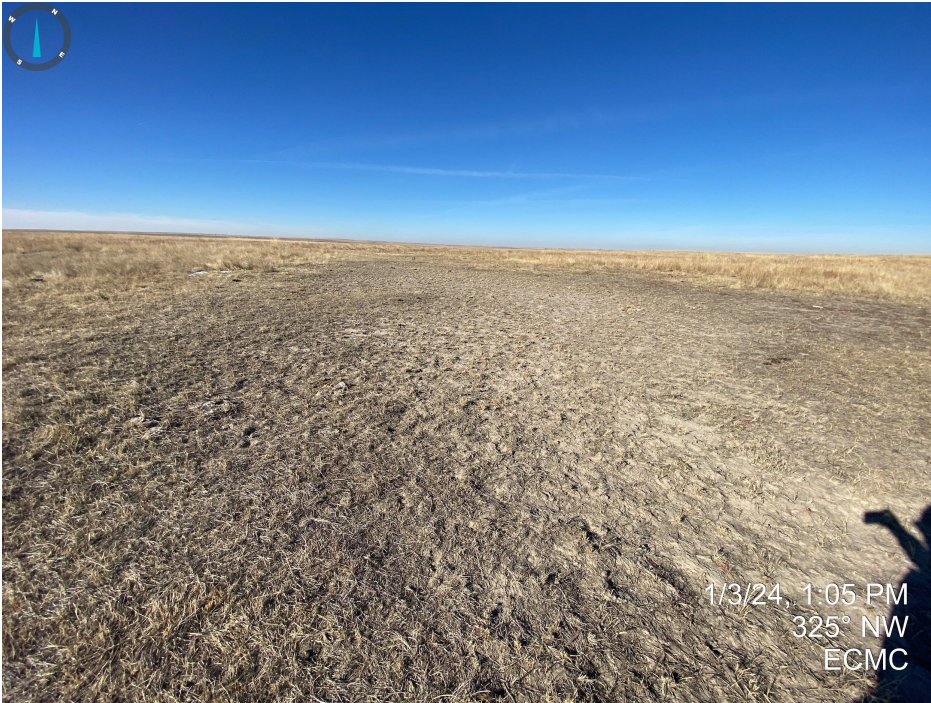
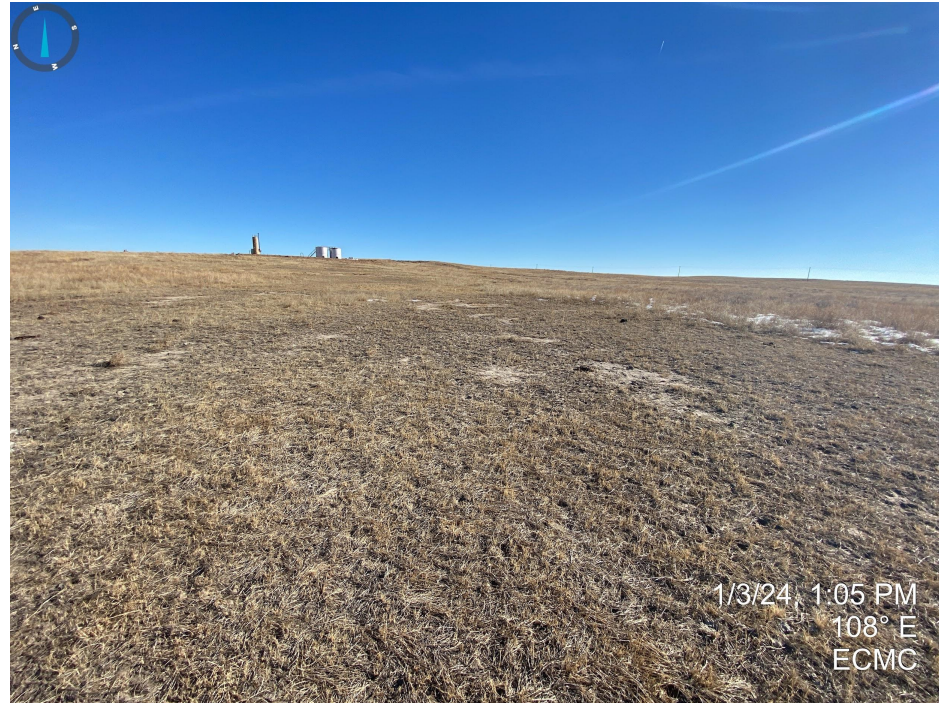
Photos 17 & 18. Taken from the western most extent of the salt kill impacted area.

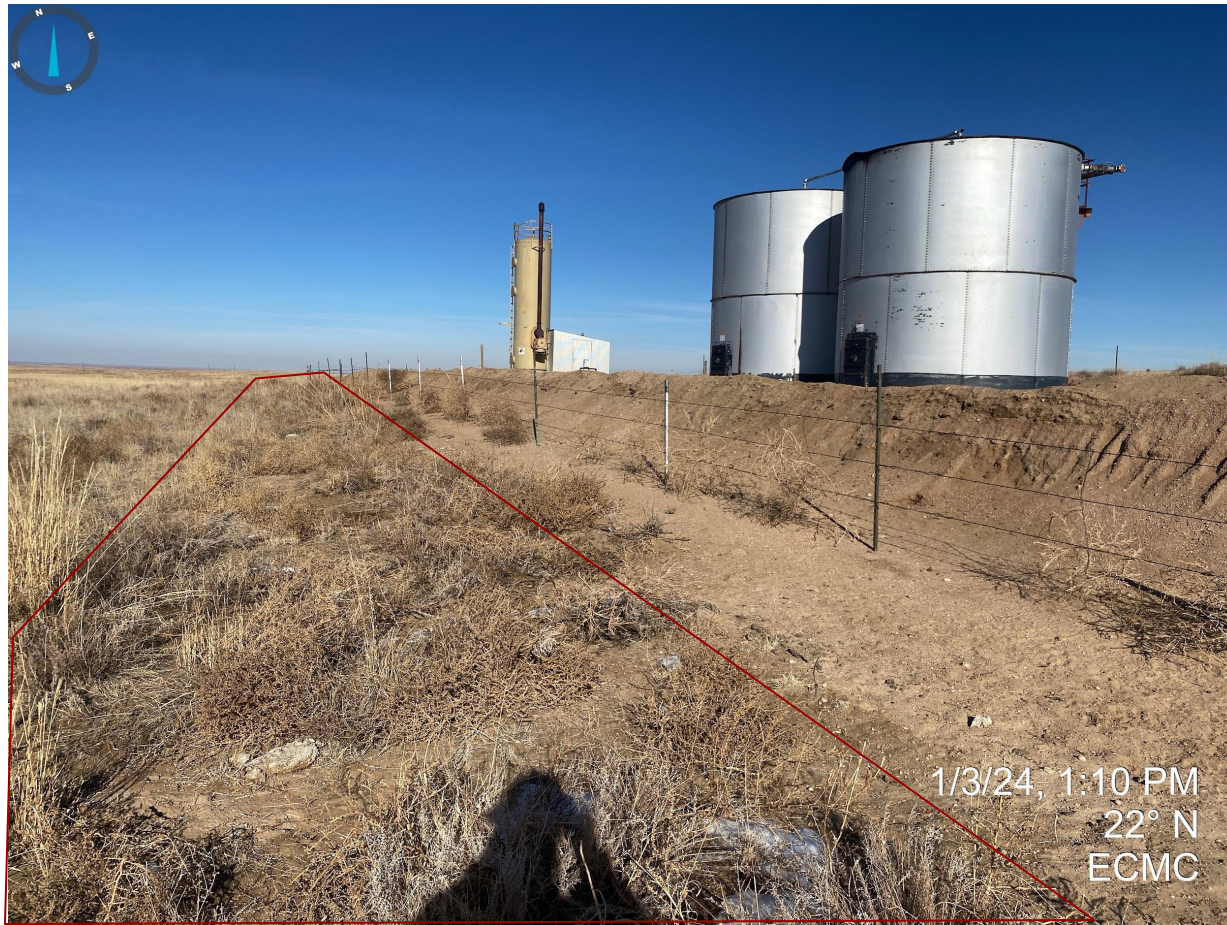
Photo 19. Western side of the tank battery; undesirable vegetation (e.g. russian thistle and kochia) observed.

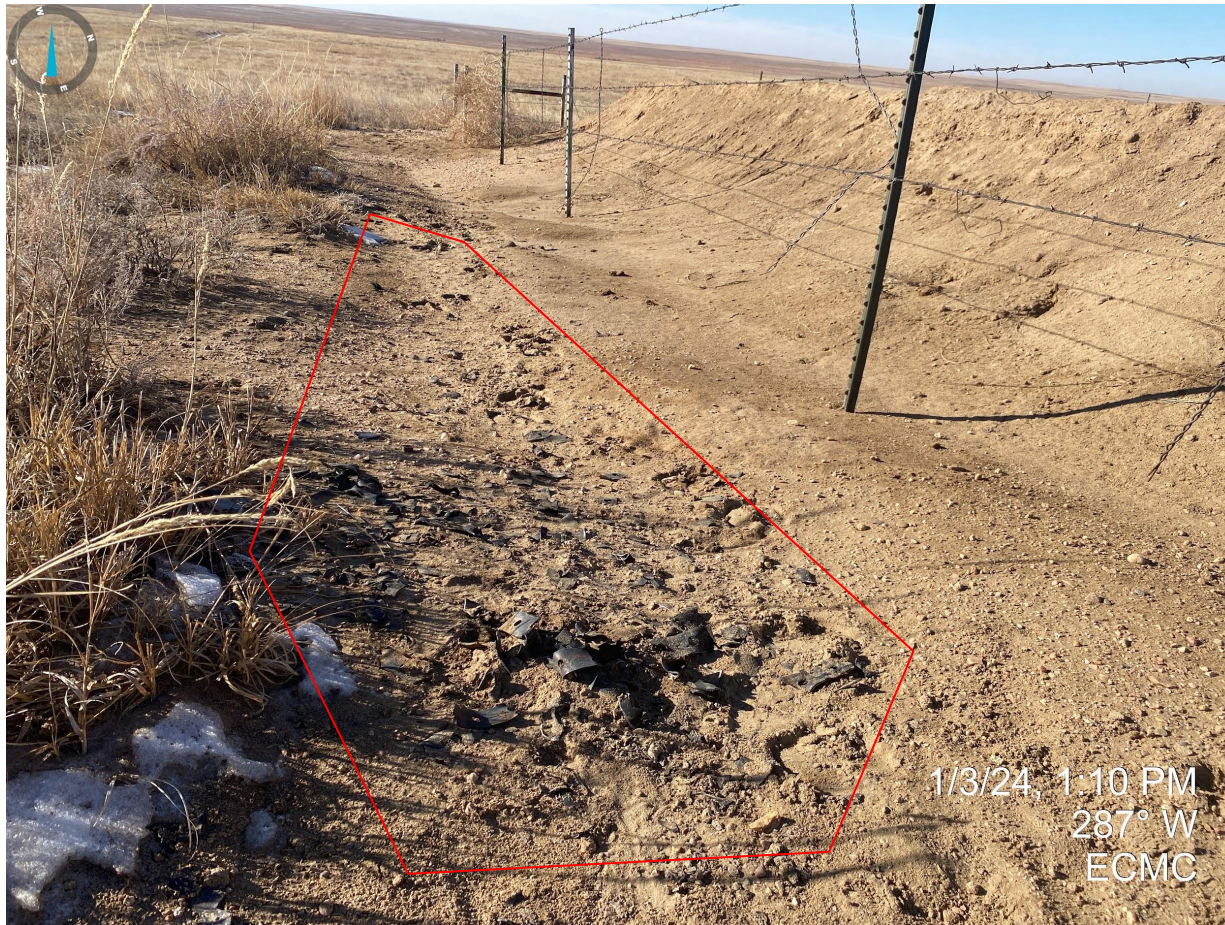
Photo 20. Plastic debris observed on the southern end of the tank battery.
