Interim Reclamation and Stormwater Inspection

Date: 01/03/2024

Operator: WESTERN OPERATING COMPANY - 95620

Location ID: 313654

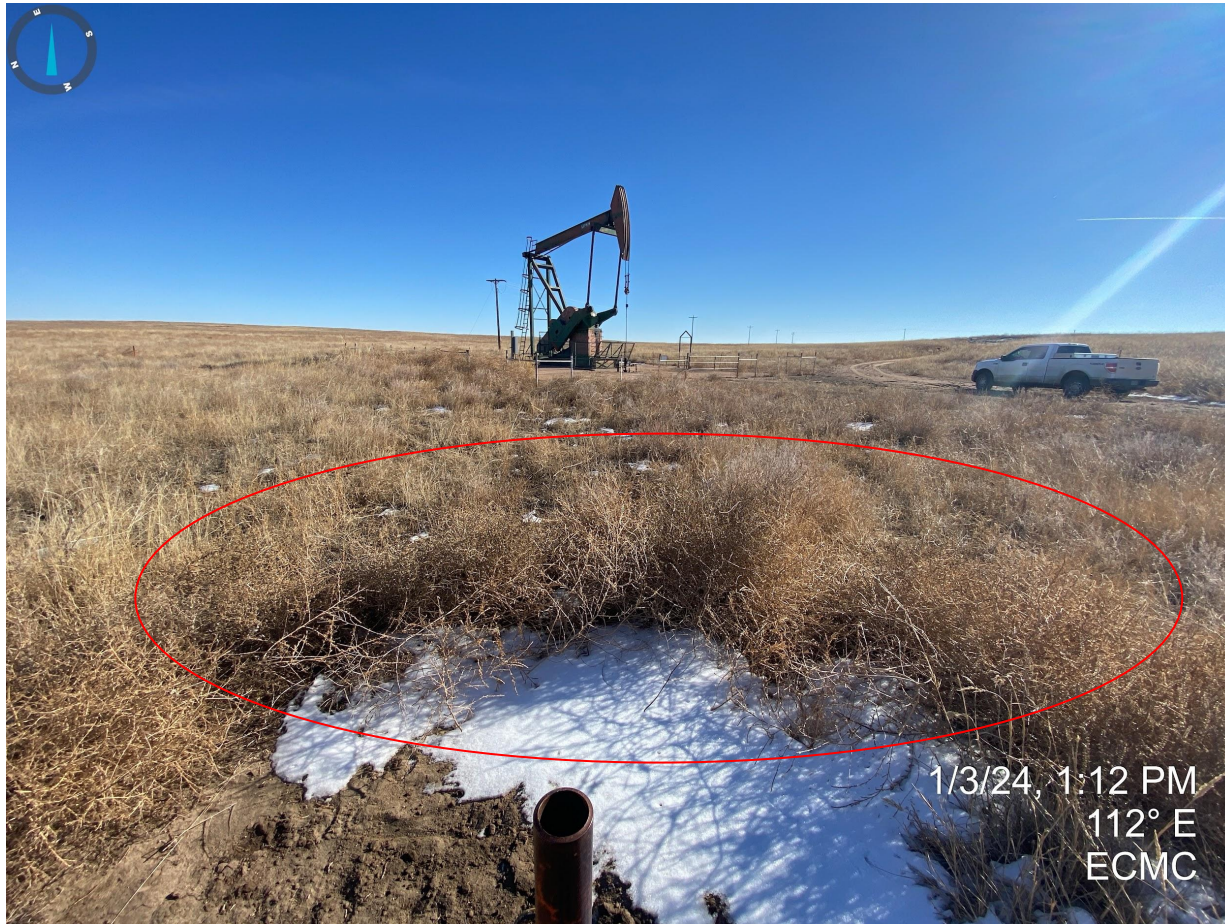
Photo 21. Northwest corner of the well location. Photo illustrates undesirable vegetation (e.g. russian thistle and kochia) throughout the interim areas.

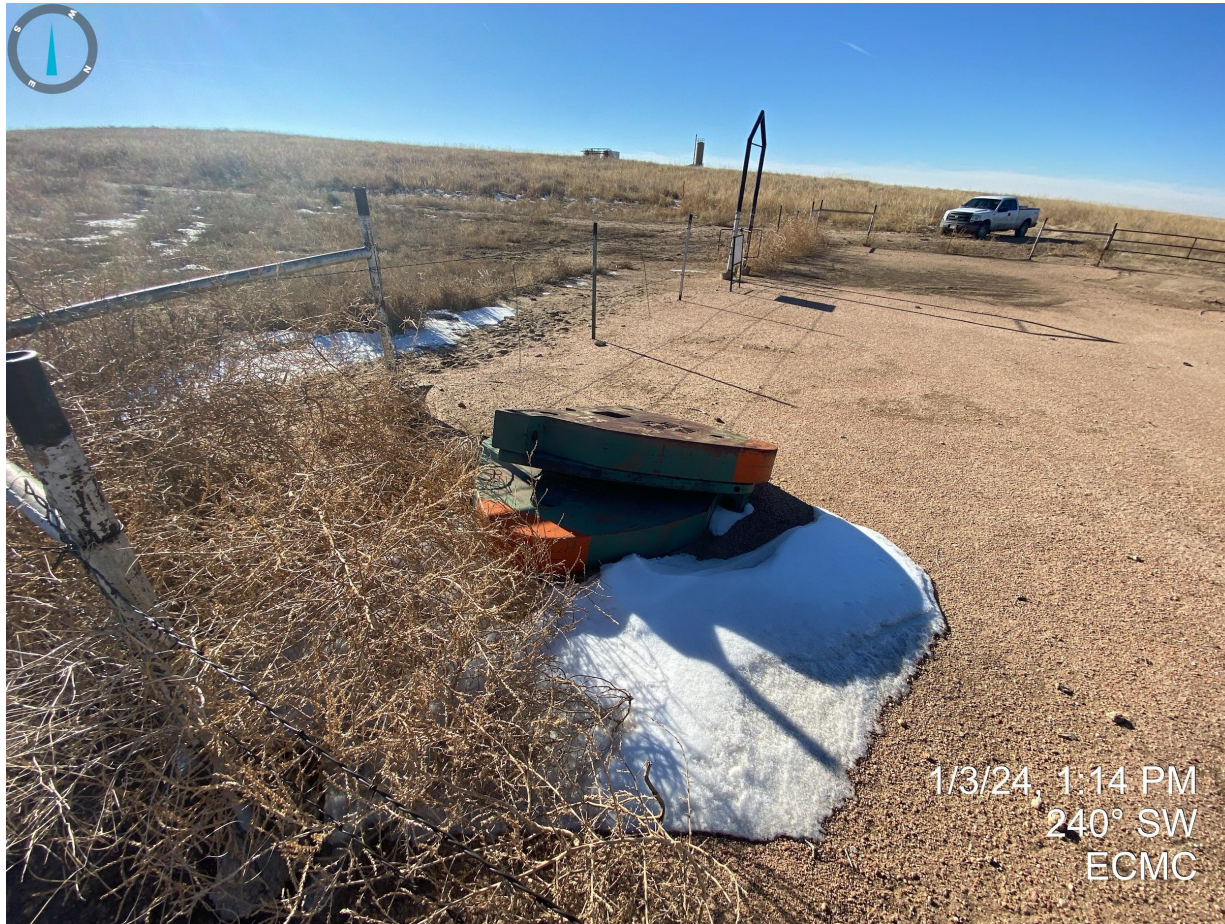
Photo 23. Unused equipment observed at the well location.

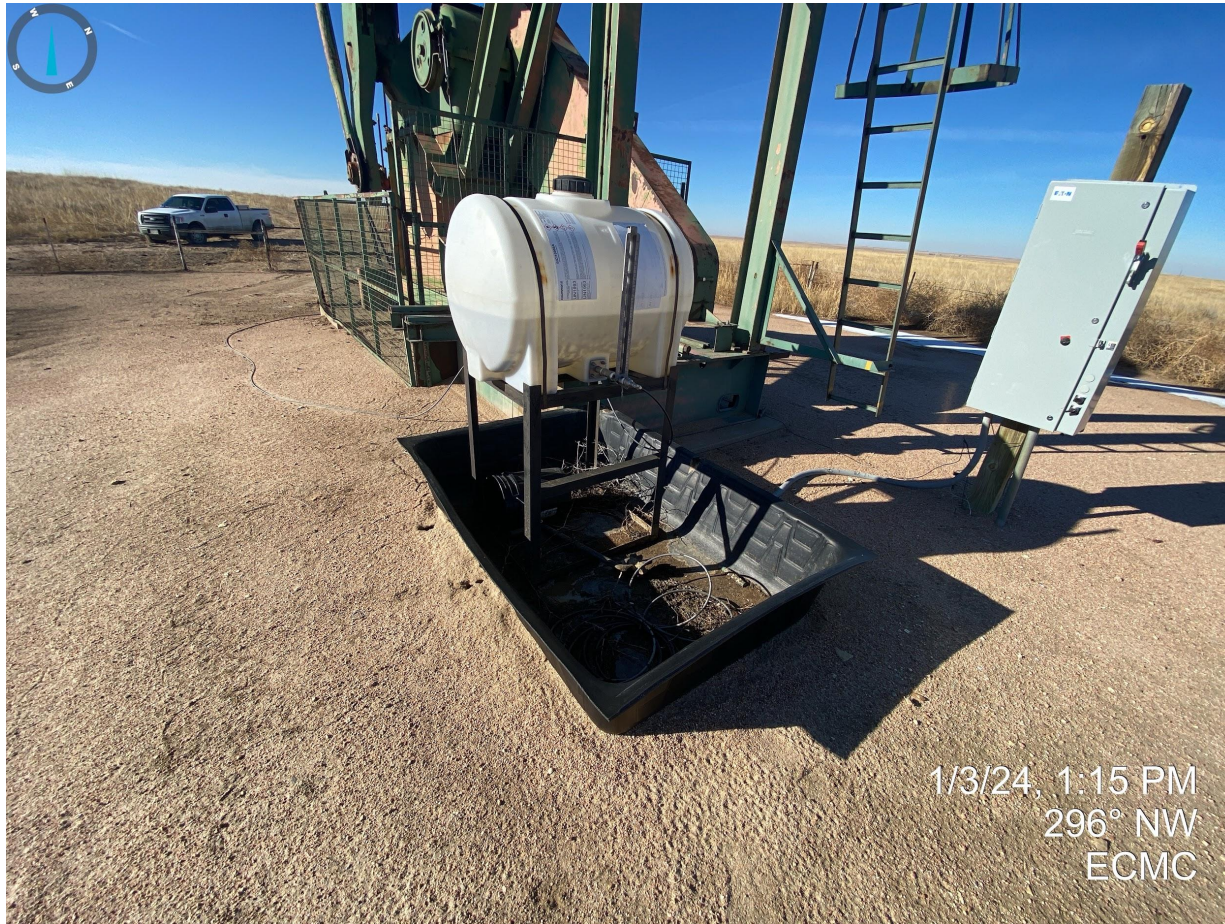
Photo 24. No wildlife exclusion equipment observed at day tank secondary containment.

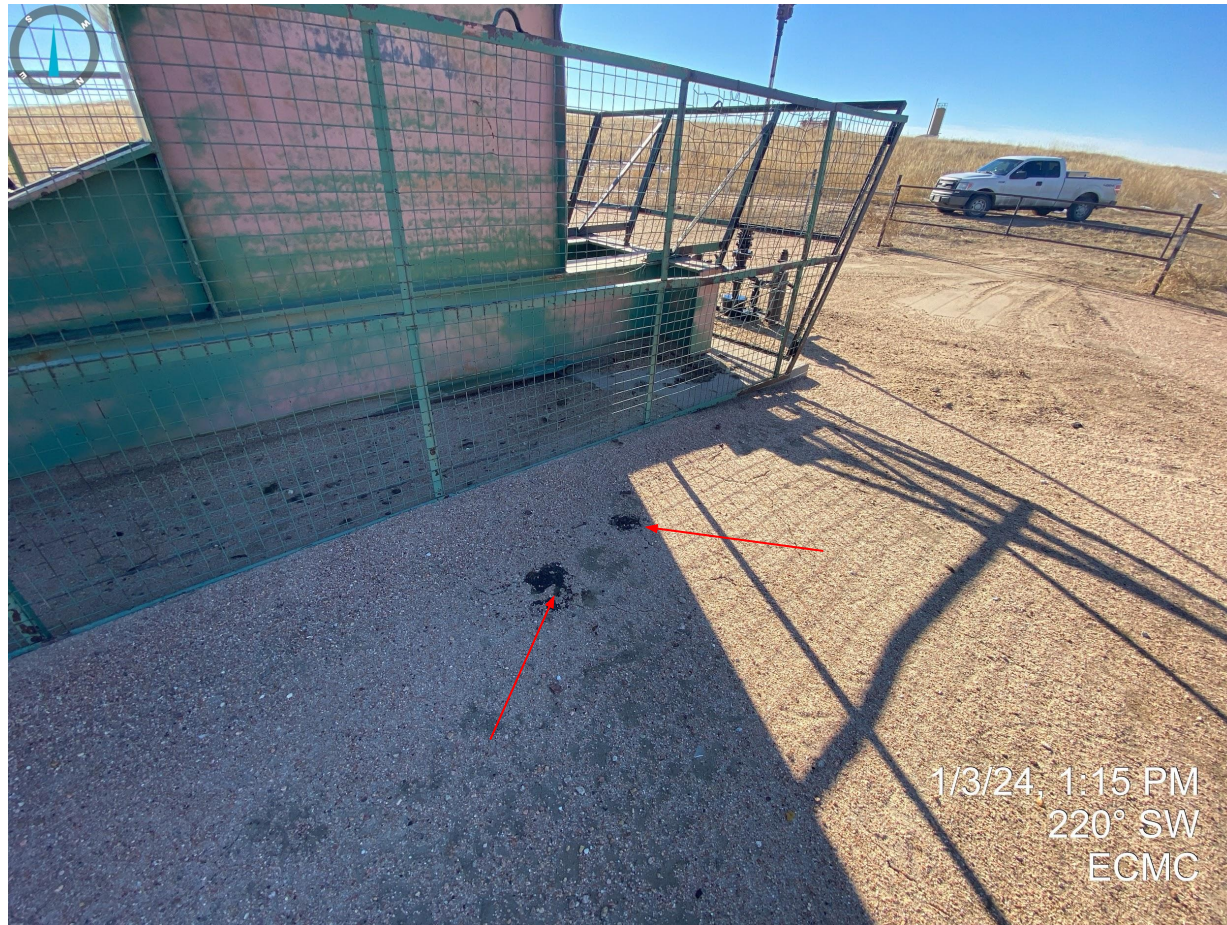
Photo 25. Stained soil at pumpjack.

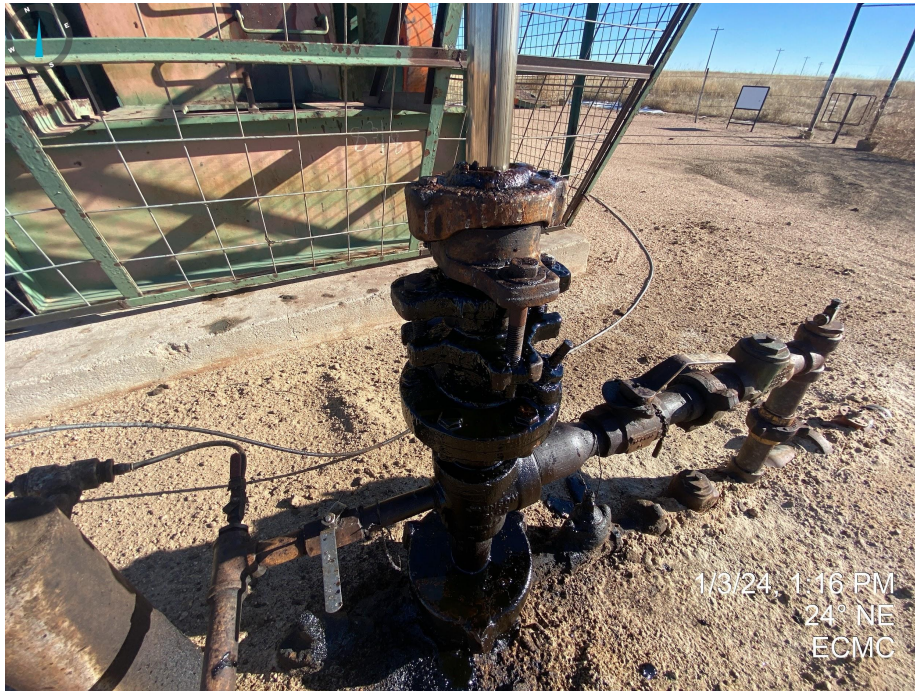
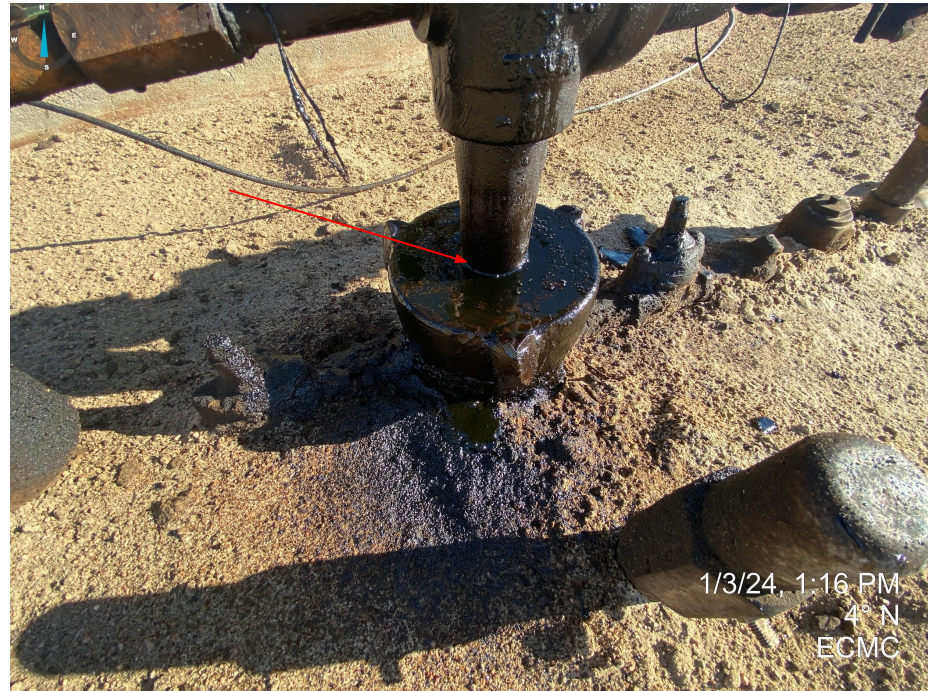
Photo 26. Stained soil and visible leak at wellhead.
