Inspection Photos

Loc: 324809

Operator: WESTERN OPERATING COMPANY

Inspection Date: 1/10/2024

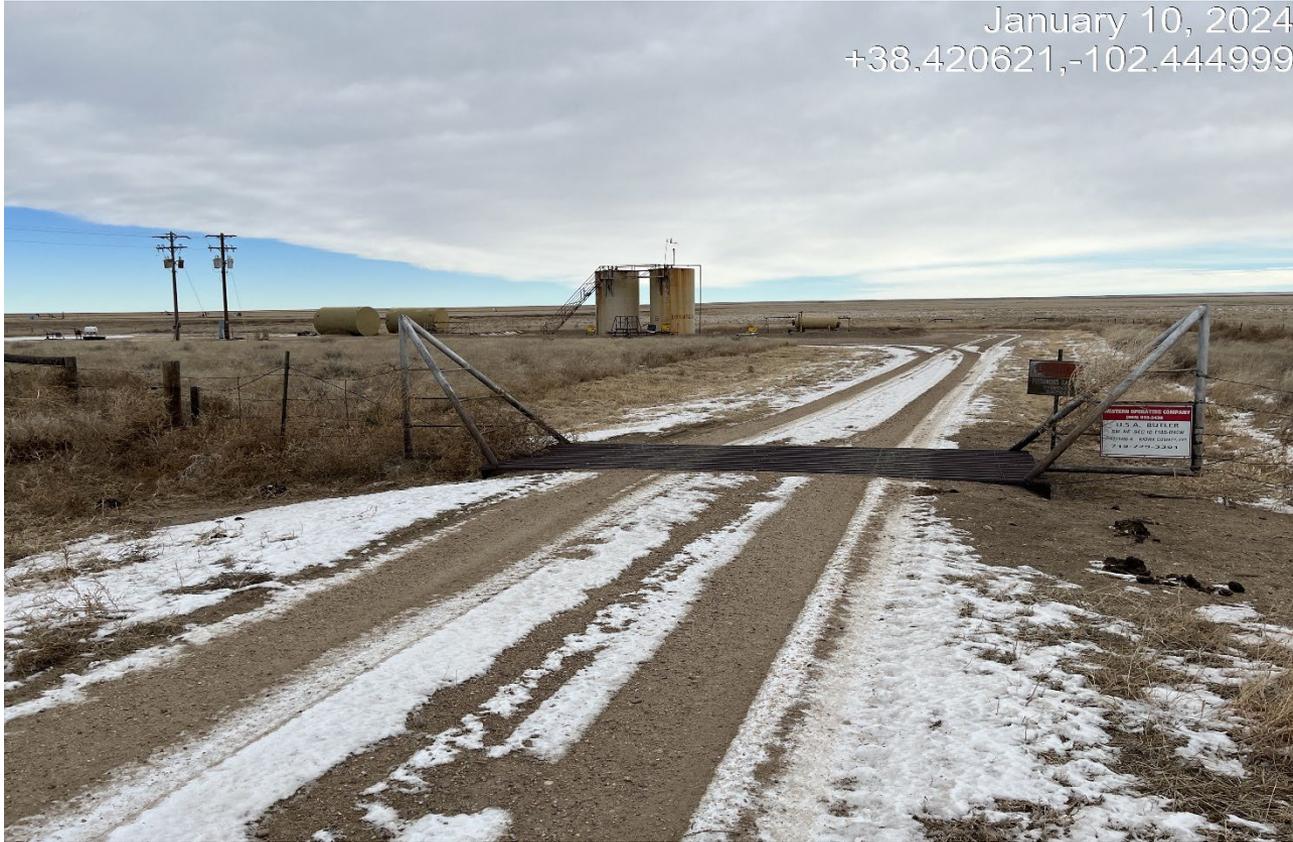
Photo 1. Facing east at the access road toward the location.

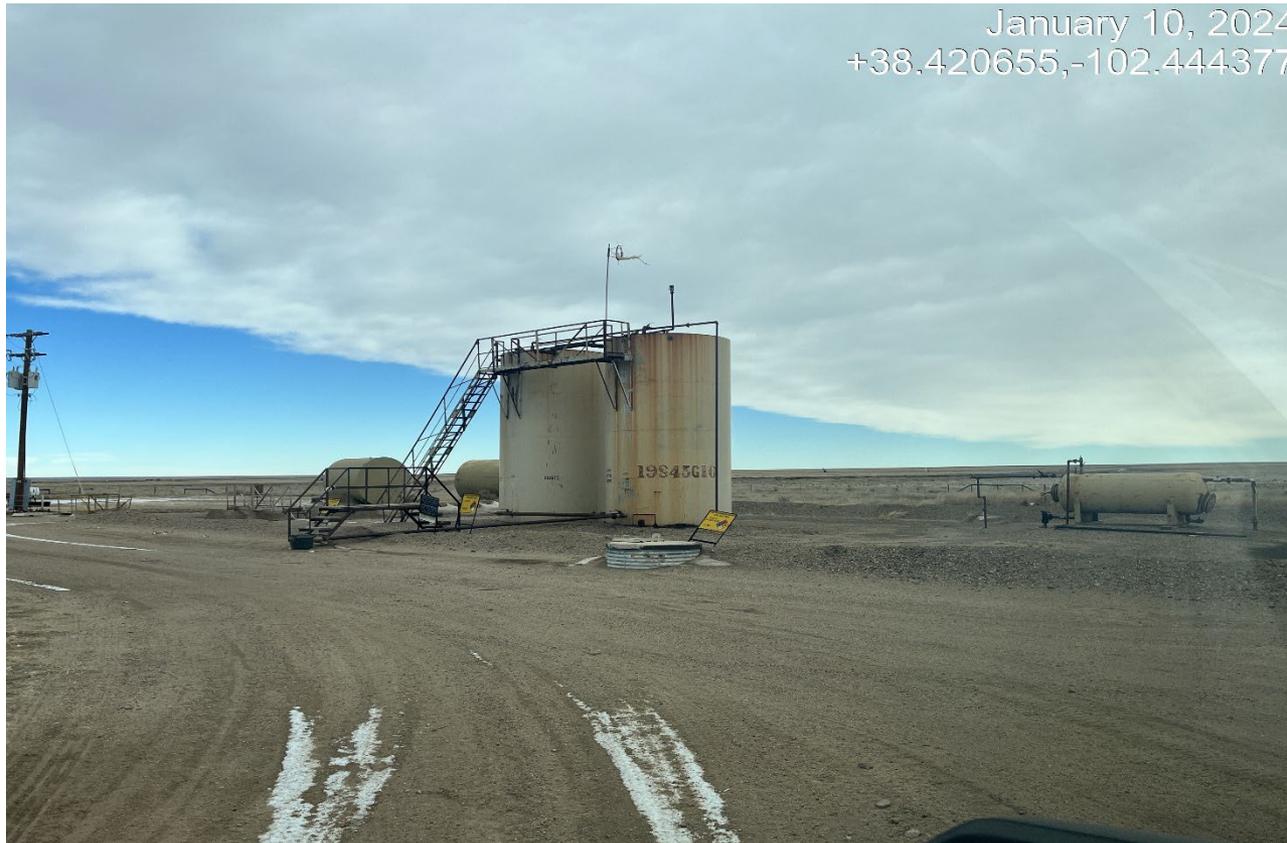
Photo 2. Facing northeast towards the tank battery. The wind sock for H2s needs to be replaced.

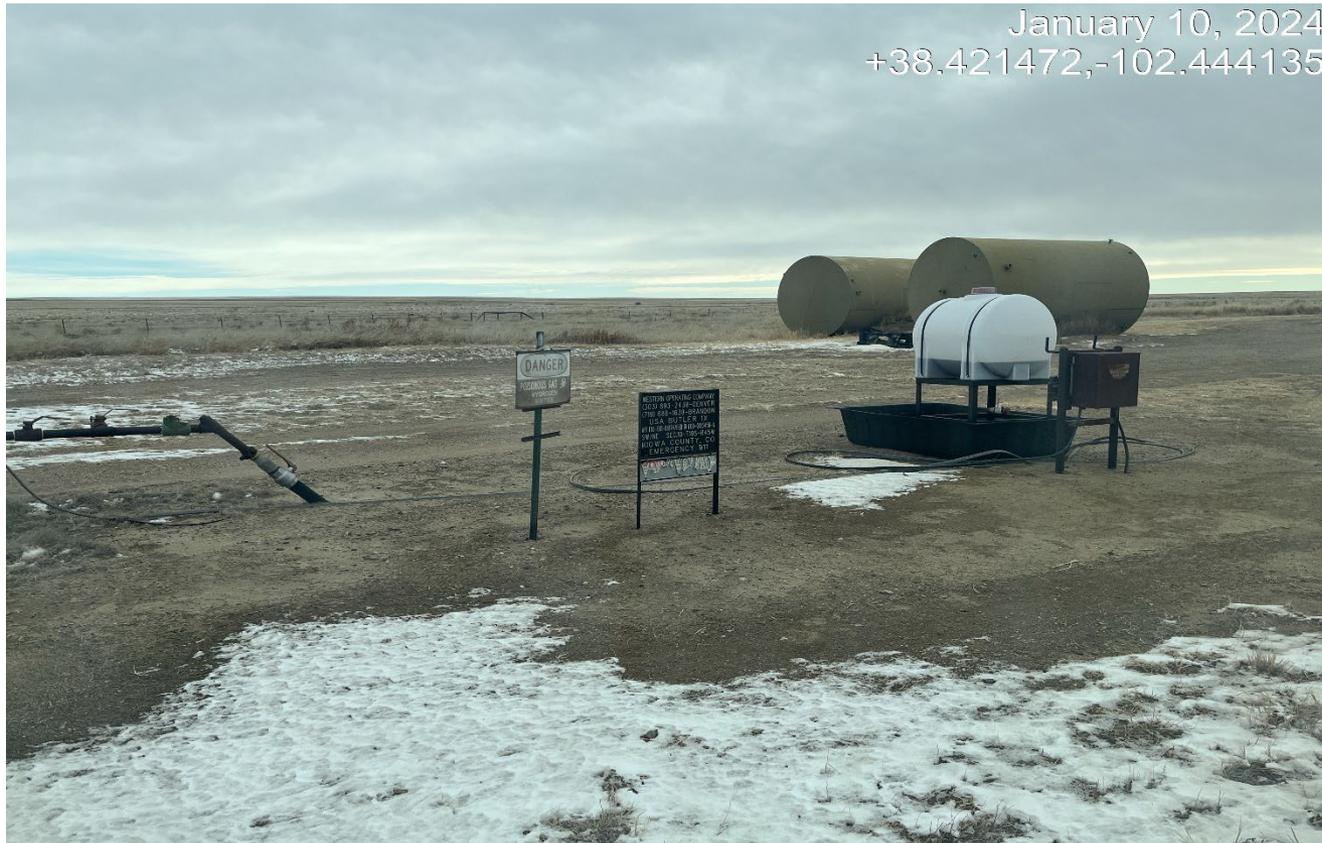
Photo 3. Facing southeast at the wellsite.

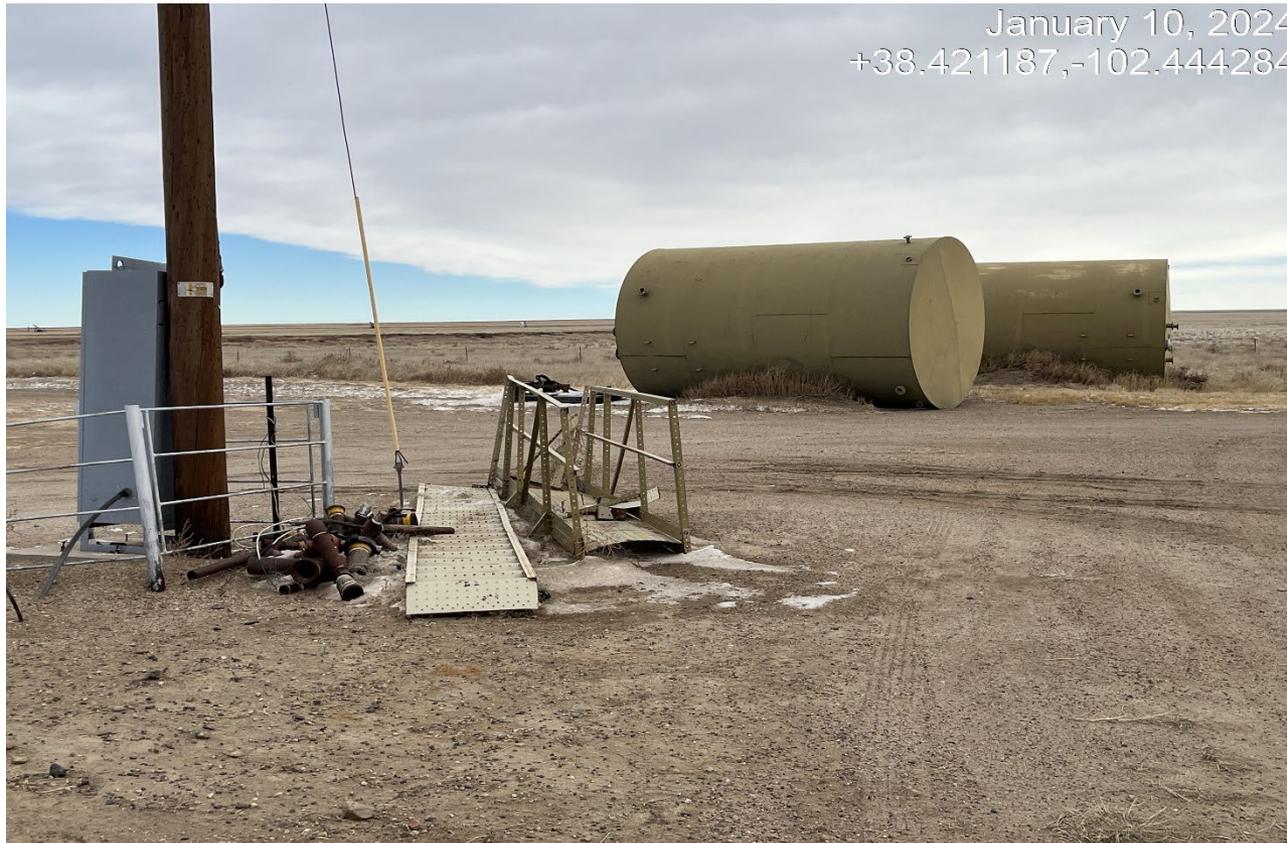
Photo 4. Facing east. There are two steel tanks that are unused that need to be removed along with various parts by the power pole.
