# Inspection Photos

Loc: 384227

Operator: WESTERN OPERATING COMPANY

Inspection Date: 1/10/2024

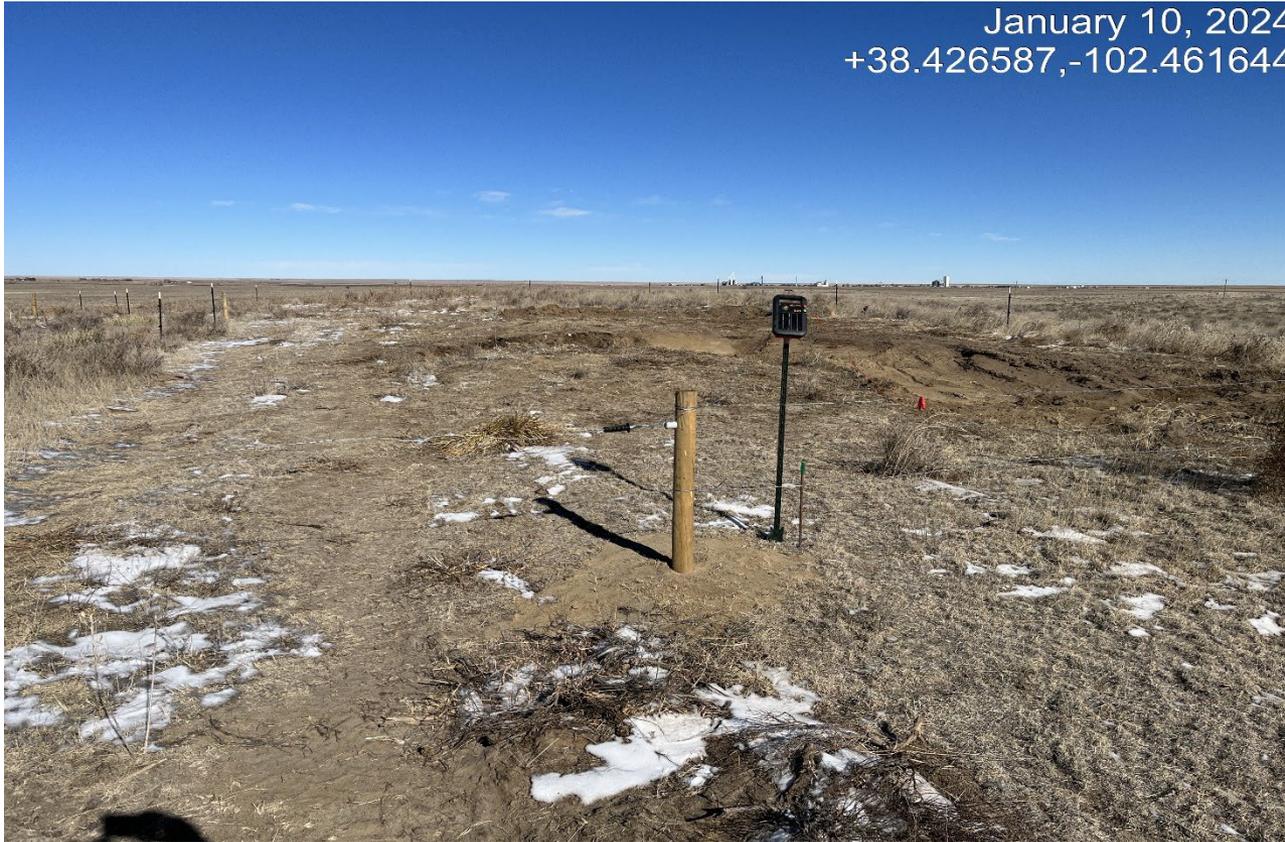
**Photo 1.** Facing north near the location. This area has been fenced and excavation has occurred of impacted soils from historic release.

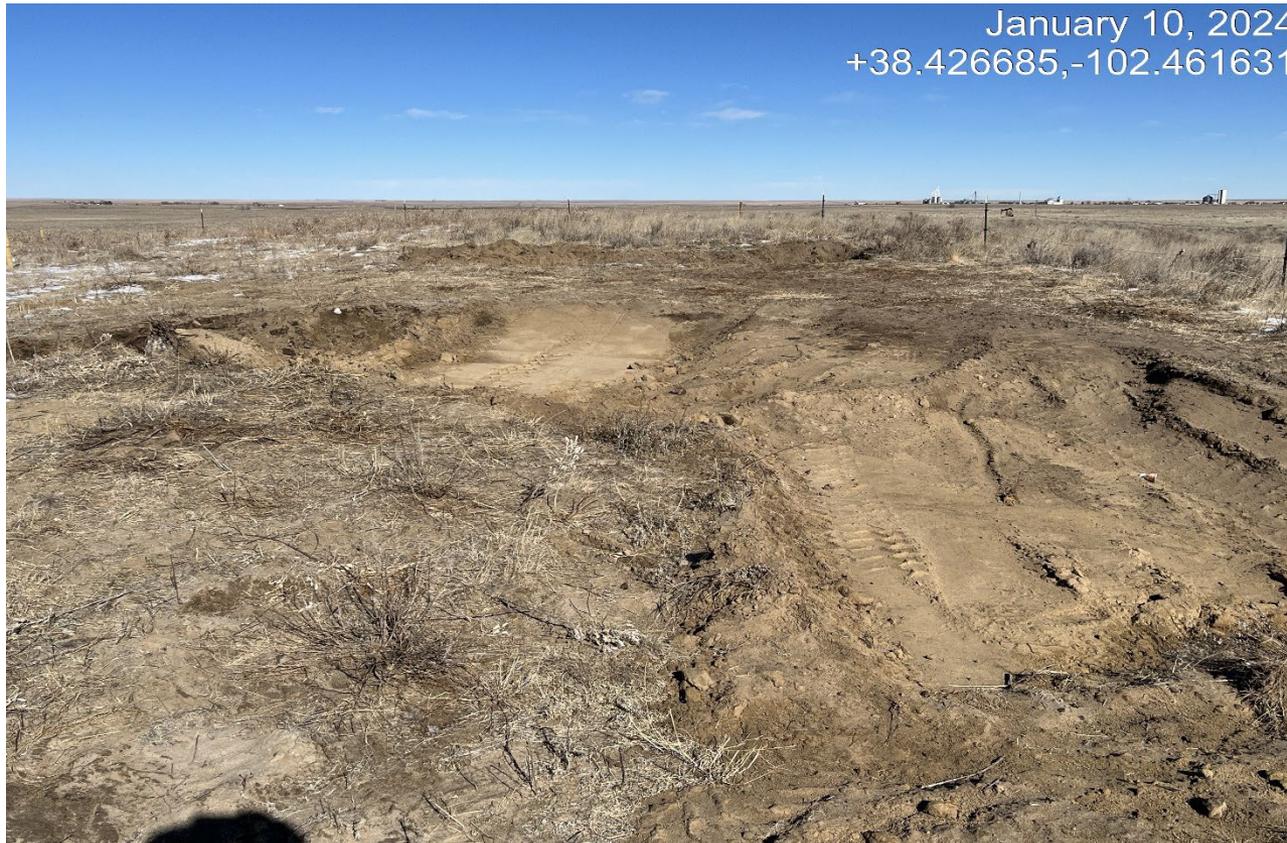
**Photo 2.** There has been excavation and removal of impacted soils

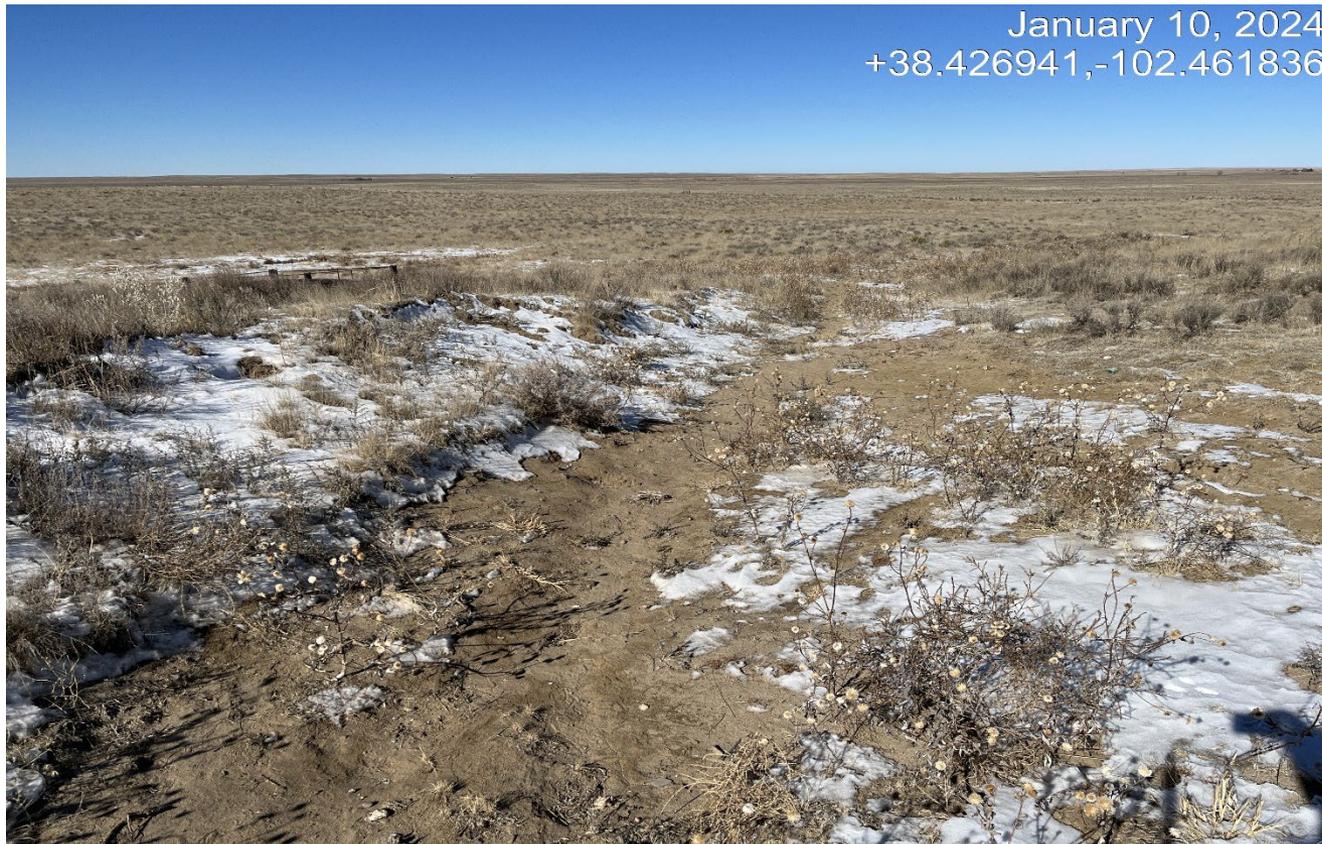
**Photo 3.** Facing northwest at the abandoned wellsite location. The sandy soils have not revegetated and need to be seeded and reclaimed.

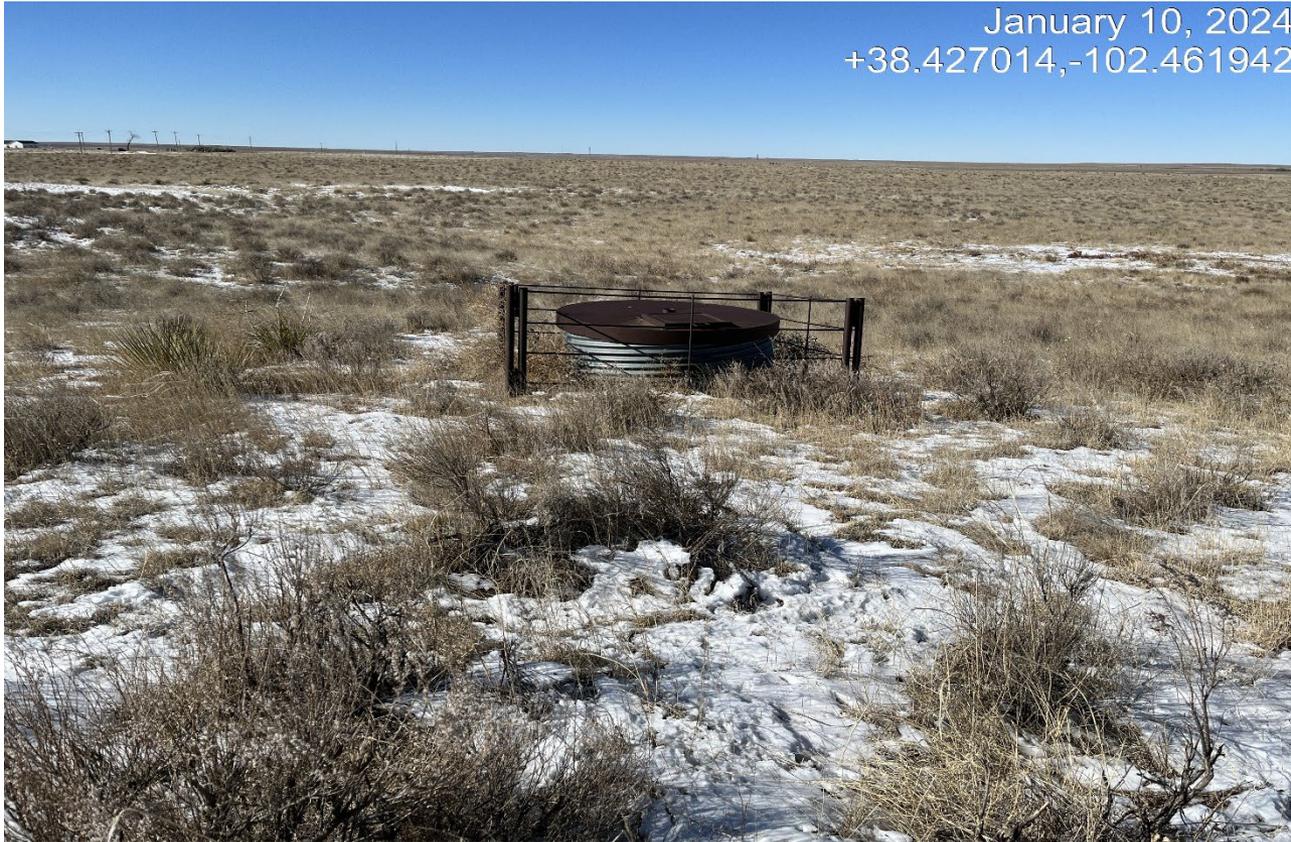
**Photo 4.** Facing southwest near the abandoned wellsite is abandoned flowline cellar that needs to be removed. Lat/Long:38.42706, -102.46211.

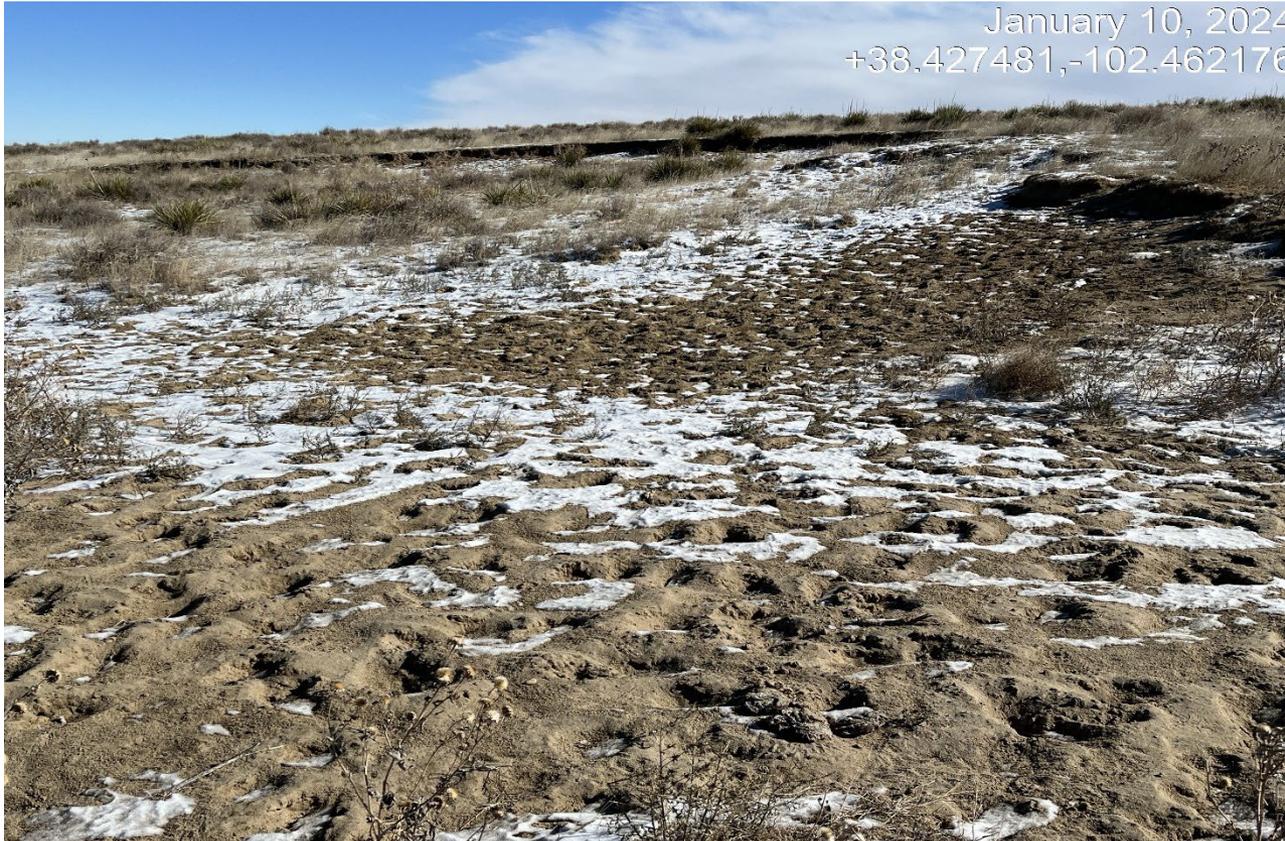
**Photo 5.** Facing east at the abandoned wellsite location. The sandy soils have not revegetated and need to be seeded and reclaimed.

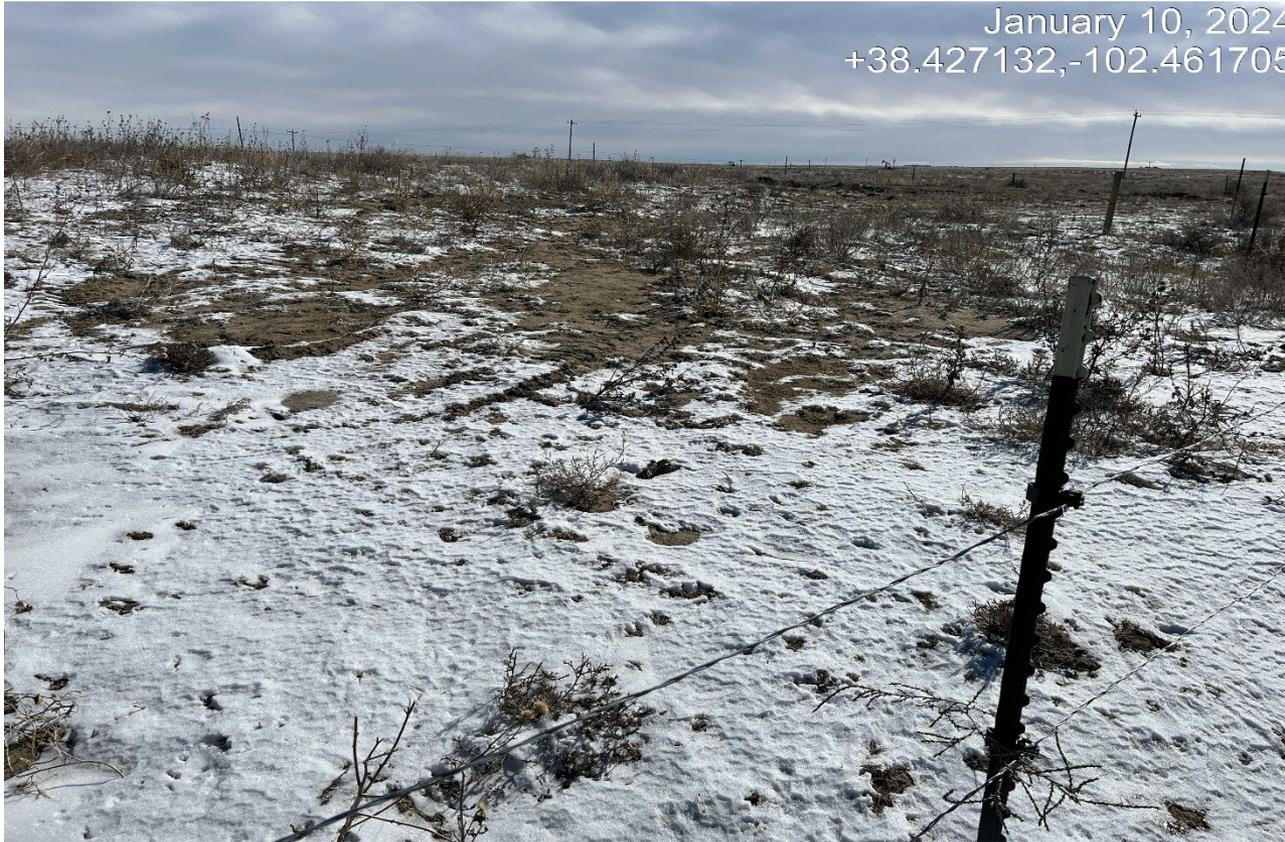
**Photo 6.** Facing southeast at the location. This area has not revegetated and needs to be seeded and stabilized. There is a 1 wire electric fence installed.

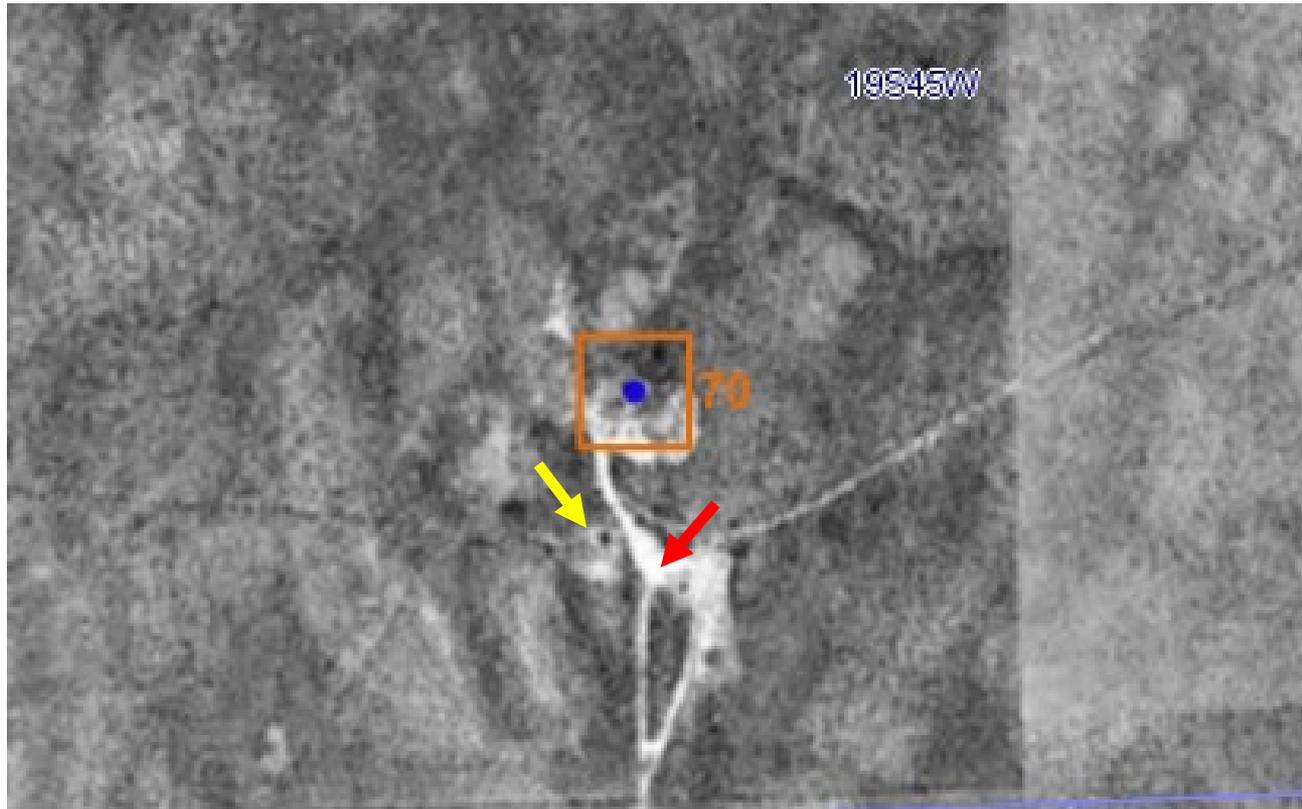
**Photo 7.** This is a 1990's aerial image of the wellsite. The yellow arrow shows the flowline cellar, red arrow shows where impacted soil has been excavated.
