Inspection Photos

Loc: 427573

Operator: INVESTMENT EQUIPMENT LLC

Inspection Date: 1/10/2024

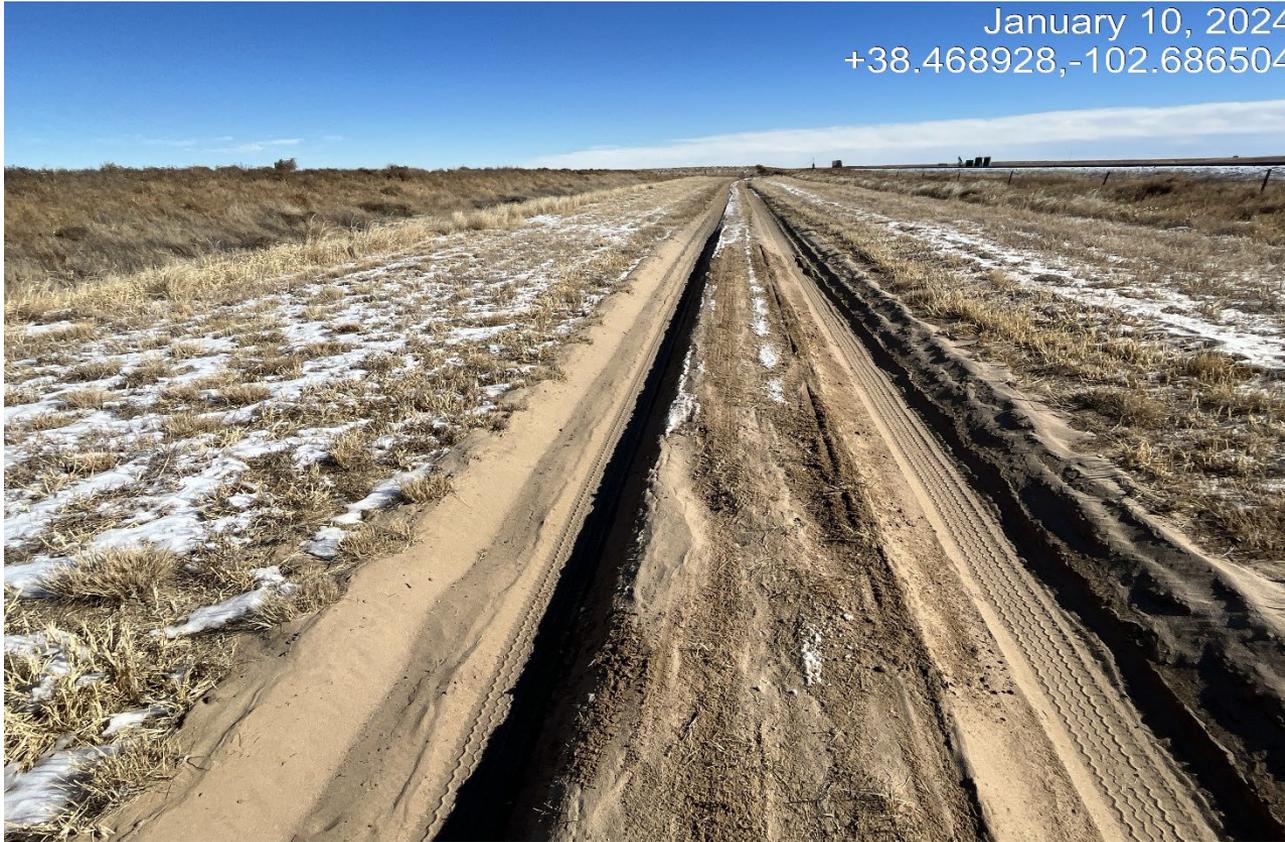
Photo 1. Facing east along the access road. There is deep ruts along this area of the road which is not stabilized.

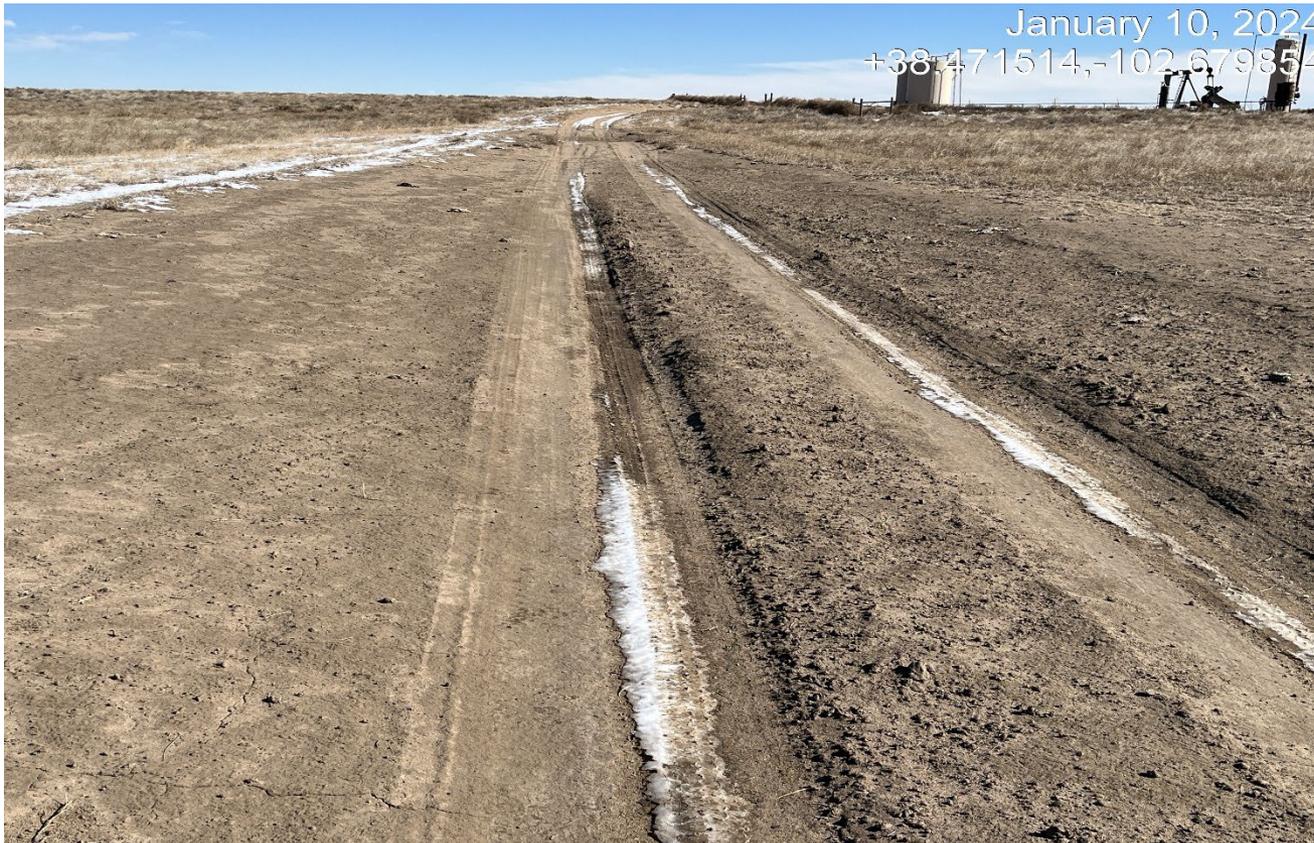
Photo 2. Facing east along the road near the location. This area is swalled and the road has been widened due to vehicle driving avoid this area during wet conditions..

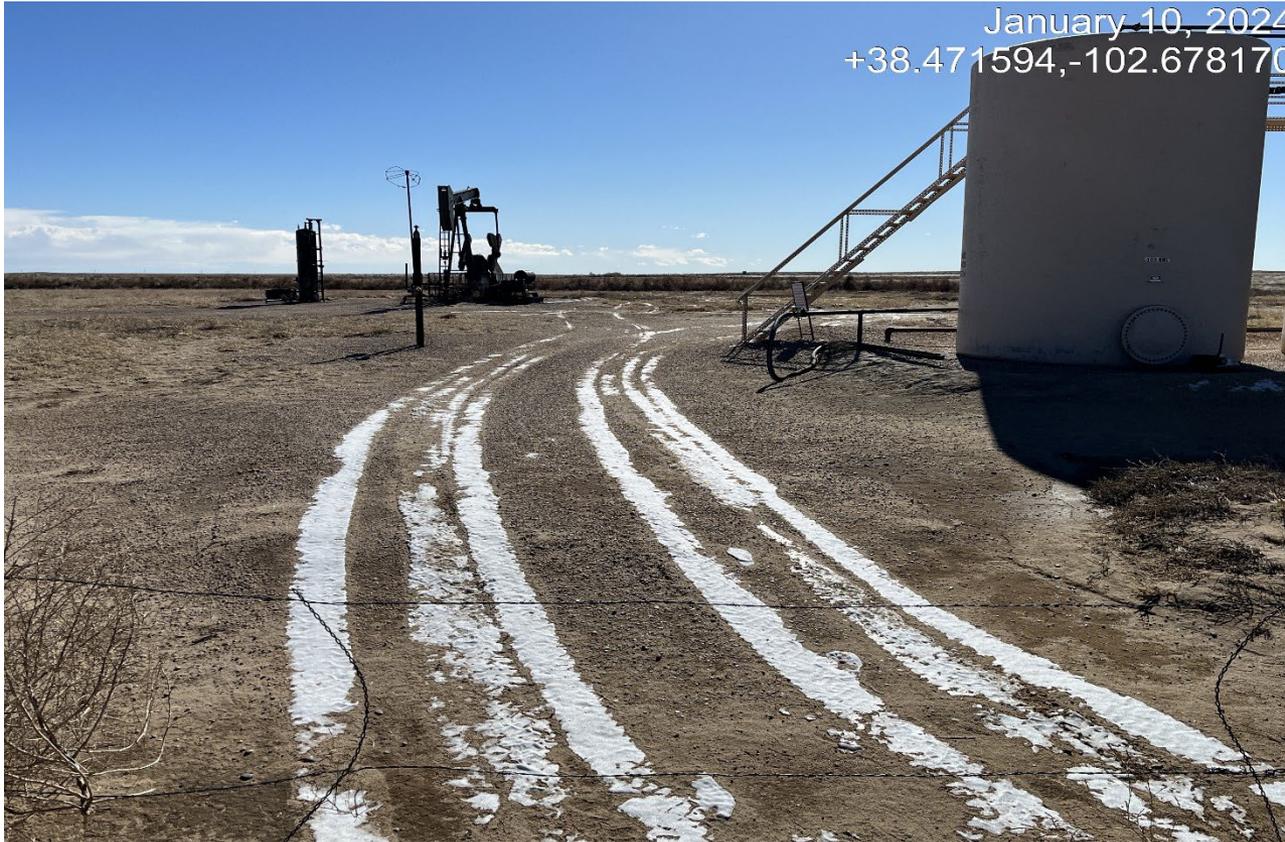
Photo 3. Facing southeast toward the wellsite.

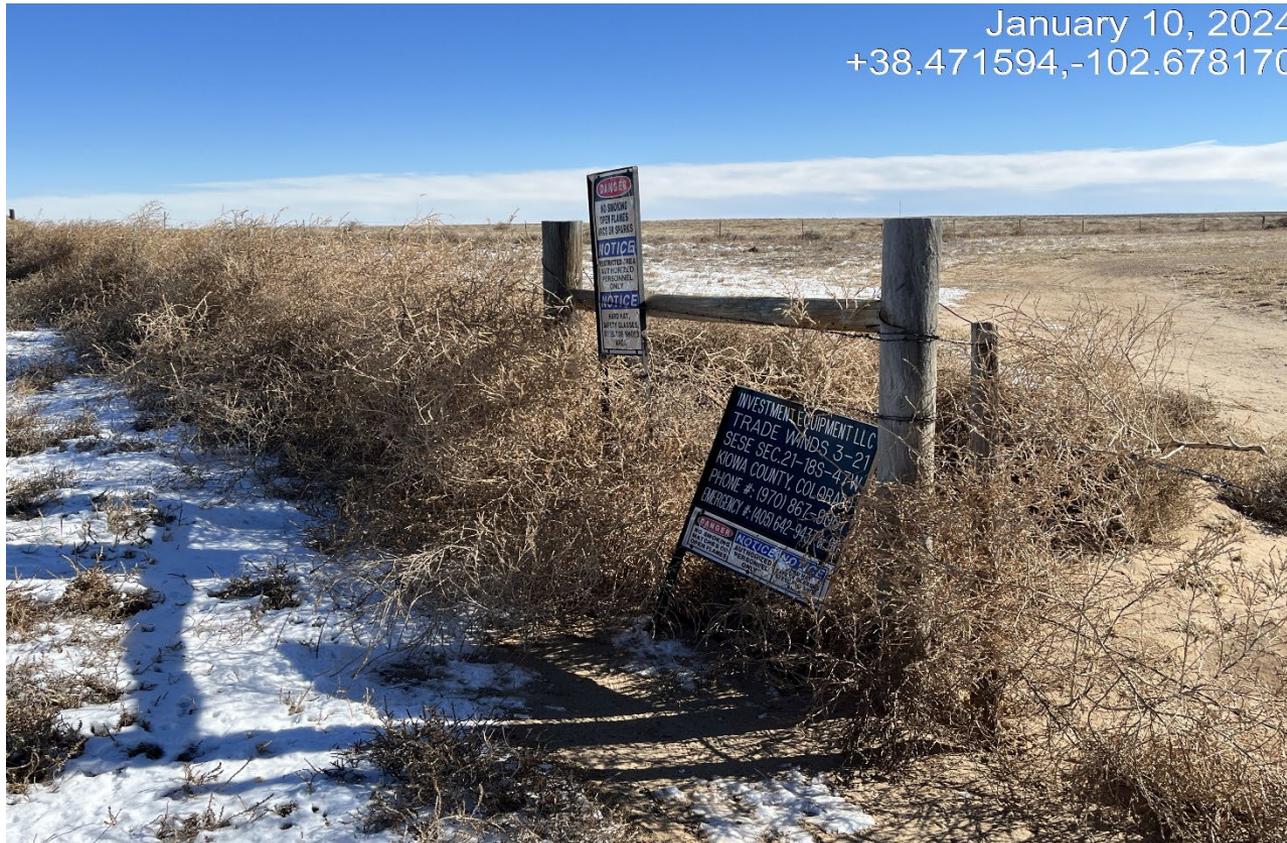
Photo 4. There is undesirable weed debris along the fence line that needs to be removed..

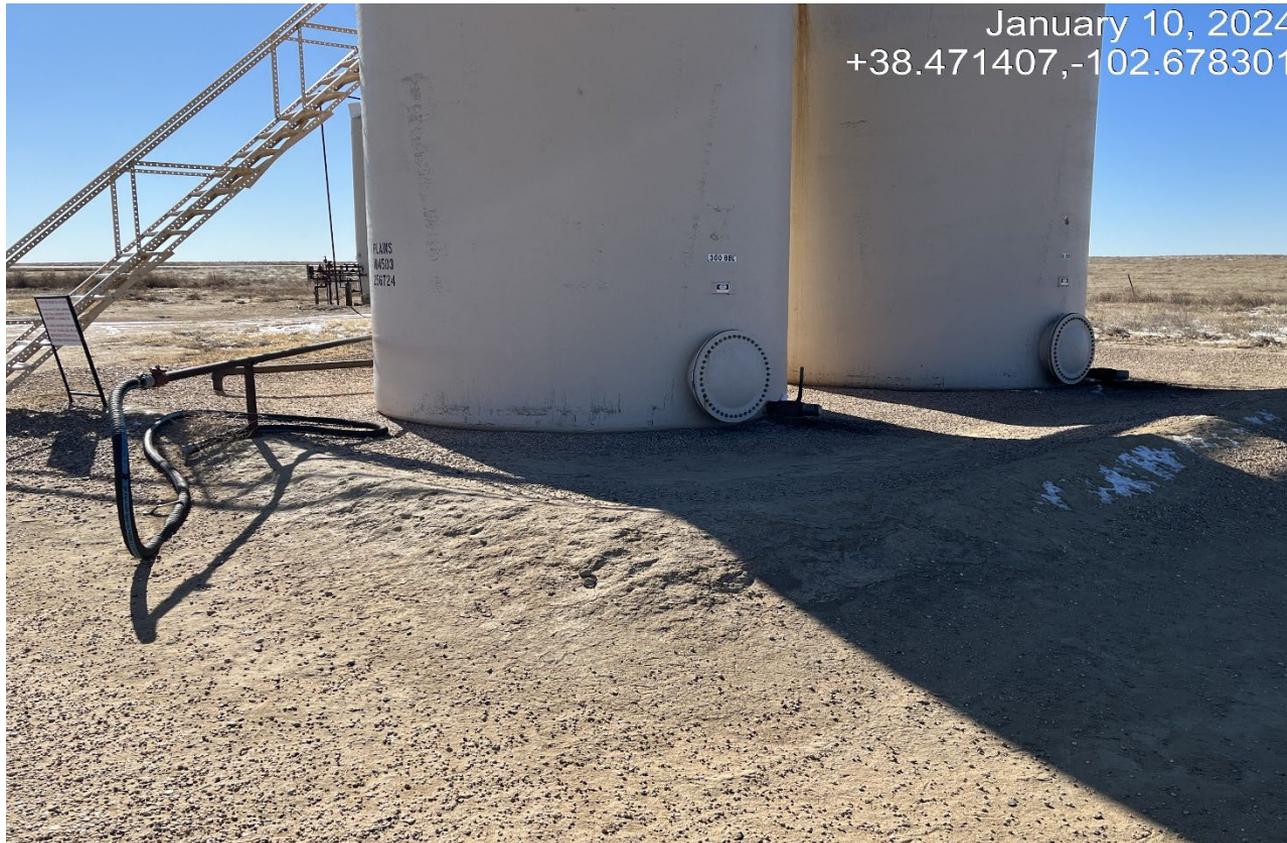
Photo 5. The berm around the tanks are inadequate to contain a spill.

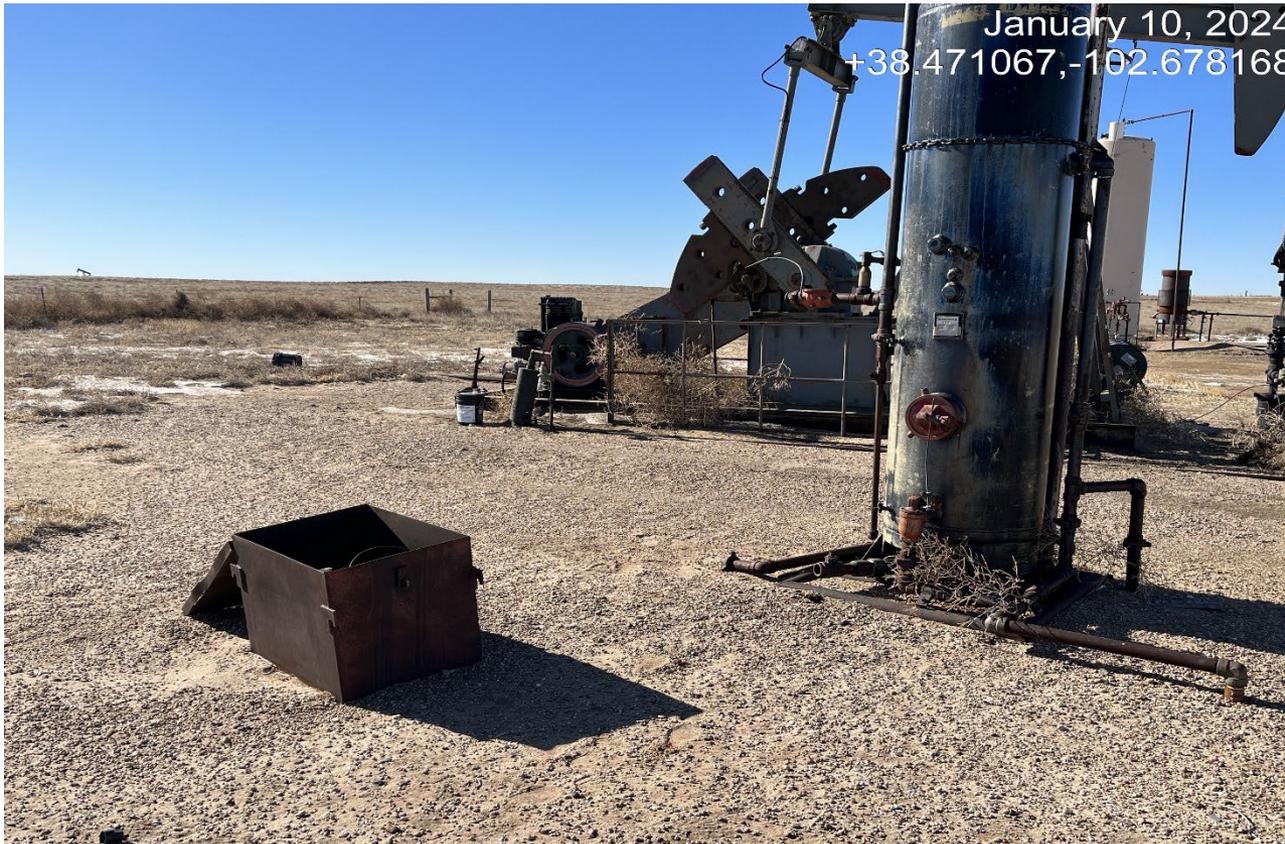
Photo 6. Facing toward the well head and separator.

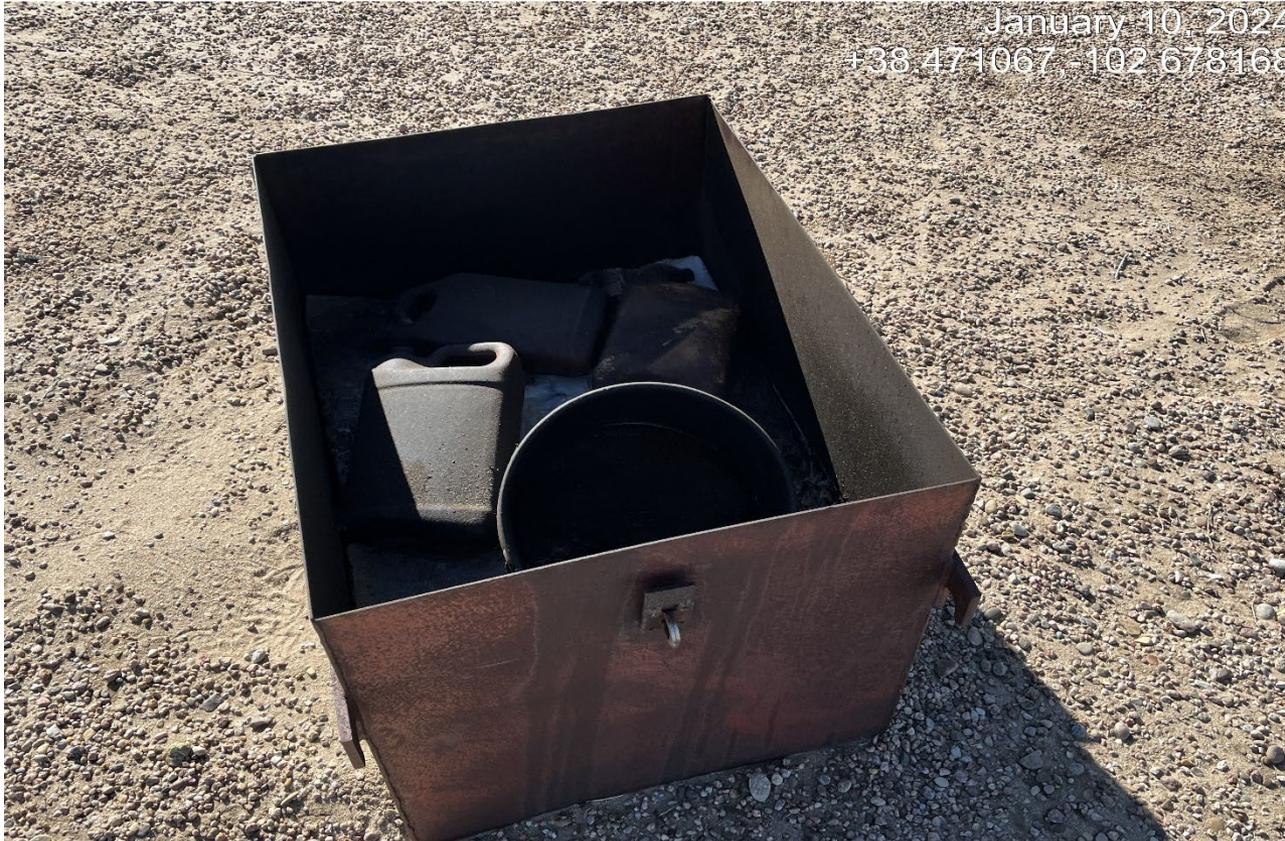
Photo 7. There is oil containers and oil fluid stored in this metal box that needs to be removed..

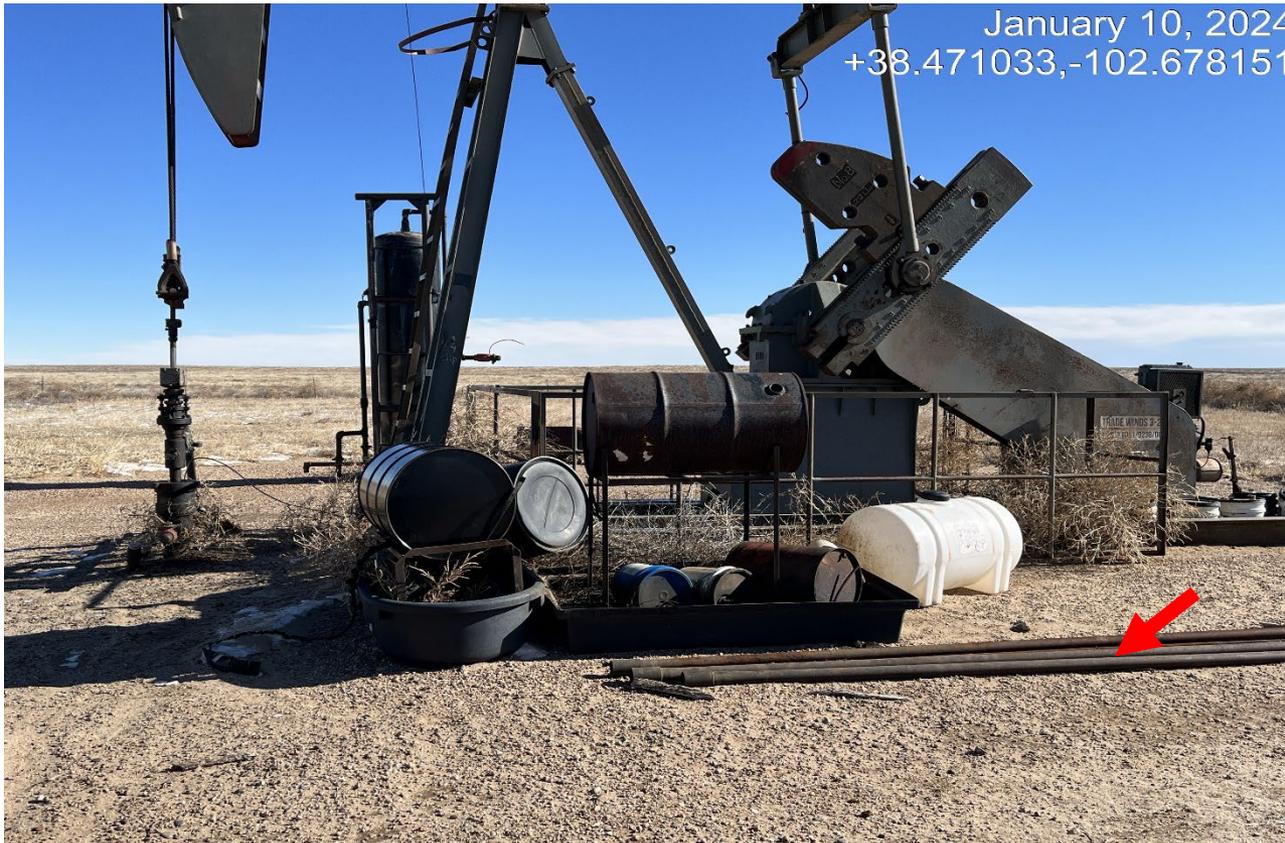
Photo 8. Facing toward the pumpjack. Unused pipe and containers need to be removed.

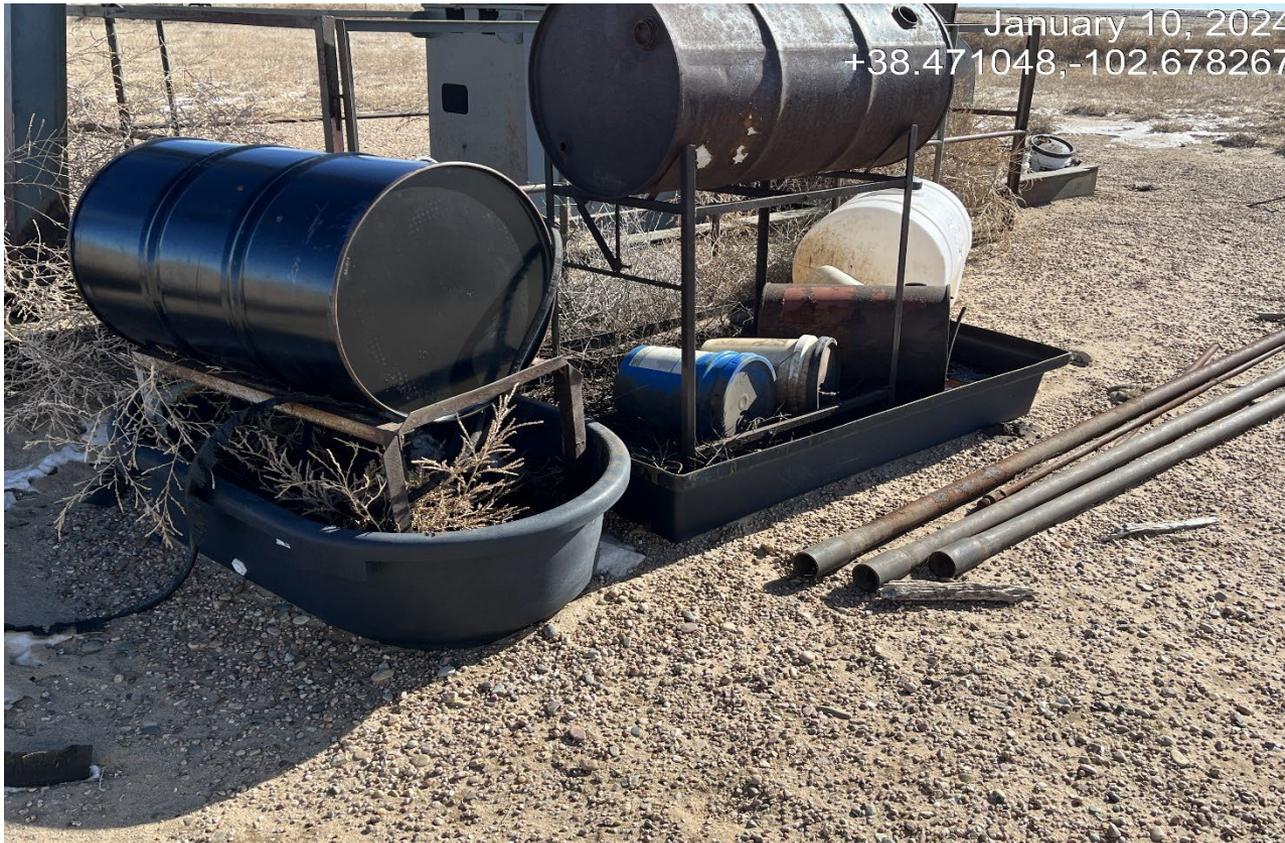
Photo 9. There are oil fluids and empty containers in the containment at red arrow that needs to be cleaned up and removed.
