# Inspection Photos

Loc: 417910

Operator: INVESTMENT EQUIPMENT LLC

Inspection Date: 1/10/2024

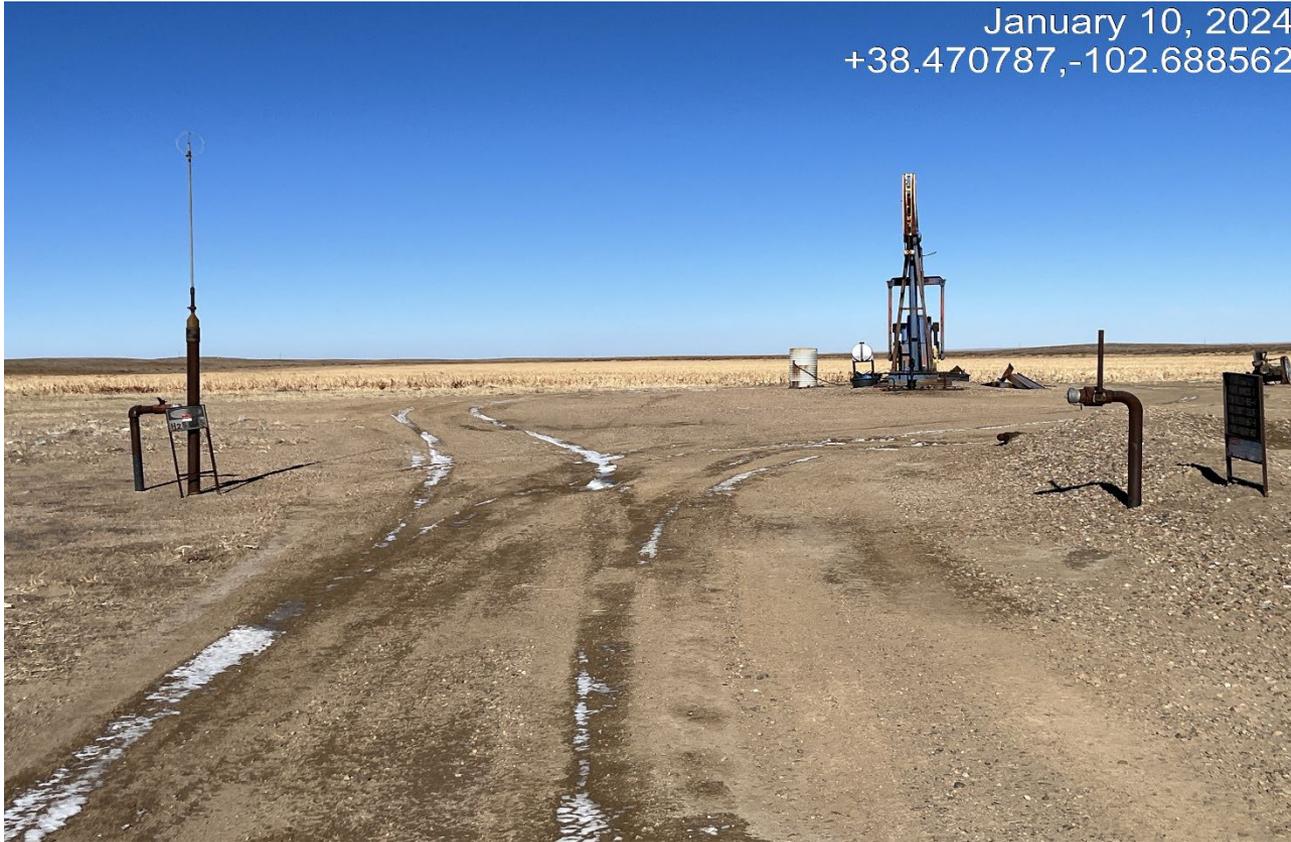
**Photo 1.** Facing north toward the wellsite. The wind sock is no longer present.

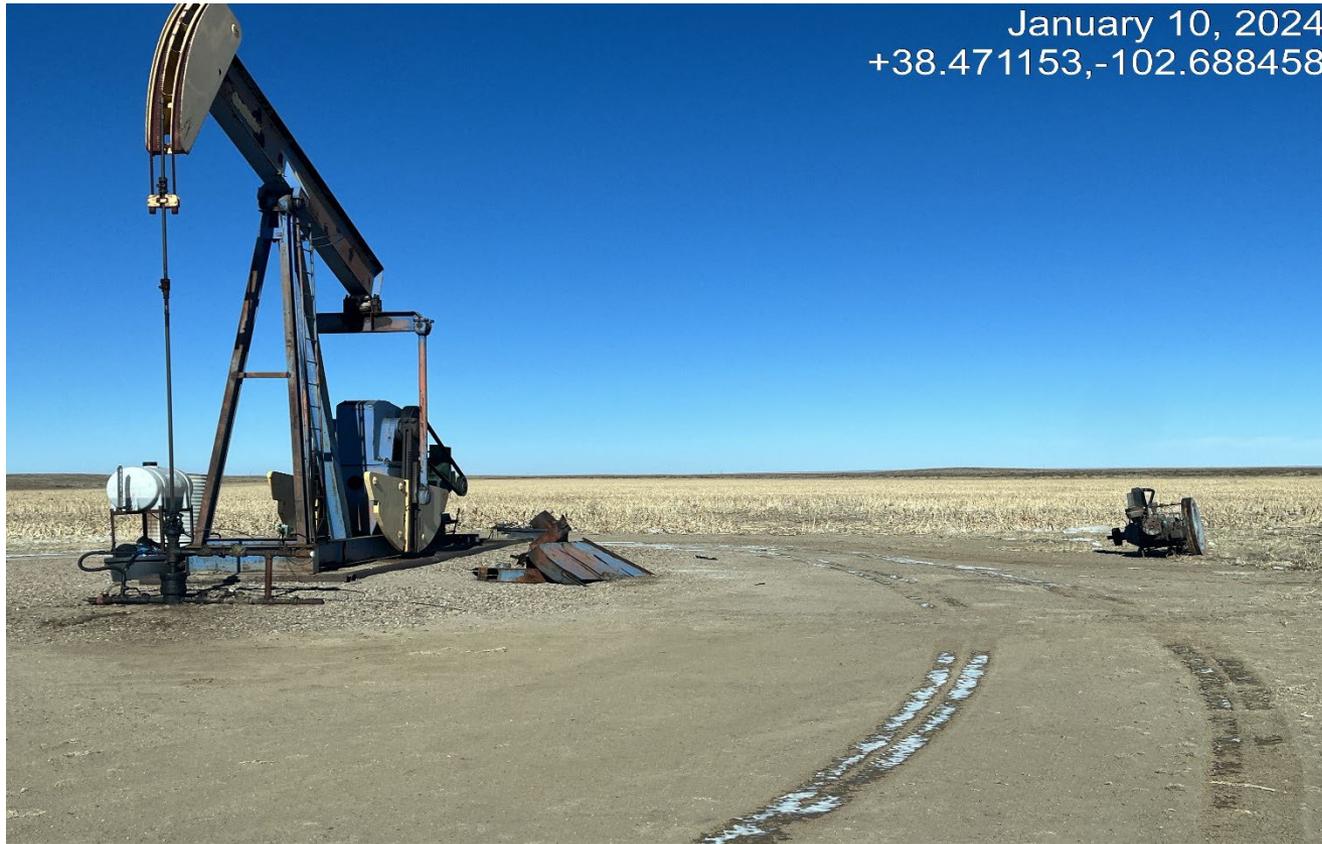
**Photo 2.** There are unused parts laying on the ground next to the pumpjack.

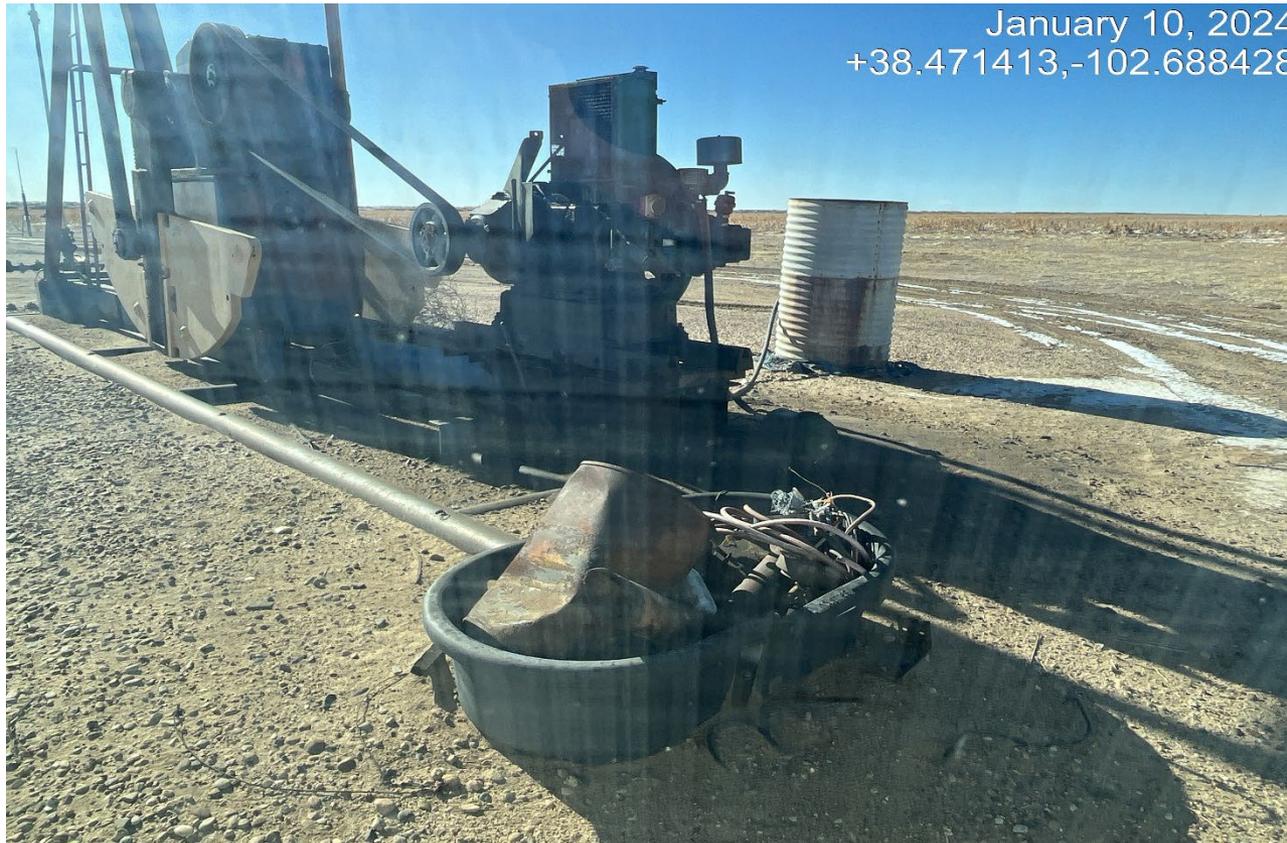
**Photo 3.** There is parts and trash debris inside this broken container that needs to be removed..

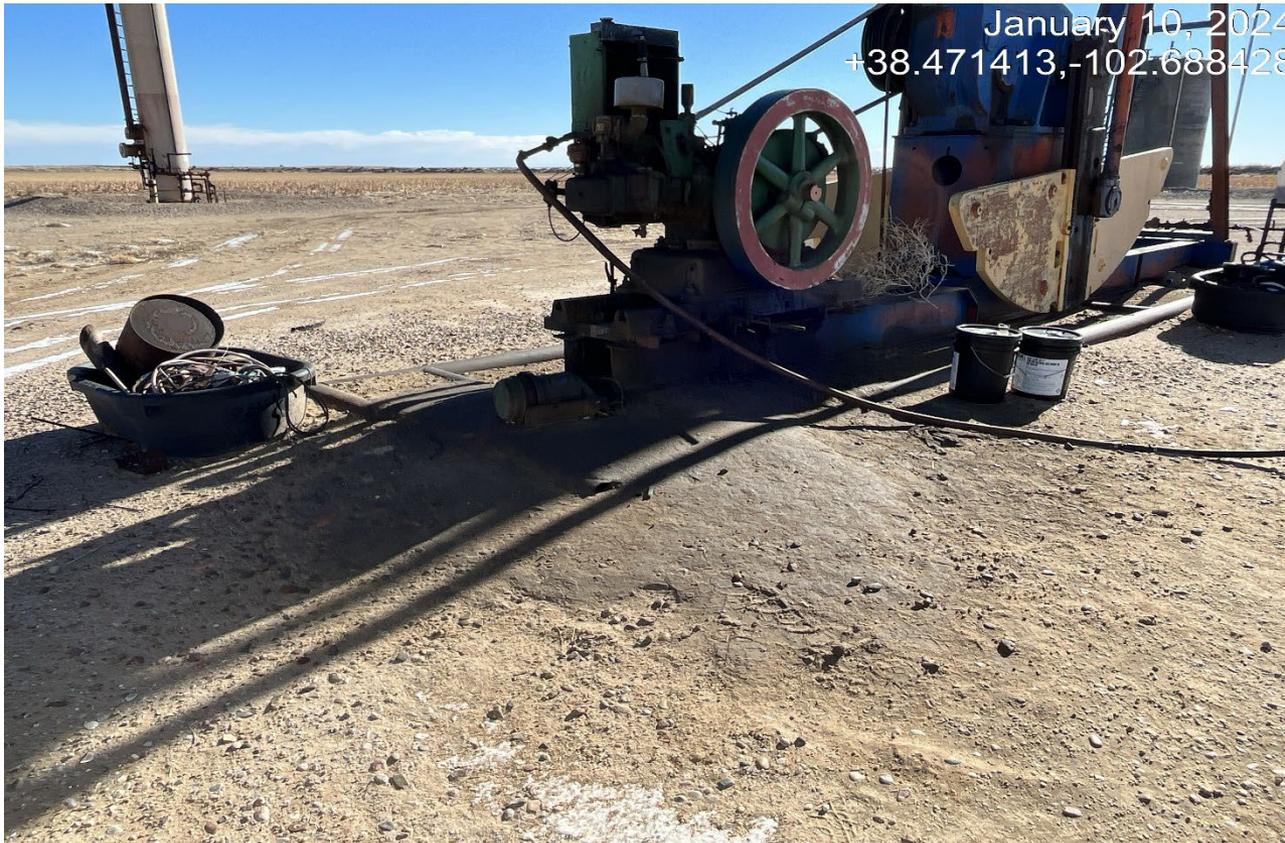
**Photo 4.** There is oil stained soil next to the engine pumpjack that needs to be cleaned up.

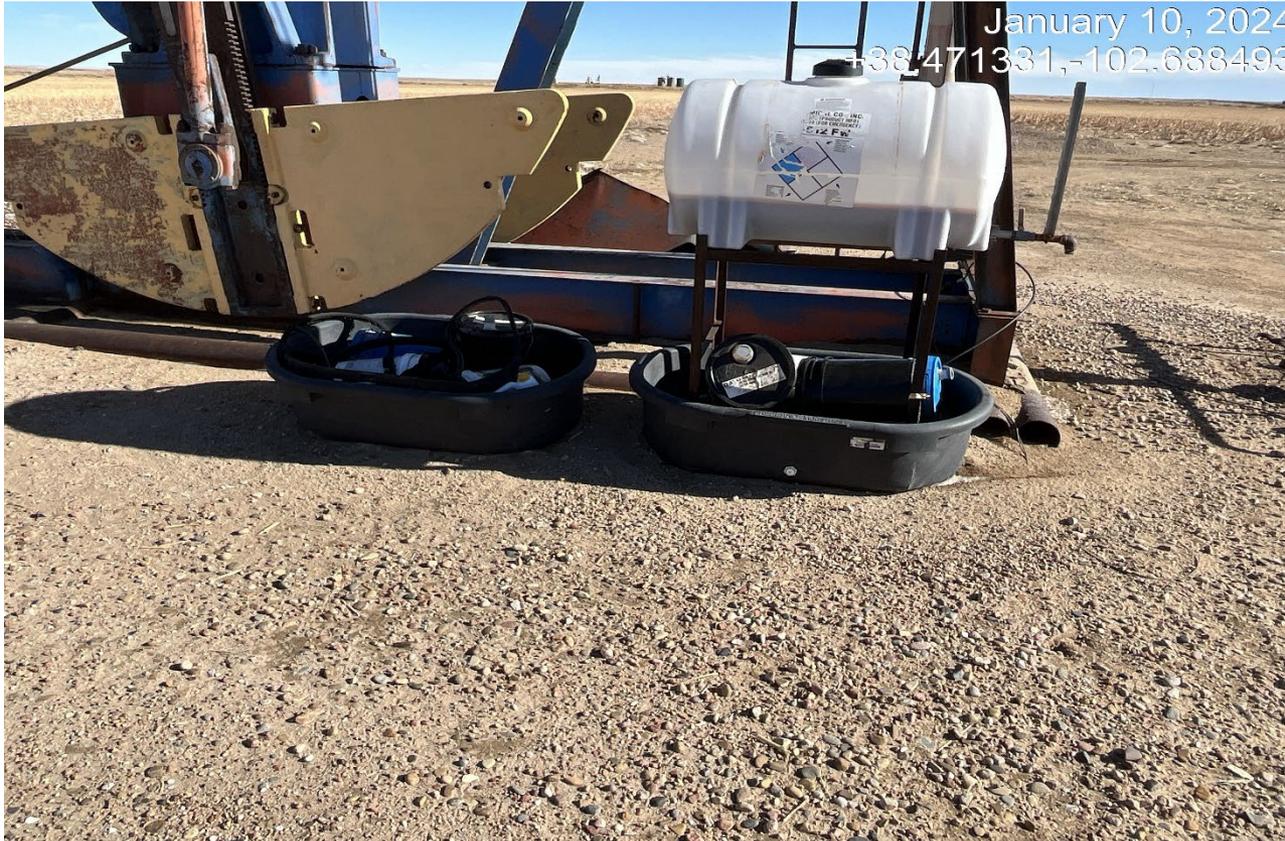
**Photo 5.** There are various and empty containers inside the containment that need to be thrown away..

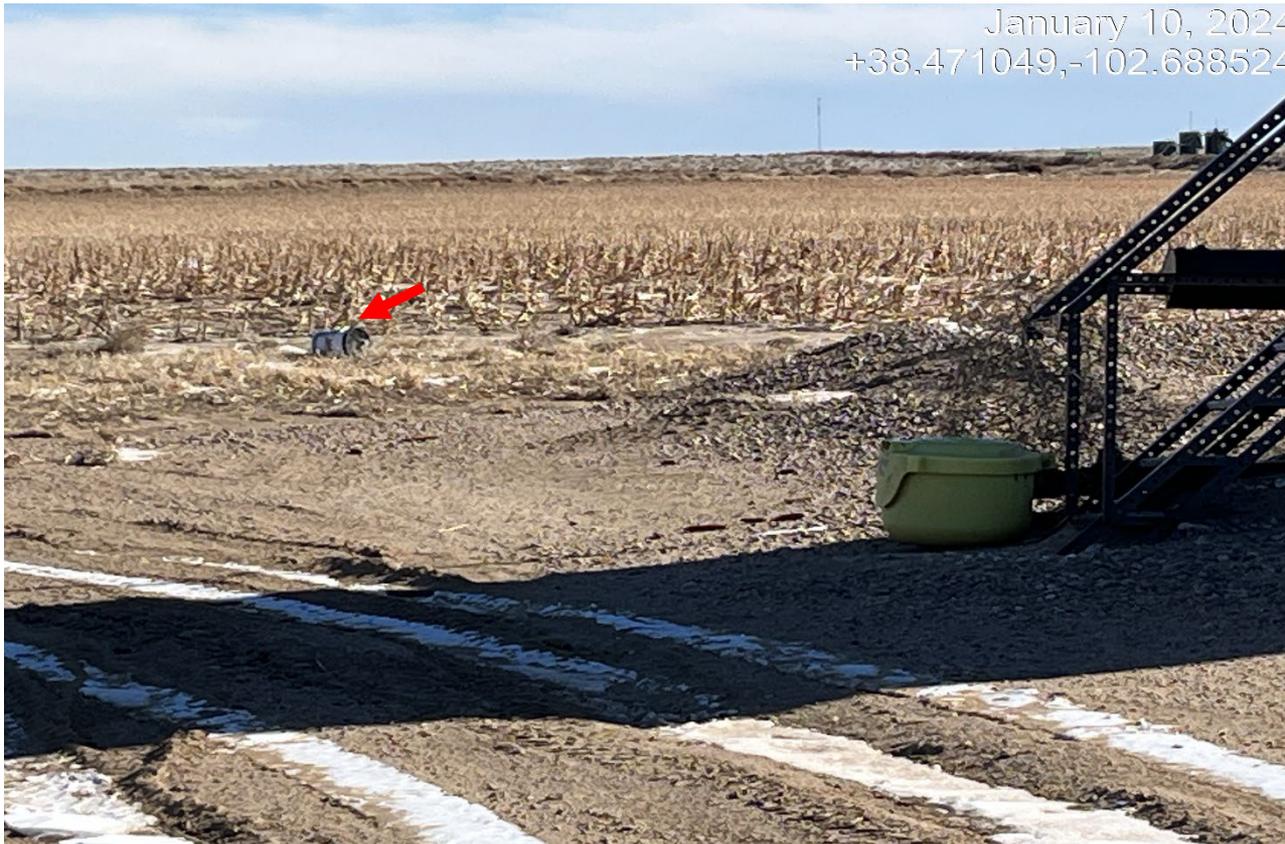
**Photo 6.** One of the empty oil containers has blown at into the field.
