Inspection Photos

Location Name: CAERUS PICEANCE LLC DAYBREAK FEDERAL 30-6 (PG30) Pad

Location #: 334657

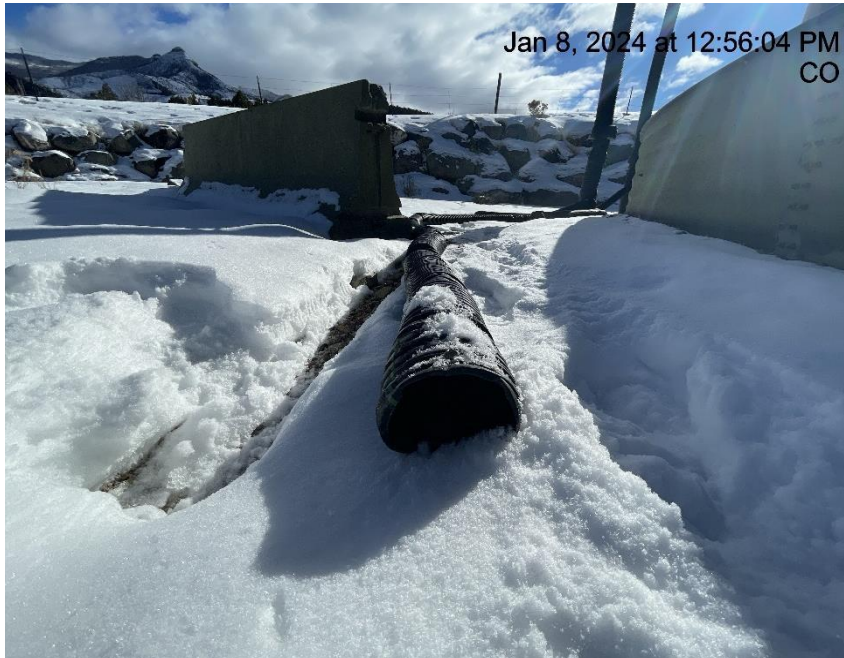
Photo # 2037 From inspection 708902741 flowline heating insulation open ended

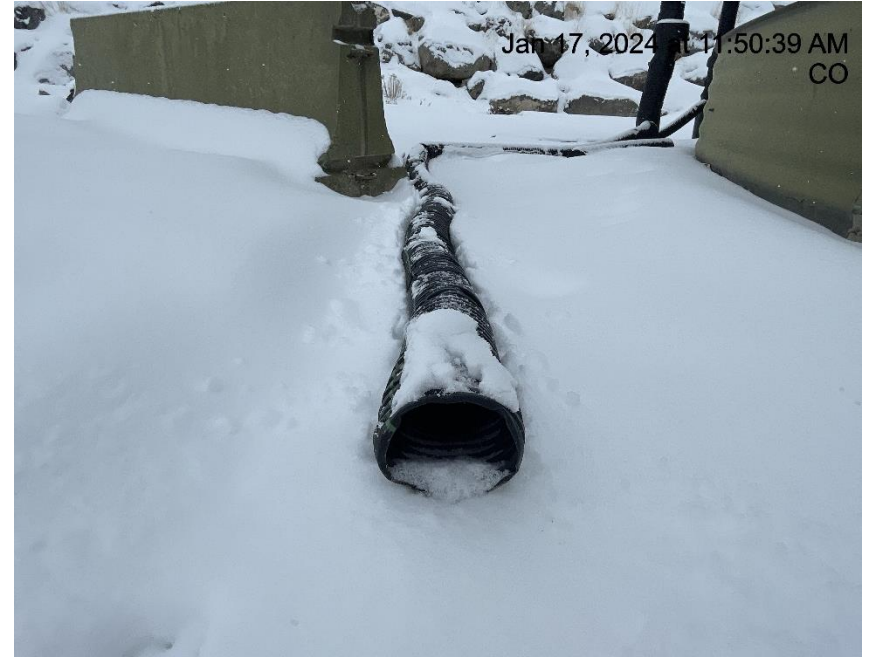
Photo # 2975 Flowline heating insulation open ended

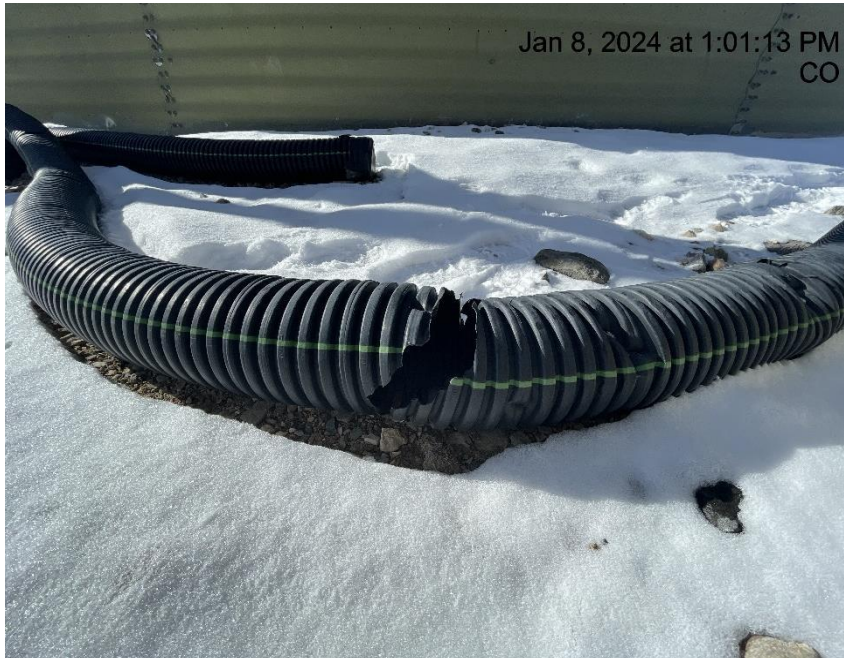
Photo # 2038 From inspection 708902741 hole in flowline heating insulation/wildlife hazard

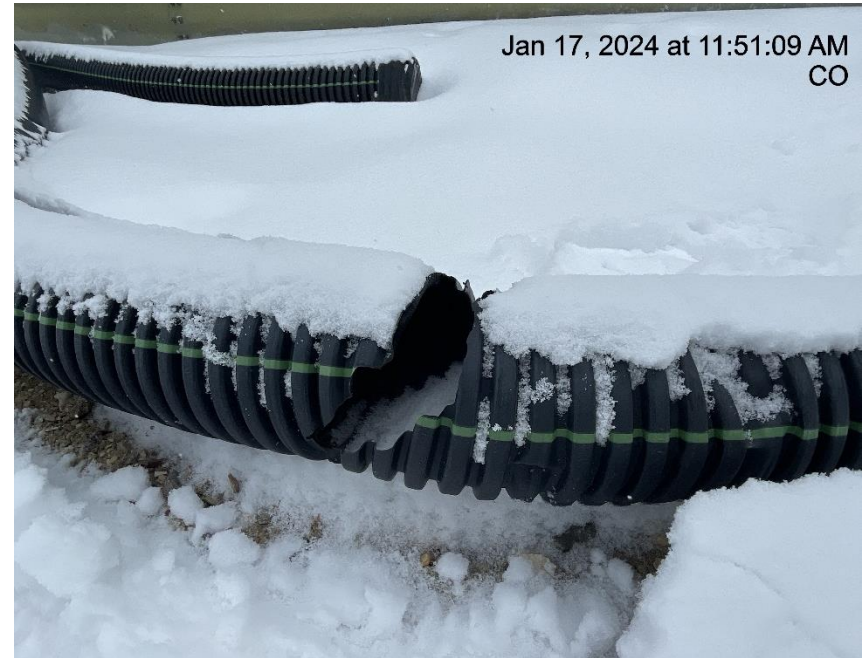
Photo # 2976 Hole in flowline heating insulation/wildlife hazard
