Inspection Photos

1/16/2024

Operator: TEP ROCKY MOUNTAIN LLC #96850

Location ID: 335788

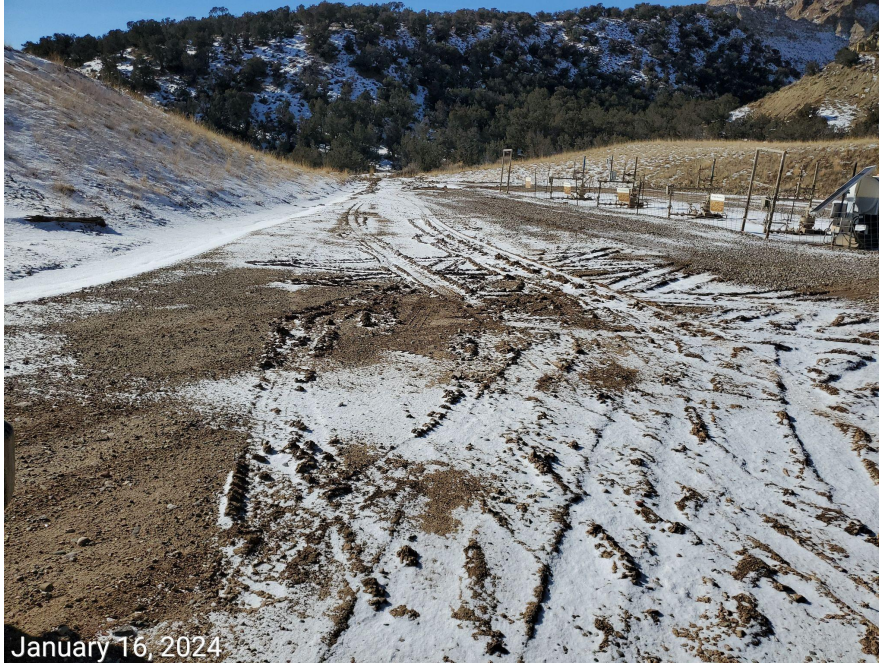
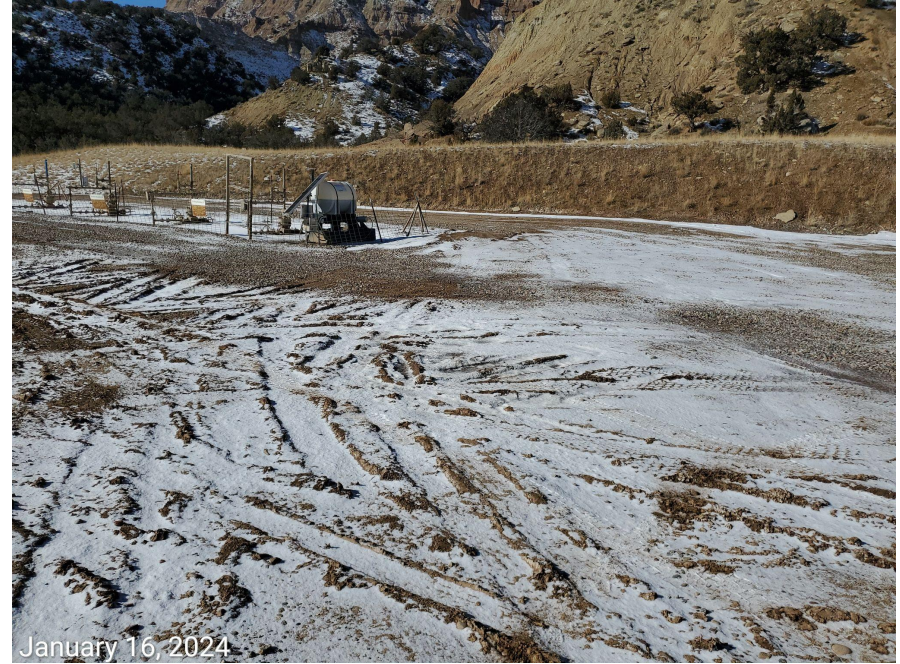
Photo 1: Photos 1-2 taken from the southern working pad surface of the Location. Photos provide an overview of the Location from southwest, west, north to northeast. Photos also examples showing BMPs to stabilize the working pad surface, as well as to minimize erosion, degradation and off-site sediment transport are missing or insufficient.

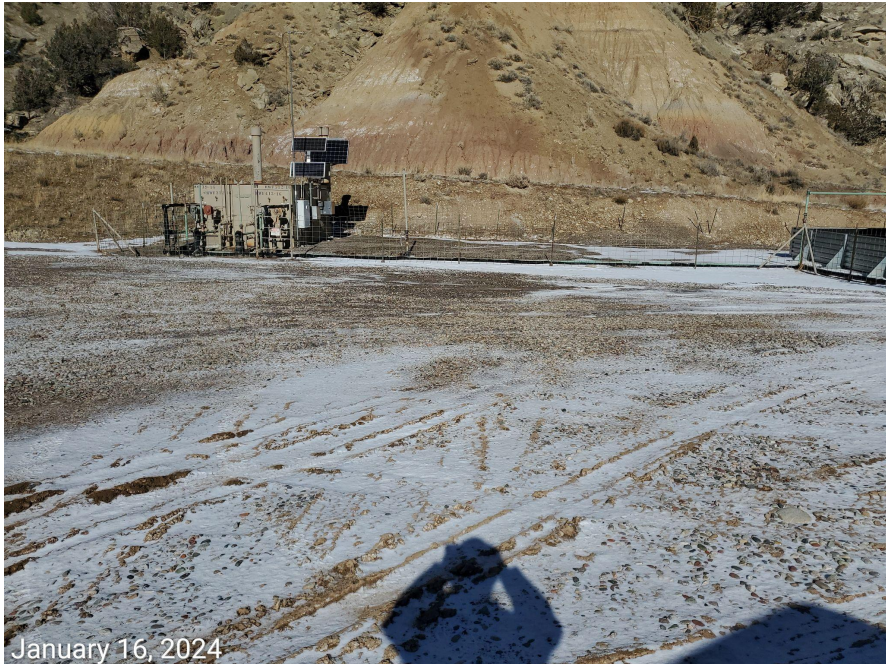
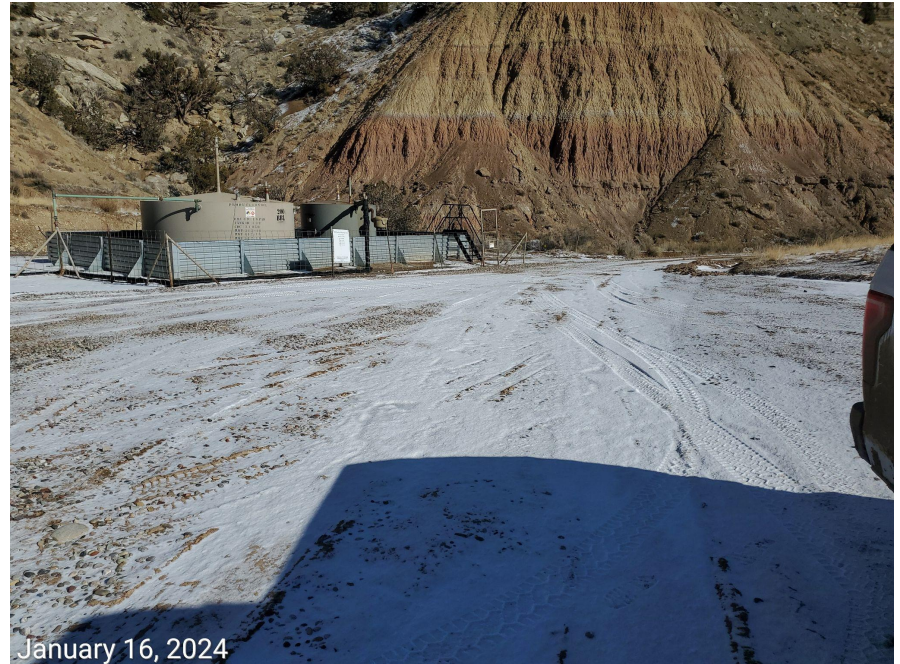
Photo 2: Photos taken from the east end of the Location. Photos provide an overview of the Location from southwest to west.

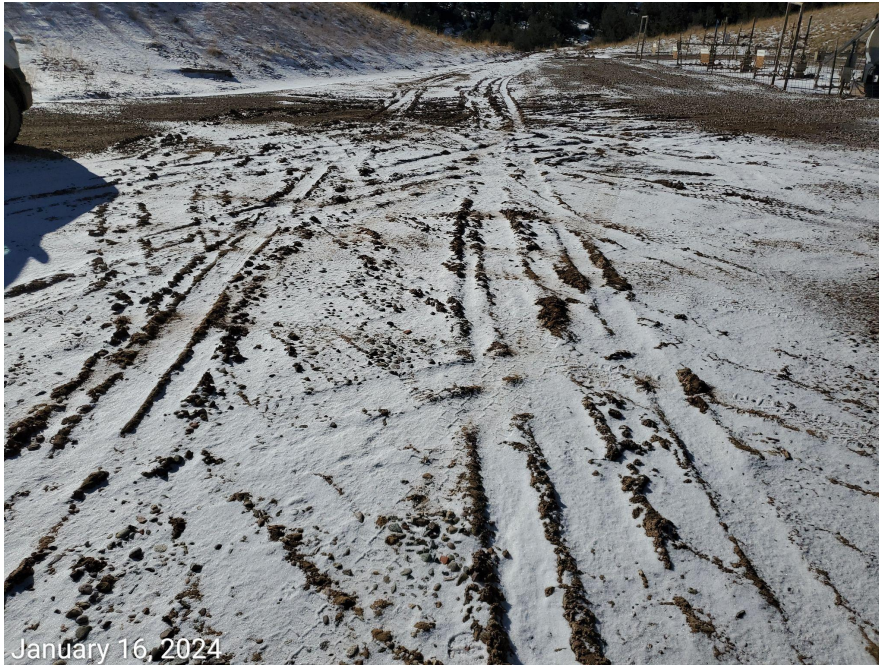
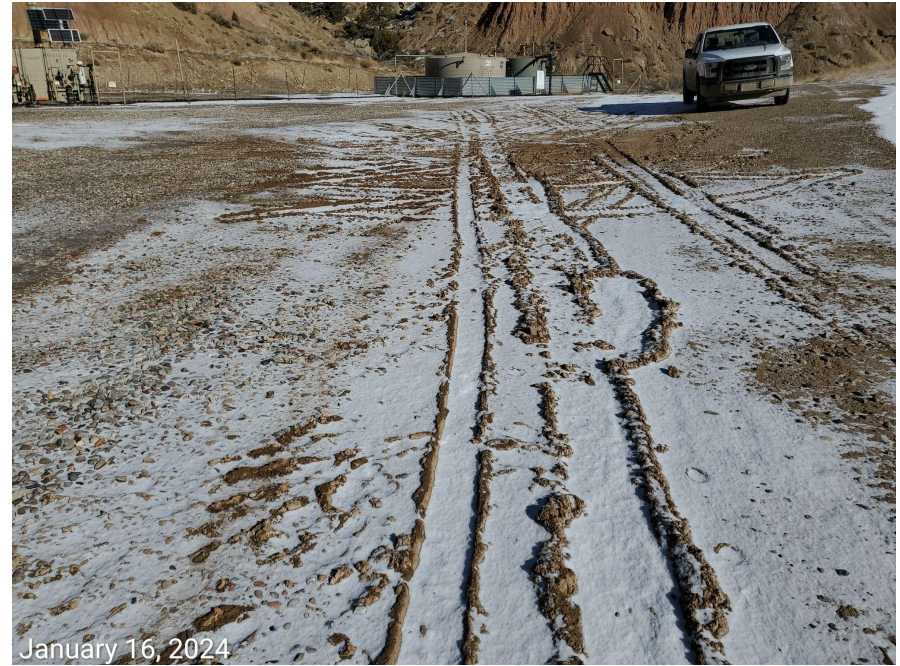
Photo 3: Photos taken examples showing BMPs to stabilize the working pad surface, as well as to minimize erosion, degradation and off-site sediment transport are missing or insufficient.

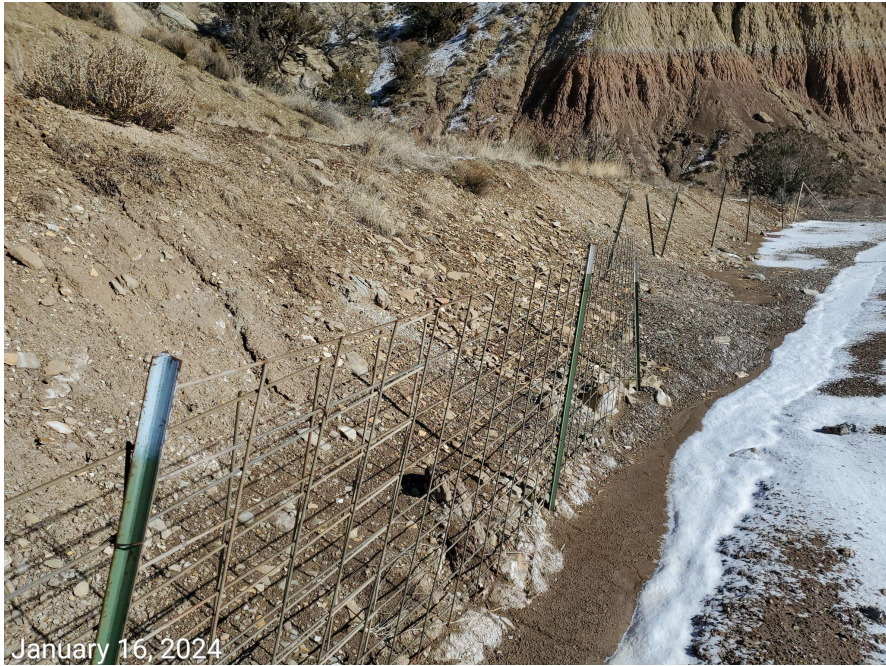
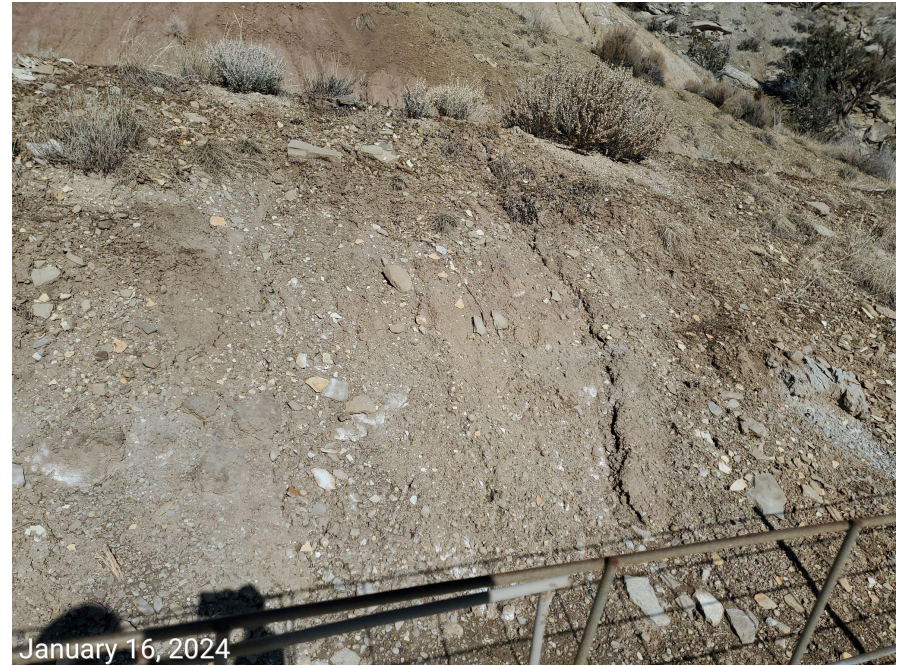
Photo 4: Photos taken from the slopes behind the tank battery facility. Stormwater and erosion control BMPs are missing or insufficient. Soil are bare and erosion degradation is apparent. Sediment eroded from the slopes are deposited within a ditch, which discharges off-site.

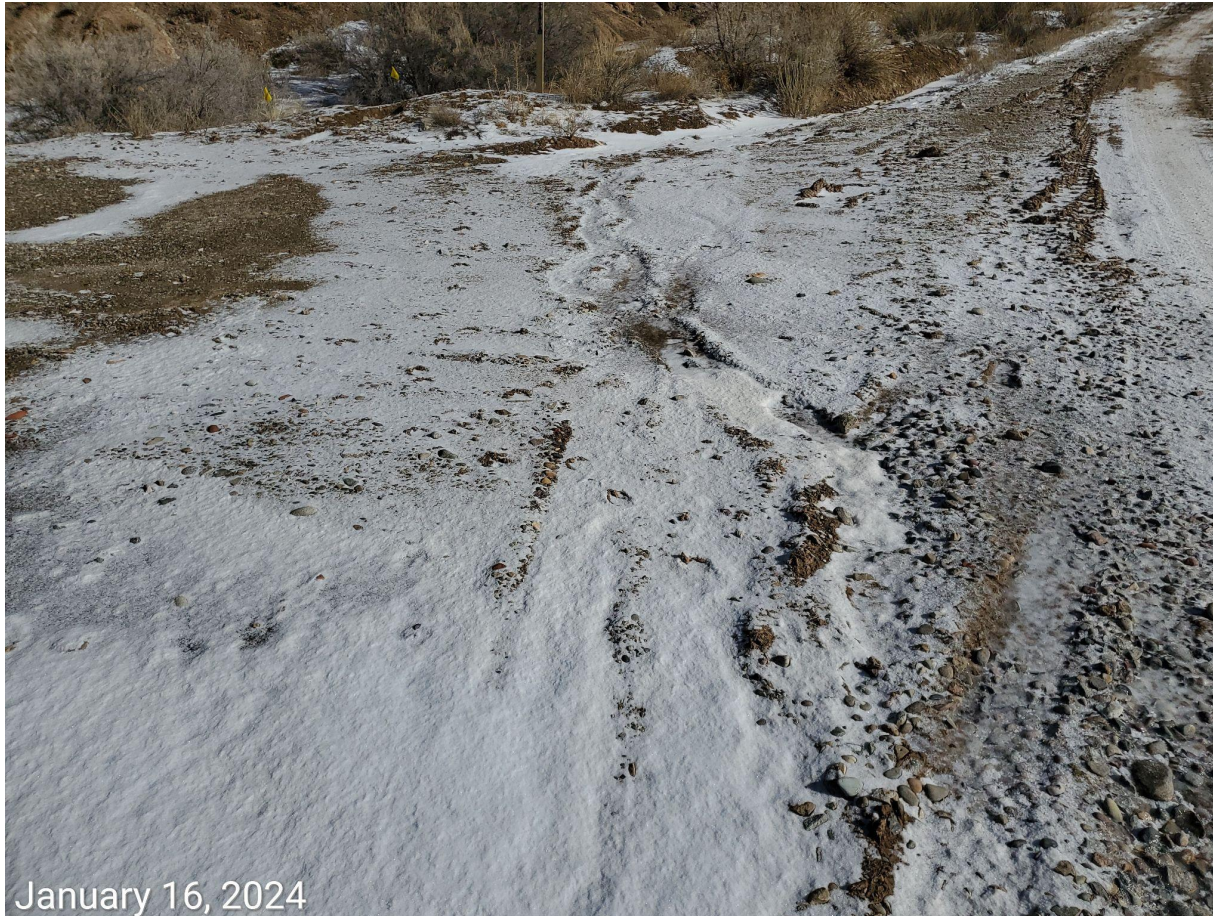
Photo 5: Photo taken from the north end of the Location; stormwater runoff from the working pad surface is resulting in erosion and degradation.

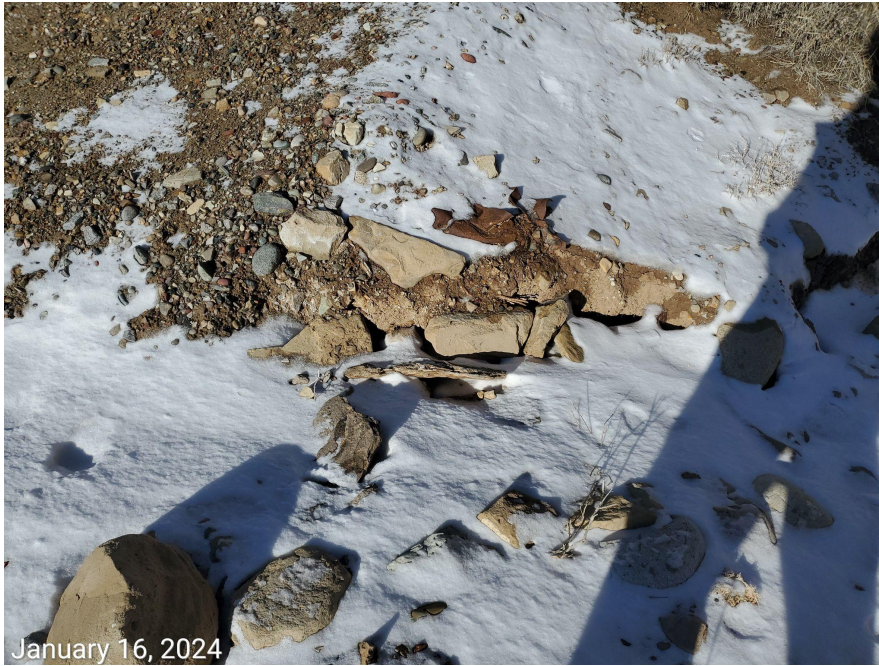
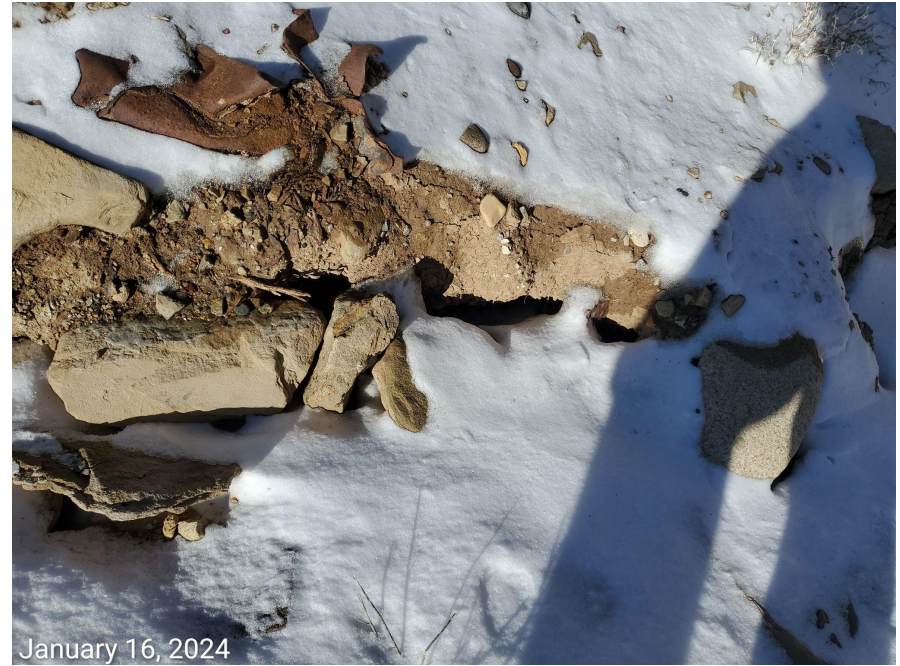
Photo 6: Photo taken from the stormwater outlet on the north end of the Location, near the entrance. Outlet has not been installed or maintained in accordance with good engineering practices; stormwater has eroded areas of the control beneath/around the rip-rap material; geotextile lining in conjunction with rip-rap not observed per good engineering practices.

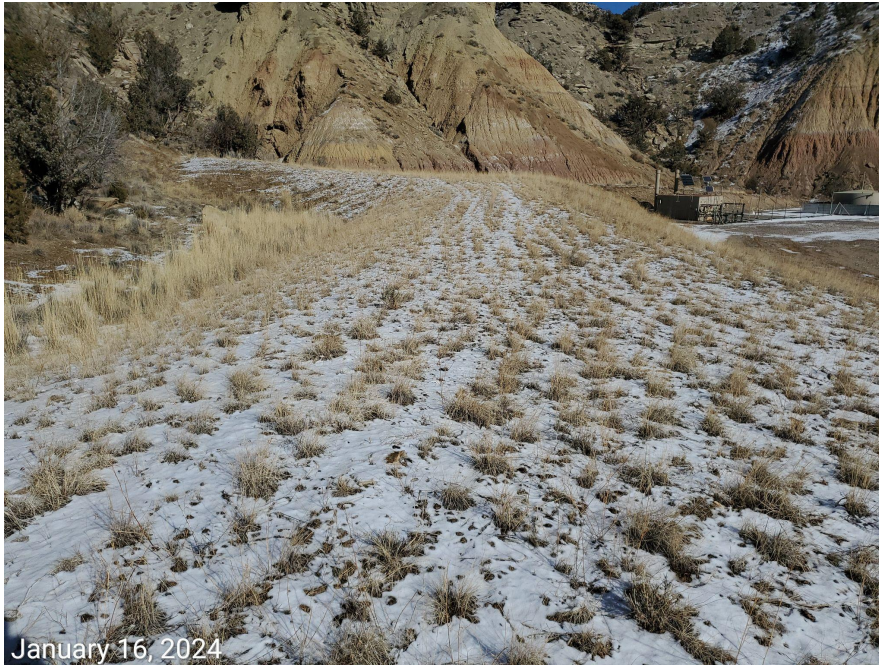
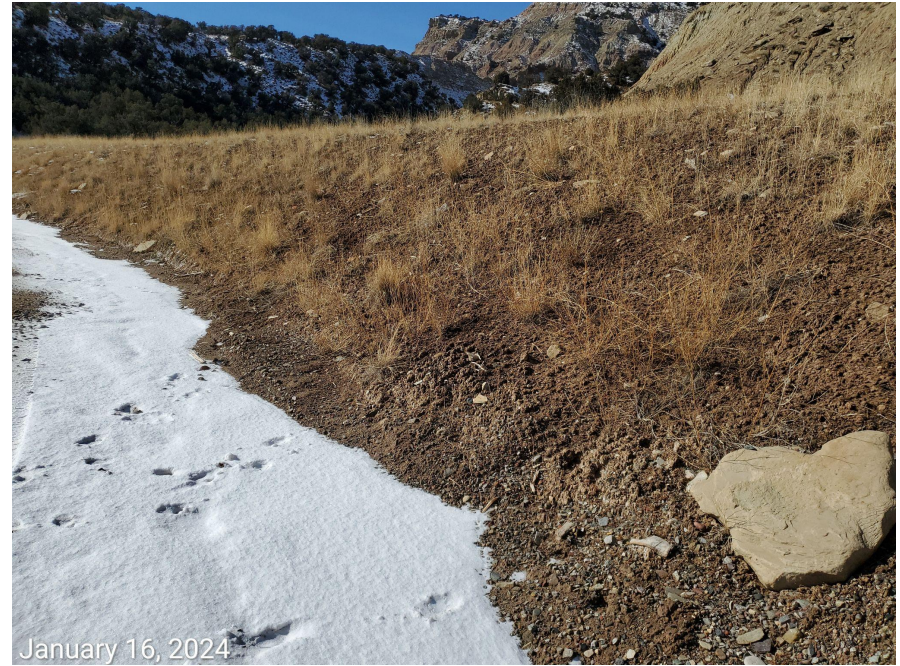
Photo 7: Photos examples of the interim areas of the Location. Slopes (photo right) may require additional revegetation efforts to ensure uniform establishment.
