Inspection Photos

Operator: TEP ROCKY MOUNTAIN LLC #96850

Location ID: 335174

Inspection Doc: 696205539

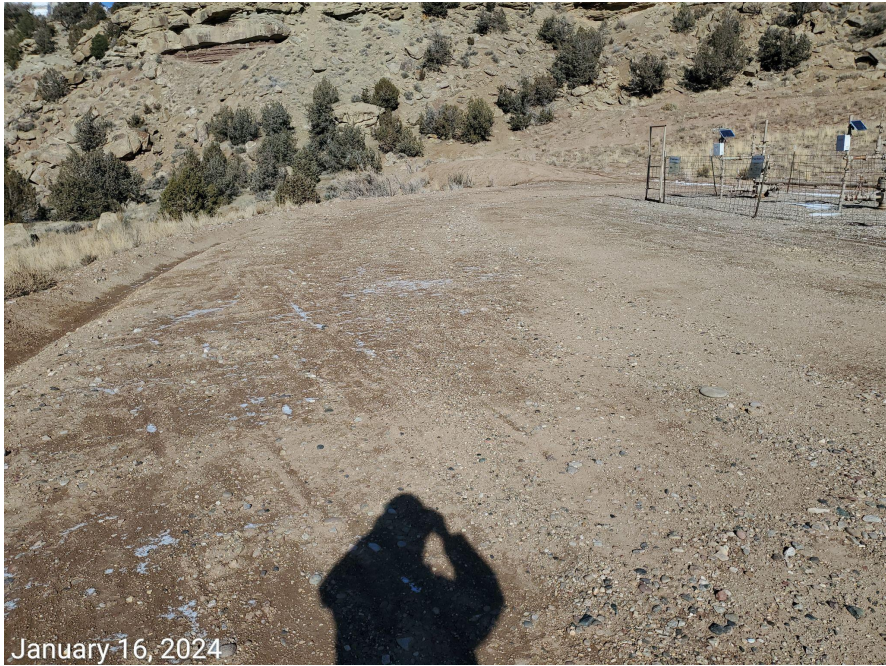
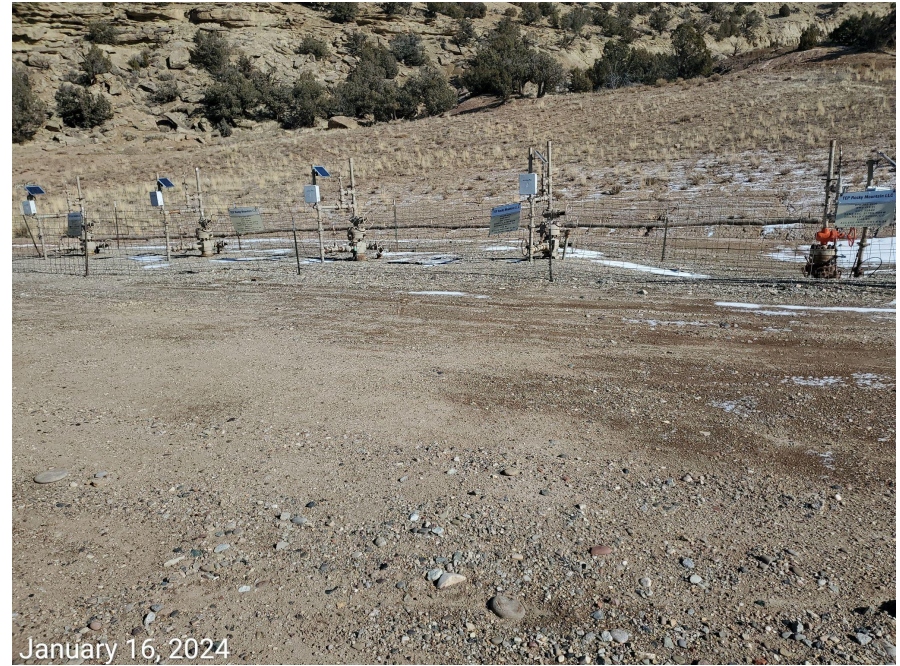
Photo 1: Photos taken from the west end of the well's working pad surface of the Location. Photos provide an overview of the Location from north, northeast, southeast to south.

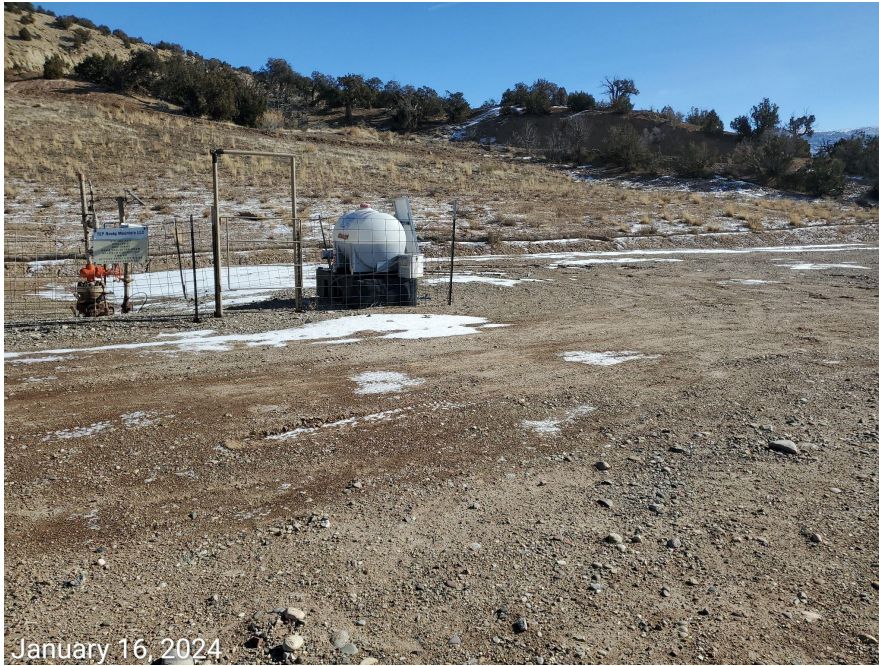
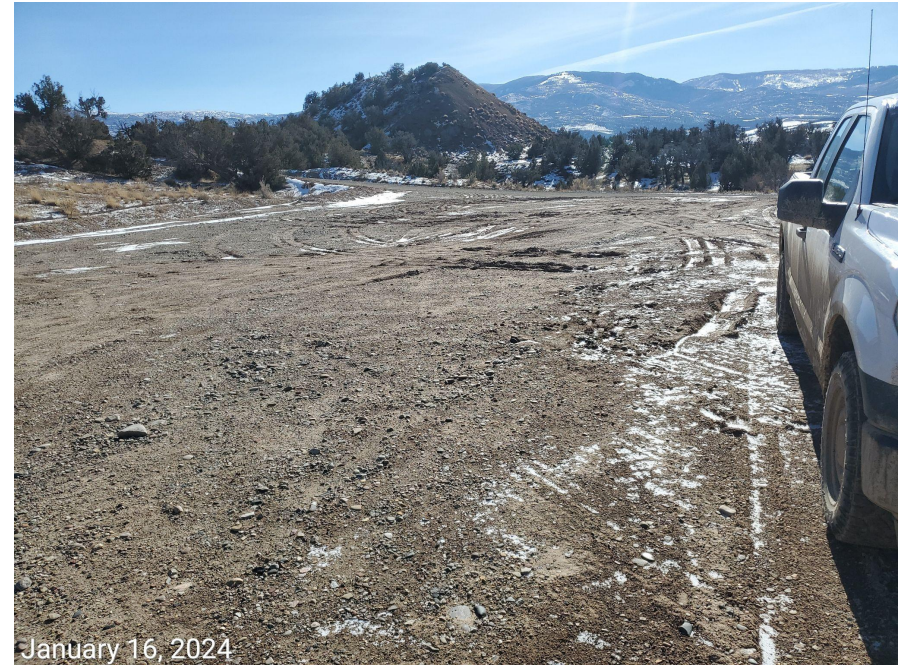
Photo 2: See comments under photo 1.

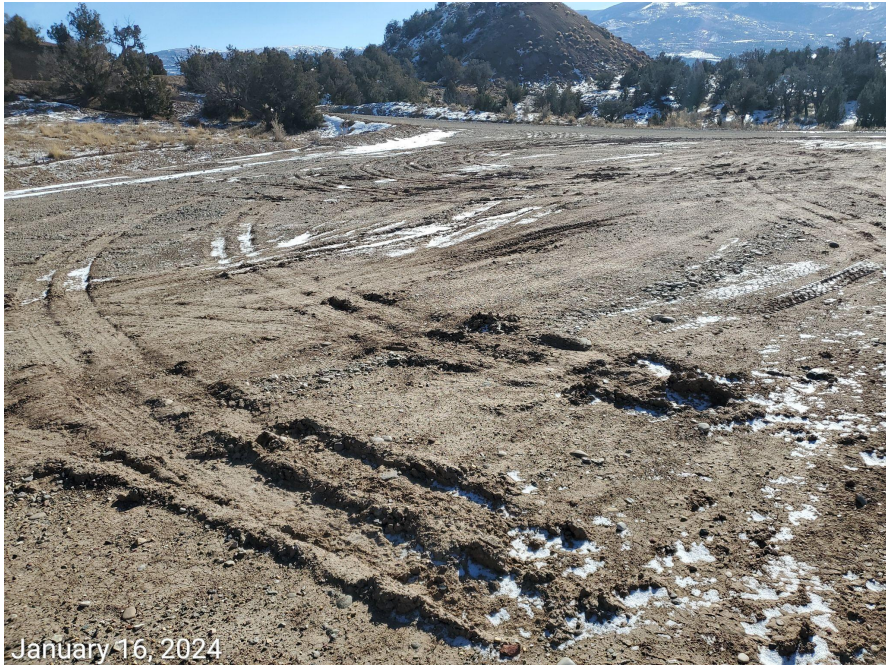
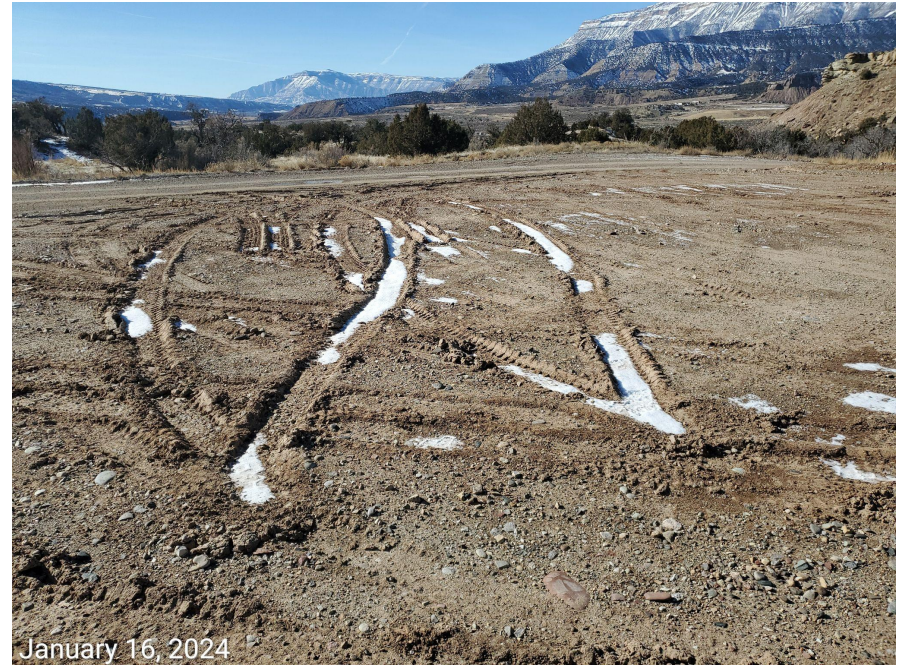
Photo 3: Photos examples showing BMPs to stabilize the working pad surface, as well as to minimize erosion, degradation and off-site sediment transport are missing or insufficient.

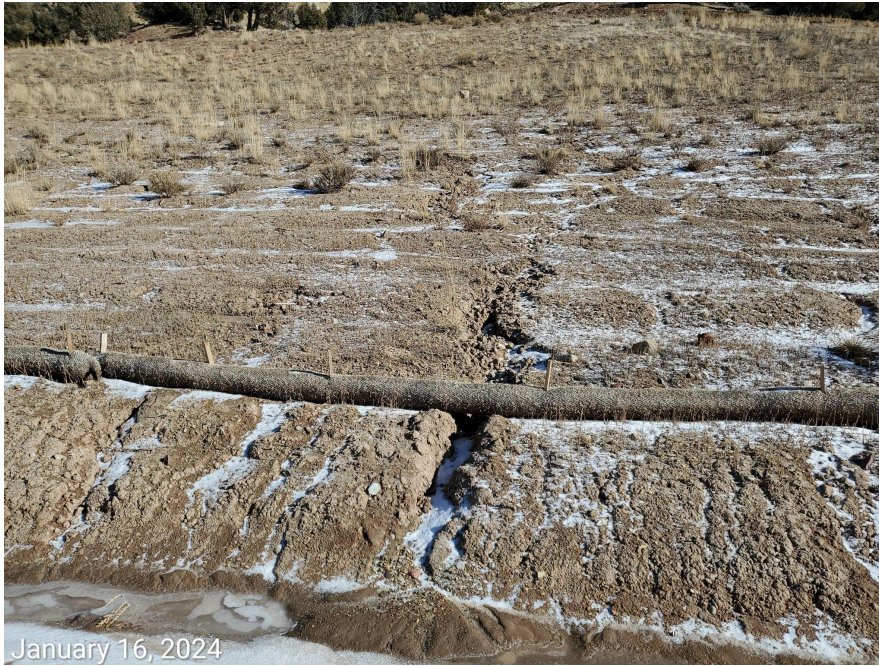
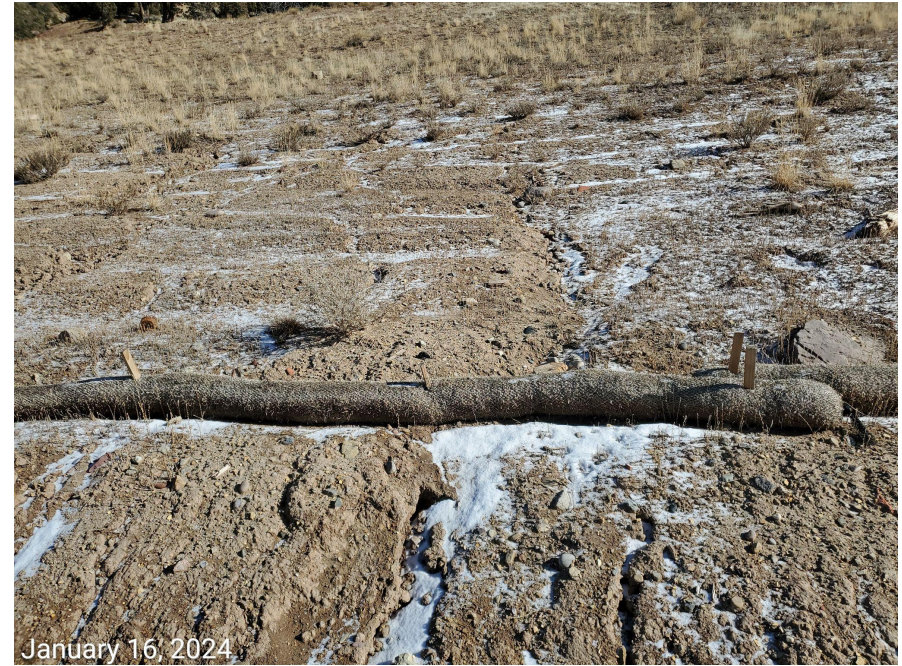
Photo 4: Photos taken from the eastern working pad surface of the well site. Photos examples of interim areas not progressing towards 1003 standards. Photos also examples showing stormwater and erosion control BMPs are missing or insufficient; BMPs to minimize erosion and degradation within the interim areas are inadequate; erosion log (wattles) has not been installed or maintained per good engineering practices resulting stormwater cutting beneath the BMP and degradation to the ditch.

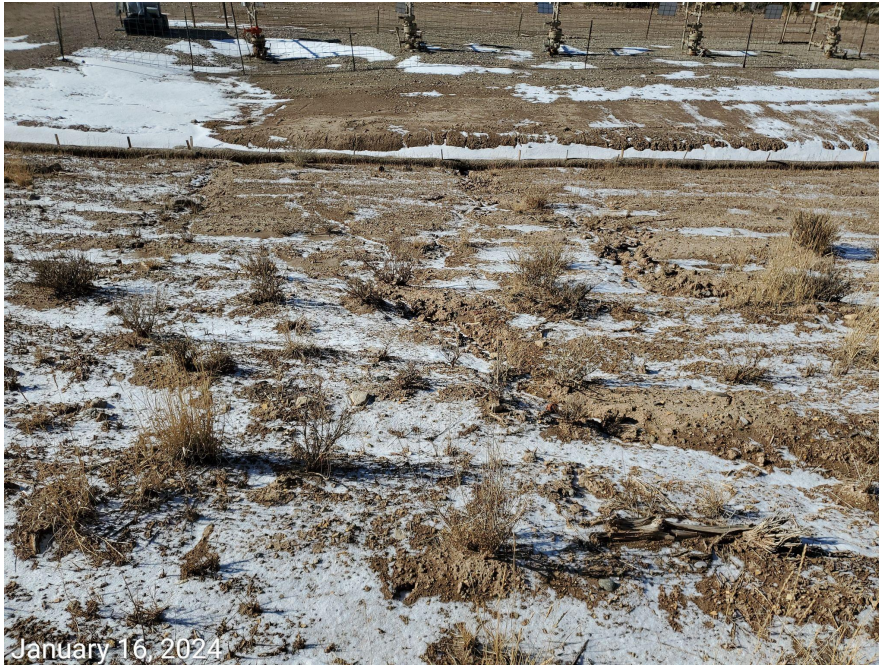
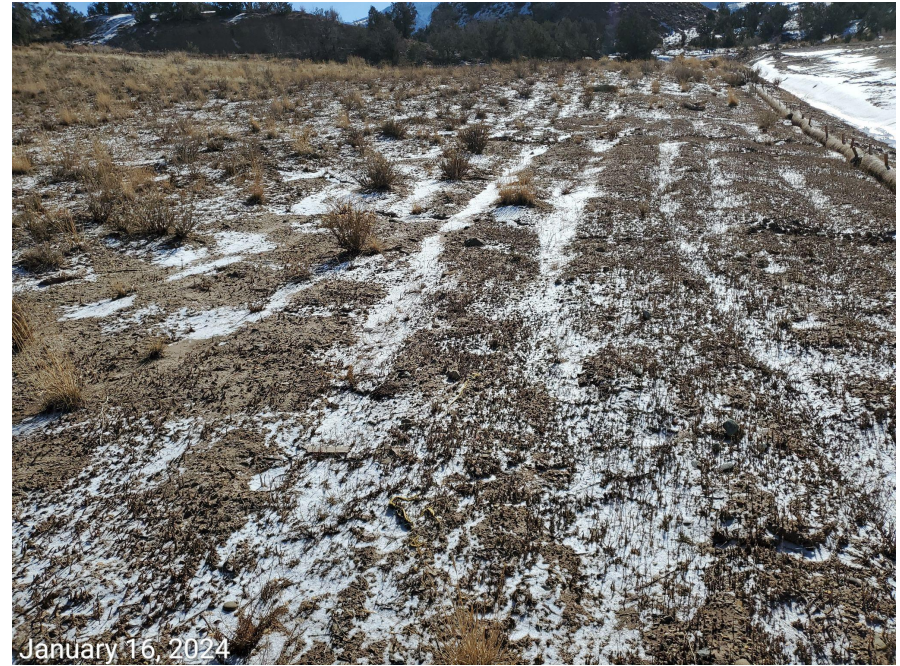
Photo 5: Photos taken from the eastern interim areas of the Location. Photos examples of interim areas not progressing towards 1003 standards. Photos also examples showing stormwater and erosion control BMPs are missing or insufficient; BMPs to minimize erosion and degradation within the interim areas are inadequate. Additional reclamation effort and stormwater management required in these areas.

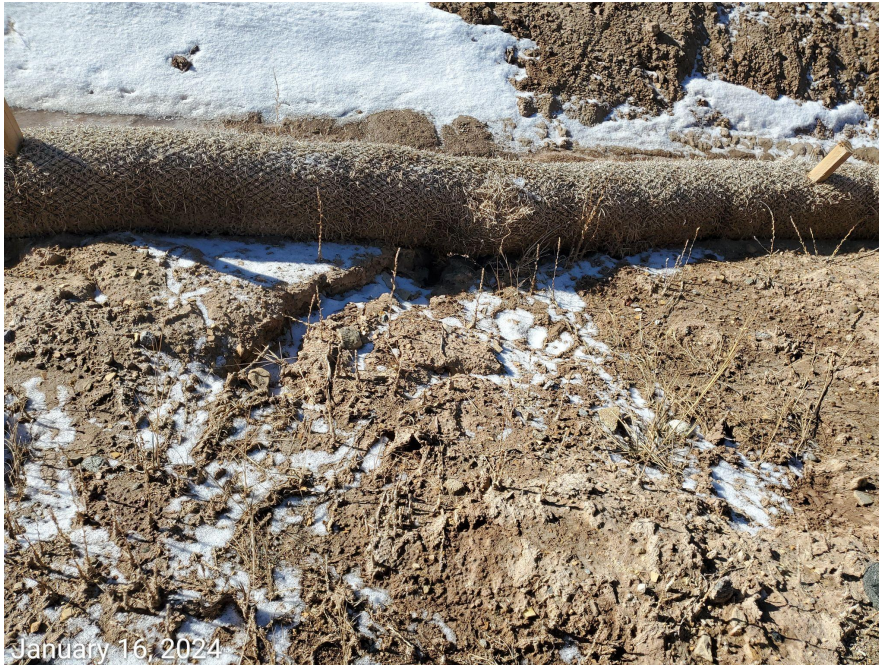
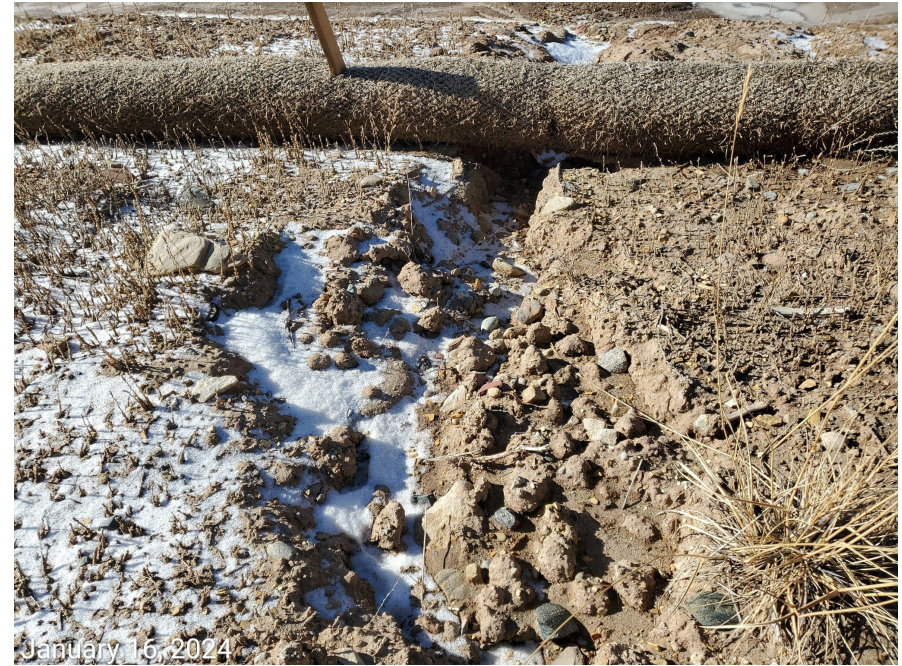
Photo 6: Erosion logs have not been installed or maintained in accordance with good engineering practices; stormwater has cut under the BMP resulting in concentrated flows and erosion degradation.

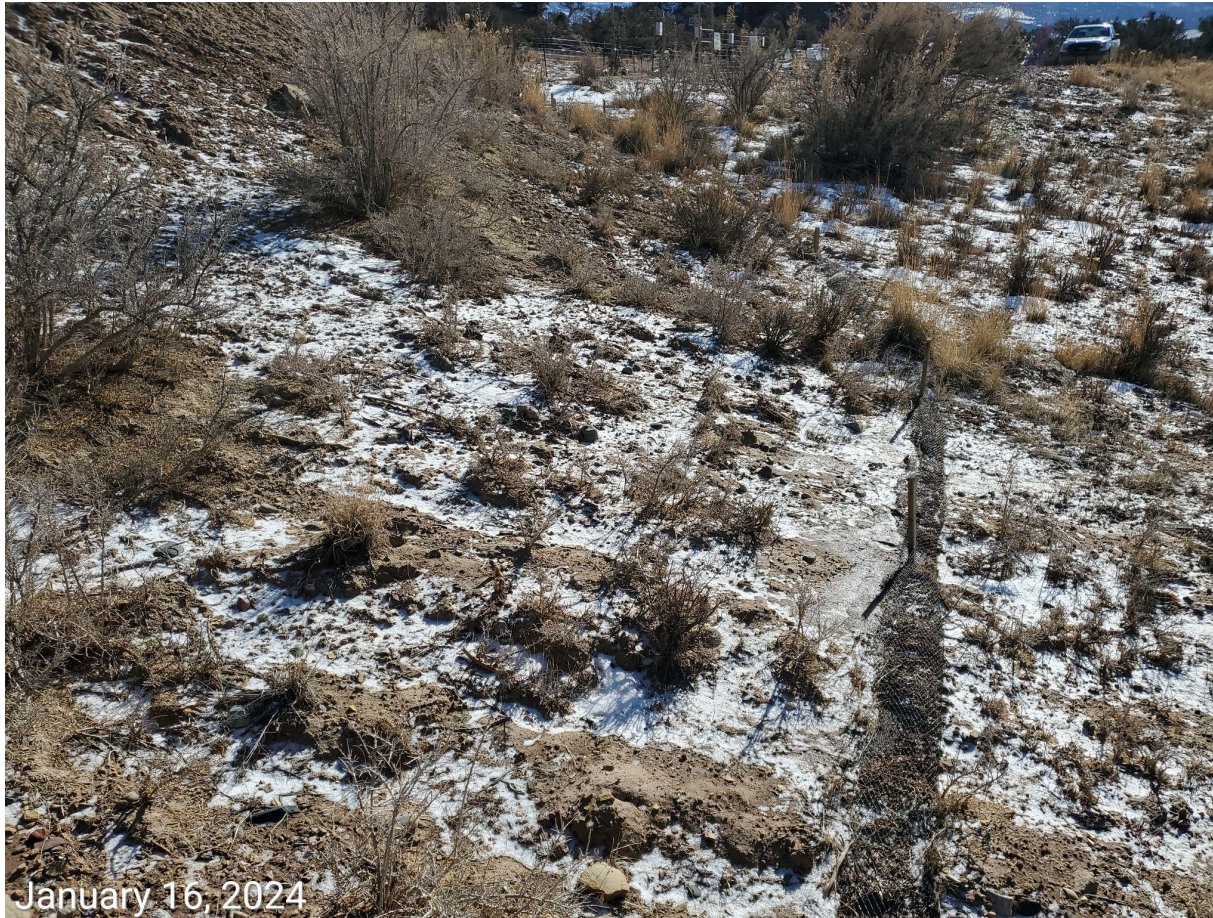
Photo 7: Photo example of erosion logs that have not been maintained in proper functioning condition. Erosion logs implemented appear to also be made of plastic material; this is an improper control, considered trash/debris and requires removal.

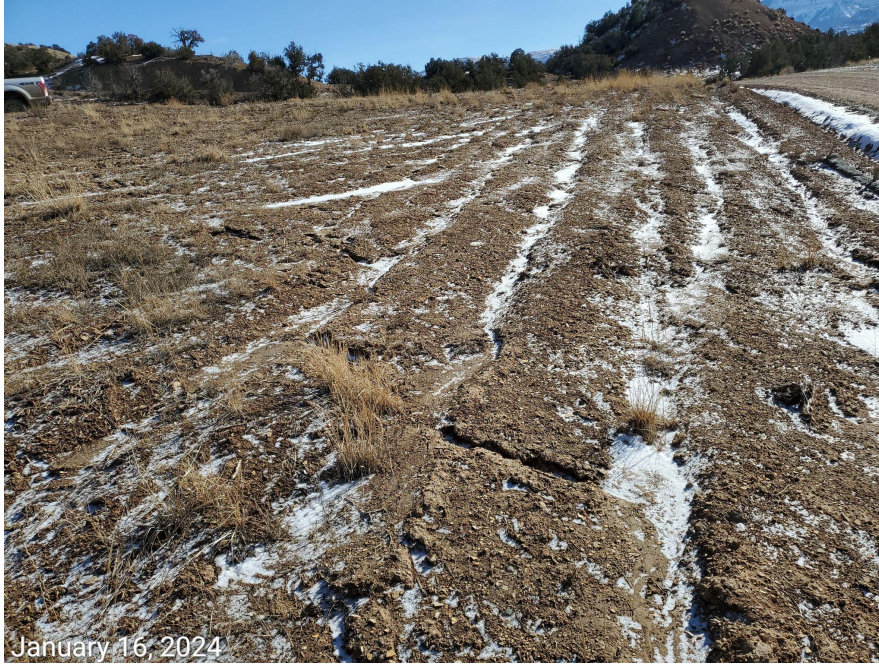
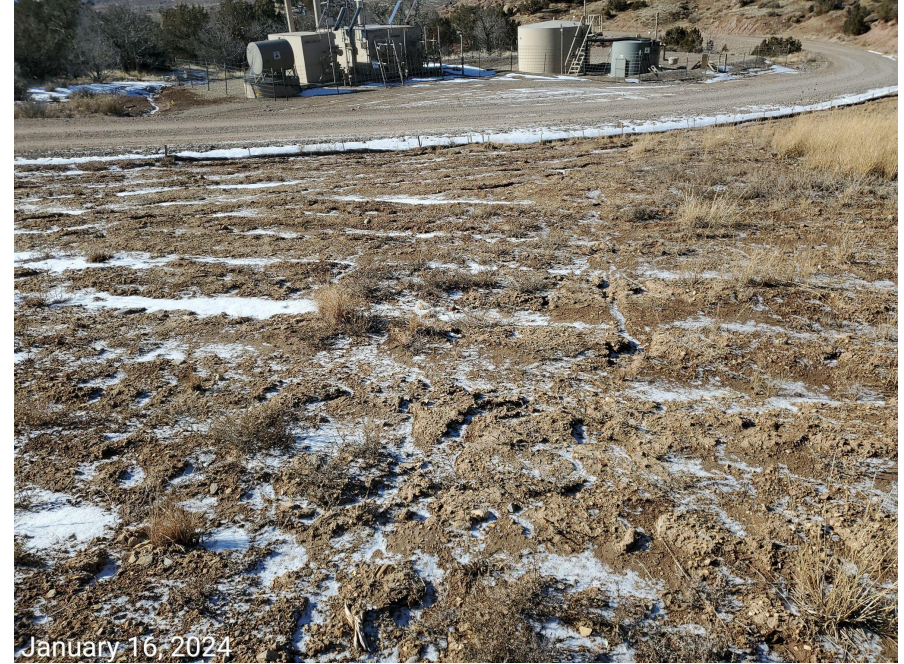
Photo 8: Photos taken from the western interim areas of the well site. Photos examples of interim areas not progressing towards 1003 standards. Photos also examples showing stormwater and erosion control BMPs are missing or insufficient; BMPs to minimize erosion and degradation within the interim areas are inadequate. Additional reclamation effort and stormwater management required in these areas.

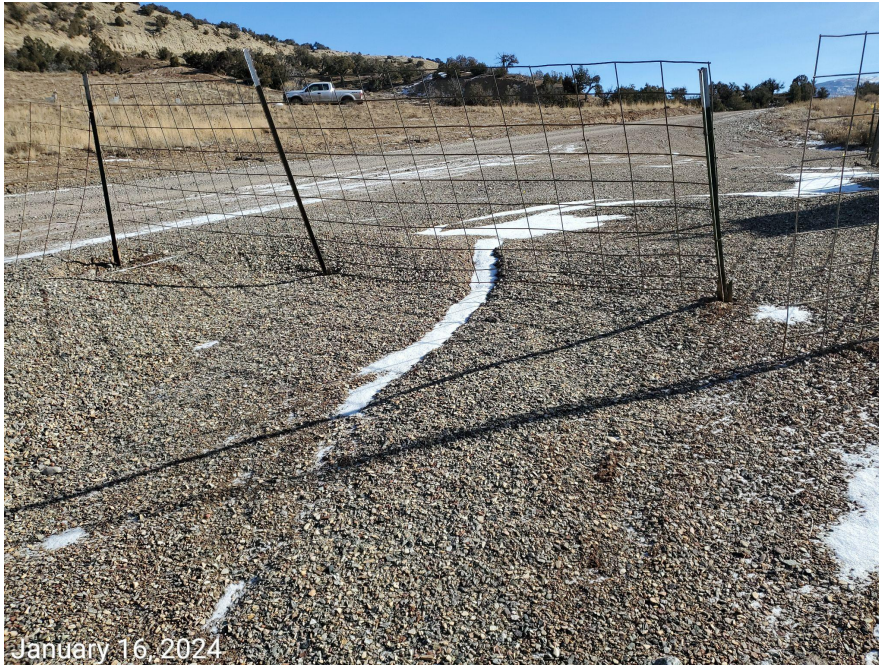
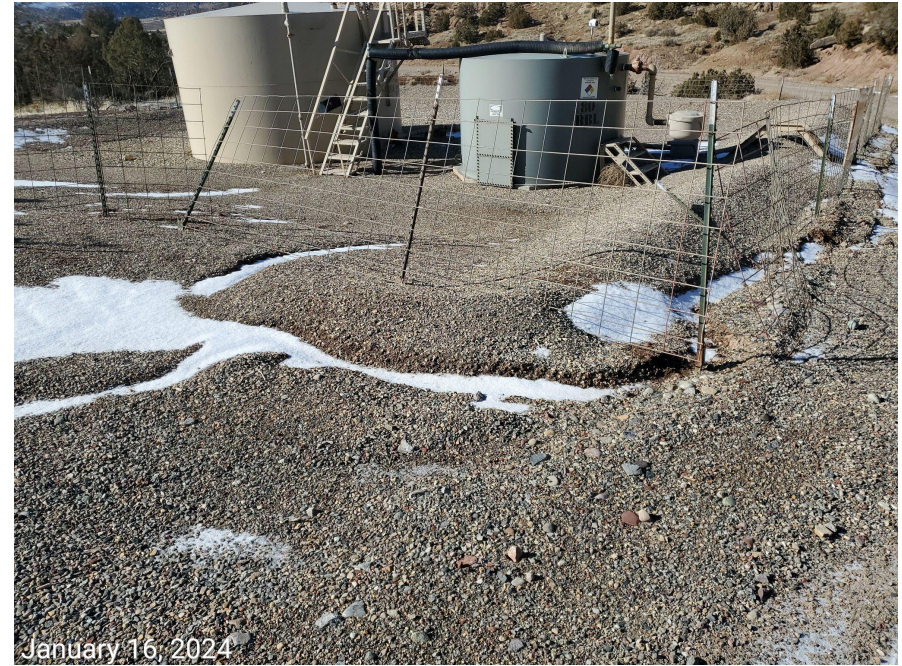
Photo 9: Photo taken from the tank battery facility. Photo shows erosion degradation due to stormwater runoff. Photo also shows fence at battery in disrepair.
