Final Reclamation and Stormwater Inspection

Date: 1/11/24

Operator: Kerr McGee Oil & Gas Onshore LP - 47120

Location ID: 332995

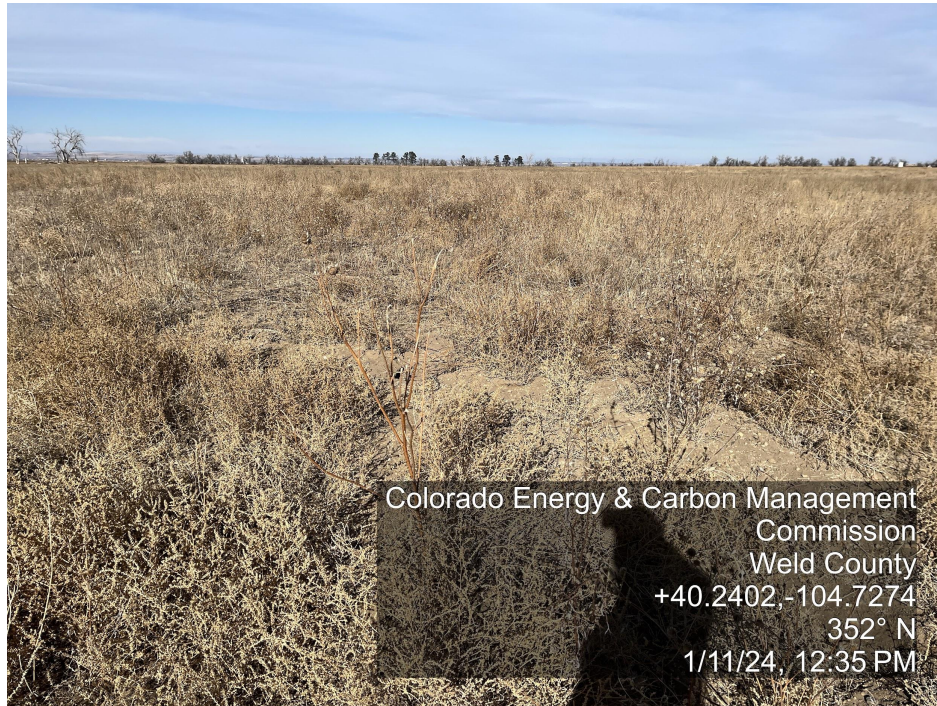
Photo 1. The photo was taken at the well location facing North. The photo illustrates the well location is dominated by russian thistle.

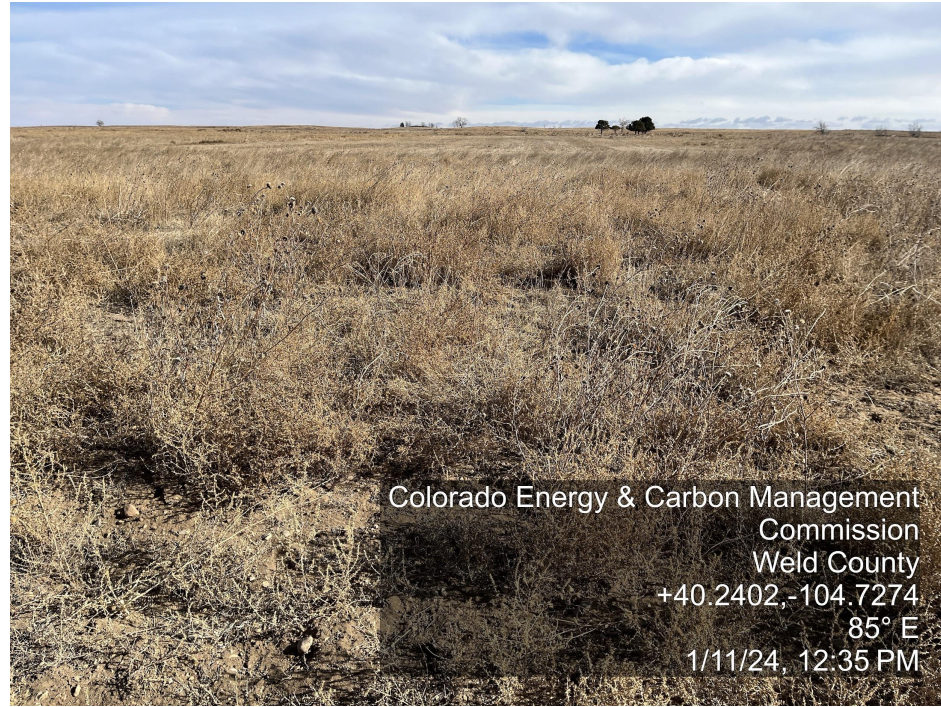
Photo 2. The photo was taken at the well location facing East. Refer to the comment for photo 1.

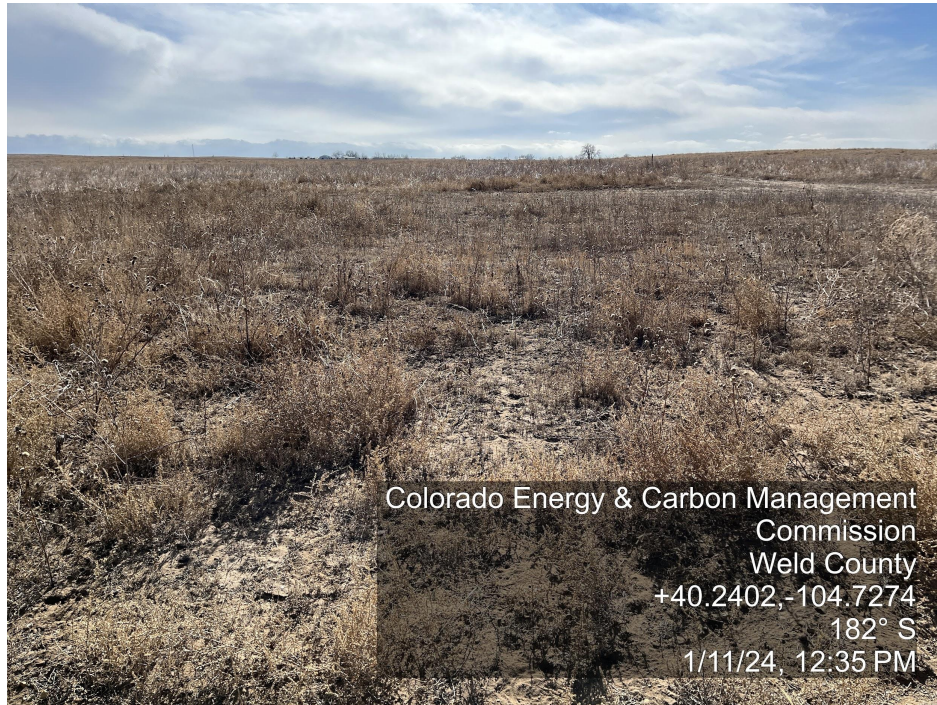
Photo 3. The photo was taken at the well location facing South.
Refer to the comment for photo 1.

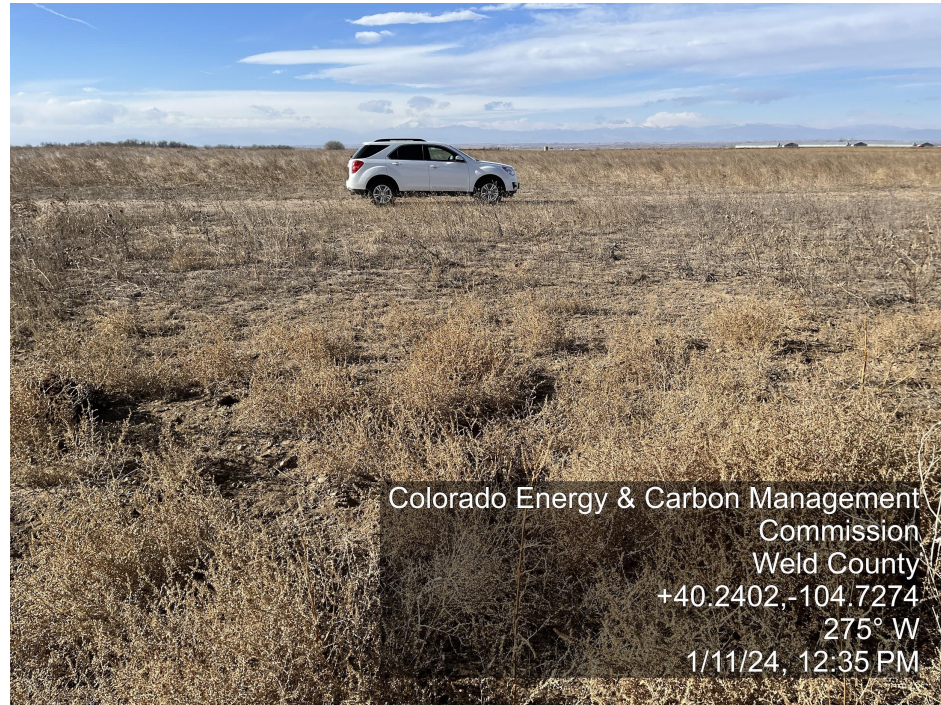
Photo 4. The photo was taken at the well location facing West.
Refer to the comment for photo 1.

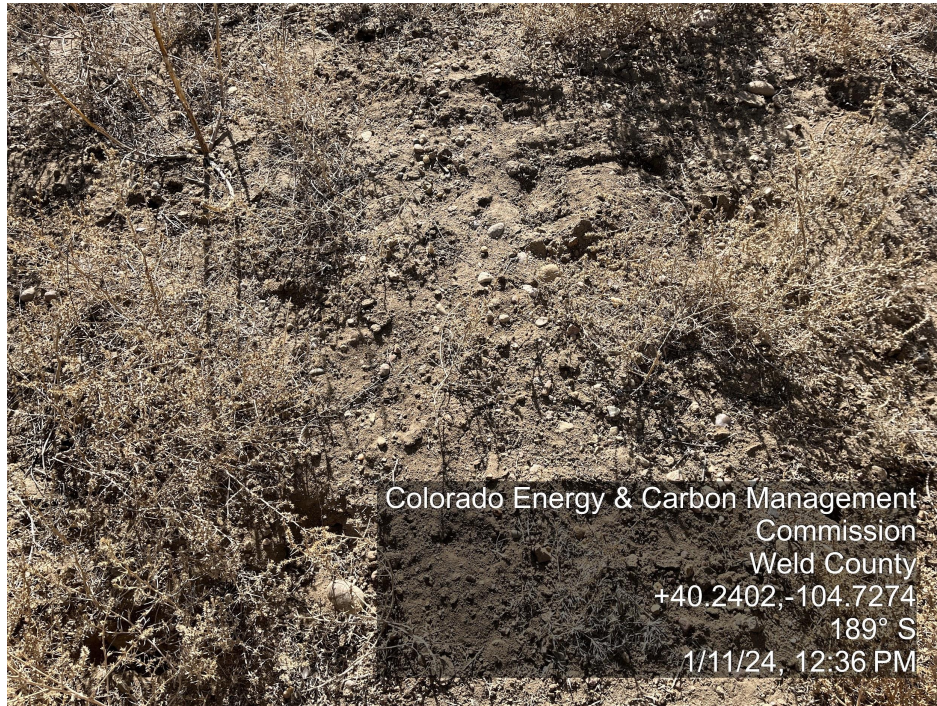
Photo 5. The photo was taken at the well location facing South. The photo illustrates that gravel still remains at the well location.

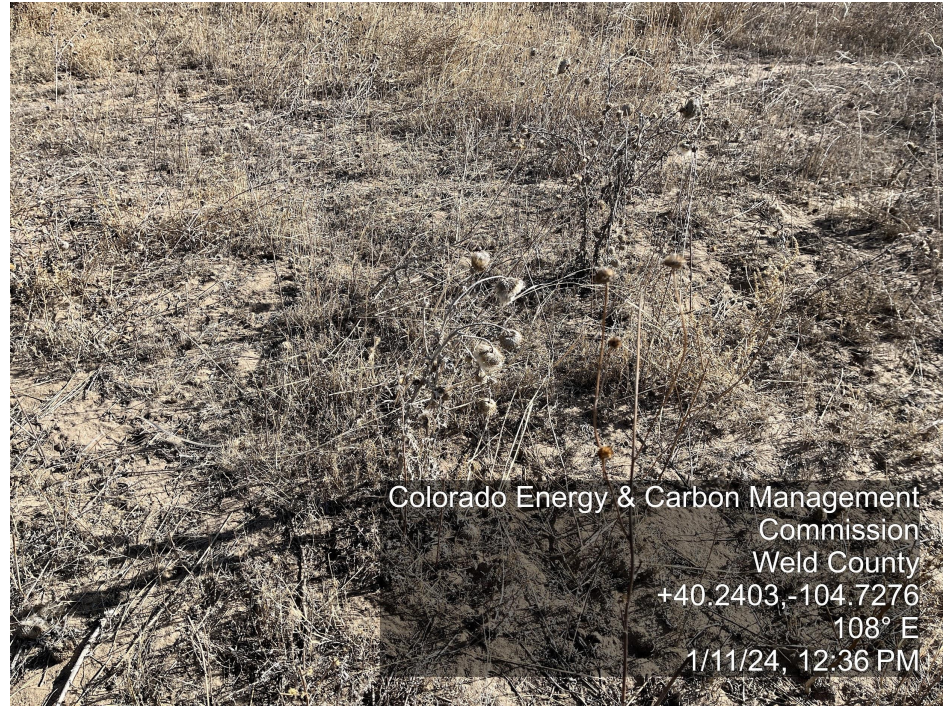
Photo 6. The photo was taken at the well location facing East. The photo illustrates that there is a stand of Musk thistle at the well location.
