Inspection Photos

Loc: 438617

Operator: DOVER ATWOOD CORPORATION

Inspection Date: 1/18/2024

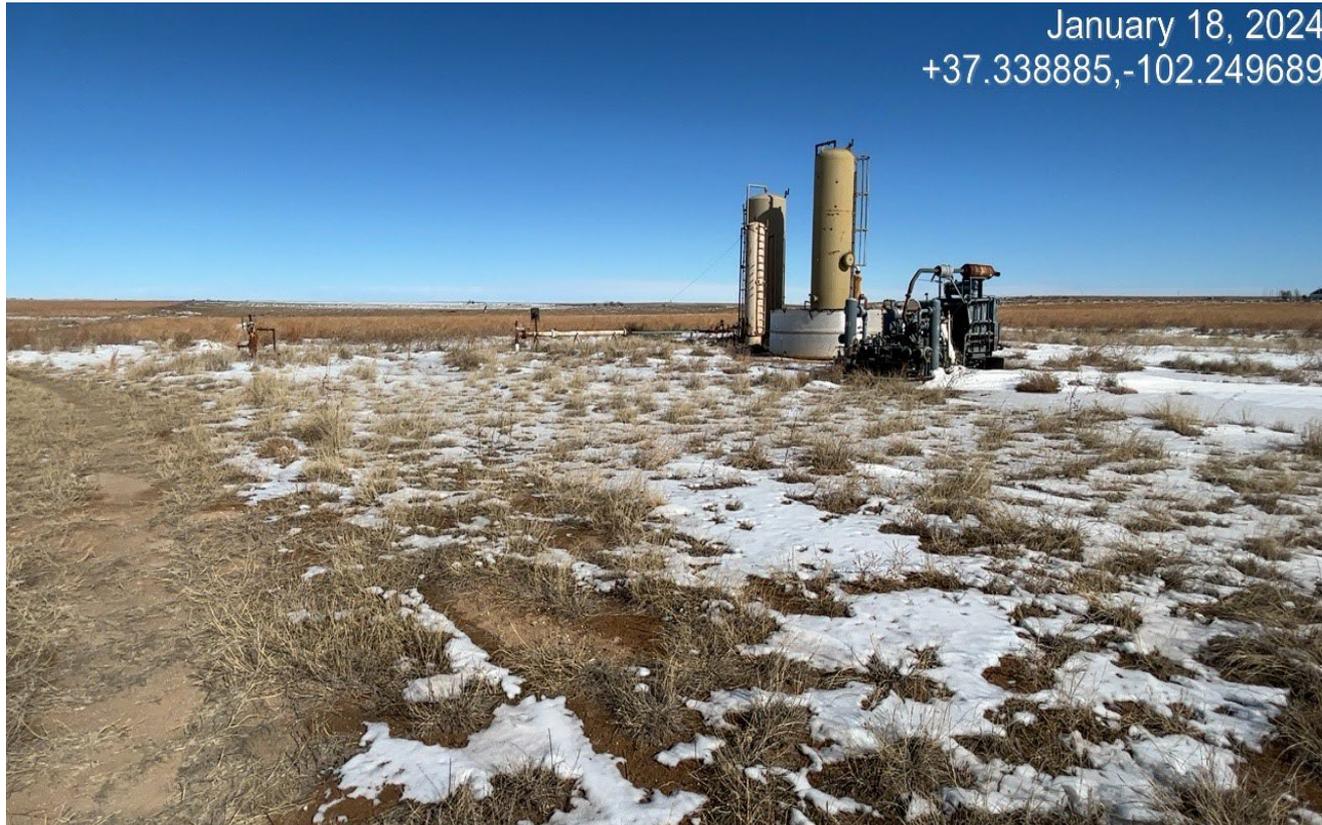
Photo 1. Facing northeast toward the gas treatment facility.

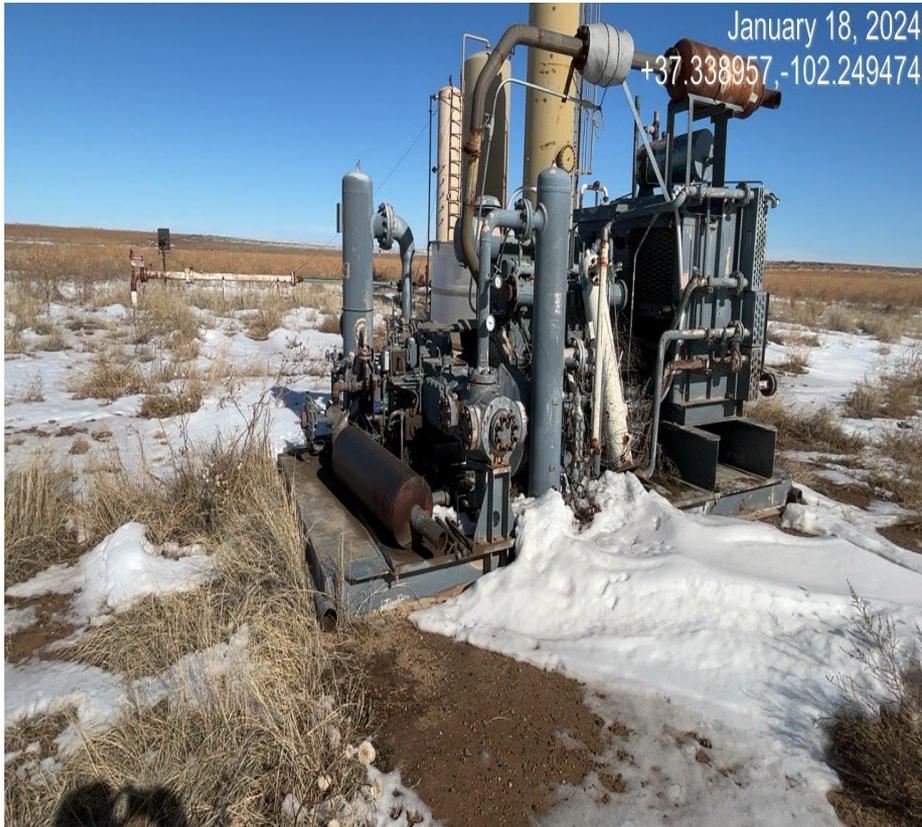
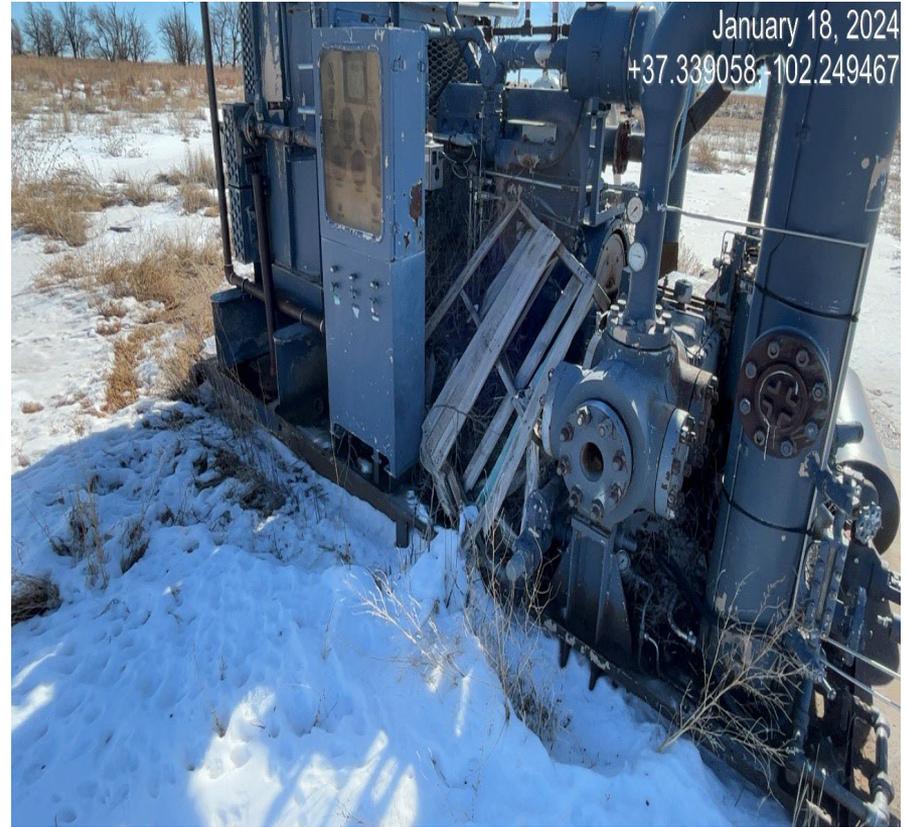
Photo 2. Photo 2. There is an unused compressor stored on location that need to be removed. The compressor engine has various unconnected parts and does not appear to be functional. Previous corrective action is not completed.

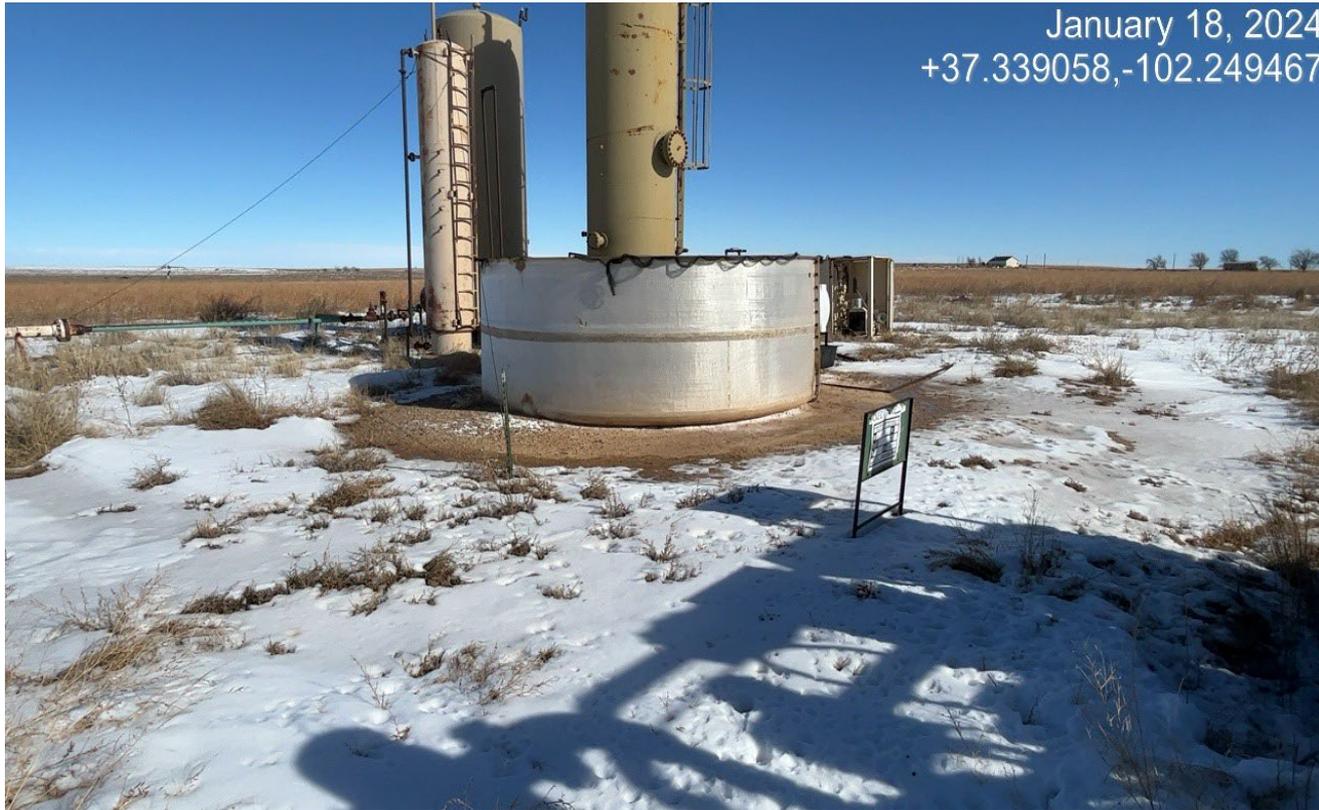
Photo 3. Facing toward the open top tank. It appears the tank has previously leaked due to white stained soil. There is no secondary containment around the tank. There is no signage on the tank. Previous corrective action is not completed.

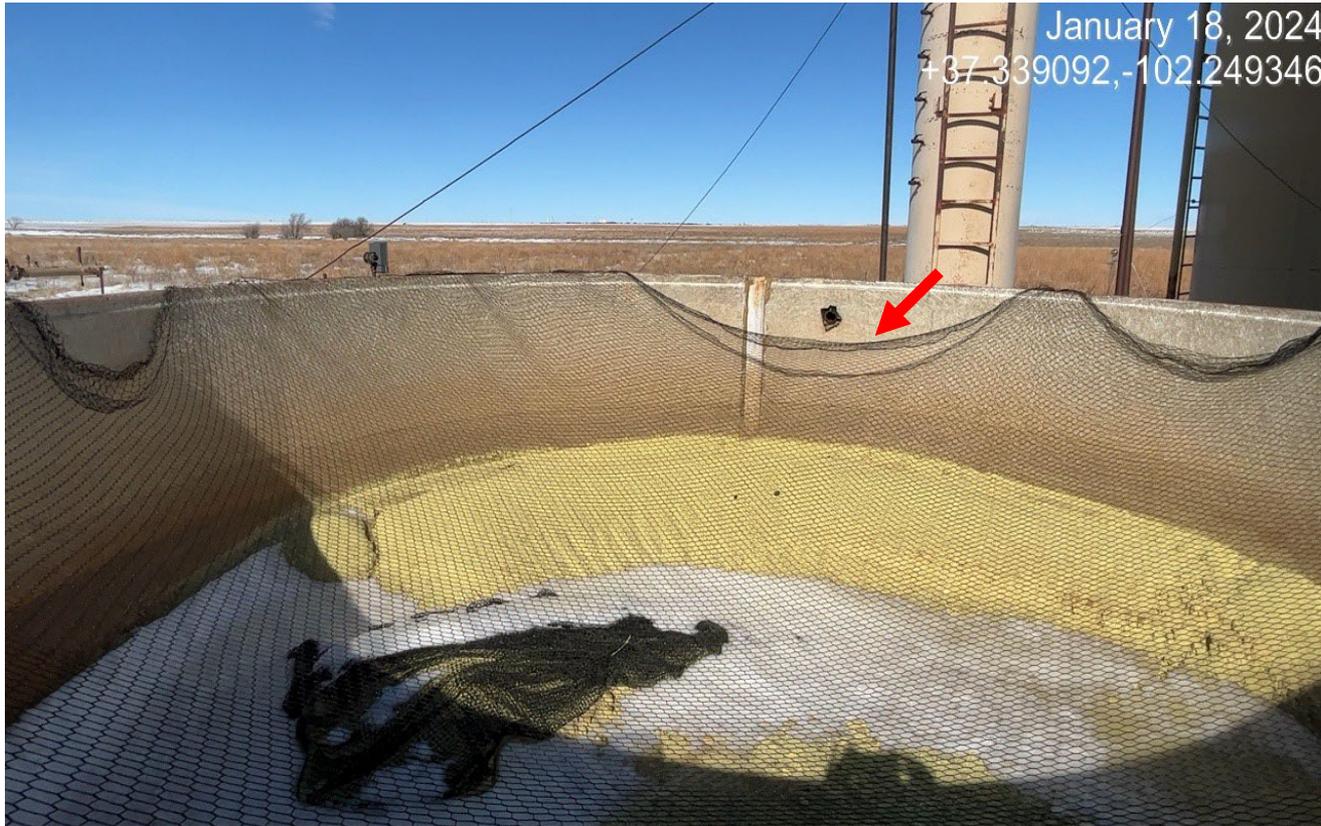
Photo 5. The netting on the open top tank has come uncovered on the edges which wildlife could gain entry.

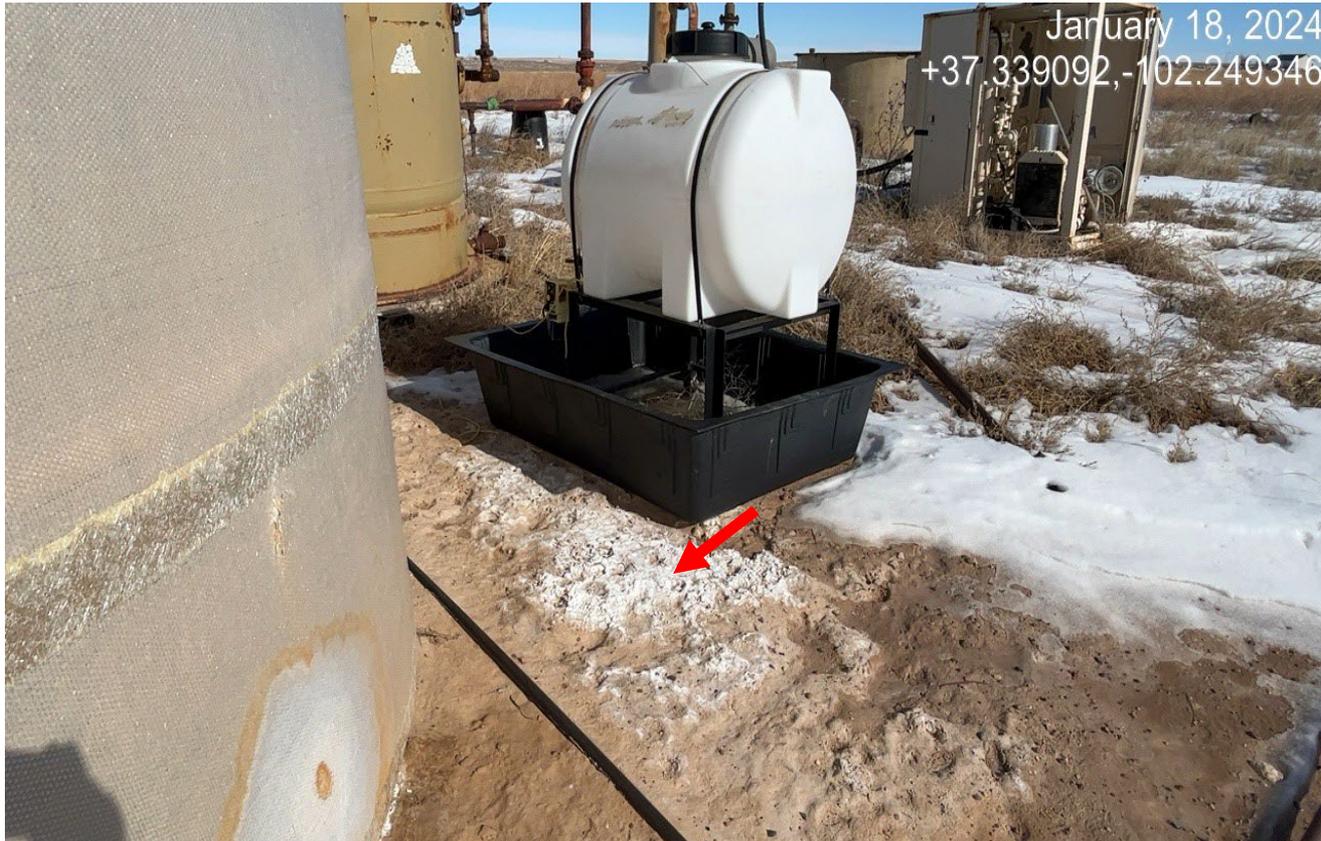
Photo 6. There is a white stained substance around the base of the open top tank. There is a new tank installed but the labeling is faded on the container so contents are unknown.

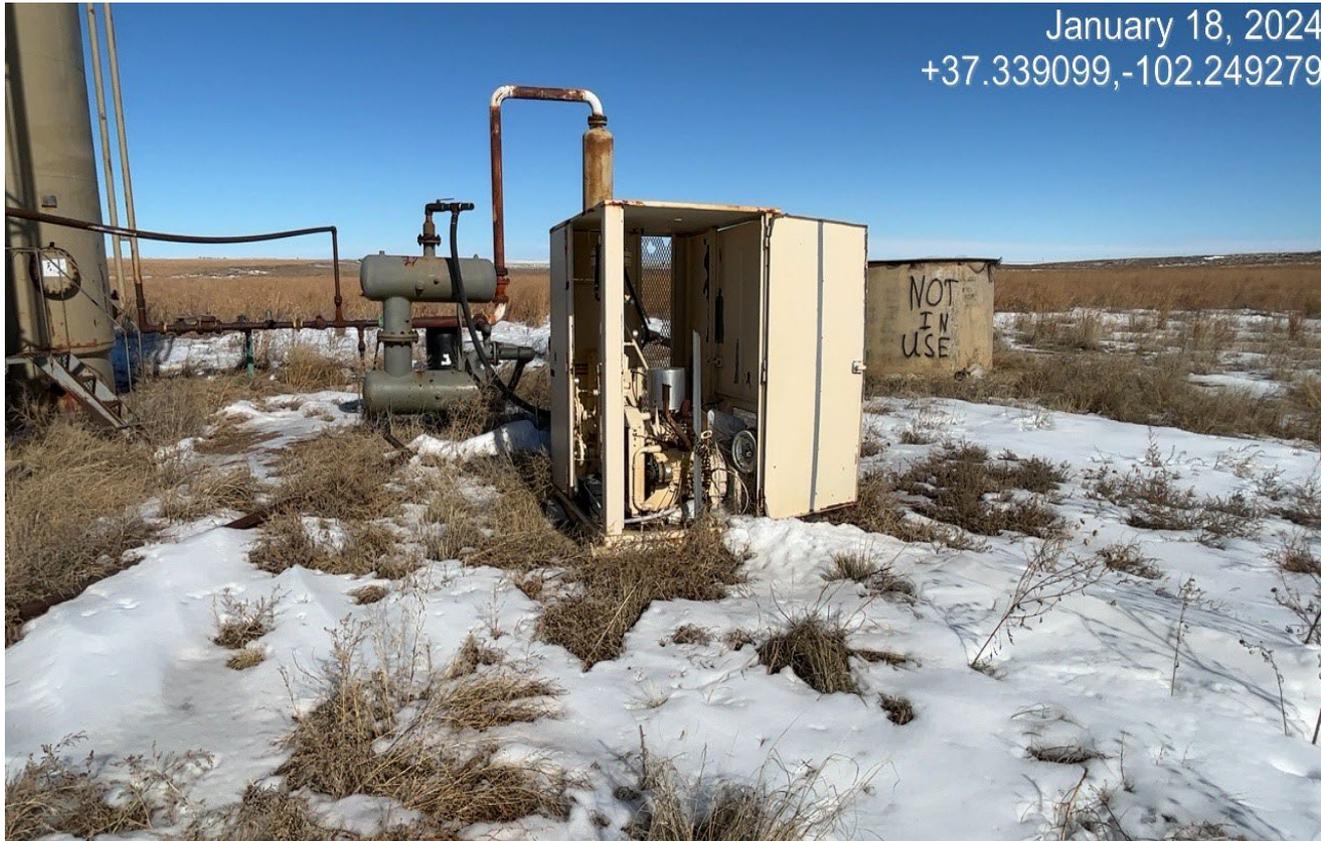
Photo 7. There is equipment not maintained and weeds grown around the equipment. Door has fallen off this shed. Previous corrective action is not completed.

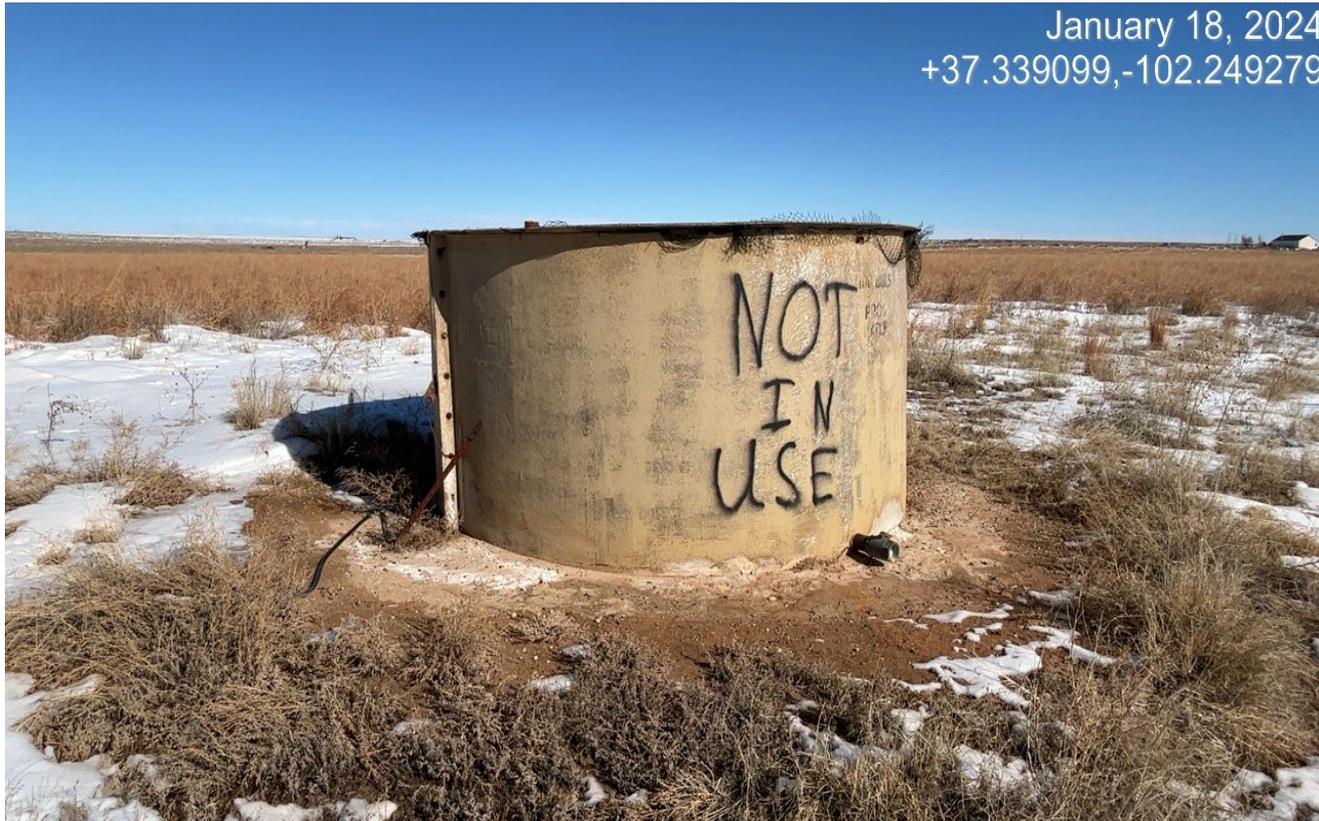
Photo 8. There is an open top tank at the east side of the location. It appears the tank has previously leaked due to white stained soil. There is no secondary containment around the tank. The signage has faded. Previous corrective action is not completed.

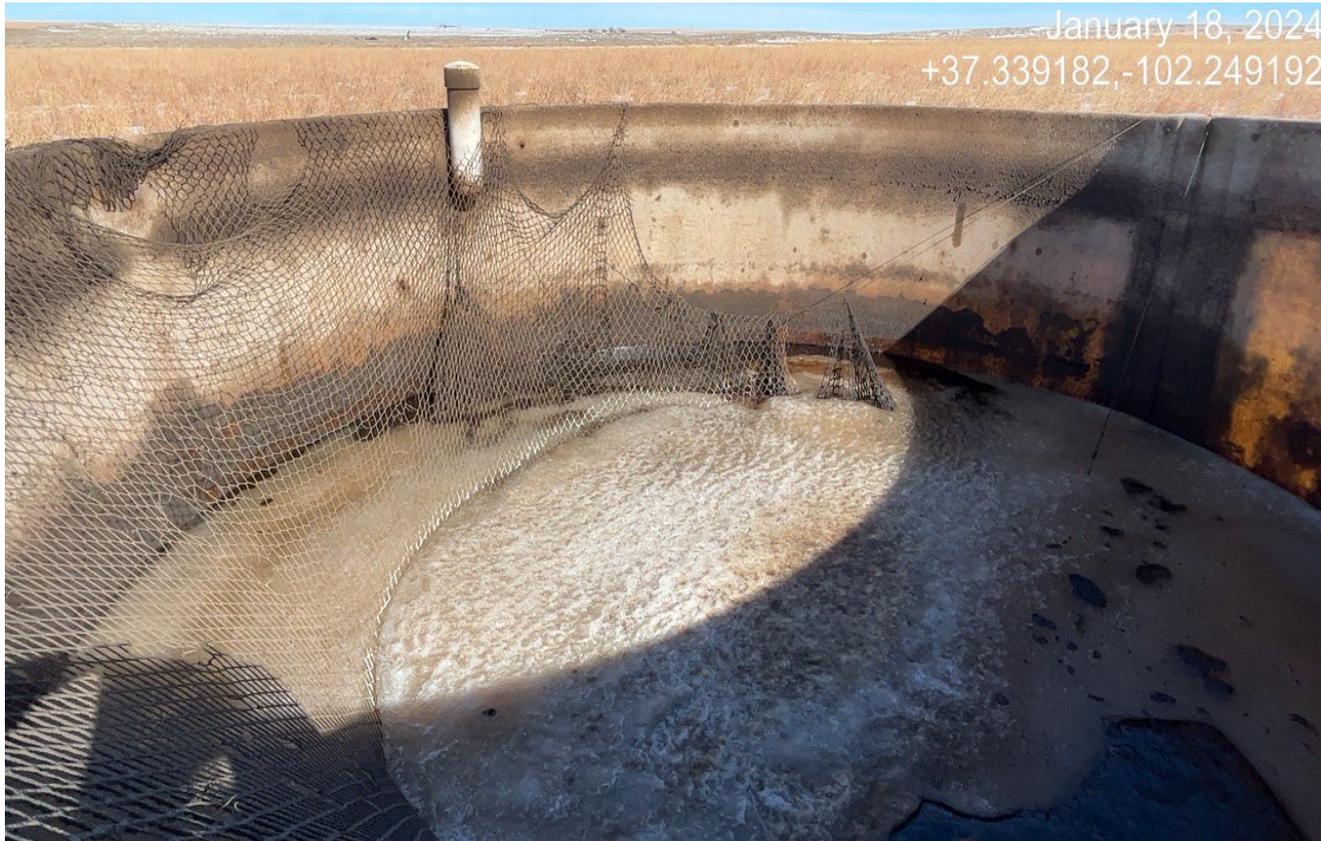
Photo 9. There is liquid in the tank and the netting is in disrepair.

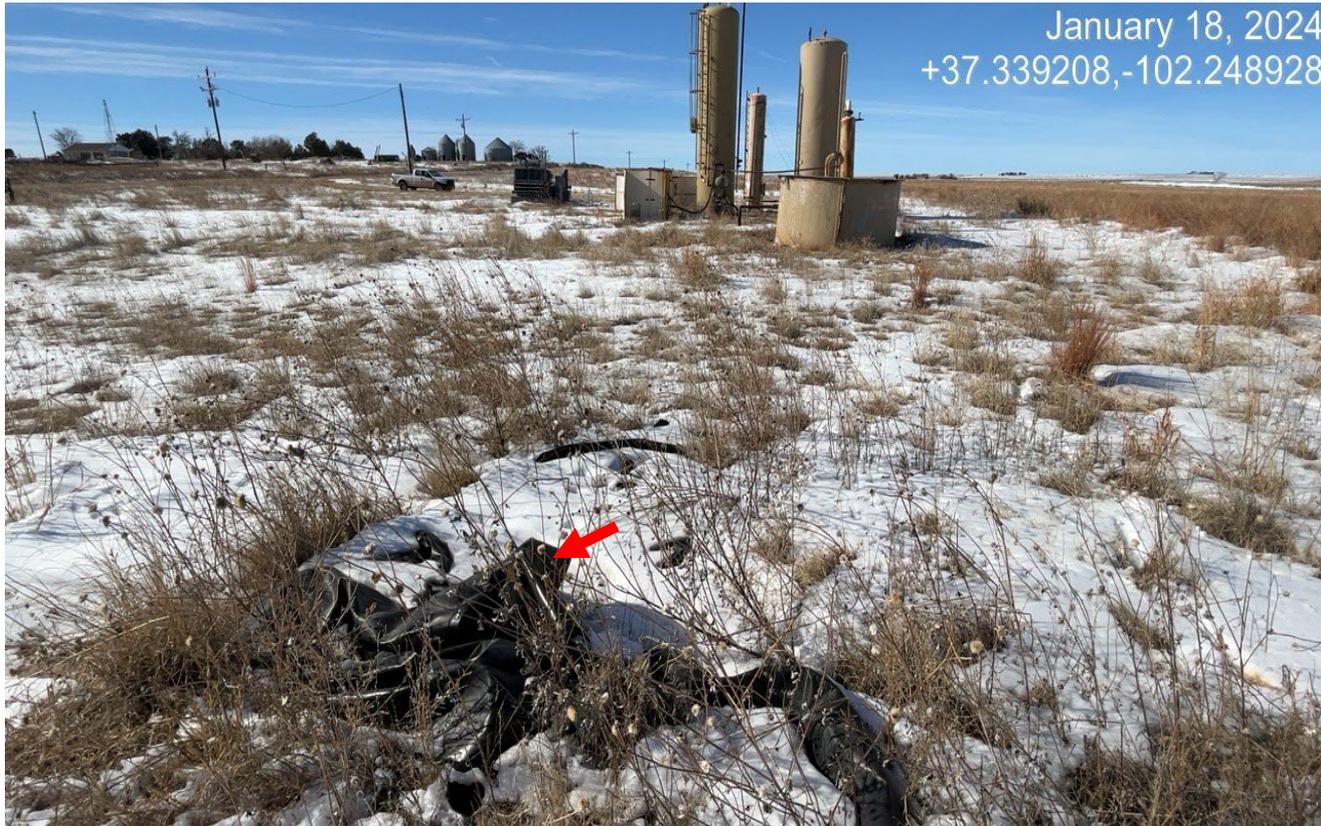
Photo 10. Facing west toward the location. There is a plastic liner debris at east side of the location that needs to be removed.

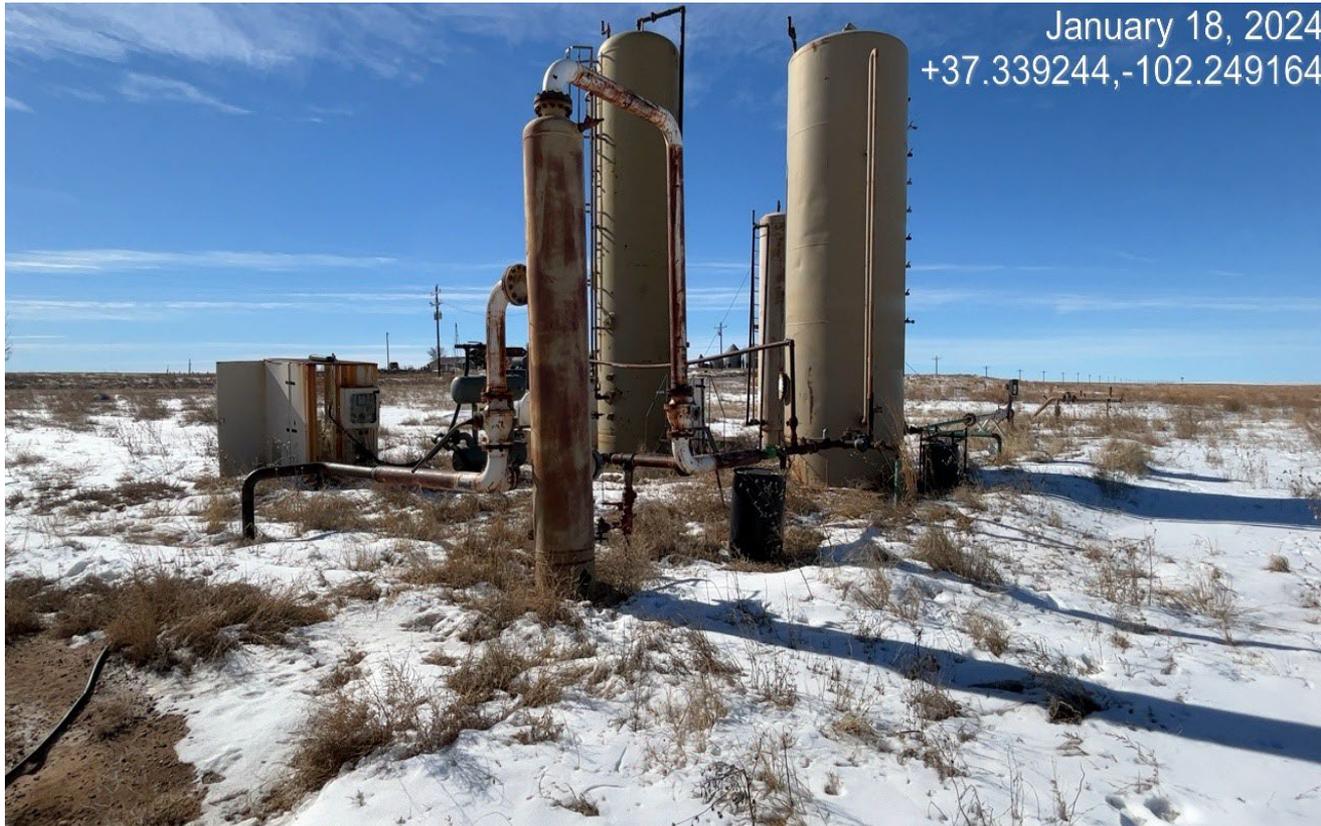
Photo 11. There is unused supplies and a black barrels with no labeling. There are weeds and vegetation around the equipment which is a fire hazard. Previous corrective action is not completed.

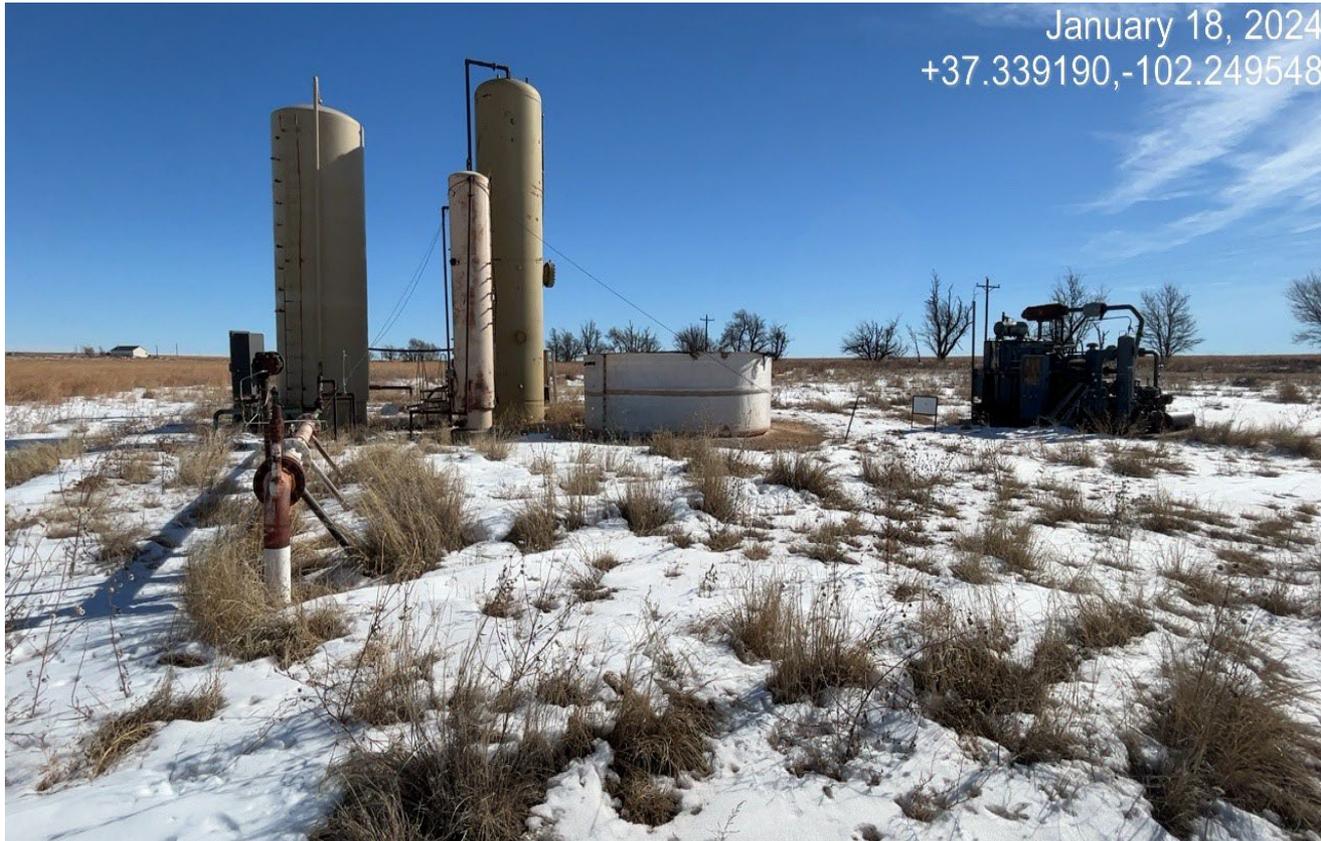
Photo 12. Facing east toward the gas treatment facility.

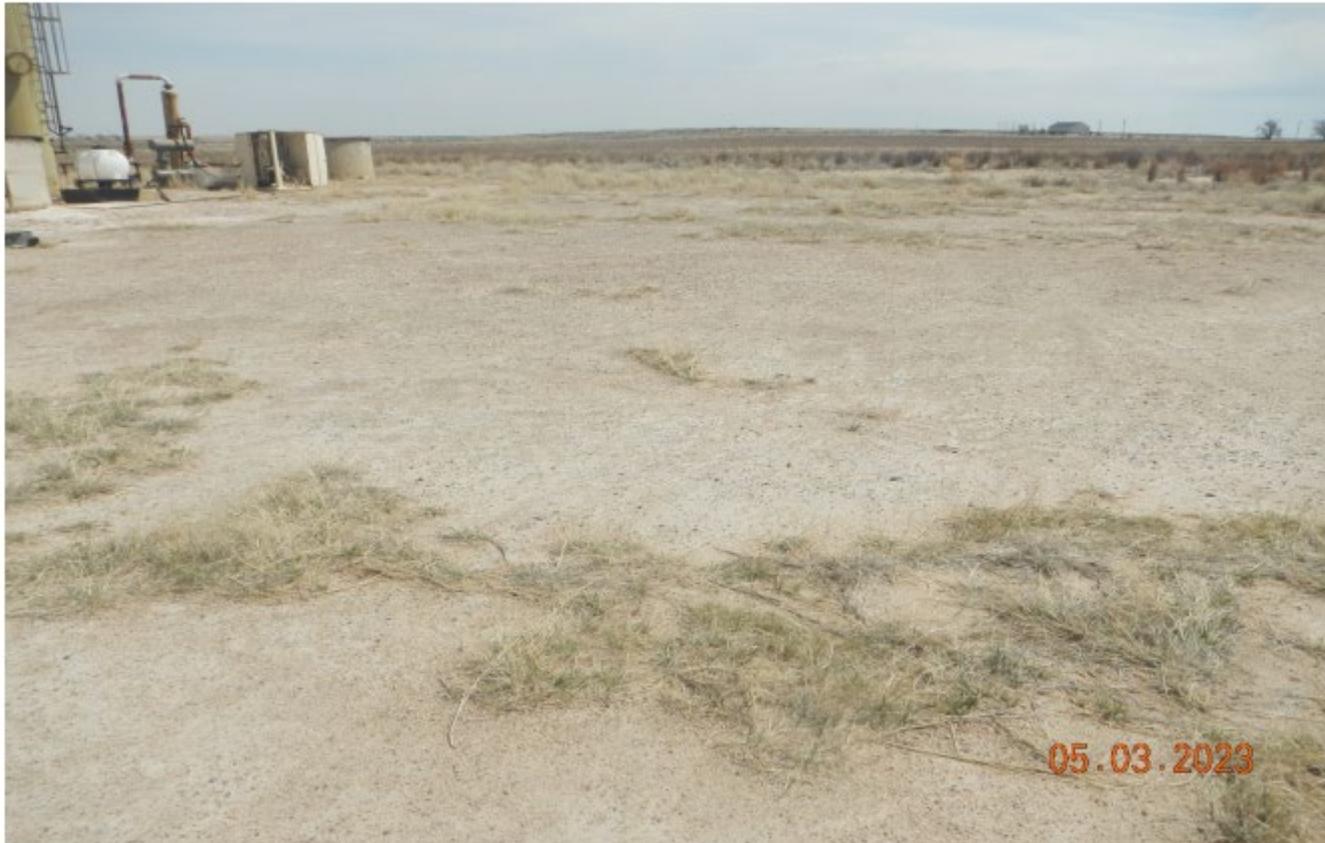
Photo 13. Photo taken during previous inspection. Facing east at the south side of the location. The surrounding disturbance area has areas that are bare of vegetation that need to be reclaimed per Rule 1003.
