Inspection Photos

Loc: 320981

Operator: DOVER ATWOOD CORPORATION

Inspection Date: 1/18/2024

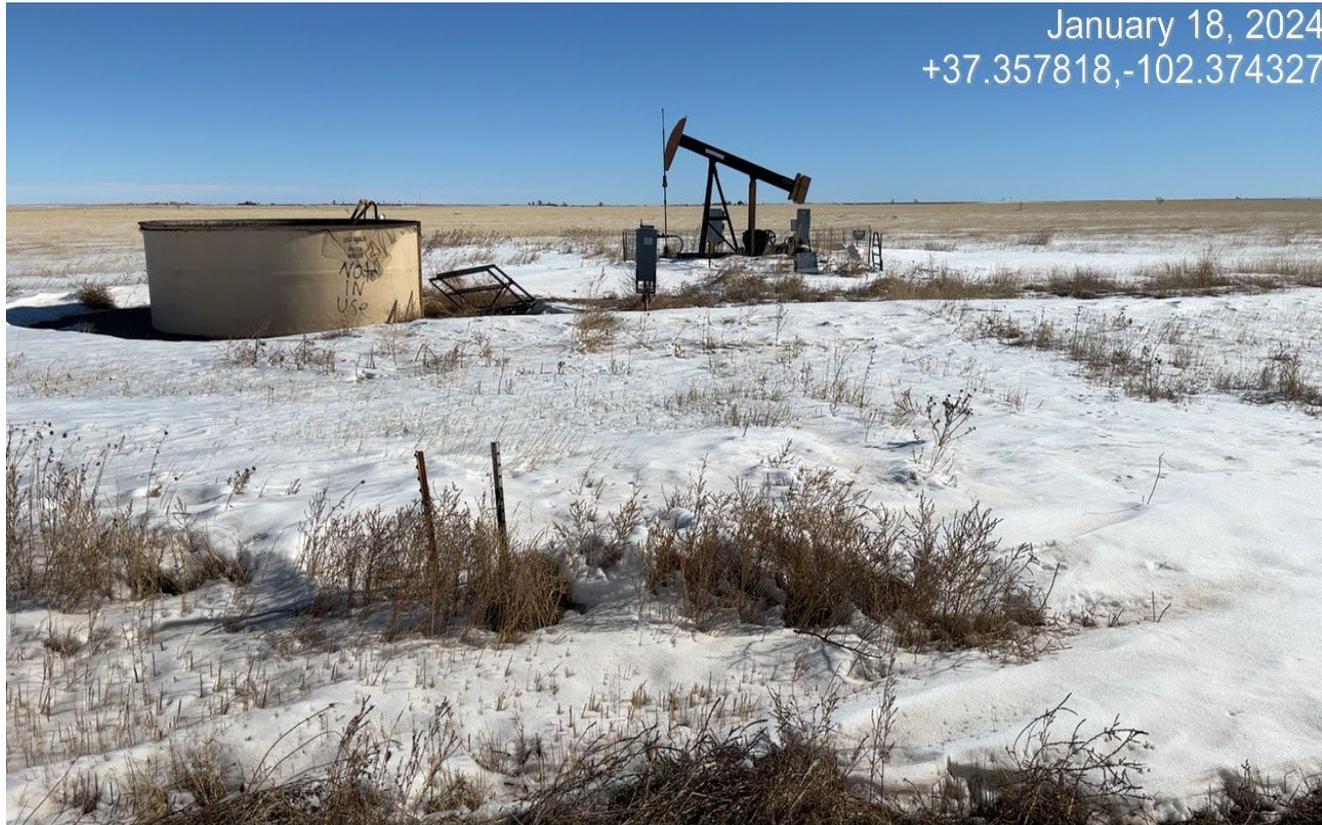
Photo 1. Facing east toward the wellsite.

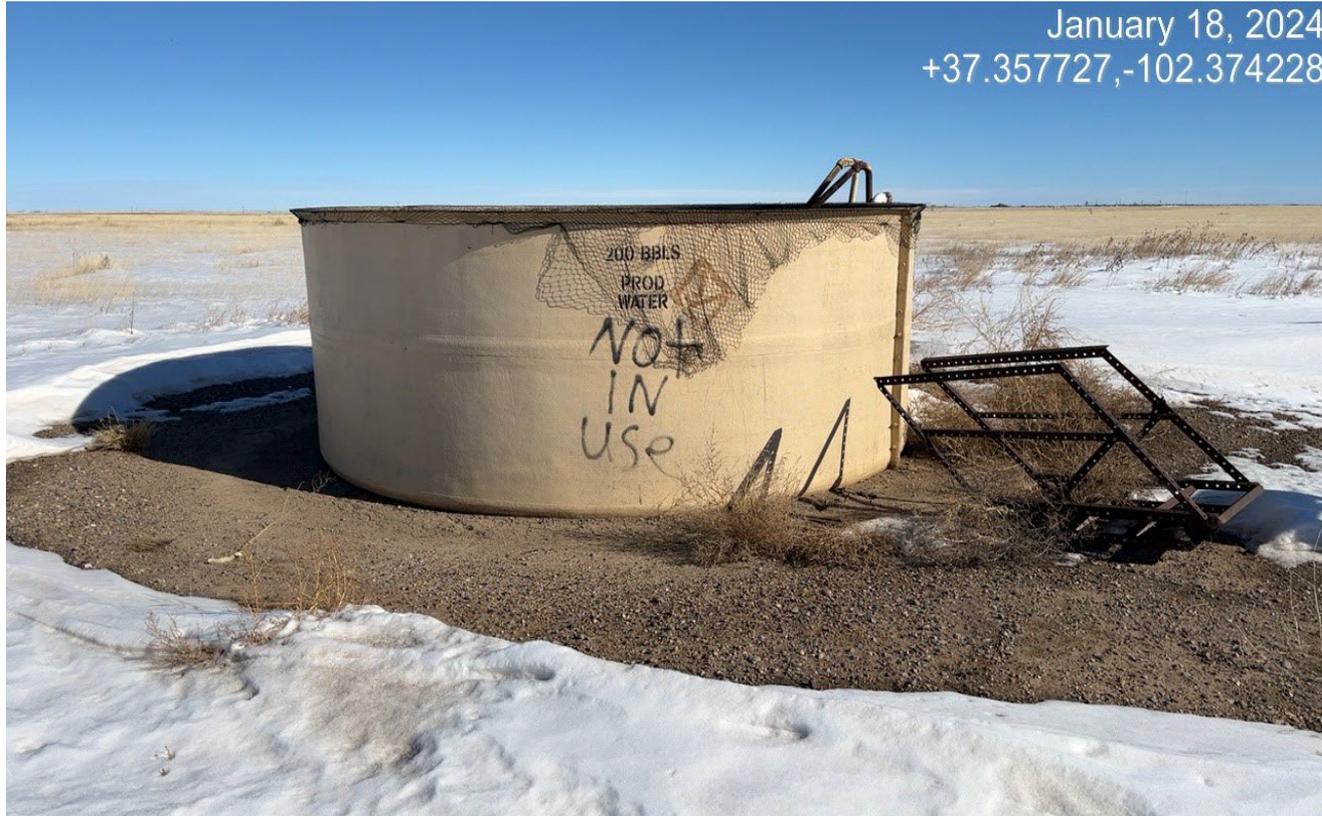
Photo 2. Facing toward the open top tank. There is not secondary containment at the tank and there is oily fluids inside the tank.

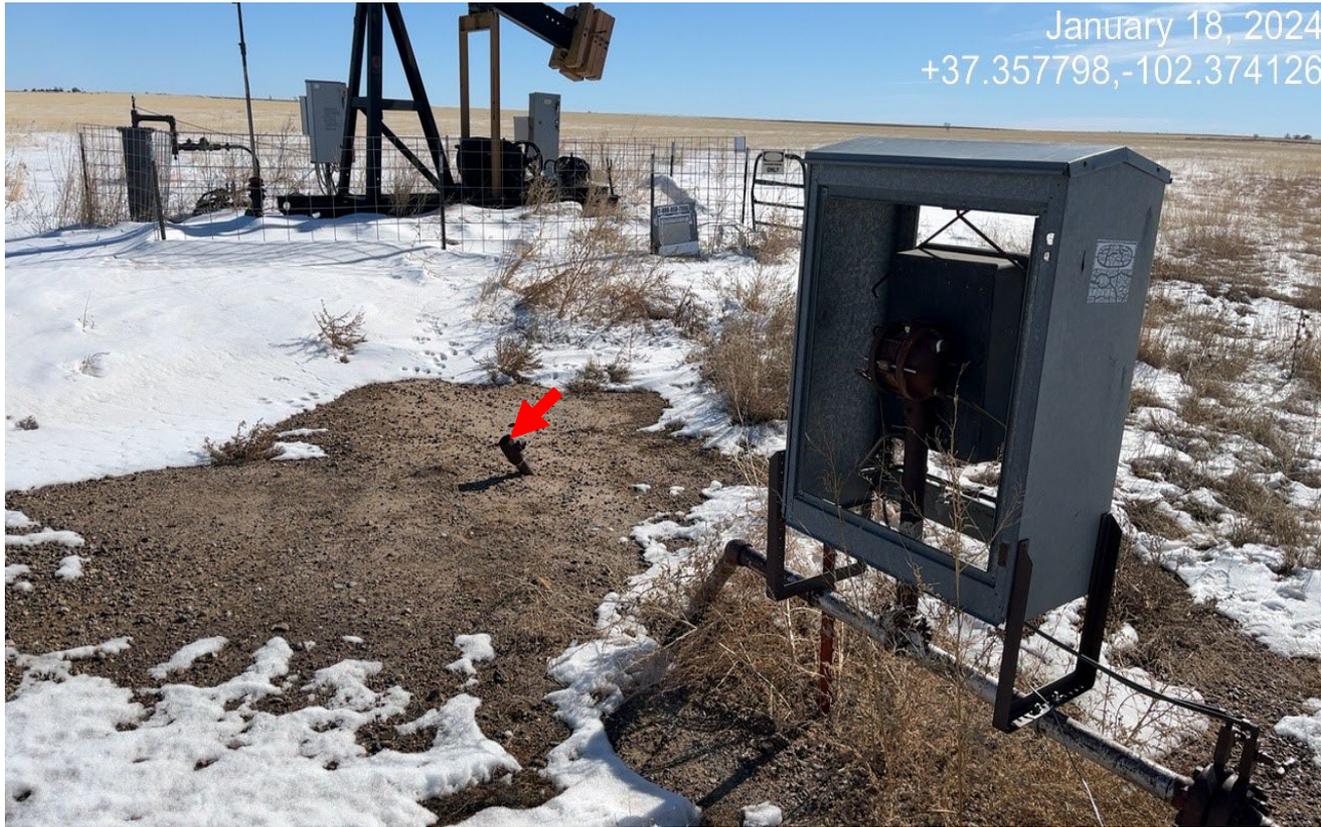
Photo 3. There is an used pipe riser at red arrow .

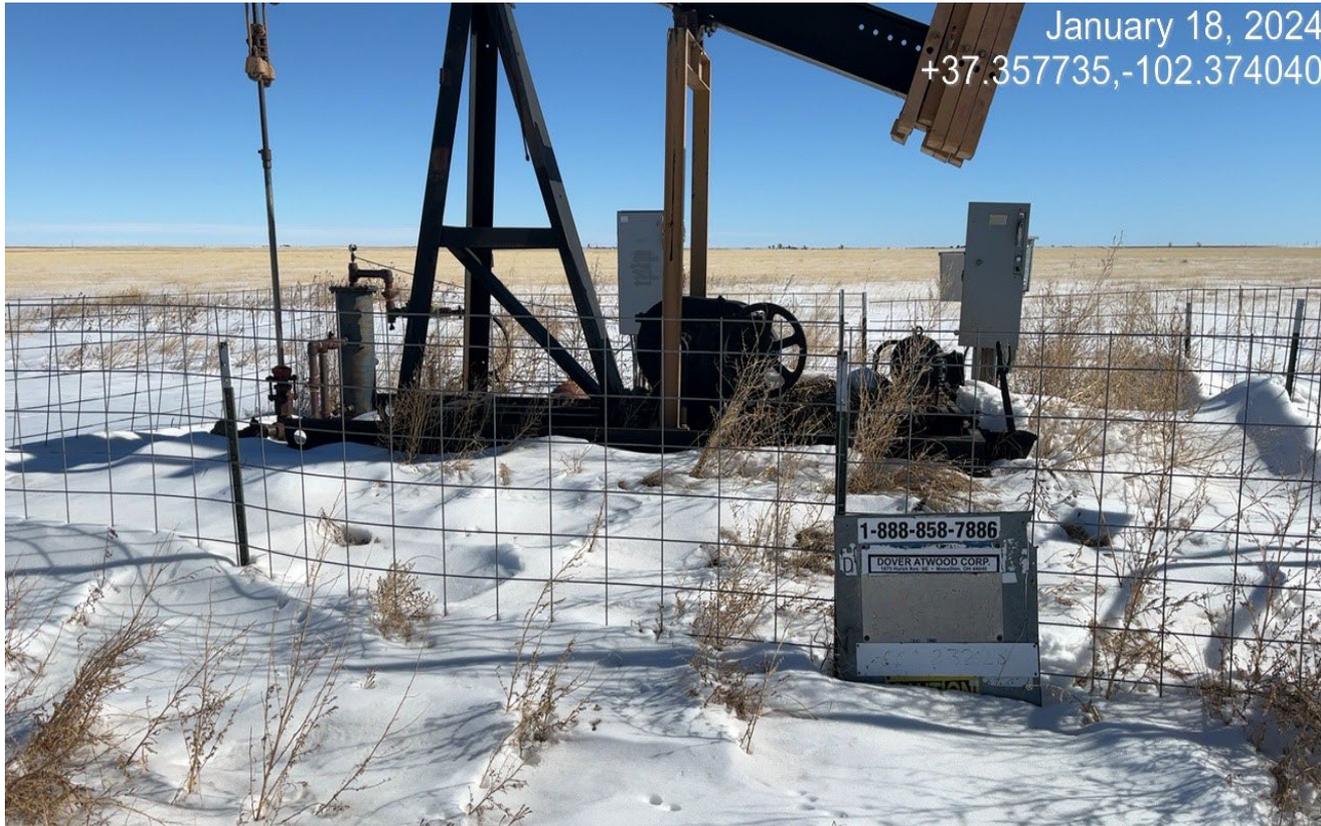
Photo 4. The sign at the wellhead is faded and not legible.
