Inspection Photos

Loc: 320975

Operator: DOVER ATWOOD CORPORATION

Inspection Date: 1/18/2024

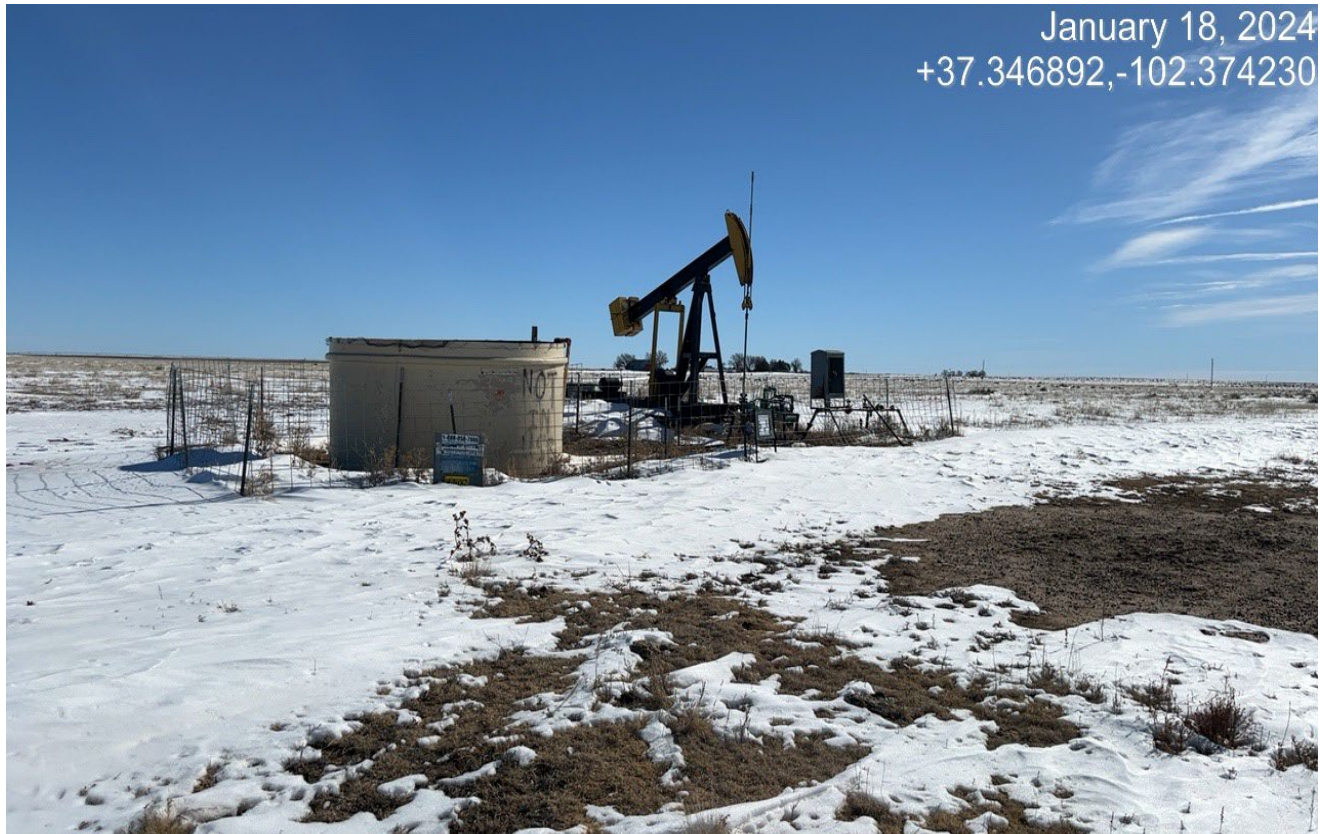
Photo 1. Facing southeast toward the wellsite.

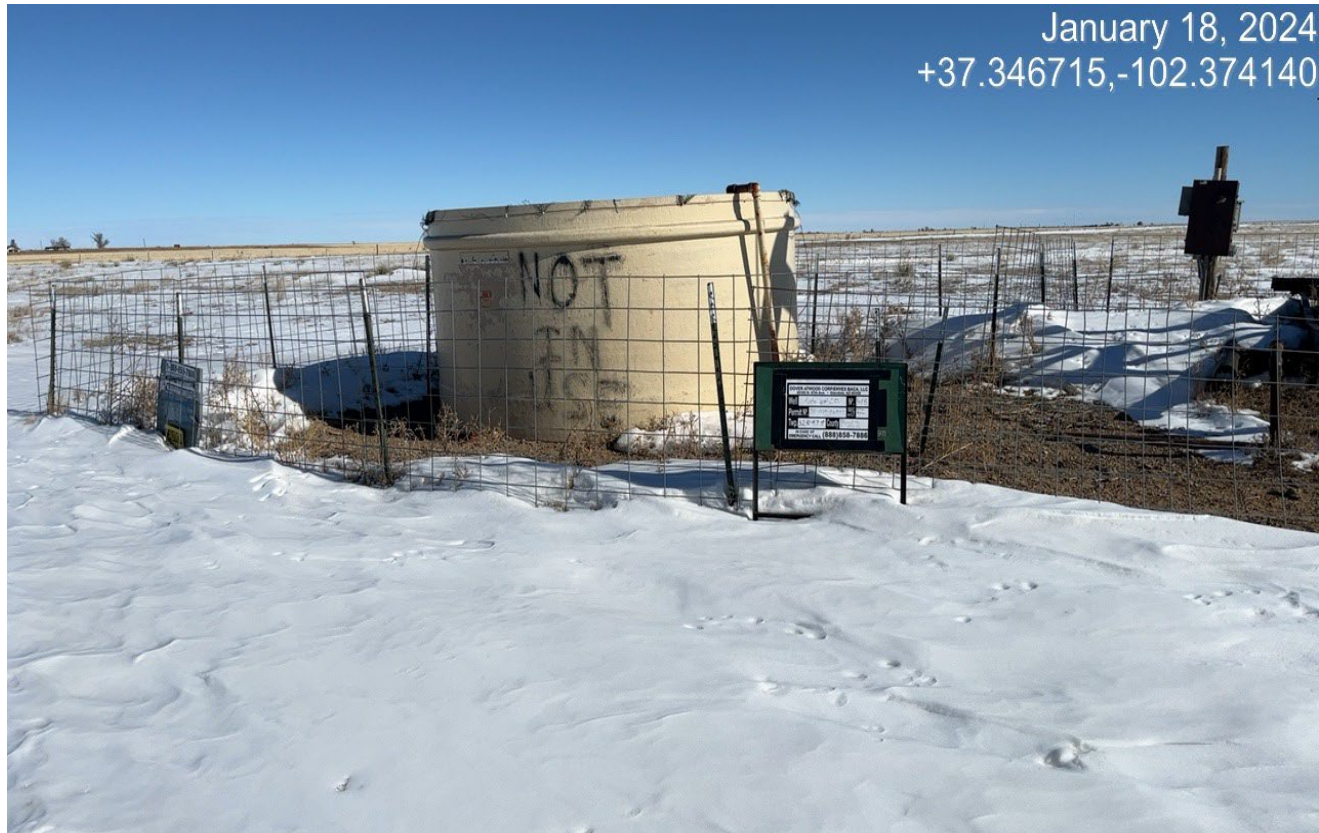
Photo 2. Facing toward the open top tank. There is not secondary containment at the tank and there is oily fluids inside the tank.

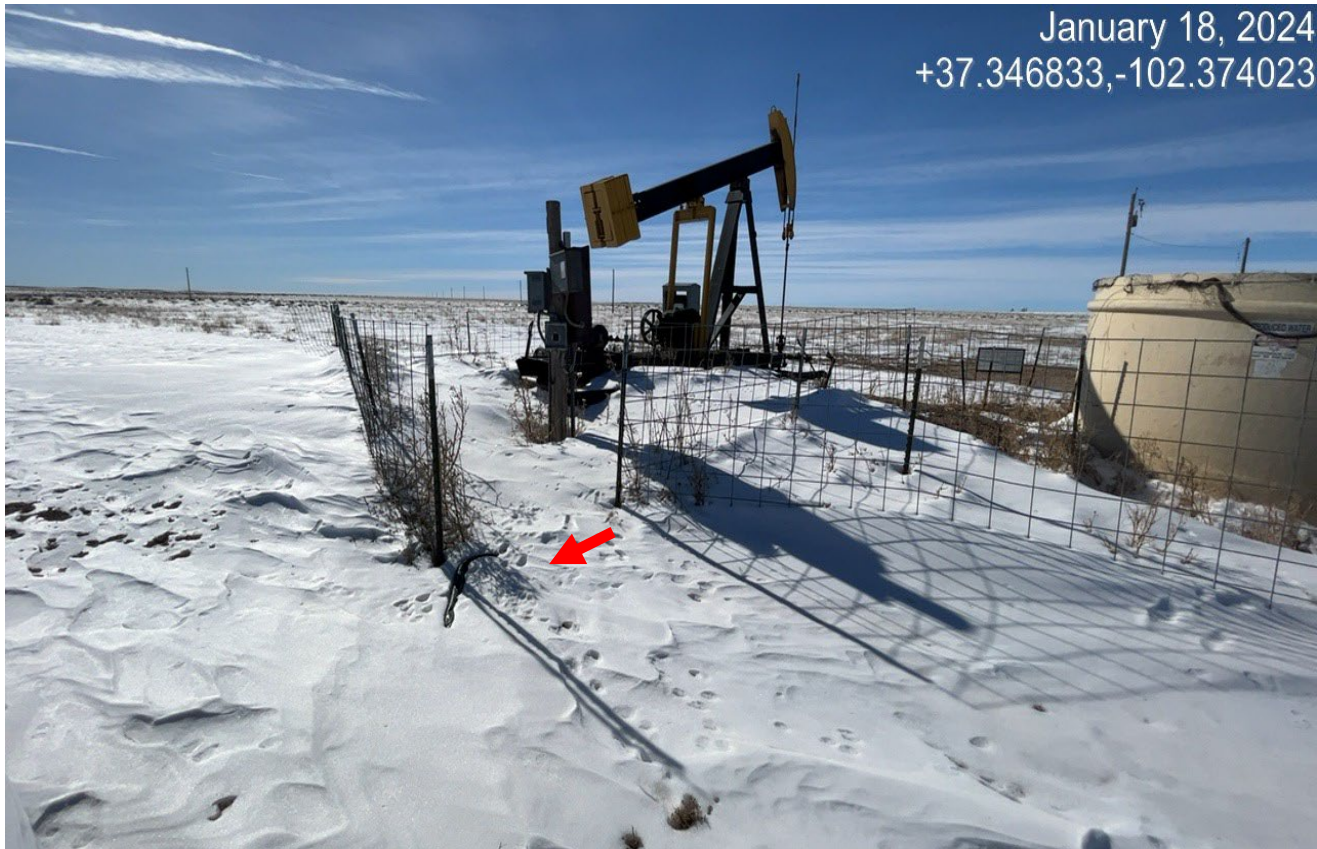
Photo 3. Facing toward the well. The gate has fallen over and is laying in the snow.
