Construction and Stormwater Inspection

Date: 01/12/2024

Location ID: 485658

Inspection Photos
Location Name: Boomhog 8-59 3
Location ID: 485658

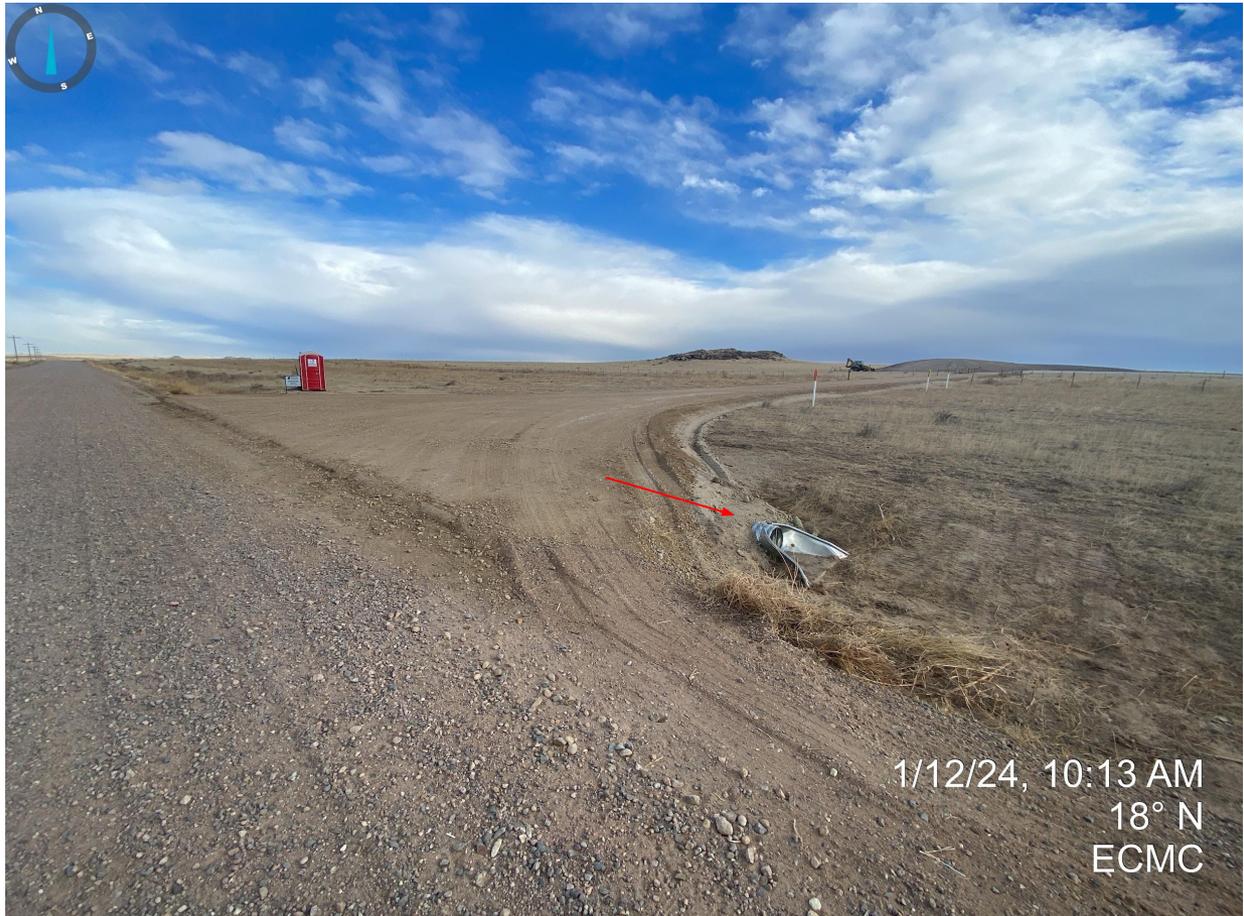
Photo 1. Soil around the culvert ends has been left unconsolidated; soils around the inlet/outlet don't appear to be compacted or otherwise stabilized.

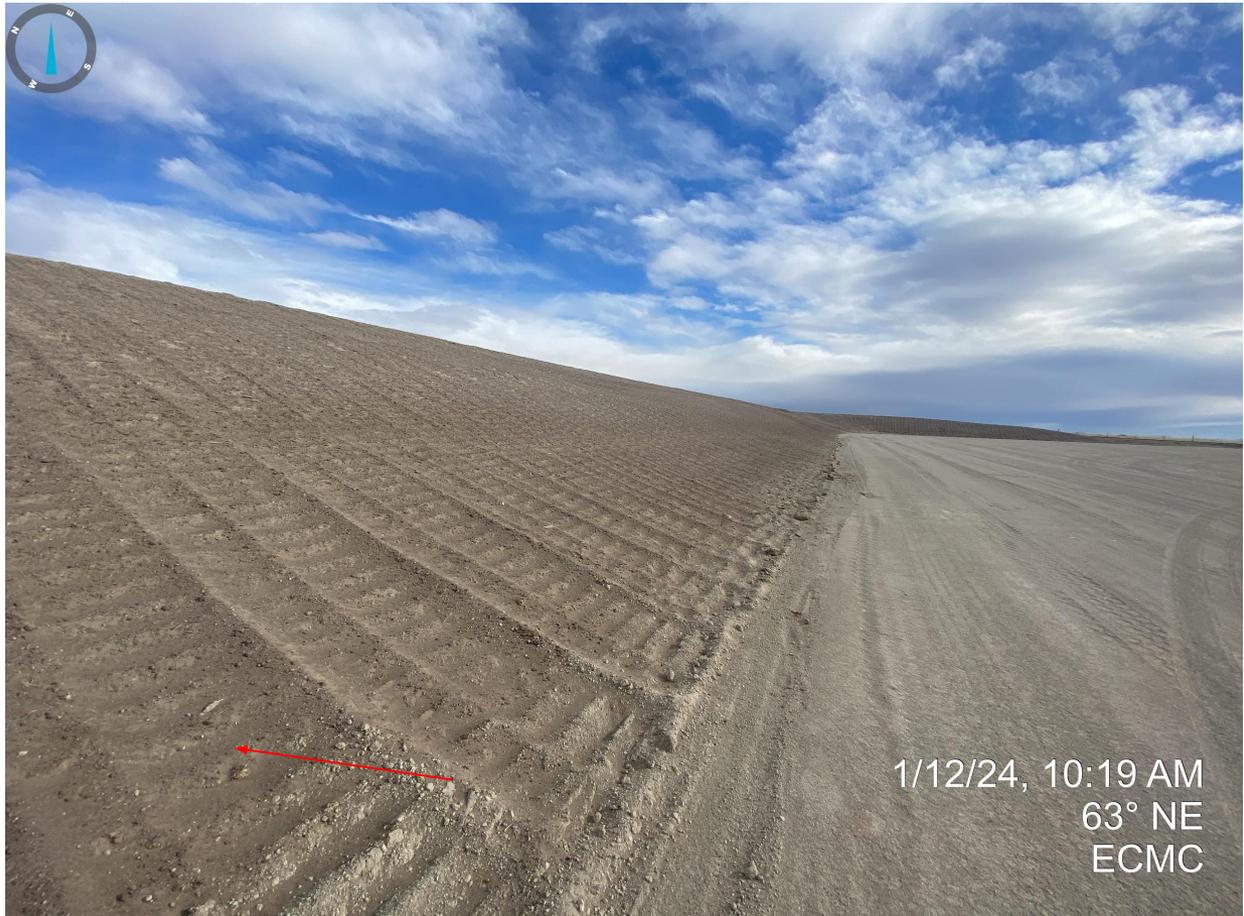
Photo 2. West side of topsoil stockpile. It appears the stockpile has been temporarily stabilized with evidence of equipment tracking, however, tracks are beginning to fill with soil which indicates additional stabilization BMPs are required.

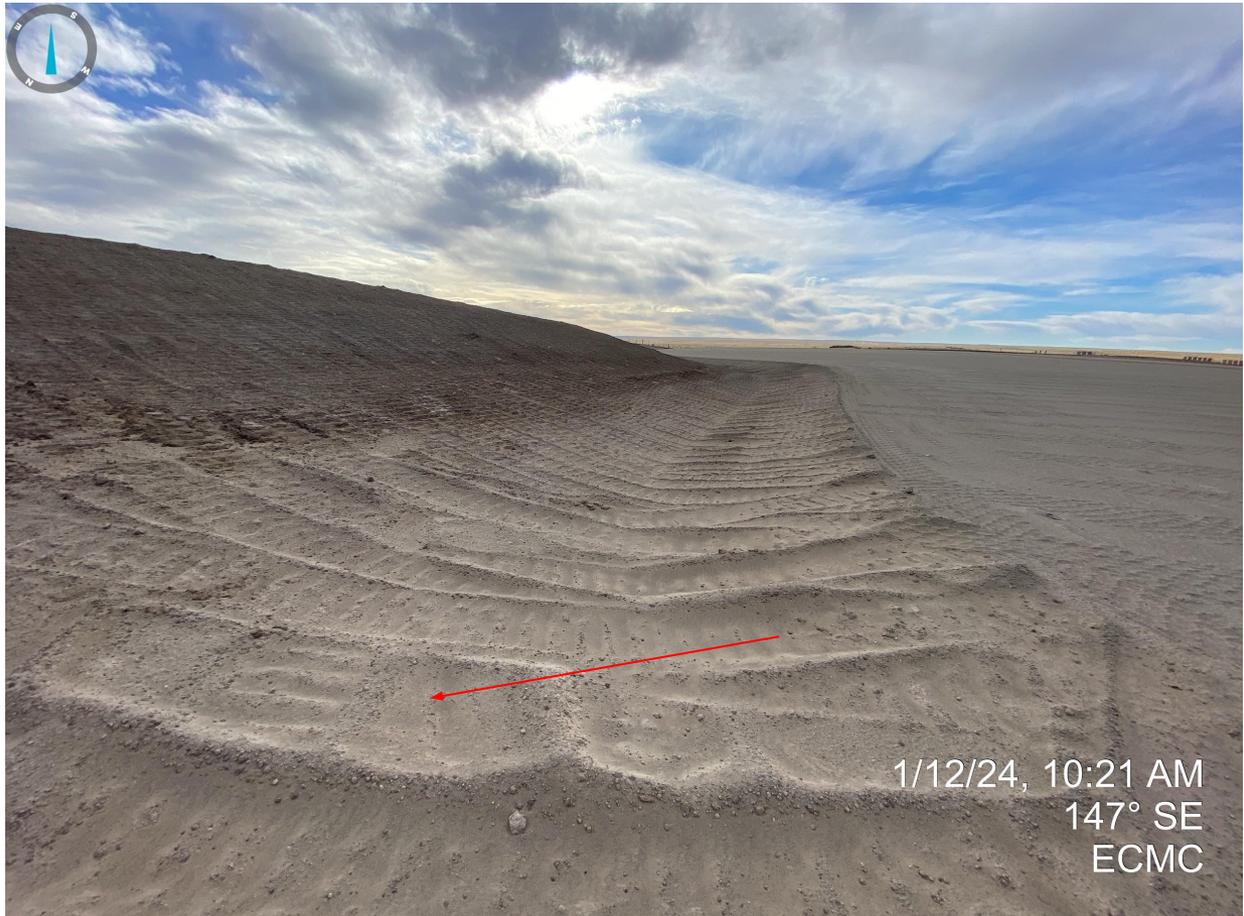
Photo 3. Northeast corner of drilling area, near stockpile. Stormwater ditches have been equipment tracked, however, tracks are beginning to fill with soil which indicates additional stabilization BMPs are required.

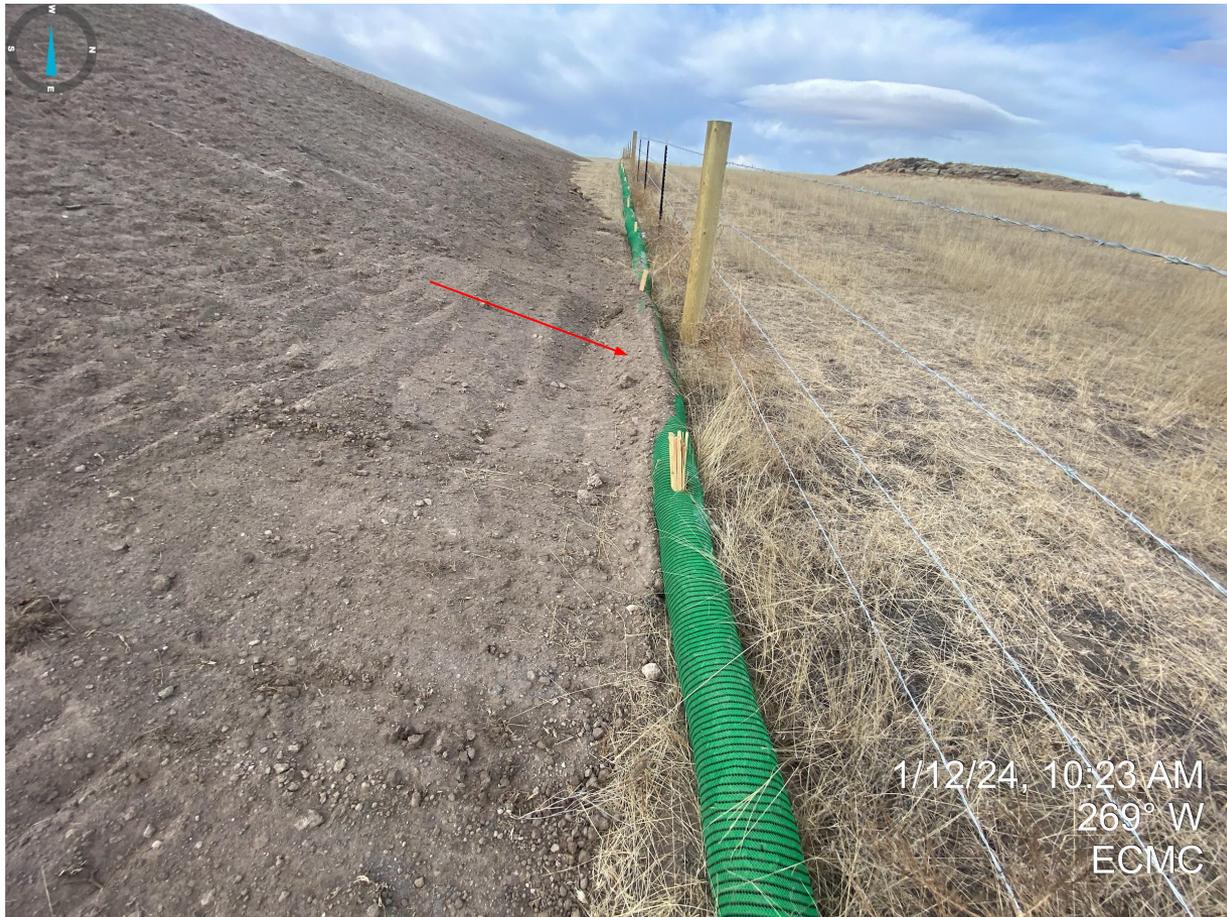
Photo 4. Northside of stockpile. Sediment controls (filtrexx) require maintenance.

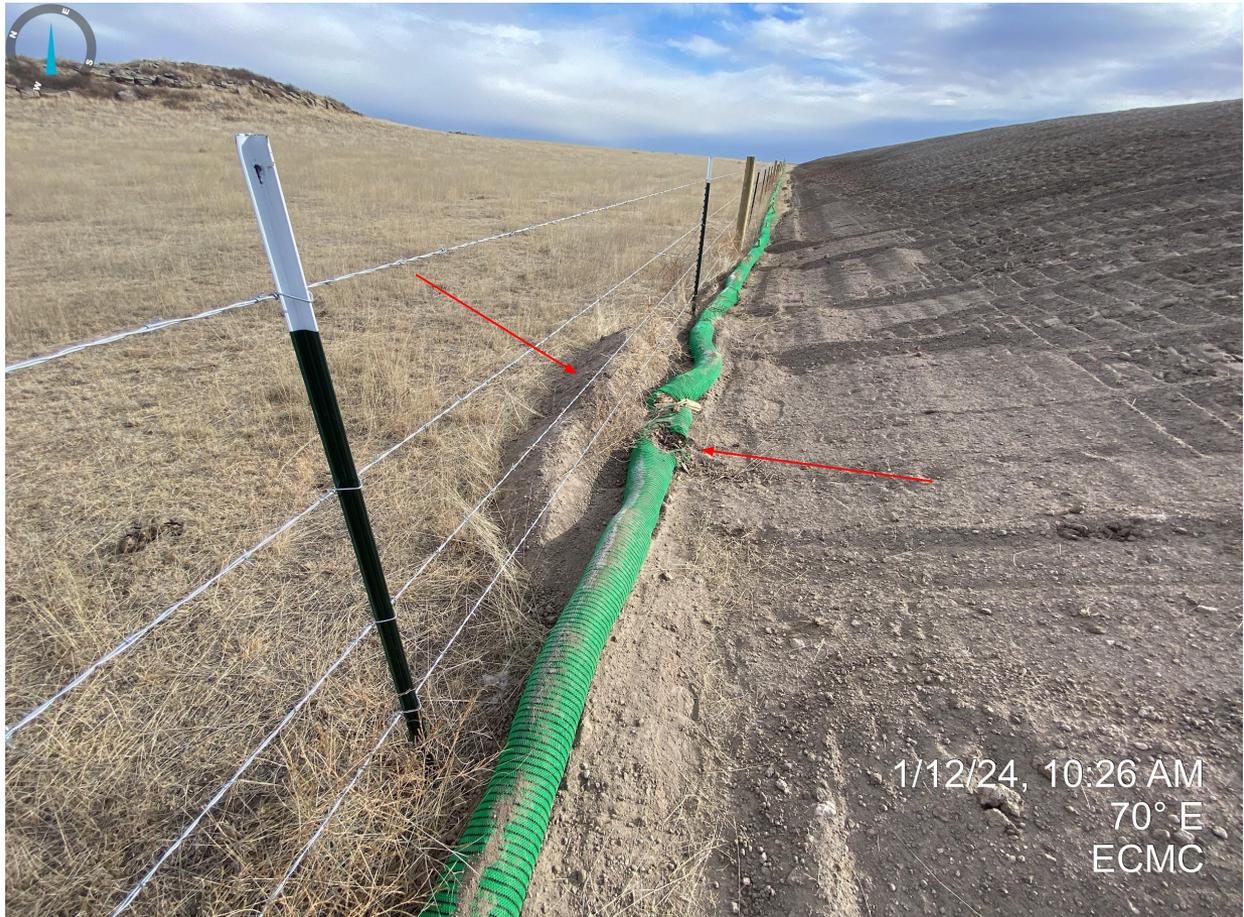
Photo 5. Northside of stockpile. Sediment controls (filtrexx) require maintenance or replacement (ripped). Soils outside of the fenced disturbance area shall be placed back to the stockpile.

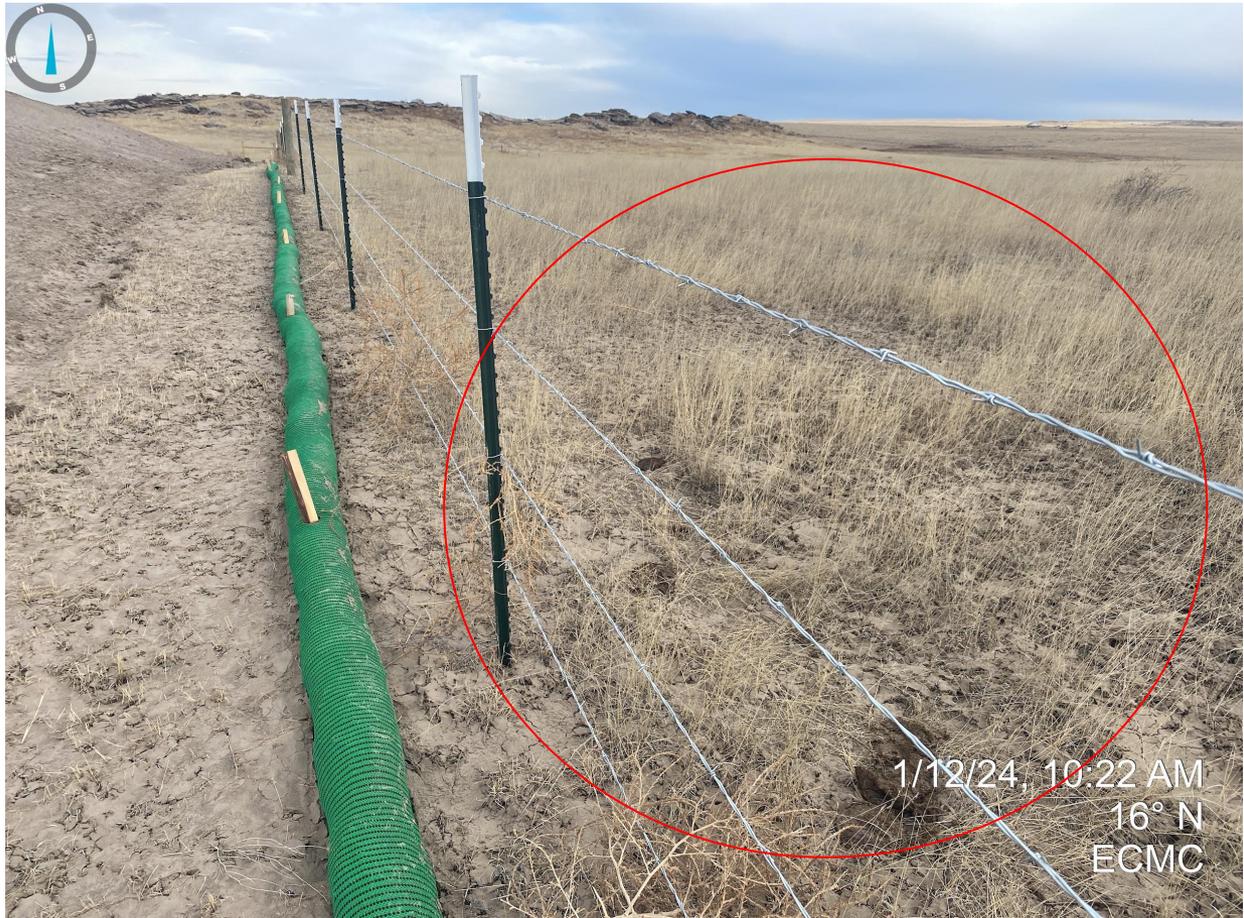
Photo 6. East side of stockpile. Evidence of wind erosion (soil deposition) outside of the fenced disturbance area resulting from unstabilized soils on the construction site.

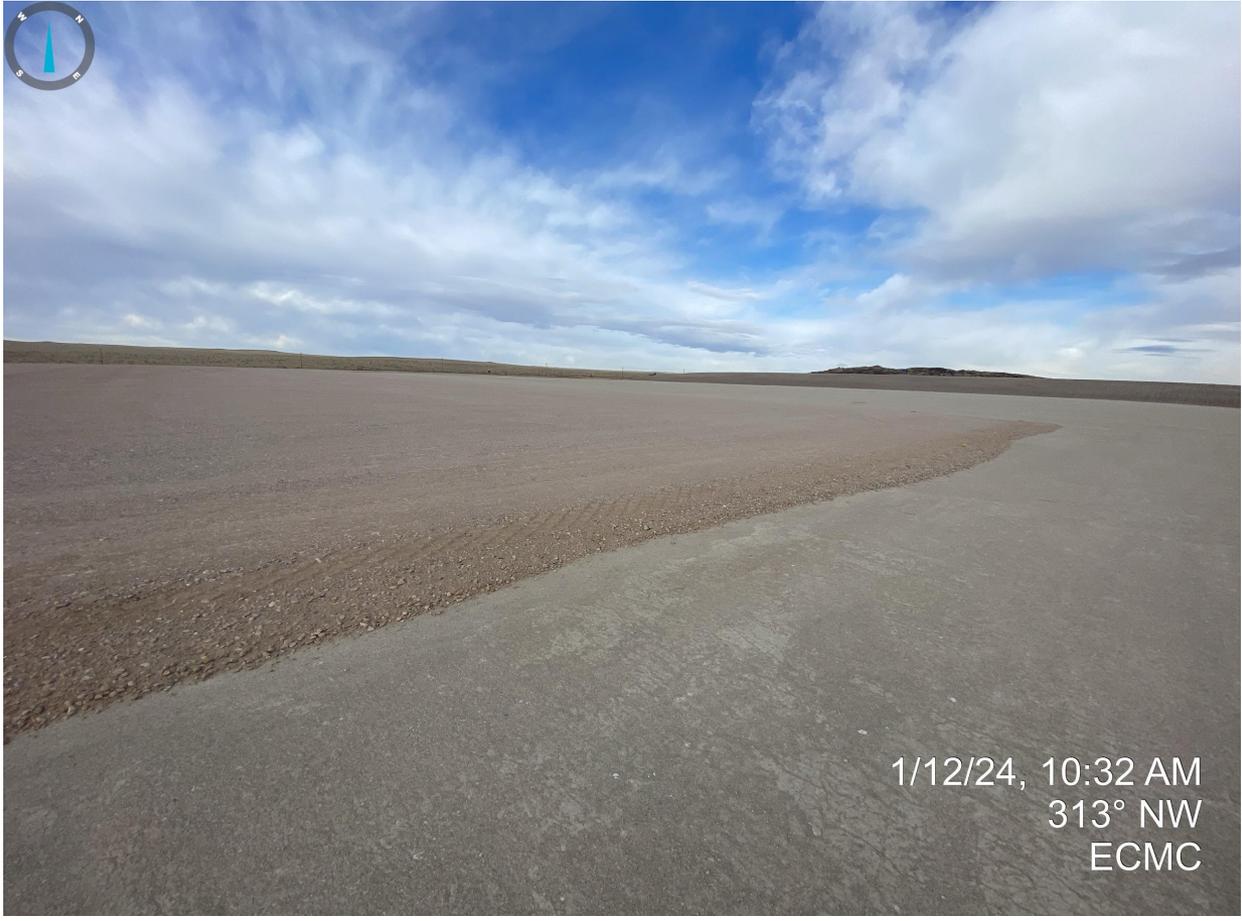
Photo 7. Taken from the approximate center of the drilling pad. Portions of the drilling pad have been paved over or otherwise compacted.

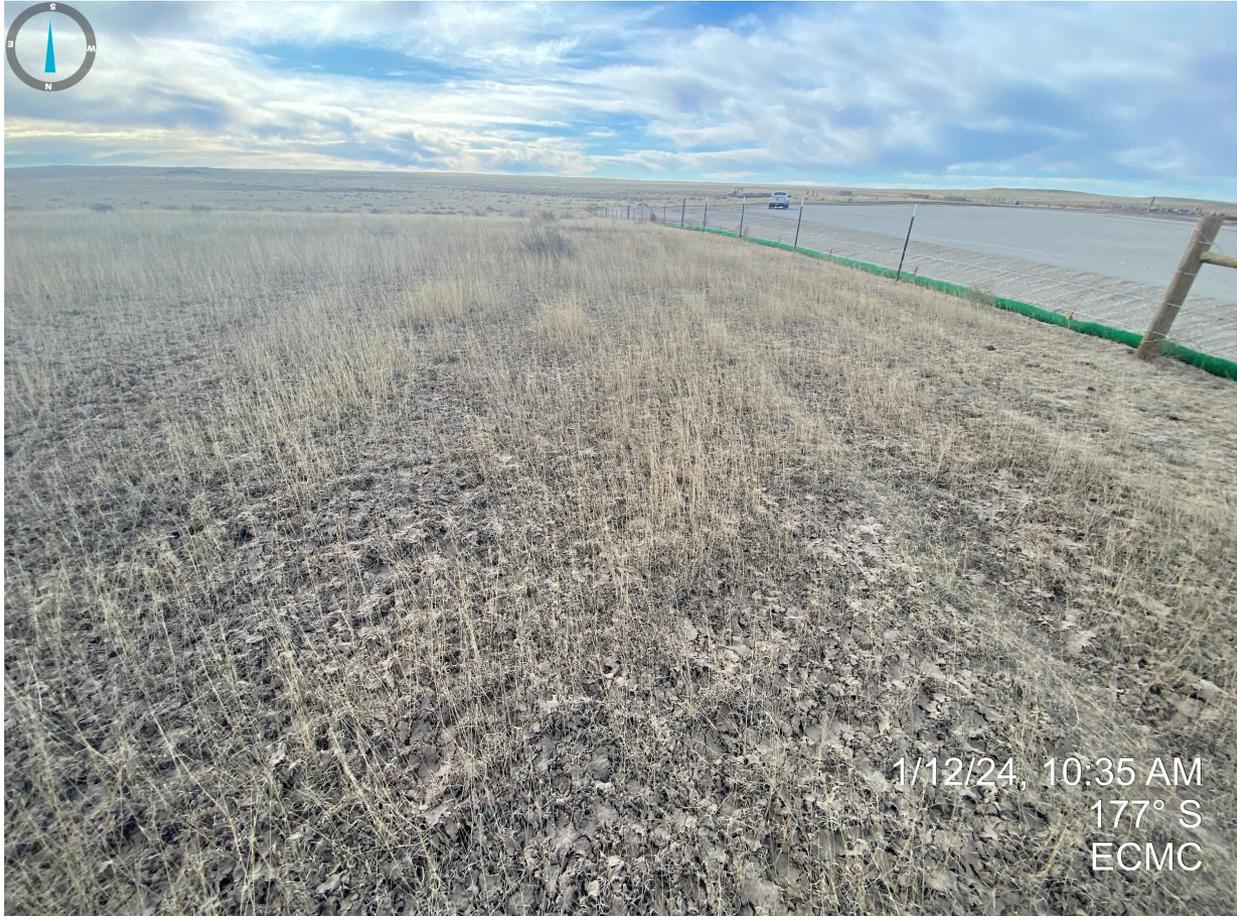
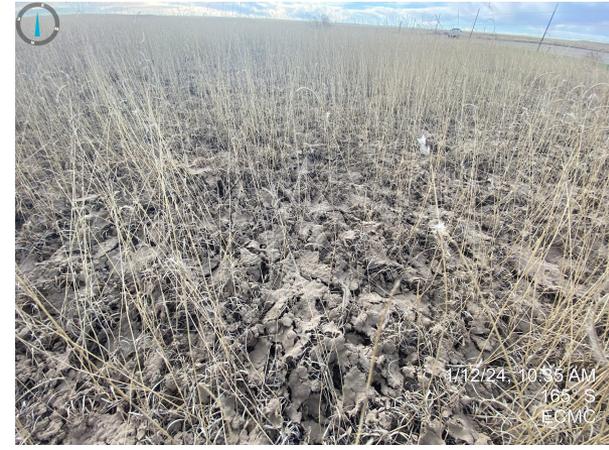
Photo 8. East side of pad construction, outside of the disturbance area. Evidence of wind erosion (soil deposition) outside of the fenced disturbance area resulting from unstabilized soils on the construction site.

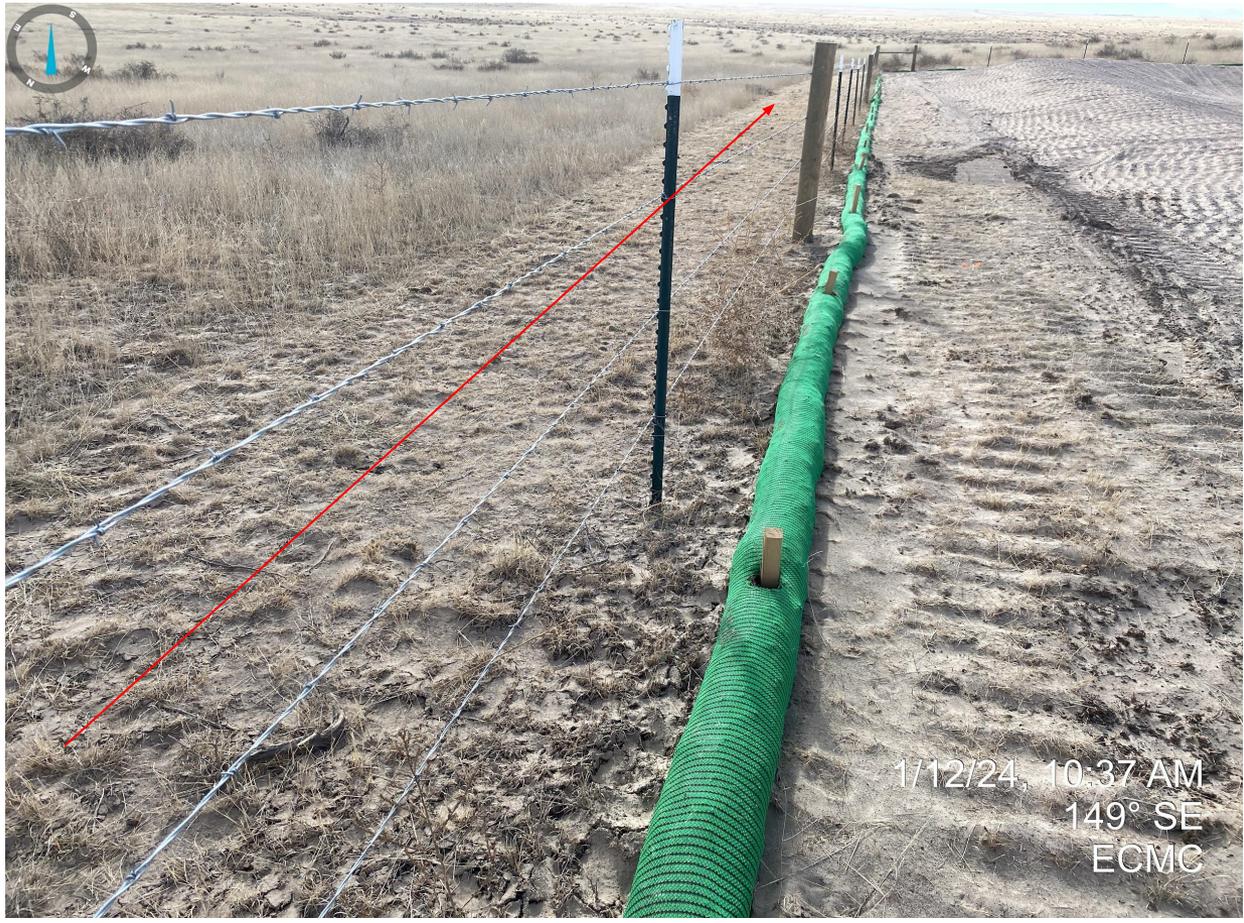
Photo 9. East side of pad construction. Evidence of wind erosion (soil deposition) outside of the fenced disturbance area resulting from unstabilized soils on the construction site.

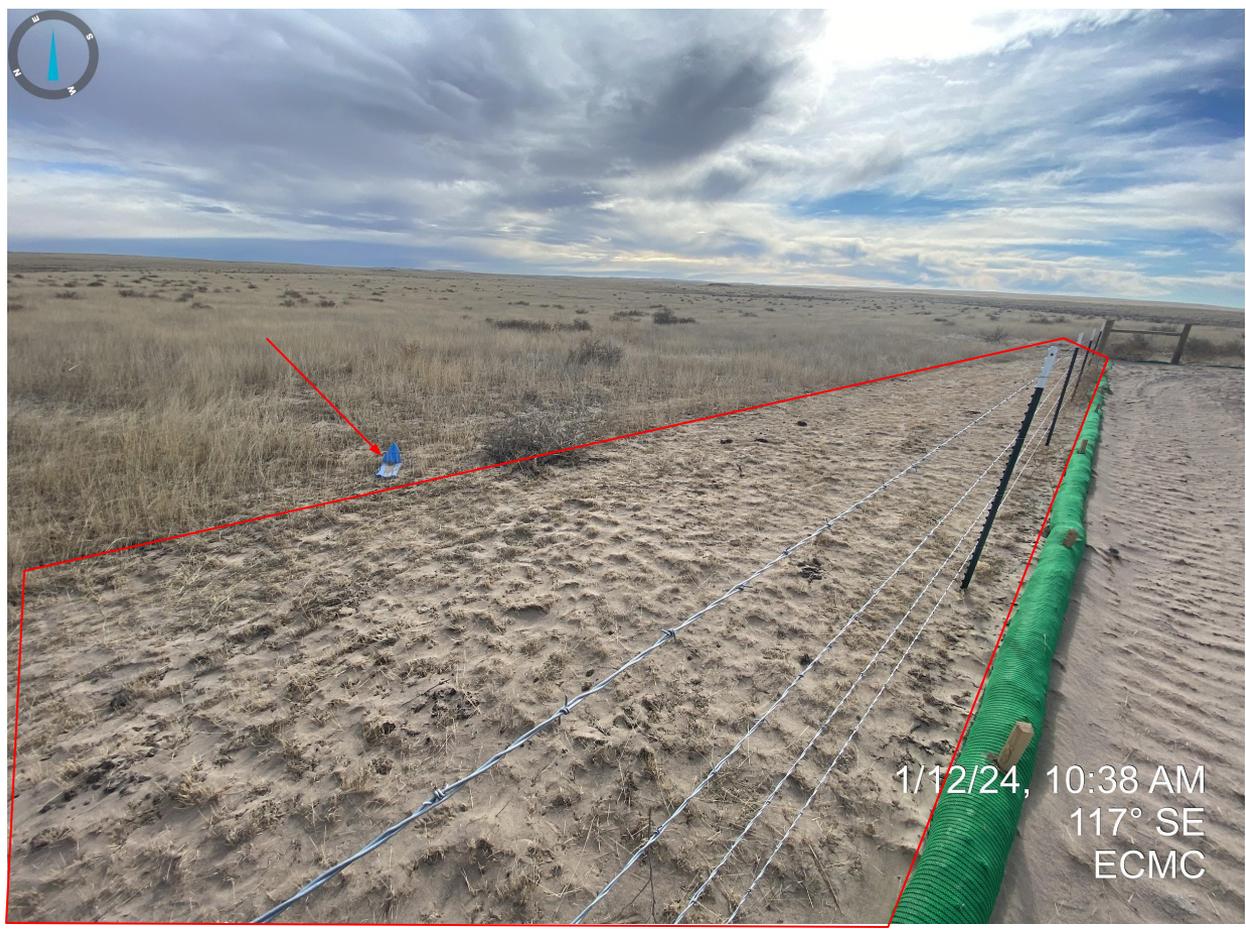
Photo 10. Continued from Photo 9. East side of pad construction. Evidence of wind erosion (soil deposition) outside of the fenced disturbance area resulting from unstabilized soils on the construction site. Also pictured (red arrow) trash/debris.

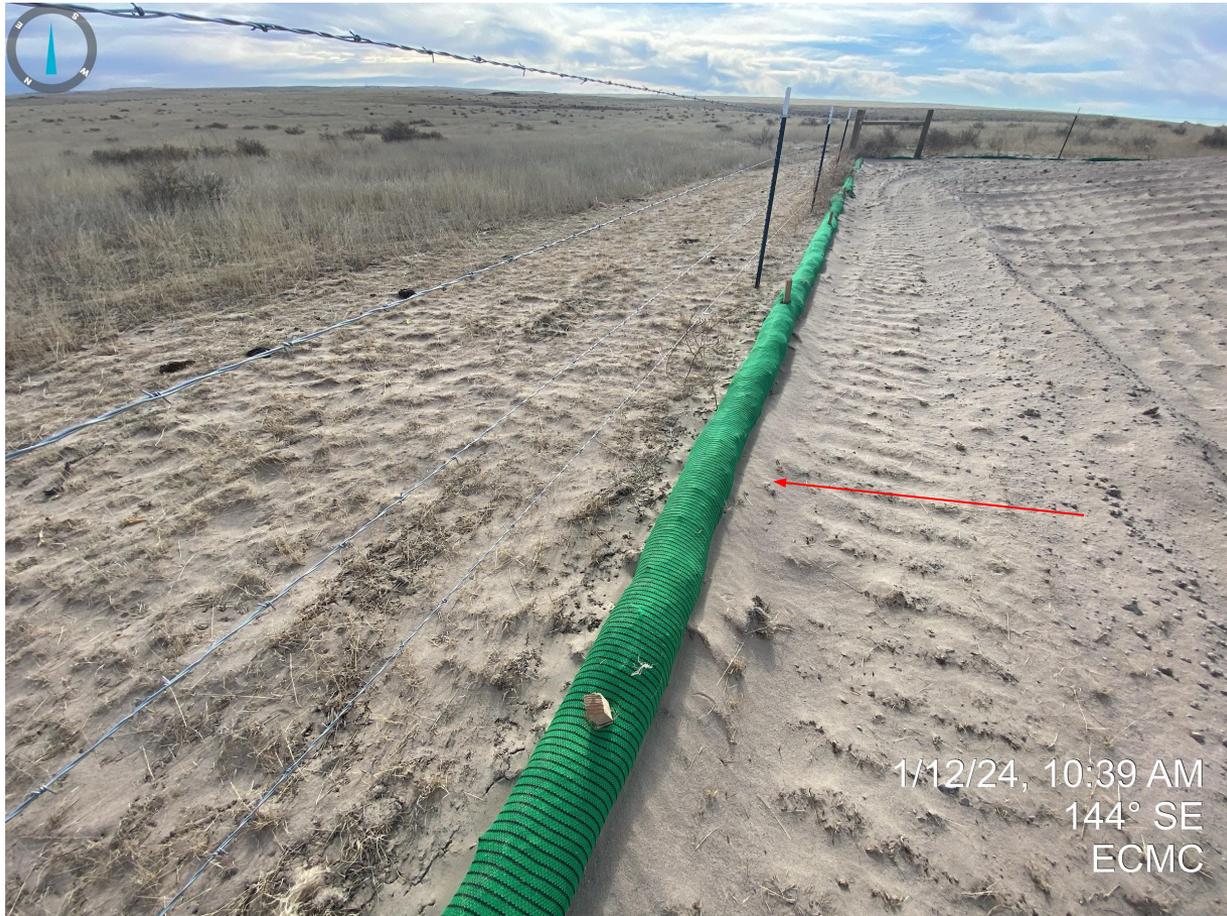
Photo 11. Filtrex requires maintenance as they're beginning to fill with soil.

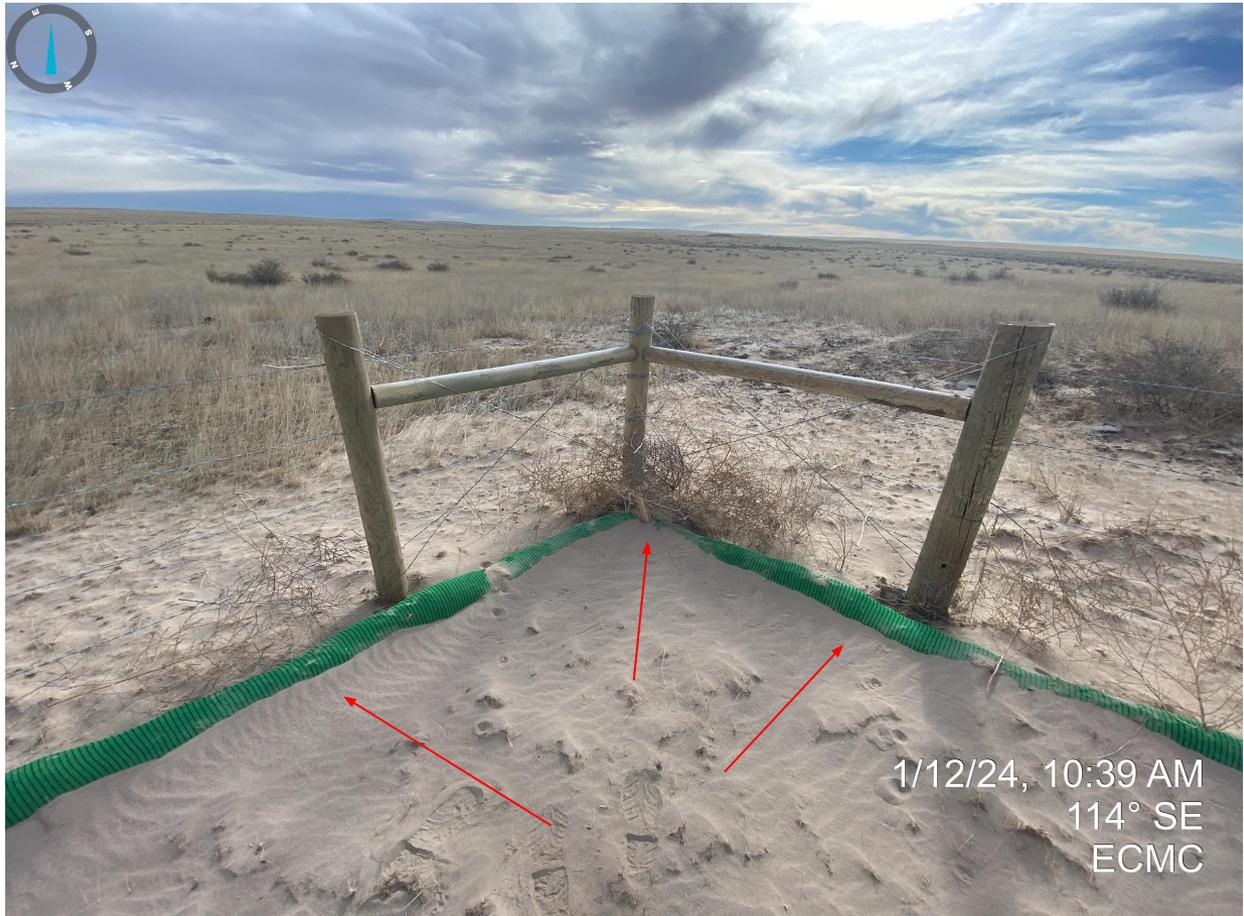
Photo 12. Southeast corner of location. Filtrexx requires maintenance as they're beginning to fill with soil.

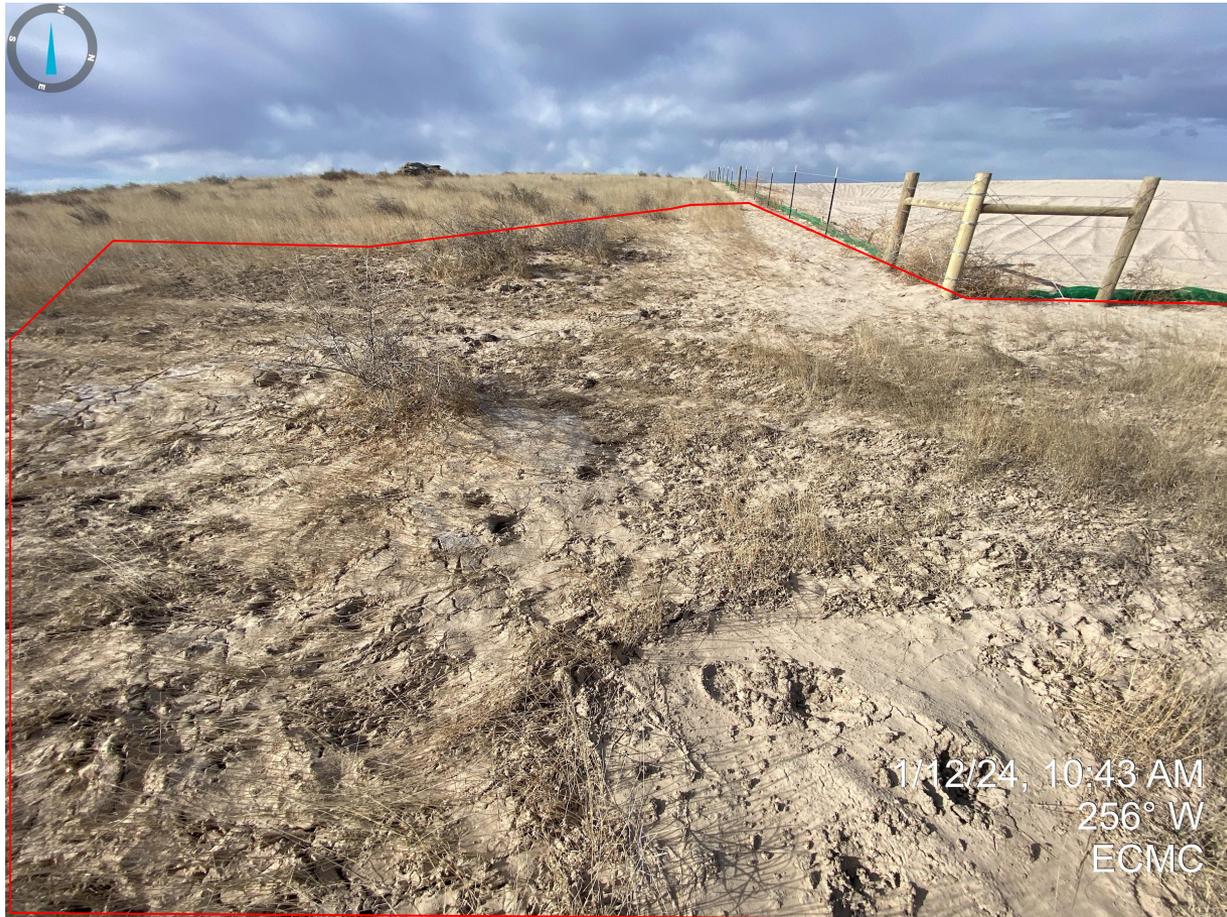
Photo 13. Southeast side of pad construction, outside of fenced disturbance area. Evidence of wind erosion (soil deposition) outside of the fenced disturbance area resulting from unstabilized soils on the construction site. Red polygon is only an approximation of new disturbance.

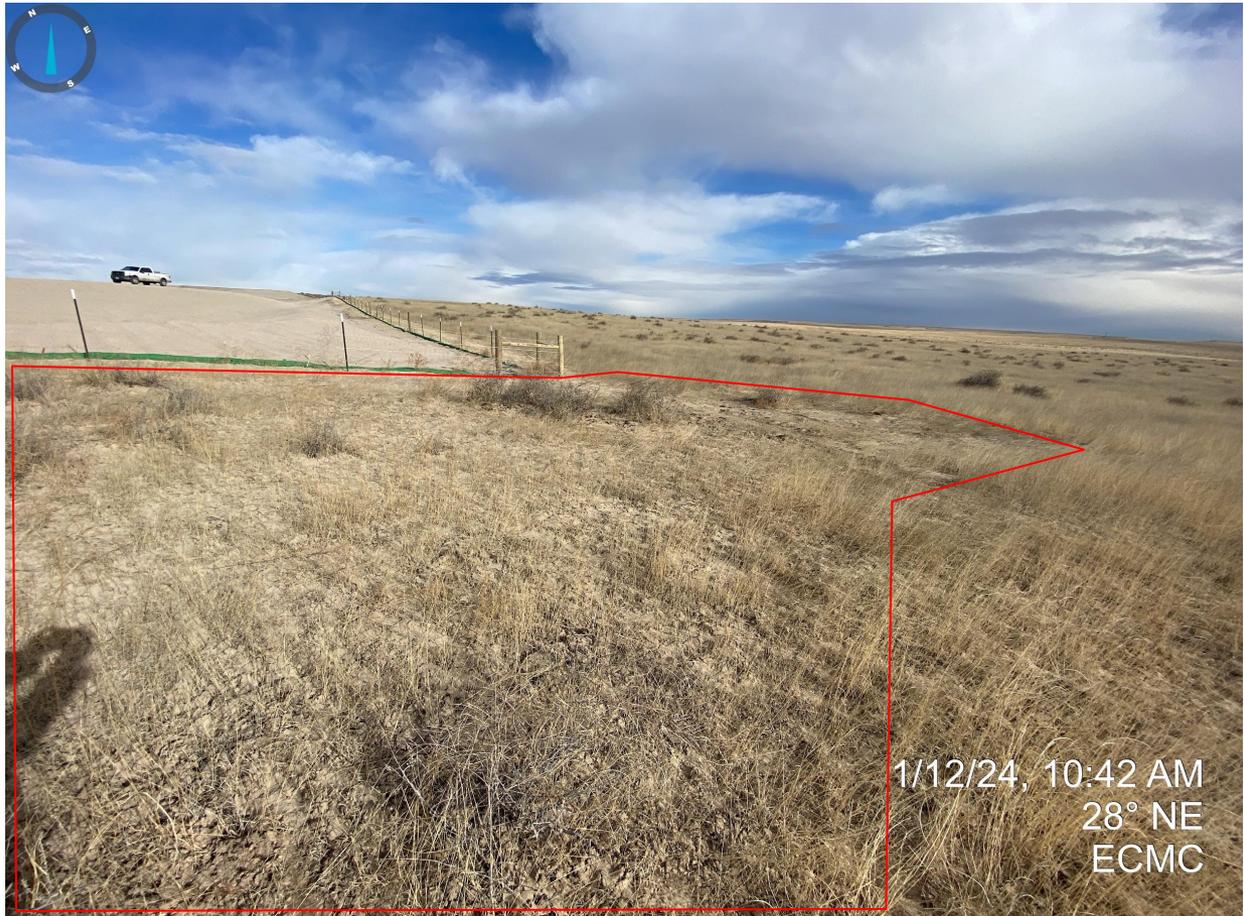
Photo 14. Southeast side of pad construction, outside of fenced disturbance area. Evidence of wind erosion (soil deposition) outside of the fenced disturbance area resulting from unstabilized soils on the construction site. Red polygon is only an approximation of new disturbance.

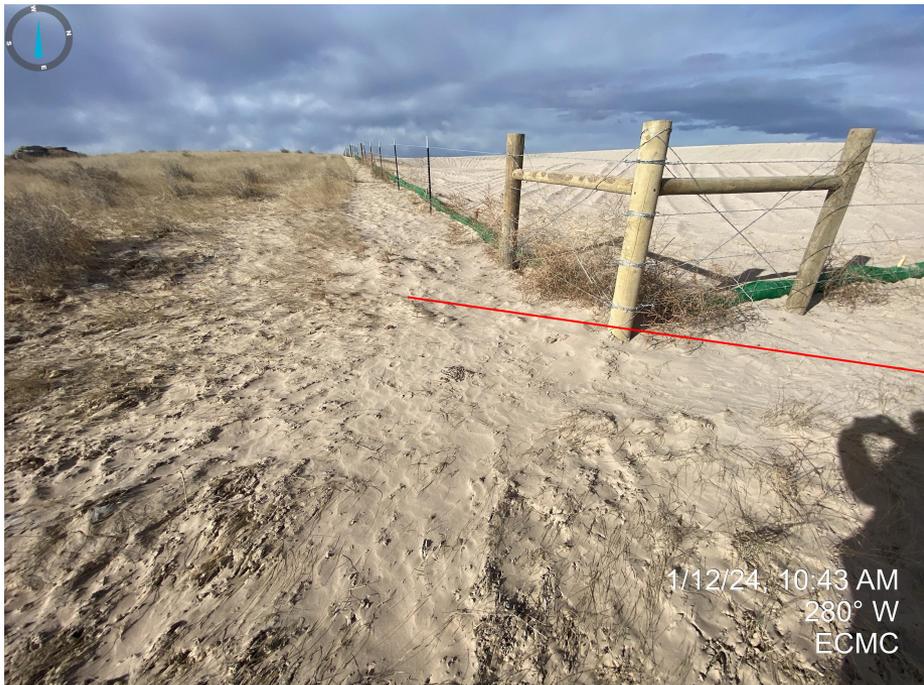
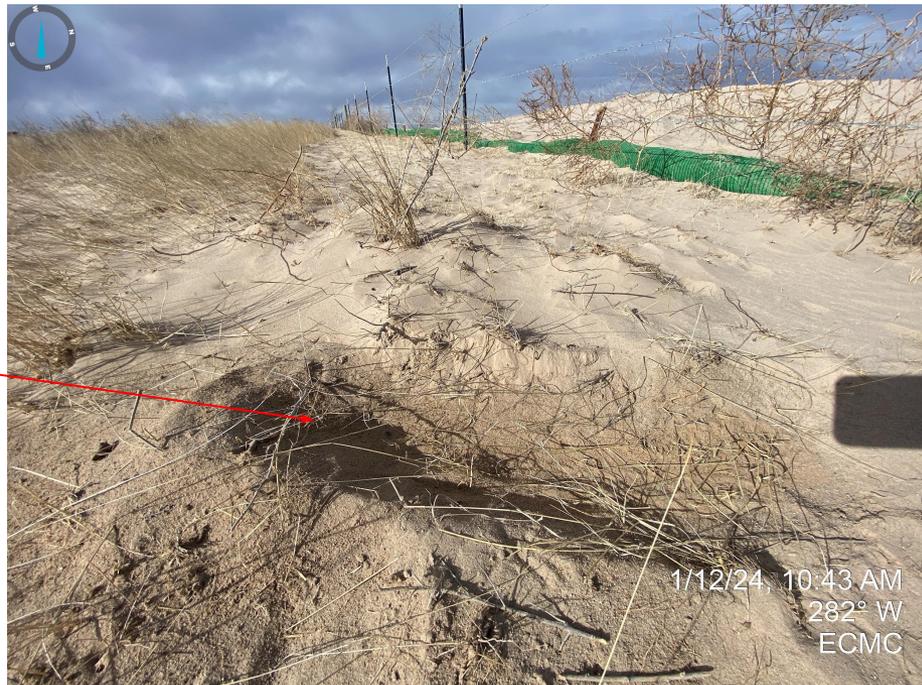
Photos 15 & 16. Taken from the southeast corner of the location, outside of the fenced disturbance area. Photo illustrates the depth of soil deposition (approximately 2"); deposition depth varied across the impacted lands.

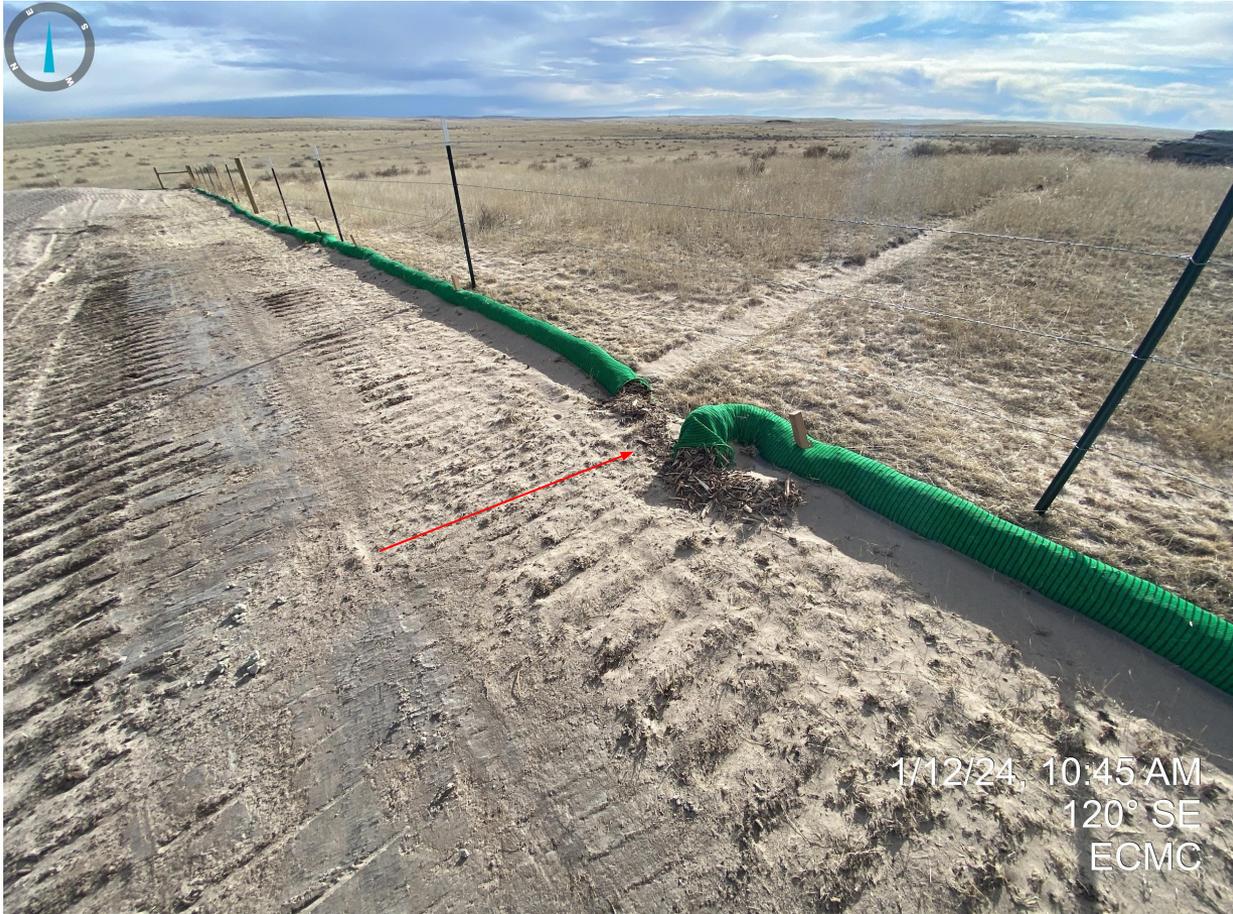
Photo 17. Southeast corner of location. Filtrexx requires repair/replacement.

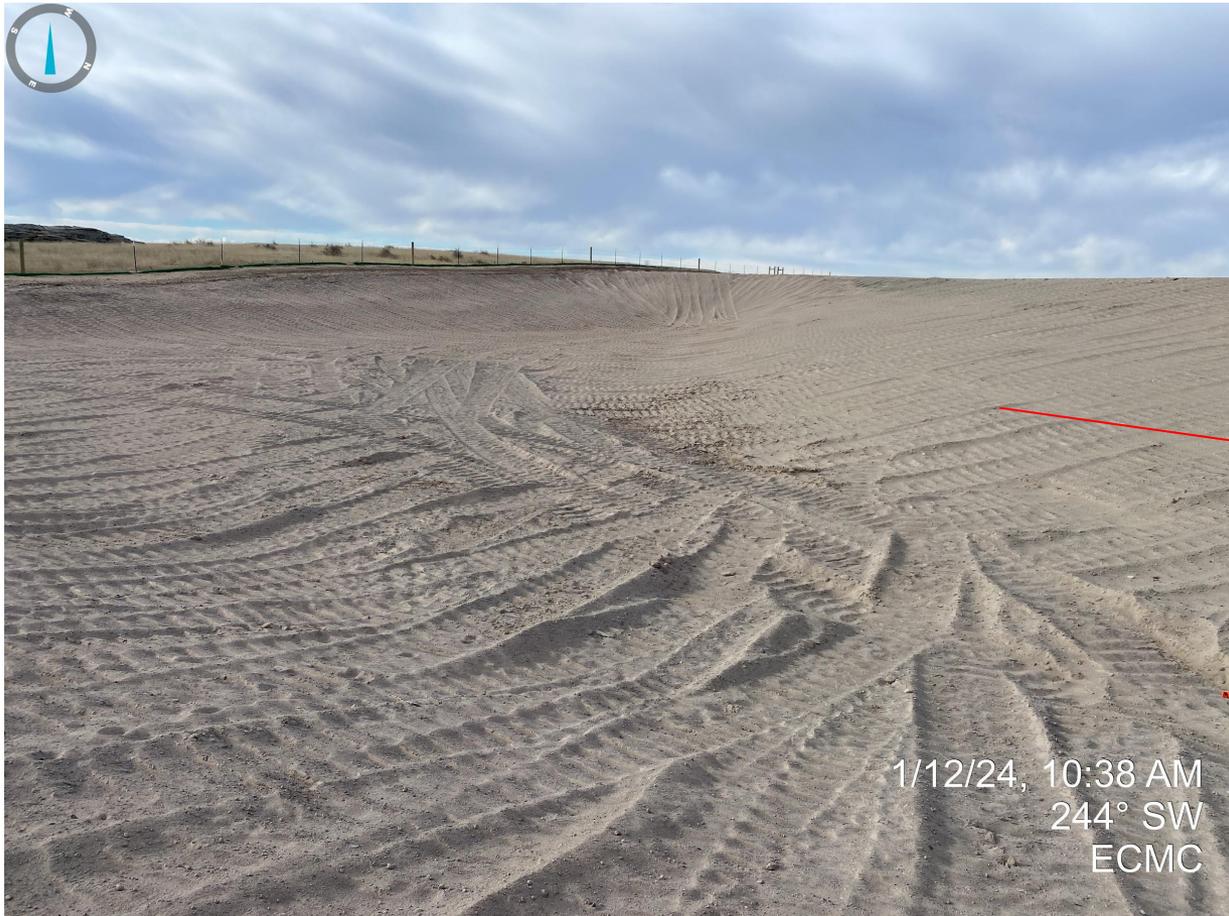
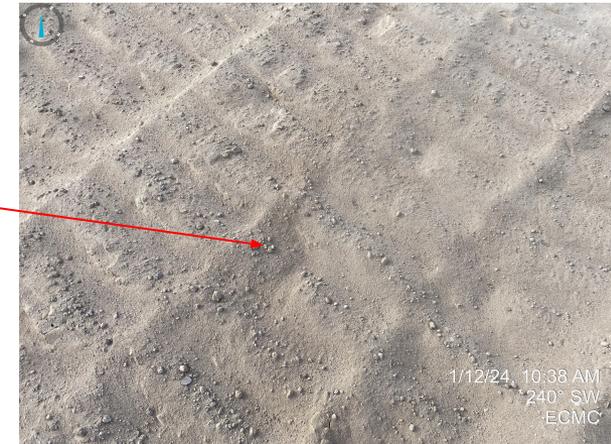
Photos 18 & 19. Southeast stormwater retention area. Stormwater controls have been equipment tracked, however, tracks are beginning to fill with soil which indicates additional stabilization BMPs are required (e.g. seeding, tackifiers, etc). The retention areas also do not appear to have any protected/armored inlet or outlets.

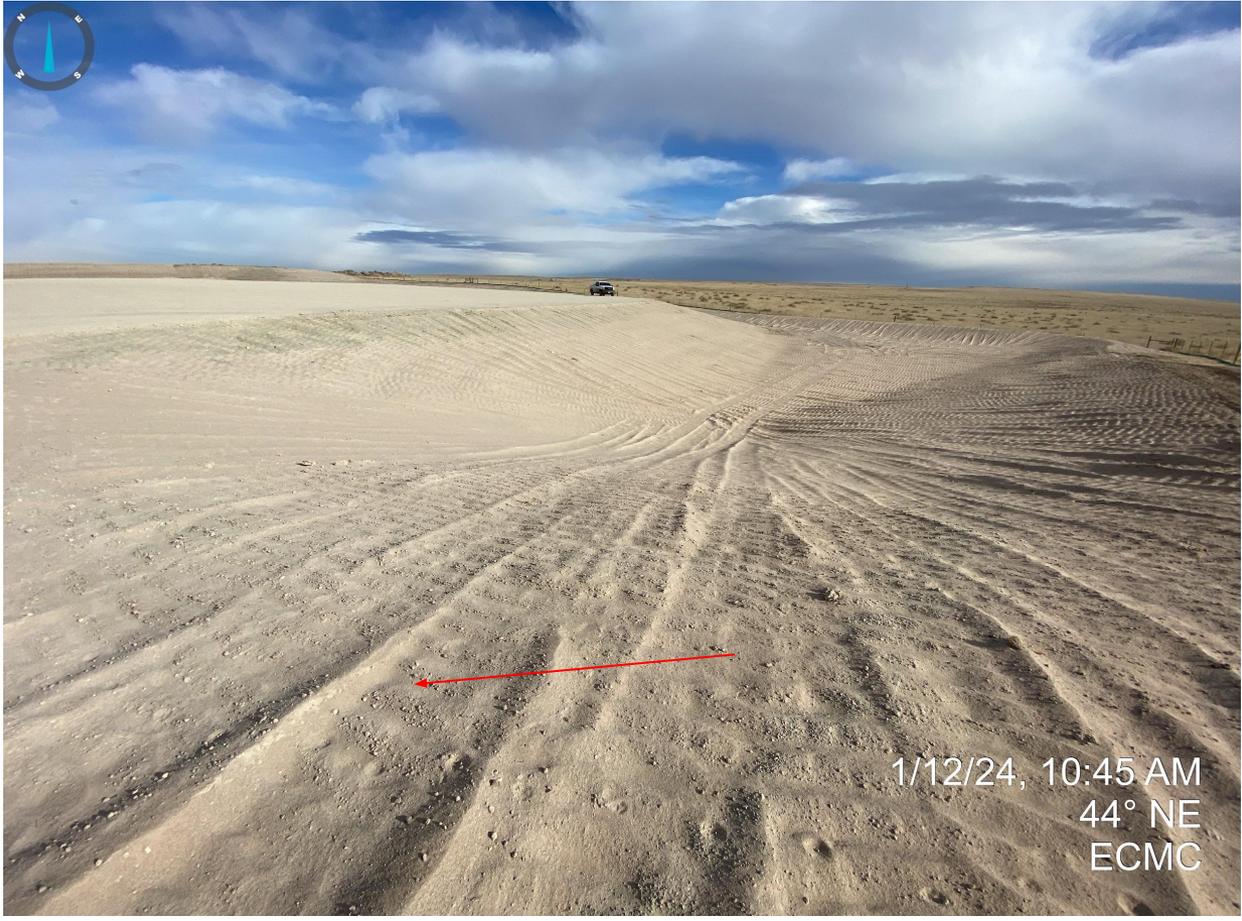
Photo 20. Southeast retention area. See comment in Photos 18 & 19. Red arrow indicates example of unstabilized soils.

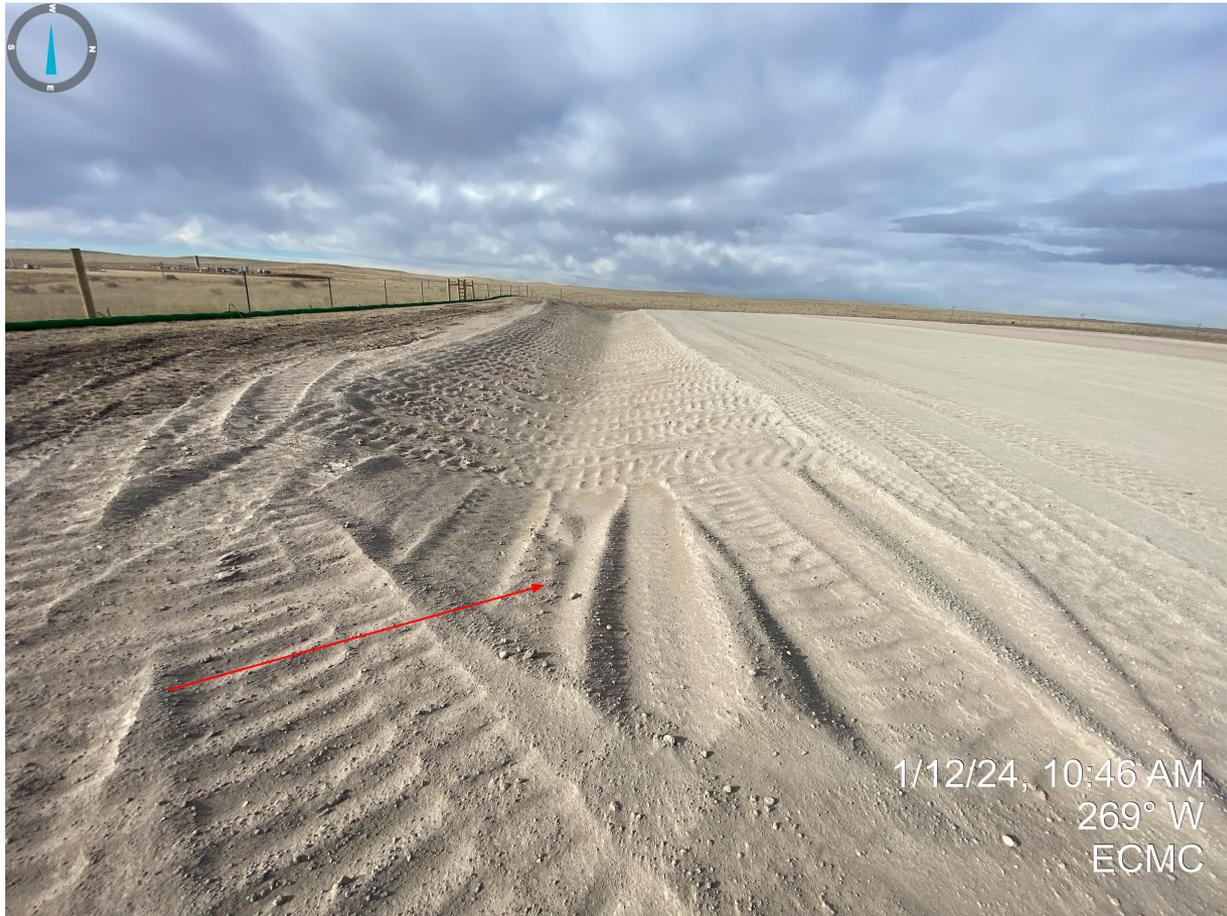
Photo 21. Unstabilized soils along the southern stormwater ditch.
