Construction and Stormwater Inspection

Date: 01/12/2024

Location ID: 485658

Inspection Photos
Location Name: Boomhog 8-59 3
Location ID: 485658

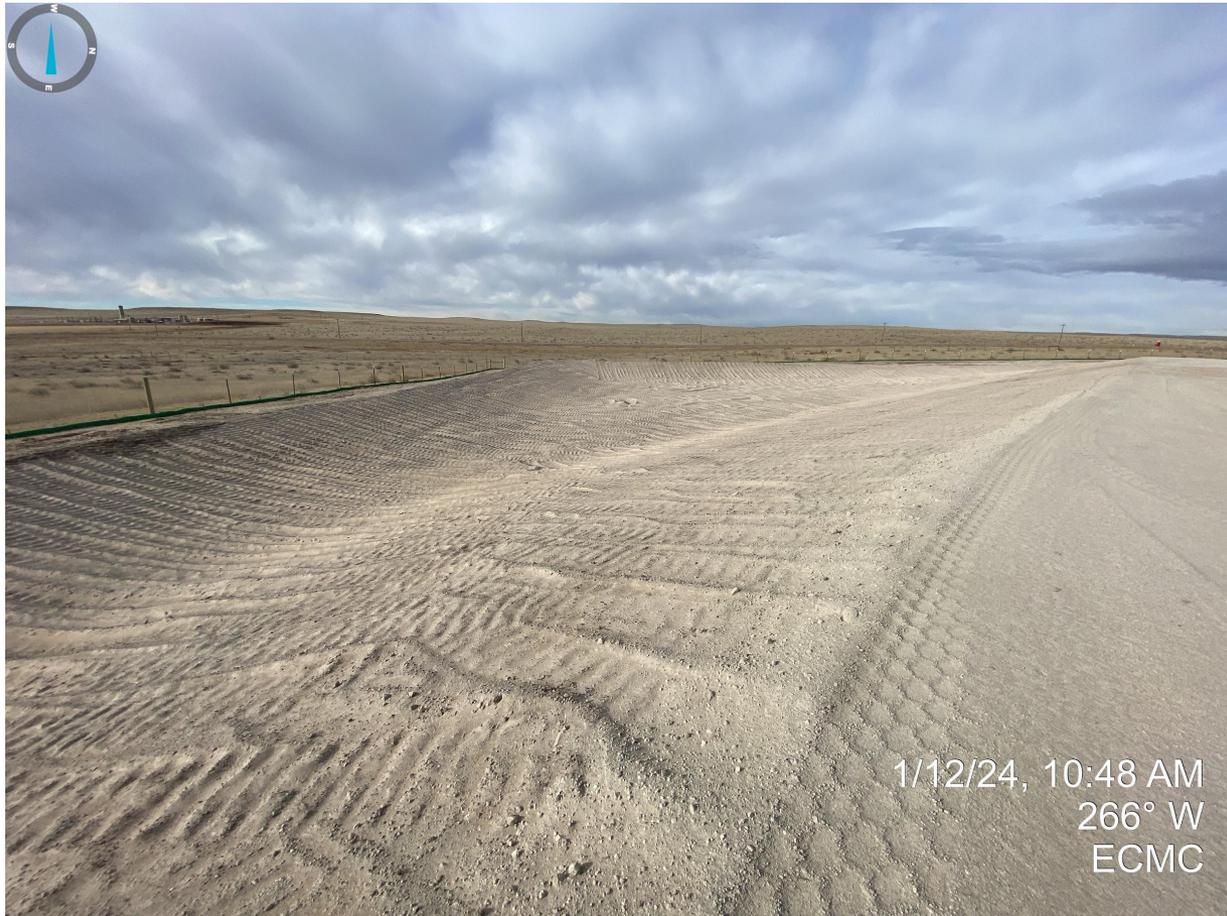
Photo 22. Southwest stormwater retention area. Stormwater controls have been equipment tracked, however, tracks are beginning to fill with soil which indicates additional stabilization BMPs are required (e.g. seeding, tackifiers, etc). The retention areas also do not appear to have any protected/armored inlet or outlets.

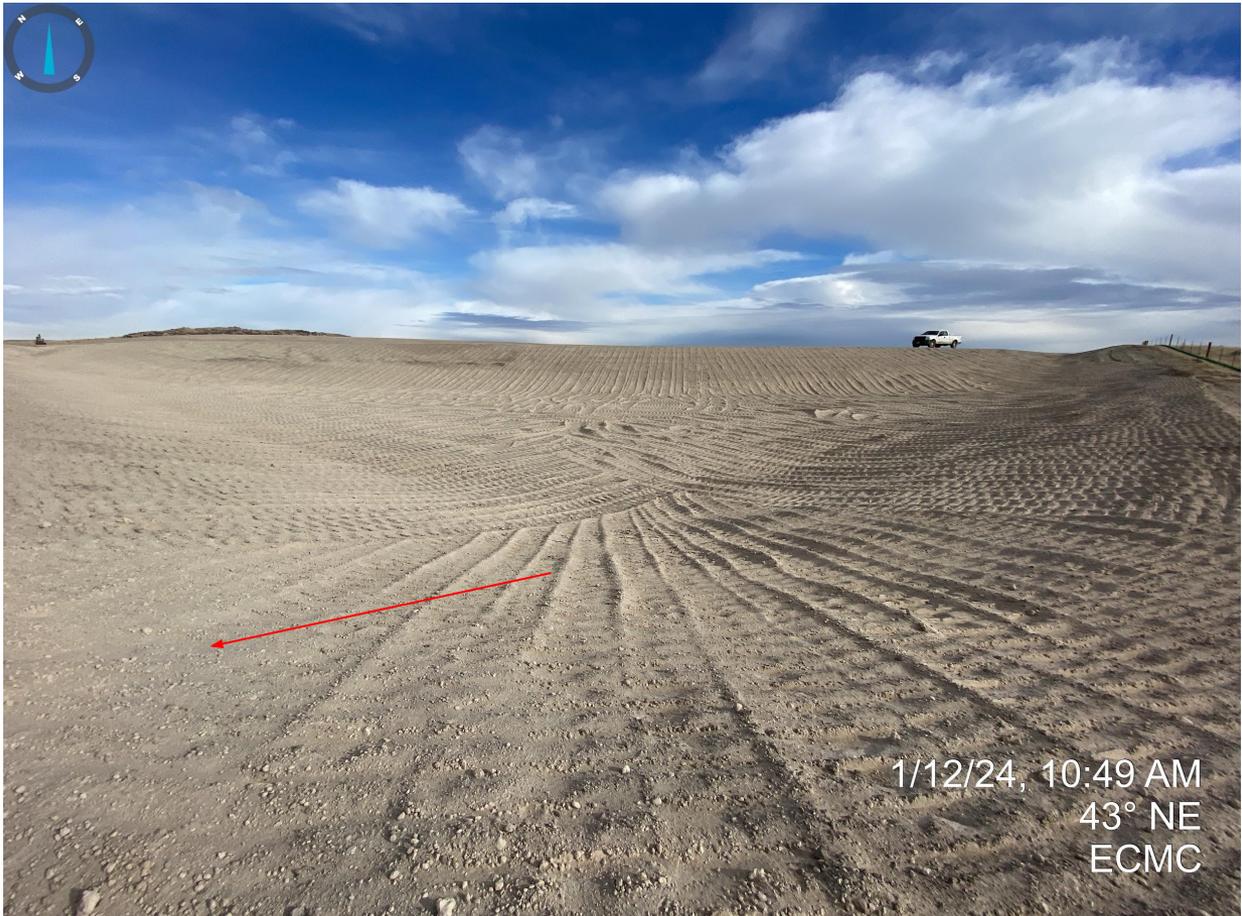
Photo 23. Southwest retention area. See comment in Photo 22. Red arrow indicates example of unstabilized soils.

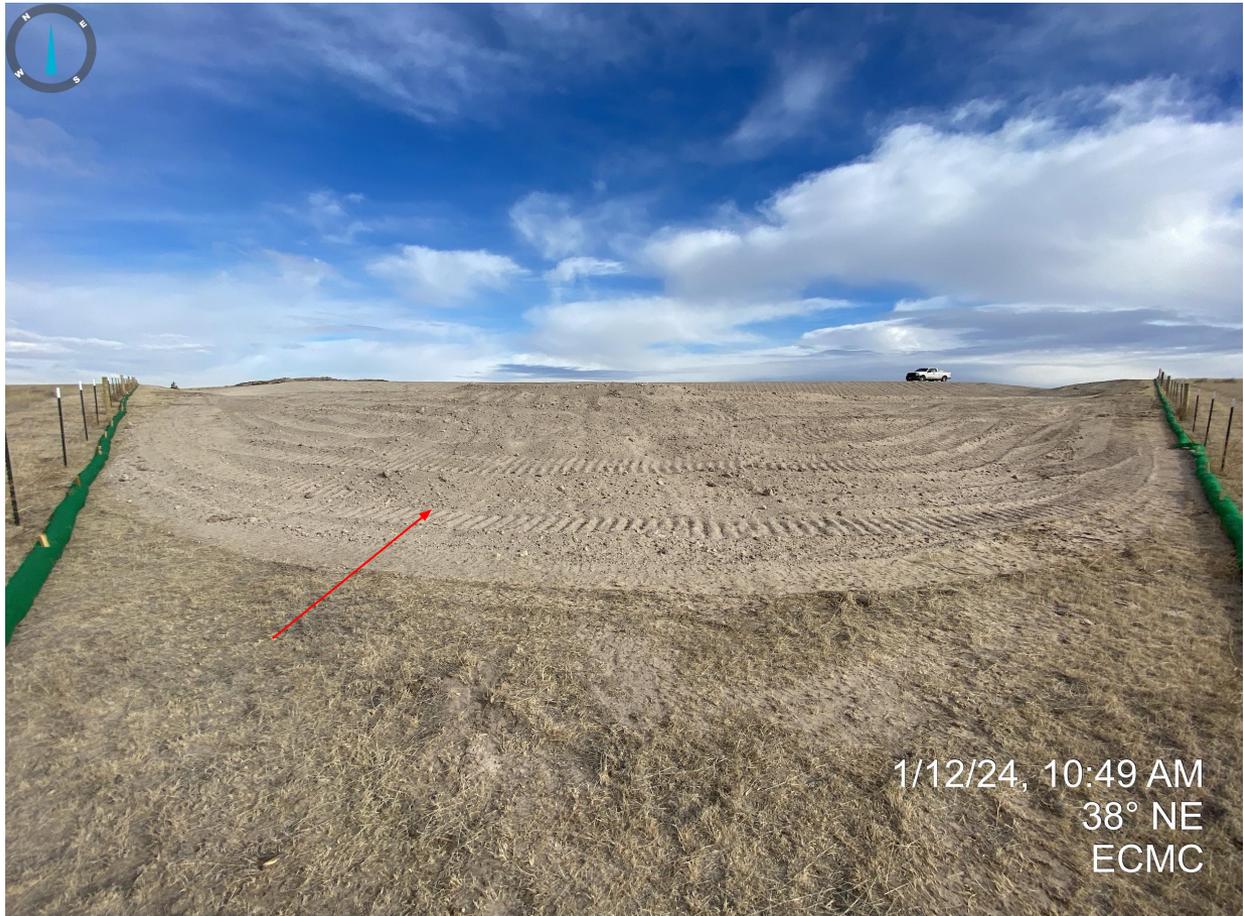
Photo 24. Improper equipment tracking (parallel to slope) on the backside of the stormwater retention area.

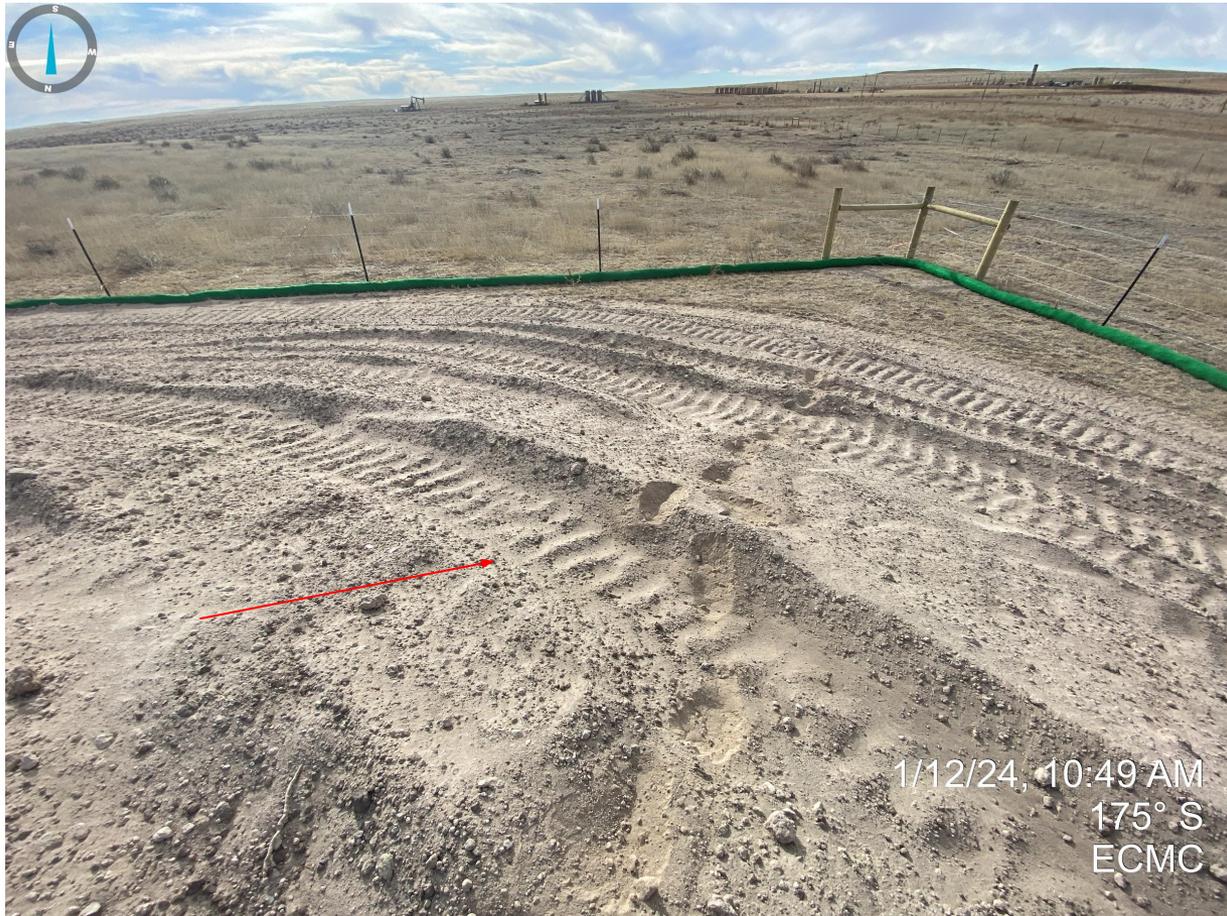
Photo 25 Continued from Photo 24. Unstabilized soils pictured.

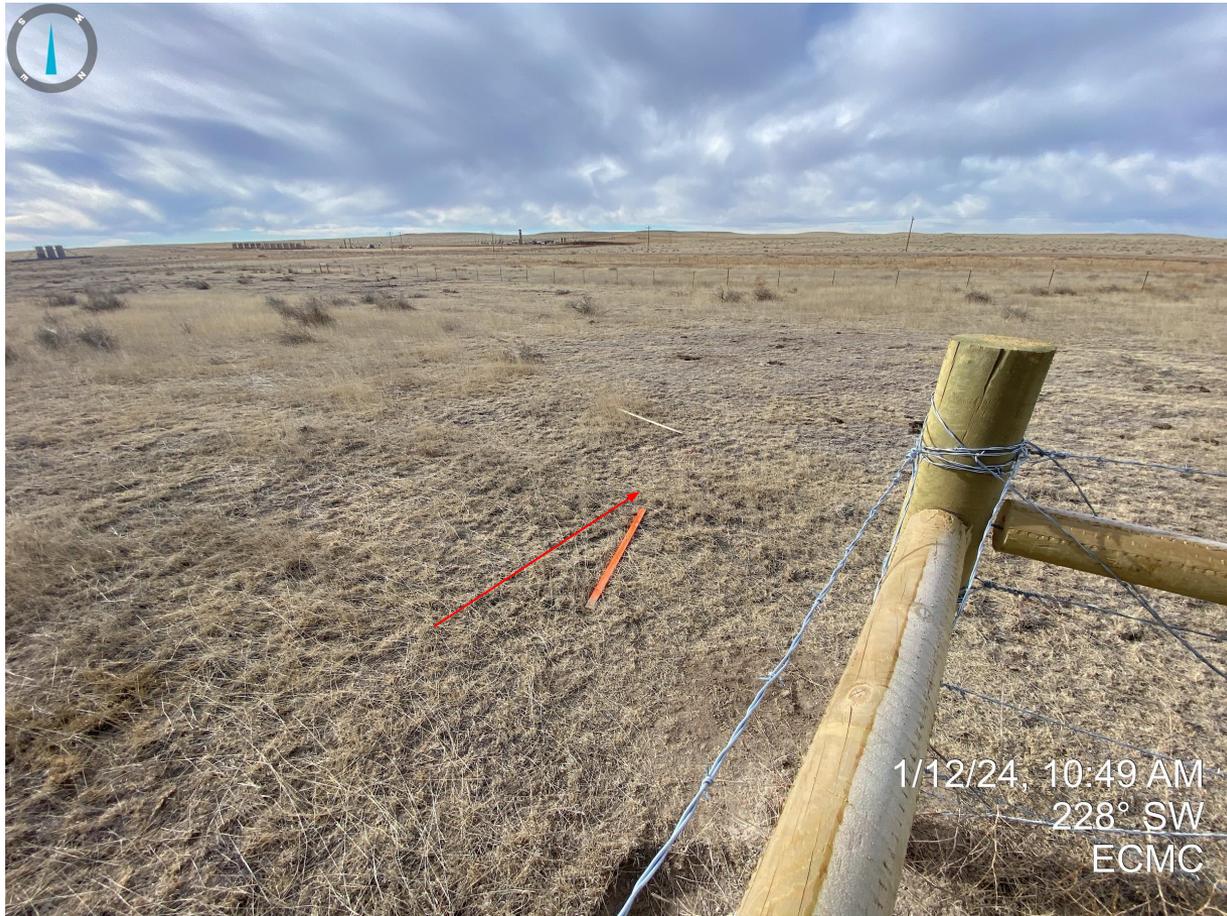
Photo 26. Trash/debris on the outside of location, southwest corner.

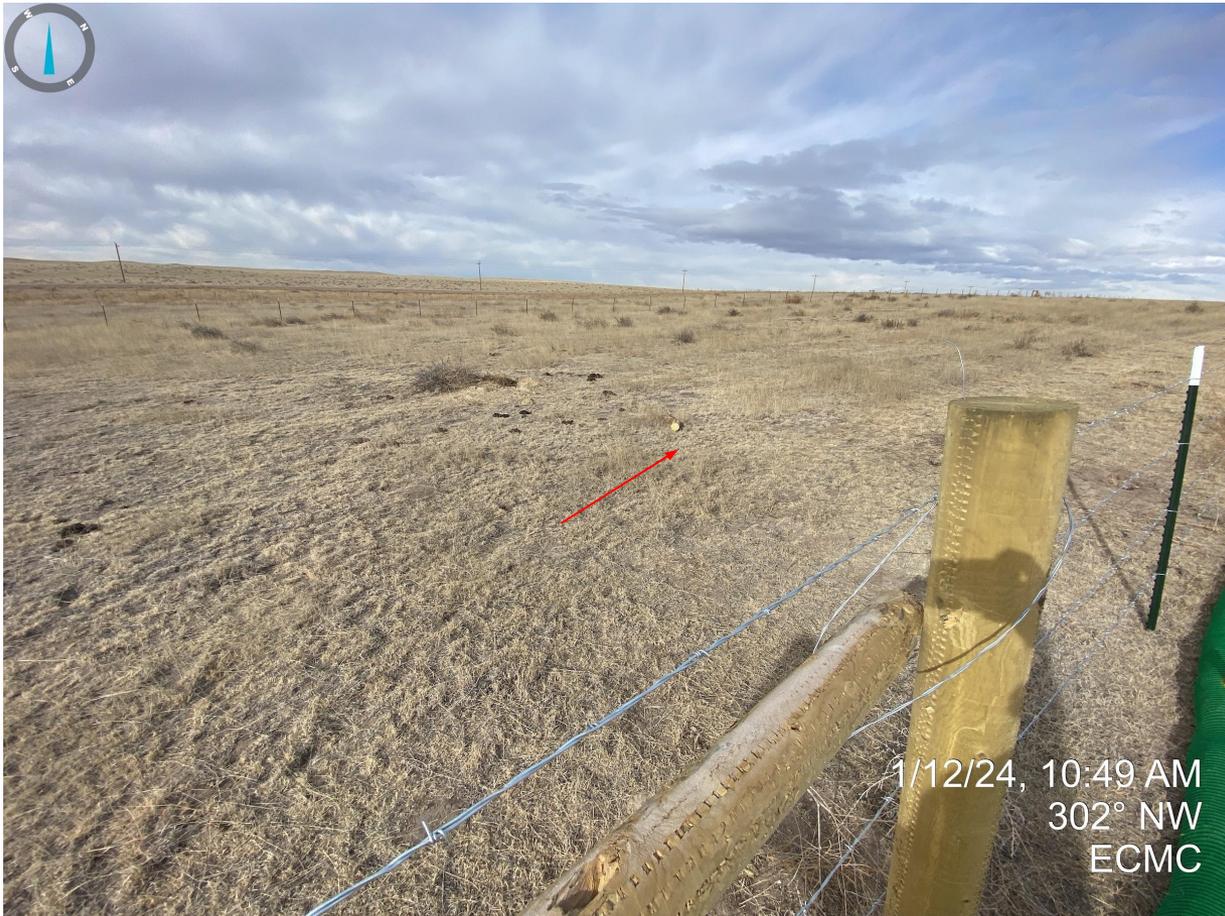
Photo 27. Trash/debris on the outside of location, southwest corner.
