Interim Reclamation and Stormwater Inspection

Operator: VERDAD RESOURCES LLC - 10651

Location ID: 427480

Inspection Document #: 708200877

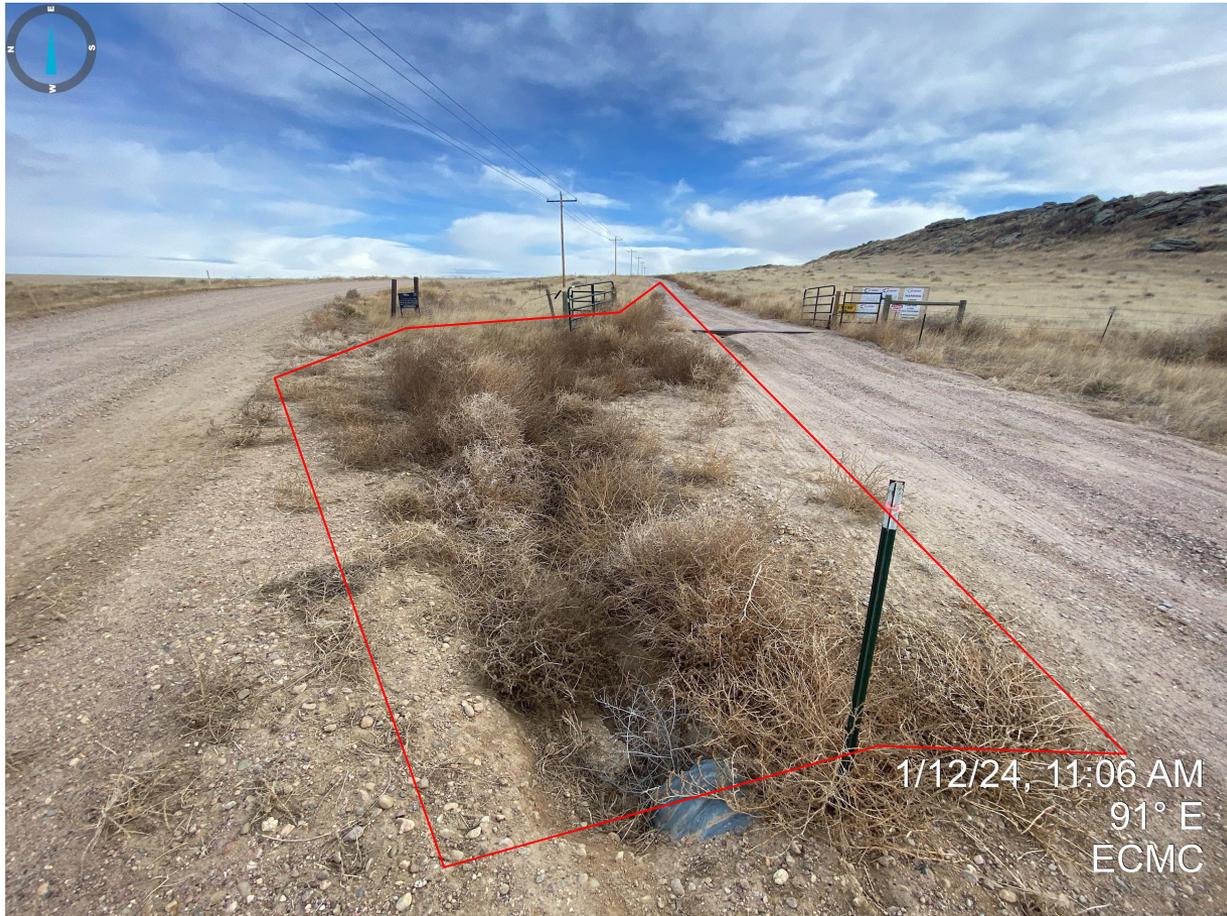
Photo 1. Undesirable vegetation observed at the location's entrance.

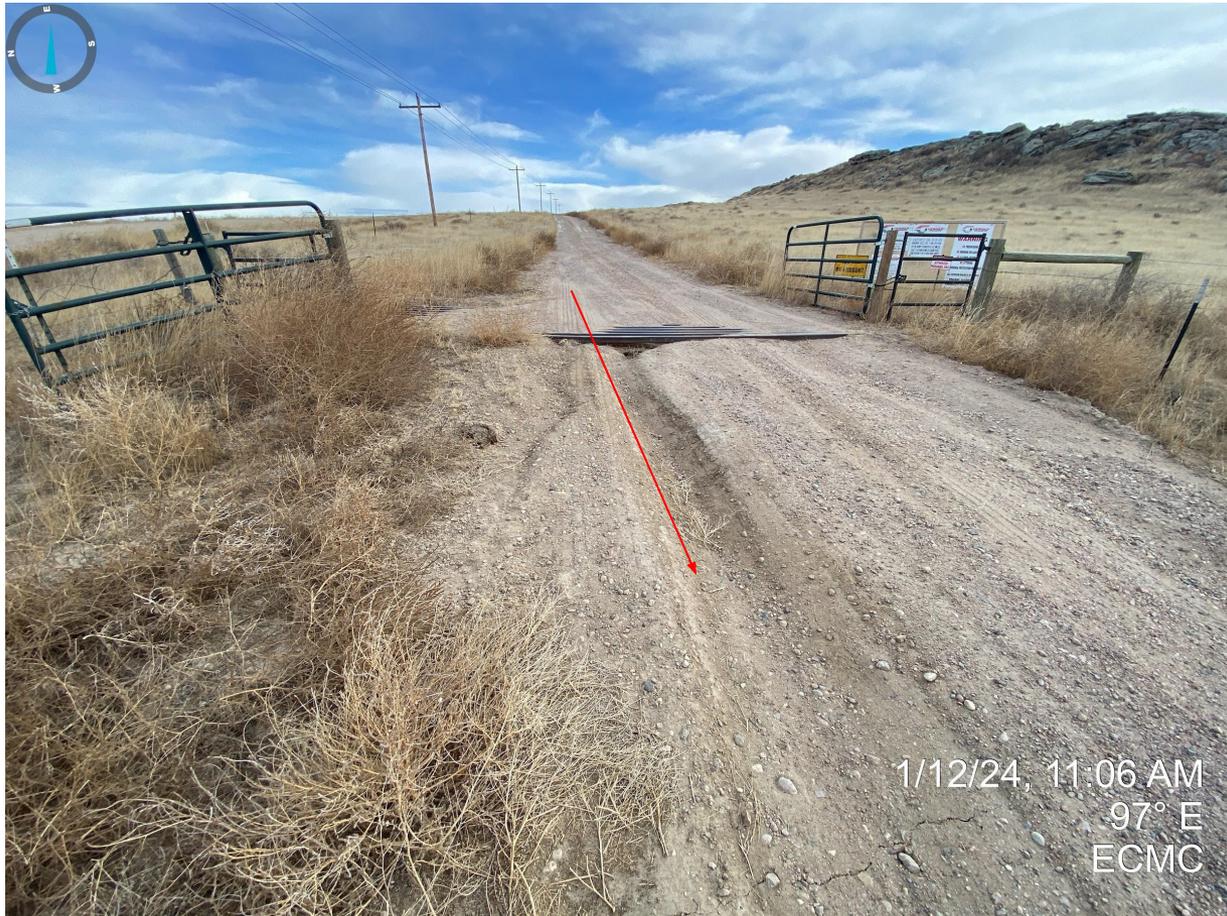
Photo 2. Erosion degradation at cattle guard.

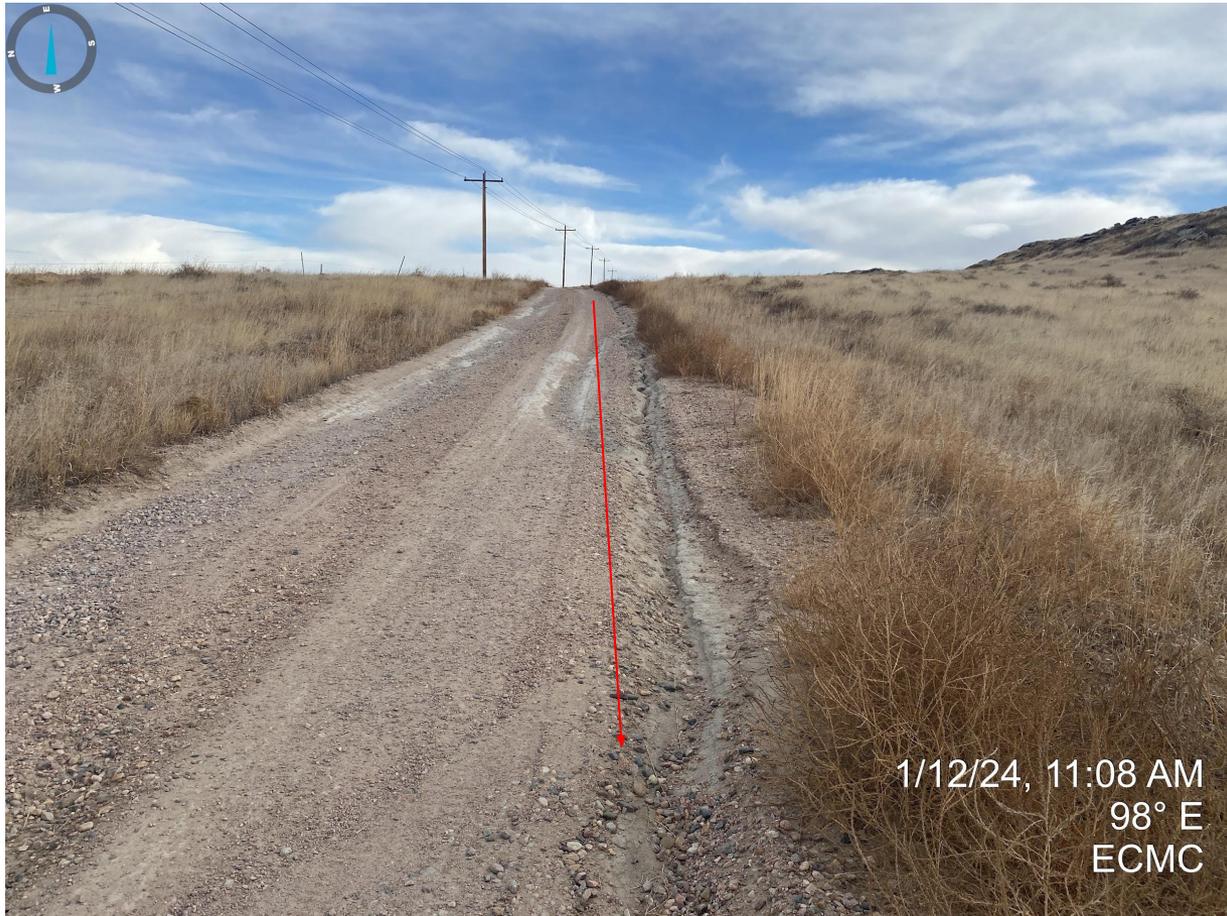
Photo 3. Erosion degradation and undesirable vegetation along the access road.

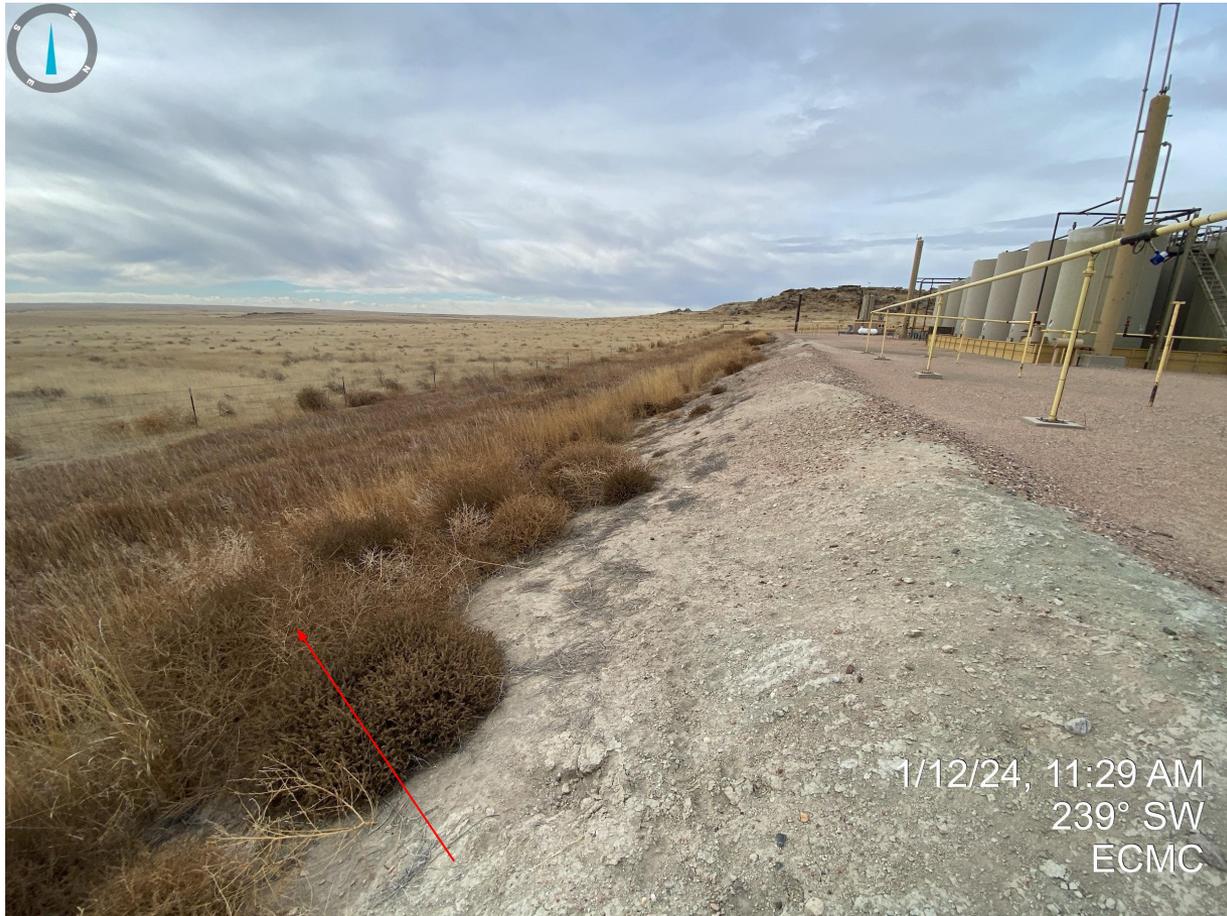
Photo 4. South side of production areas. Undesirable vegetation (e.g. russian thistle, kochia, crested wheatgrass, smooth brome) observed throughout the interim areas.

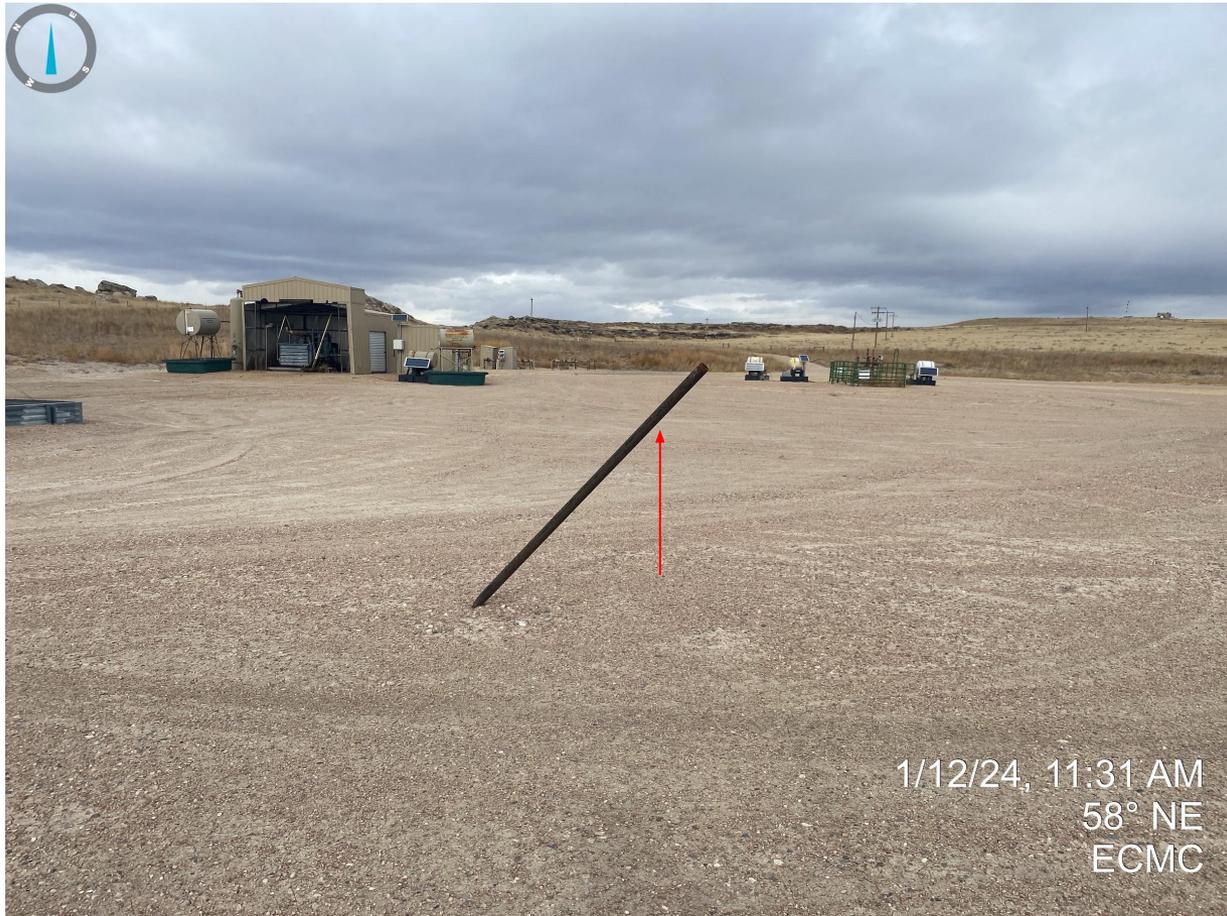
Photo 5. Unused equipment observed between the tank battery and combustor on the southwest corner of the production area.

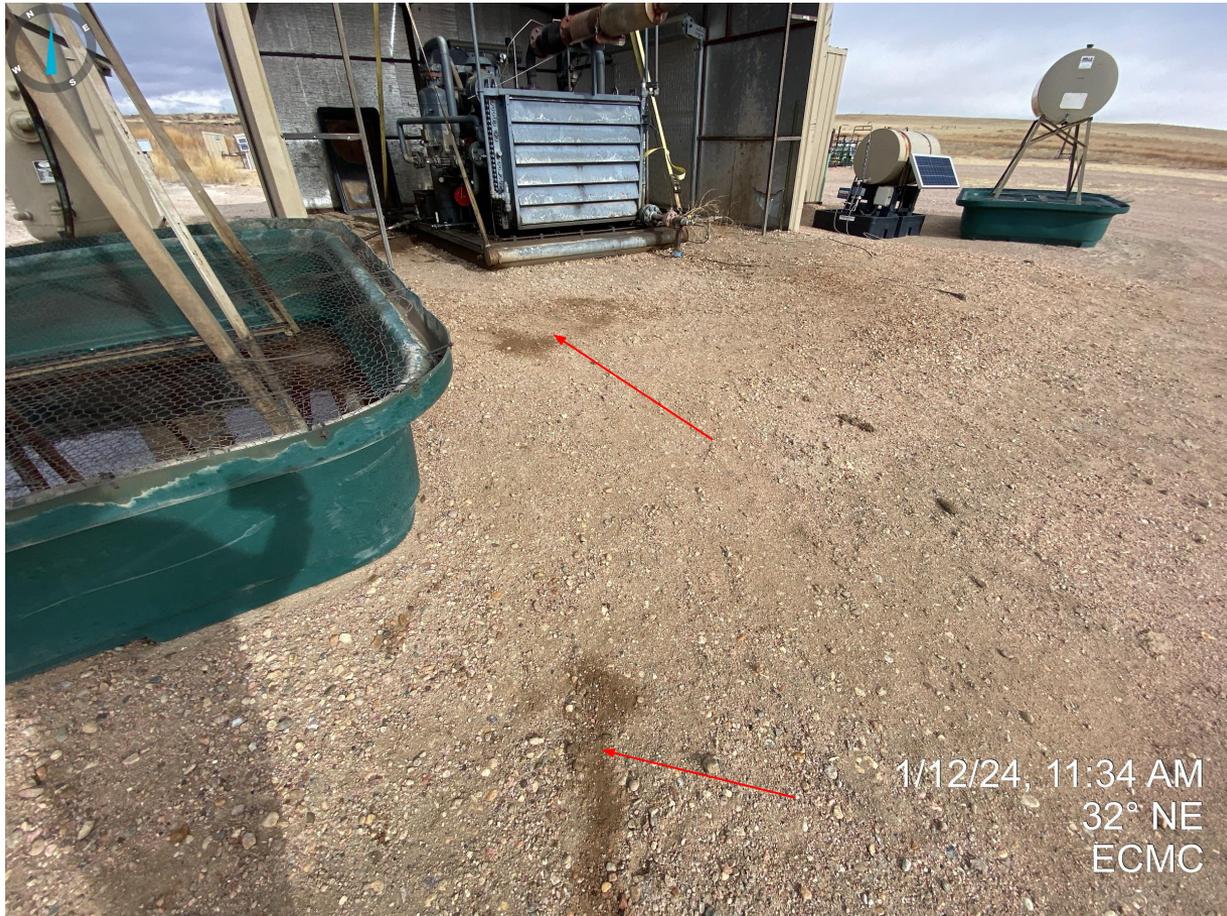
Photo 6. Stained soil at compressor station.

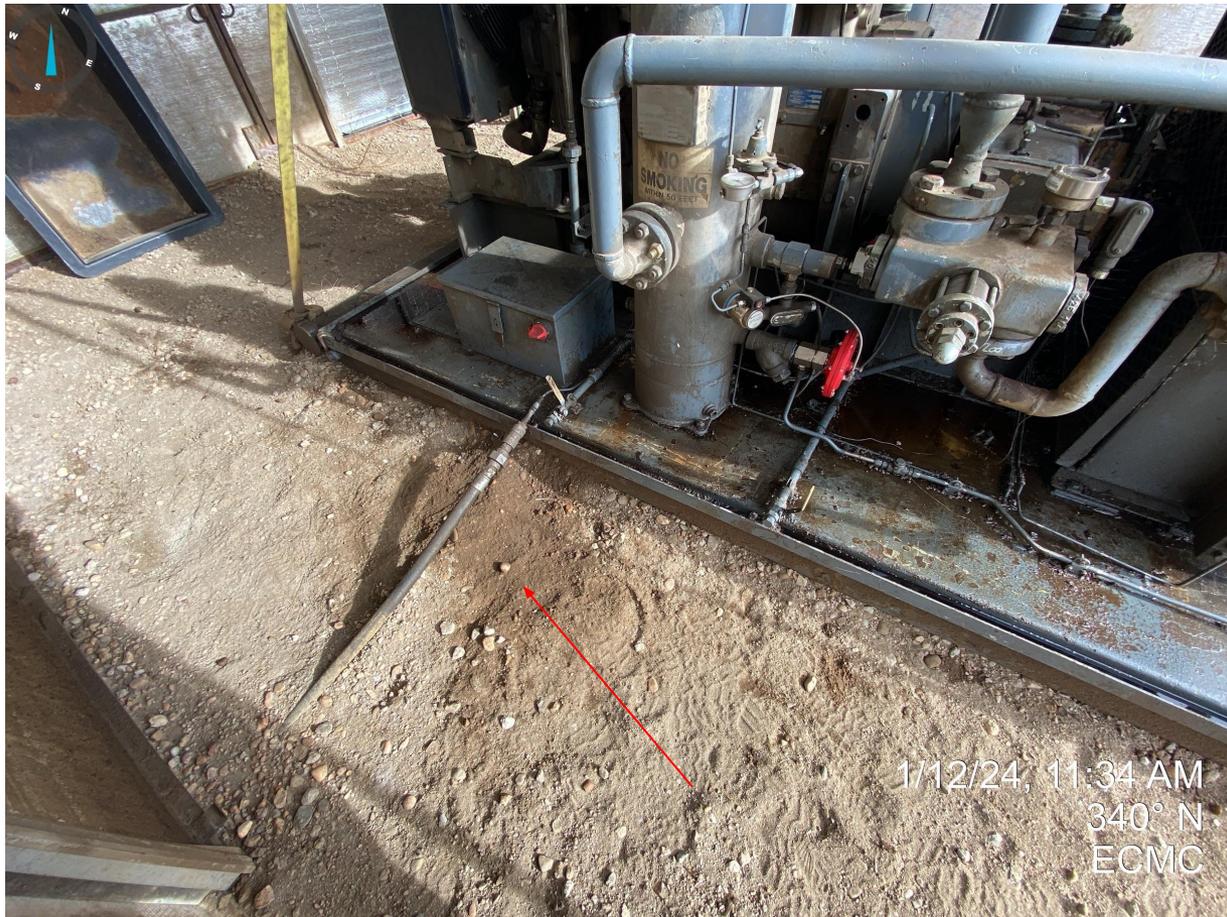
Photo 7. Stained soil at compressor station.

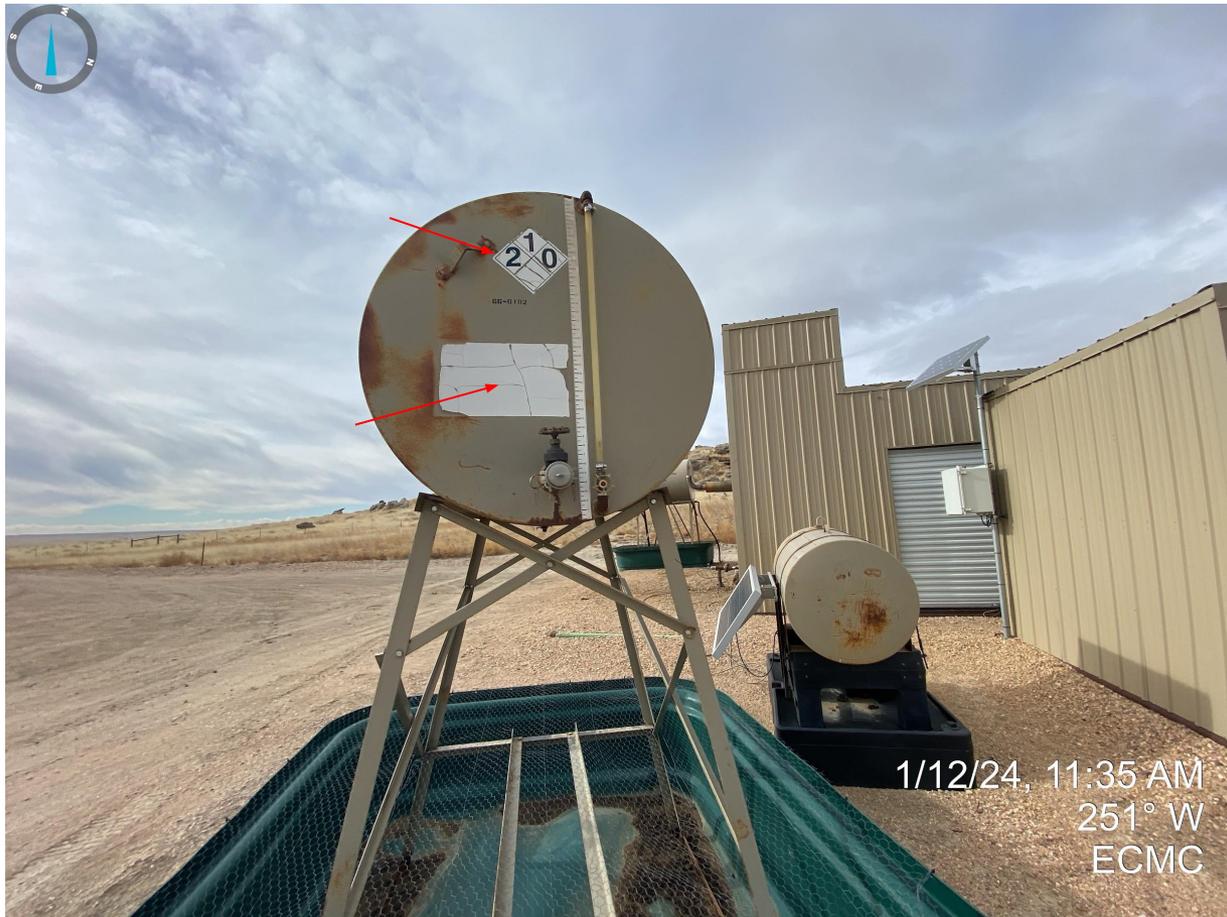
Photo 8. Tank signs/labels not legible (peeling, faded, cracked).

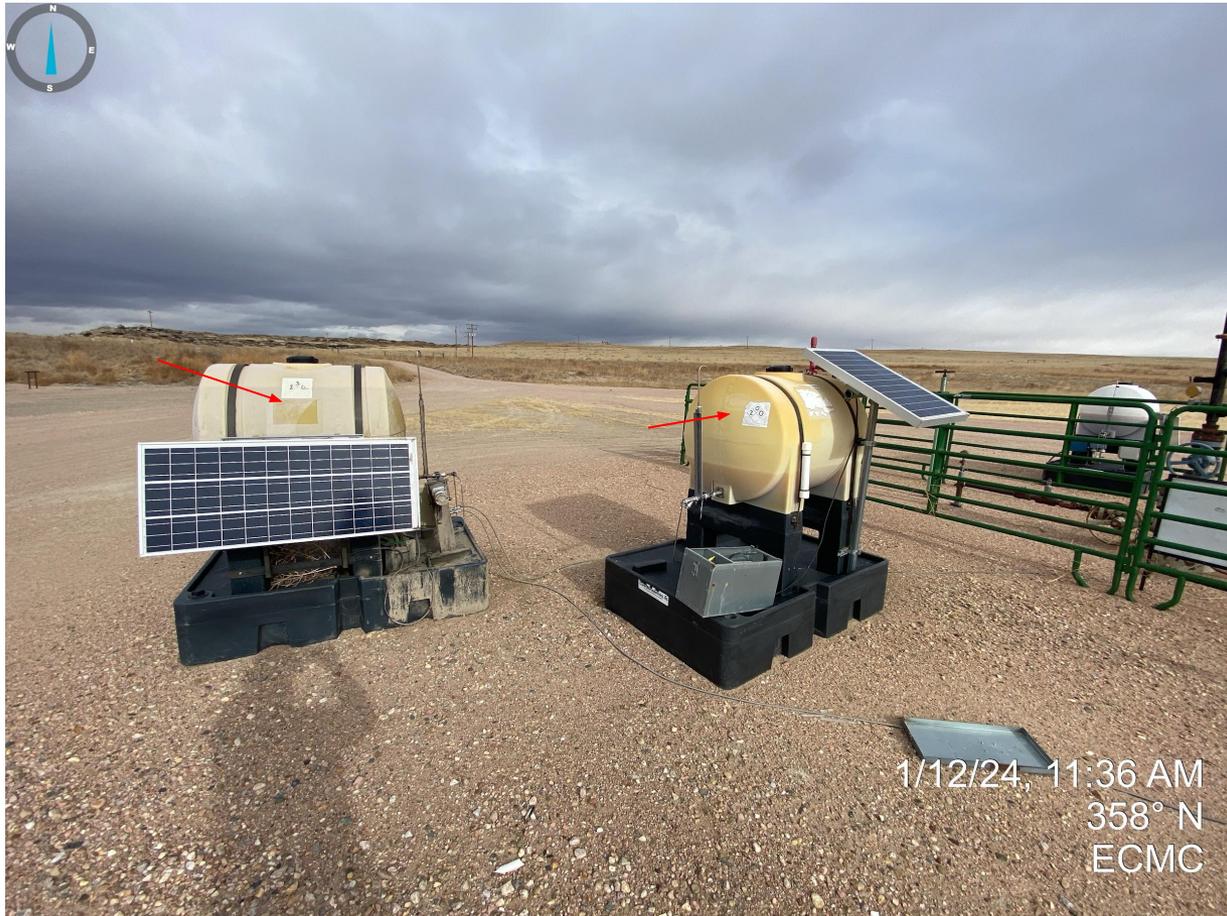
Photo 9. Tank signs/labels not legible (peeling, faded, cracked).

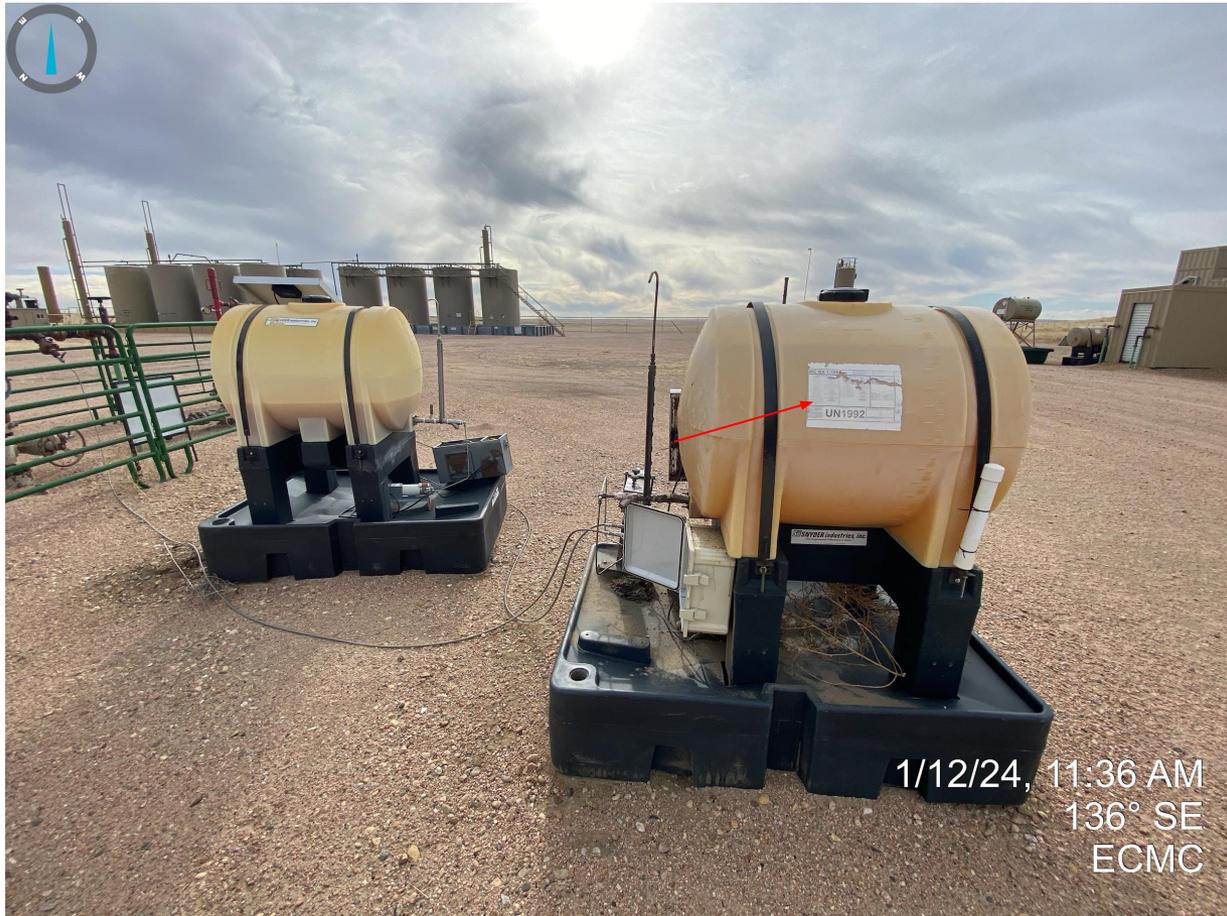
Photo 10. Opposite side of Photo 9. Tank signs/labels not legible (peeling, faded, cracked).

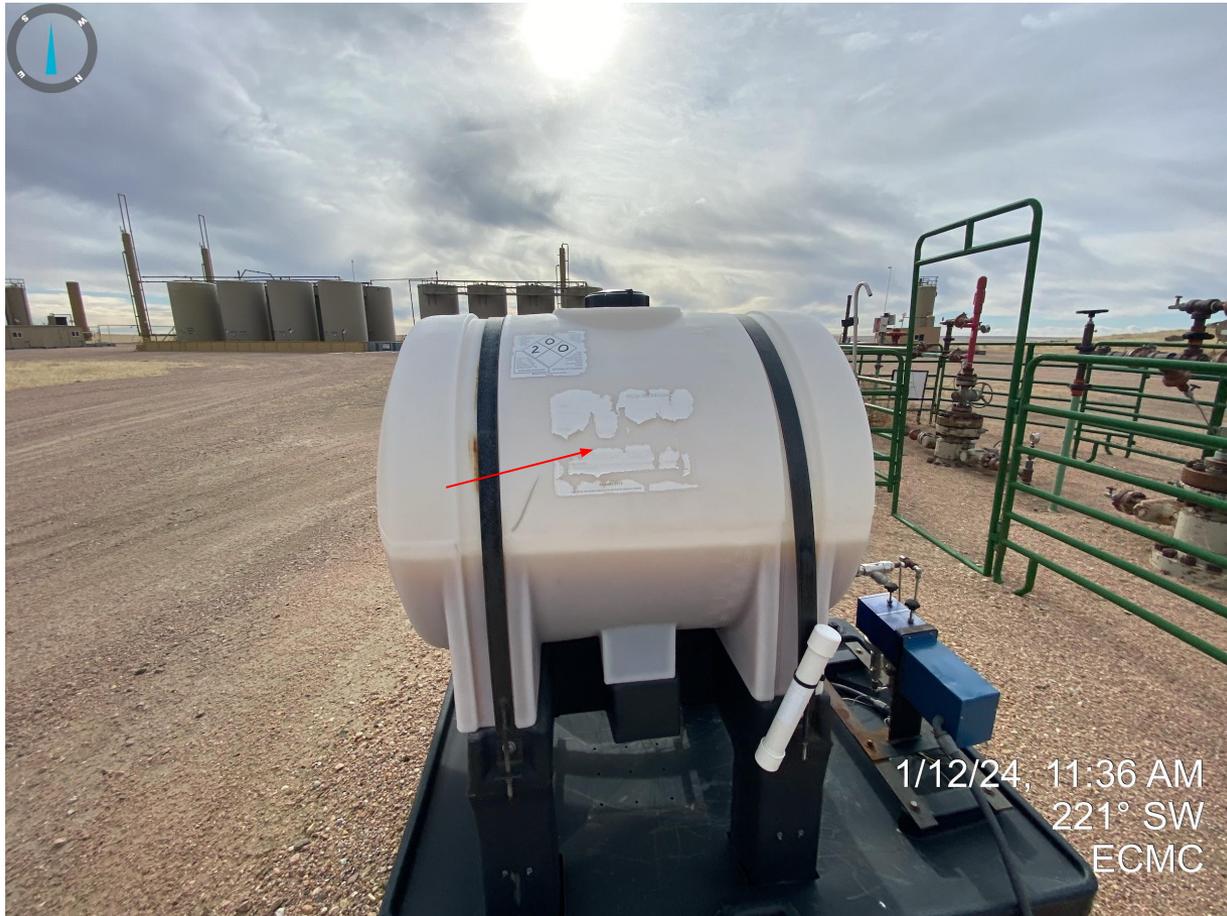
Photo 11. Tank signs/labels not legible (peeling, faded, cracked).

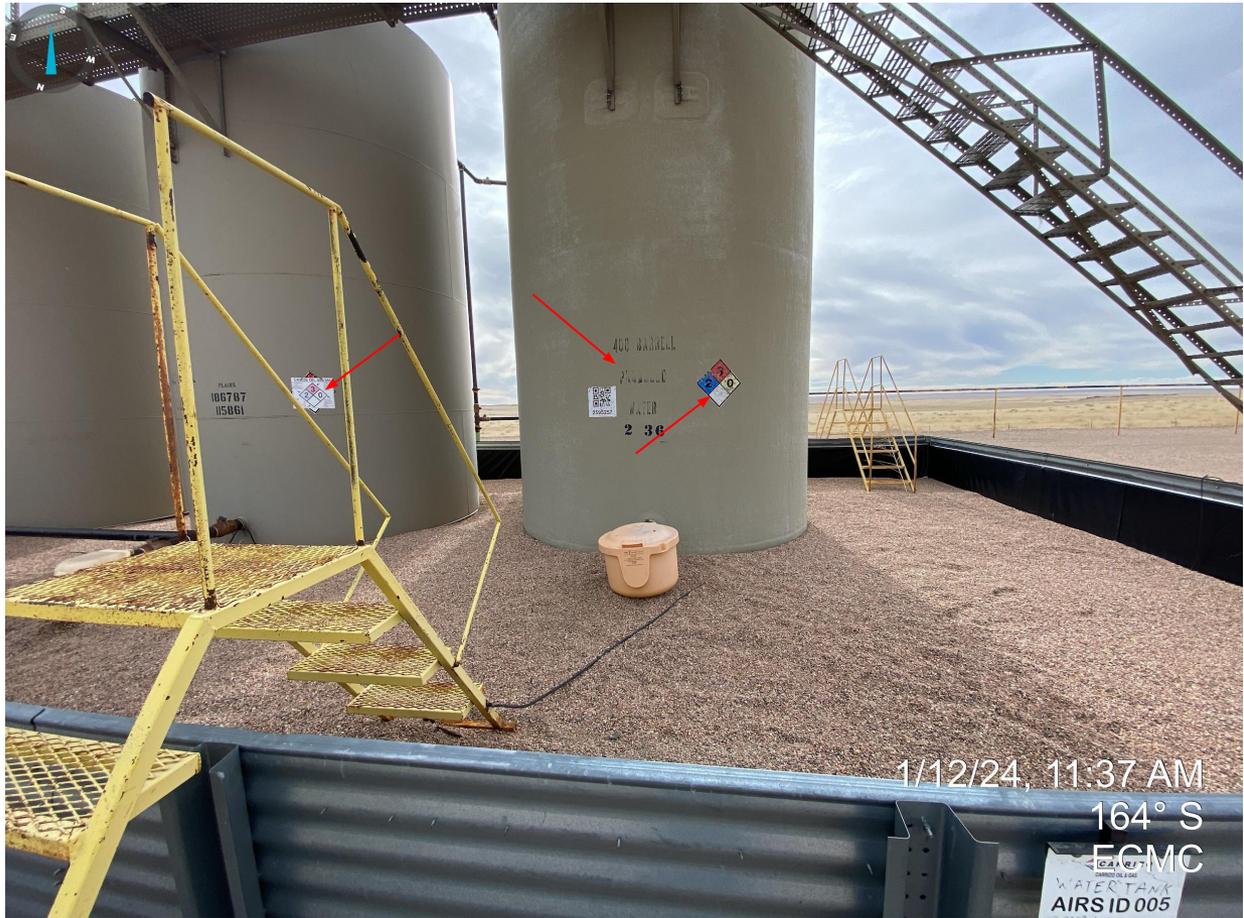
Photo 12. Tank signs/labels not legible (peeling, faded, cracked).

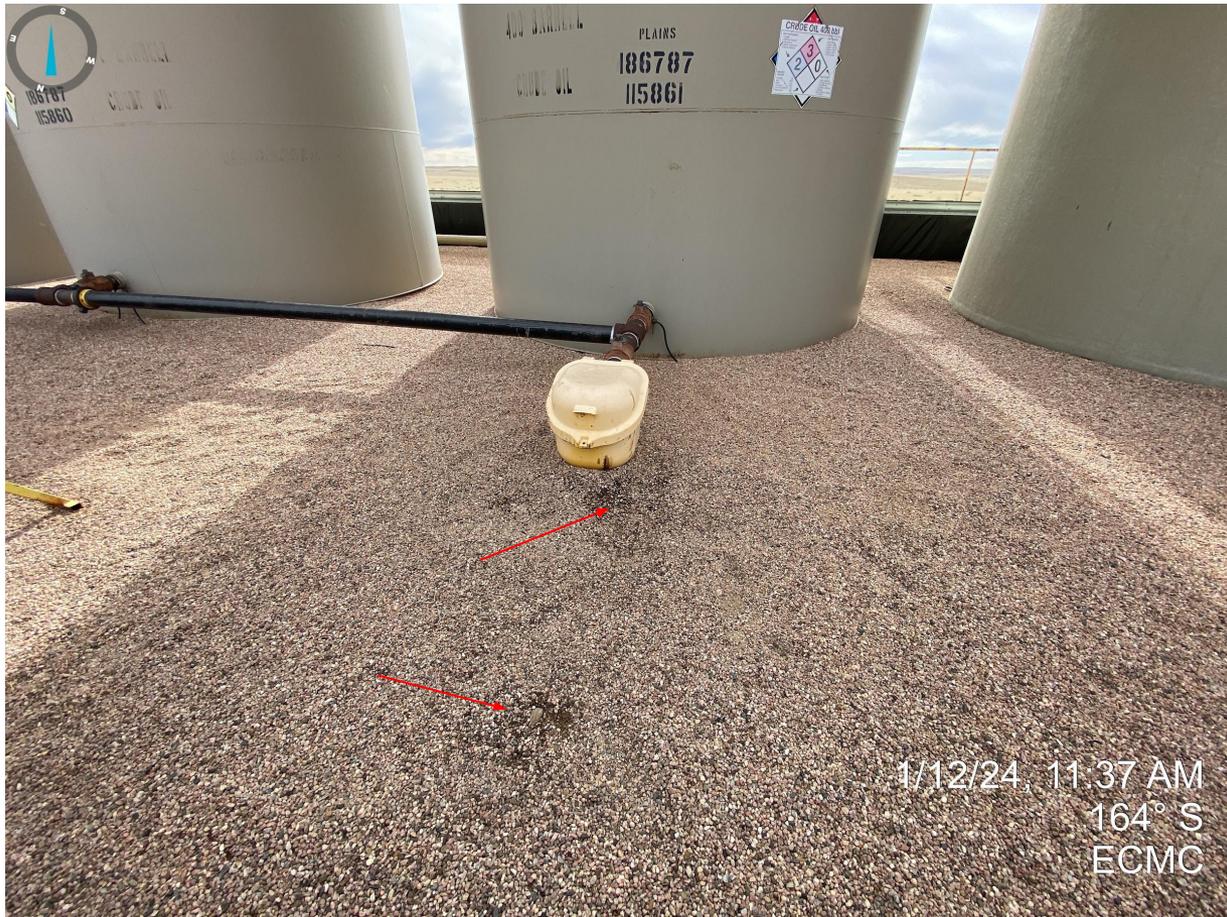
Photo 13. Stained soil at tank battery.

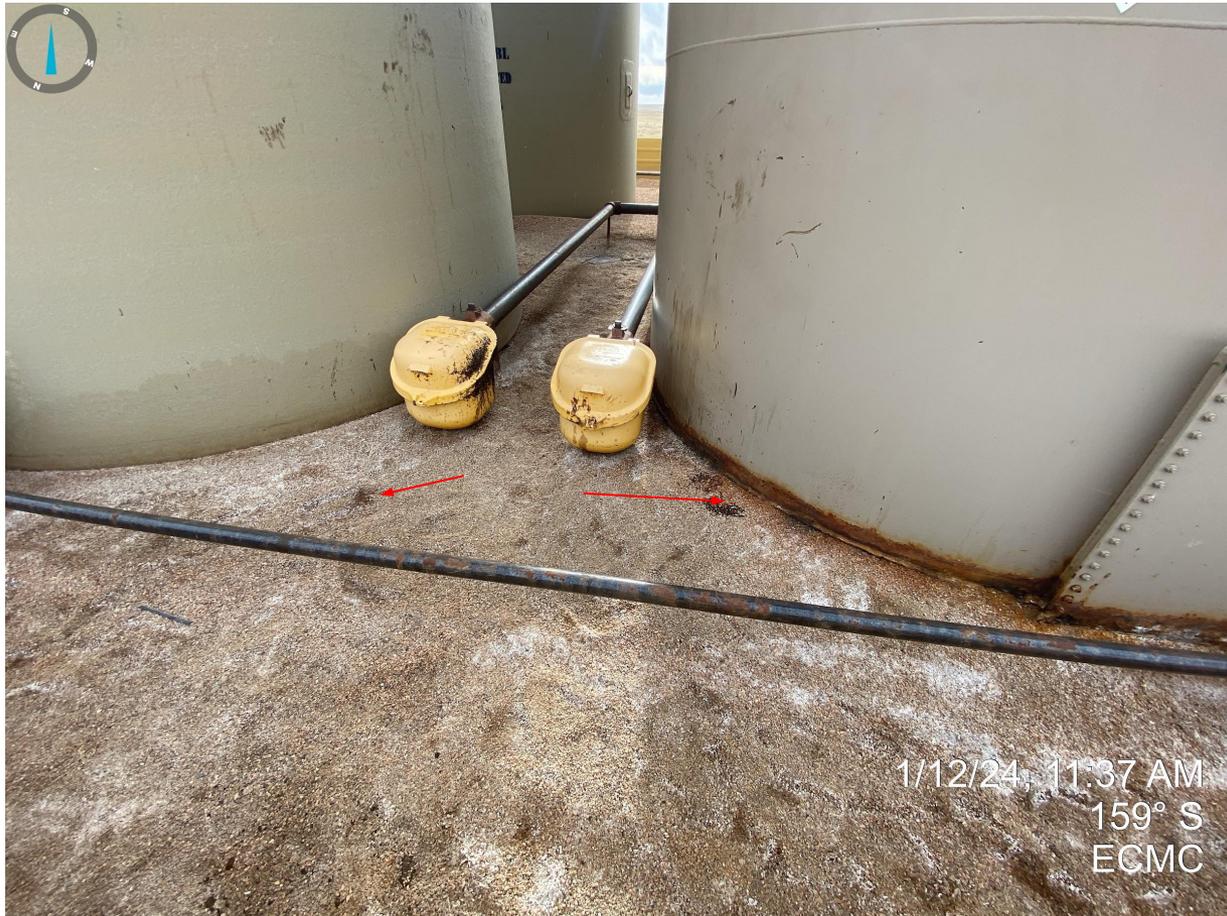
Photo 14. Stained soil at tank battery.

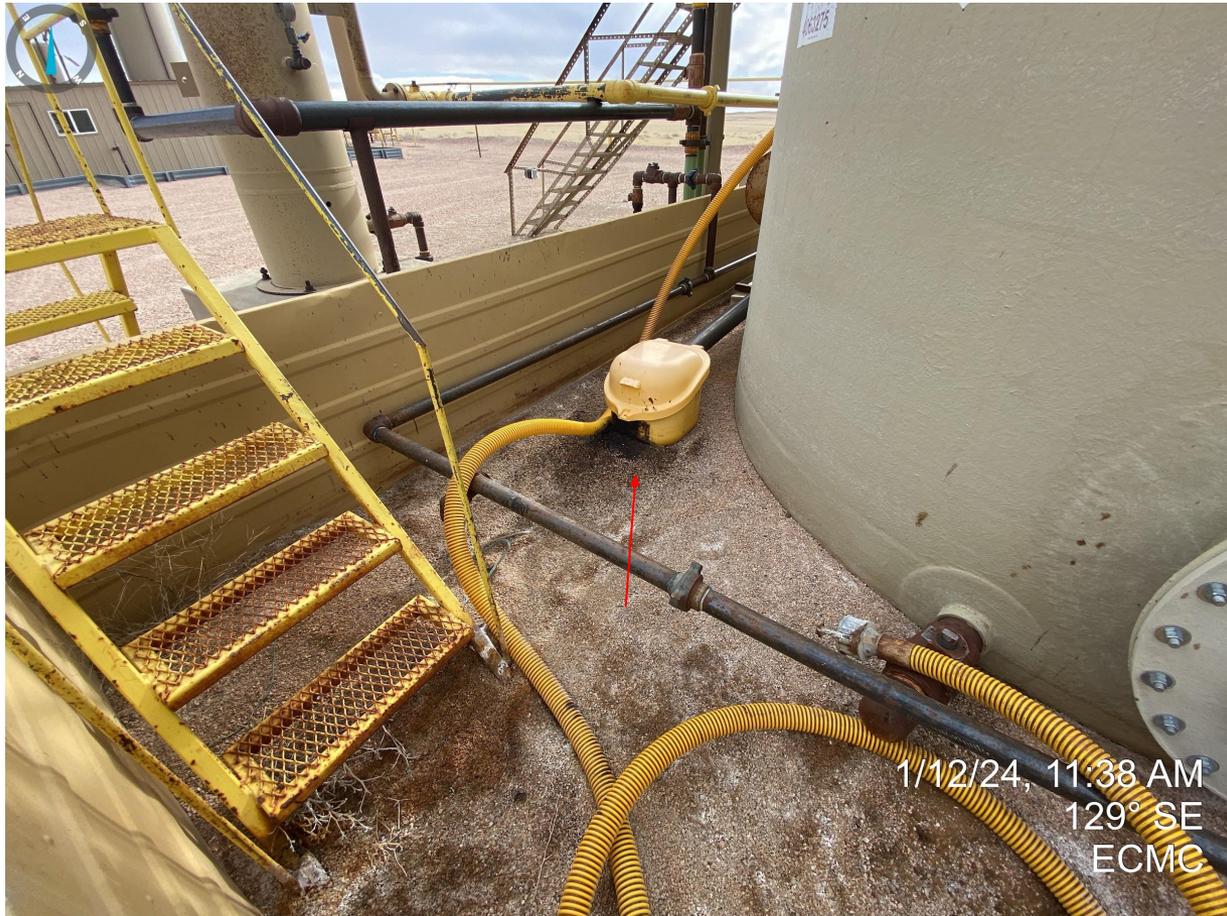
Photo 15. Stained soil at tank battery.

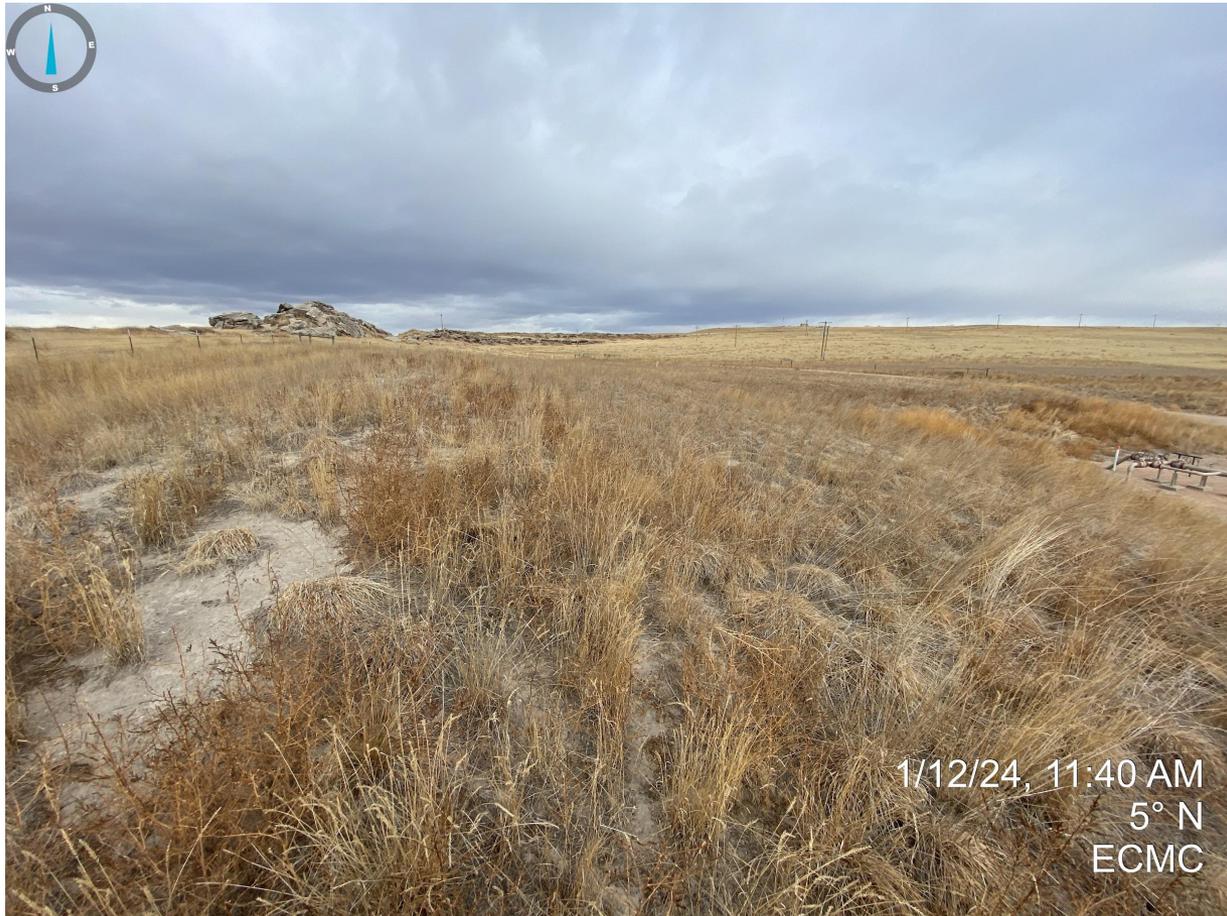
Photo 16. Taken from the west side of the location; crested wheatgrass observed throughout.

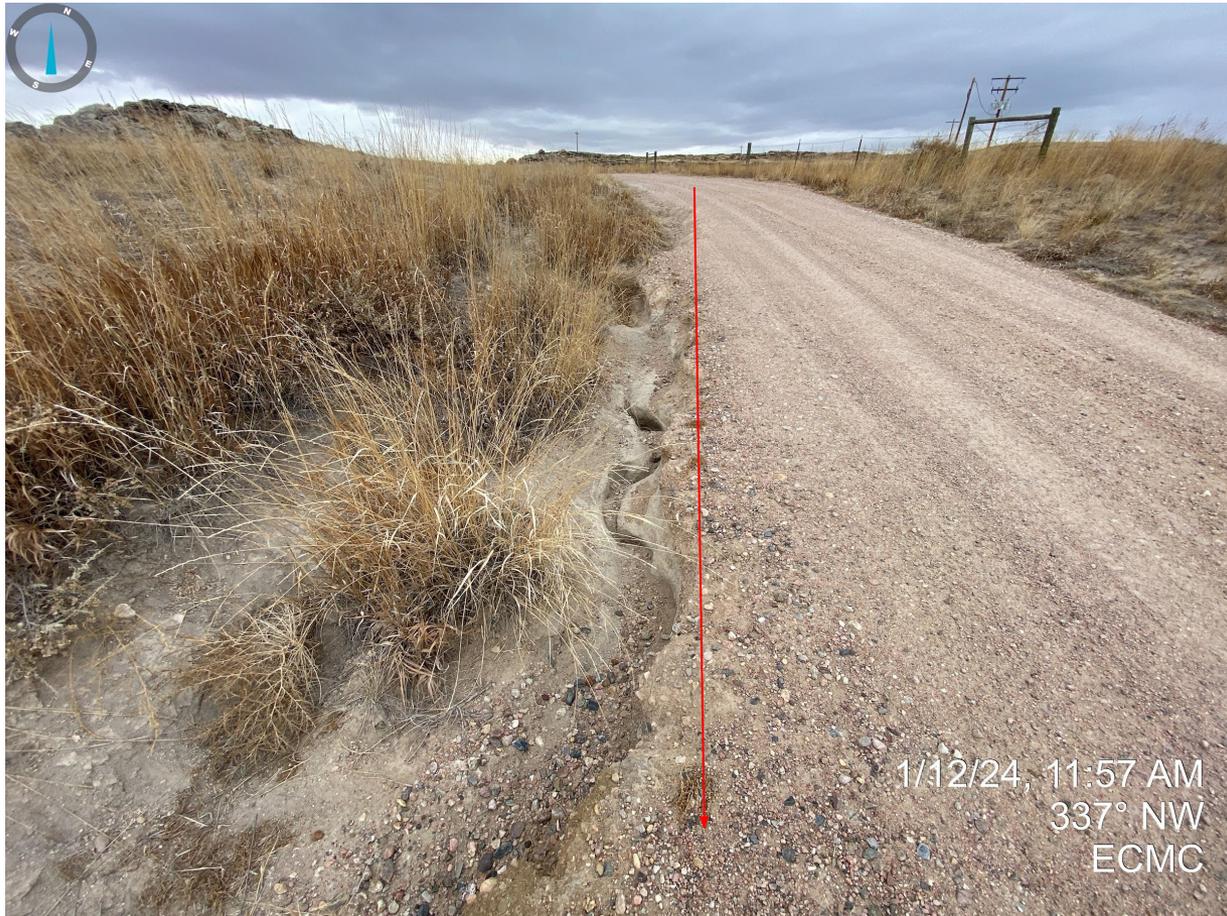
Photo 17. Gully erosion occurring on the access road leading to the production areas.

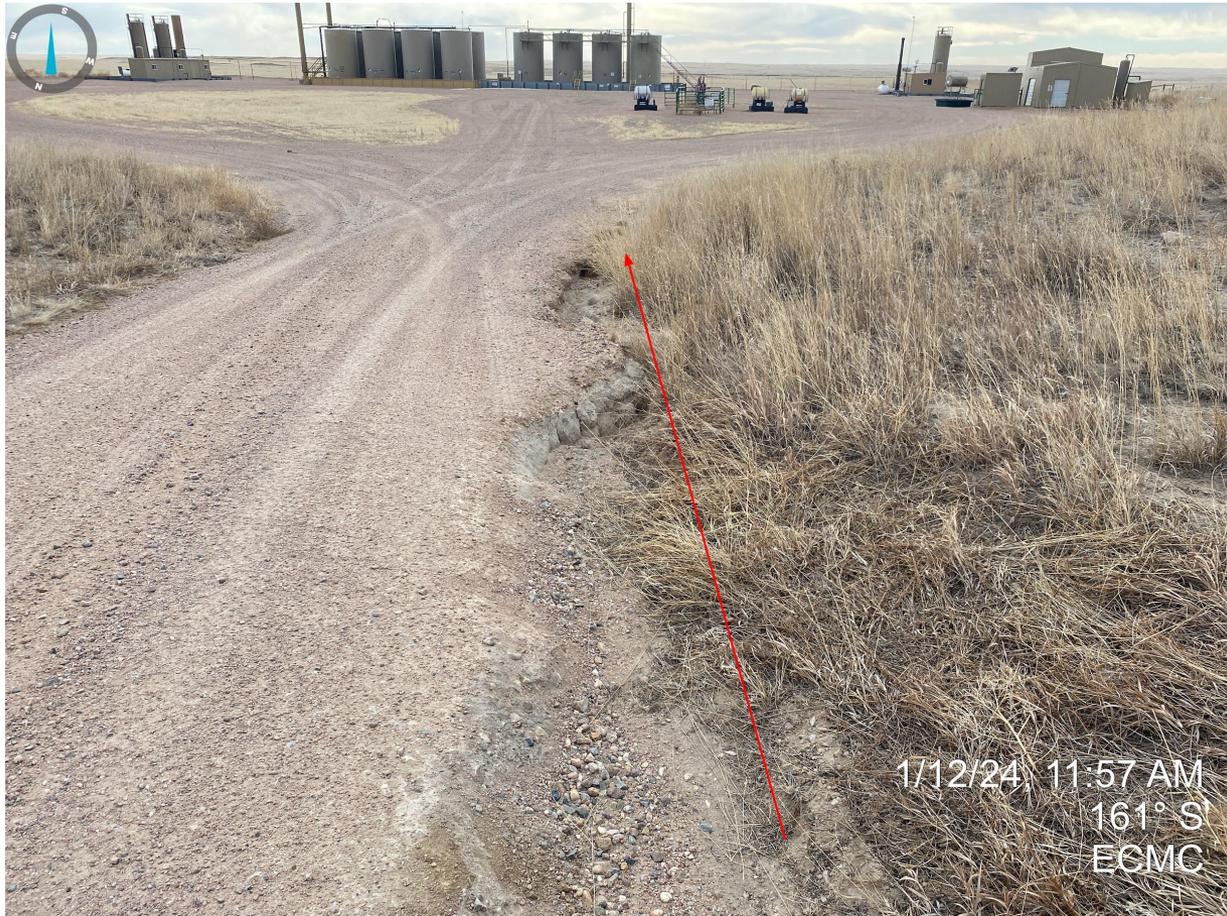
Photo 18. Gully erosion occurring on the access road leading to the production areas.

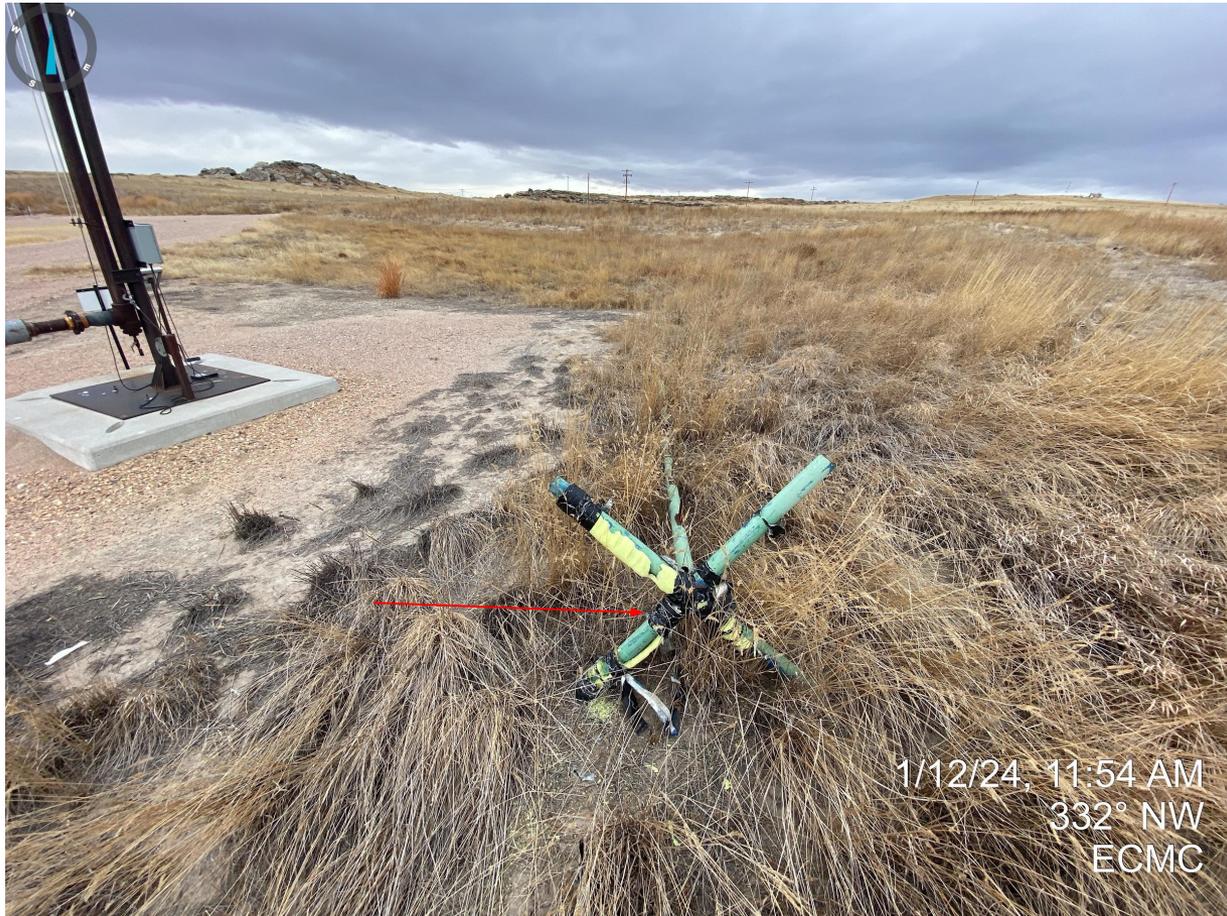
Photo 19. Unused equipment next to flare unit.

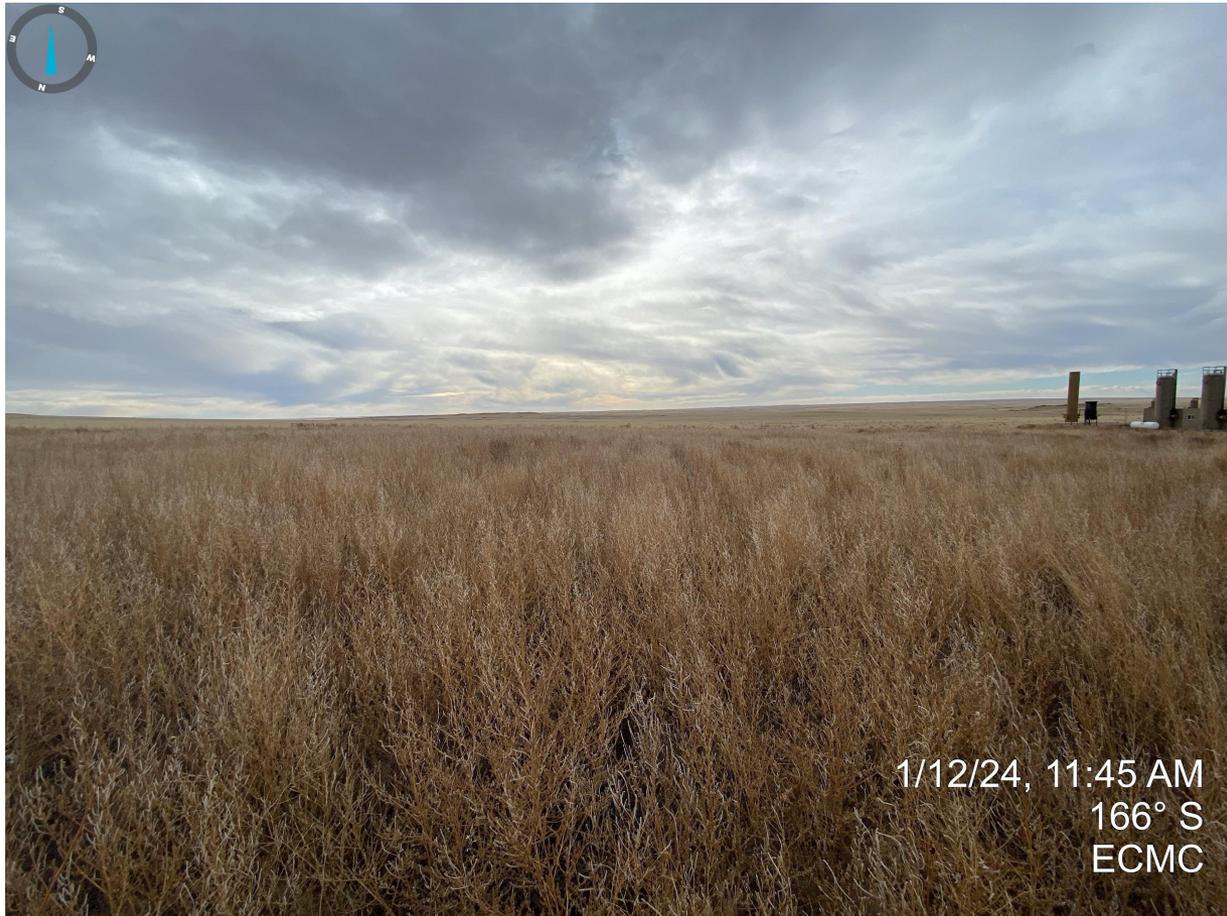
Photo 20. Taken from the reclaimed pit area. The pit area is predominantly undesirable vegetation (e.g. kochia and russian thistle). Additional weed management and reclamation activities are required in order to comply with Rule 1003 standards.
