Interim Reclamation and Stormwater Inspection

Operator: VERDAD RESOURCES LLC - 10651

Location ID: 427480

Inspection Document #: 708200877

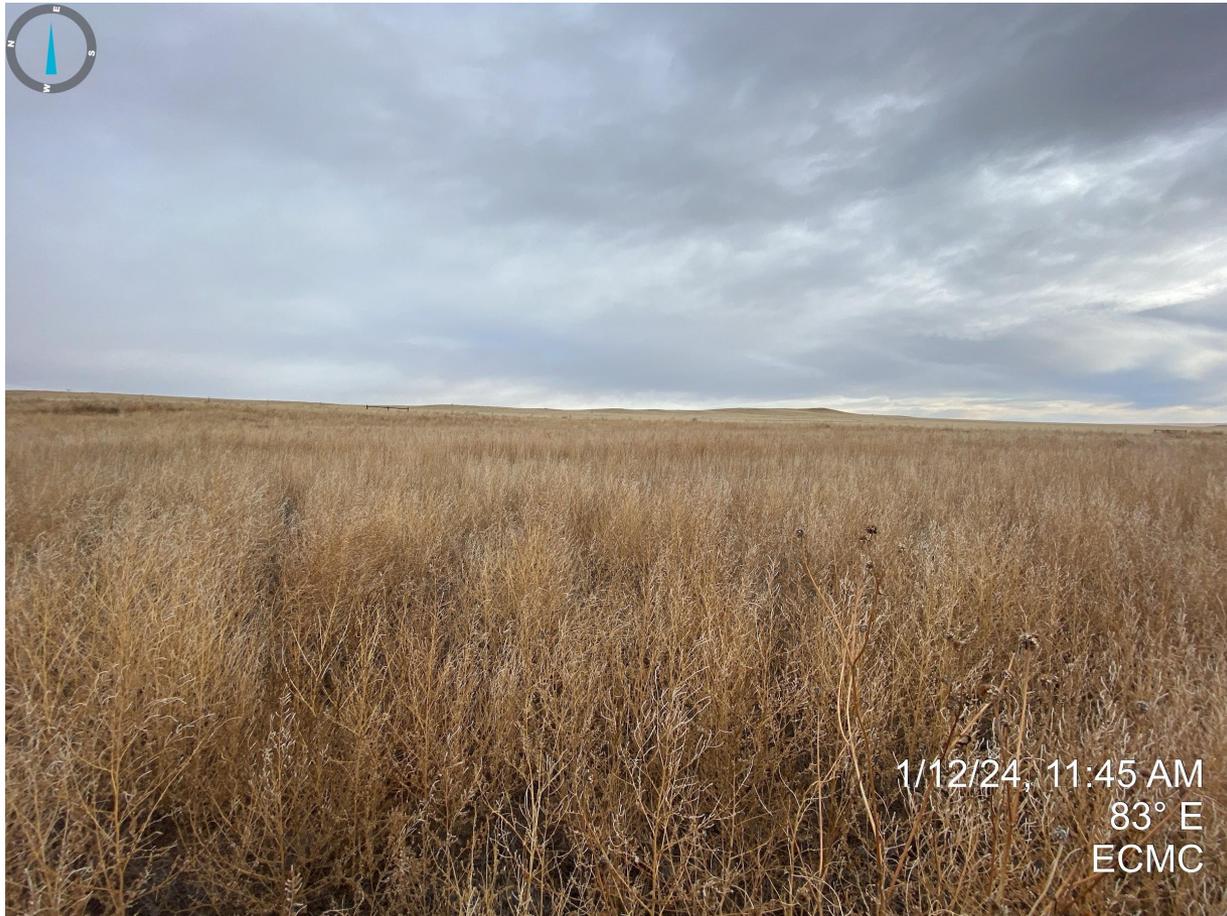
Photo 20. Taken from the reclaimed pit area. The pit area is predominantly undesirable vegetation (e.g. kochia and russian thistle). Additional weed management and reclamation activities are required in order to comply with Rule 1003 standards.

Photo 21. Reclaimed pit area; see comments in Photo 20.

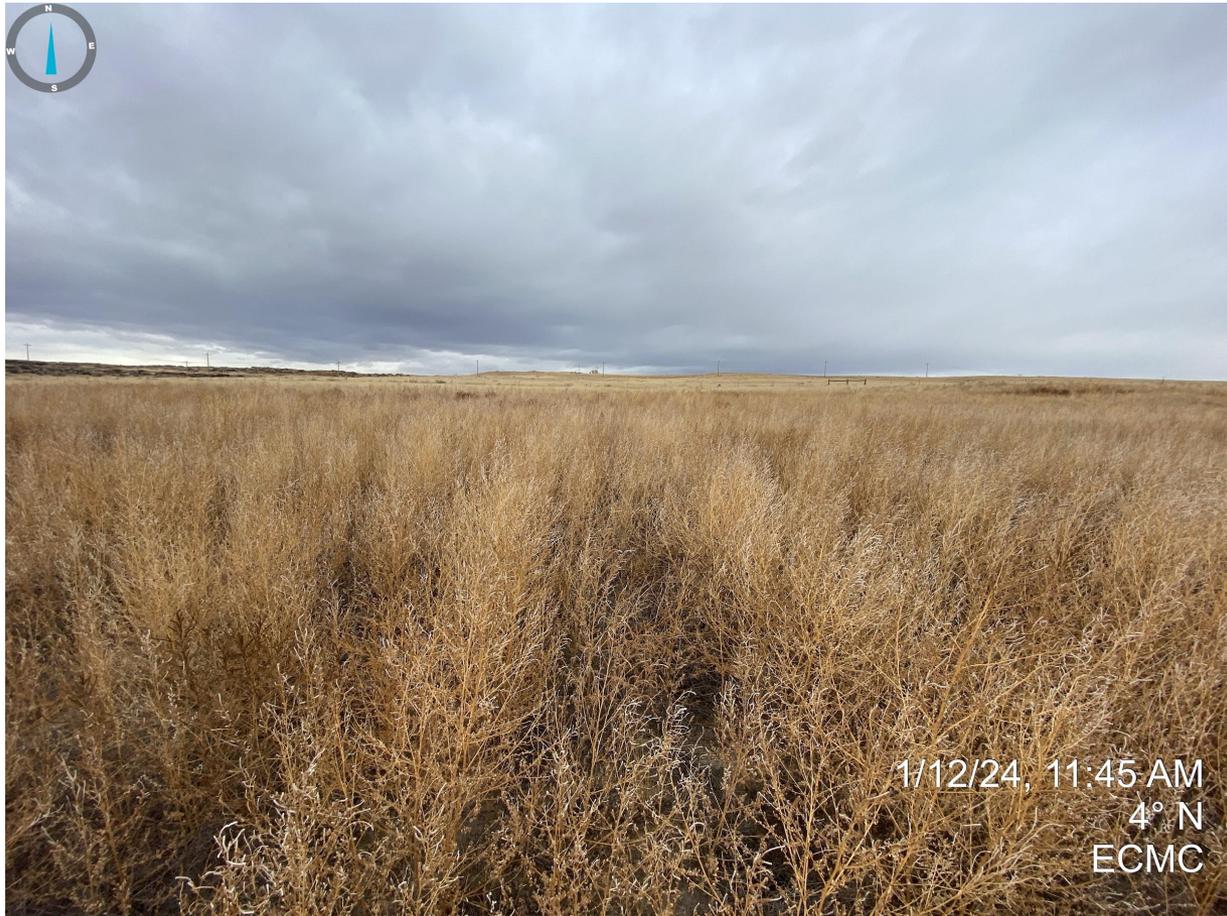
Photo 22. Reclaimed pit area; see comments in Photo 20.

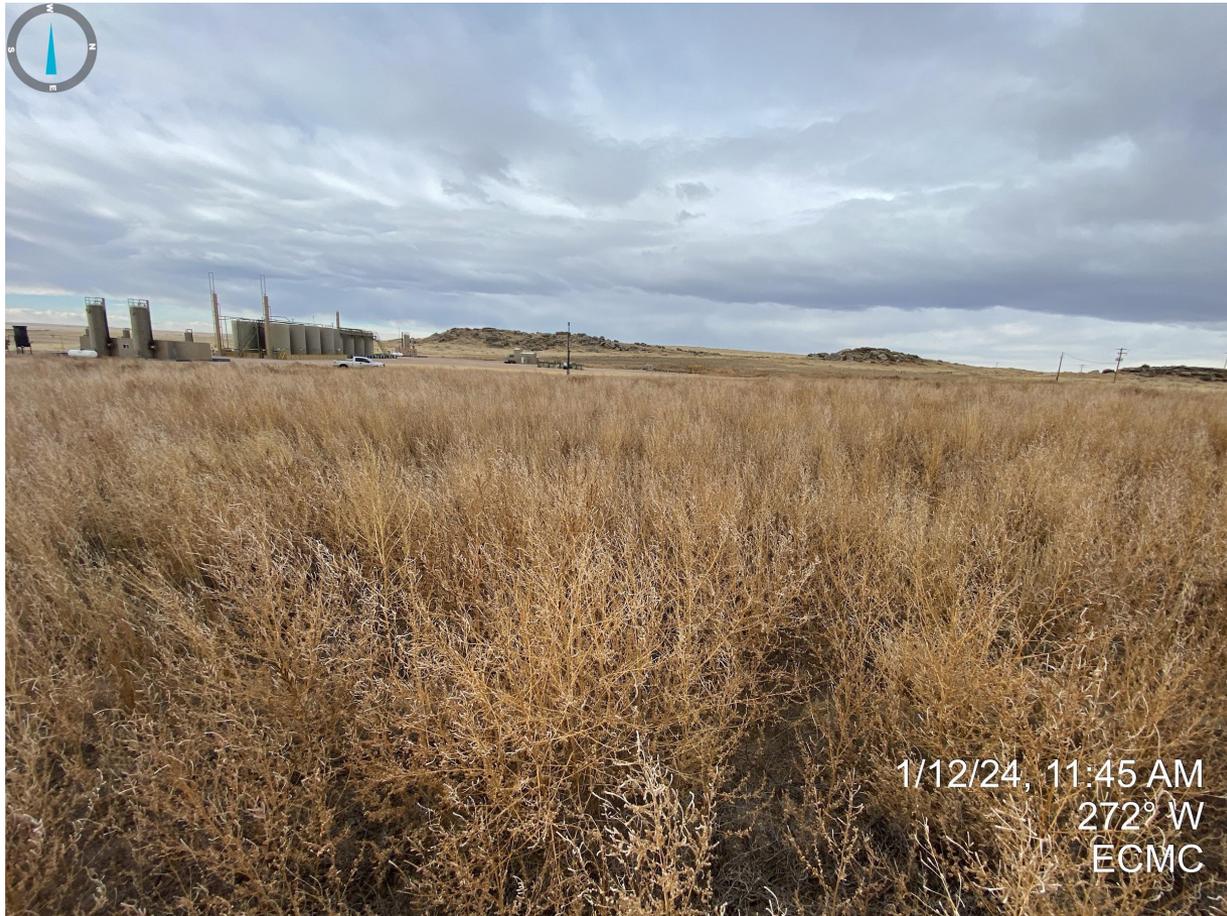
Photo 23. Reclaimed pit area; see comments in Photo 20.
