Interim Reclamation Inspection

Operator: BISON IV OPERATING LLC - 10670

Location ID: 447898

Location Name: Anderson Facility 9-59-31 Pad

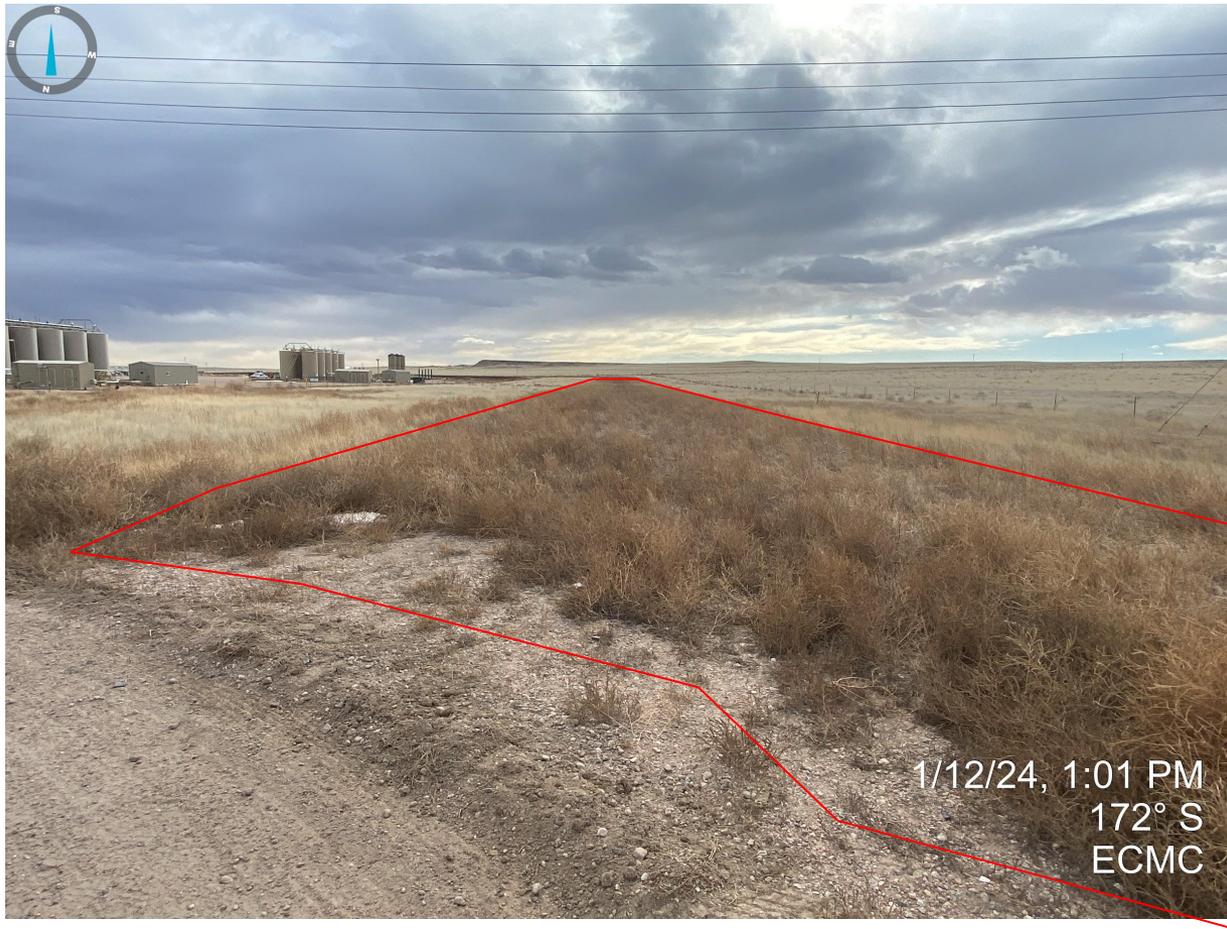
Photo 1. Former access road is predominantly weedy vegetation (e.g. kochia and russian thistle) and is not reflective of adjacent reference areas.

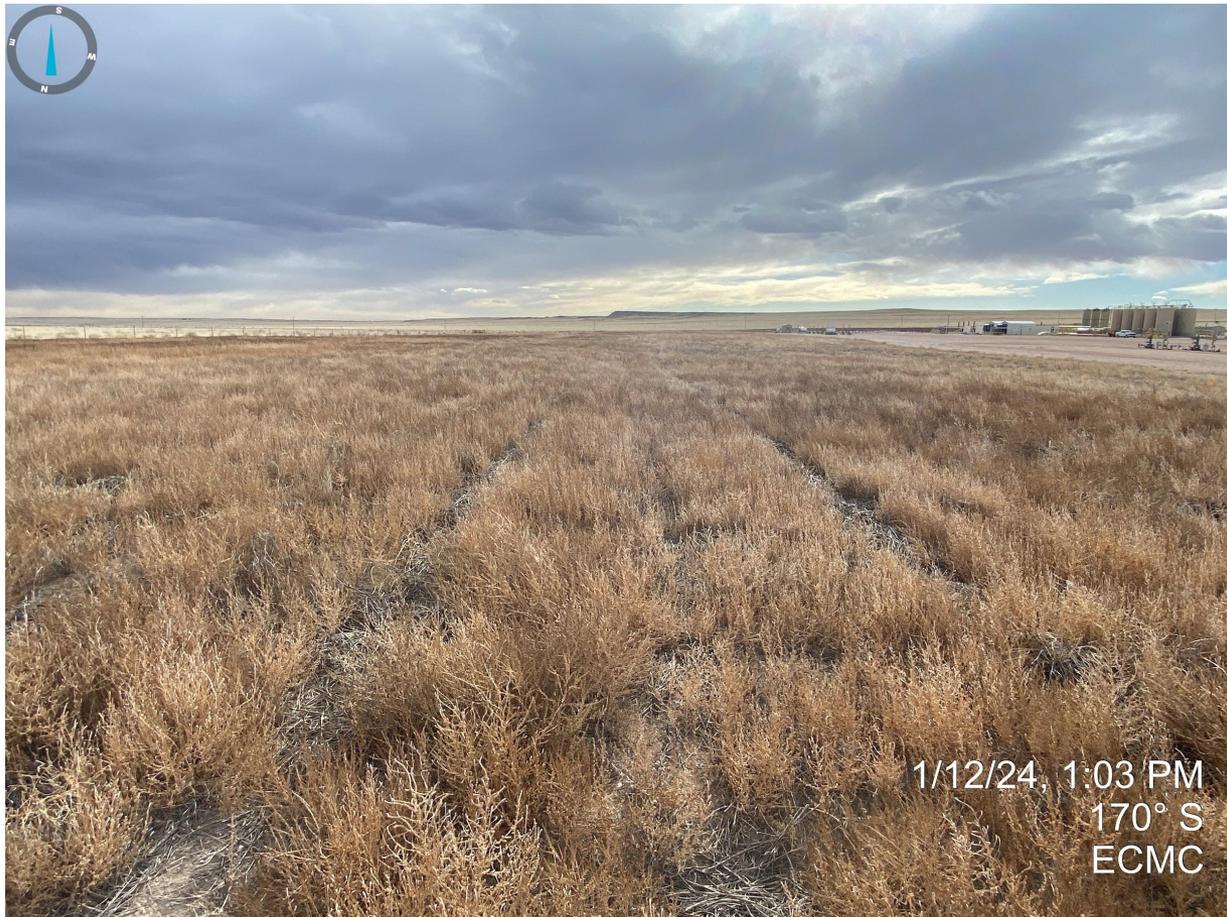
Photo 2. Eastern interim areas are predominantly weedy vegetation. Additional reclamation activities are required.

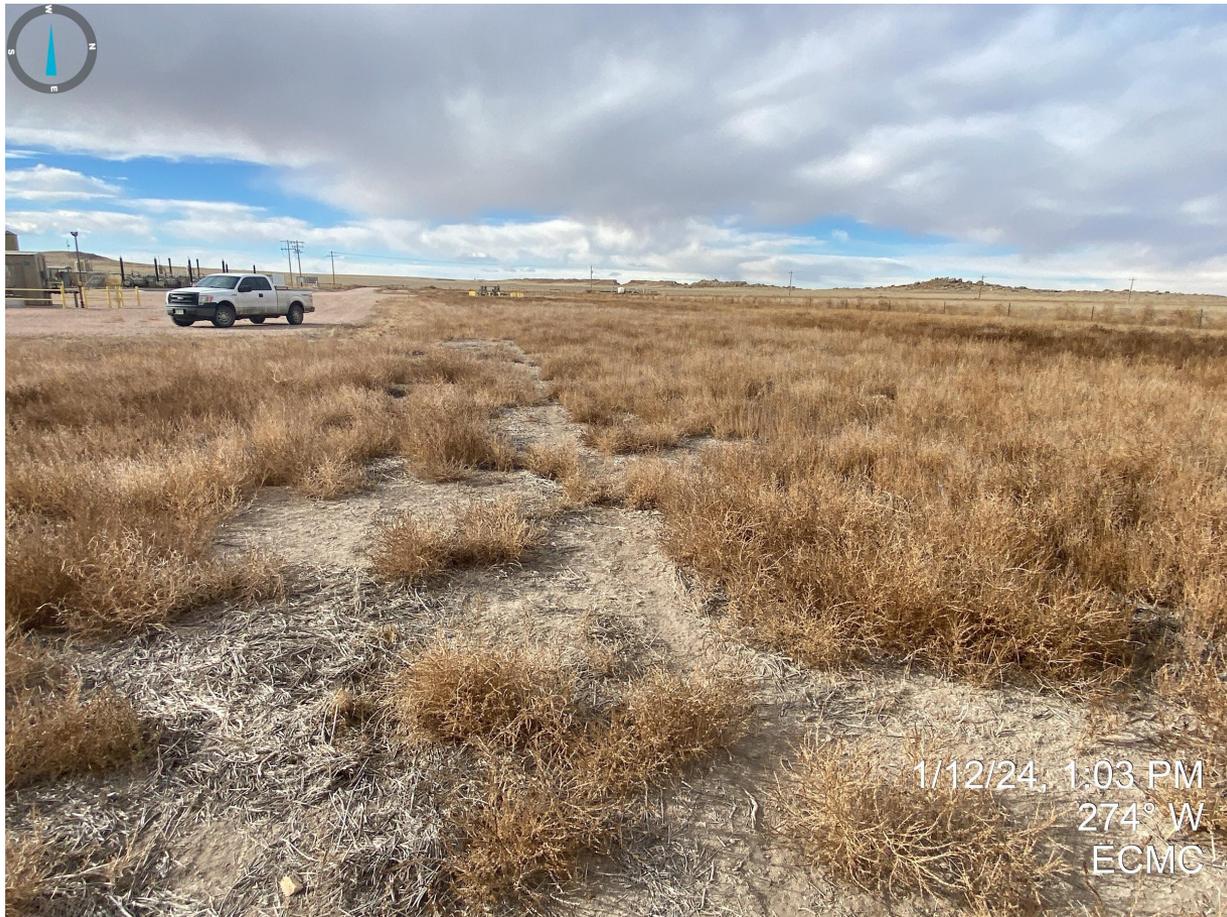
Photo 3. Northern interim areas are predominantly weedy vegetation. Additional reclamation activities are required

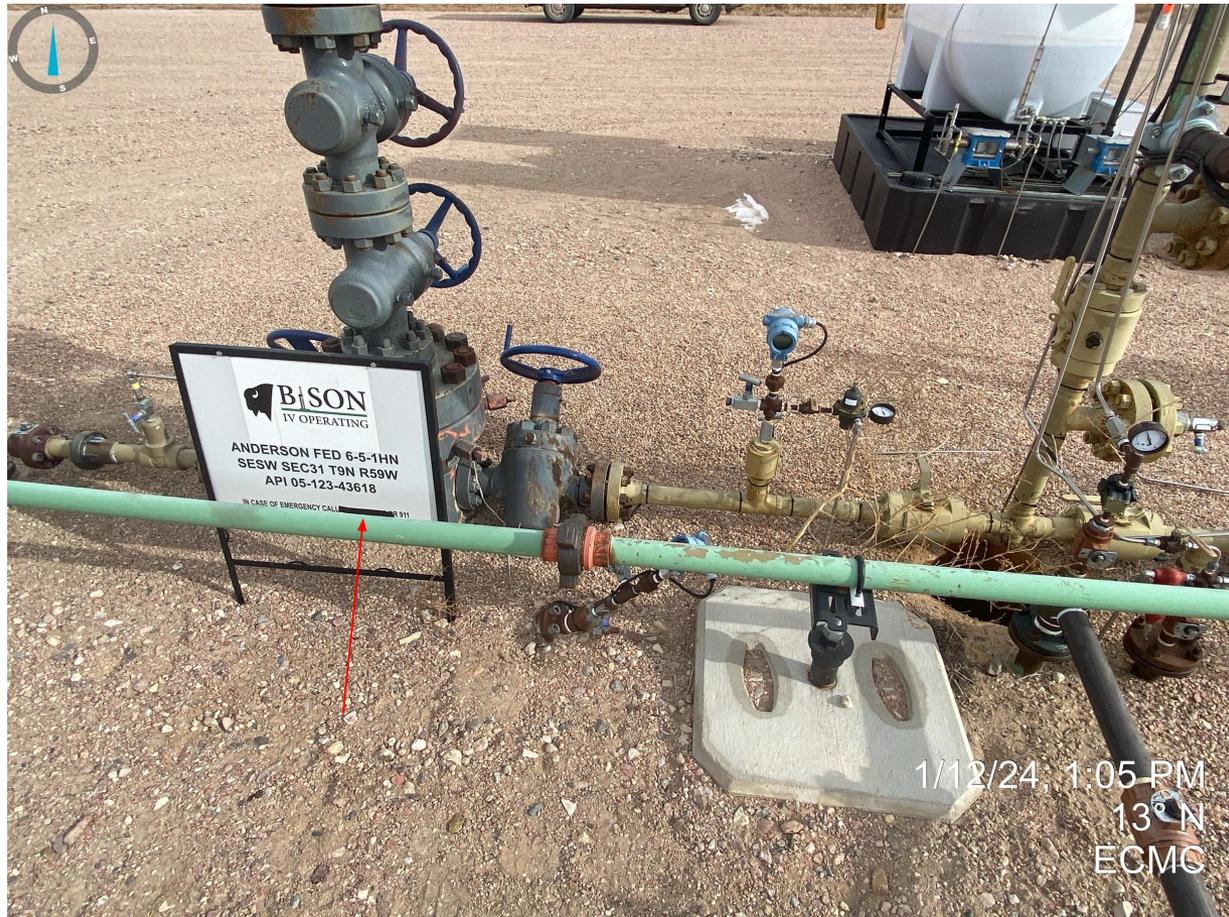
Photo 4. Emergency contact information is missing at well signs.

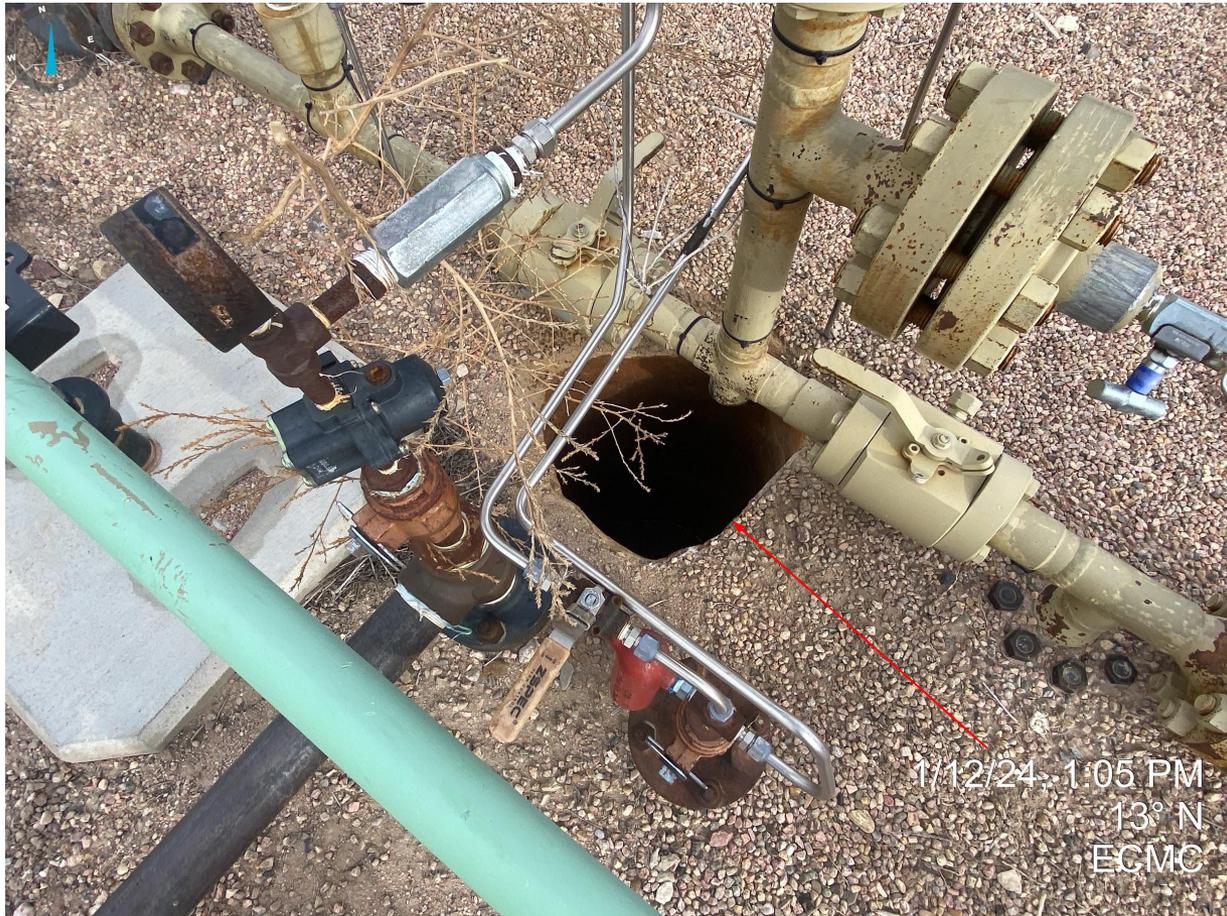
Photo 5. Opening/subsidence observed at well API #123-43618.

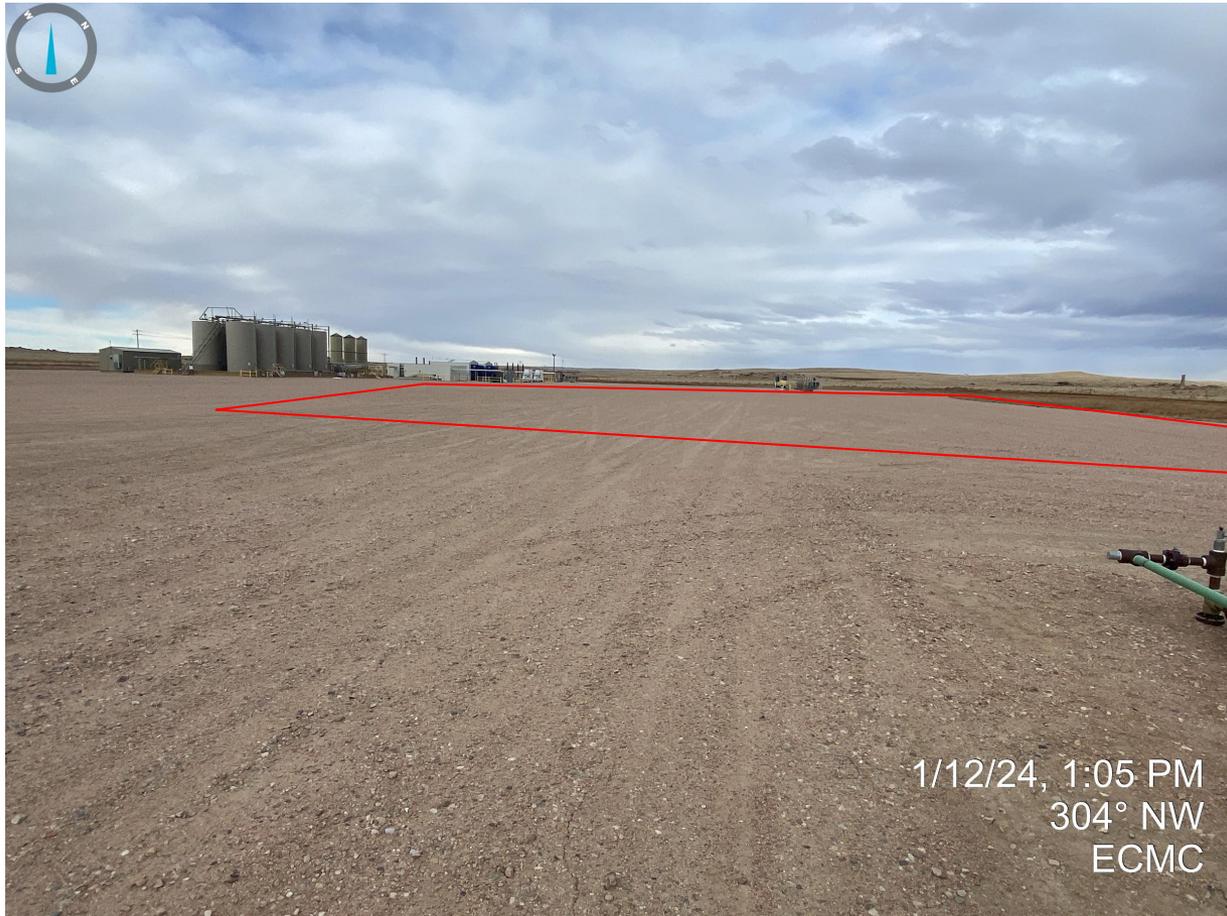
Photo 6. It doesn't appear that areas not needed for production activities have been reclaimed, illustrated by red polygon. See Photo 7 for additional.

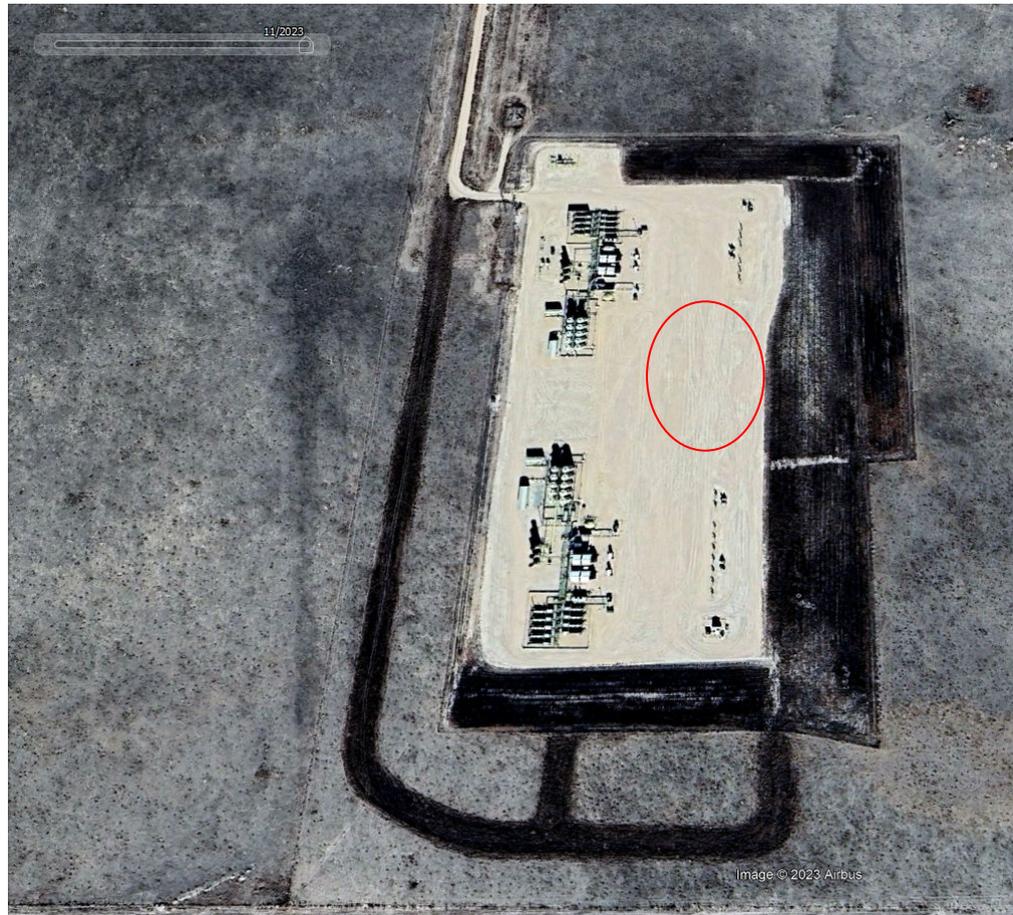
Photo 7. Google Earth aerial imagery (circa 11/2023) illustrating that areas not needed for production activities do not appear to have been reclaimed, highlighted with red circle. Approximately 1 acre has not been reclaimed.

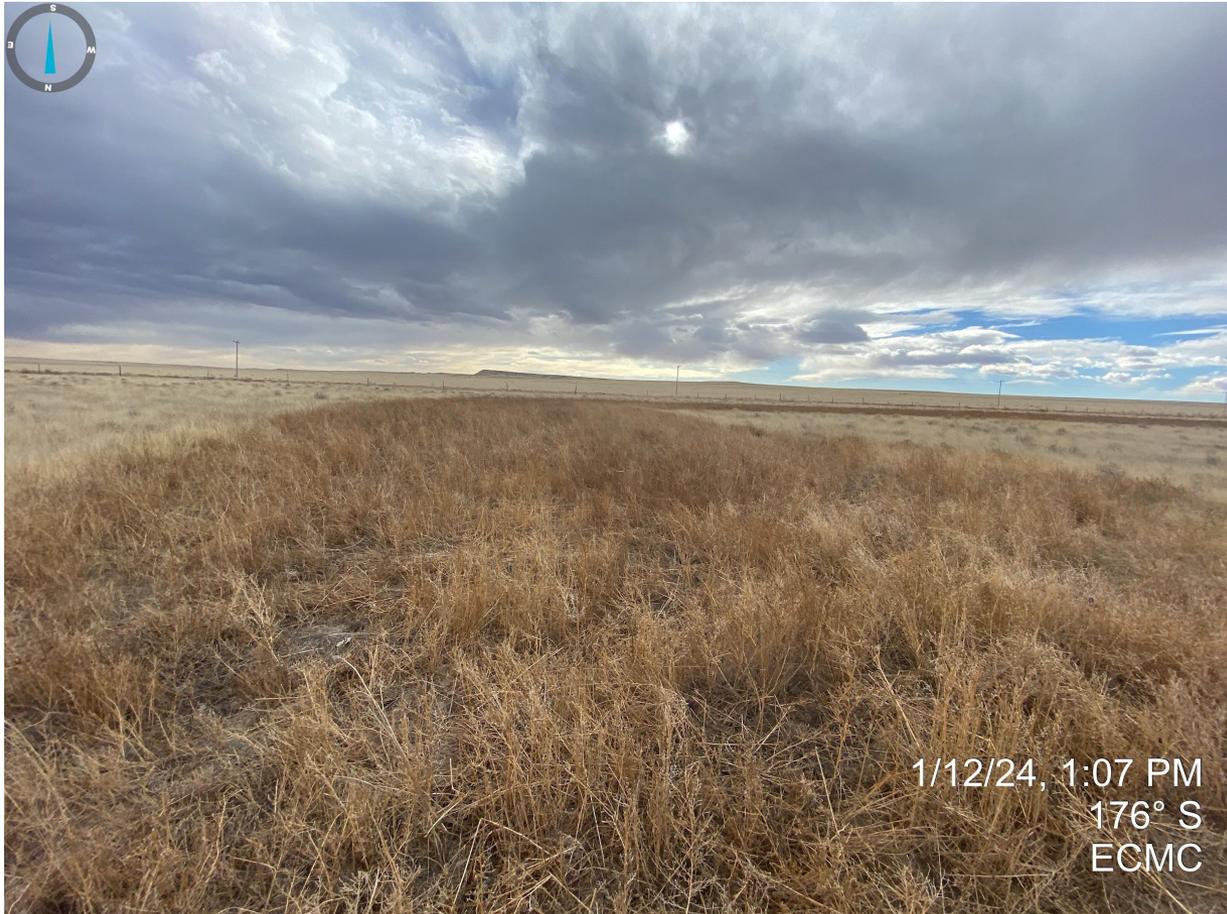
Photo 8. Former access road (south of location) is predominantly weedy vegetation (e.g. kochia and russian thistle) and is not reflective of adjacent reference areas.

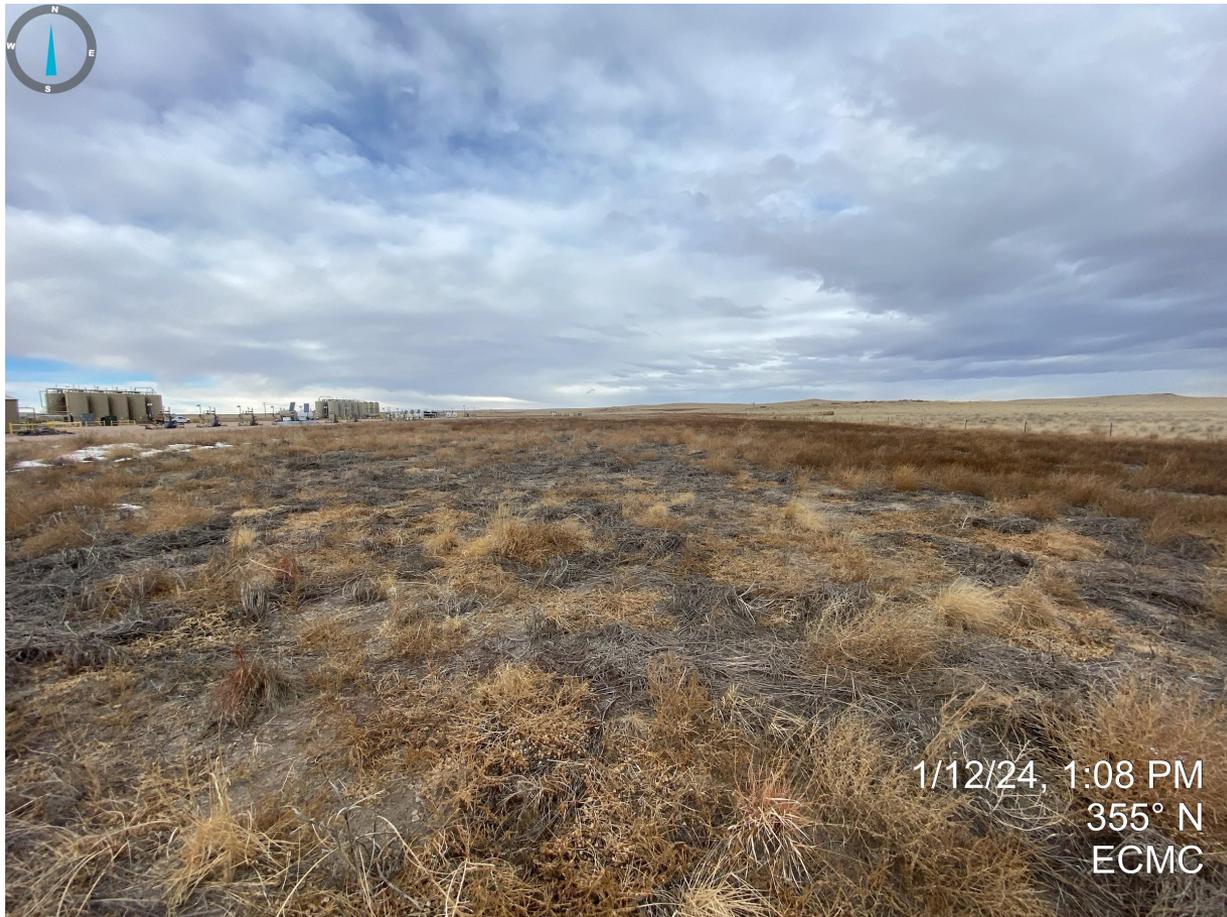
Photo 9. Eastern interim (south side of location) areas are predominantly weedy vegetation. Additional reclamation activities are required.

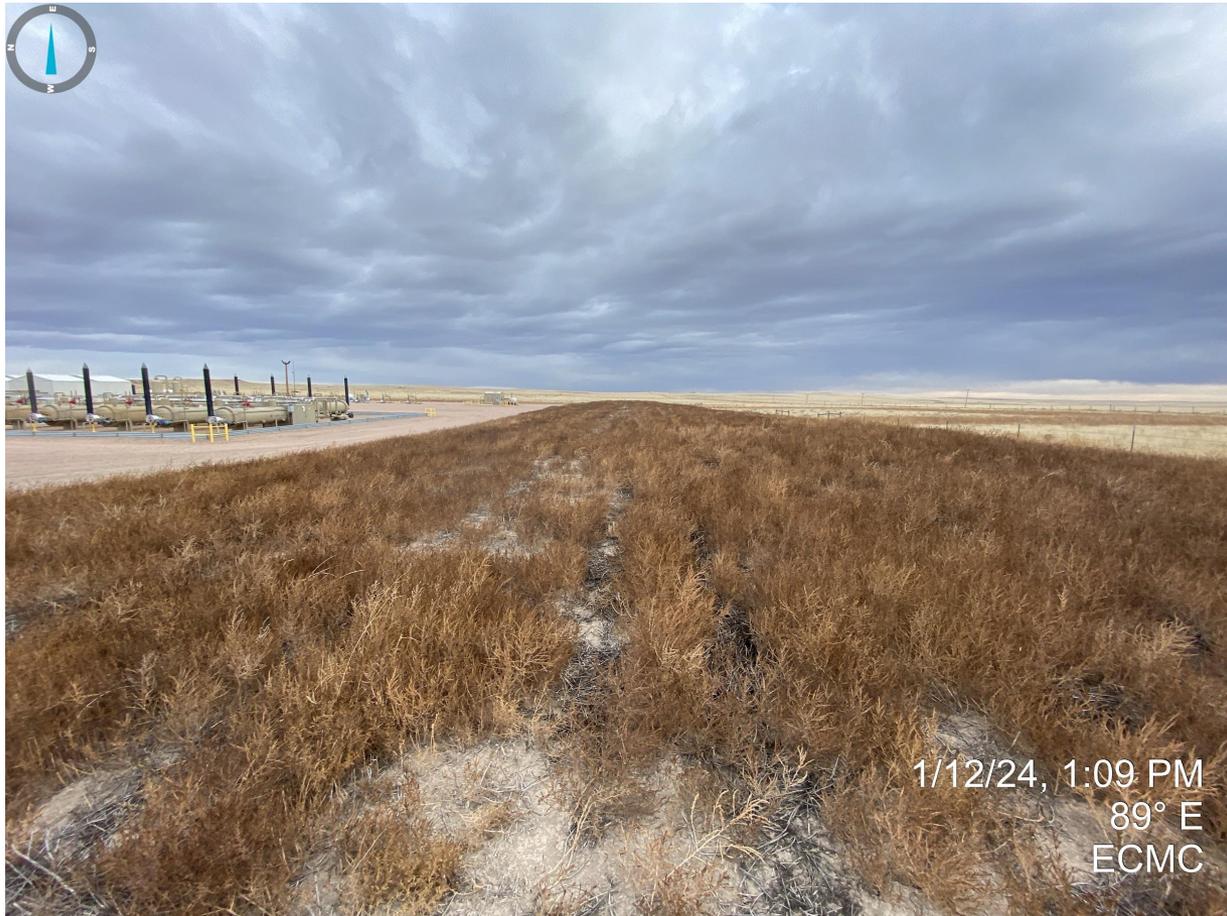
Photo 10. Topsoil stockpile is predominantly weedy vegetation. Additional reclamation activities are required.

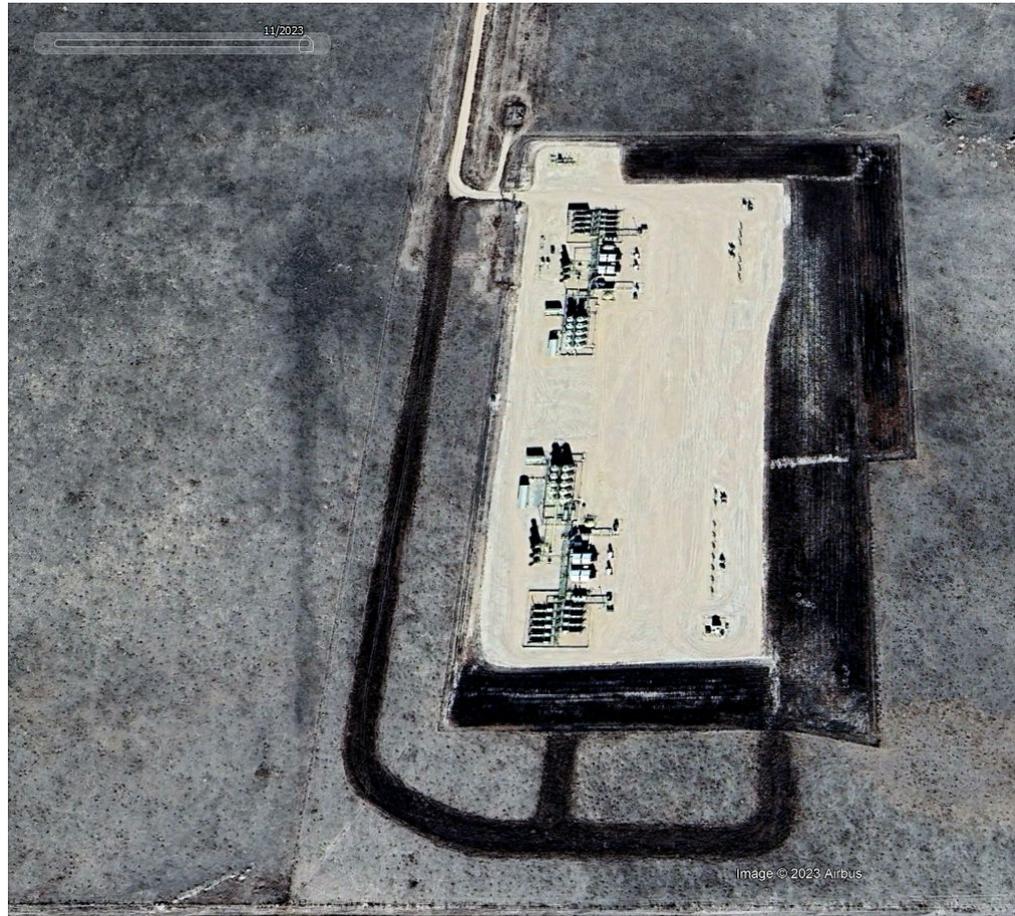
Photo 11. Google Earth aerial imagery (circa 11/2023) illustrating that darker areas/vegetation represents significant weed cover throughout the interim areas. Additional reclamation activities are required.
