Inspection Photos

Loc: 321012

Operator: DOVER ATWOOD CORPORATION

Inspection Date: 1/18/2024

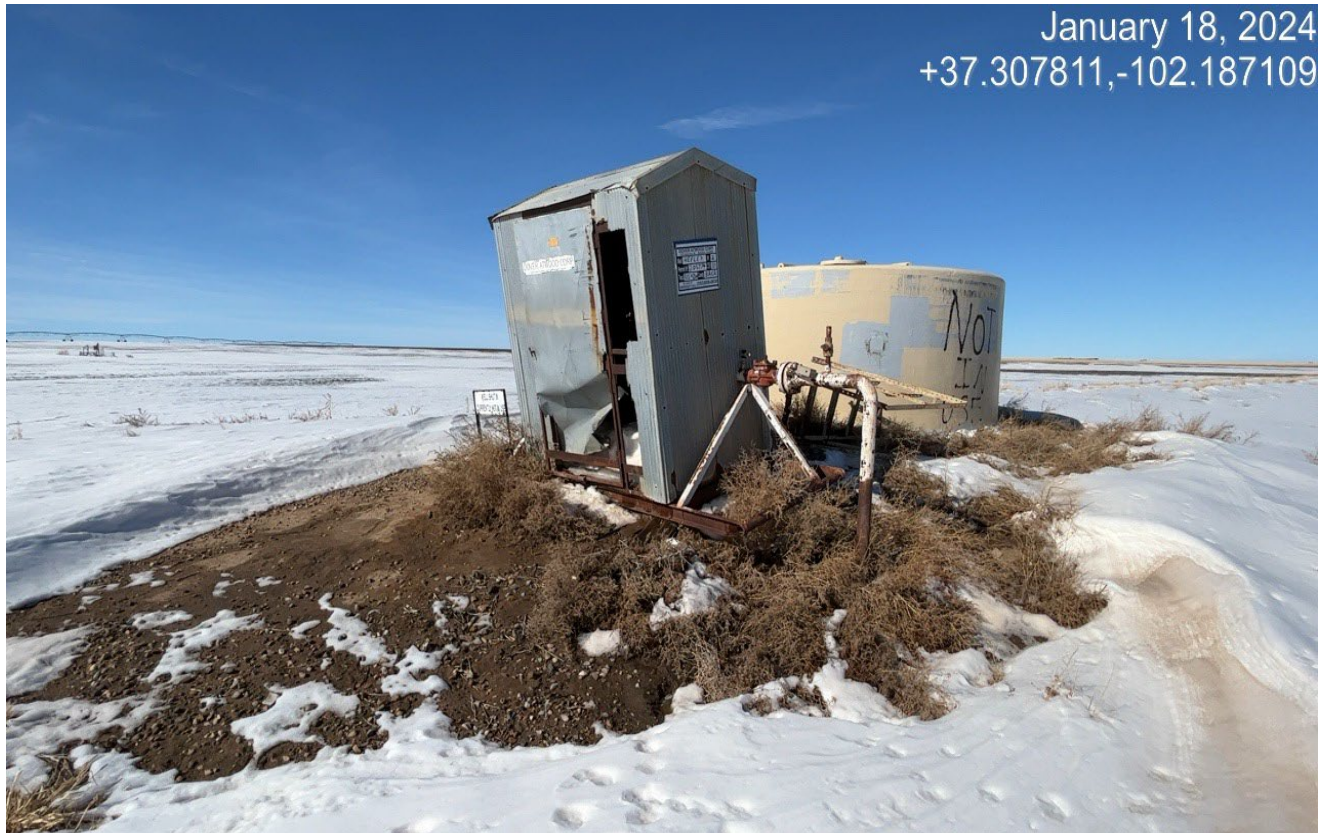
Photo 1. Facing toward the offsite tank battery.

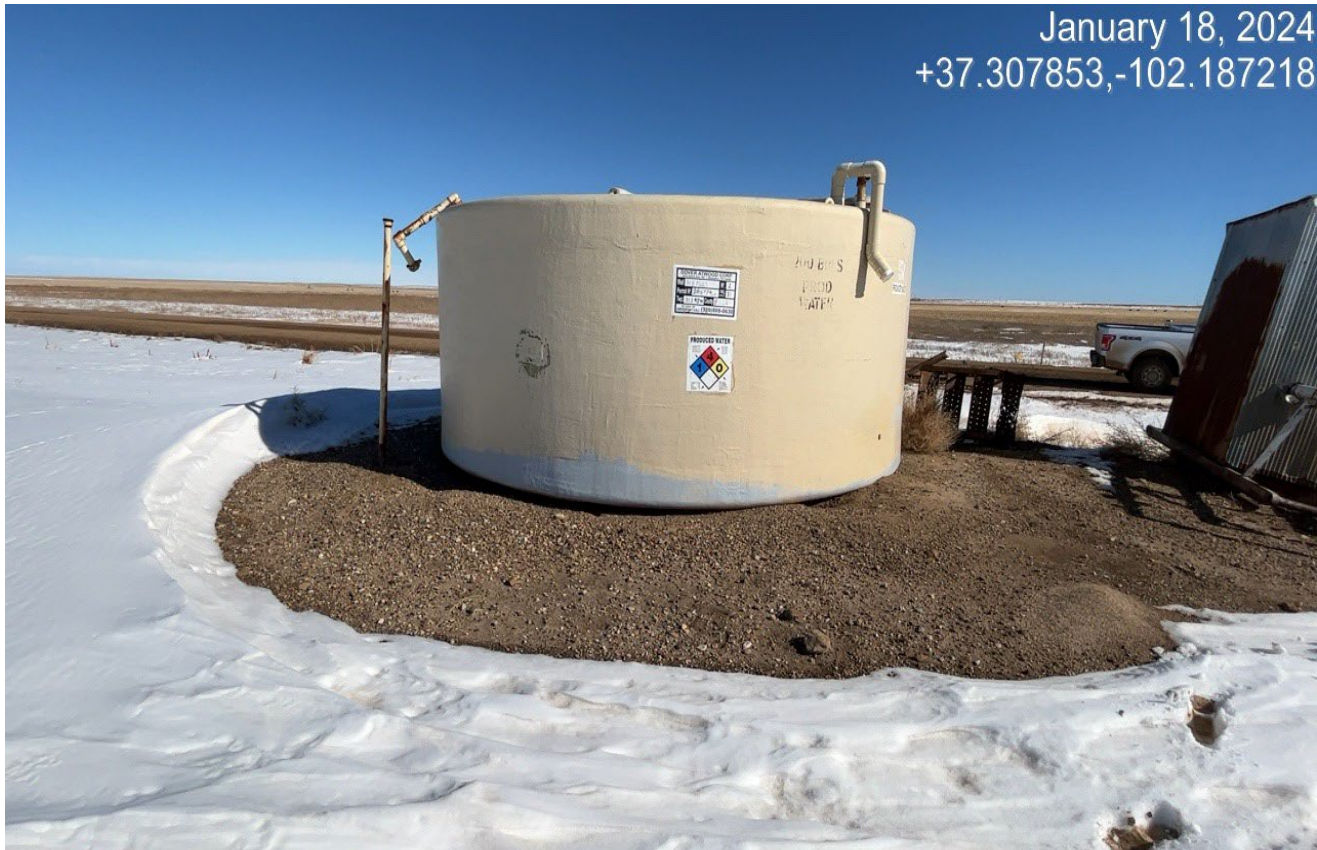
Photo 2. Facing toward the tank. There is not secondary containment at the tank.

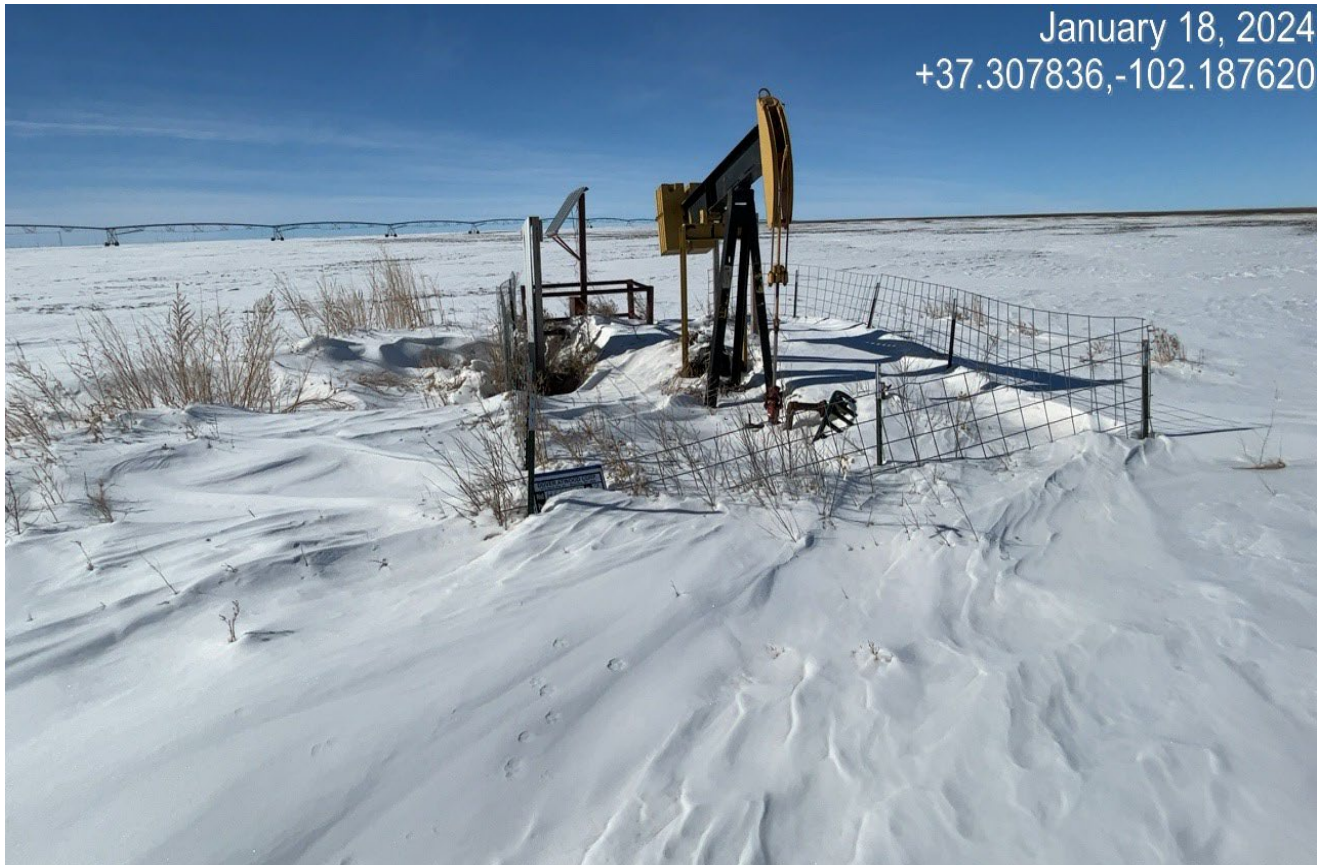
Photo 3. Facing toward the well which is under snow cover.

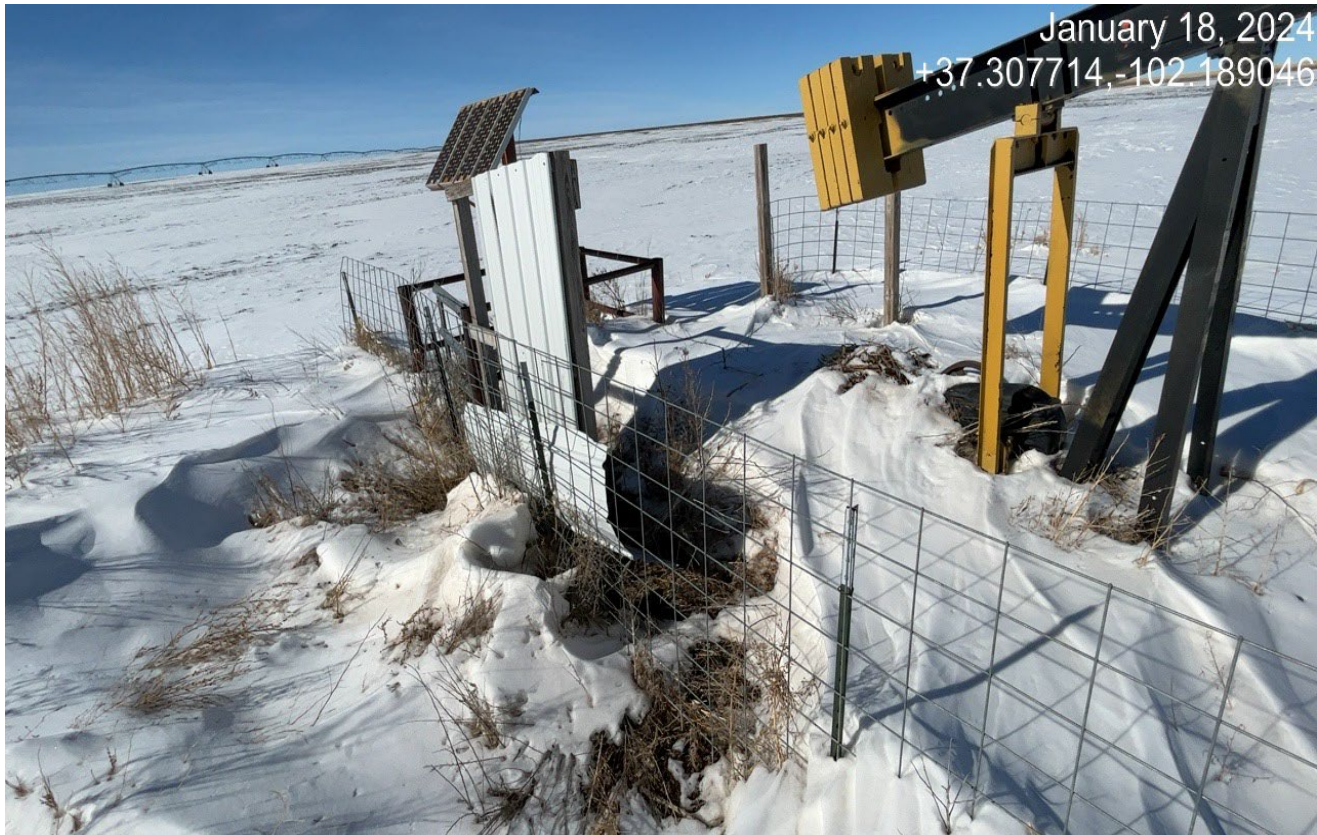
Photo 4. There appears to be vegetative debris at the pumpjack.
