## Inspection Photos

Location Name: CAERUS PICEANCE LLC FEDERAL 28-15X (PJ28) Pad

Location #: 334065

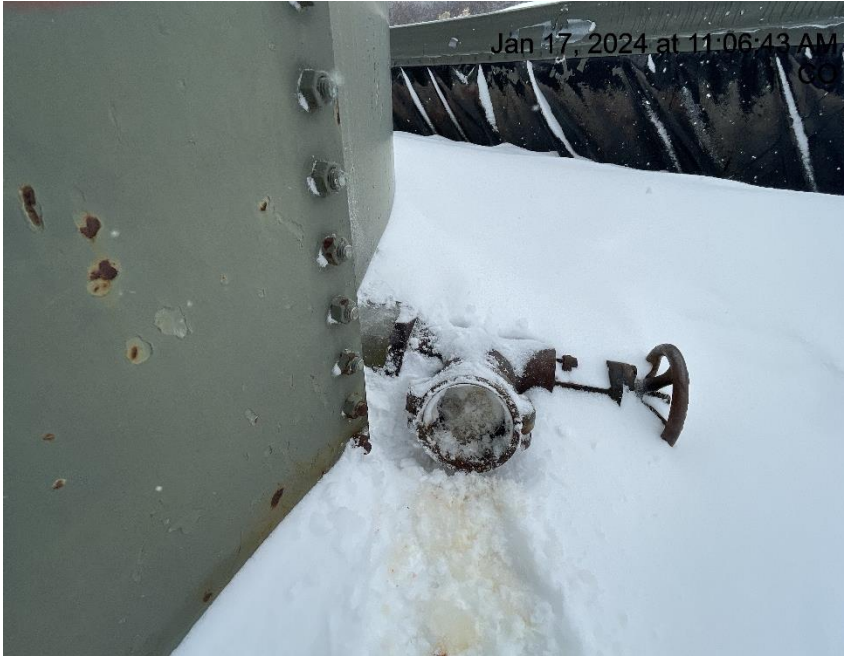
Photo # 2945 Open ended load line

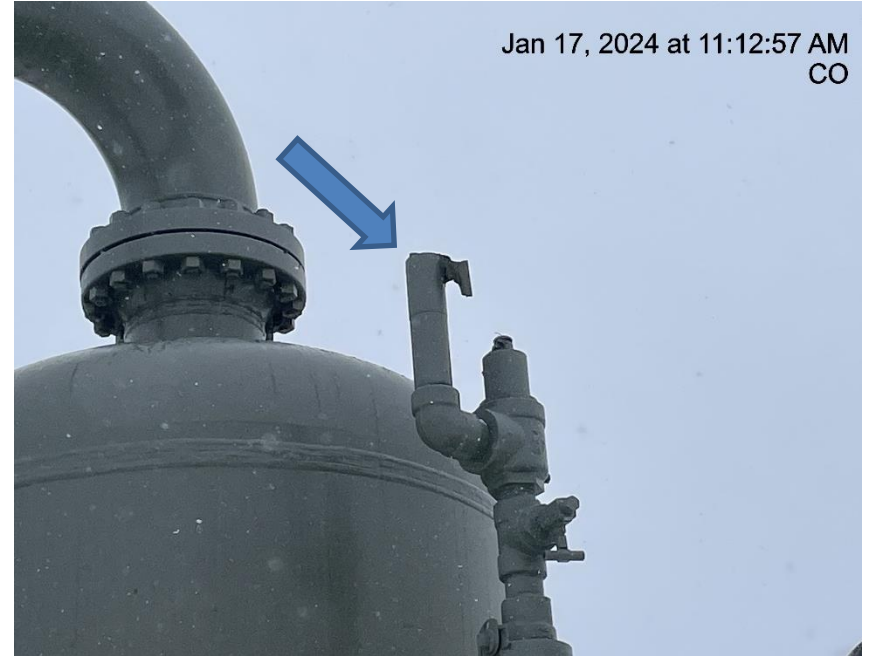
Photo # 2946 PRV vent line lacks cap
