Inspection Photos

Loc #: 484359

Operator: DESERT EAGLE OPERATING

Inspection Date: 1/18/2024

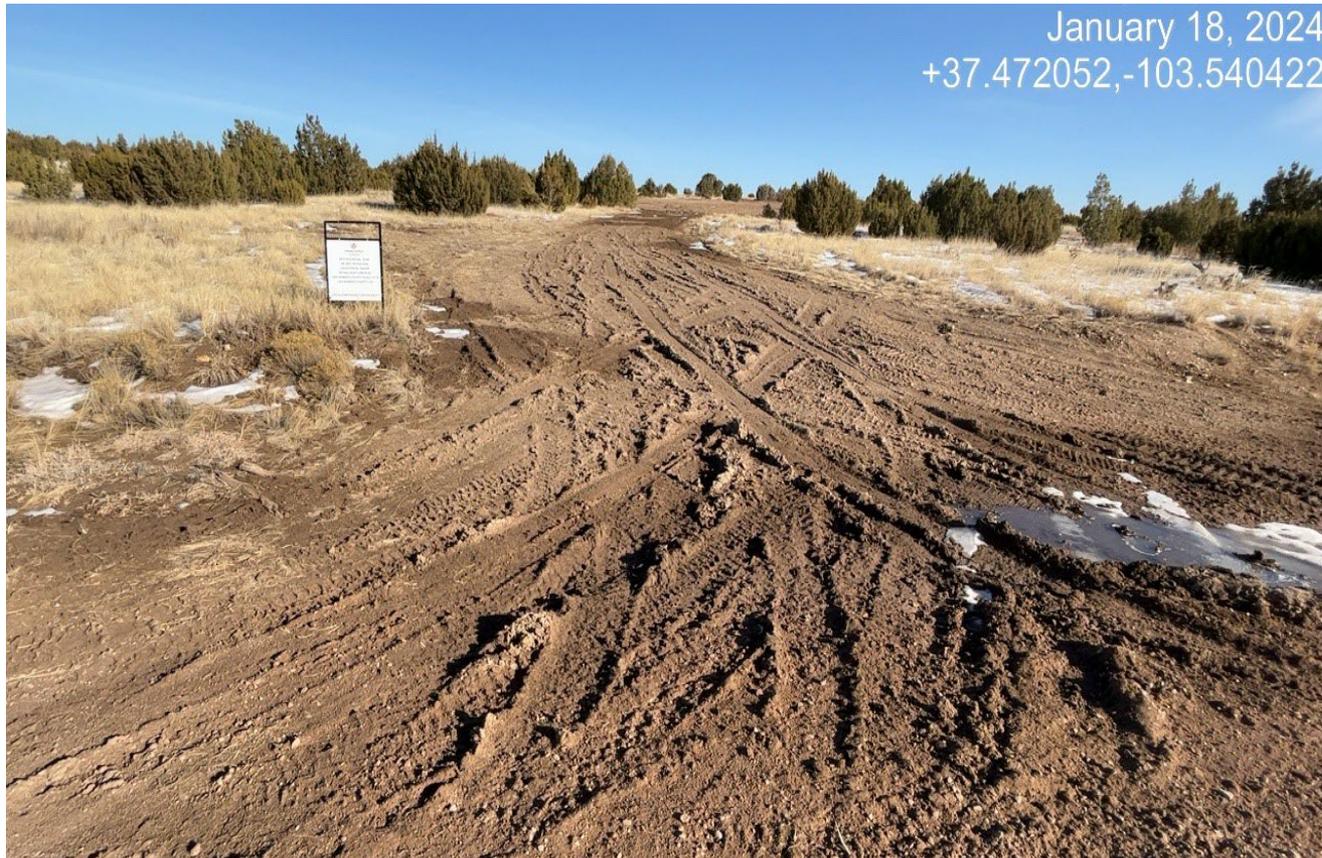
Photo 1. Facing east toward the access road standing on County Road 177. There is vehicle rutting and tracking of sediment onto the County Road. BMP's must installed to prevent sediment tracking and road degradation.

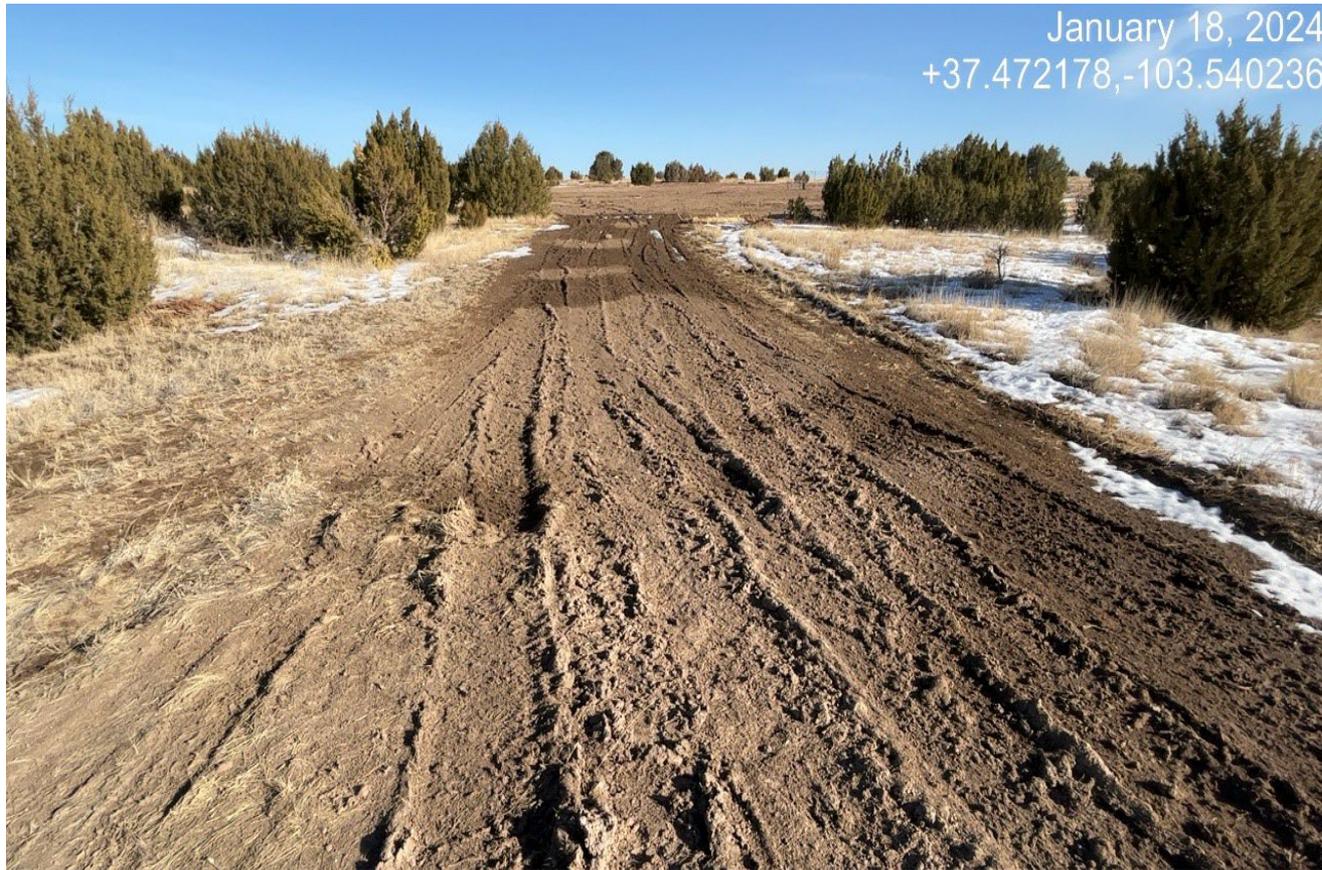
Photo 2. Facing east along the access road which is not stabilized. The topsoil of the road is not being protected from degradation. The access road should be seeded and reclaimed.

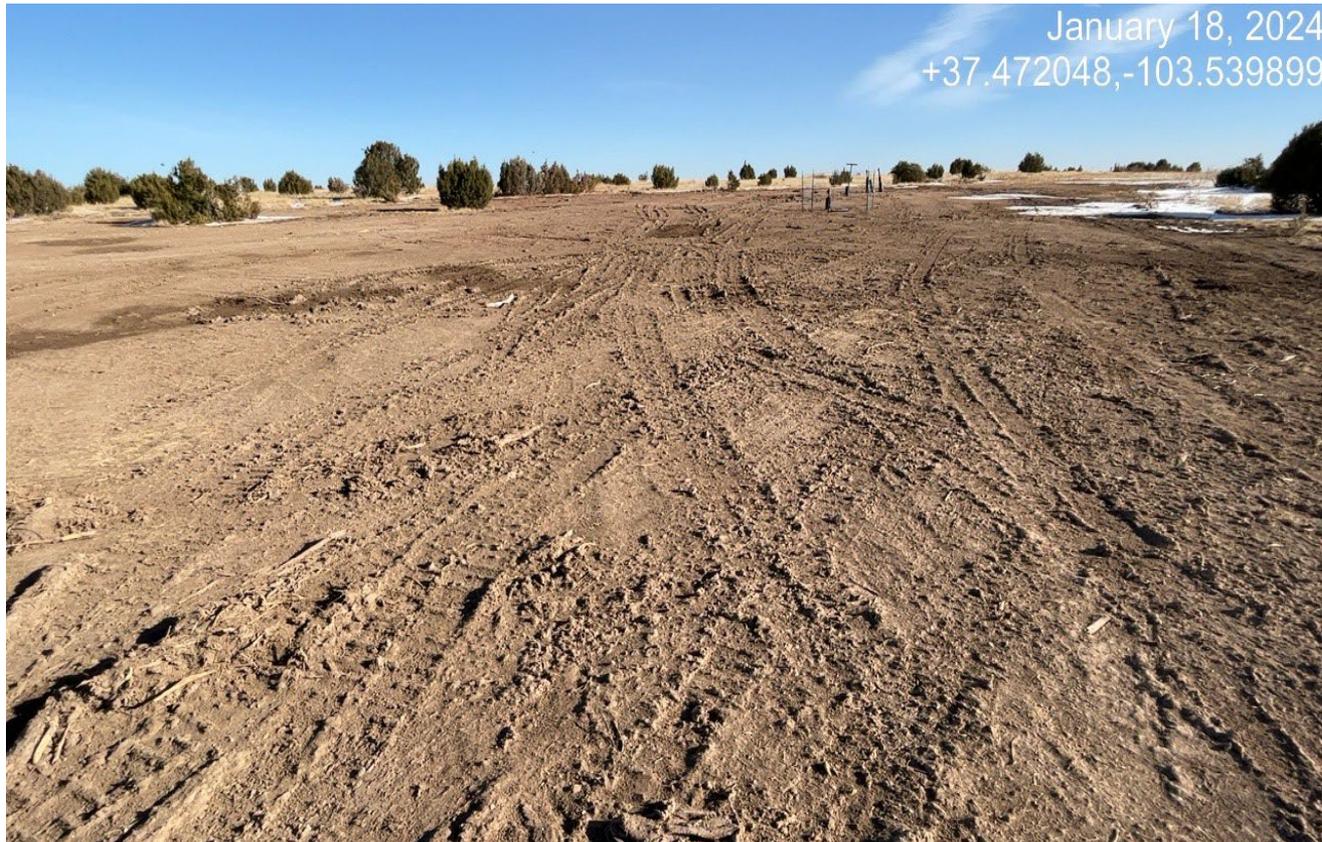
Photo 3. Facing southeast toward the location. All disturbed areas of the location will need to be decompacted and seeded prior to the upcoming growing season.

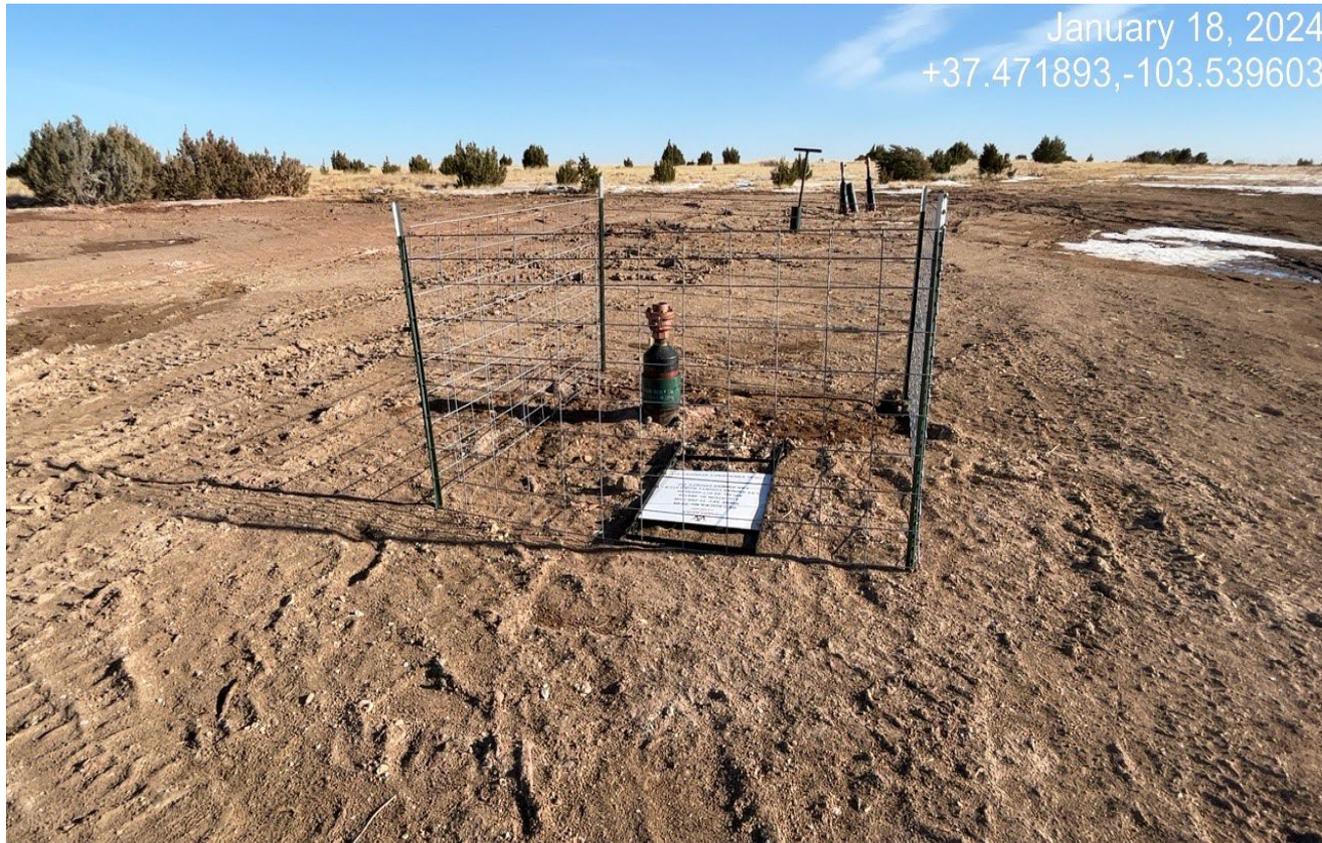
Photo 4. Facing southeast toward the well. The sign is laying on the ground not installed.

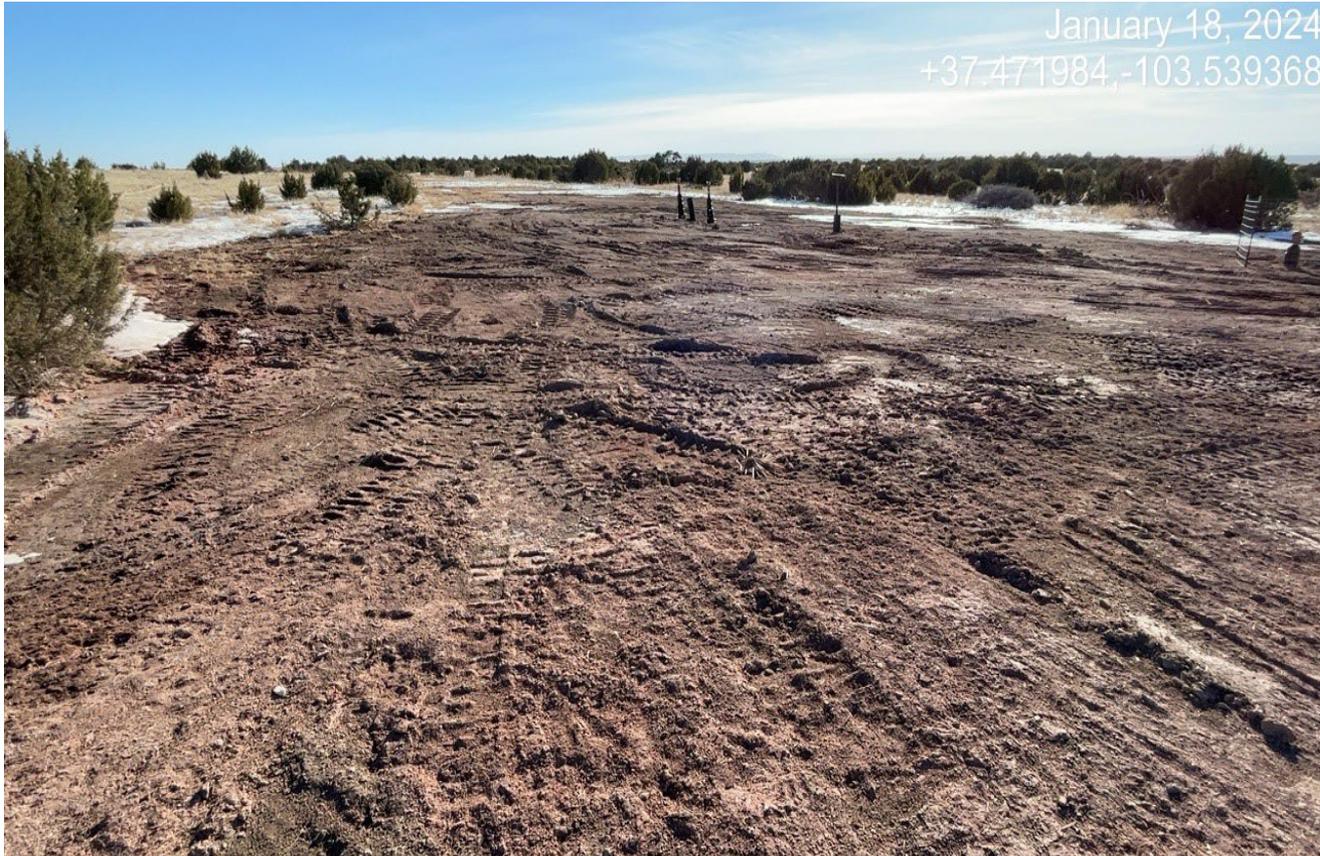
Photo 5. Facing south at the east side of the location. The drill cuttings have been removed but there is still a reddish color in this area that remains which is indicative of the drill cuttings.

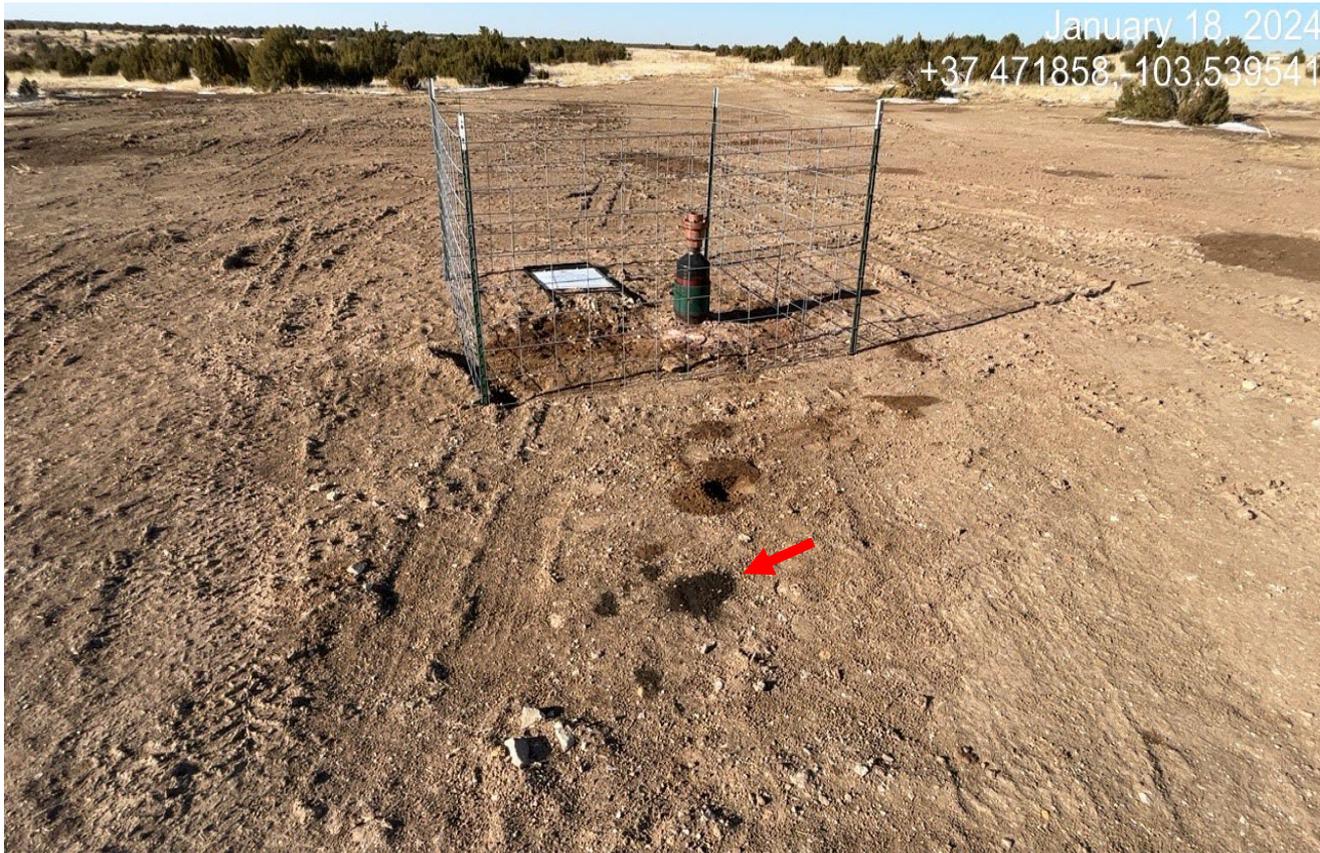
Photo 6. Facing north at the well. There is stained soils near the wellhead that need to be cleaned up..
