Inspection Photos

Loc #: 481115

Operator: DESERT EAGLE OPERATING

Inspection Date: 1/18/2024

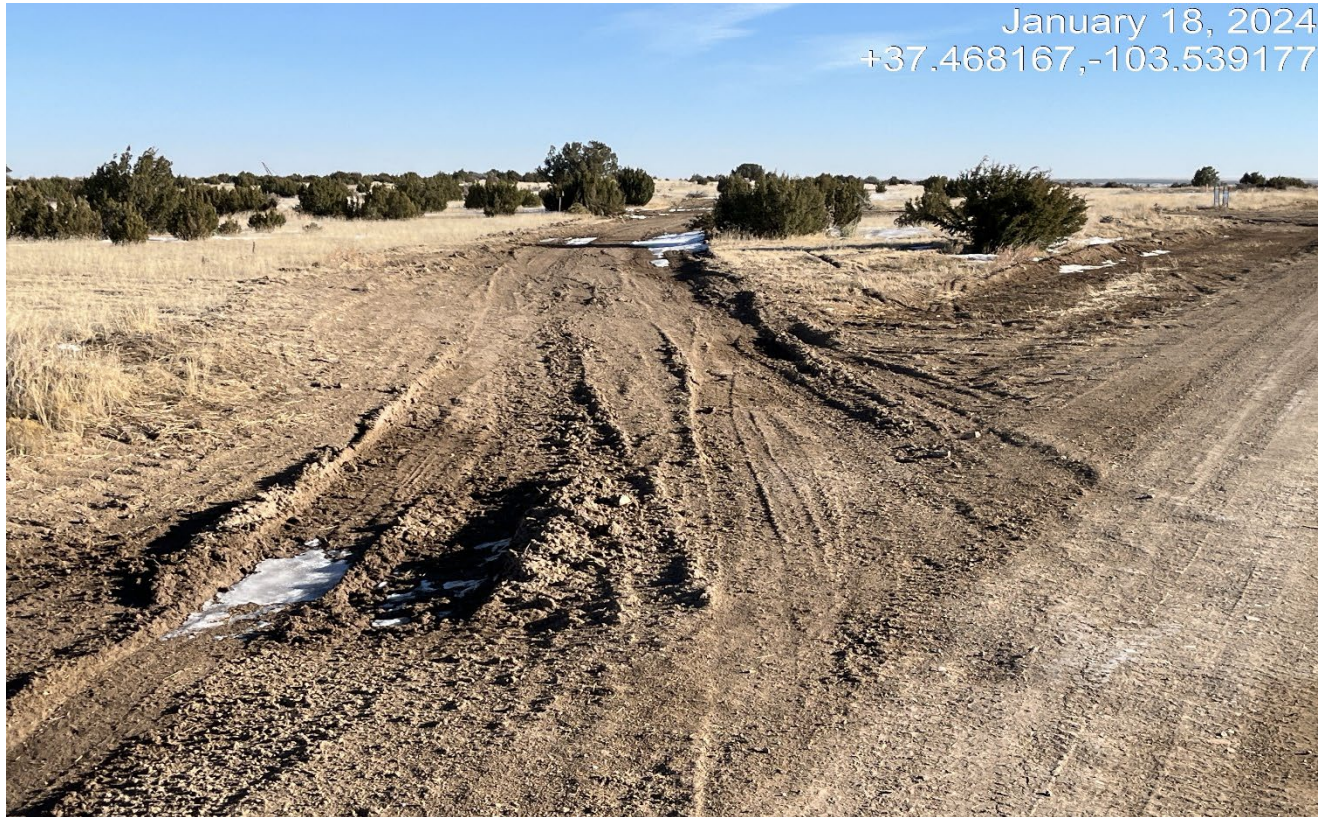
Photo 1. Facing southeast toward the access road to the Red Rocks #1-13 drill site. There is some signs rutting occurring onto the County Road.

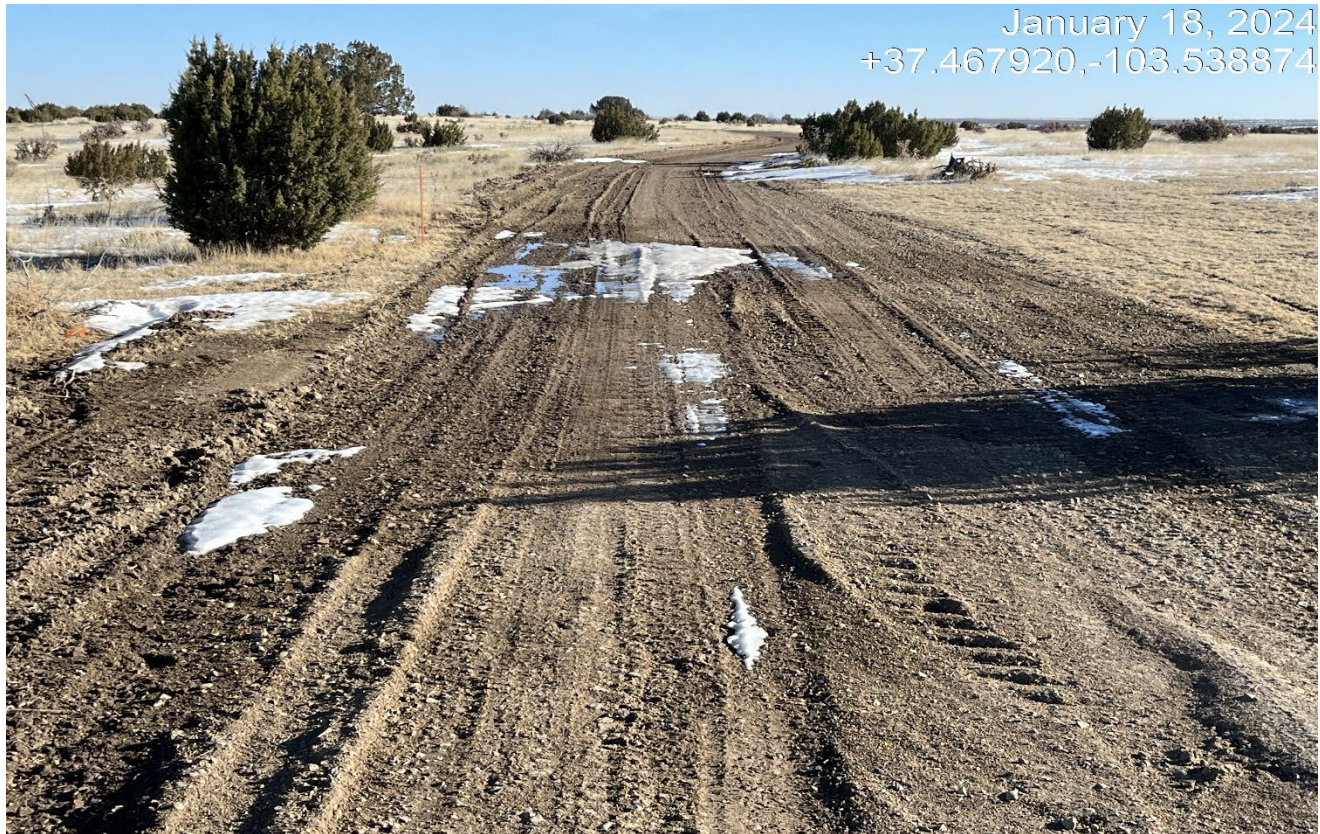
Photo 2. Facing southeast along the access road.

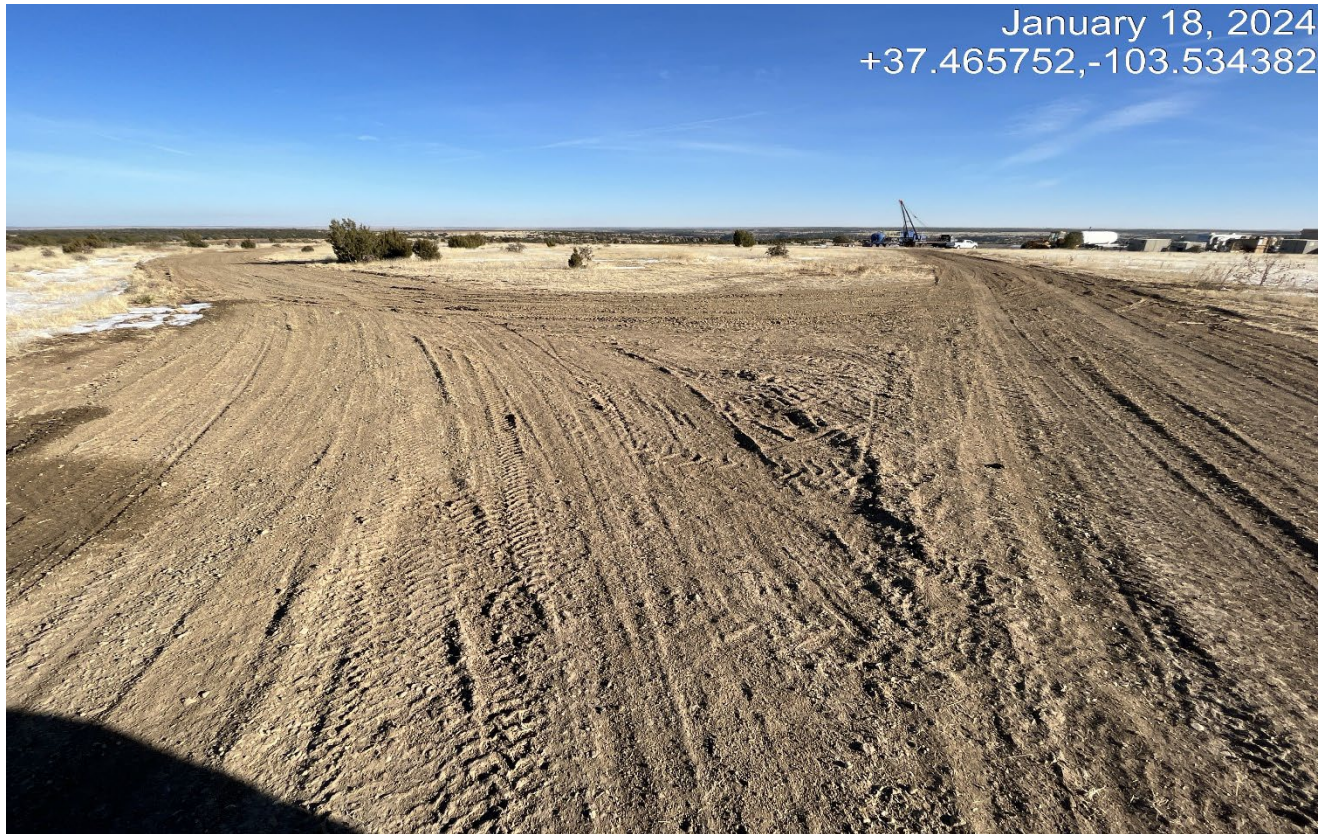
Photo 3. Facing southeast along the access road on right side. This area has been widened and disturbed due to vehicle turning.

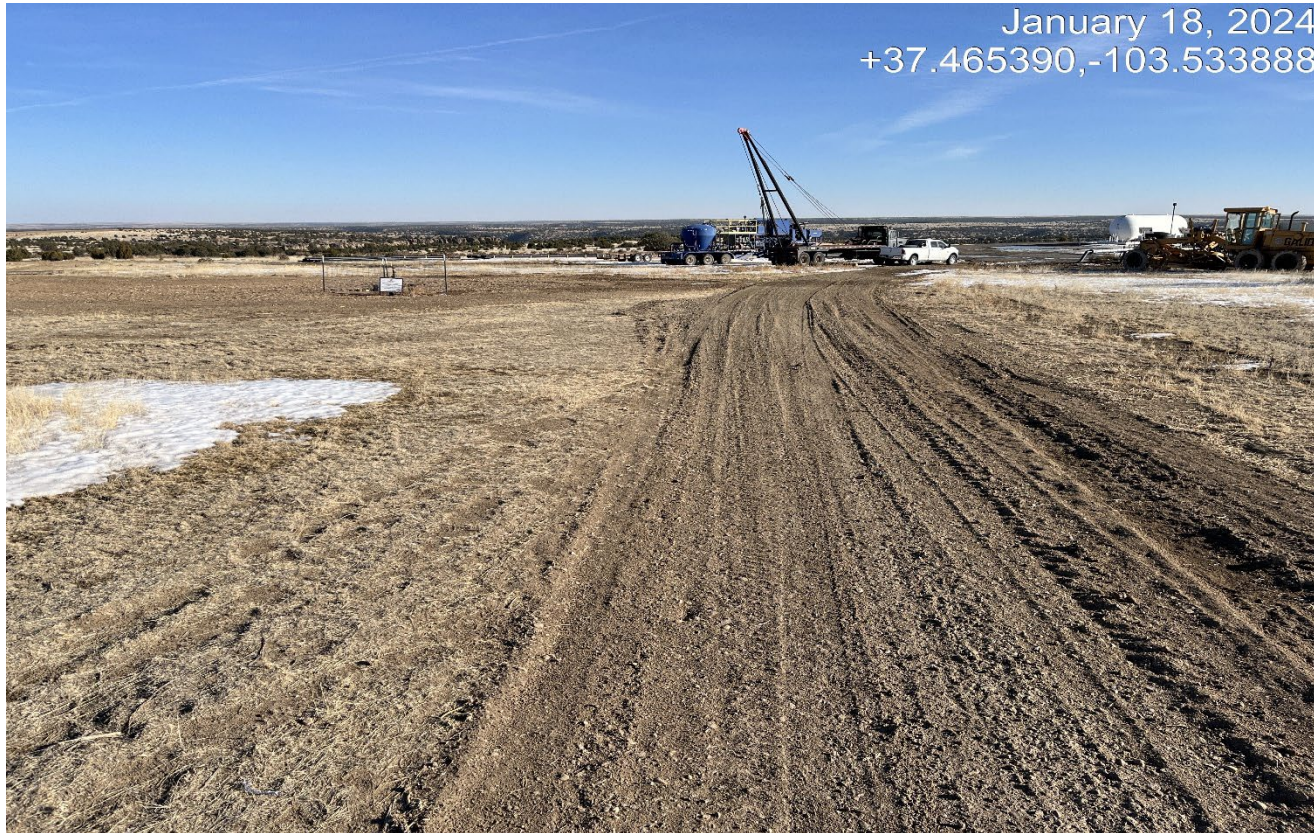
Photo 4. Facing southeast toward the Red Rocks #1-13 drill site. There is an unpermitted road cutting across the location to the processing plant. Vehicle must stay on designated access road boundary only.

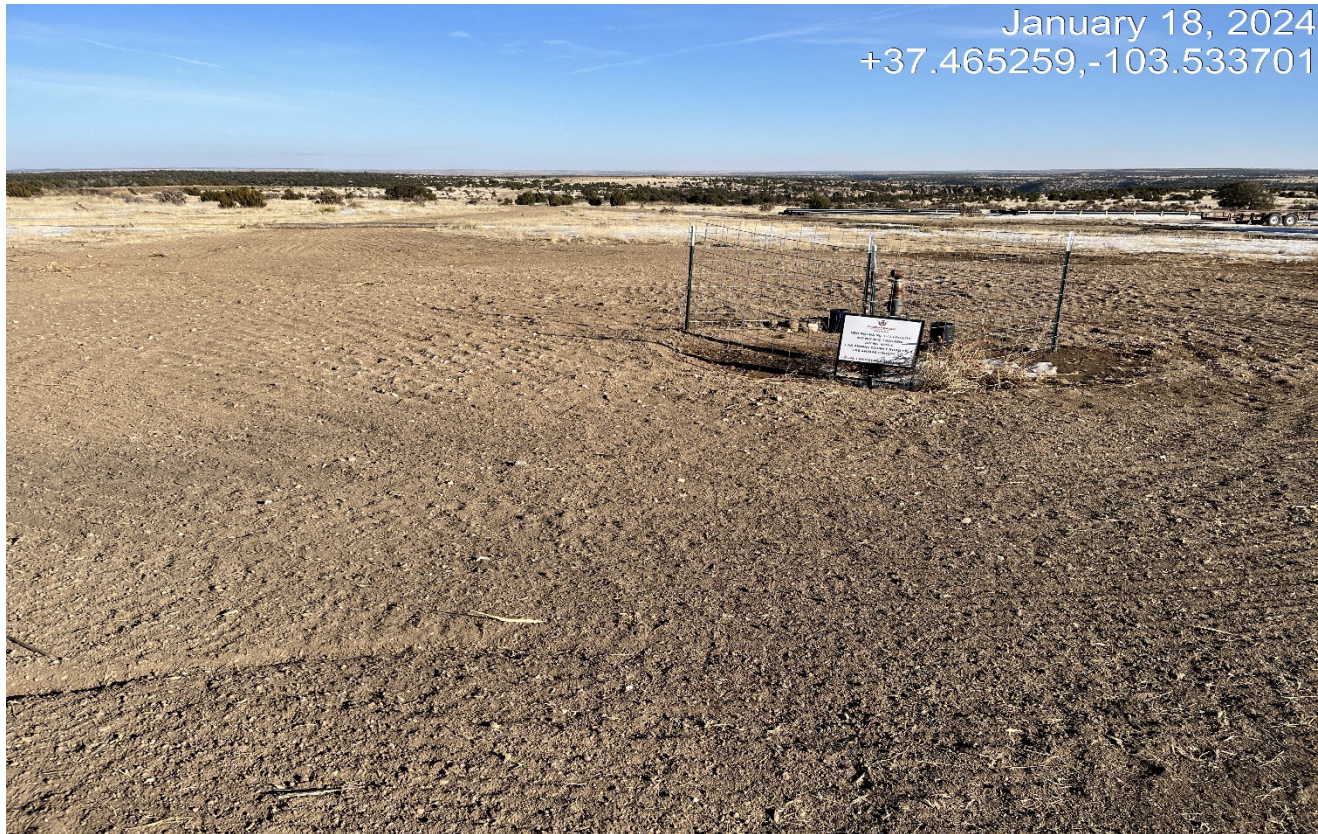
Photo 5. Facing southeast toward the well with sign posted at the wellhead.

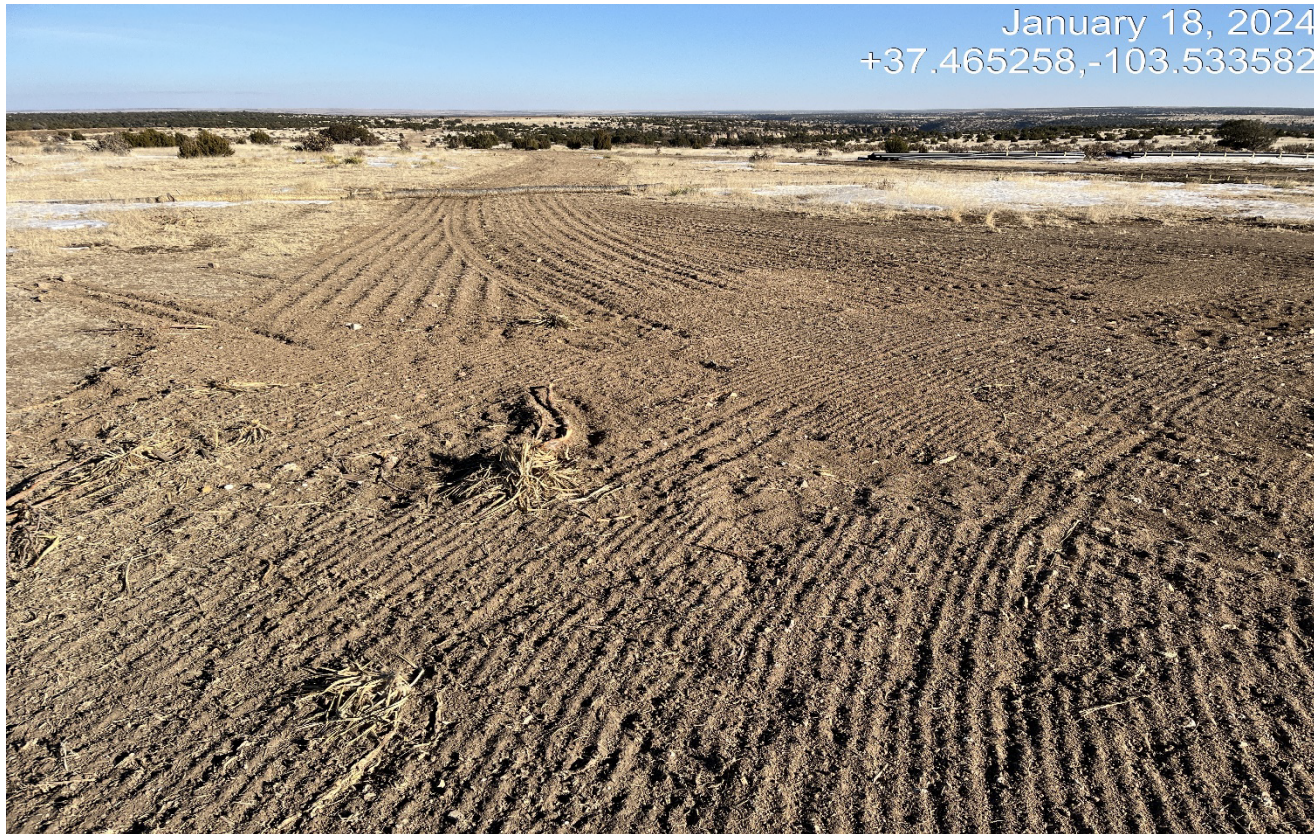
Photo 6. Facing southeast toward the flowline disturbance. It appears disturbed soils have been seeded.

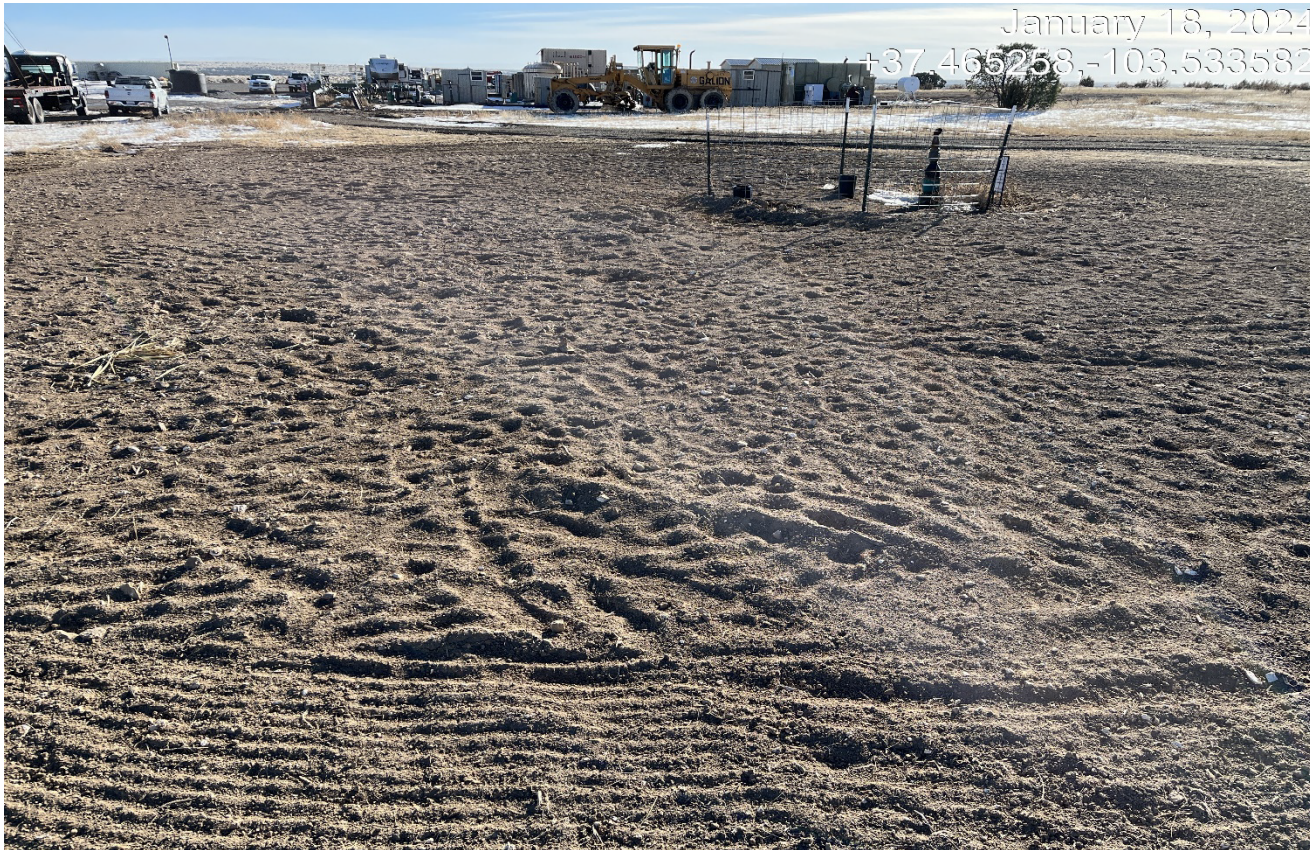
Photo 7. Facing south at the location. The excavated area at the wellhead has been backfilled and the rock debris has been removed. It is unknown what topsoil material was replaced since it was not properly salvaged. It does not appear soil closer to the well were seeded.

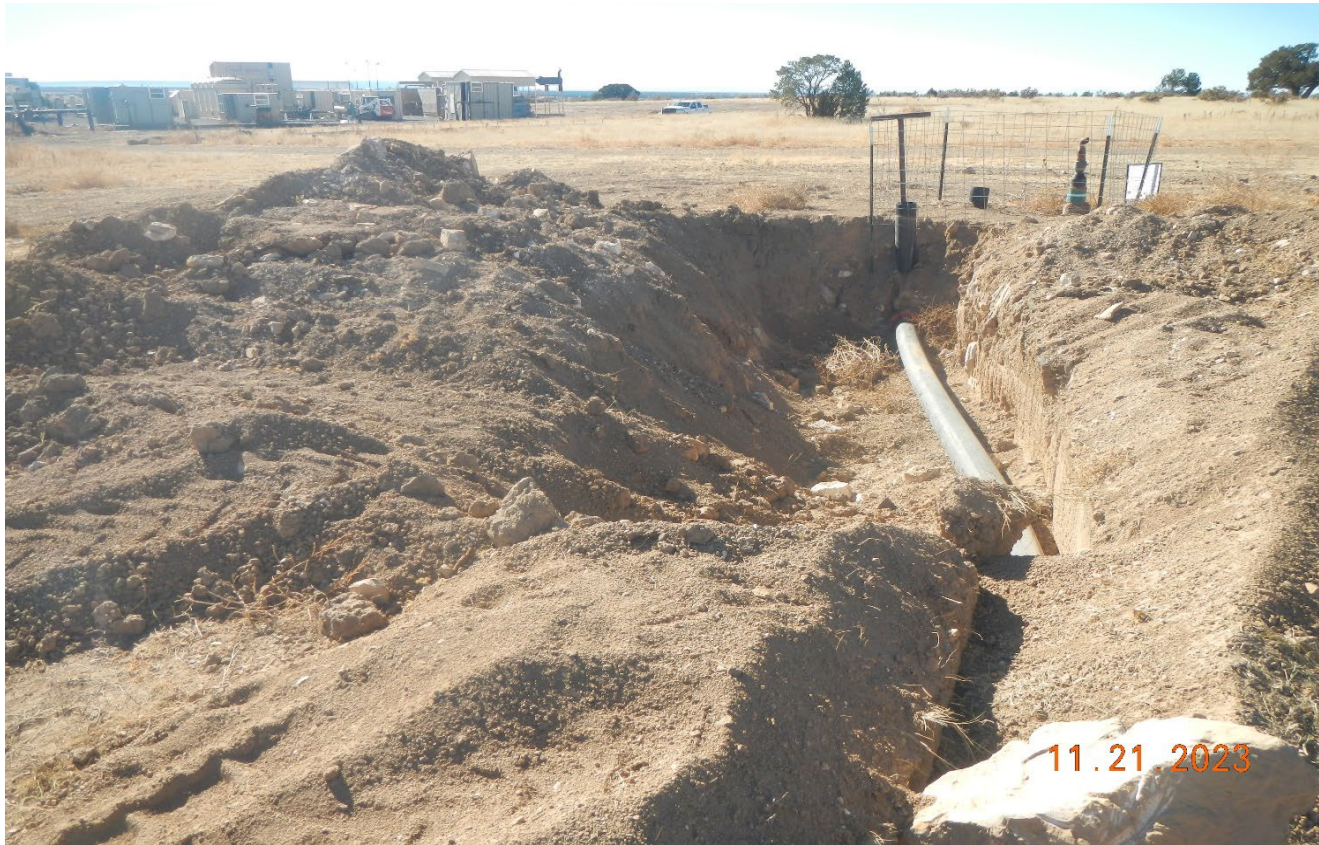
Photo 5. There is an open excavation at the wellhead and topsoil was not salvaged and protected. The open excavation at the wellhead and flowlineshow be properly marked/fenced to prevent livestock/wildlife entry.

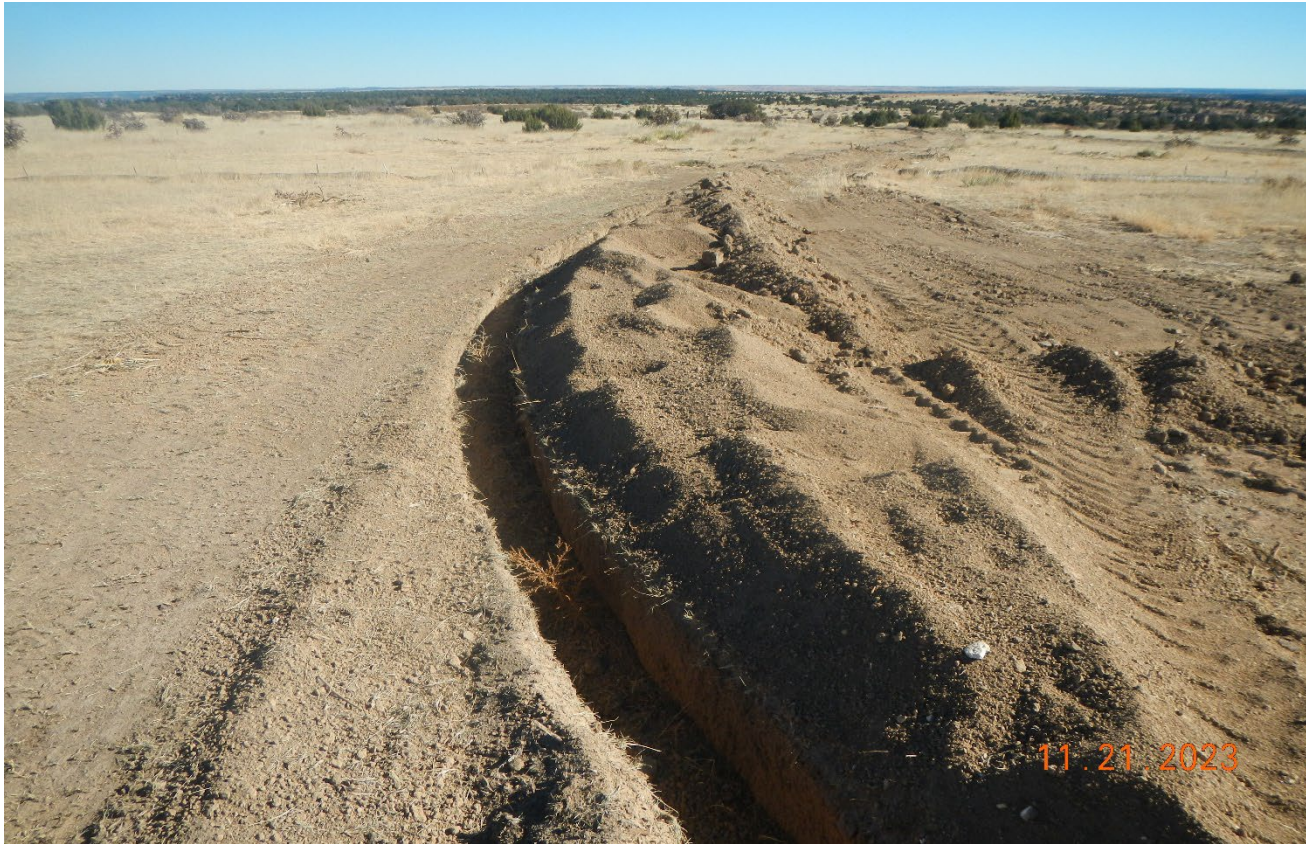
Photo 6. Facing east toward the flowline disturbance. Loose soils are susceptible to erosion and need to be stabilized.

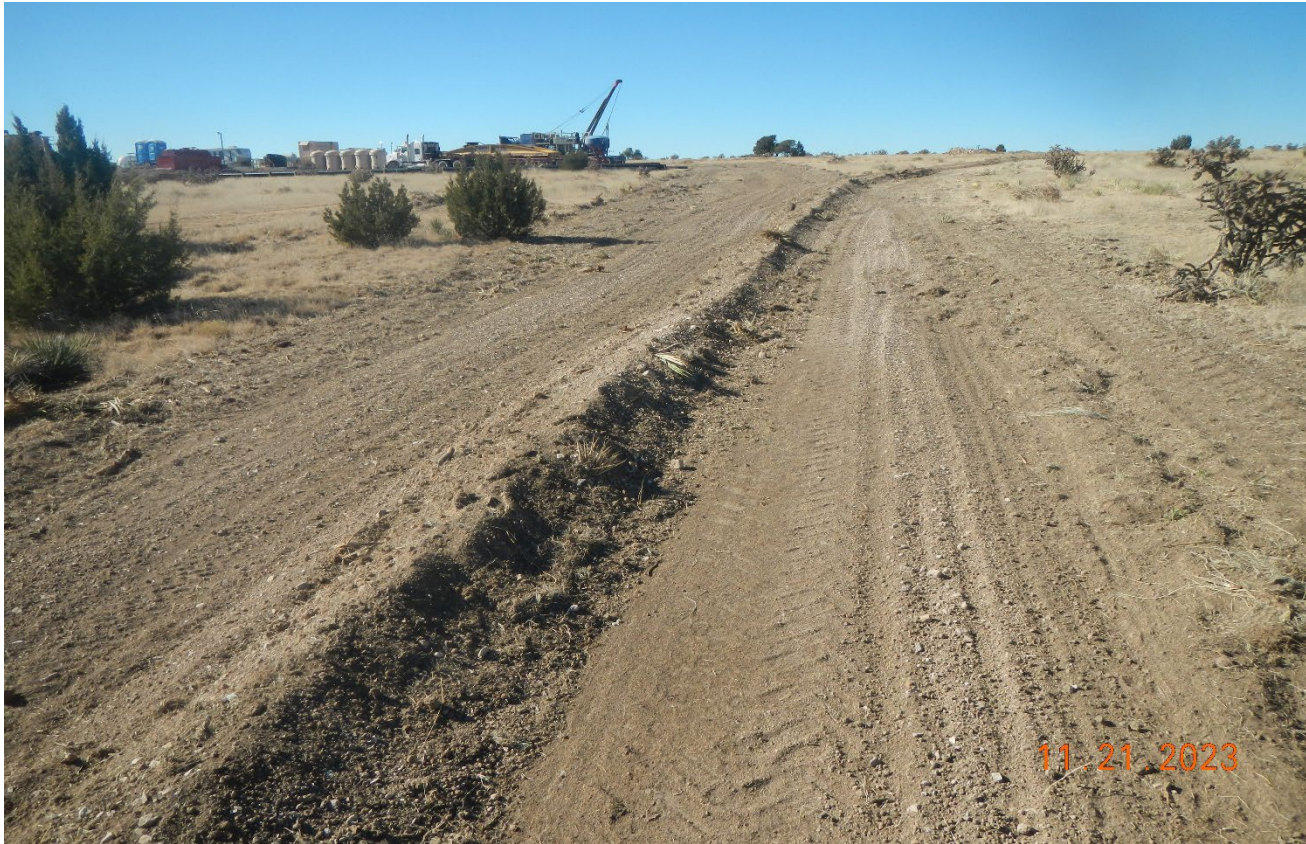
Photo 7. Standing further east of the location facing west along the flowline. Loose soils are susceptible to erosion and need to be stabilized.
