# Construction and Stormwater Inspection

Date: 01/22/2024

Operator: VERDAD RESOURCES LLC - 10651

Inspection Photos  
Location Name: Speed Goat Fed 3432-3435  
Location ID: 425474

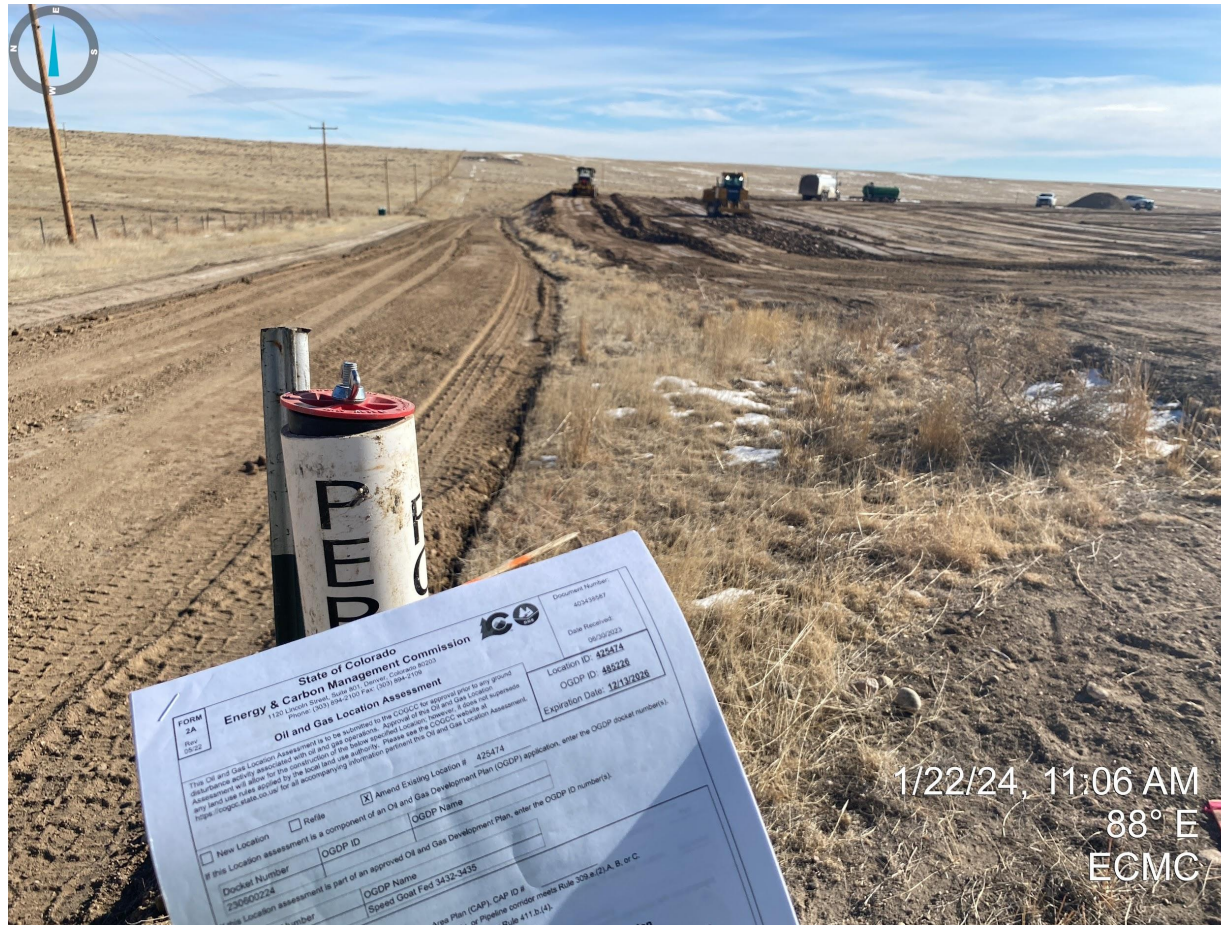
Photo 1. Form 2A posted on location.

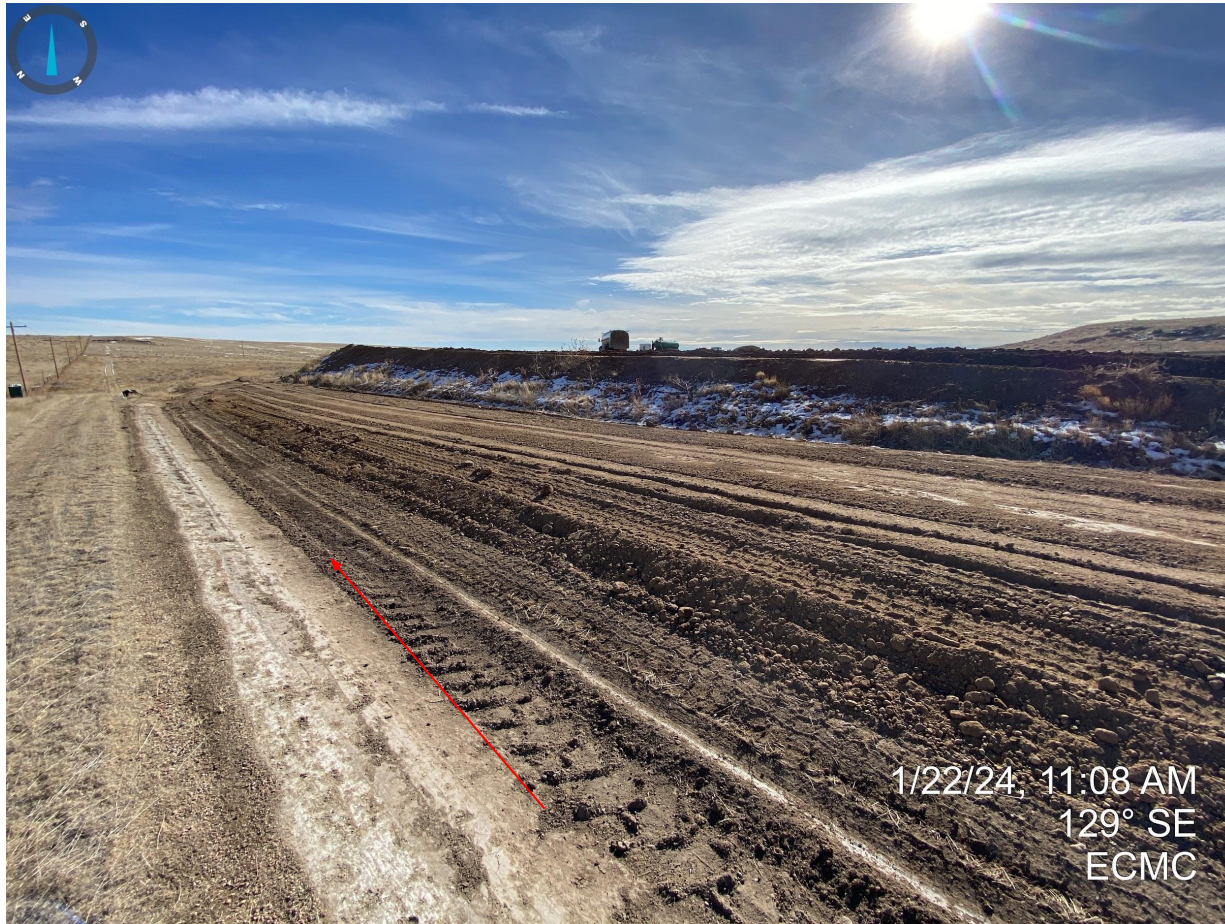
**Photo 2.** Northern portion of the construction area. Stormwater ditch has been installed around the perimeter of the disturbance area.

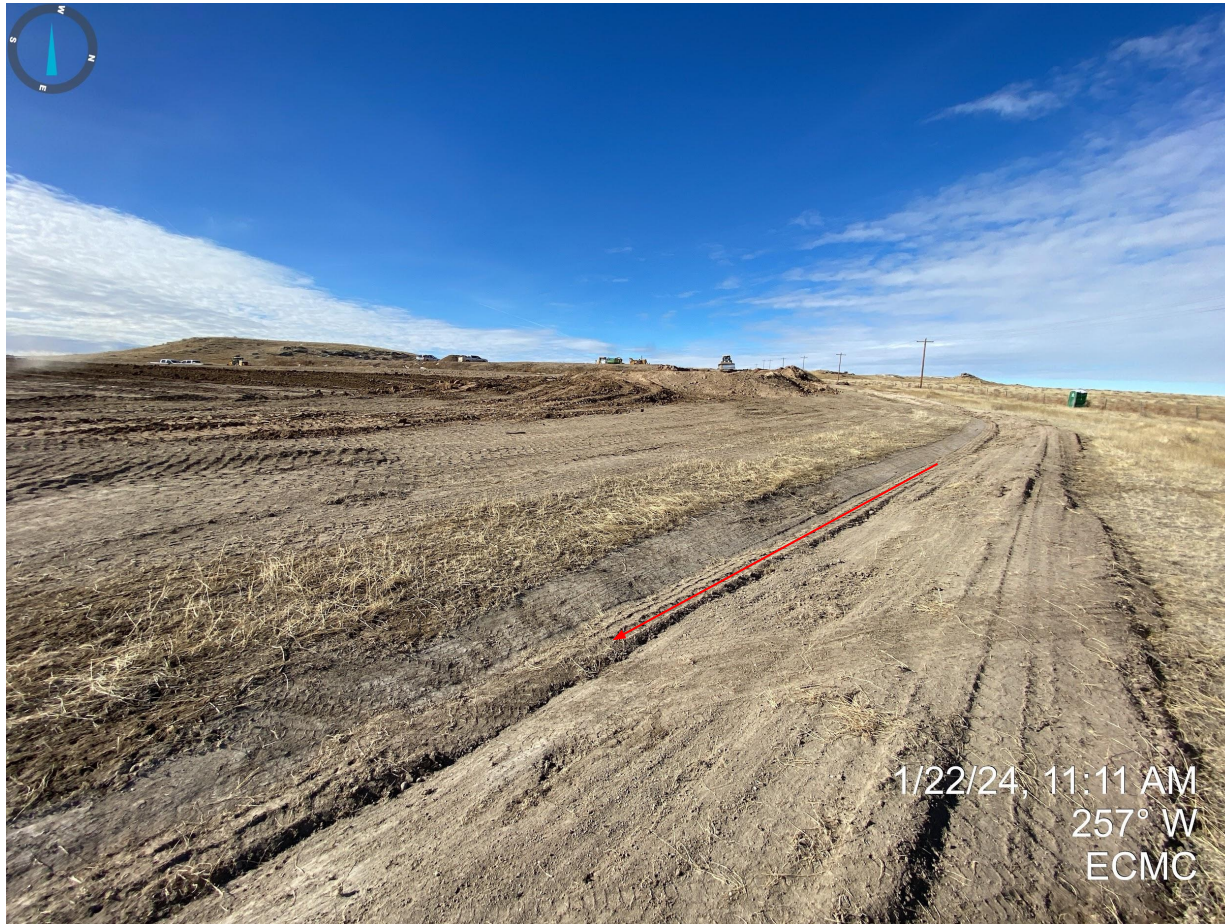
**Photo 3.** Northeastern portion of the construction area. Stormwater ditch has been installed around the perimeter of the disturbance area.

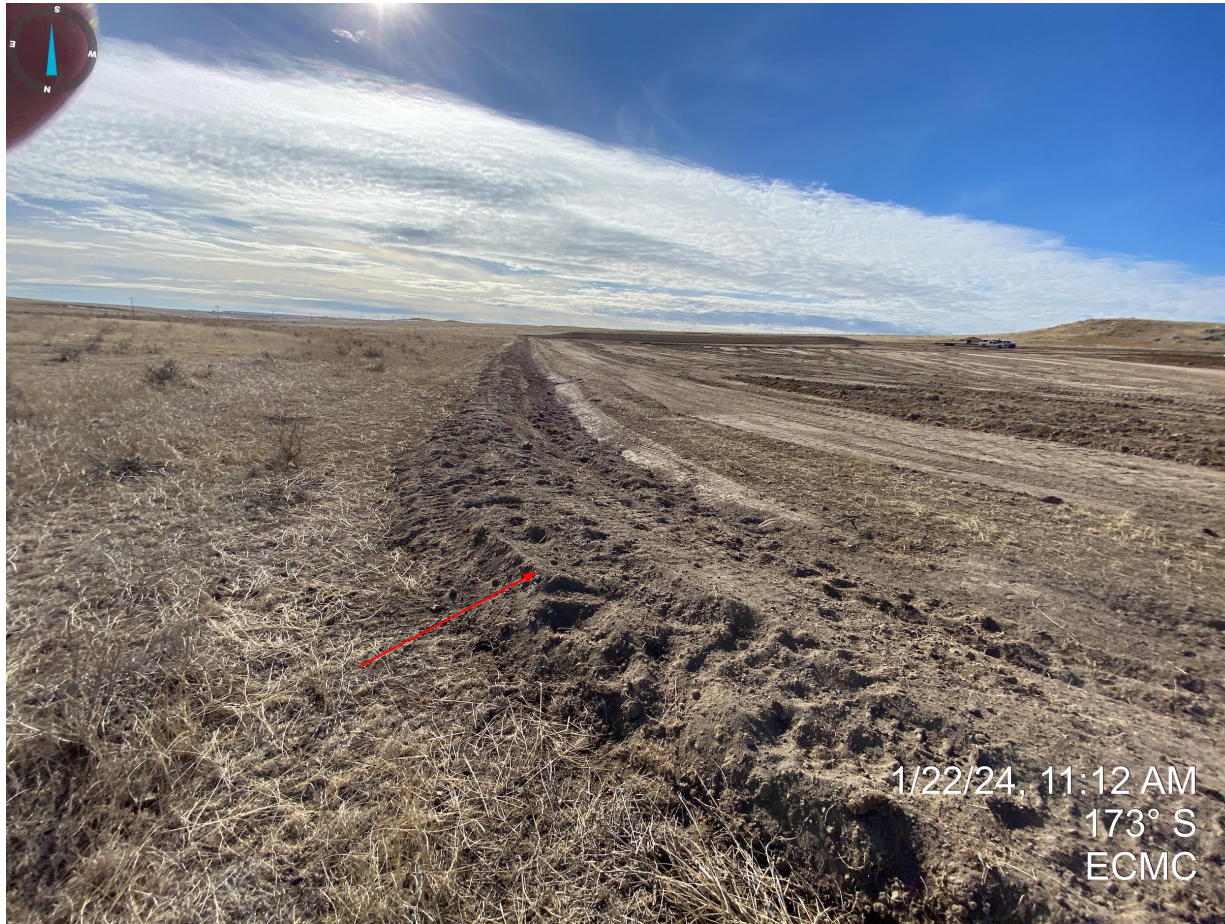
**Photo 4.** Northeastern portion of the construction area. Perimeter berm material is unconsolidated and requires BMPs to stabilize the soils. At the time of this inspection, Staff observed a road grader wheel packing the berm on the western side of the location; the Operator shall ensure all soils are adequately stabilized.

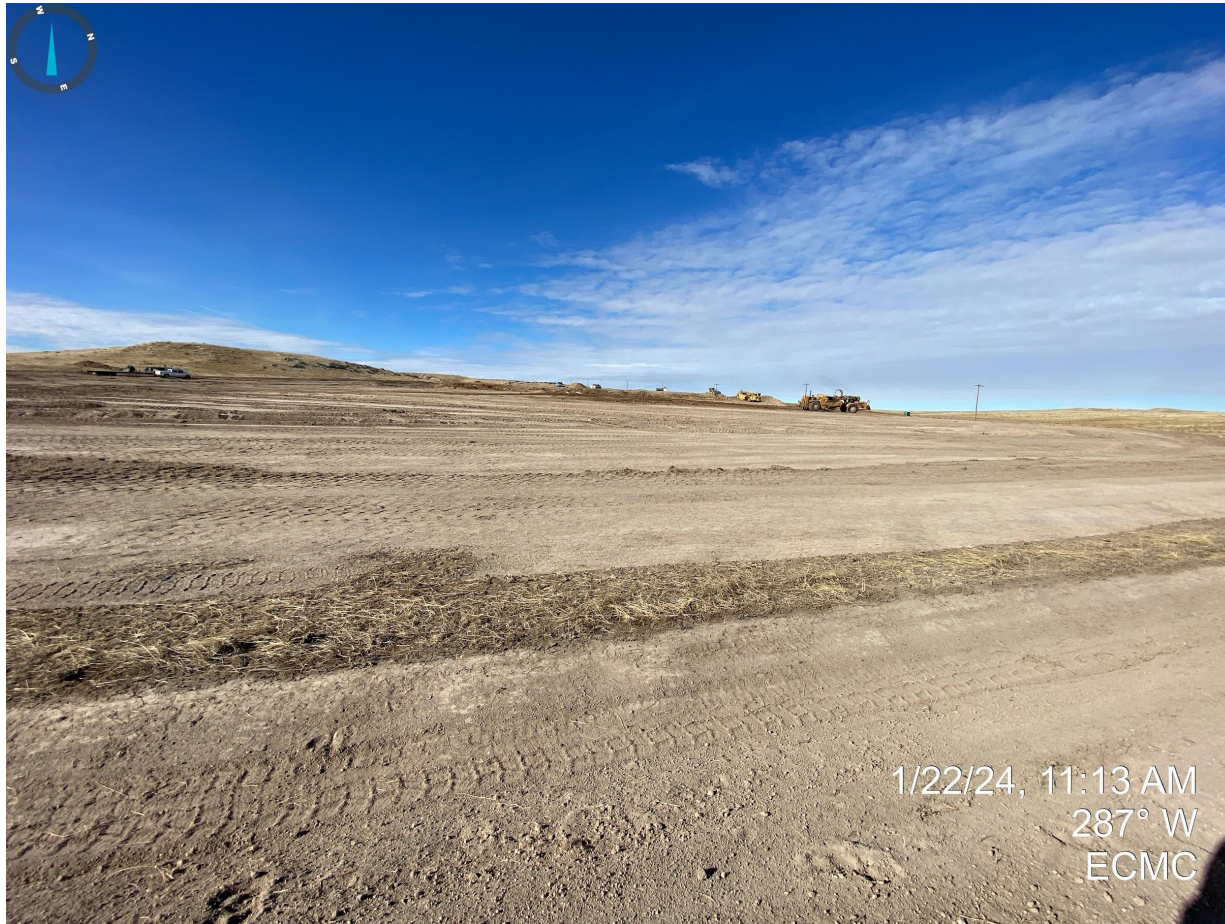
**Photo 5.** Taken from the east side of the location. Photo depicts topsoil salvage area.

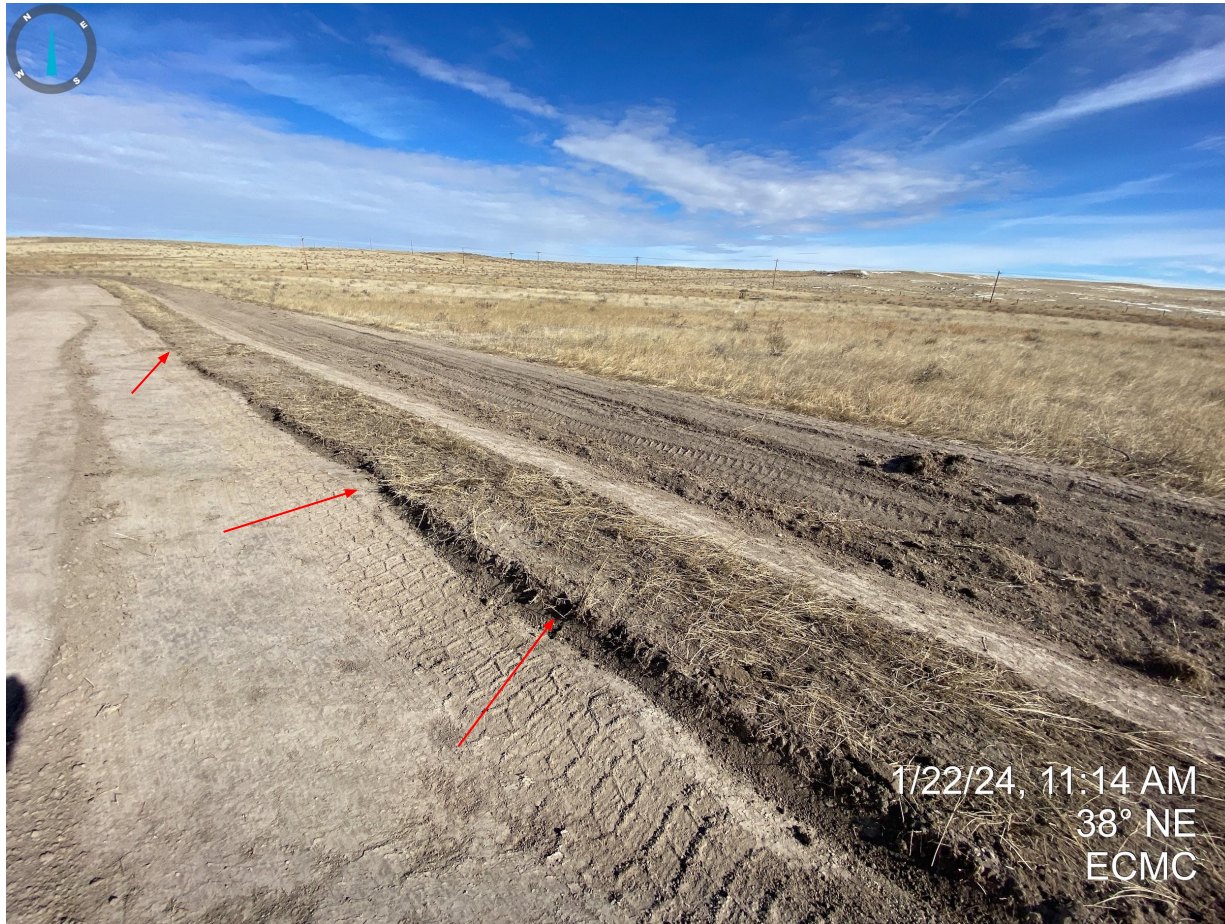
**Photo 6.** Taken from the east side of the location. Photo illustrates cut from topsoil salvage operations; the visible cut of the undisturbed topsoil vs the salvage area varied in depths of 3-6”.

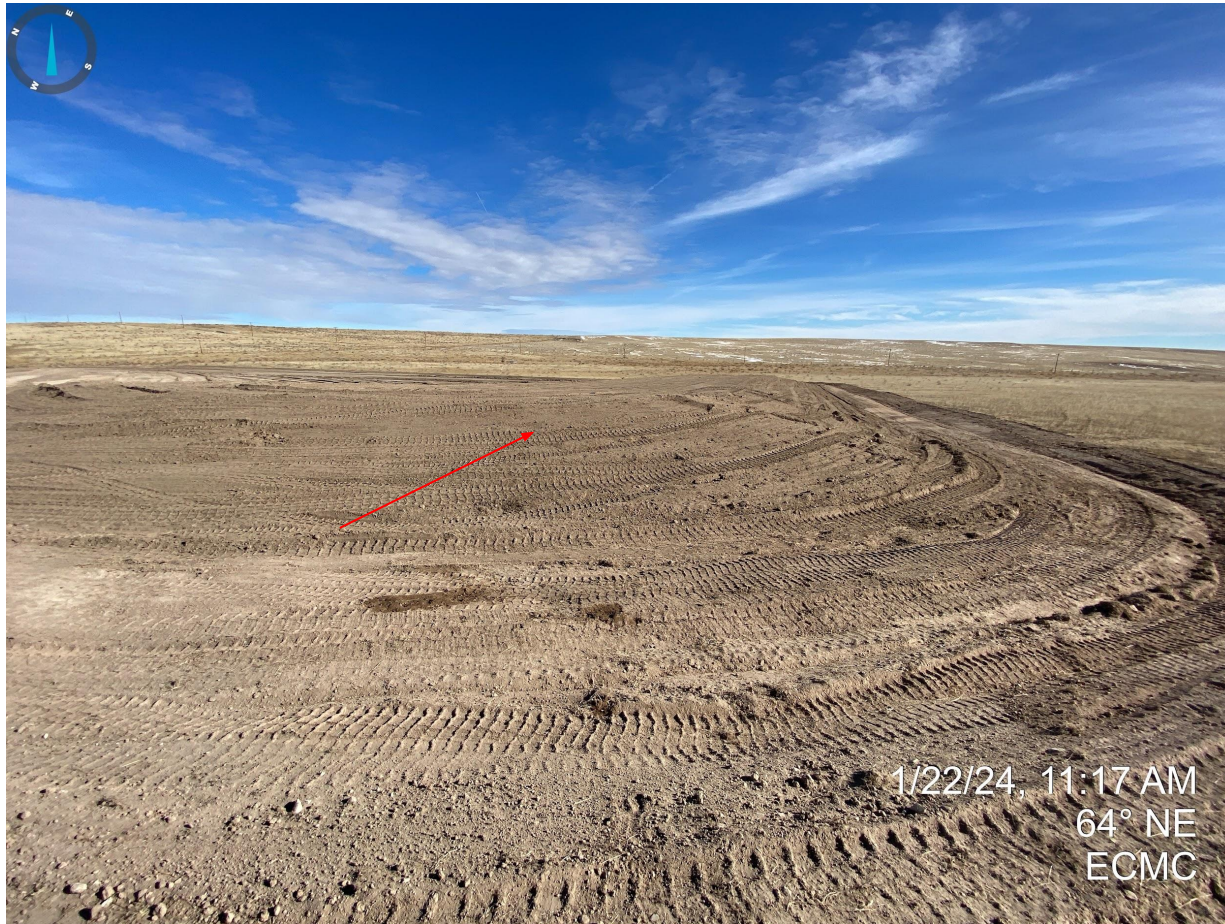
**Photo 7.** Taken from the western side of the topsoil stockpile. Staff estimates the topsoil stockpile is approximately 4,000 CY, which differs from the Operator submitted Topsoil Protection Plan estimates of 5,557 CY. Additionally, the topsoil stockpile requires temporary stabilization (e.g. equipment tracking, tackifiers, etc) to protect soils; construction activities were ongoing at the time of this inspection.

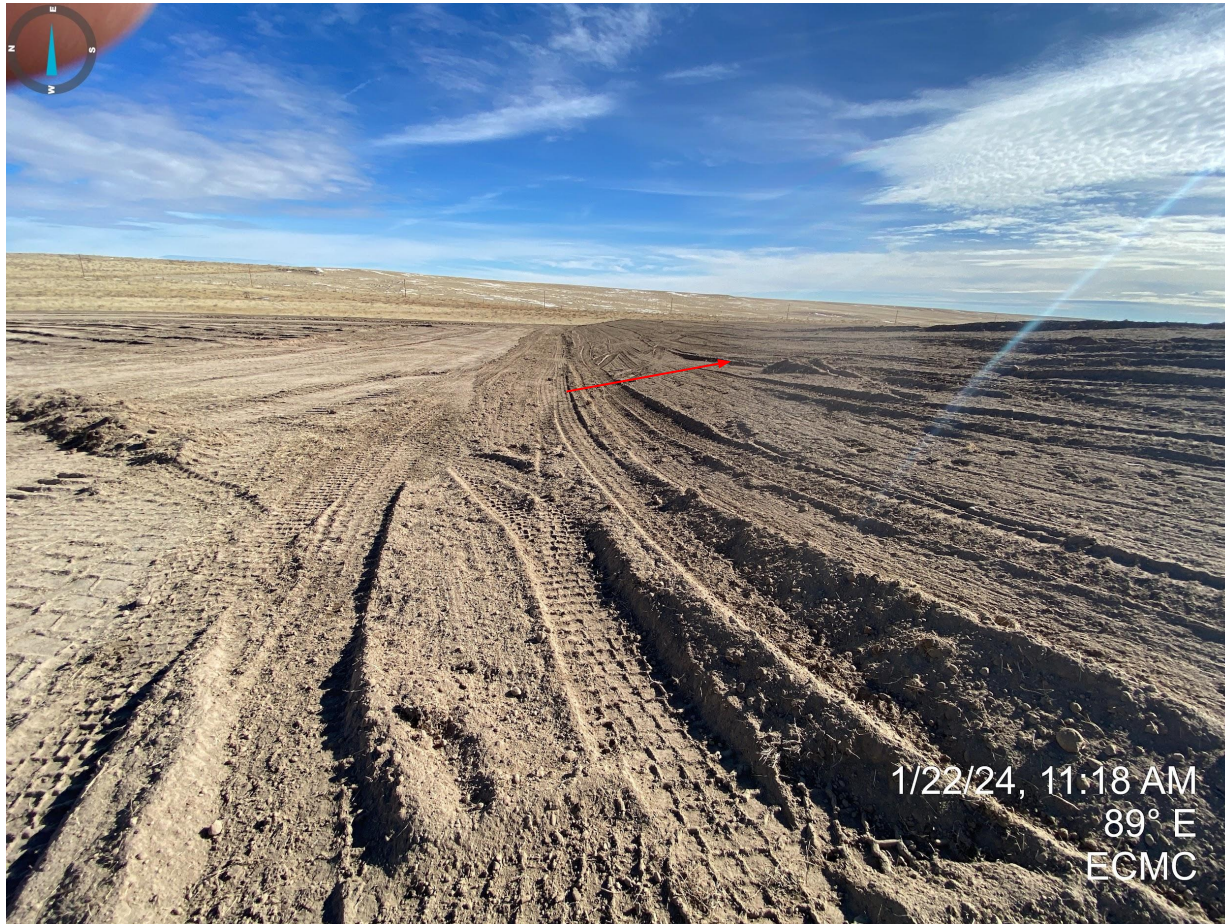
**Photo 8.** Northwest corner of stockpile; see comments in Photo 6.

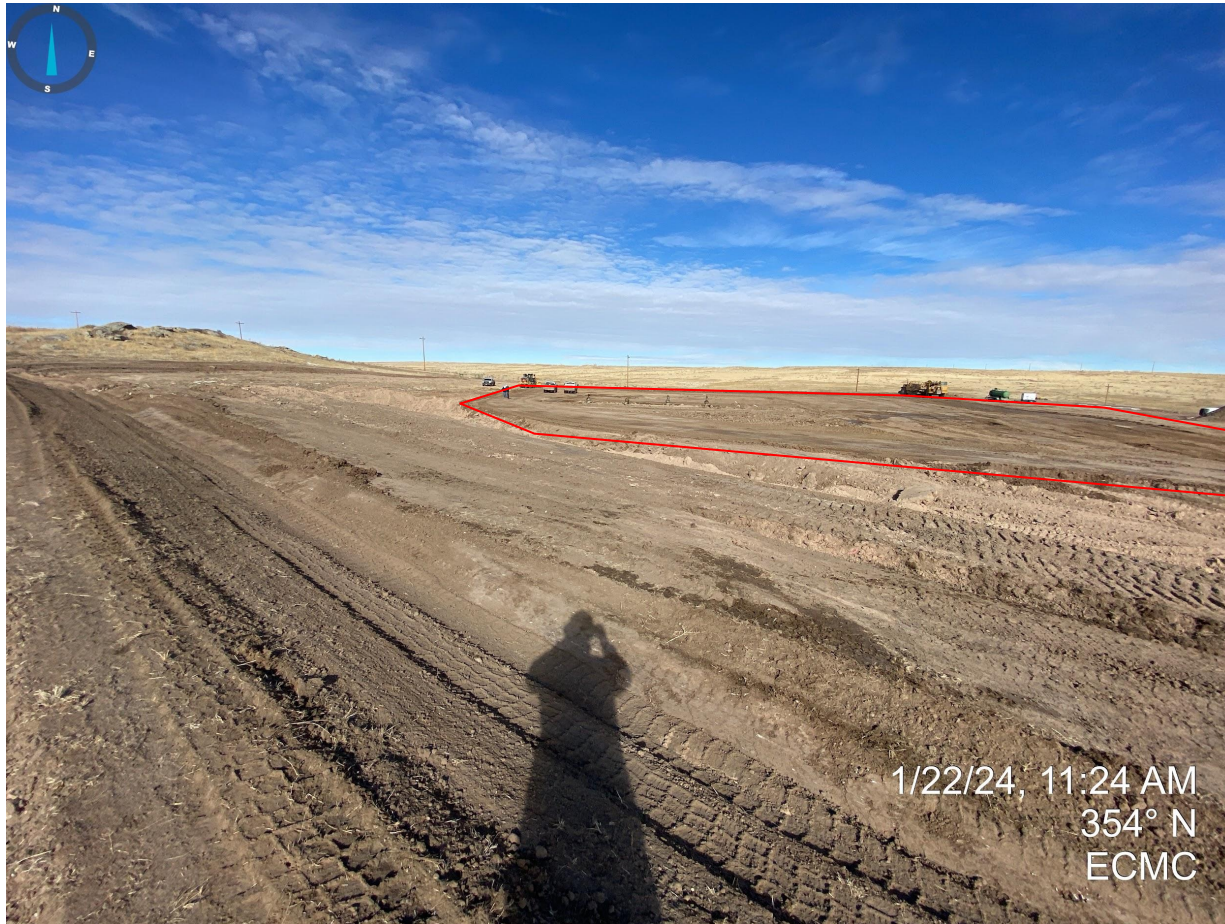
**Photo 9.** Taken from the southern portion of the location, overlooking the original disturbance area (red outline) and the new disturbance area.

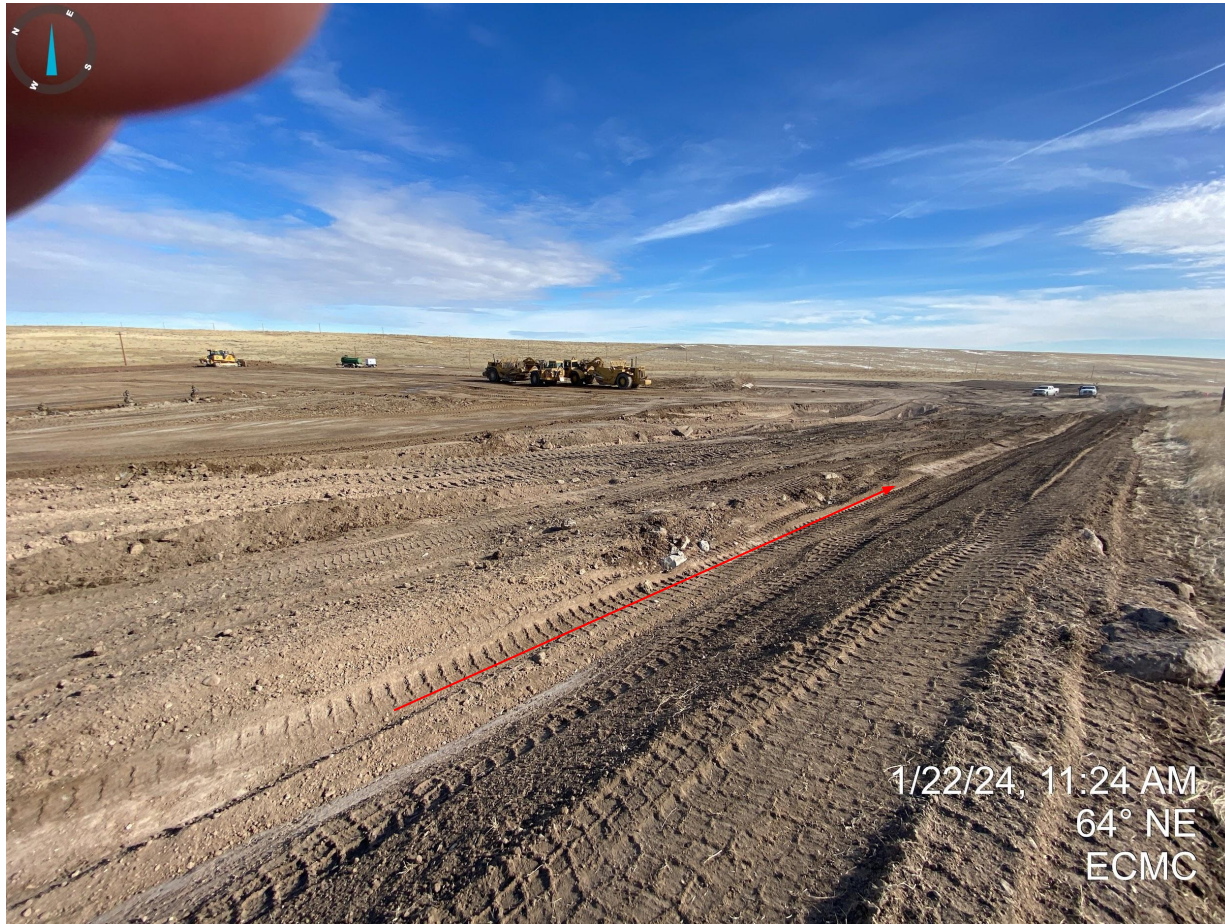
**Photo 10.** Taken near the southwest corner of the location. Photo illustrates perimeter ditch and berm.

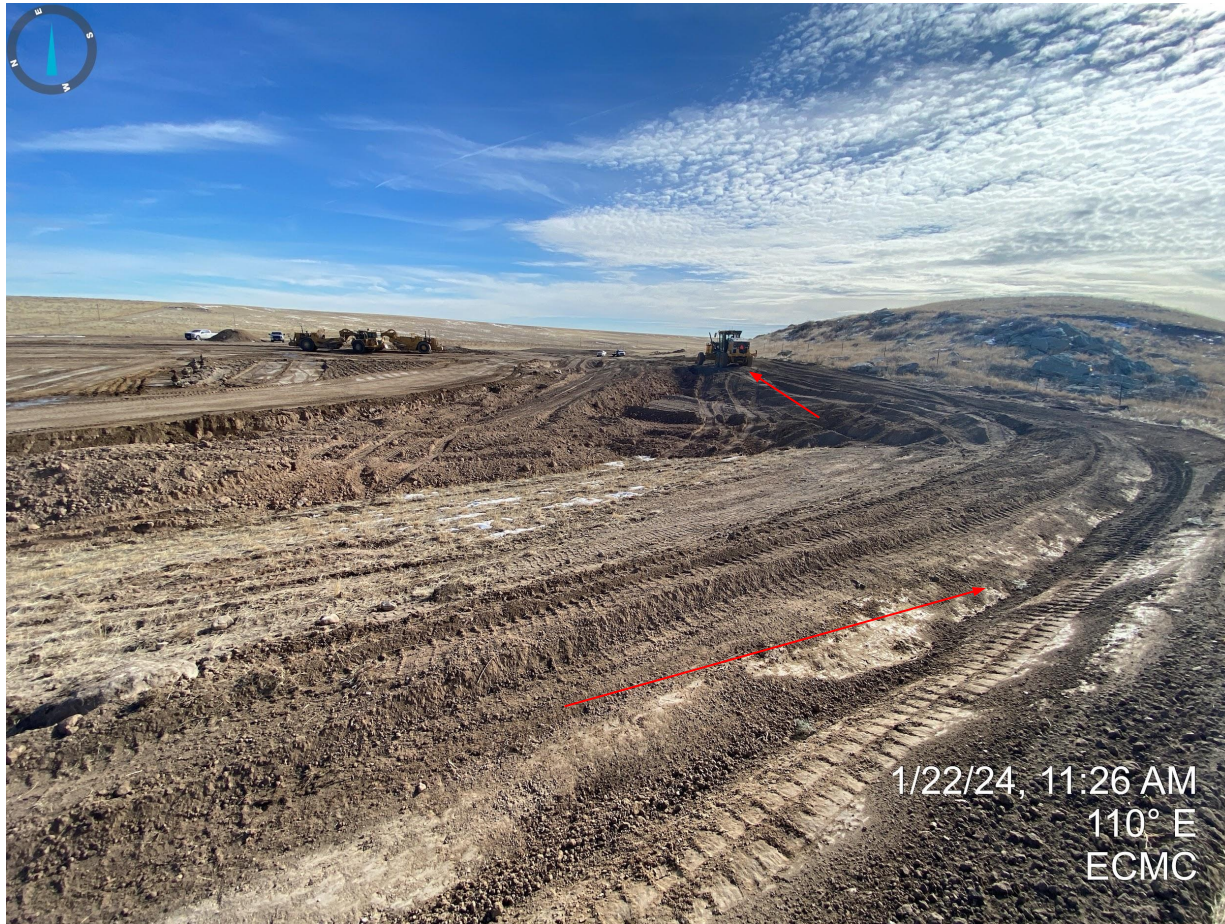
**Photo 11.** Taken from the western portion of the location. Photo illustrates crew using road grader to compact/wheel pack the perimeter ditch and berm BMPs.
