Inspection Photos

Location: Riverton 14-21 and Riverton 14-21 TR

Facility ID: 333395

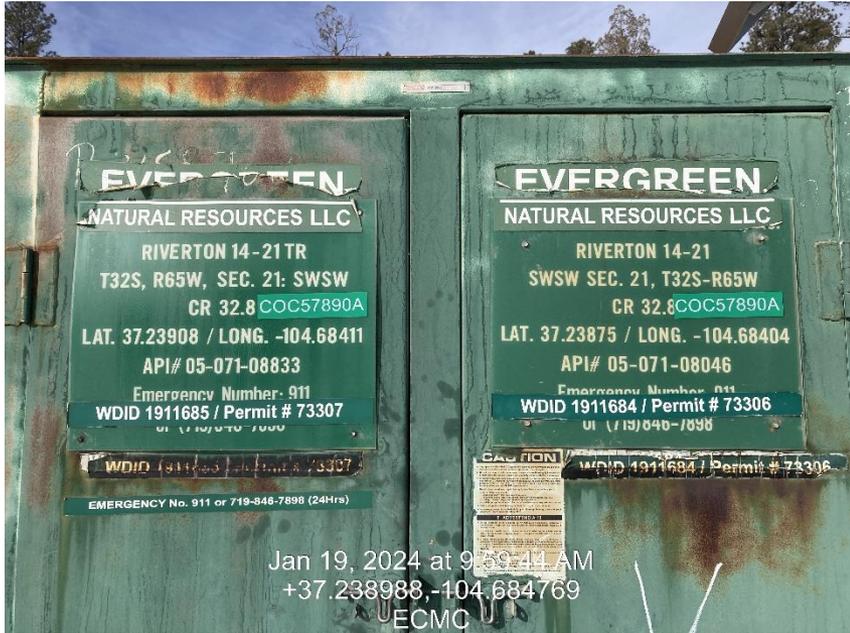
Photo 1 –Well Site Placard

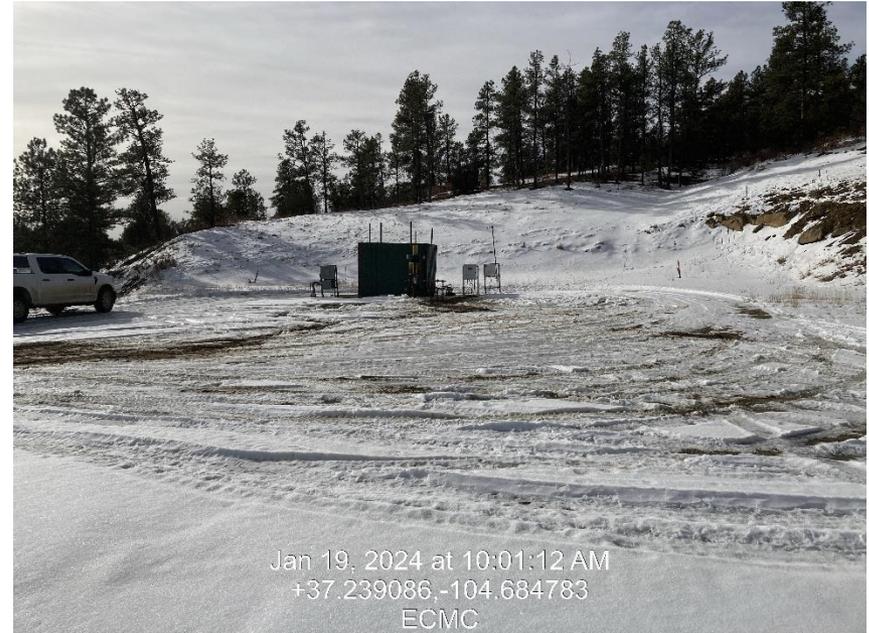
Photo 2 – Well location looking south

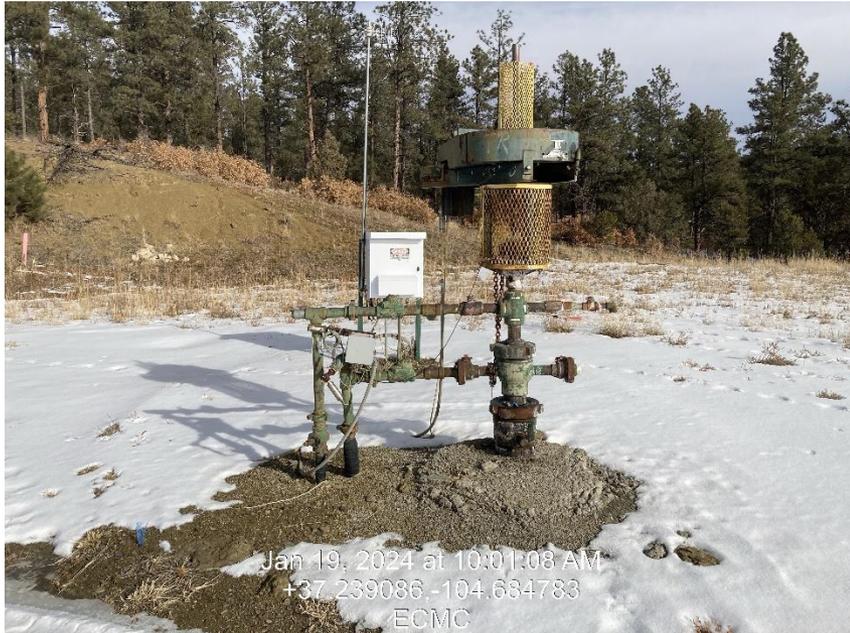
Photo 3 – TR Well location looking North

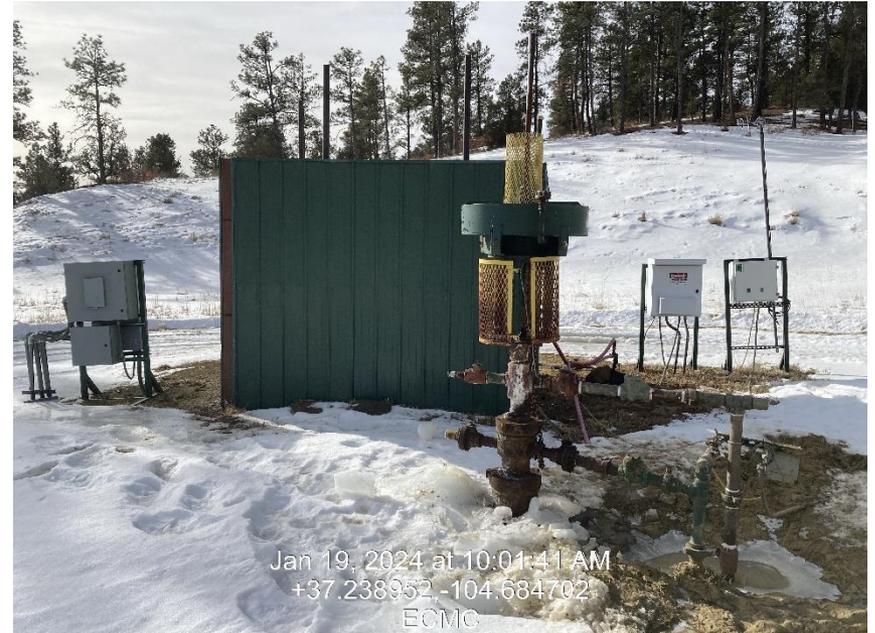
Photo 4 – KV Wellhead looking south

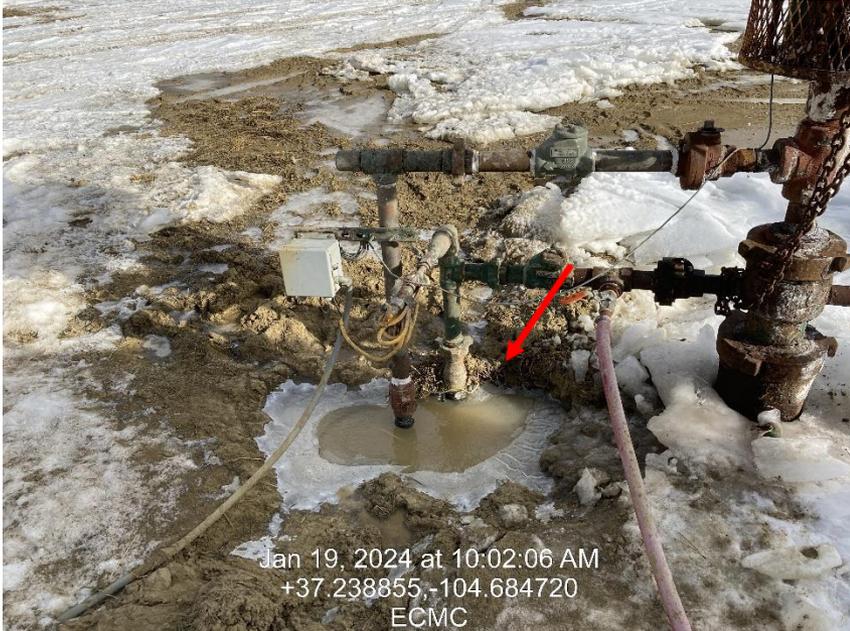
Photo 5 – Spill Start

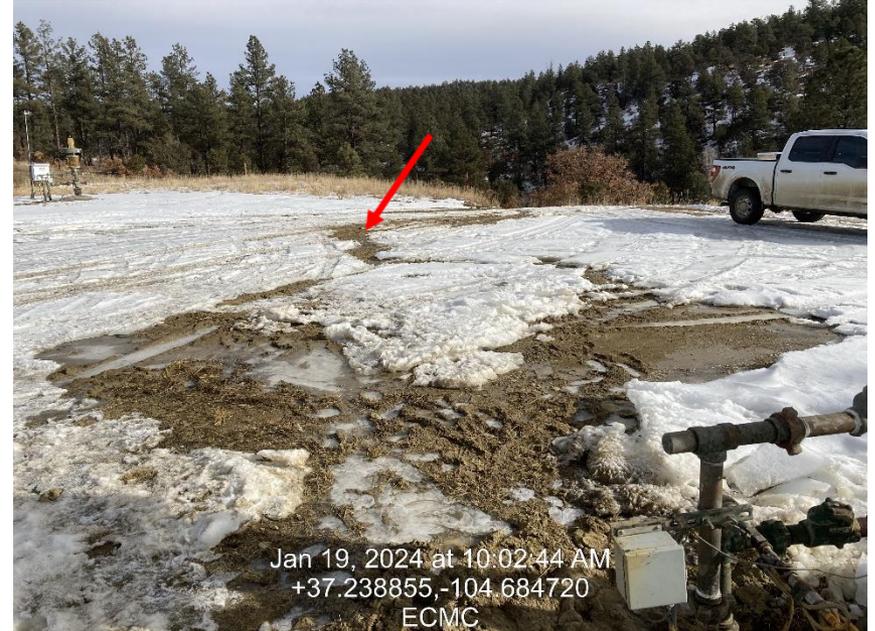
Photo 6 – Spill path looking Northeast

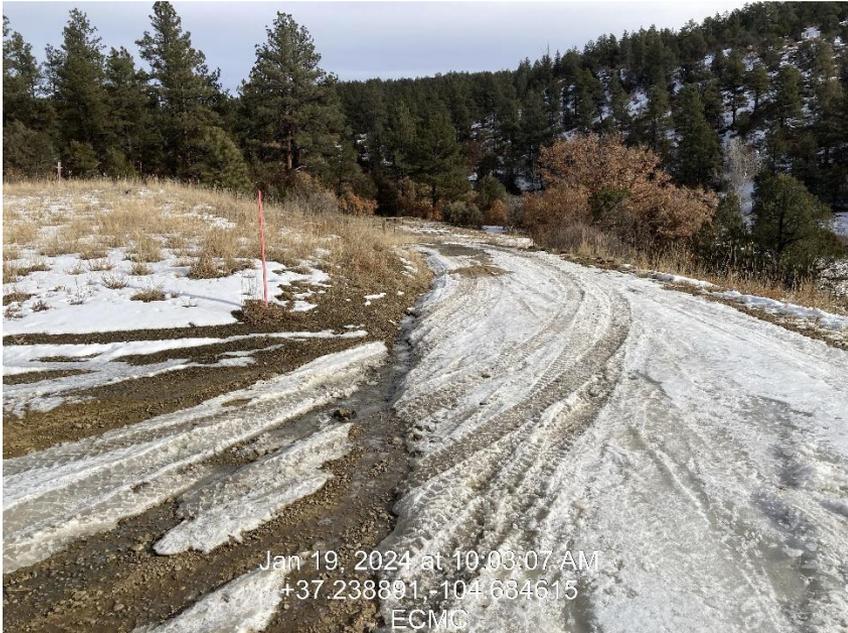
Photo 7 – Point along spill path

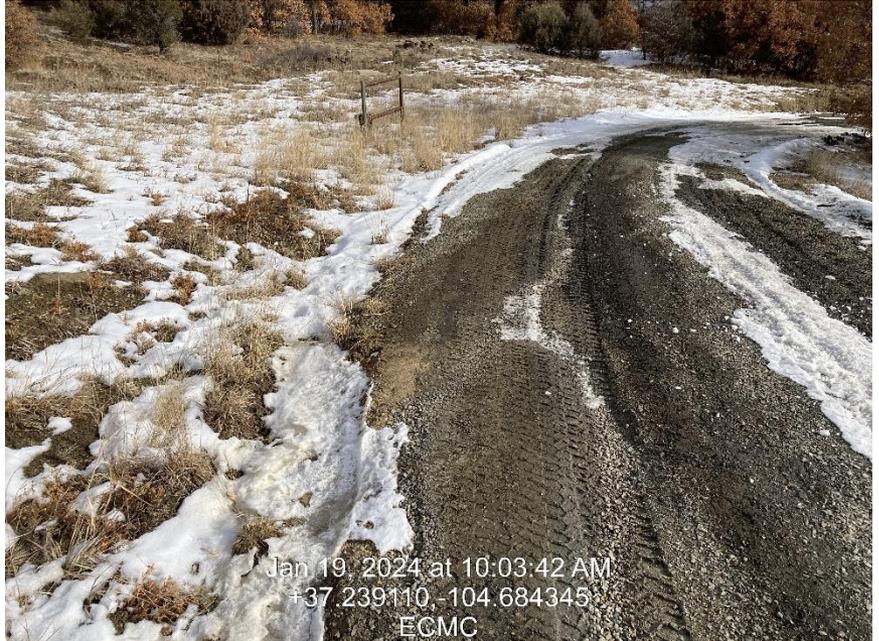
Photo 8 – Looking to spill endpoint

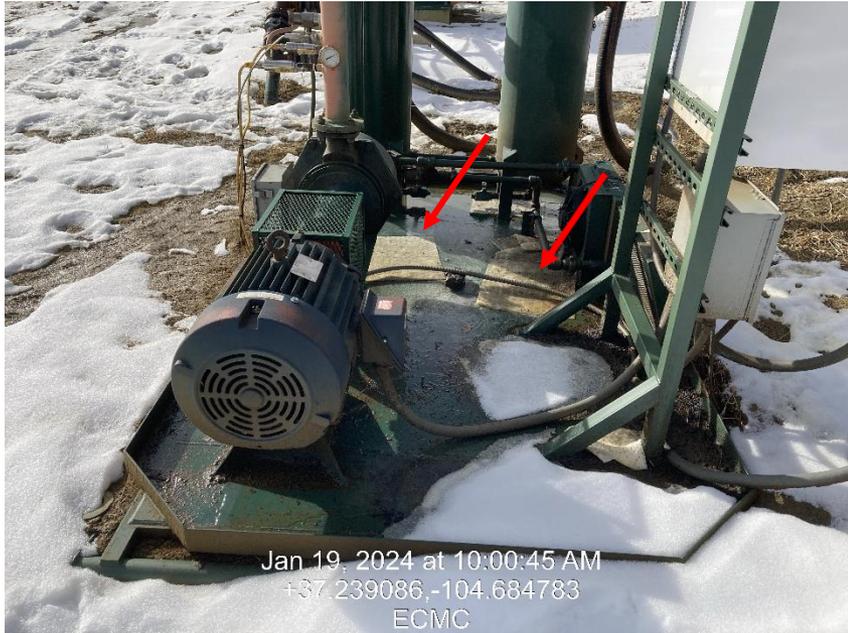
Photo 9 – Electric Compressor with oil diapers in skid pan.
