Construction and Stormwater Inspection

Date: 01/22/2024

**Energy & Carbon Management
Commission**

Inspection Photos
Location Name: Wade 8-59 17 Pad
Location ID: 484554

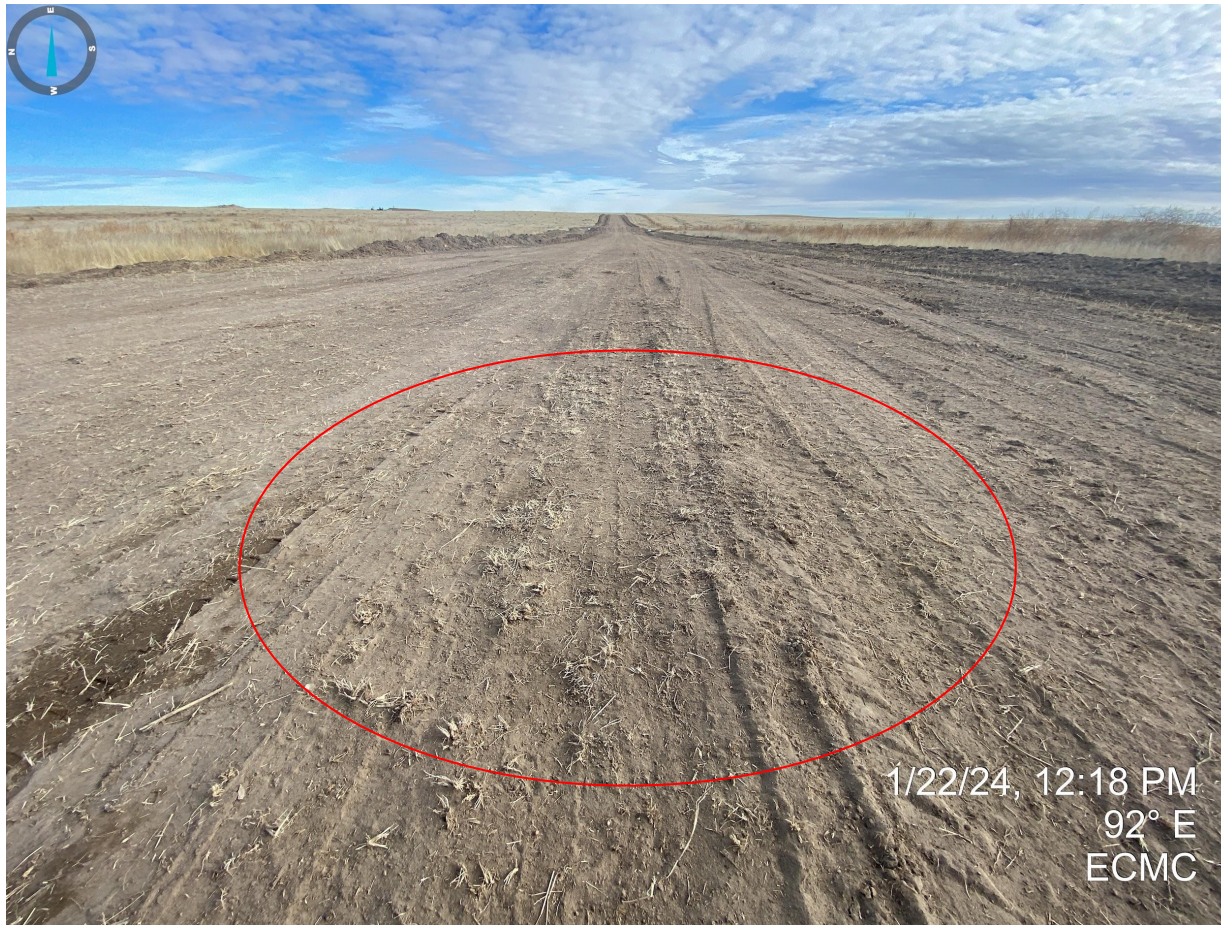
Photo 1. Taken from the location entrance, west side of the new access road. It doesn't appear that all topsoil has been salvaged from the access road with the presence of organic matter seen in the photo.

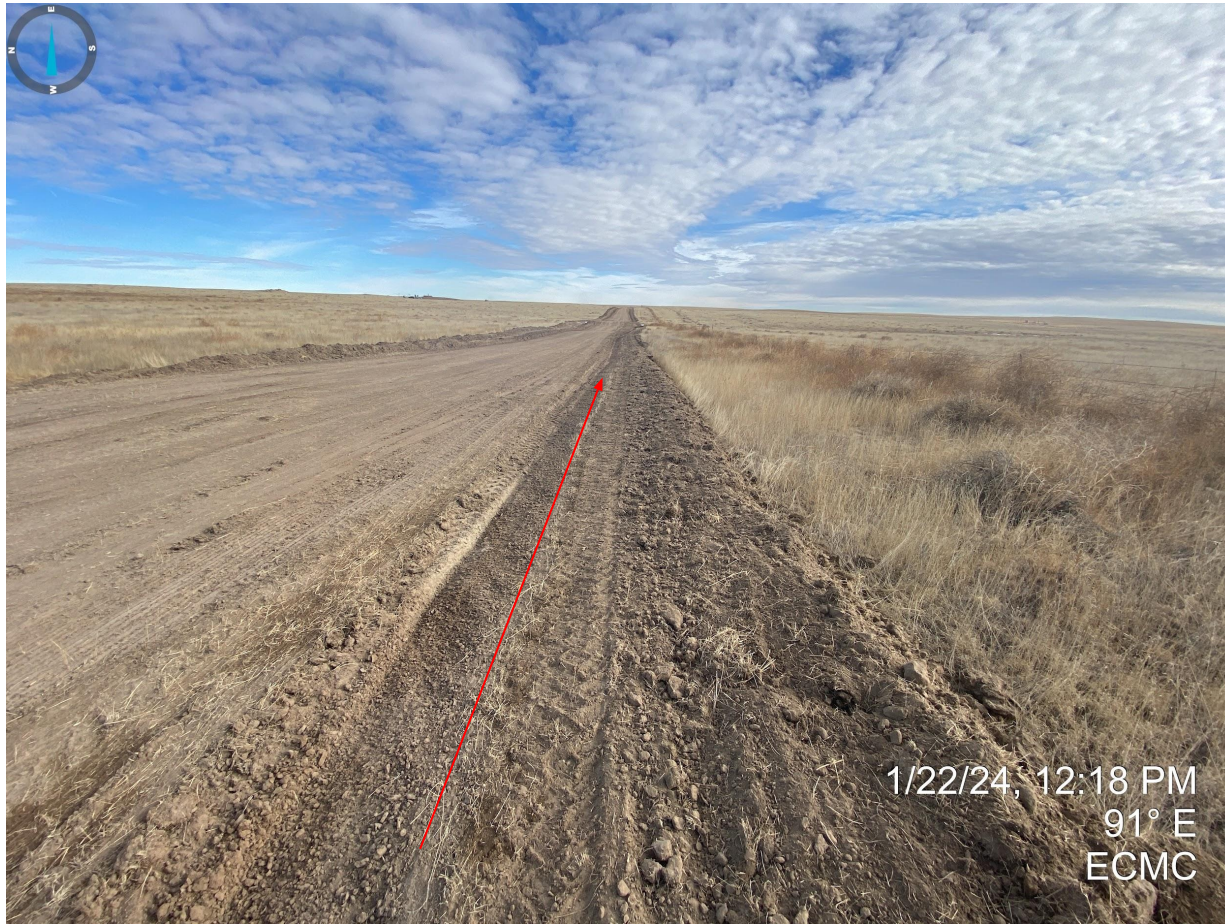
Photo 2. Taken from the western portion of the access road, near the entrance. A ditch and berm has been constructed, however the berm material is not consolidated and requires additional BMPs to protect from wind and water erosion.

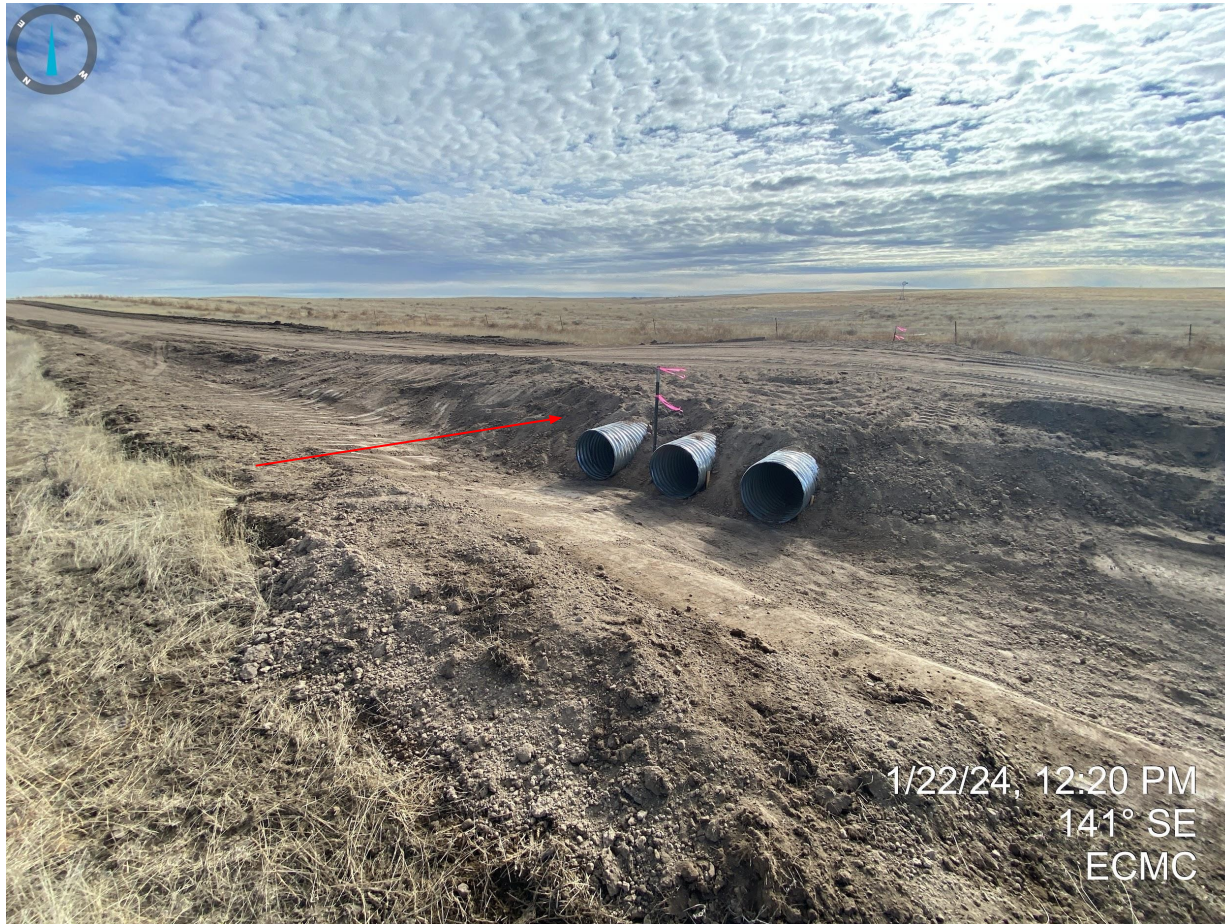
Photo 3. Taken from the access road. It appears that topsoil has been used as fill material at one of the culvert crossings. Stormwater BMPs are still in process as construction activities are ongoing.

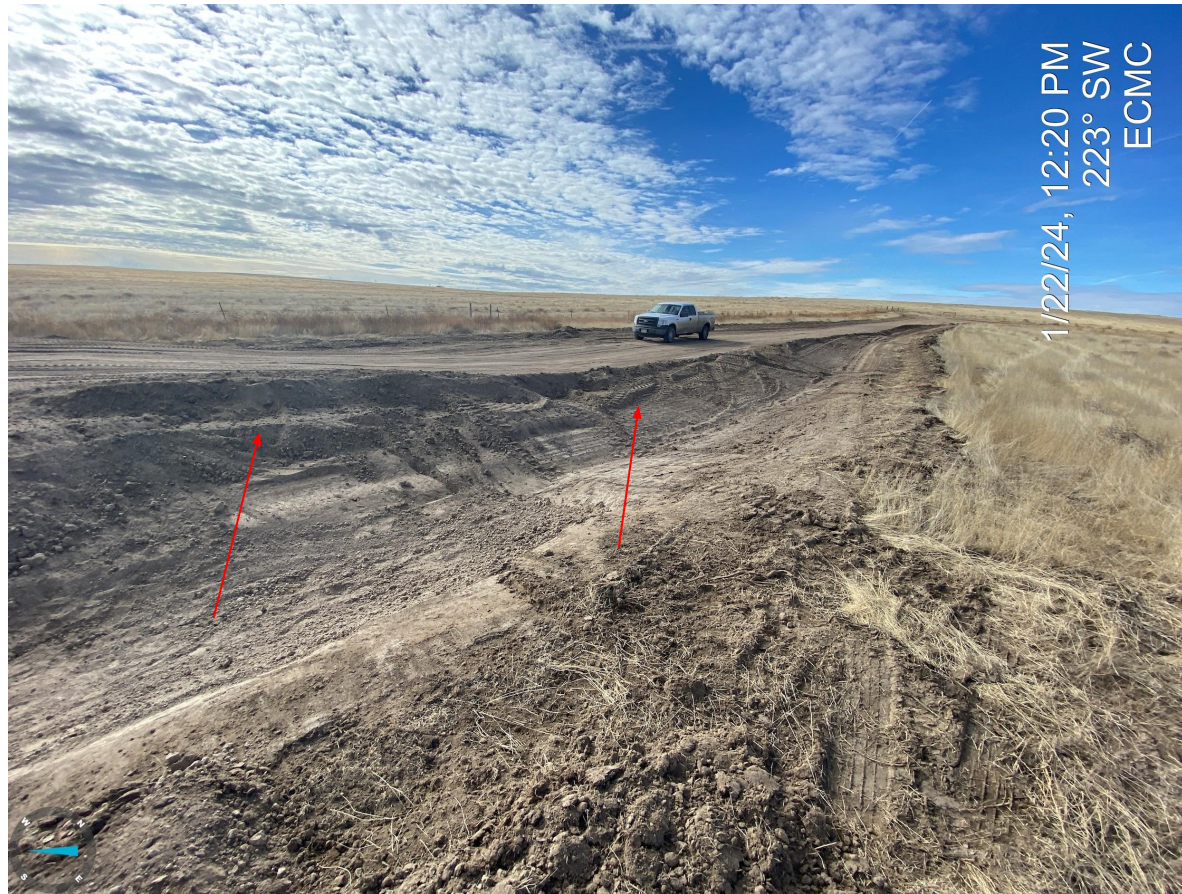
Photo 4. Taken at the western culvert crossing. It appears that topsoil has been used as fill material at one of the culvert crossings.

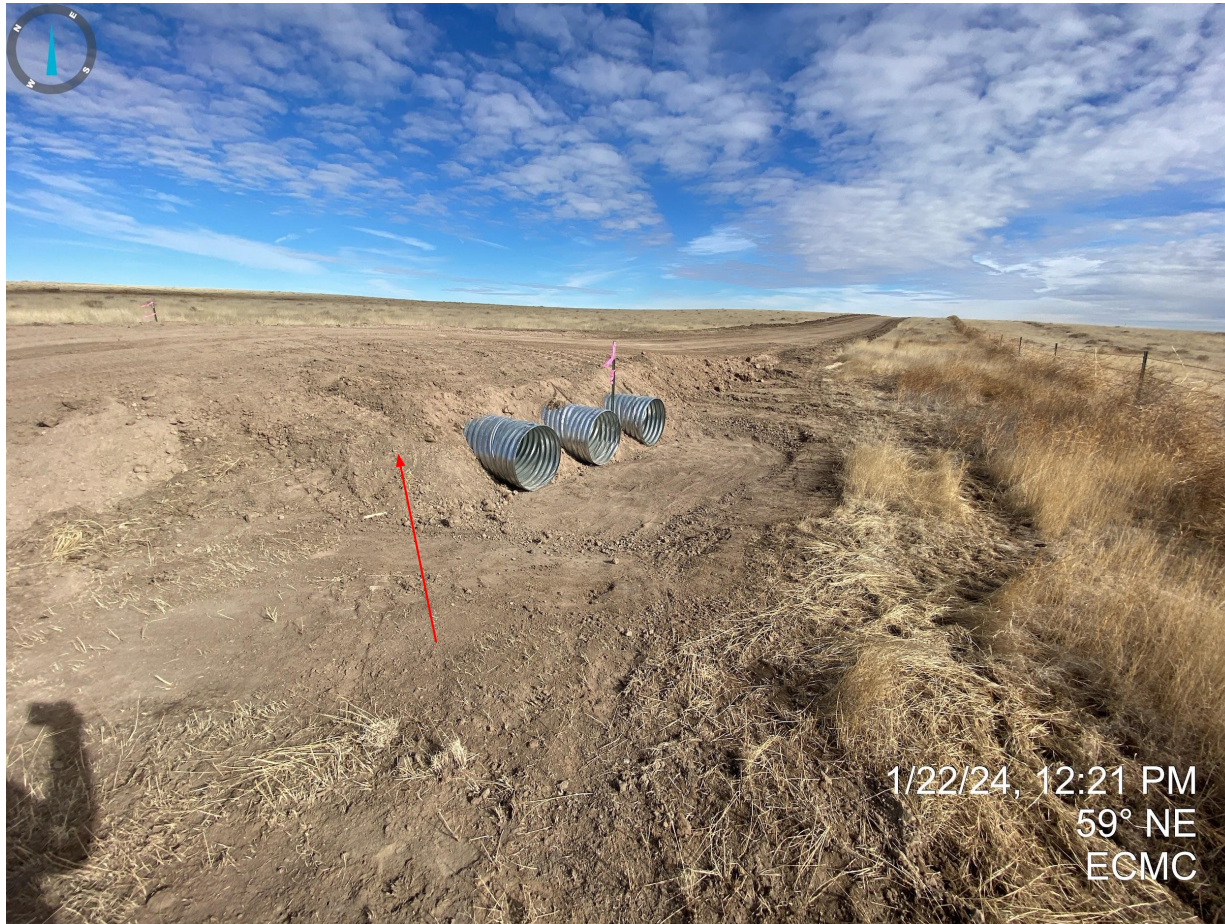
Photo 5. Taken at the western culvert crossing. It appears that topsoil has been used as fill material at one of the culvert crossings.

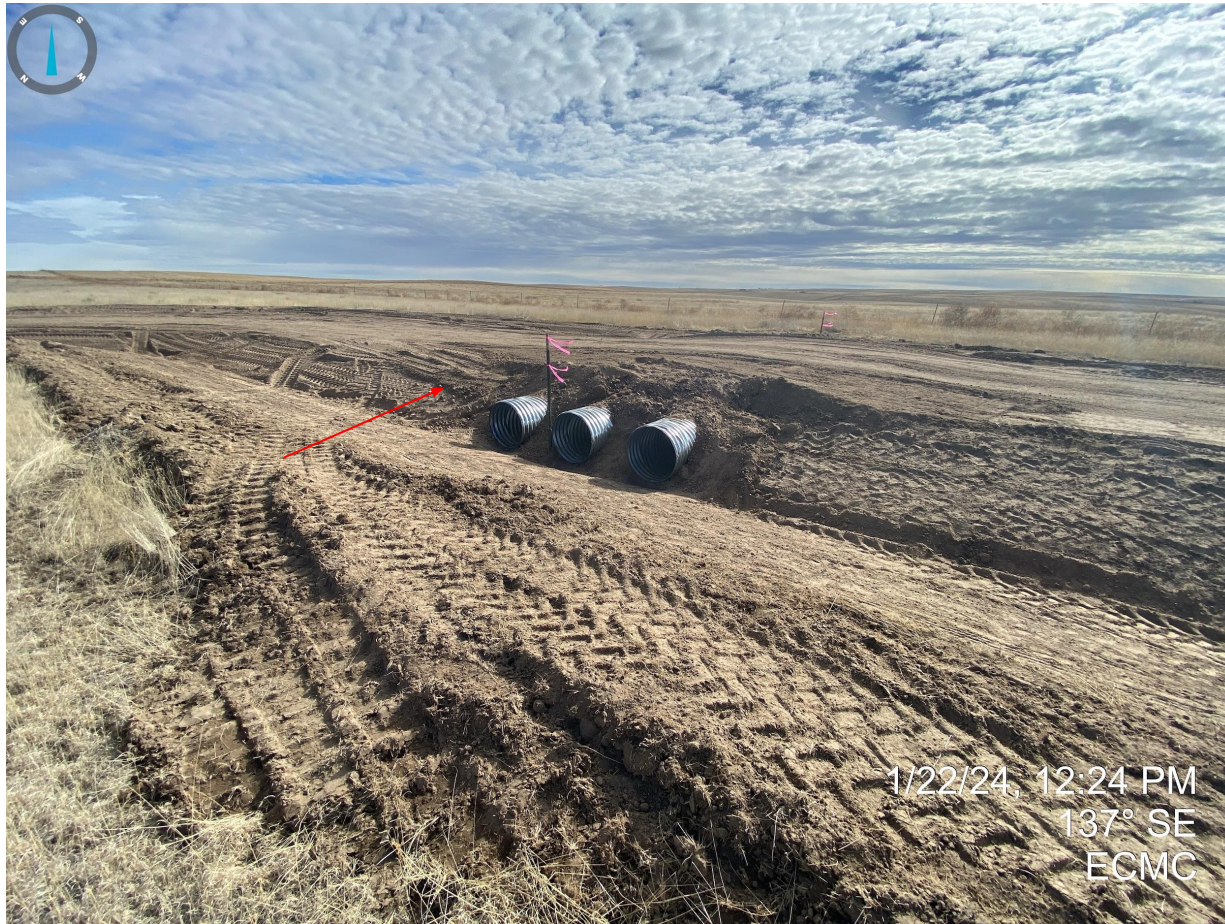
Photo 6. Taken at the eastern culvert crossing. It appears that topsoil has been used as fill material at one of the culvert crossings. Stormwater BMPs are still in process as construction activities are ongoing.

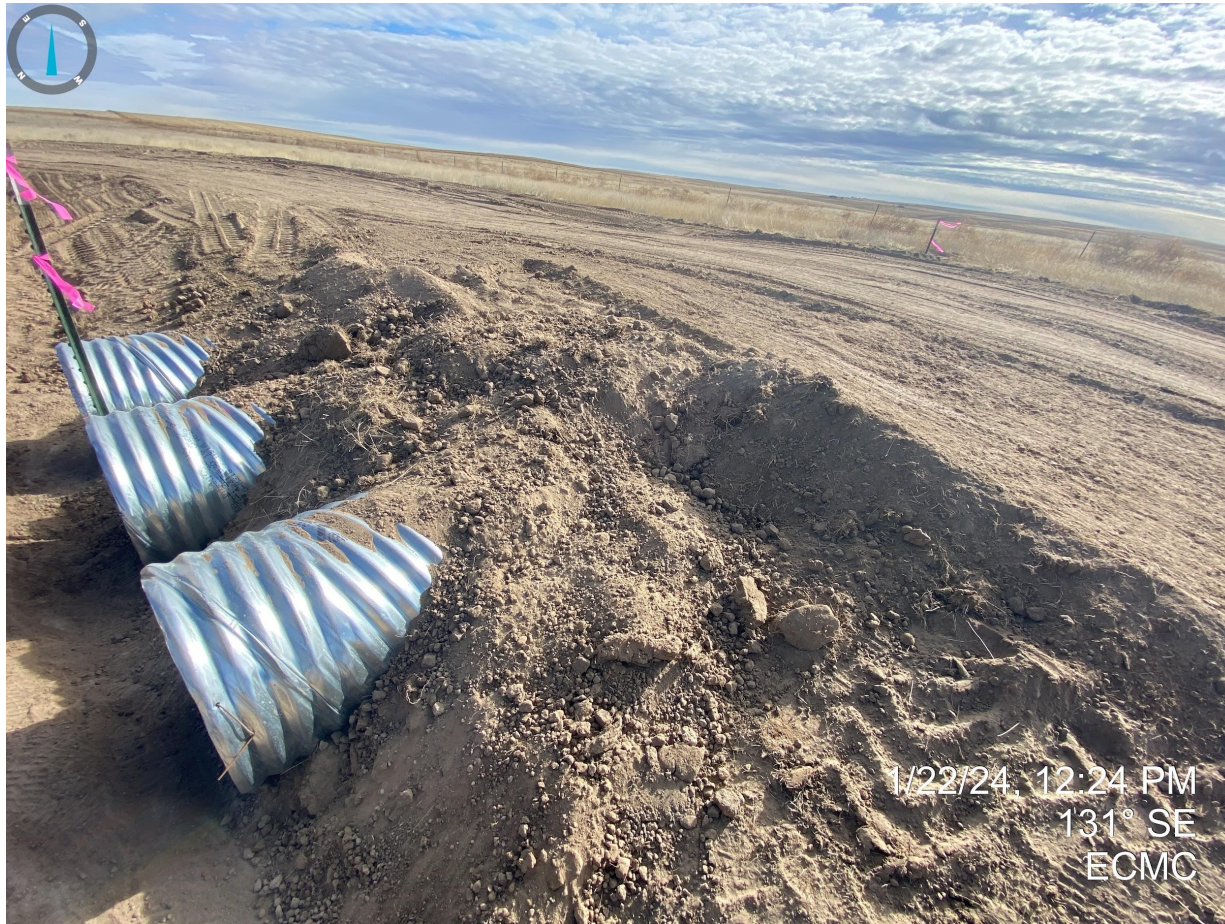
Photo 7. Taken at the eastern culvert crossing. It appears that topsoil has been used as fill material at one of the culvert crossings.

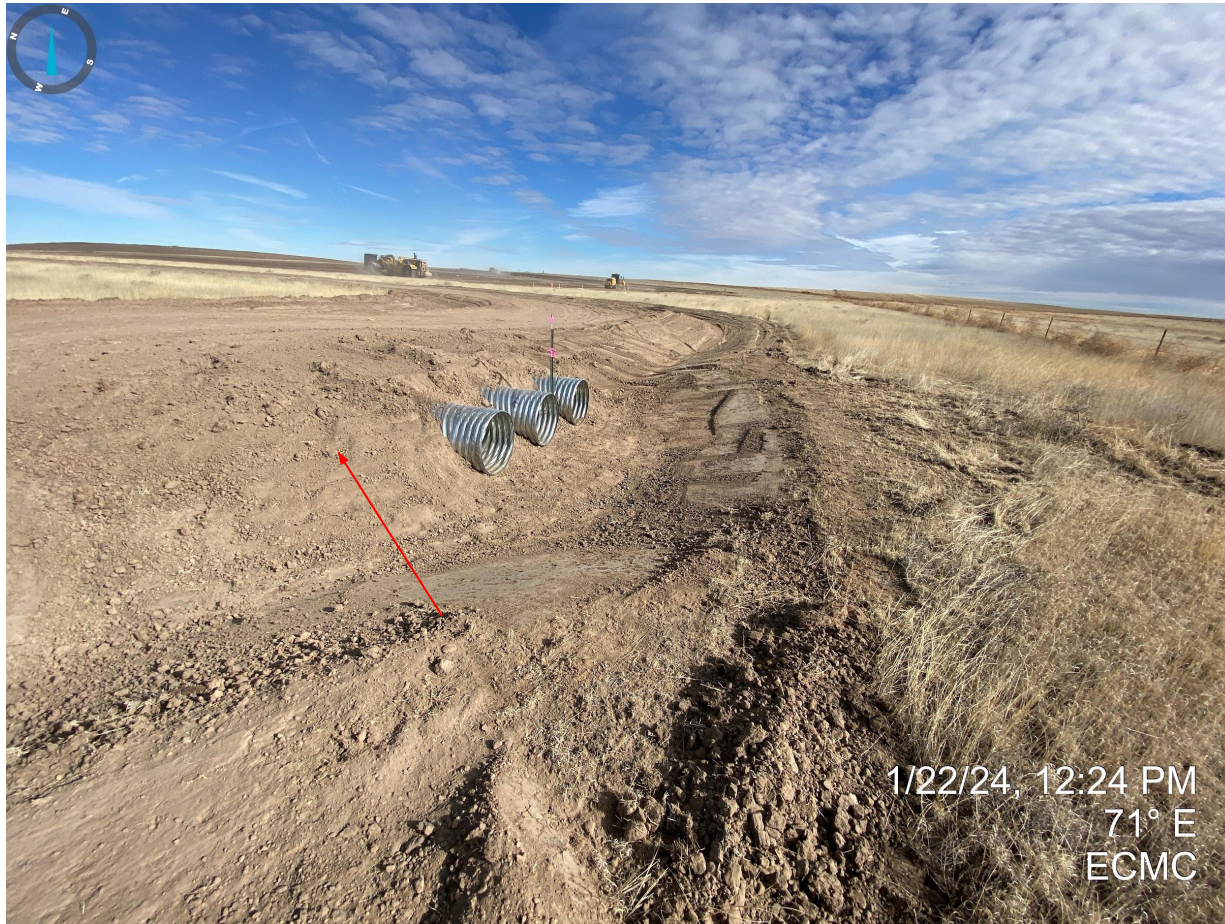
Photo 8. Taken at the eastern culvert crossing. It appears that topsoil has been used as fill material at one of the culvert crossings. Stormwater BMPs are still in process as construction activities are ongoing.

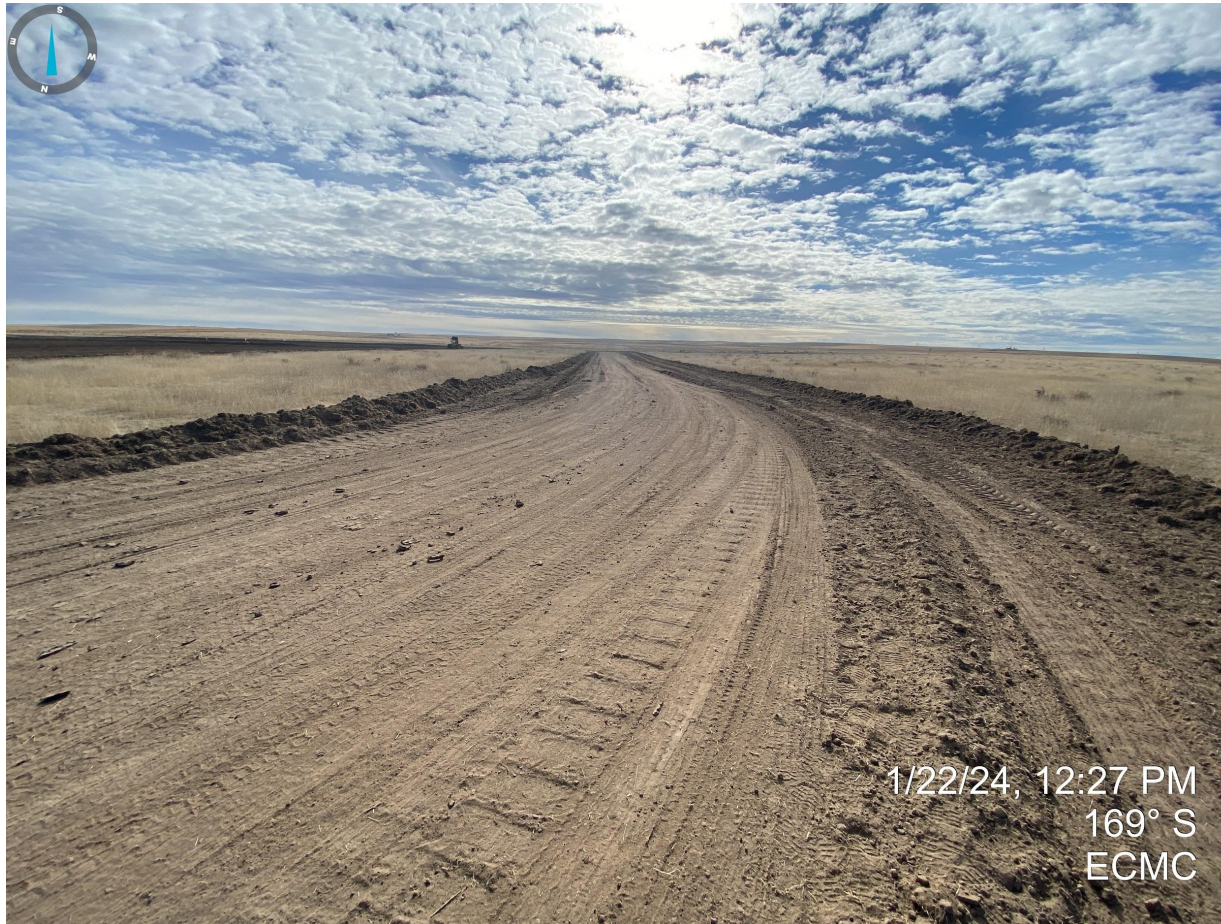
Photo 9. Taken near the location entrance, facing south along the new access road. It doesn't appear that all topsoil has been salvaged from the access road.

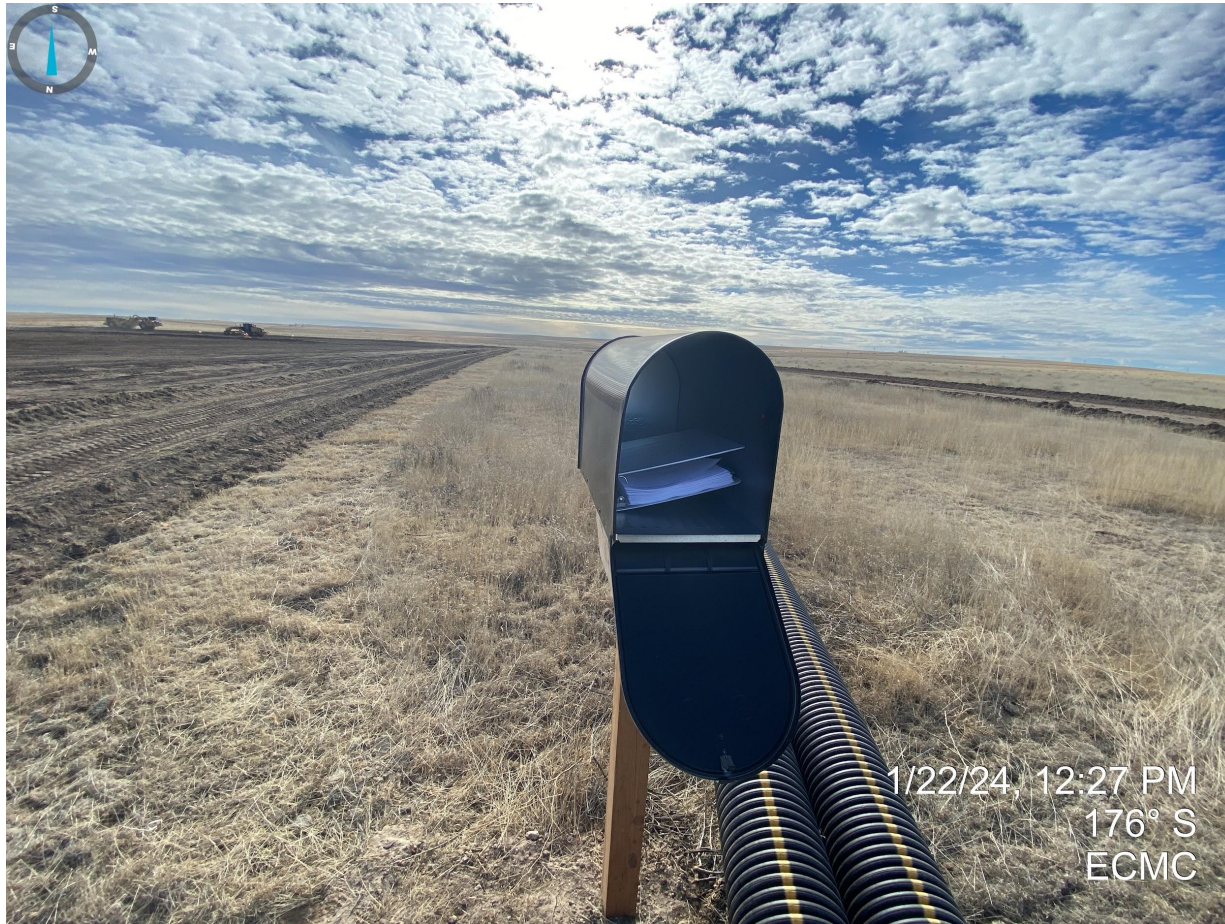
Photo 10. Form 2A posted on location.

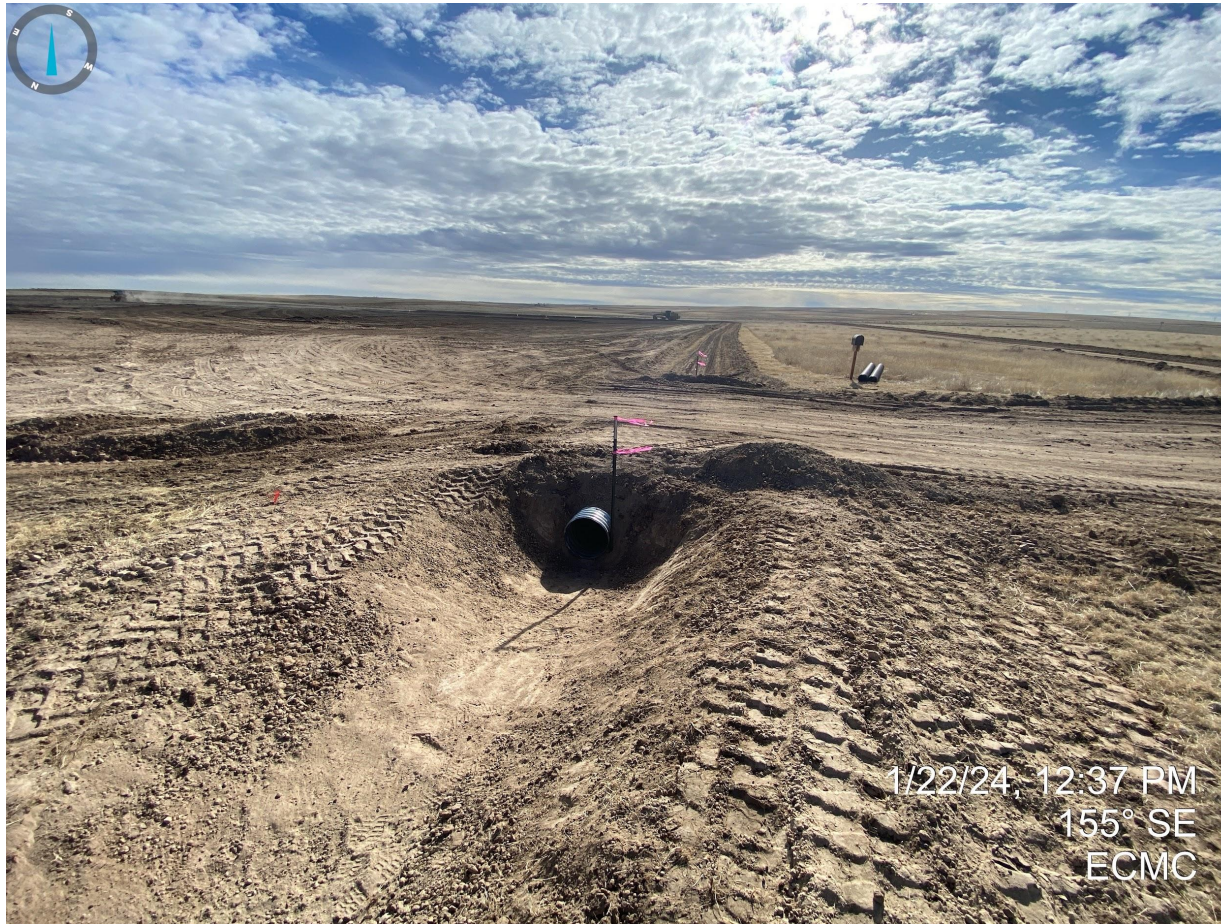
Photo 11. Taken near the location entrance. Photo illustrates that a perimeter ditch and berm has been constructed around the construction area. Some BMPs are still in-process (e.g. stabilized outlet/inlet).

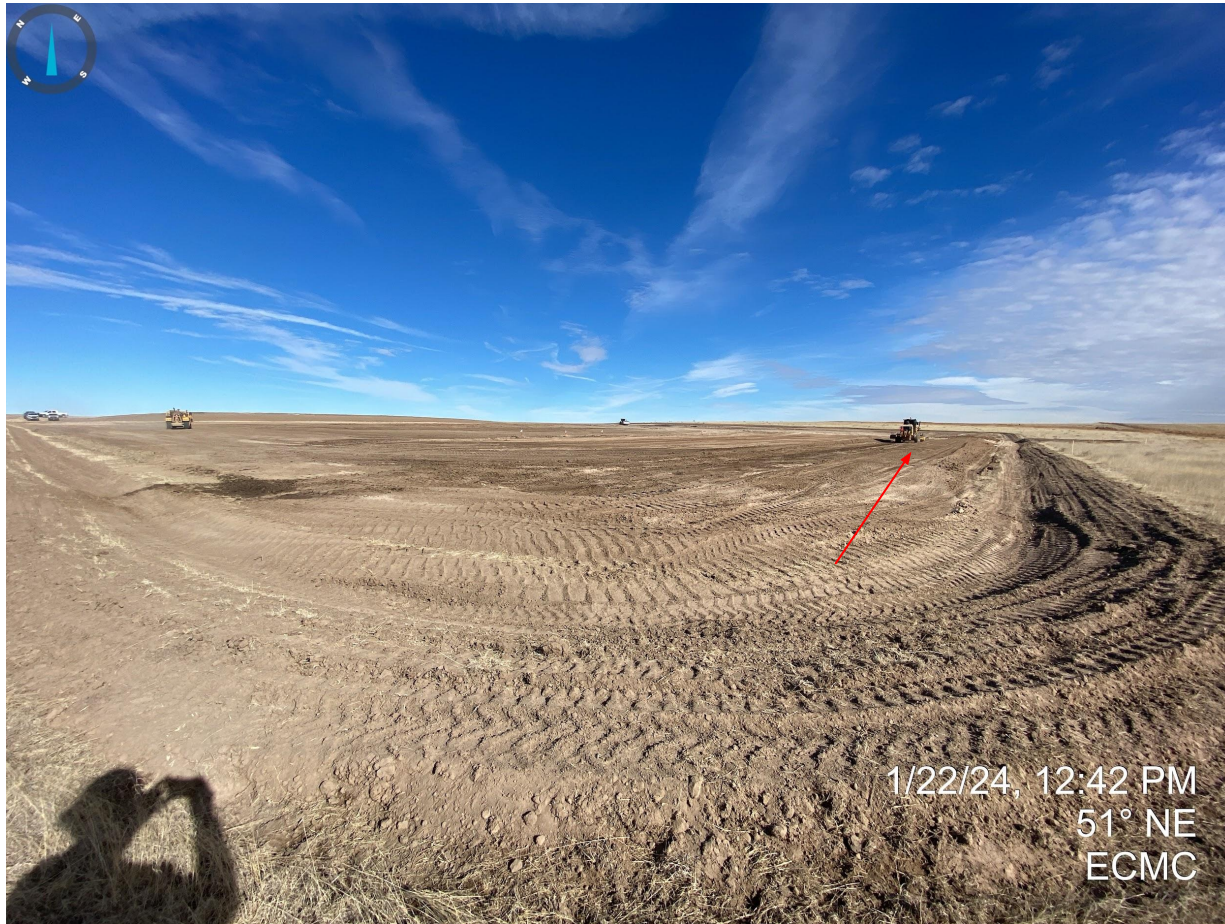
Photo 12. Taken from the southwest corner of the location. Perimeter ditch and berm has been constructed around the construction area. Crews were observed to be building a stormwater detention area (background of photo with red arrow).

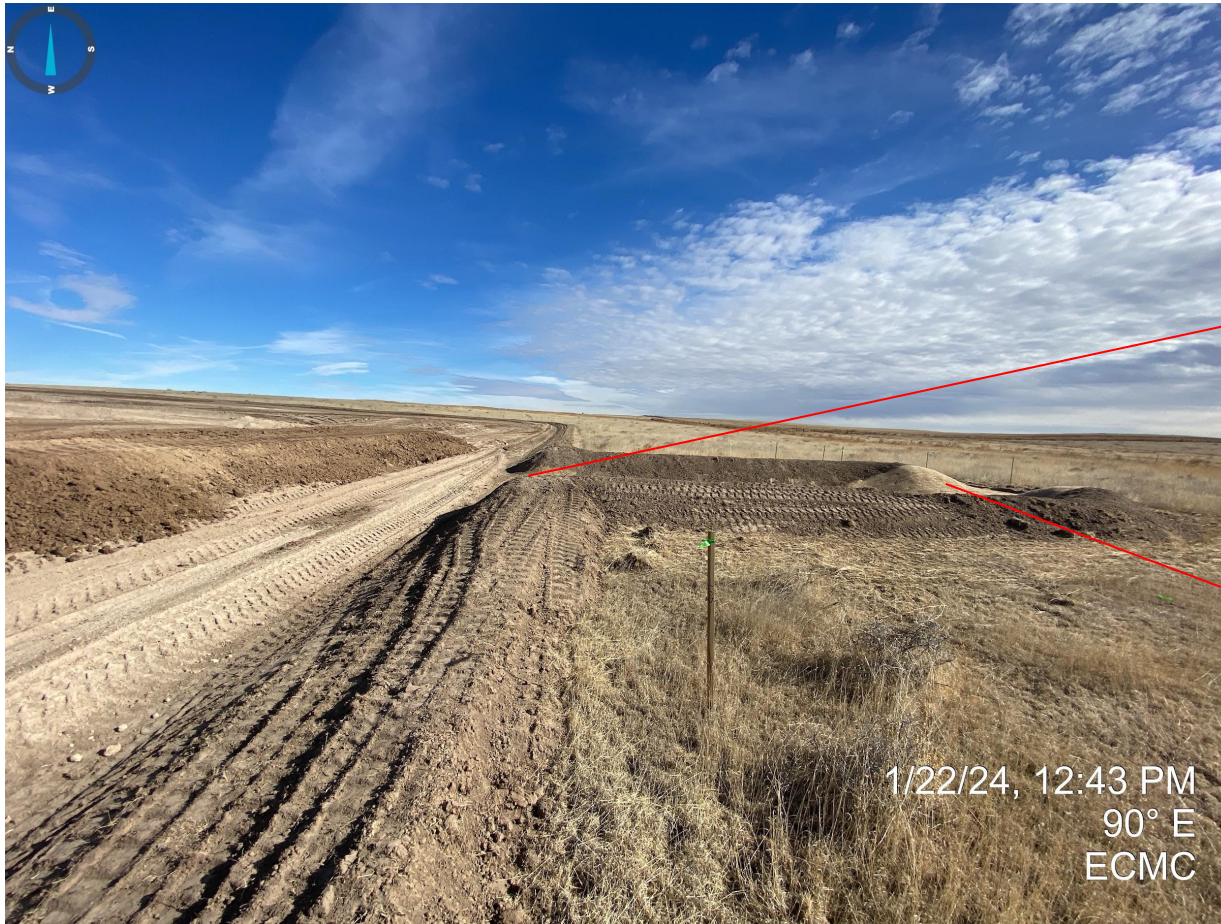
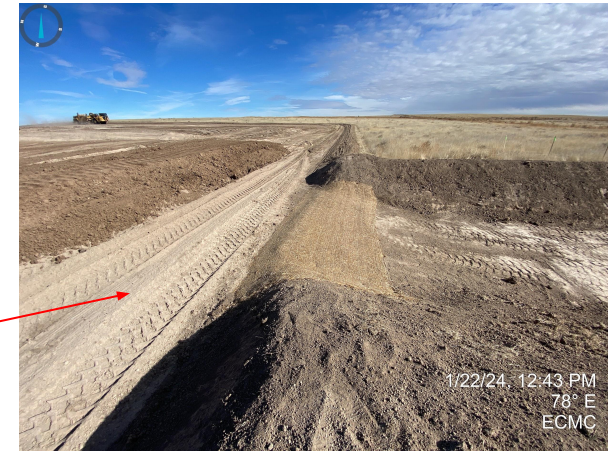
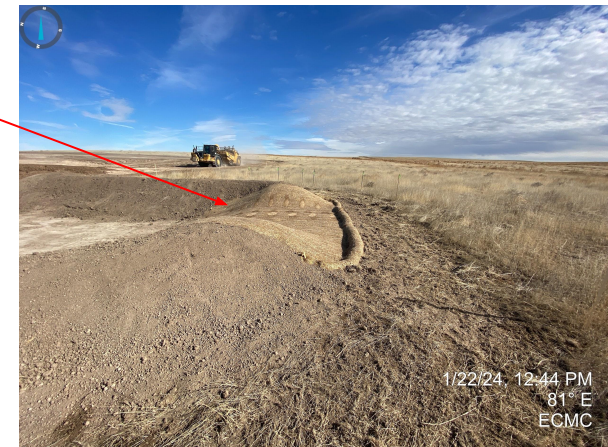
Photo 13. Sediment trap located on the southern portion of the location; temporarily stabilized inlet/outlet BMPs.

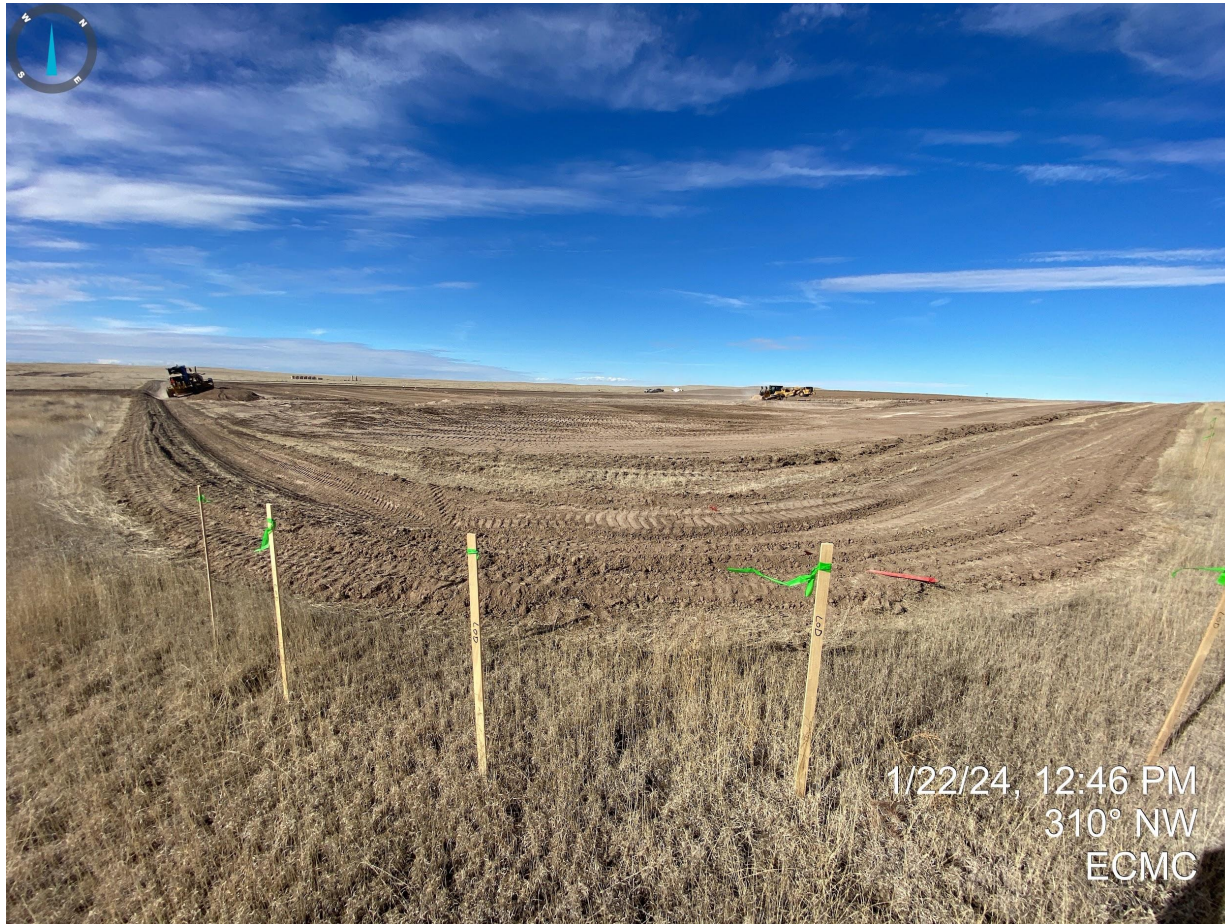
Photo 14. Taken from the southeast corner of the location. Perimeter ditch and berm has been constructed around the construction area.

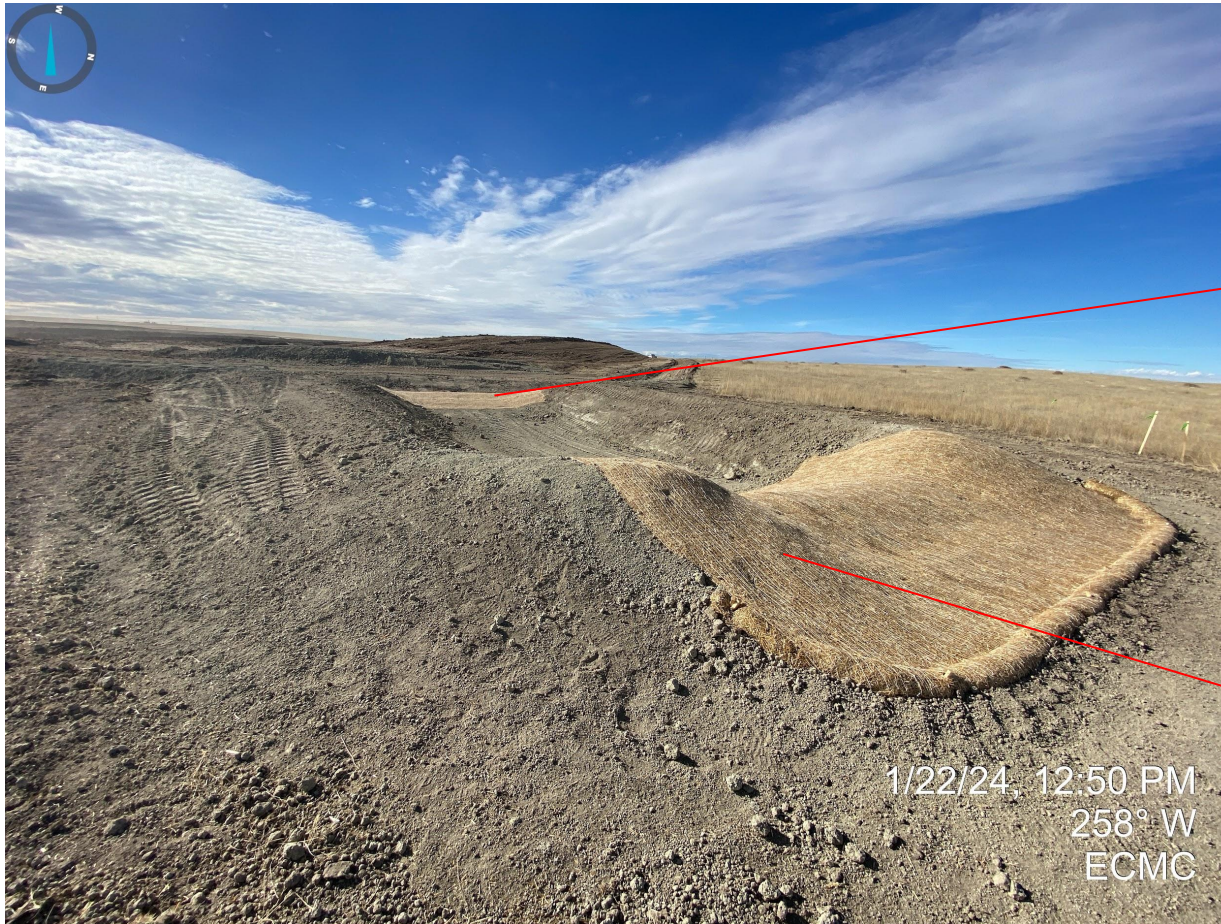
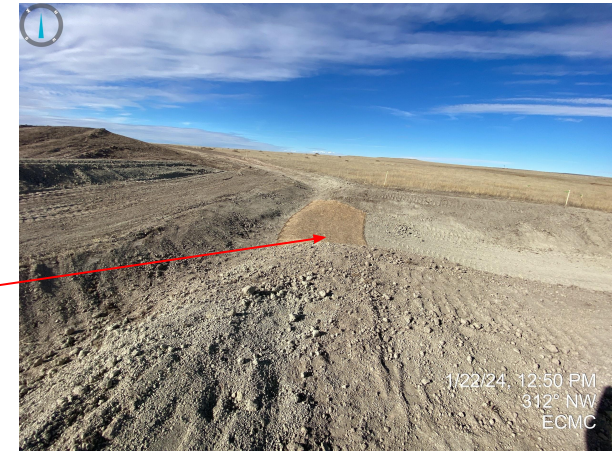
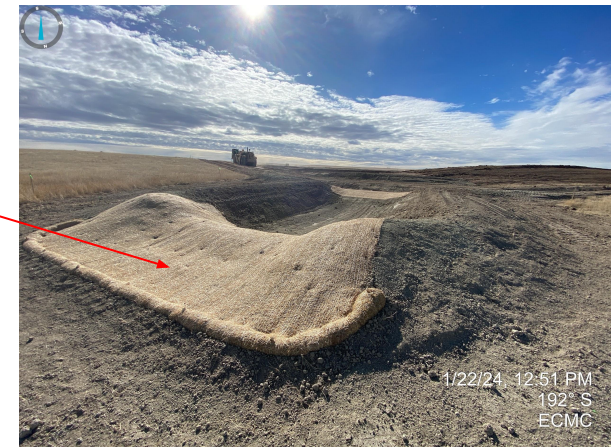
Photo 15. Sediment trap located on the northeast corner of the location; temporarily stabilized inlet/outlet BMPs.

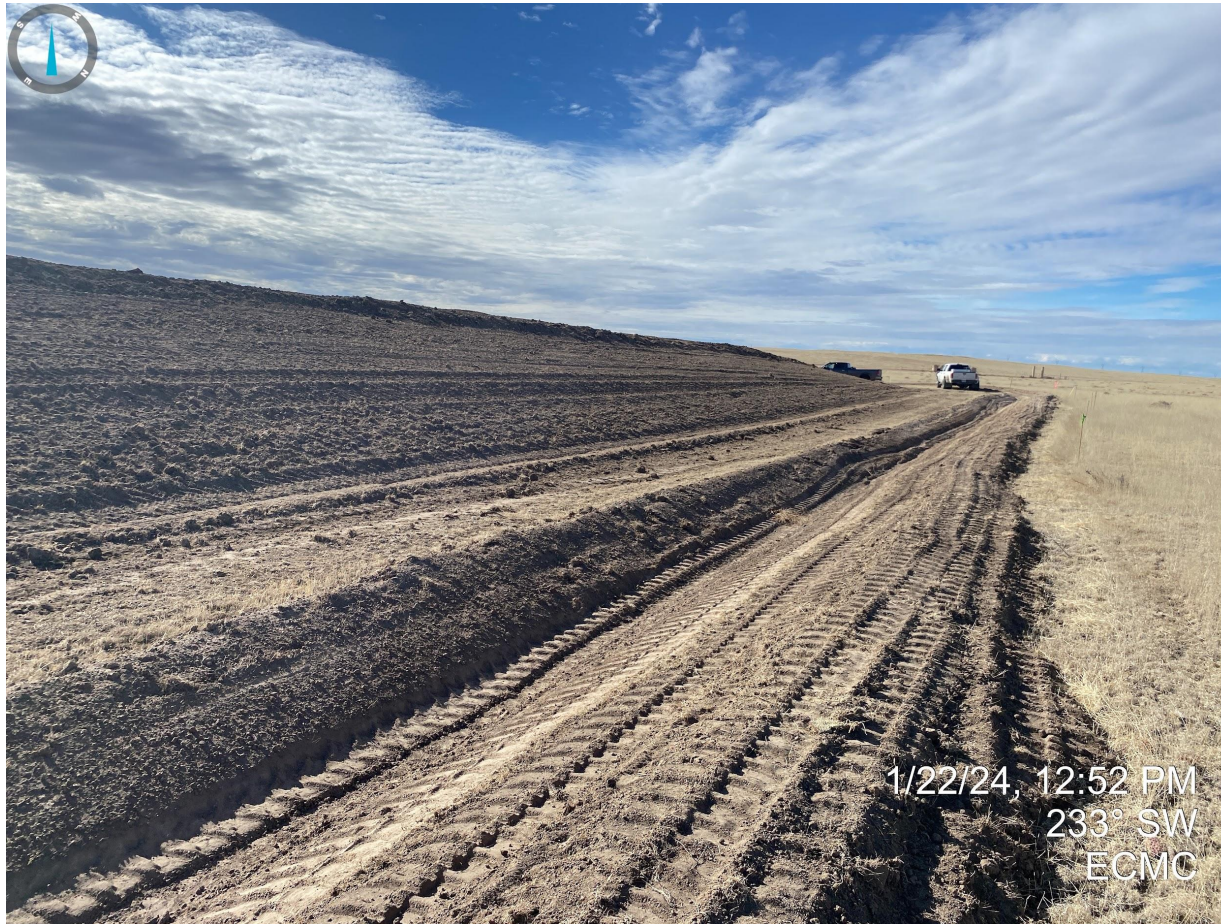
Photo 16. Taken on the northern portion of the location, near the topsoil stockpile. Perimeter ditch and berm observed.

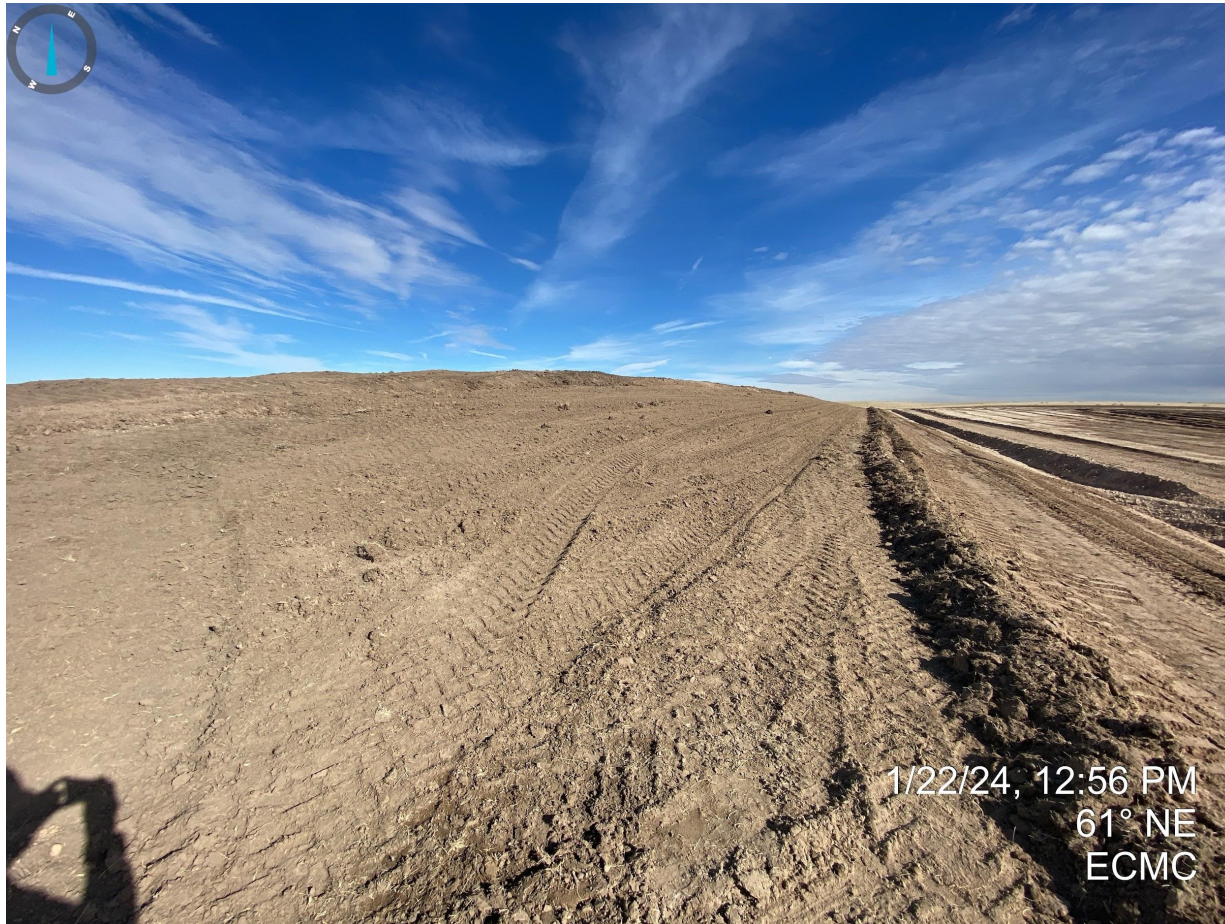
Photo 17. Taken from the southwest corner of the topsoil stockpile. It appears that topsoil from the drilling area has been stockpiled on the northern portion of the pad. Construction activities are ongoing and the Operator shall ensure that all stockpiled soils are temporarily stabilized (e.g. tracking, tackifier, etc) to prevent wind and water erosion degradation.

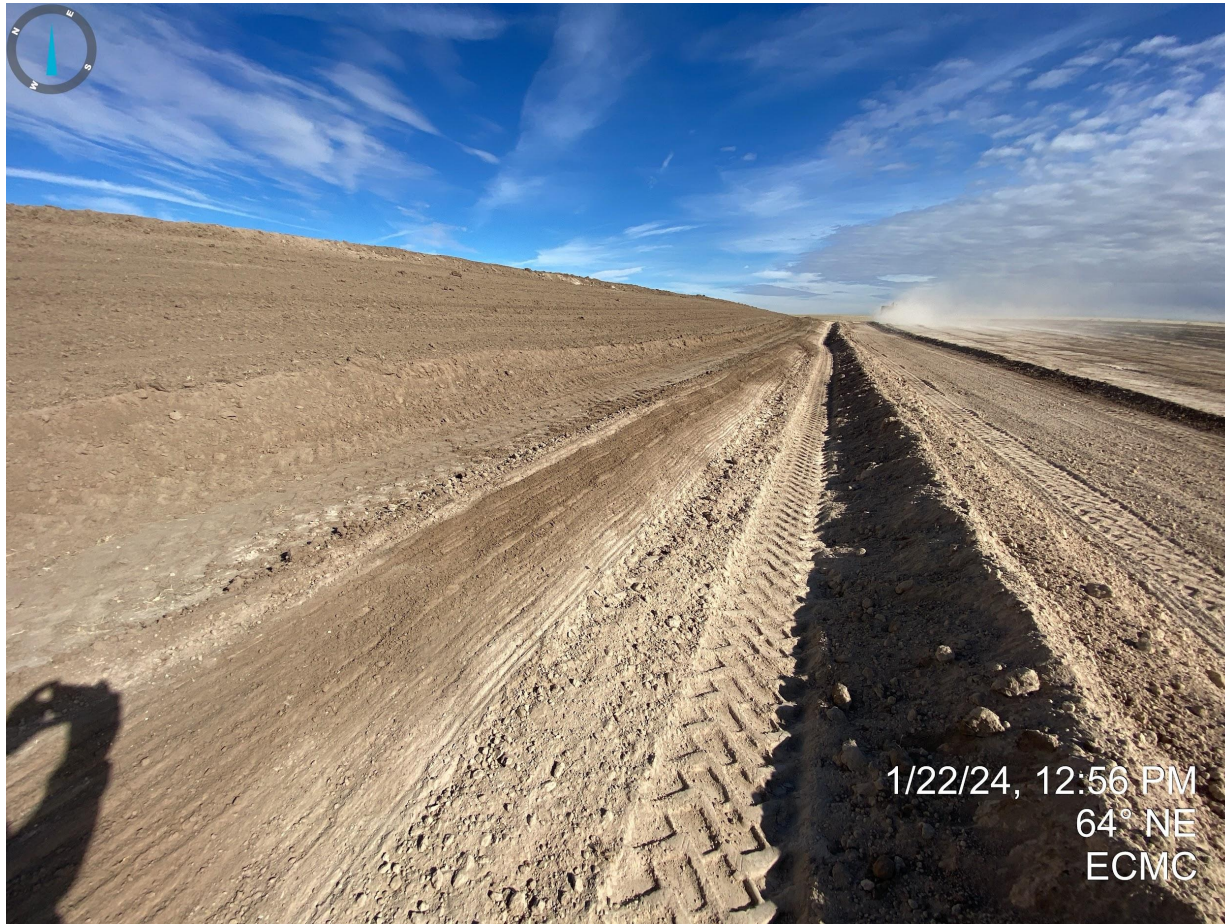
Photo 18. Taken from the southern/center portion of the topsoil stockpile. See comments in Photo 17.
