Inspection Photos
UPRR 50 Pan Am D-1 Flowline Spill
Spill ID 482826

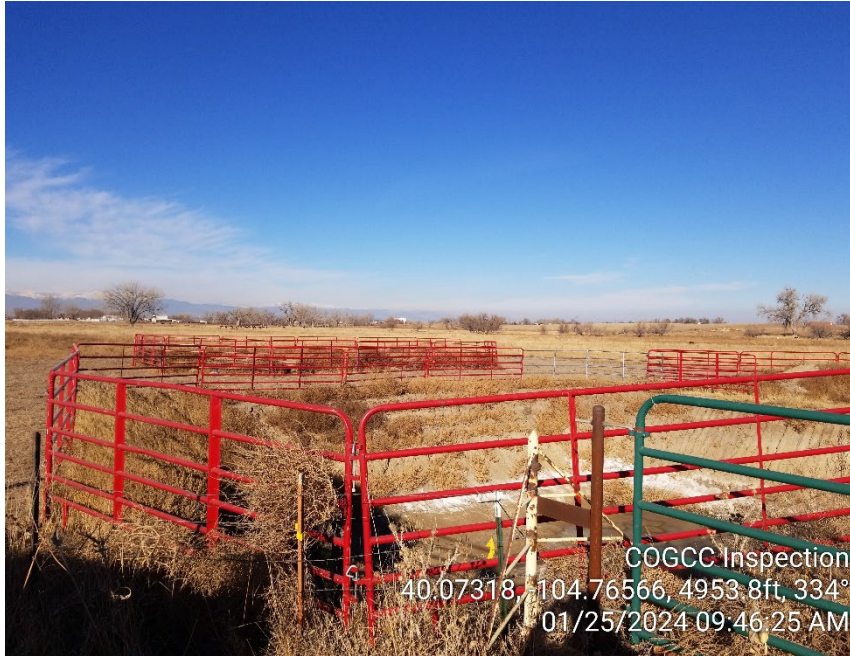
Photo 1 – Open excavation

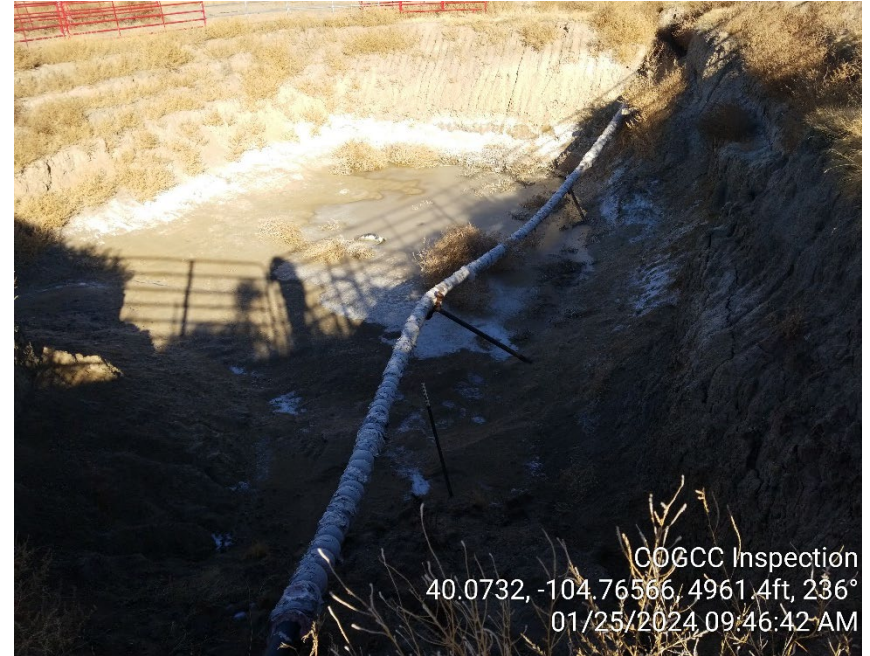
Photo 2 - Open excavation

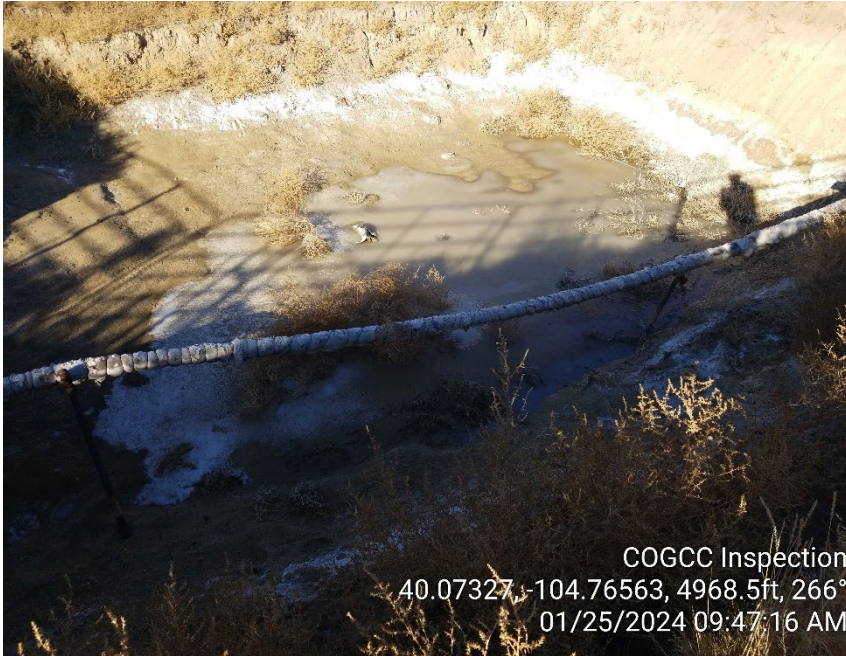
Photo 3 – Open excavation

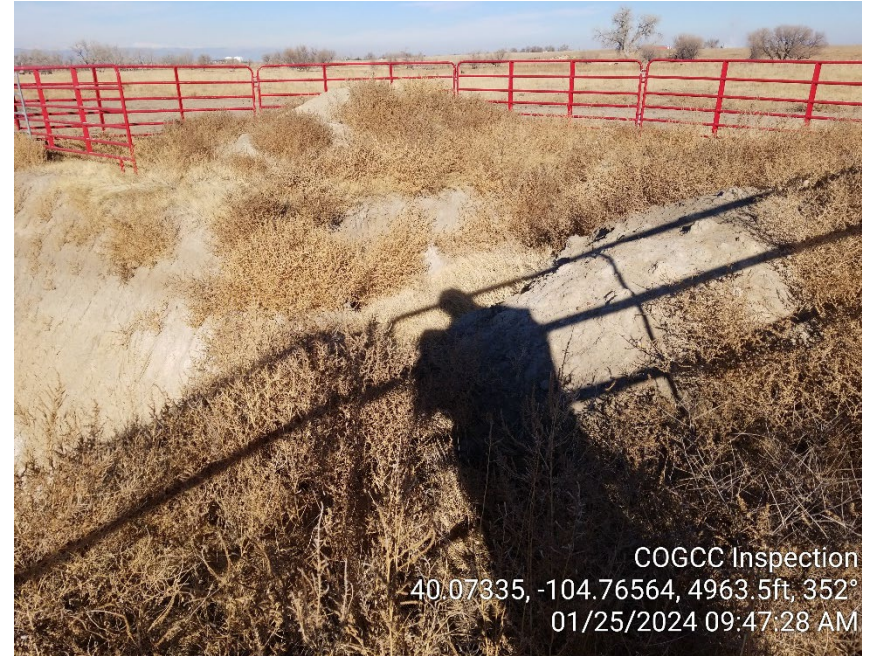
Photo 4 - Open excavation

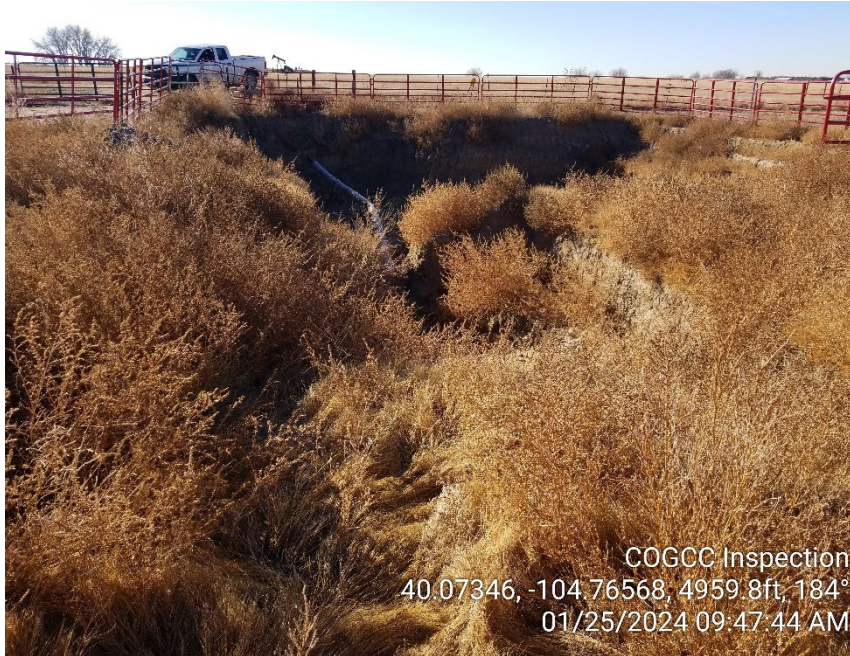
Photo 5 – Open excavation

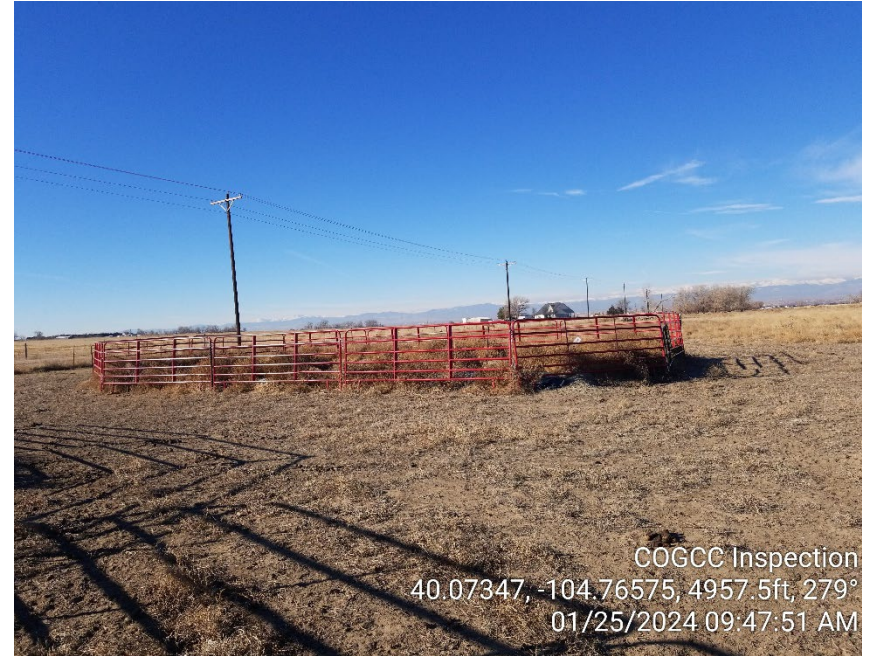
Photo 6 - Former E&P Waste area

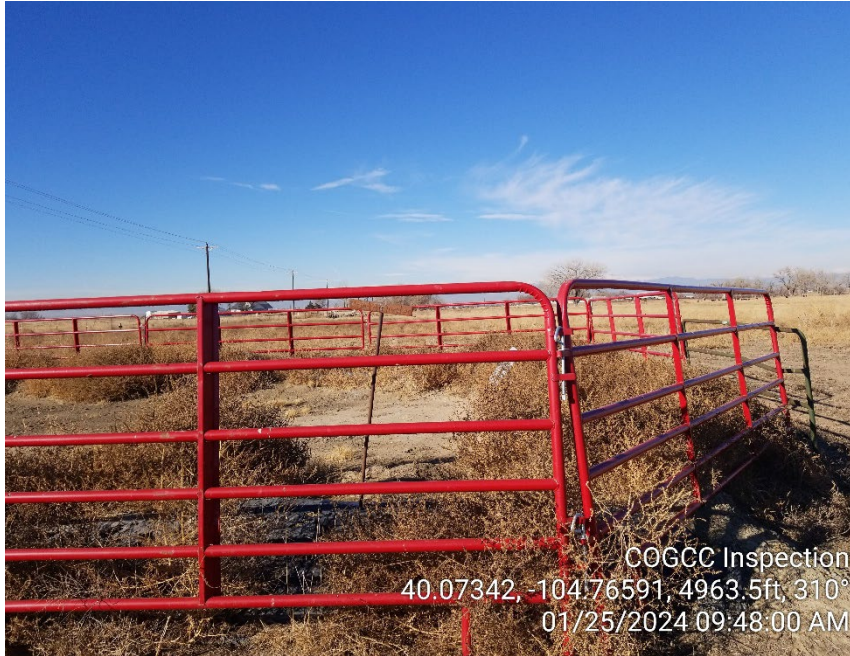
Photo 7 – Former E&P Waste area

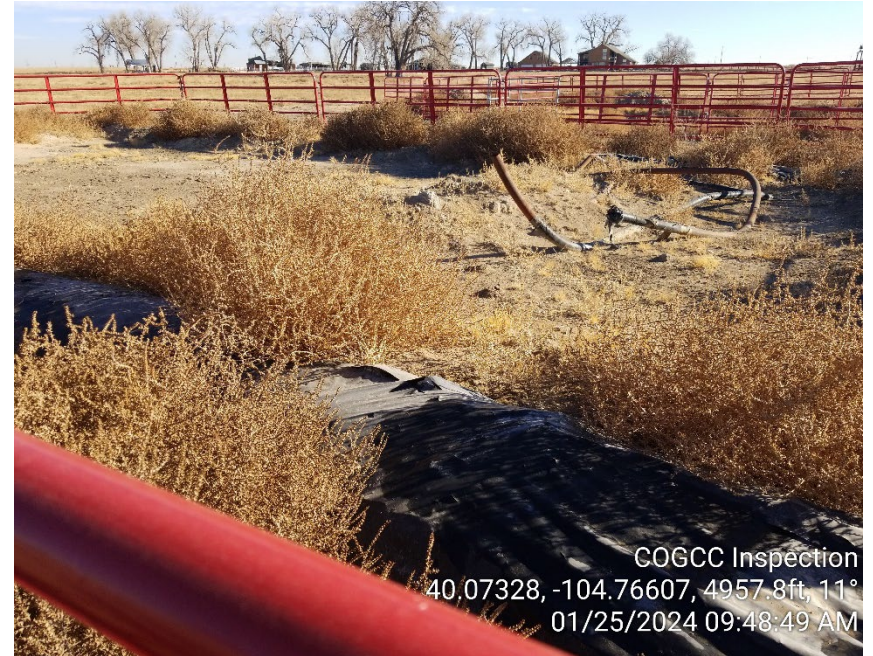
Photo 8- Former E&P Waste area

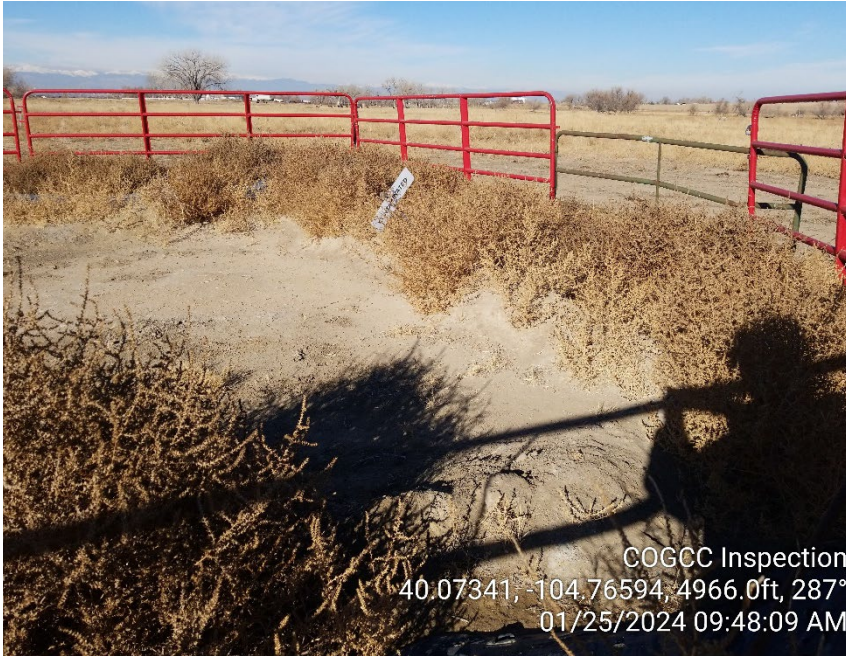
Photo 9 – Former E&P Waste area

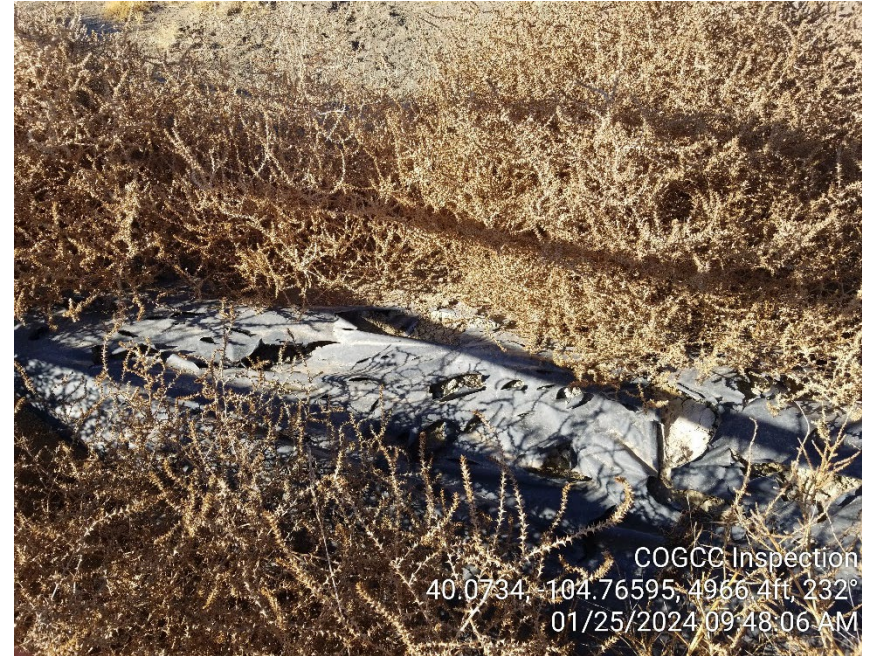
Photo 10 - Former E&P Waste area. Holes in lining.
