Interim Reclamation and Stormwater Inspection

Date: 01/24/2024

Operator: WESTERN OPERATING COMPANY - 95620

Inspection Photos
Location Name: Propst B3X
Location ID: 312229

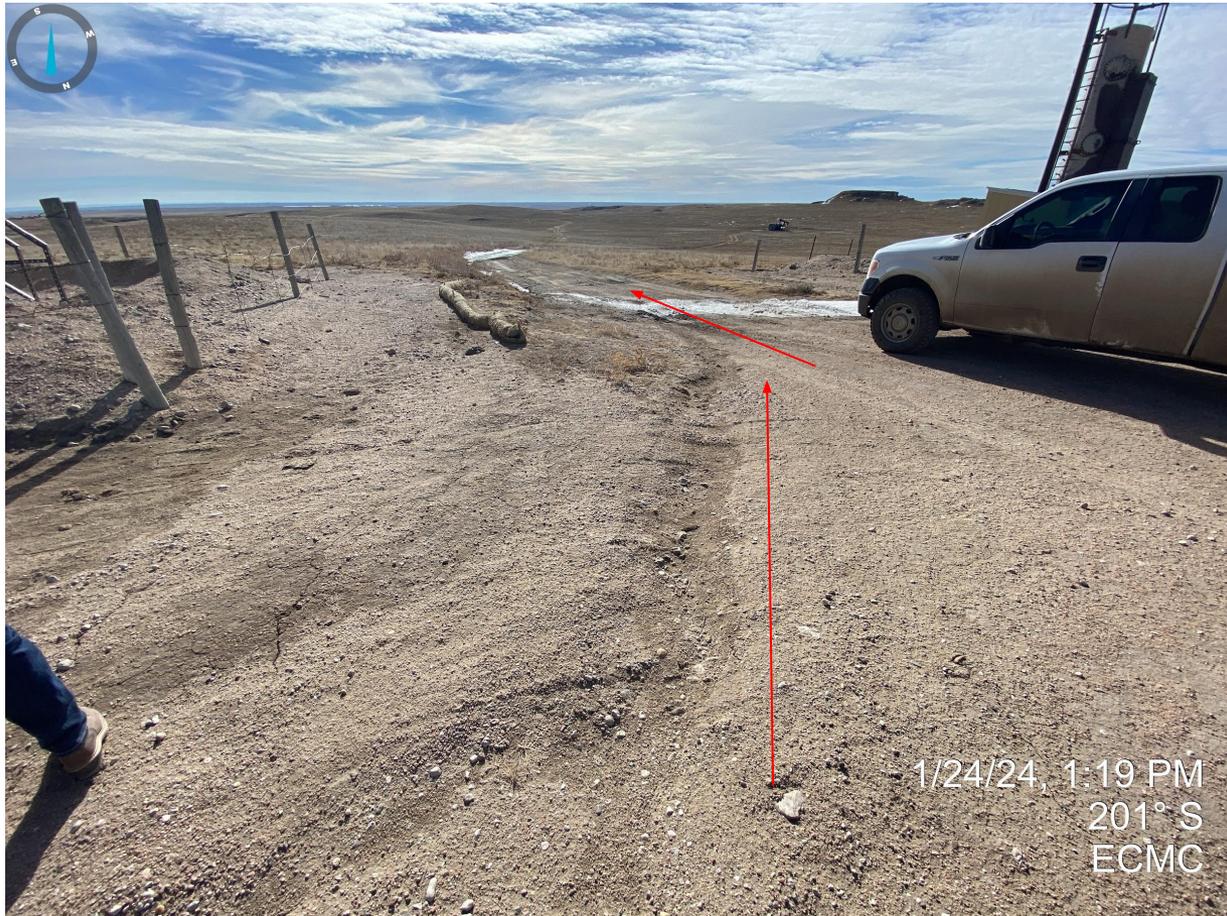
Photo 1. Erosion degradation occurring along the production areas and the access road leading to the well.

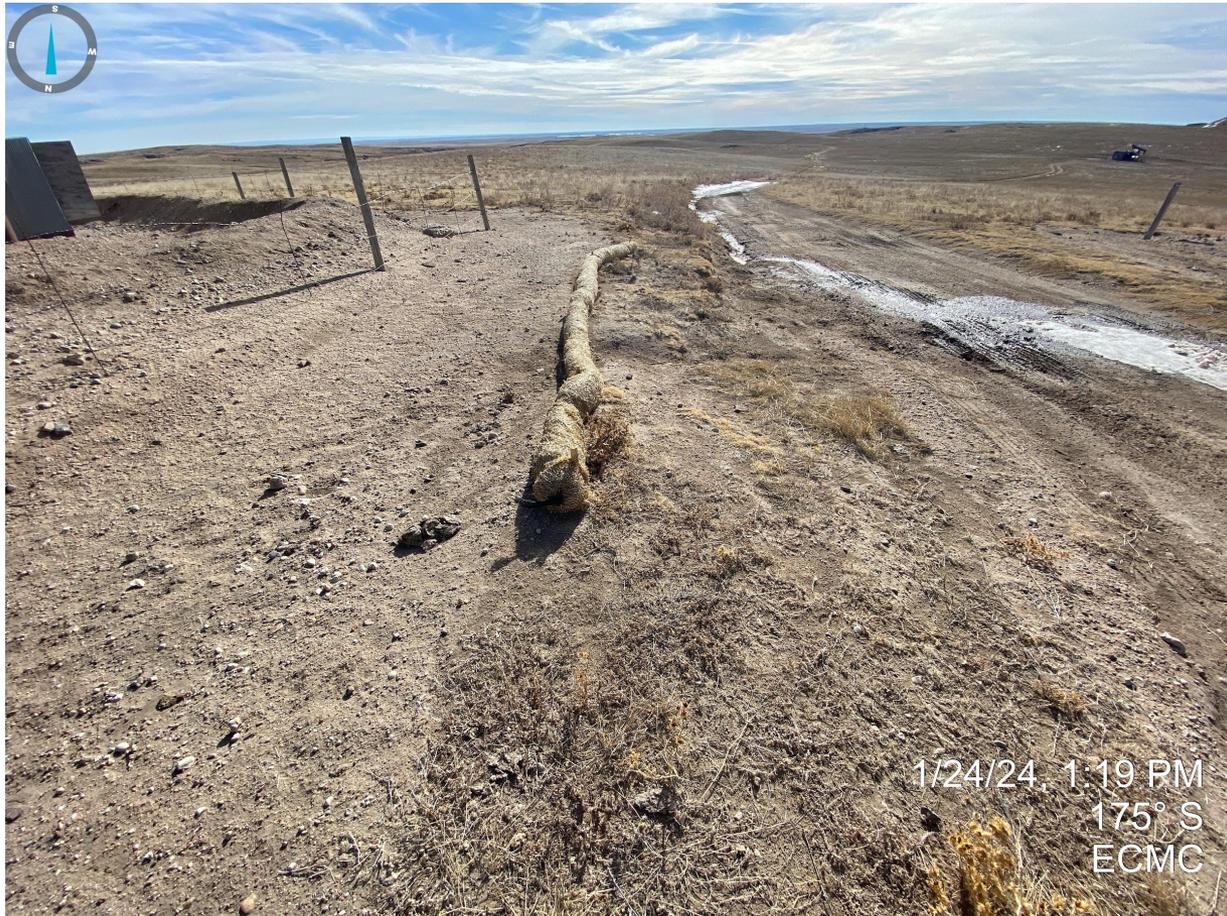
Photo 2. Stormwater control measure/BMPs does not appear to be properly installed per good engineering practices (e.g. trenched and backfilled).

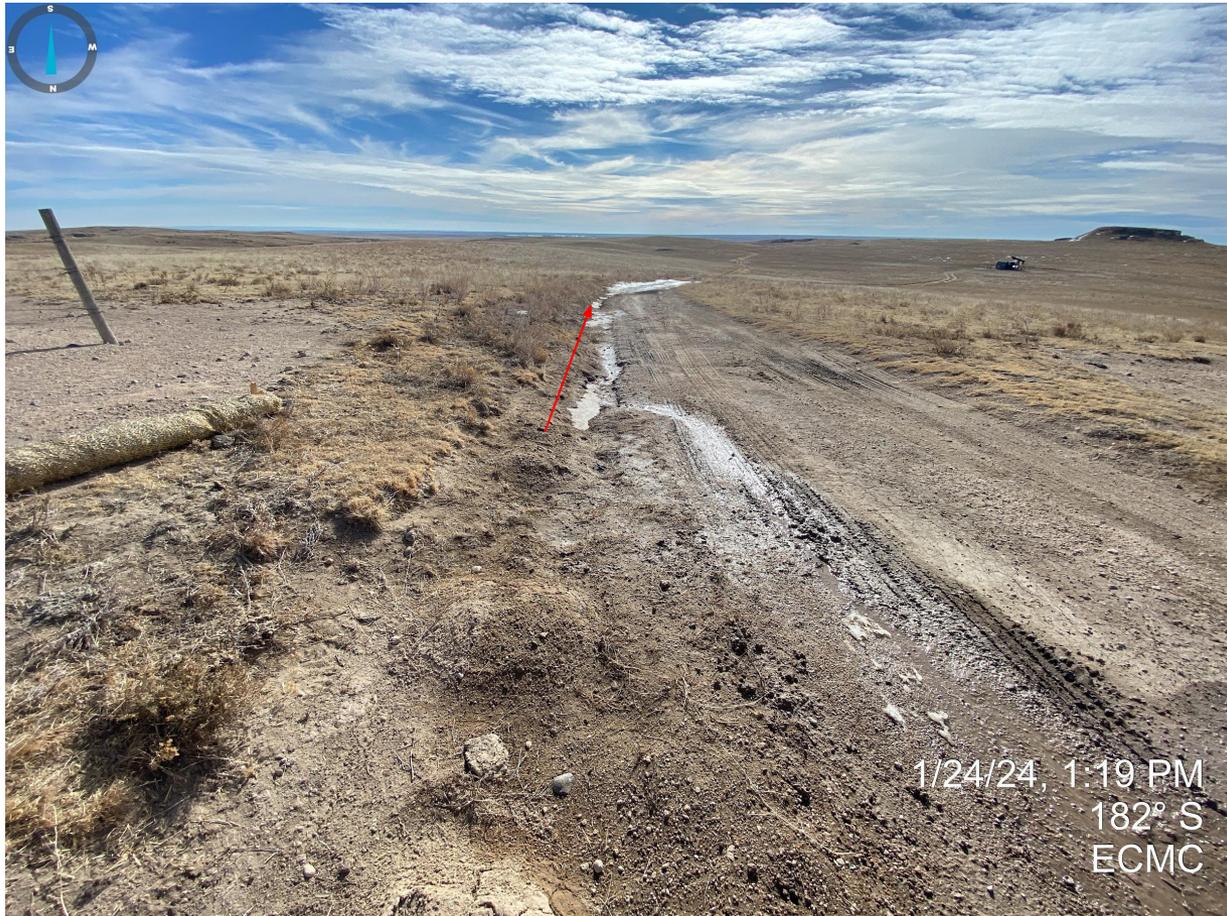
Photo 3. Erosion degradation occurring along the access road to the well location.

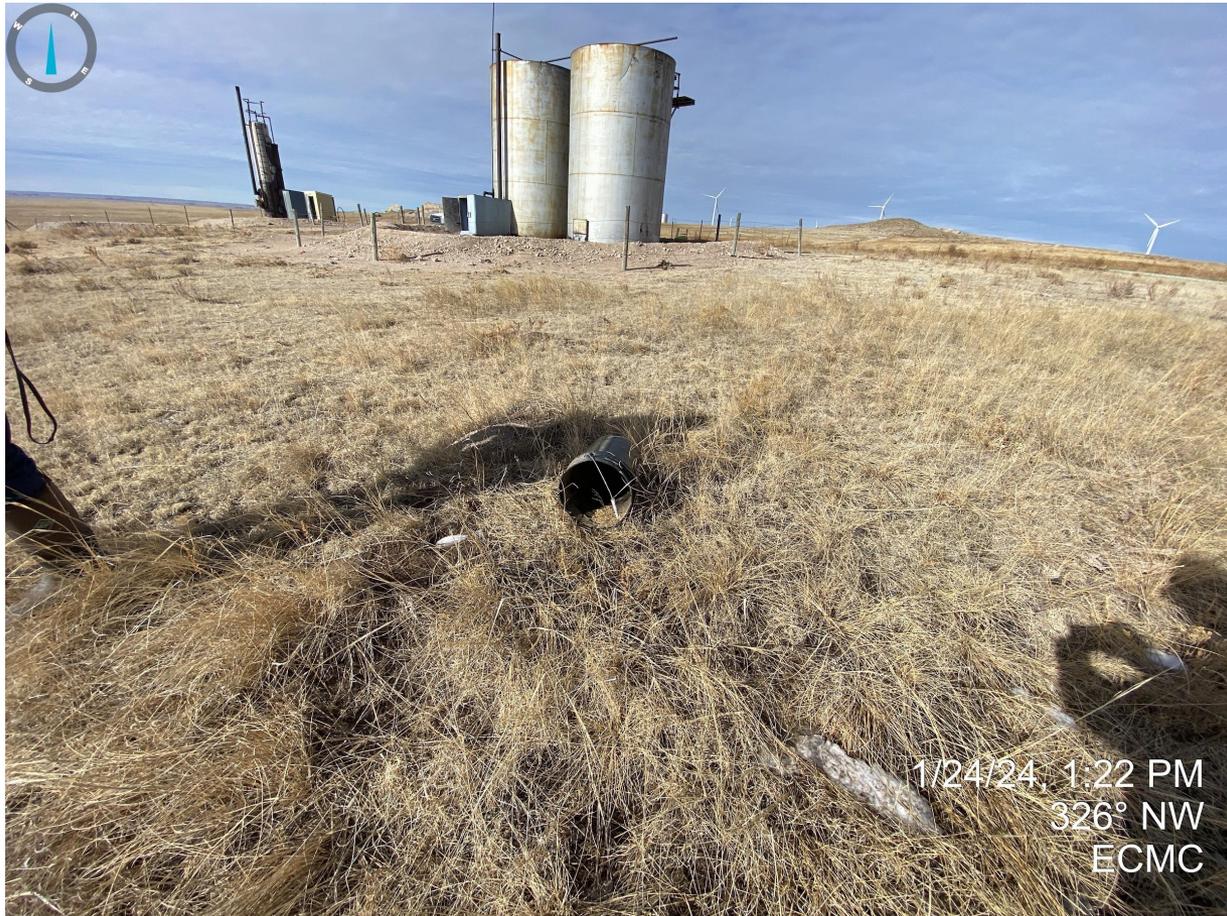
Photo 4. Trash and debris observed southwest of the tank battery.

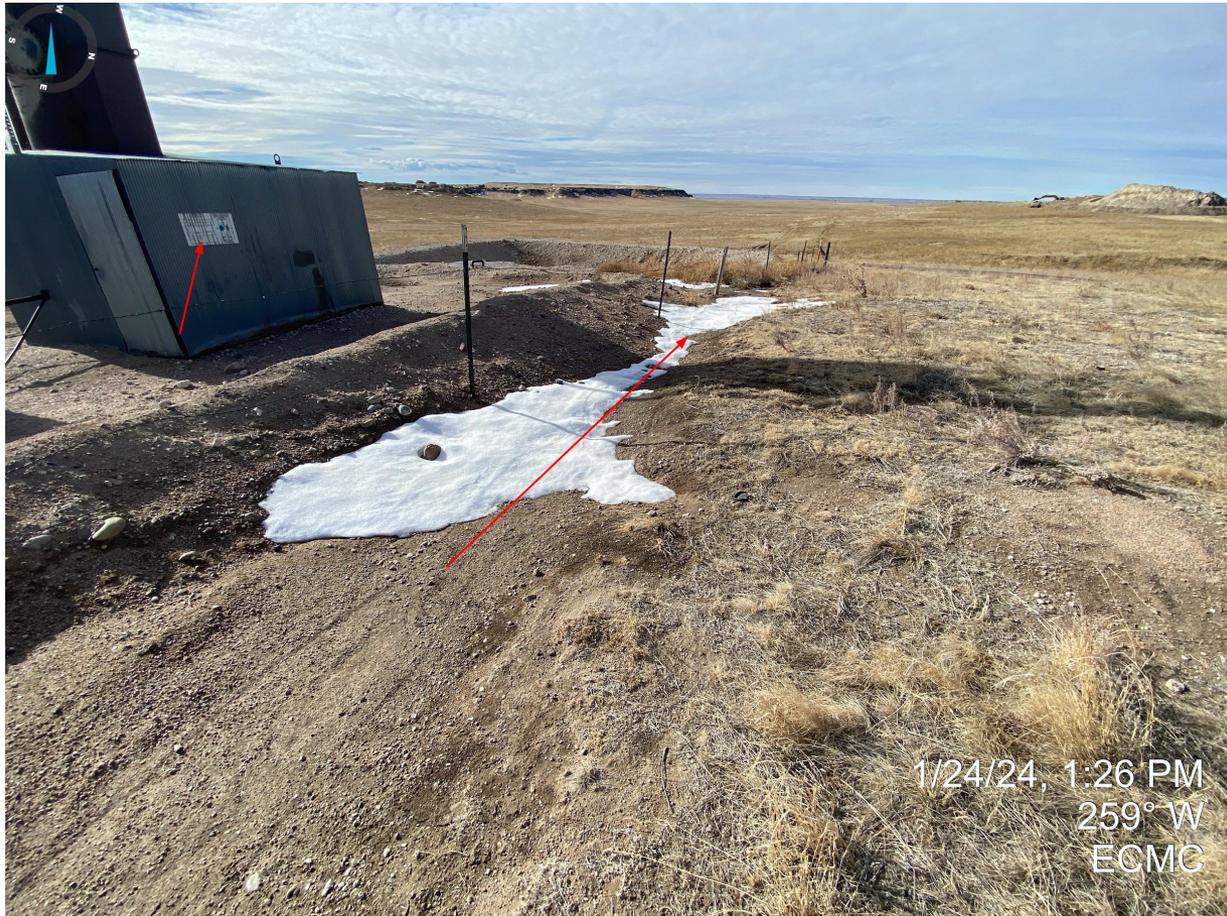
Photo 5. NFPA placard has not been replaced at shed and stormwater erosion degradation observed along the north side of the pit.

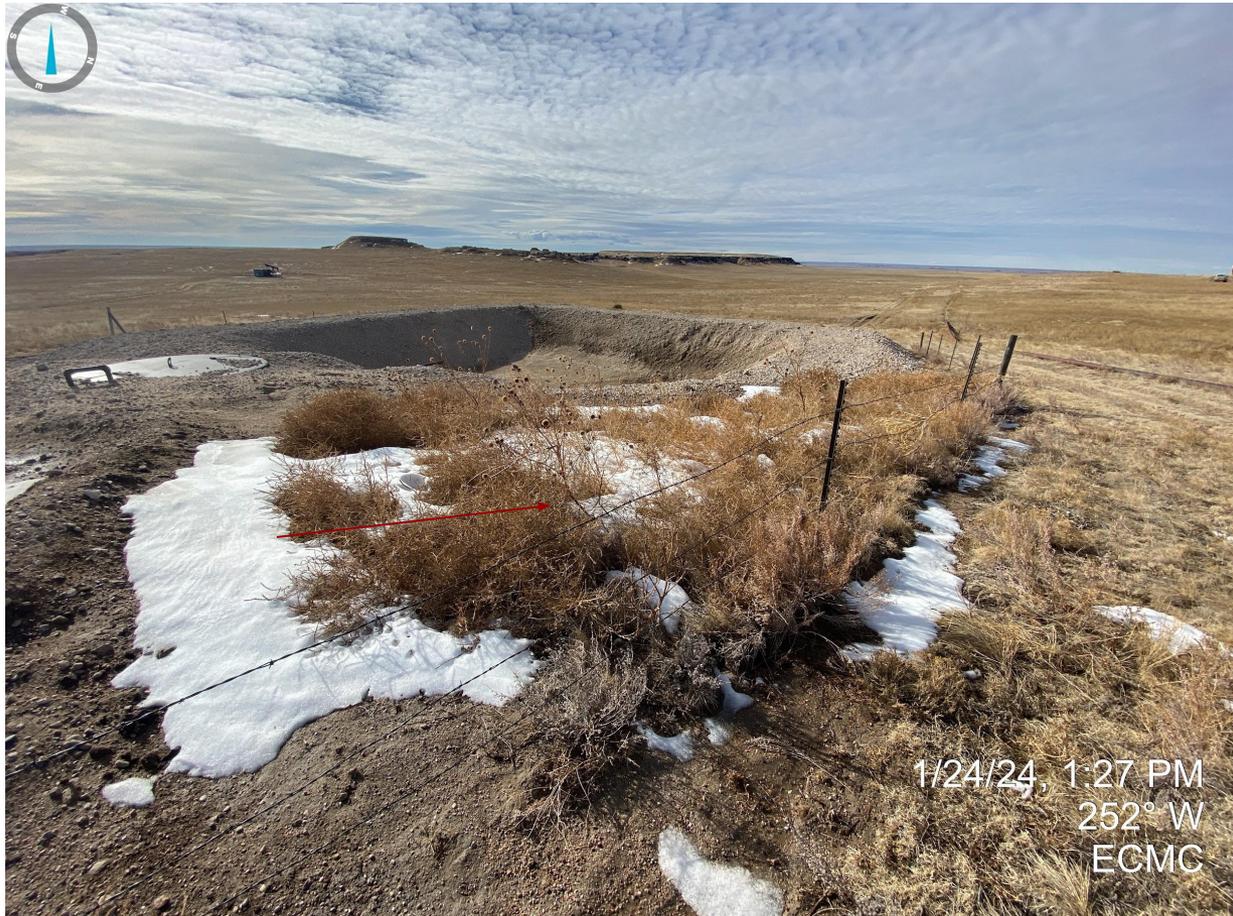
Photo 6. Tumbleweed accumulations near the pit are considered debris and require removal.

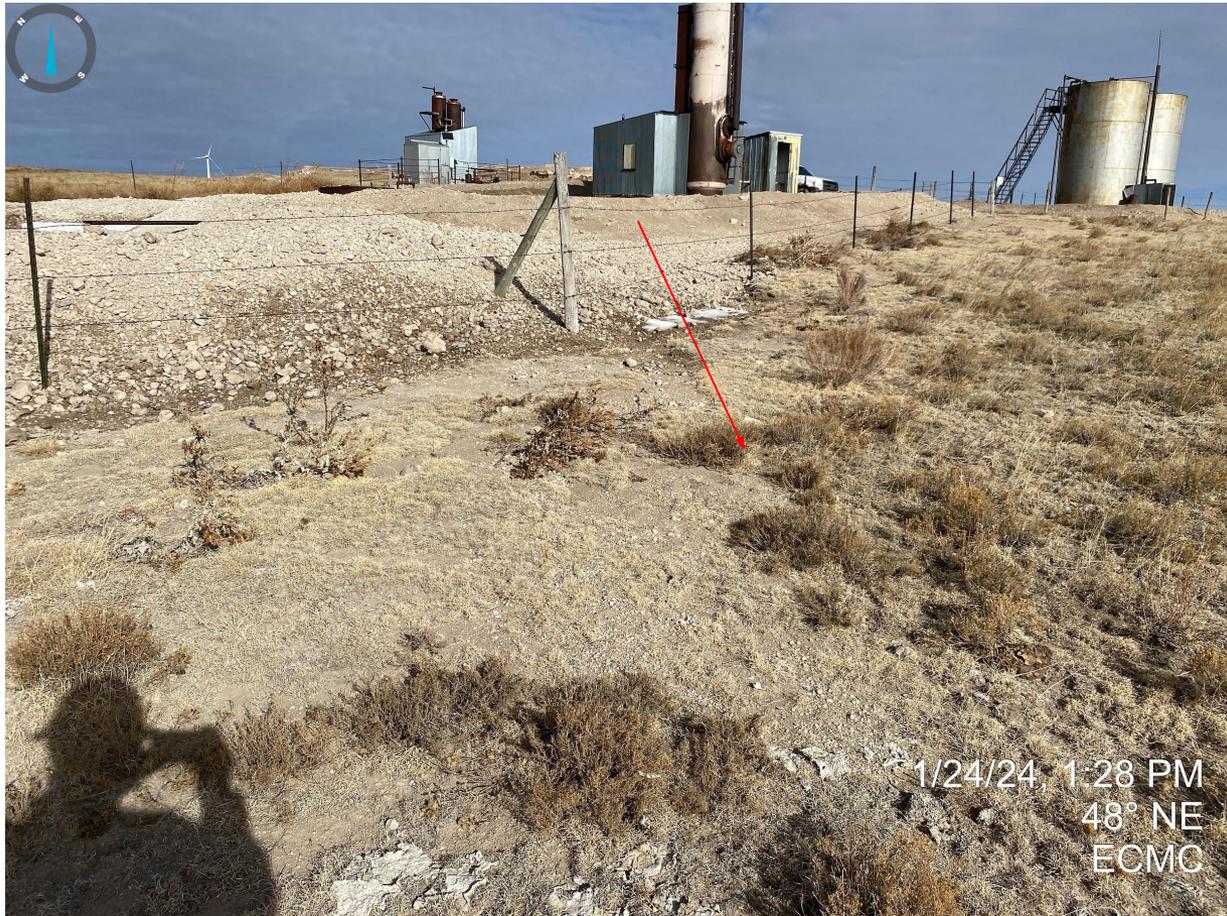
Photo 7. Erosion degradation occurring from the pit areas leading into the adjacent reference areas.

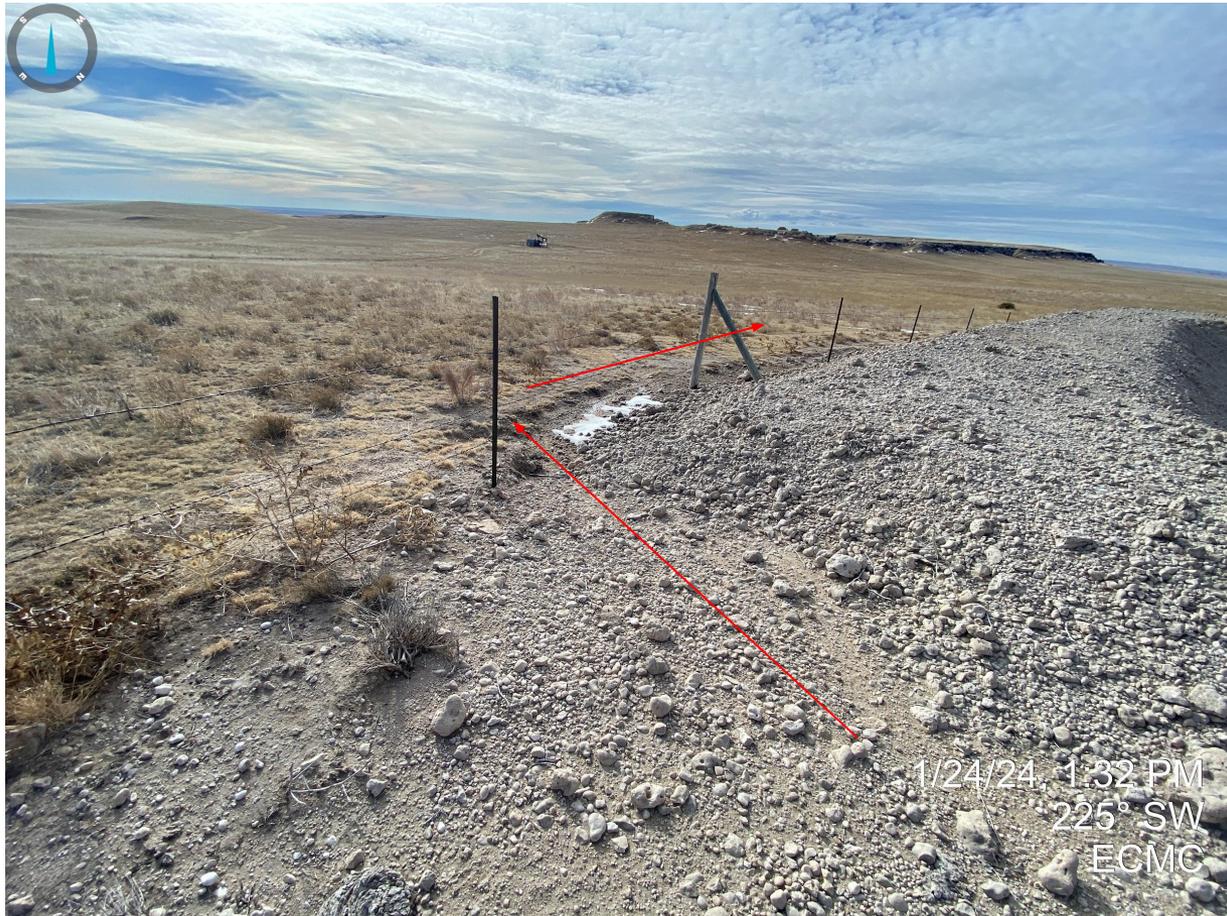
Photo 8. Continued from Photo 7, facing southwest.

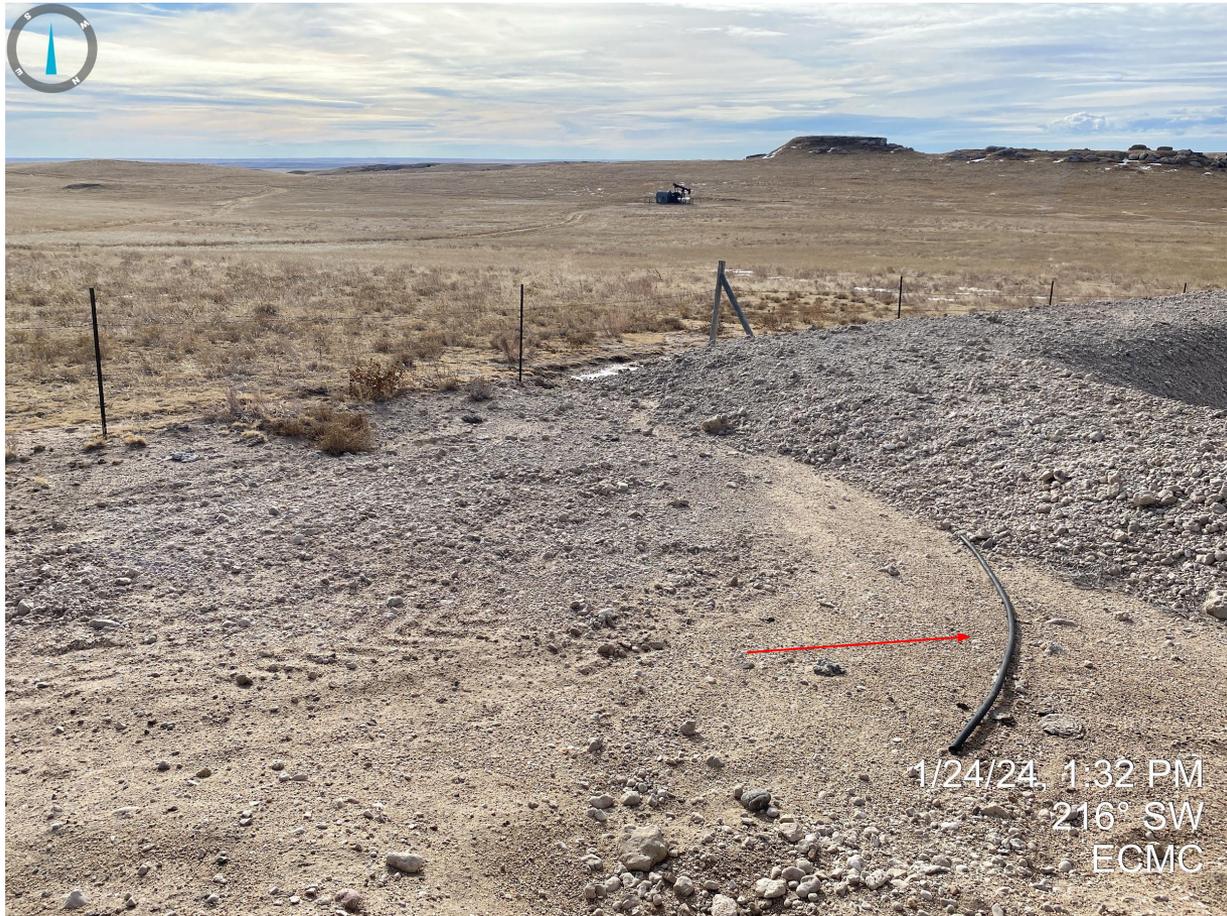
Photo 9. Debris/trash within pit area.

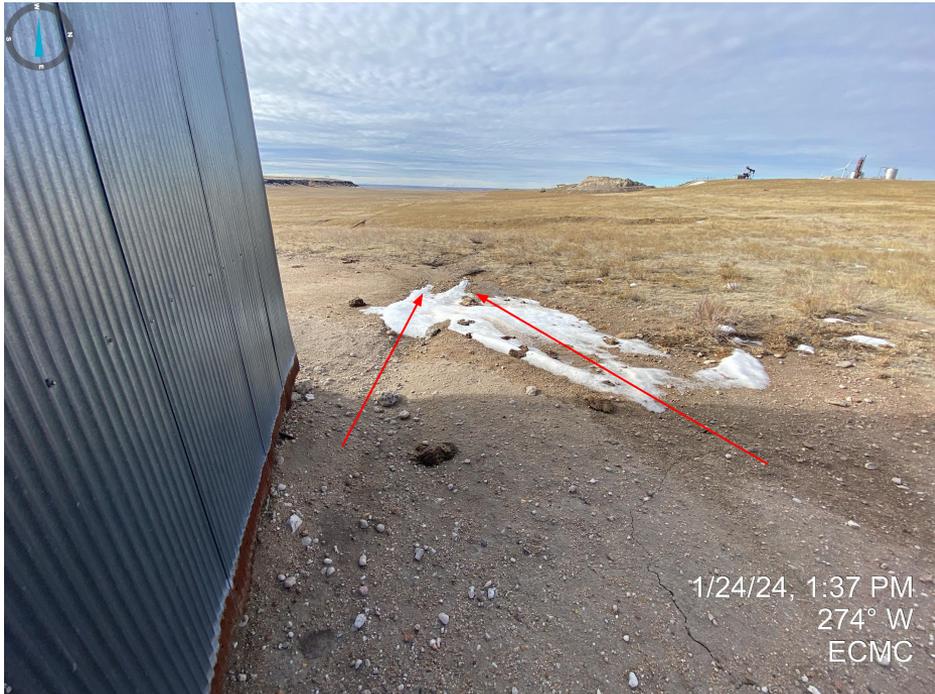
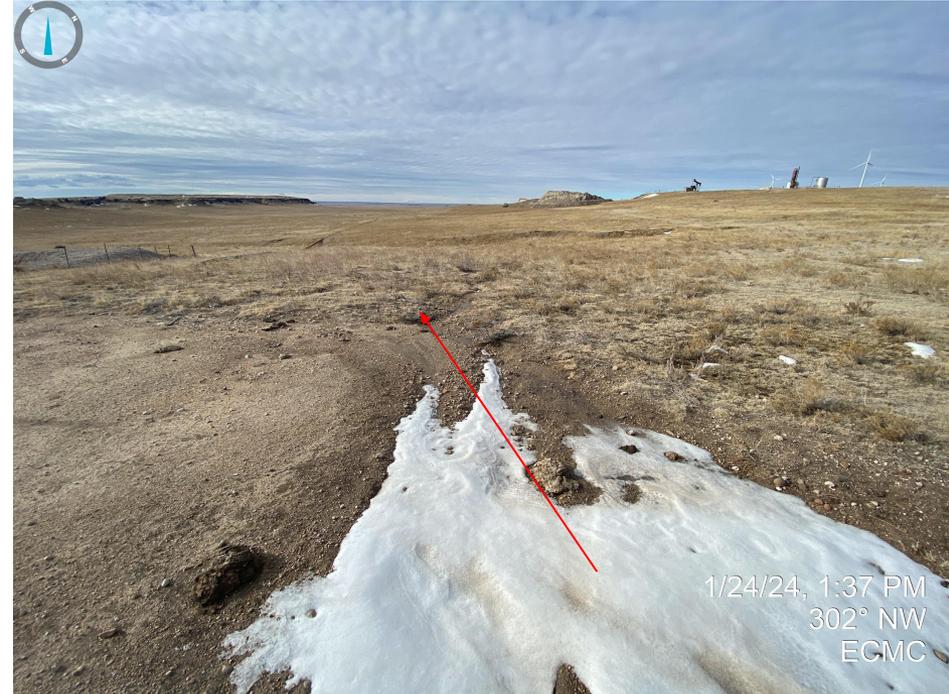
Photos 10 & 11. Erosion degradation occurring north of the meter shed. No visible stormwater control measures observed.

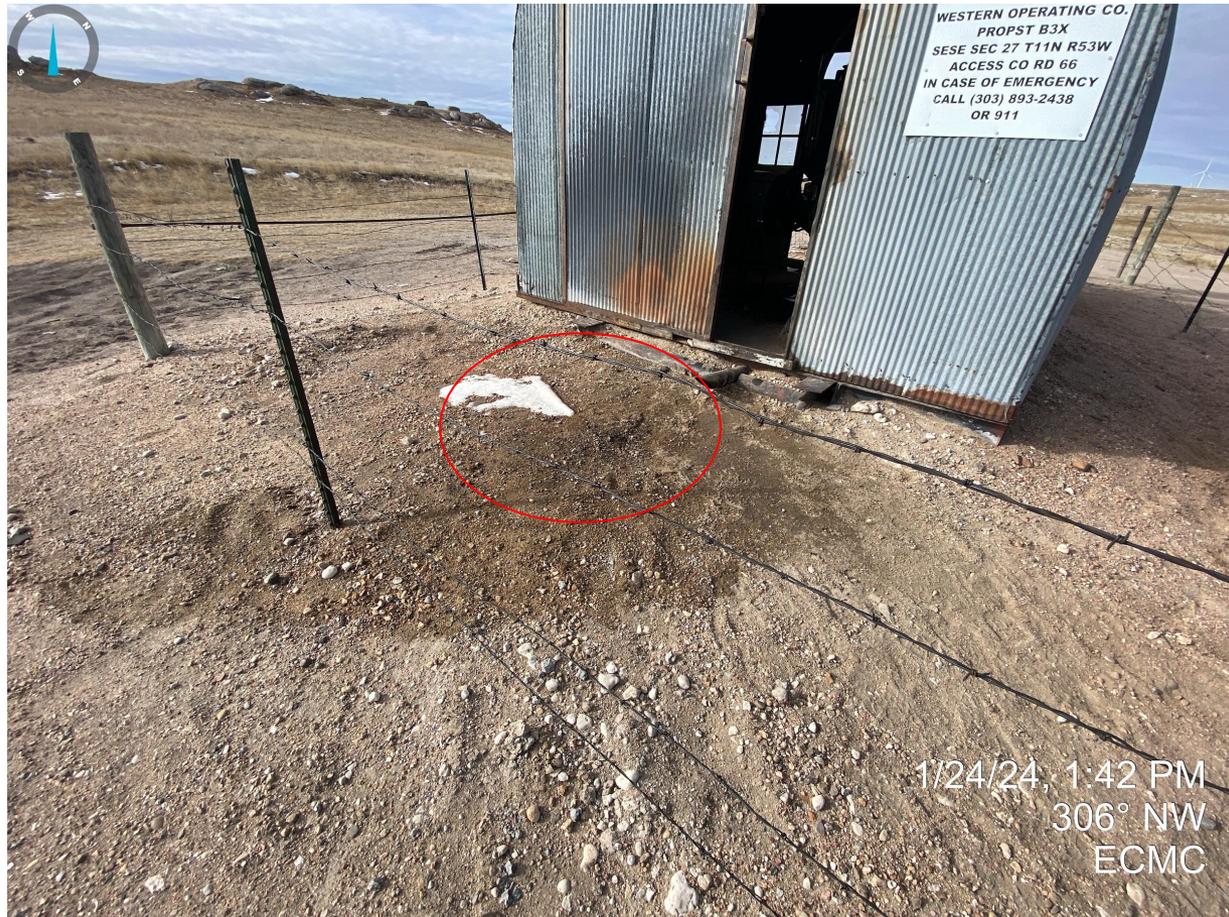
Photo 12. Stained soil previously observed near pumpjack exhaust does not appear to have been cleaned up (red circle); other discoloration is likely from snowmelt.

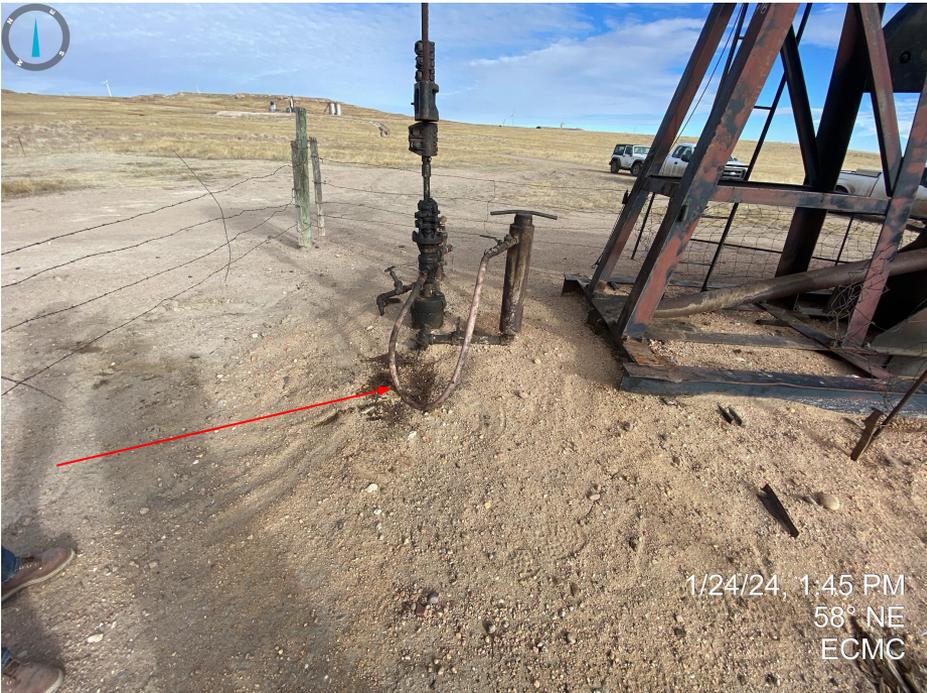
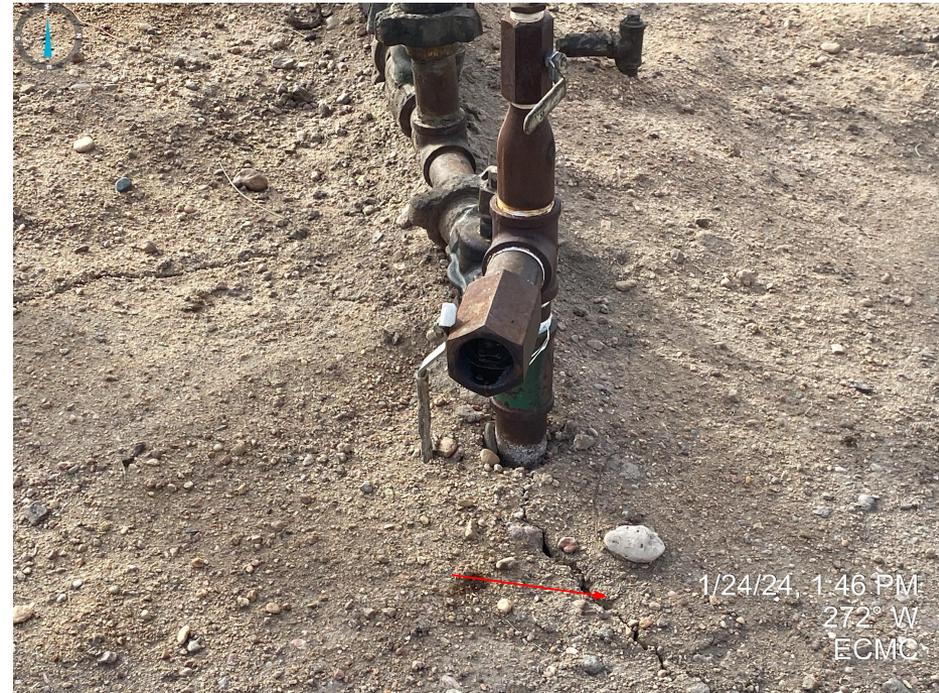
Photos 13 & 14. Stained soil observed near wellhead and fittings.

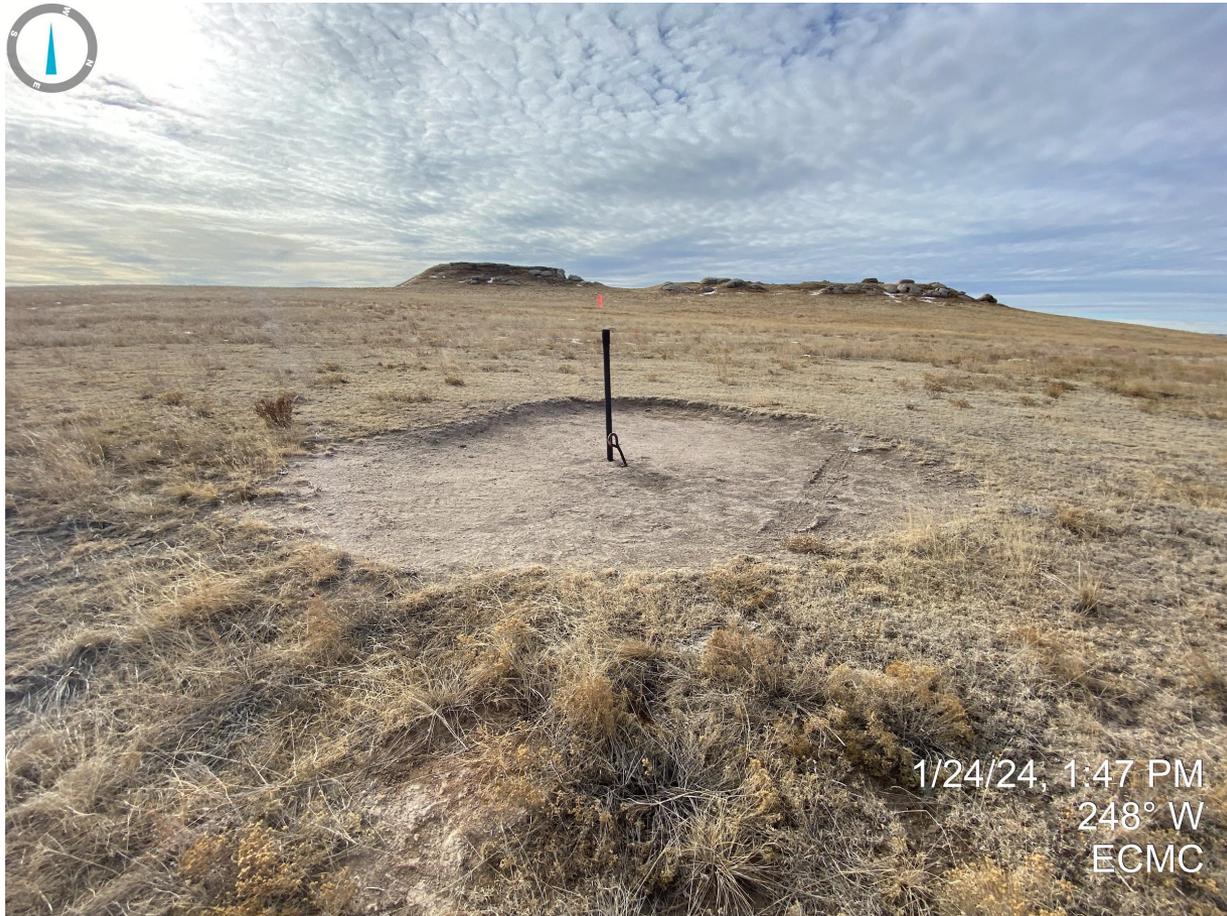
Photo 15. Northwest guyline anchor has been installed.
