# Interim Reclamation and Stormwater Inspection

Date: 01/24/2024

Operator: WESTERN OPERATING COMPANY - 95620

Location ID: 312291

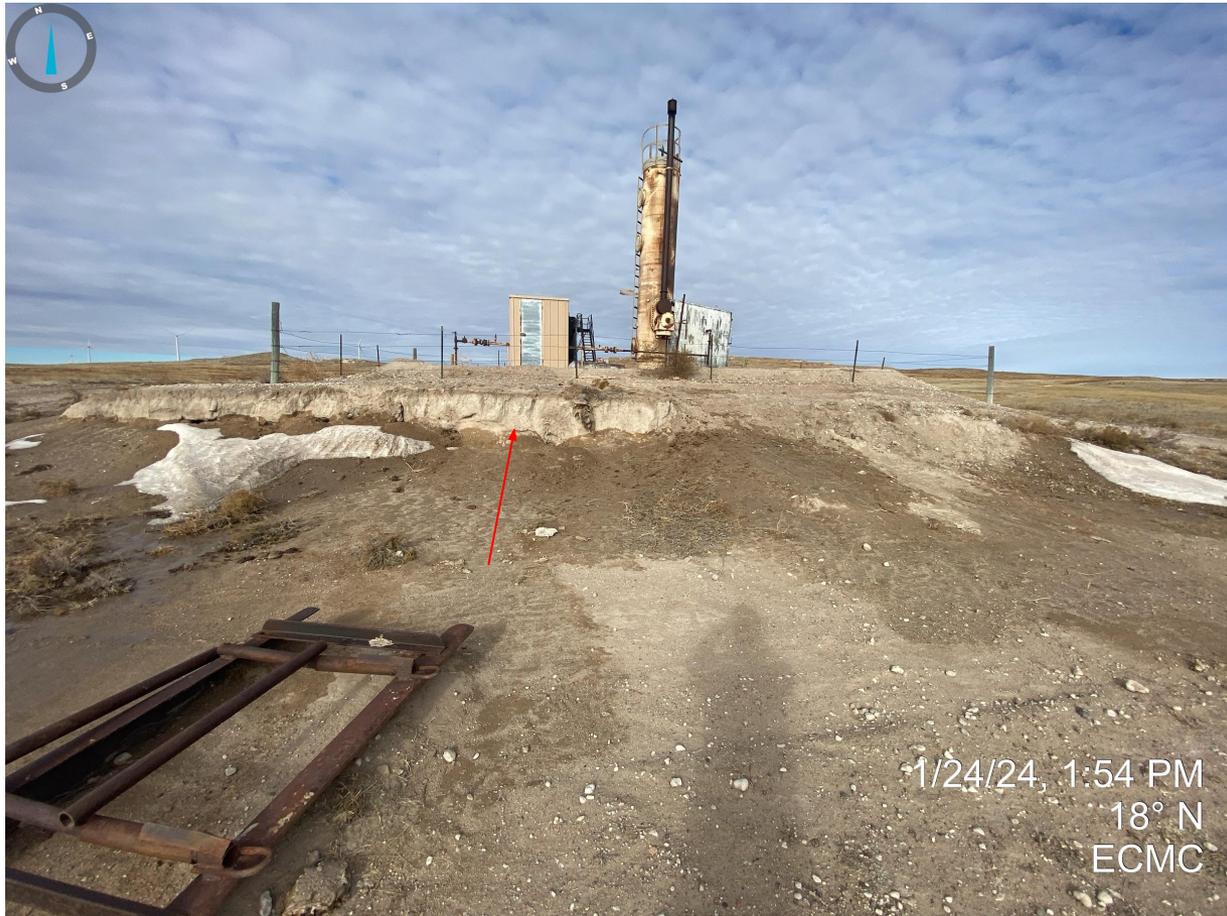
**Photo 1.** Taken near the vertical heater treater. Erosion degradation previously documented does not appear to have been repaired, and there is no evidence that stormwater control measures have been implemented to protect the unstabilized soils.

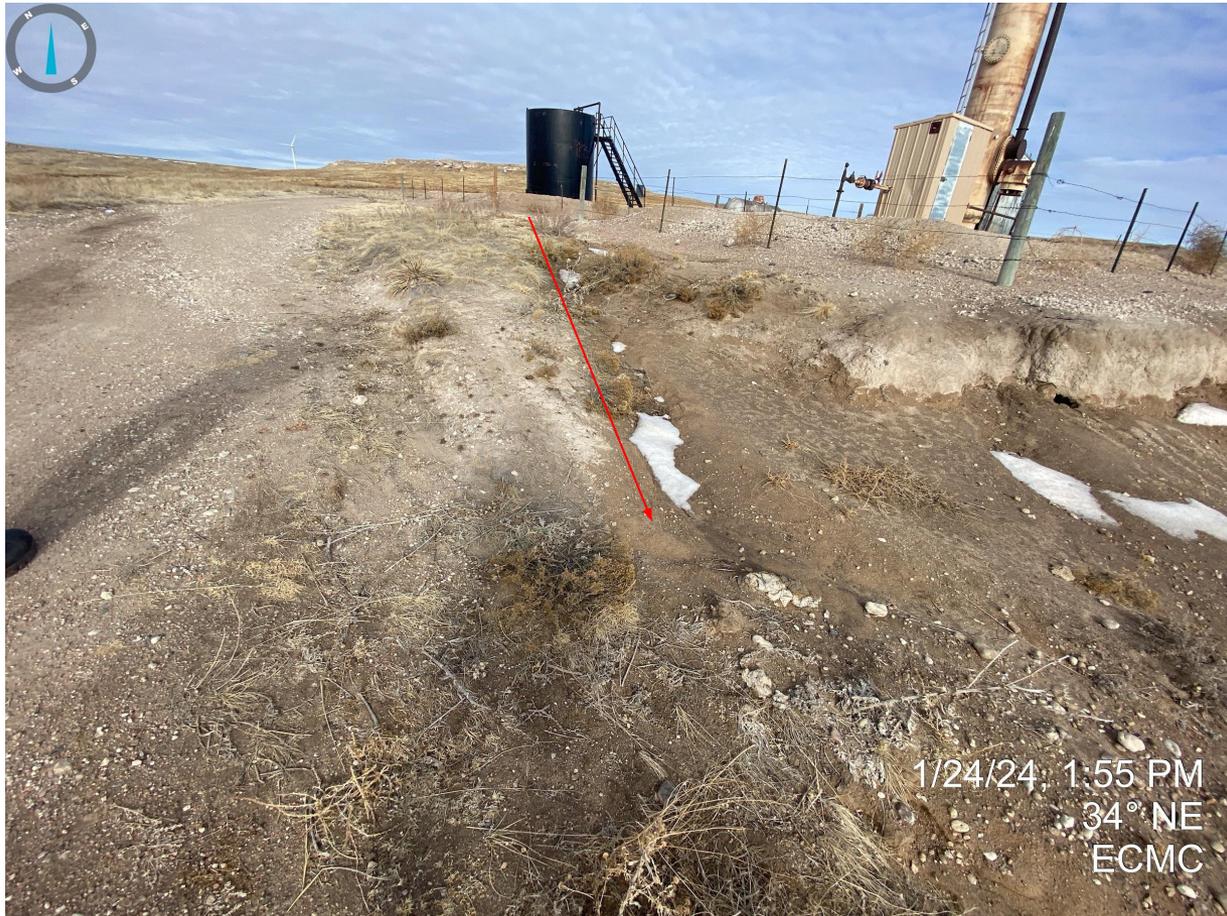
**Photo 2.** Taken near the vertical heater treater; see comments in Photo 1.

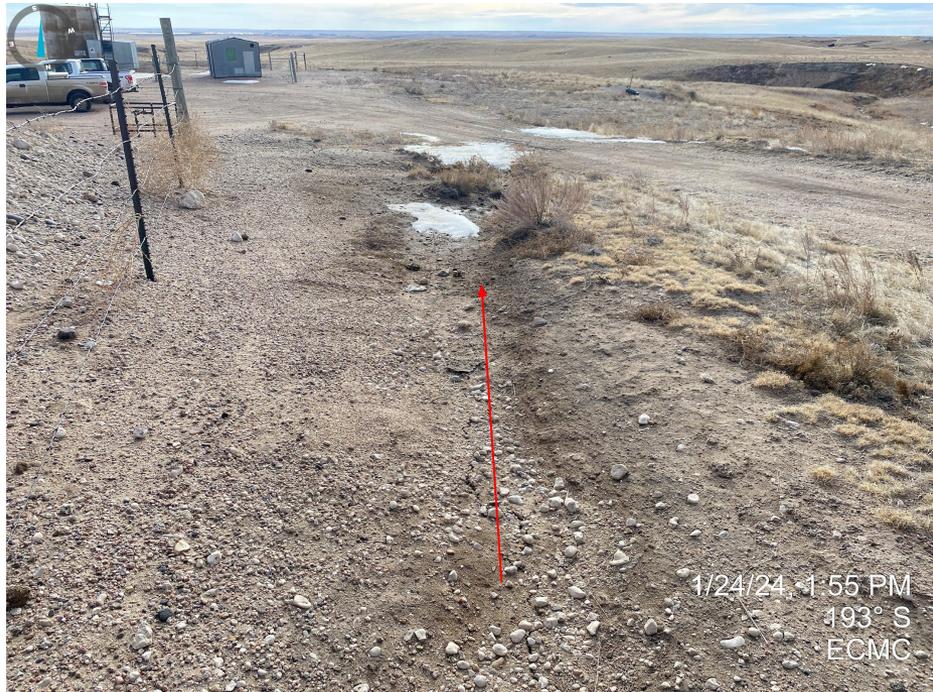
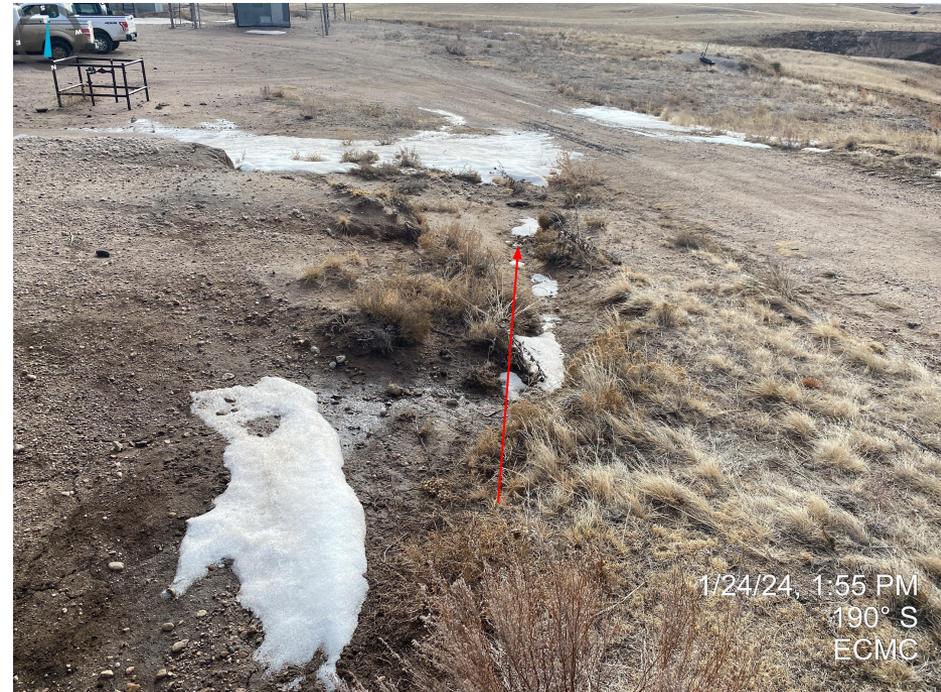
**Photos 3 & 4.** Taken near the vertical heater treater; see comments in Photo 1.

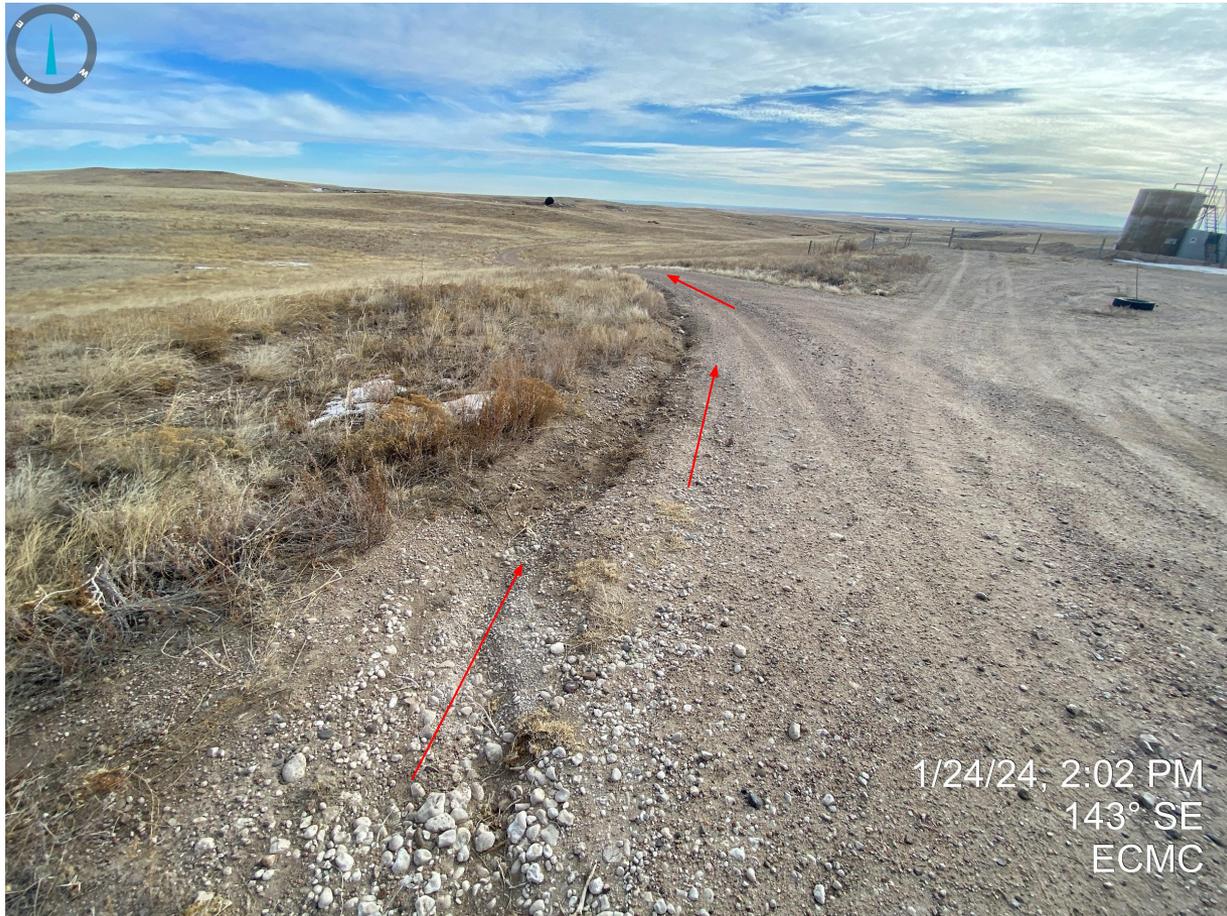
**Photo 5.** Taken from the access road east of the pit. Evidence of erosion degradation, previously documented, does not appear to have been repaired/stabilized with no evidence of control measures/BMPs observed that would prevent further erosion of the access road.

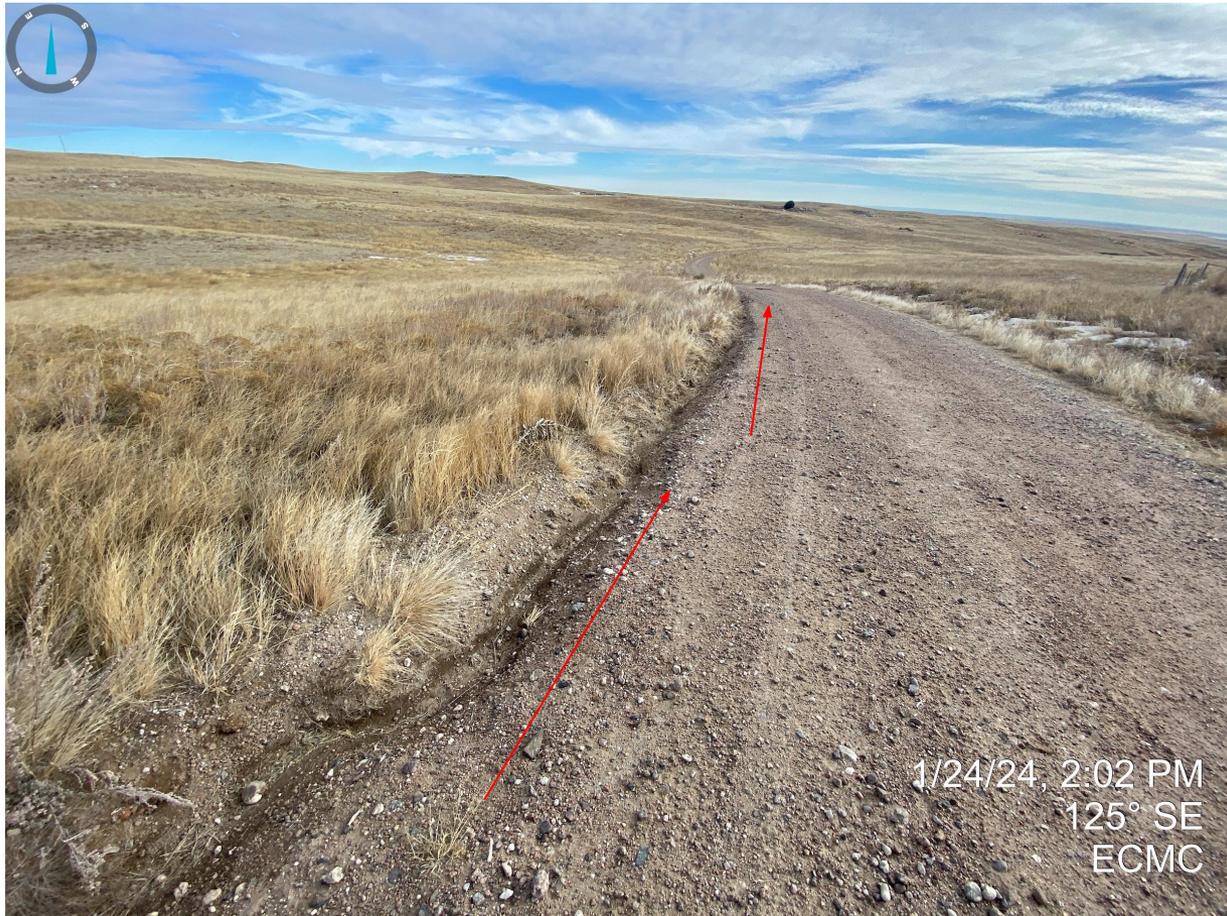
**Photo 6.** Taken from the access road east of the pit; see comments in Photo 5.

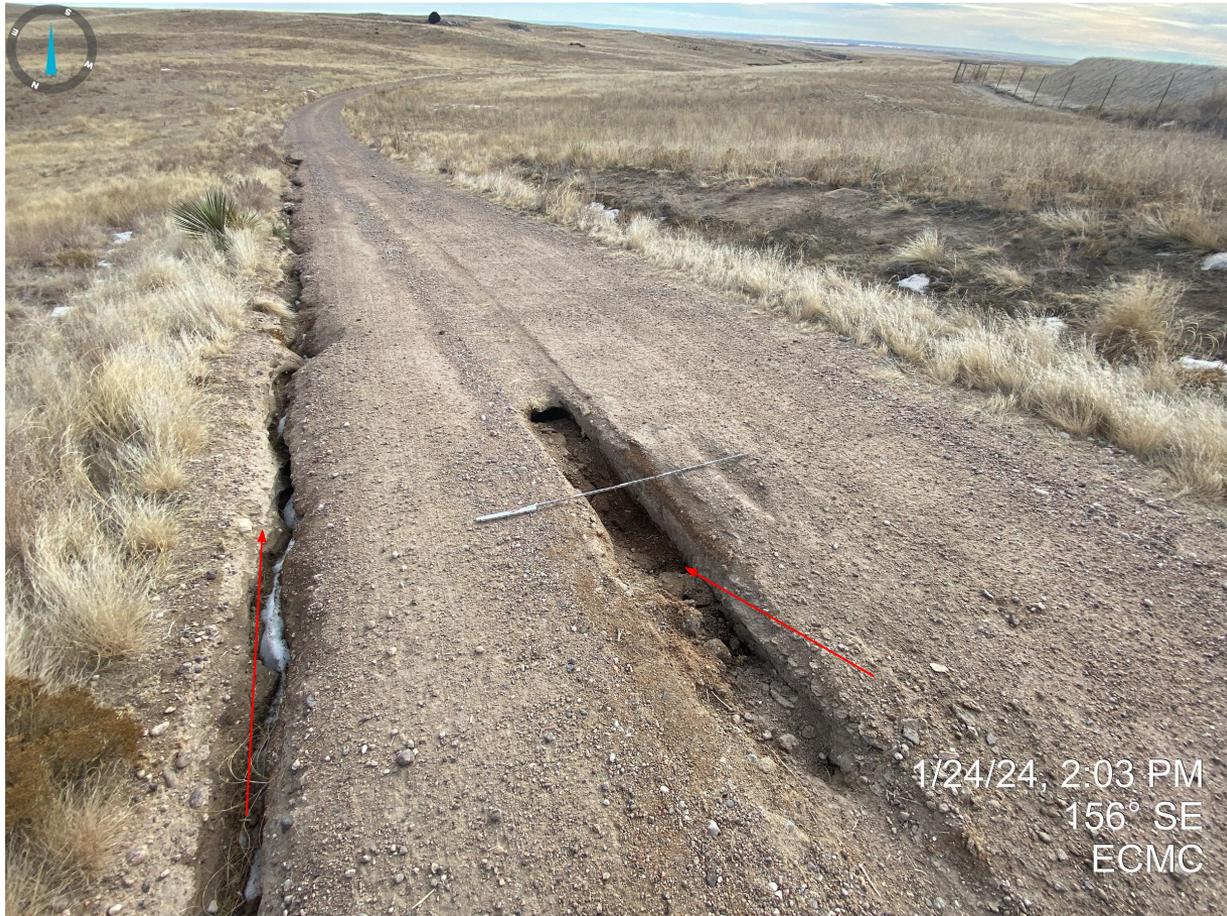
**Photo 7.** Subsidence observed along the access road. Also pictured, erosion degradation along the access road.

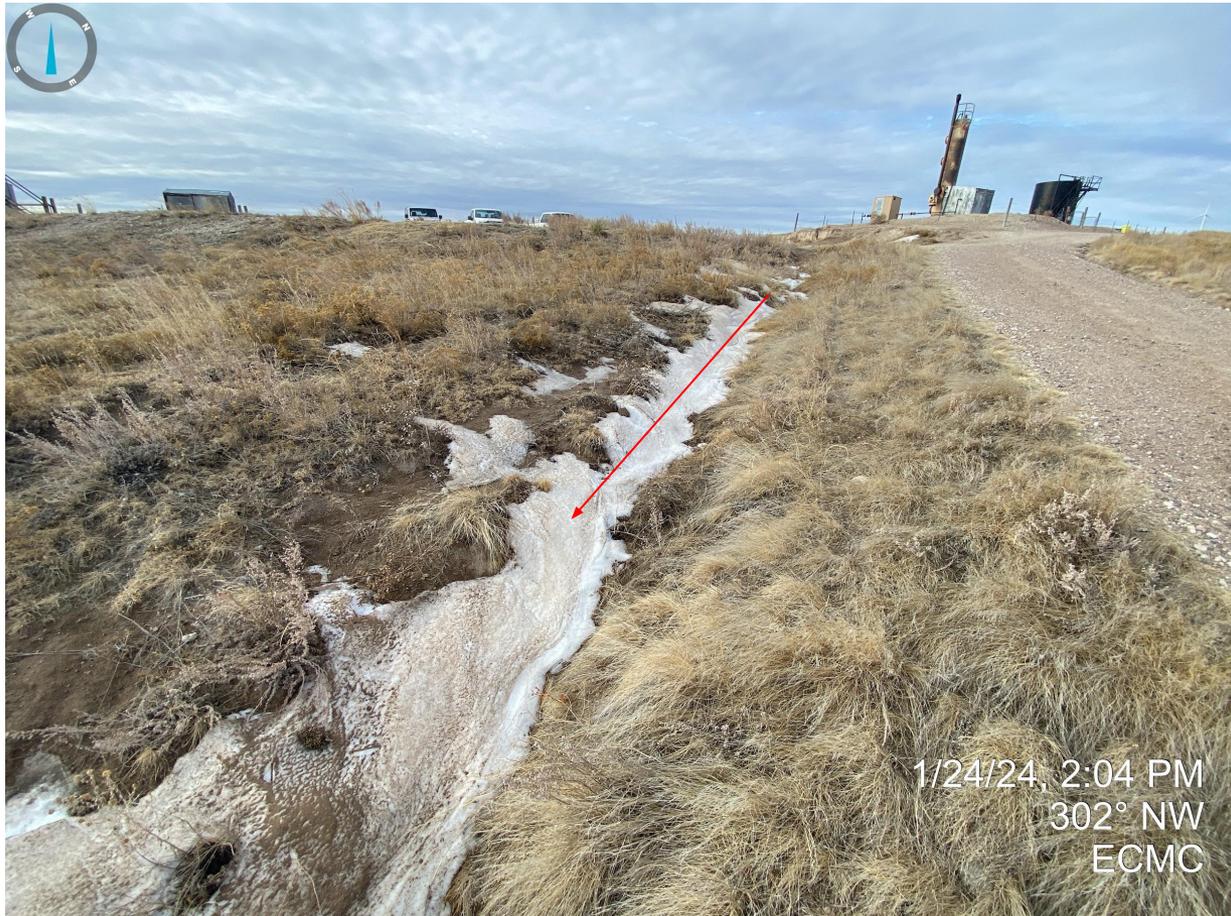
**Photo 8.** Taken from the access road east of the pit; see comments in Photo 5.

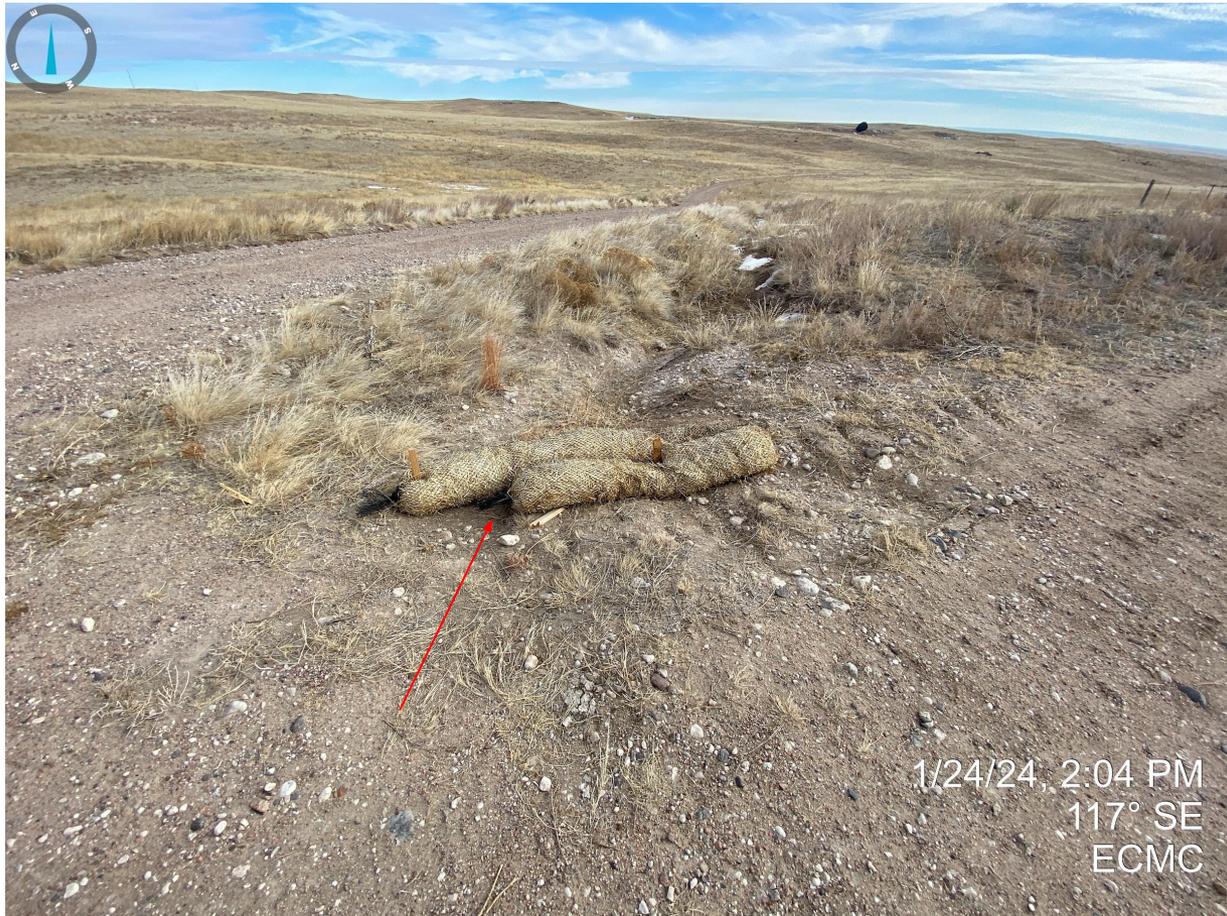
**Photo 9.** Stormwater control measures installed near the production areas/access road do not appear to be properly installed per good engineering practices (e.g. trenched and backfilled).

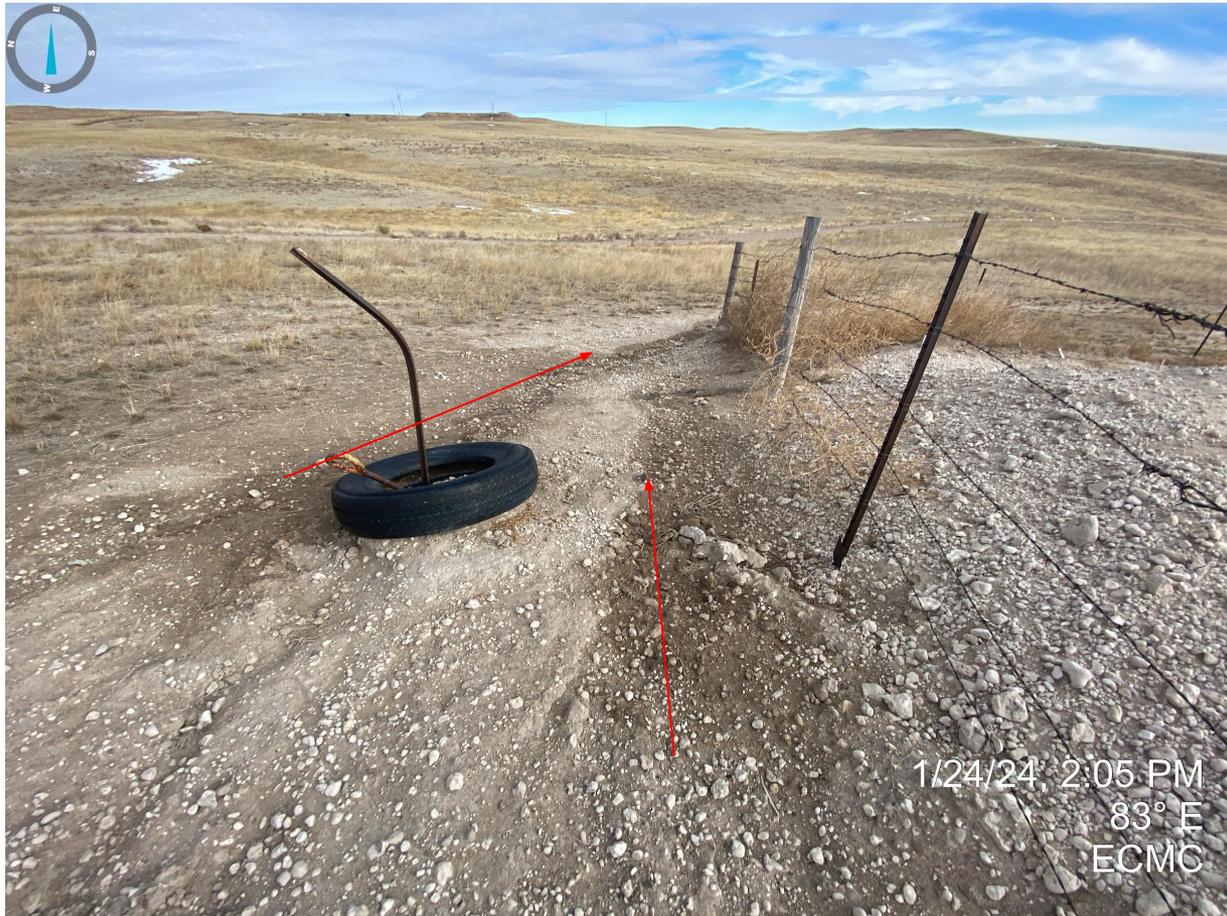
**Photo 10.** No apparent stormwater control measures/BMPs installed near the northeast corner of the pit.

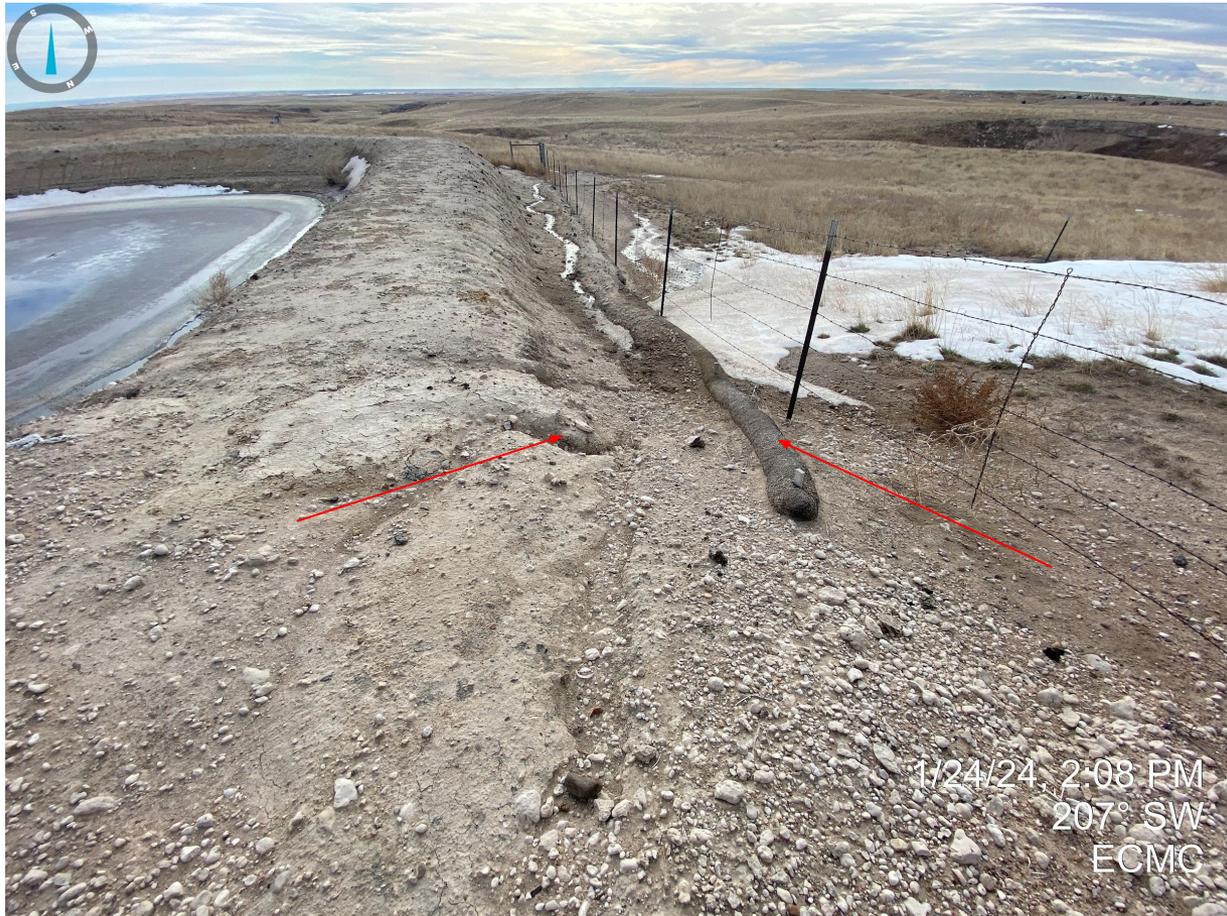
**Photo 11.** Taken from the northwestern portion of the pit. Photo illustrates erosion degradation on the pit walls and inadequate stormwater control measures around the base, or perimeter, of the pit.

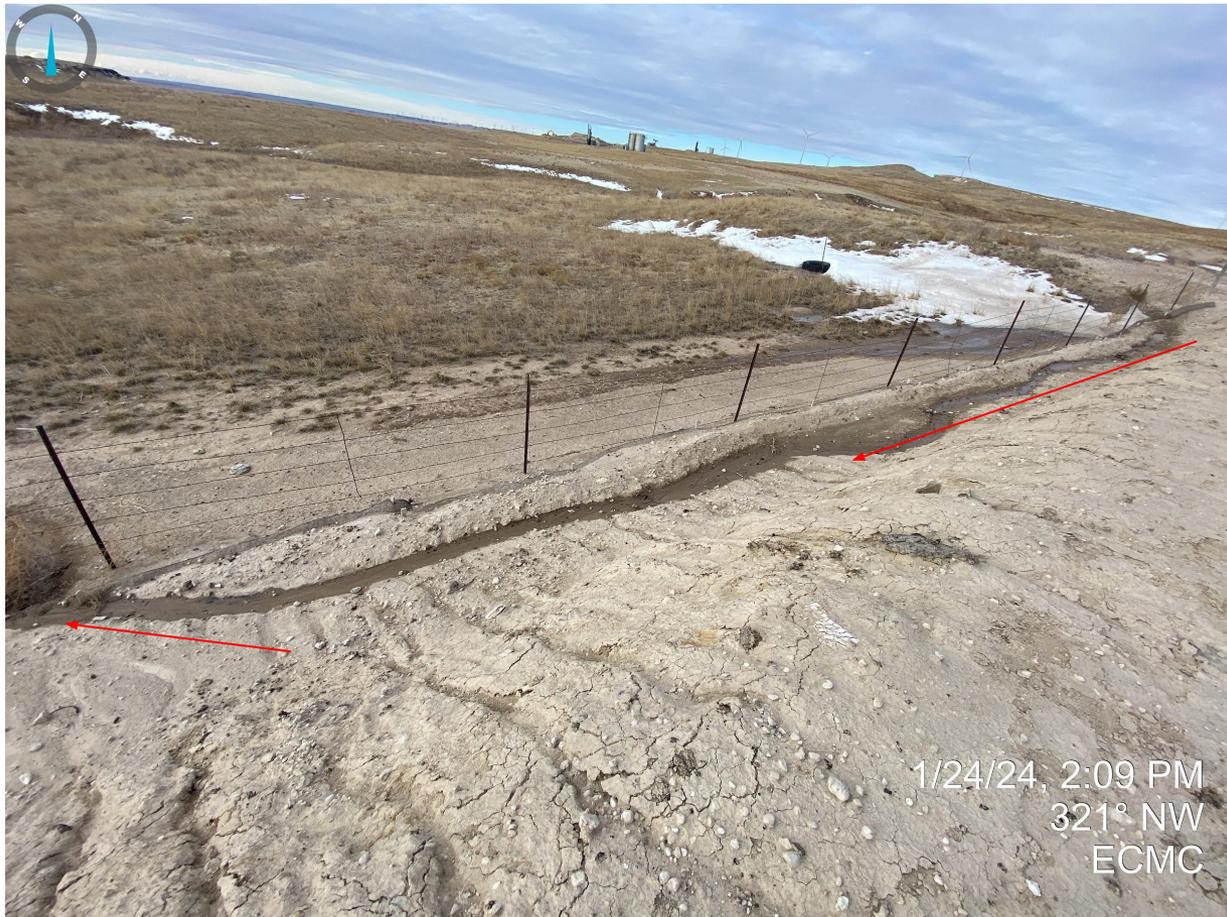
**Photo 12.** Taken near the southwest corner of the pit. During this inspection, Staff observed stormwater actively discharging off location into the adjacent salt kill areas. Stormwater control measures are inadequate for this location.

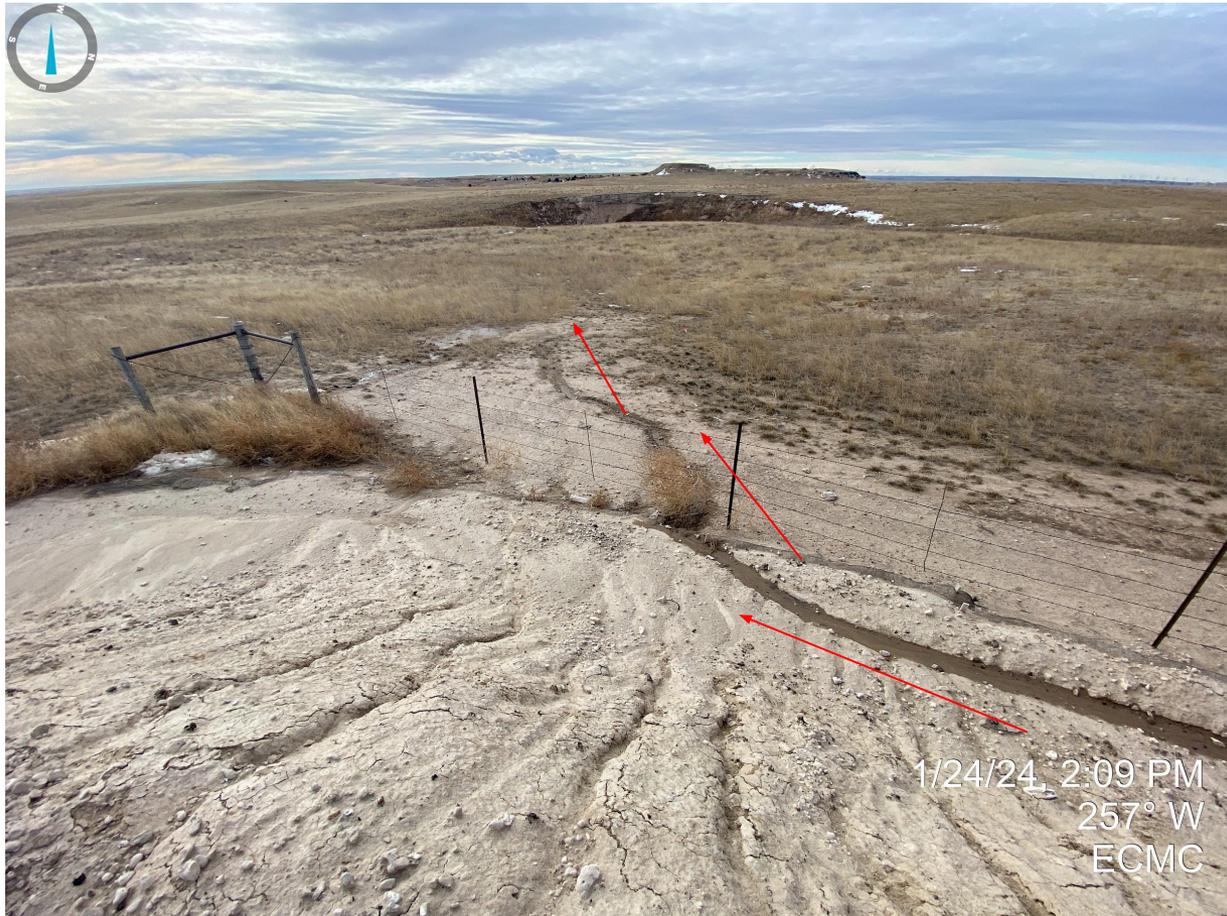
Photo 13. Continued from Photo 12.

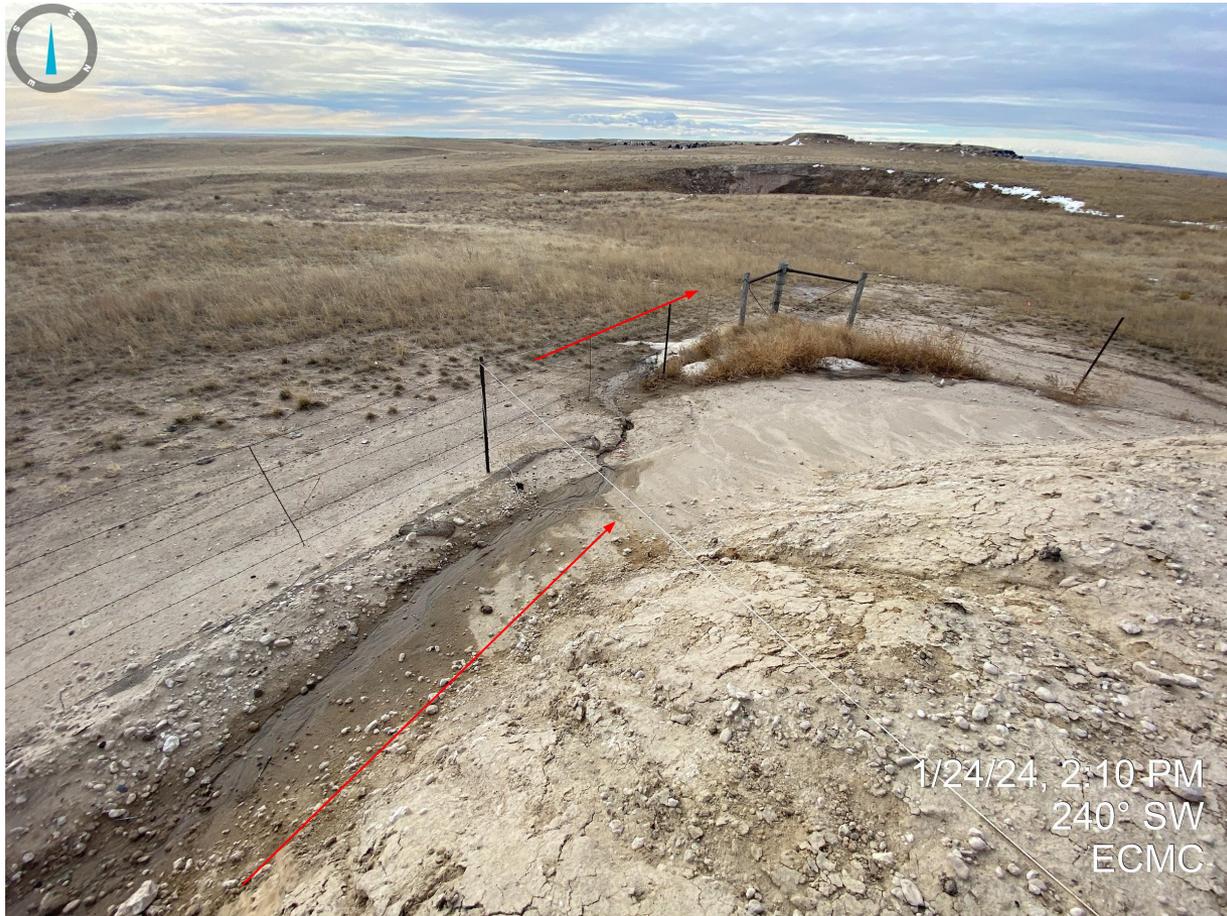
**Photo 14.** Southwest corner of the pit; see comments in Photo 12.

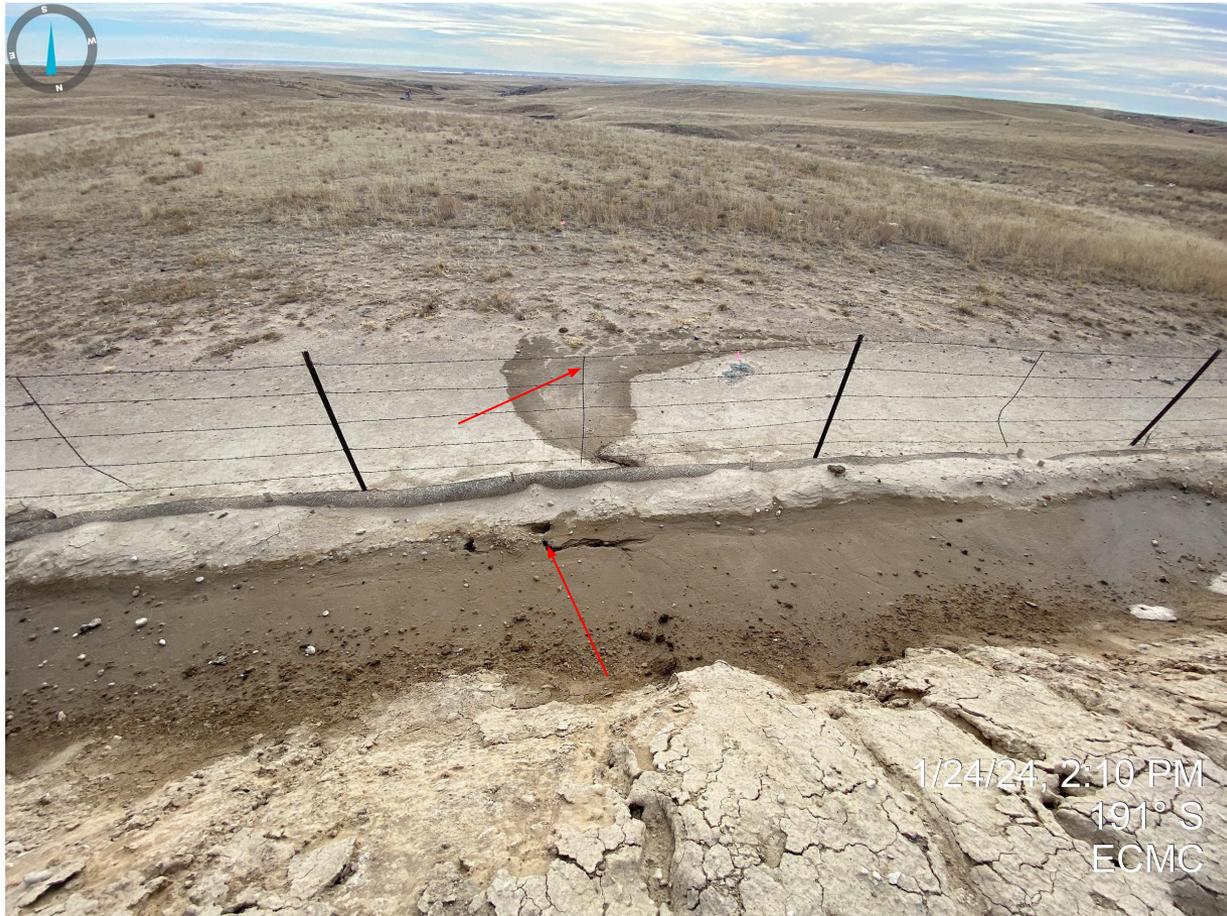
**Photo 15.** Southern portion of the pit; See comments in Photo 12.

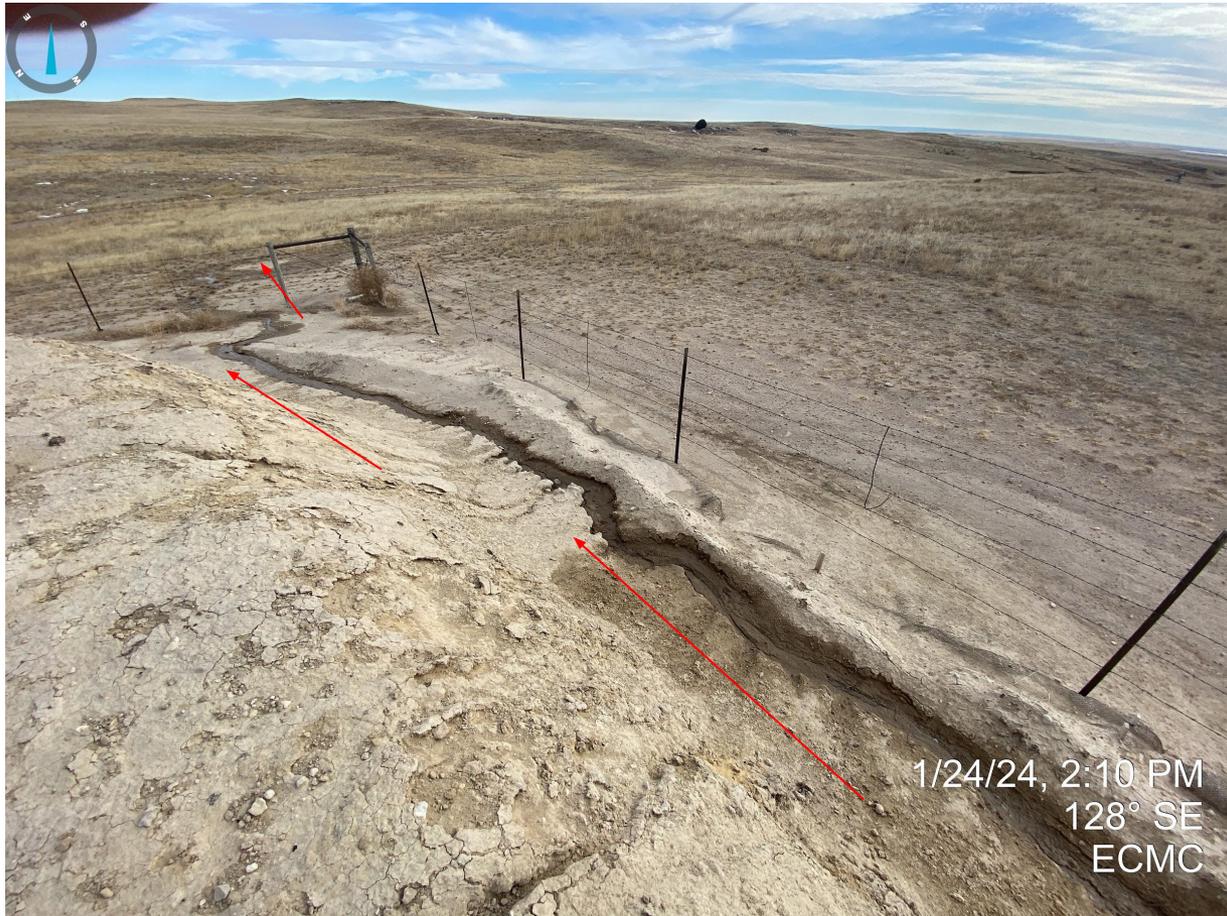
**Photo 16.** Taken near the southeast corner of the pit; see comments in Photo 12.

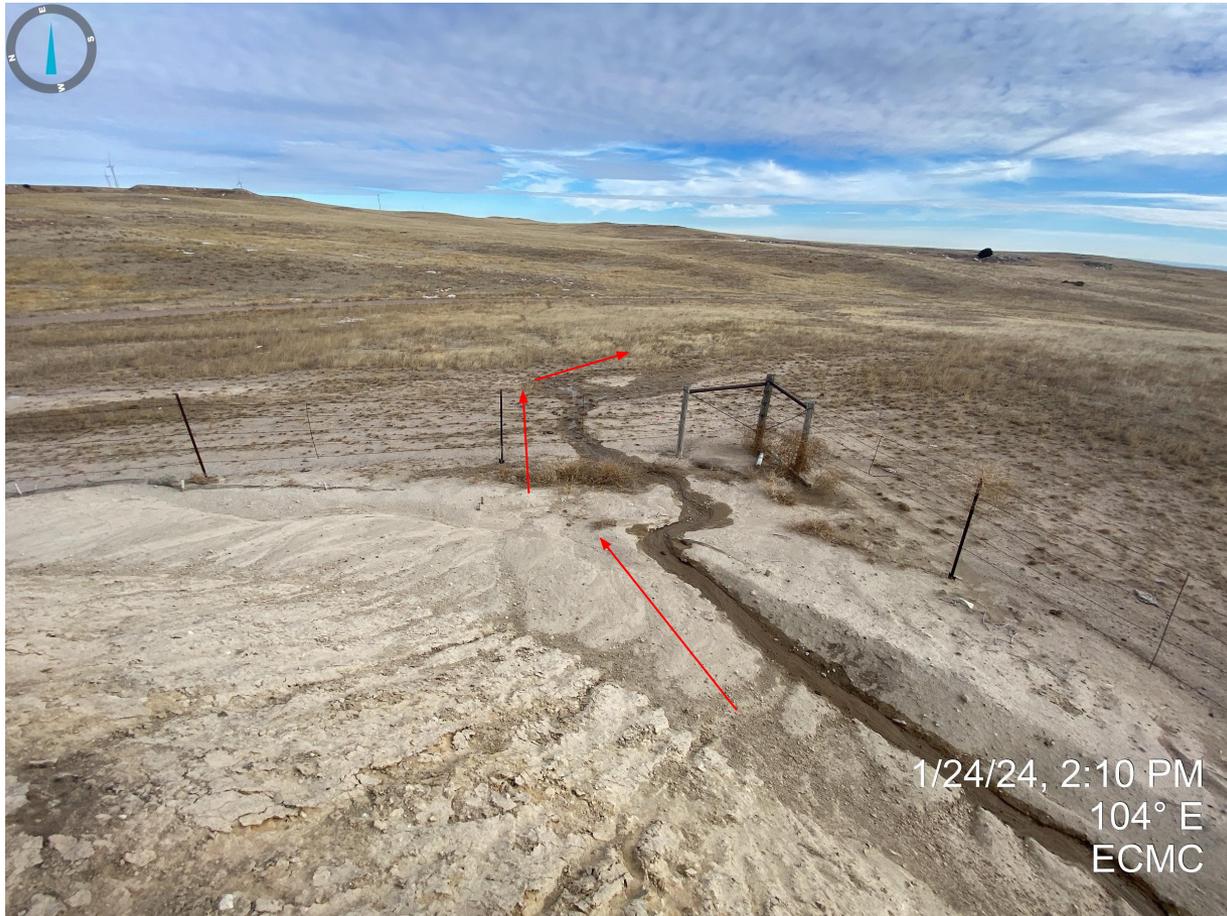
**Photo 17.** Southeast corner of the pit; see comments in Photo 12.

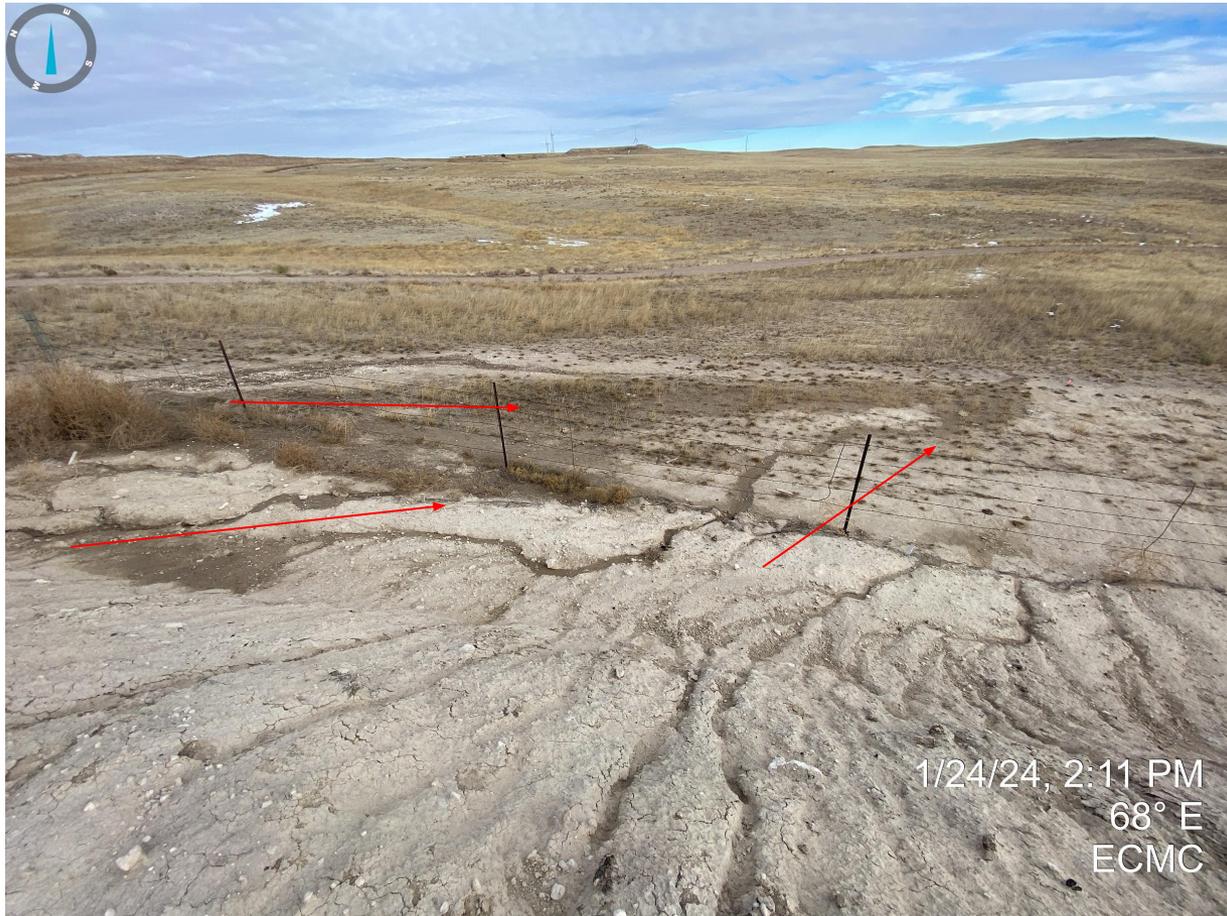
**Photo 18.** Northeast corner of the pit; see comments in Photo 12.

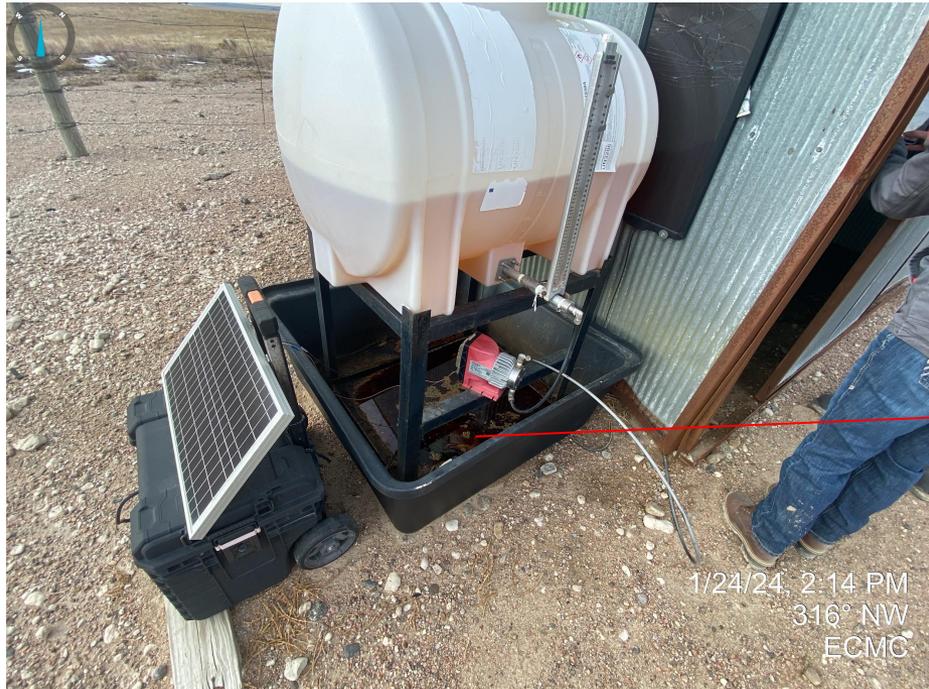
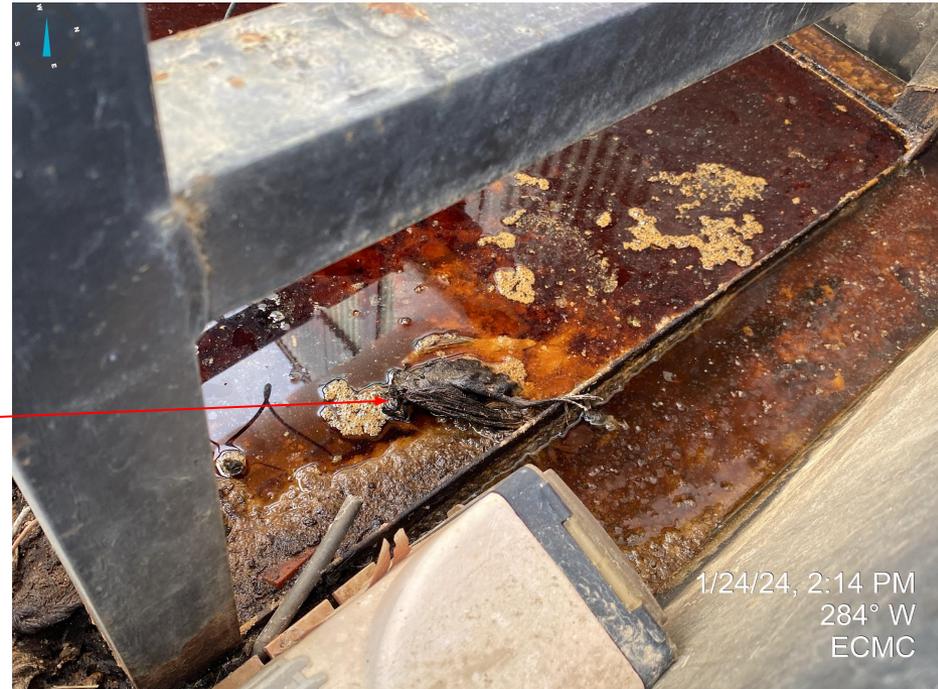
**Photo 19.** A wildlife mortality was observed within an uncovered secondary containment at the injection well day tank.
