Storm Water Management and Erosion control

Location Name: CAERUS PICEANCE LLC MURRAY-68S96W 1SWSW Pad

Location #: 334182

COLORADO
Energy & Carbon Management
Commission
Department of Natural Resources

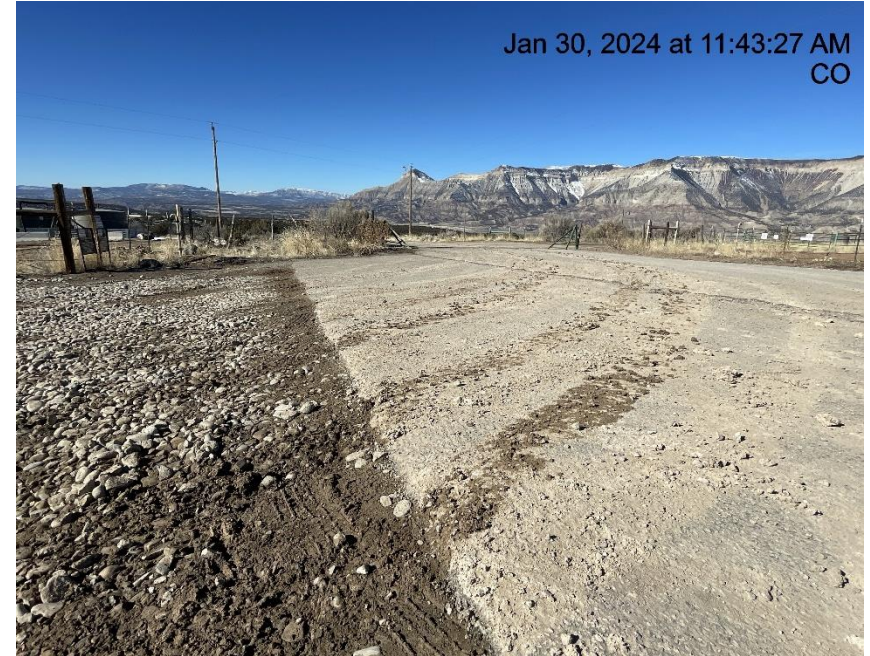
Photo # 4819 Insufficient tracking BMP's/tracking off location & onto to CR 306 (Spring Creek RD)

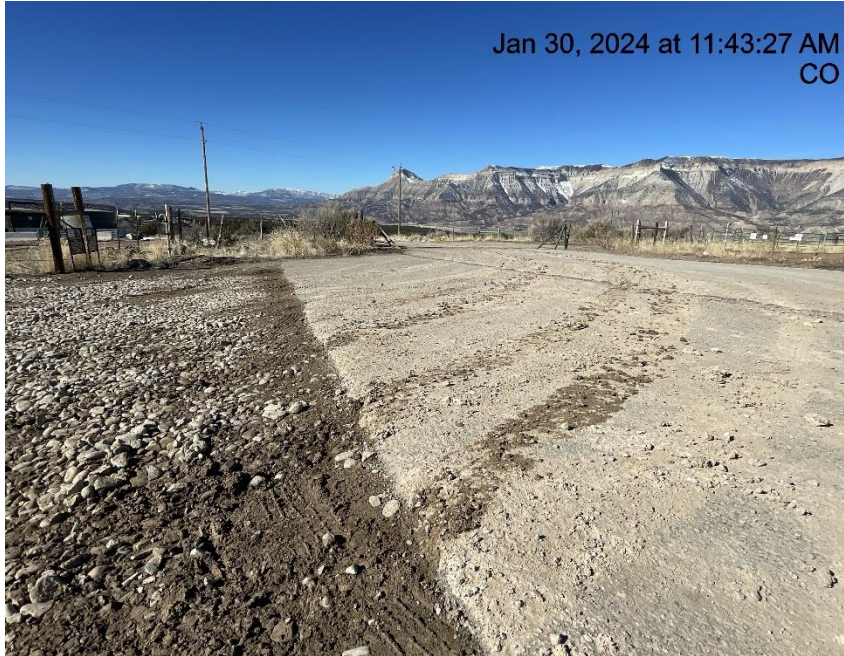
Photo # 4820 Insufficient tracking BMP's/tracking off location & onto to CR 306 (Spring Creek RD)

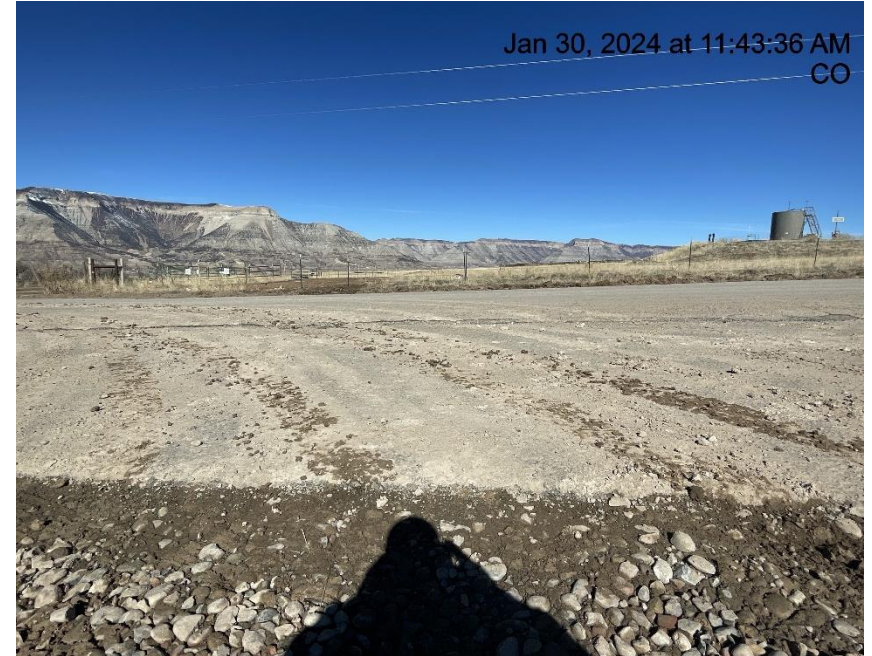
Photo # 4821 Insufficient tracking BMP's/tracking off location & onto to CR 306 (Spring Creek RD)

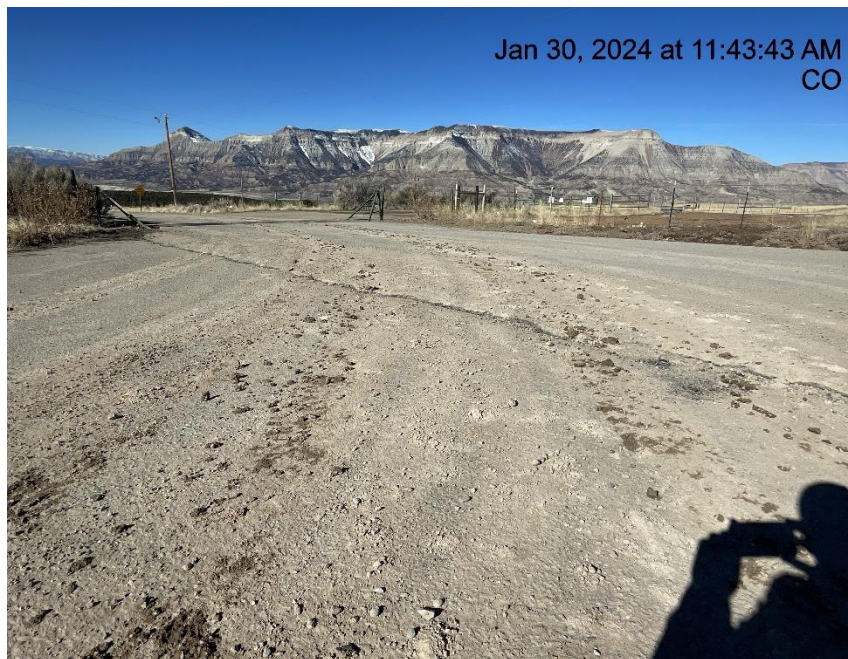
Photo # 4822 Insufficient tracking BMP's/tracking off location & onto to CR 306 (Spring Creek RD)

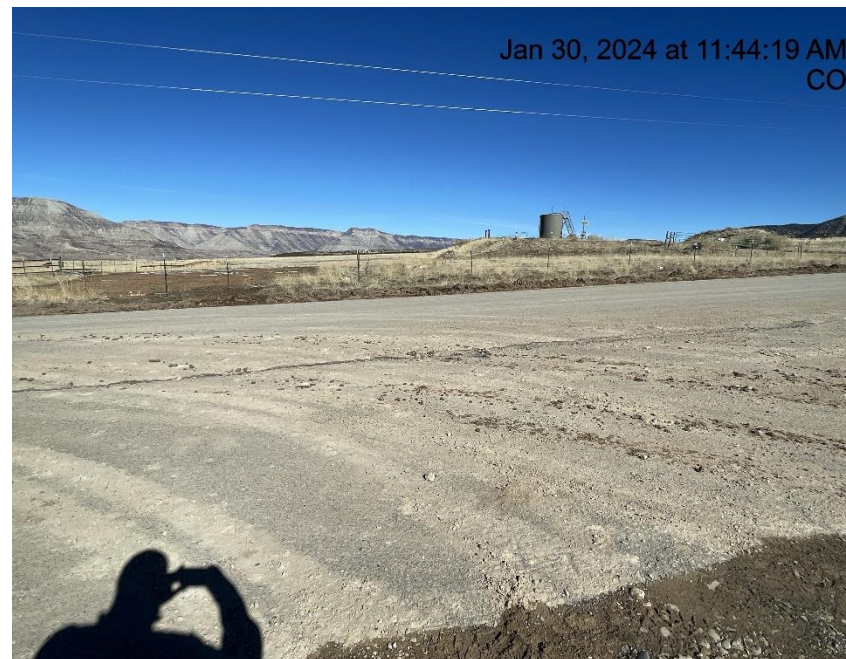
Photo # 4823 Insufficient tracking BMP's/tracking off location & onto to CR 306 (Spring Creek RD)

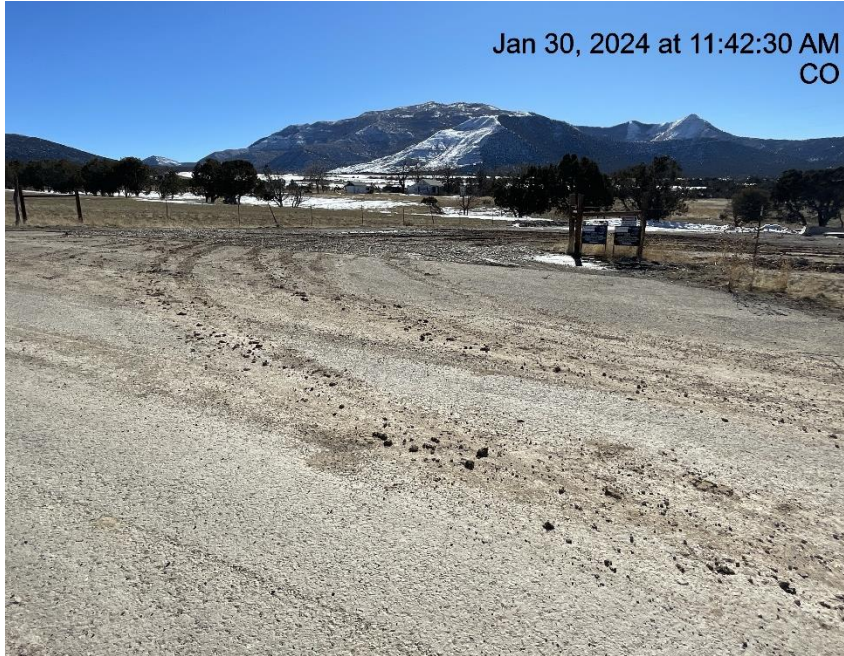
Photo # 4824 Insufficient tracking BMP's/tracking off location & onto to CR 306 (Spring Creek RD)

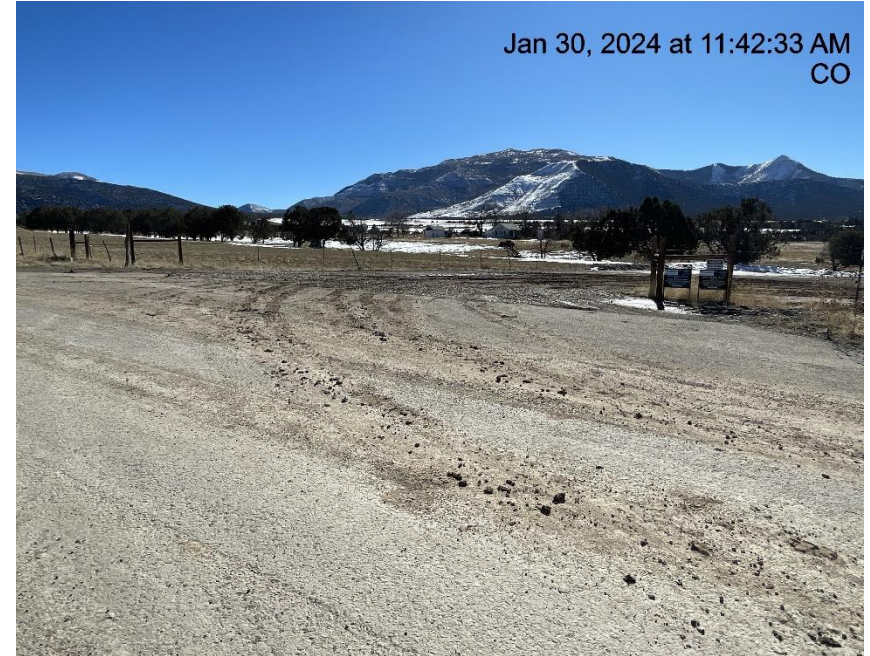
Photo # 4825 Insufficient tracking BMP's/tracking off location & onto to CR 306 (Spring Creek RD)

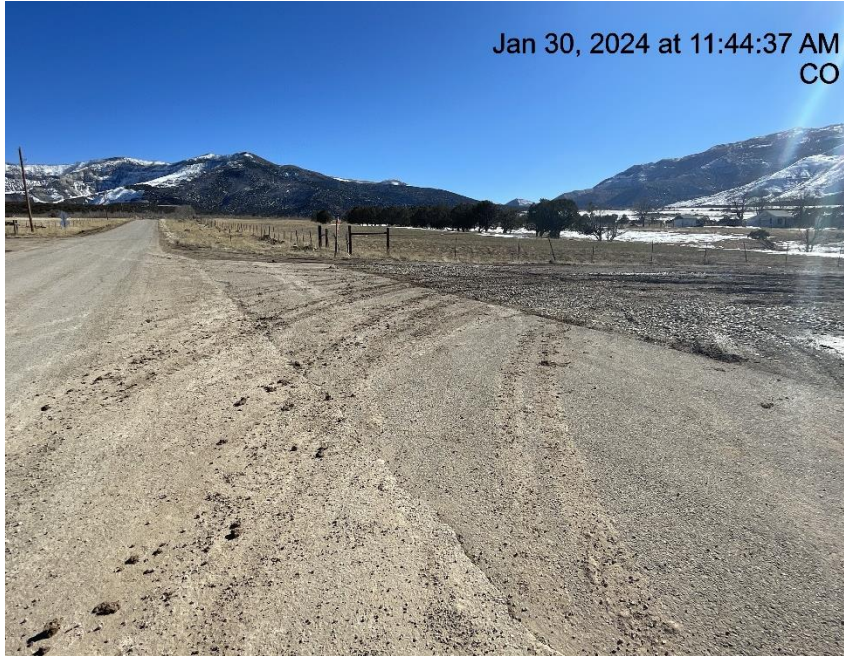
Photo # 4826 Insufficient tracking BMP's/tracking off location & onto to CR 306 (Spring Creek RD)

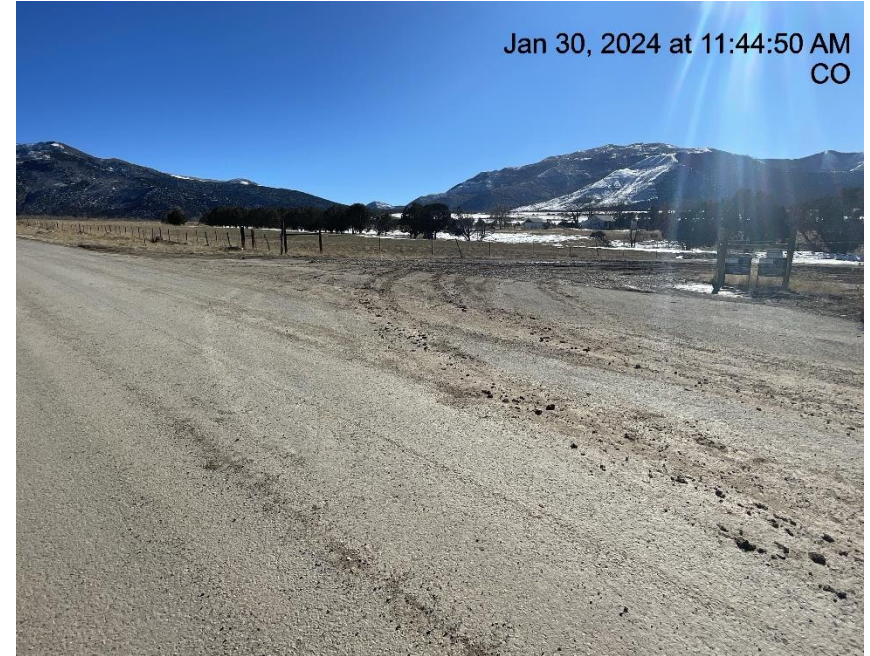
Photo # 4827 Insufficient tracking BMP's/tracking off location & onto to CR 306 (Spring Creek RD)

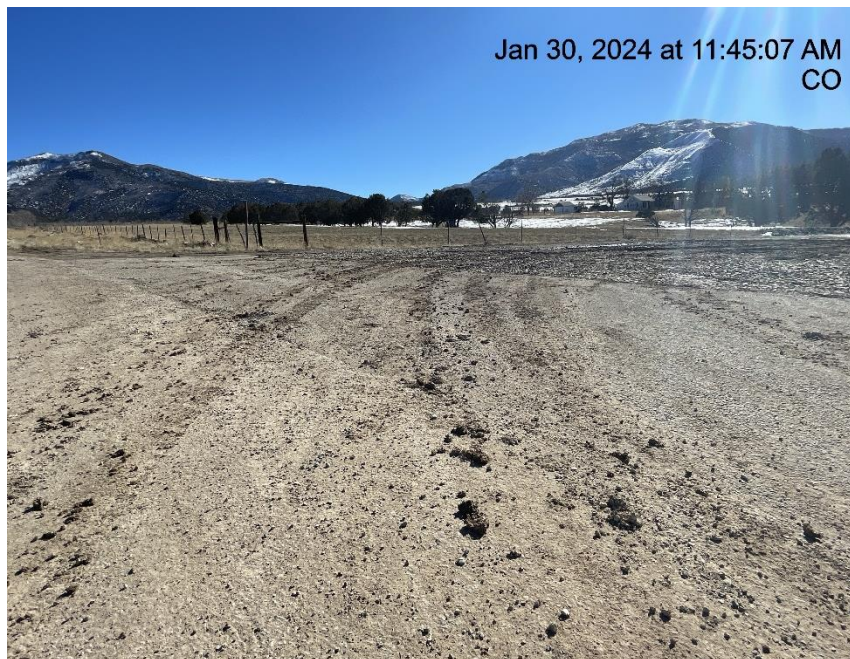
Photo # 4828 Insufficient tracking BMP's/tracking off location & onto to CR 306 (Spring Creek RD)

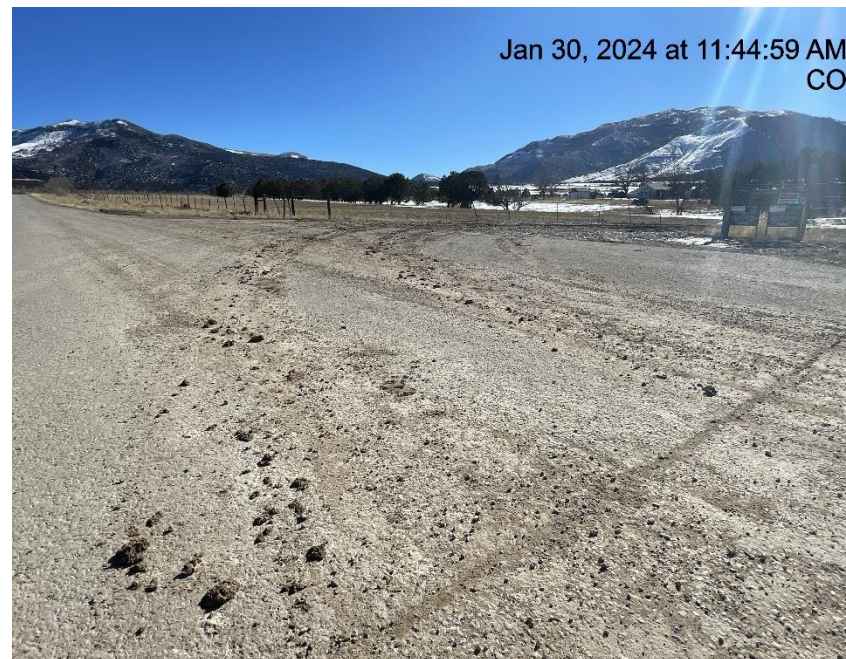
Photo # 4829 Insufficient tracking BMP's/tracking off location & onto to CR 306 (Spring Creek RD)

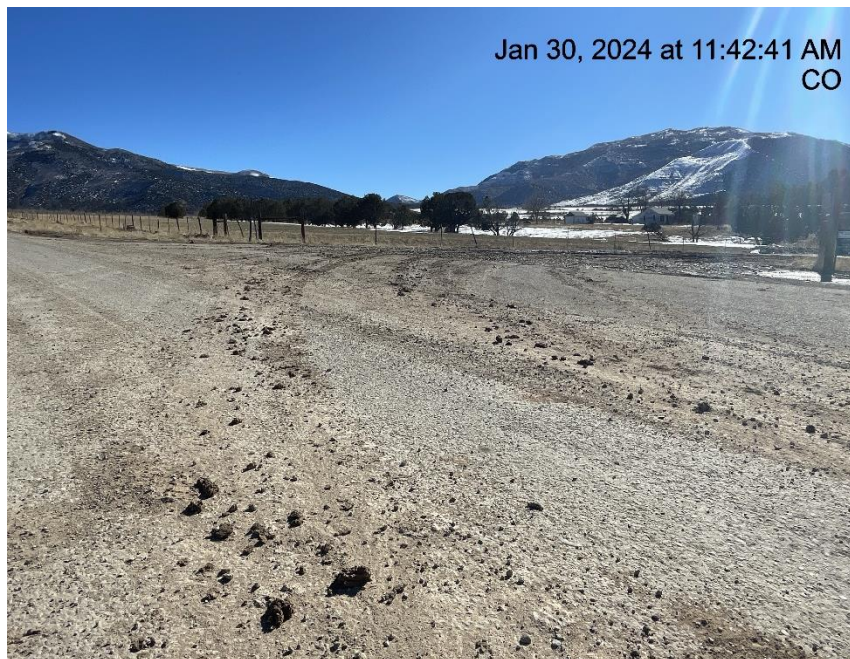
Photo # 4830 Insufficient tracking BMP's/tracking off location & onto to CR 306 (Spring Creek RD)

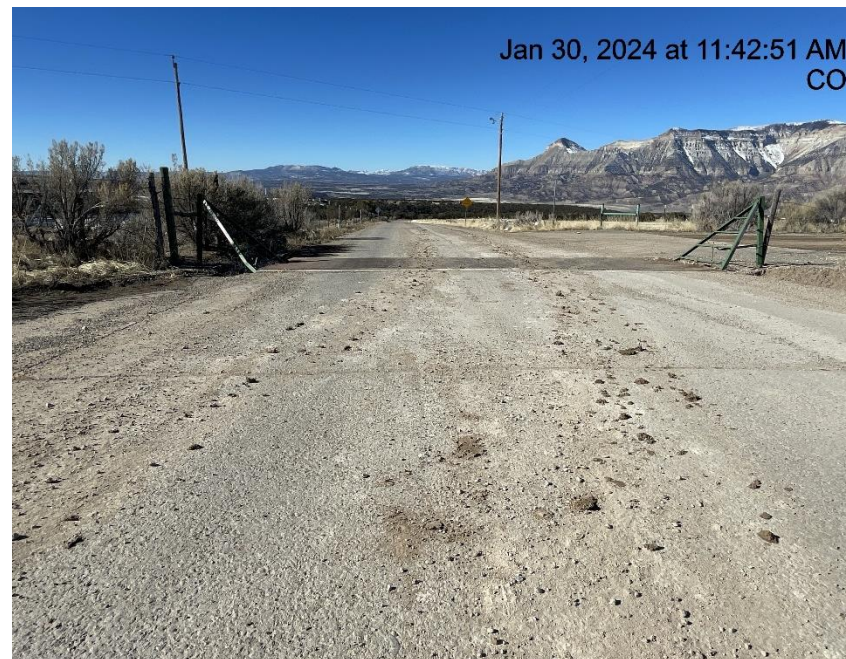
Photo # 4831 Insufficient tracking BMP's/tracking off location & onto to CR 306 (Spring Creek RD)

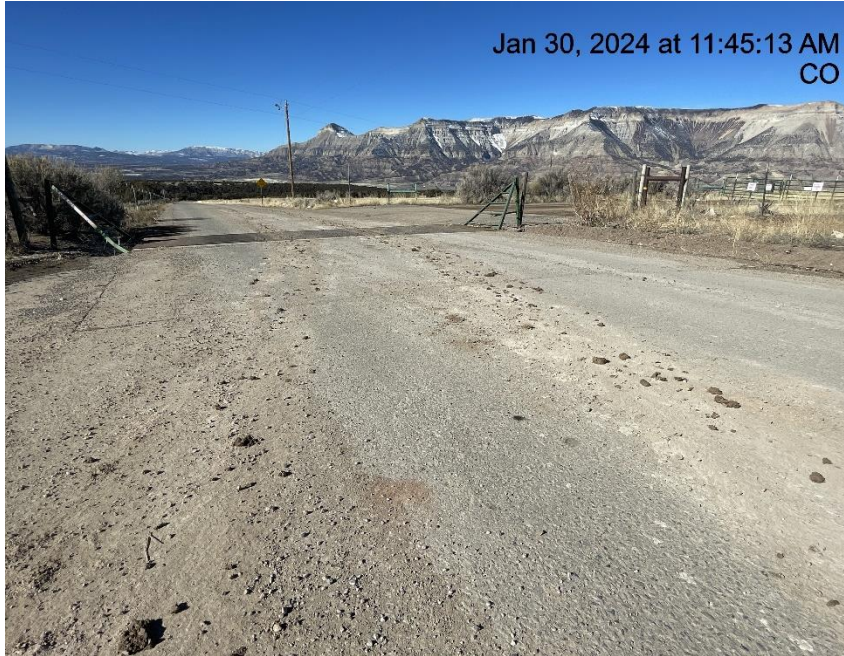
Photo # 4832 Insufficient tracking BMP's/tracking off location & onto to CR 306 (Spring Creek RD)

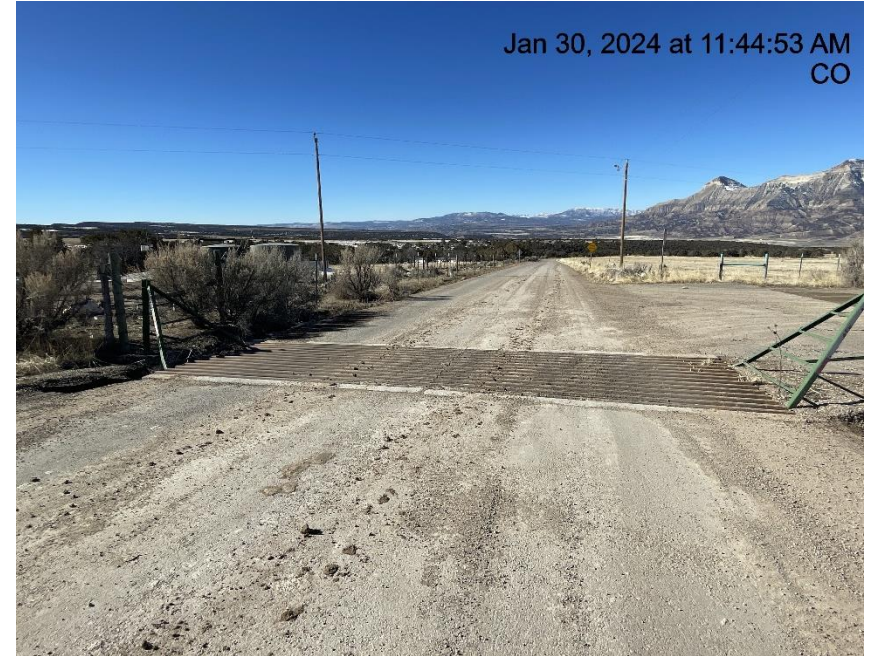
Photo # 4833 Insufficient tracking BMP's/tracking off location & onto to CR 306 (Spring Creek RD)

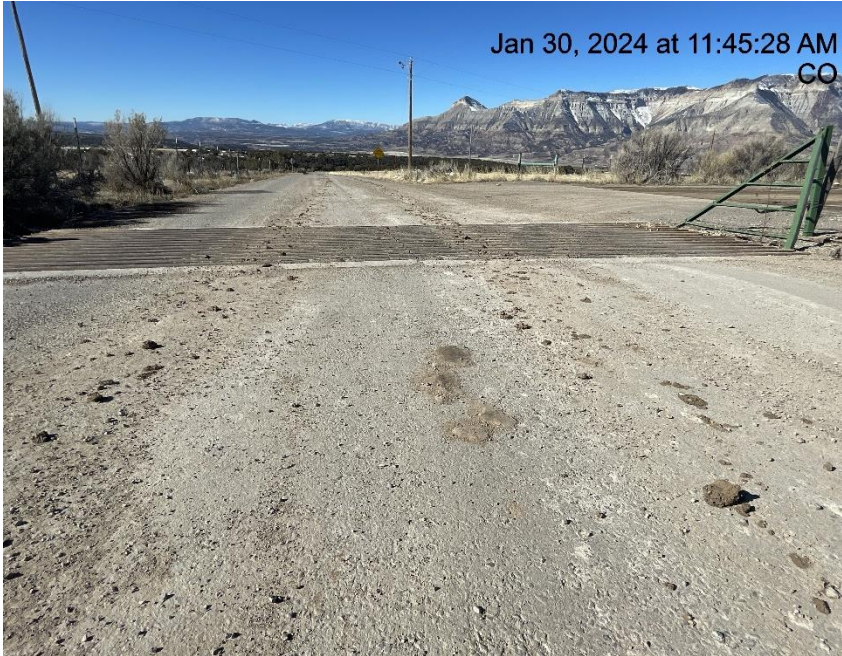
Photo # 4834 Insufficient tracking BMP's/tracking off location & onto to CR 306 (Spring Creek RD)

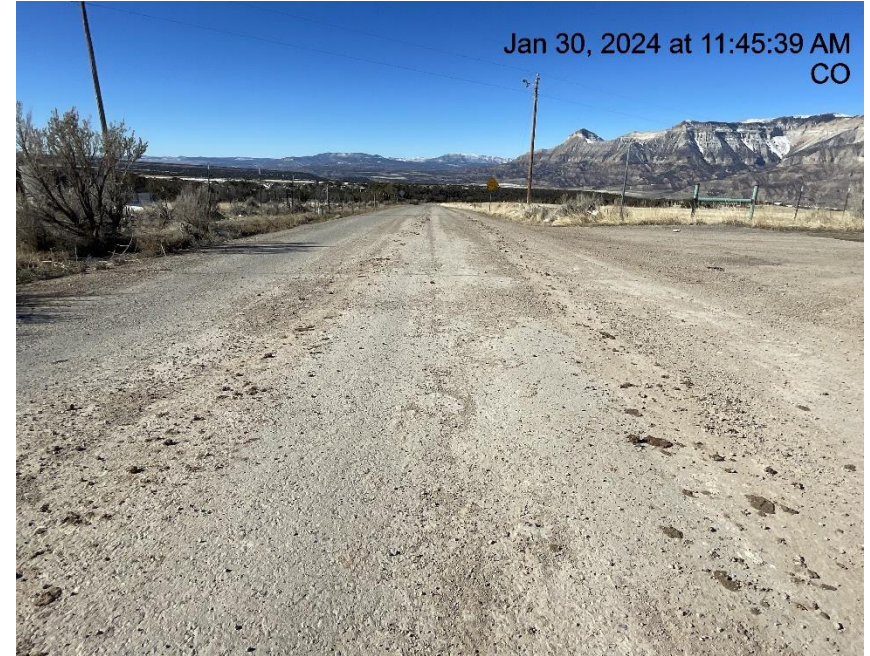
Photo # 4835 Insufficient tracking BMP's/tracking off location & onto to CR 306 (Spring Creek RD)

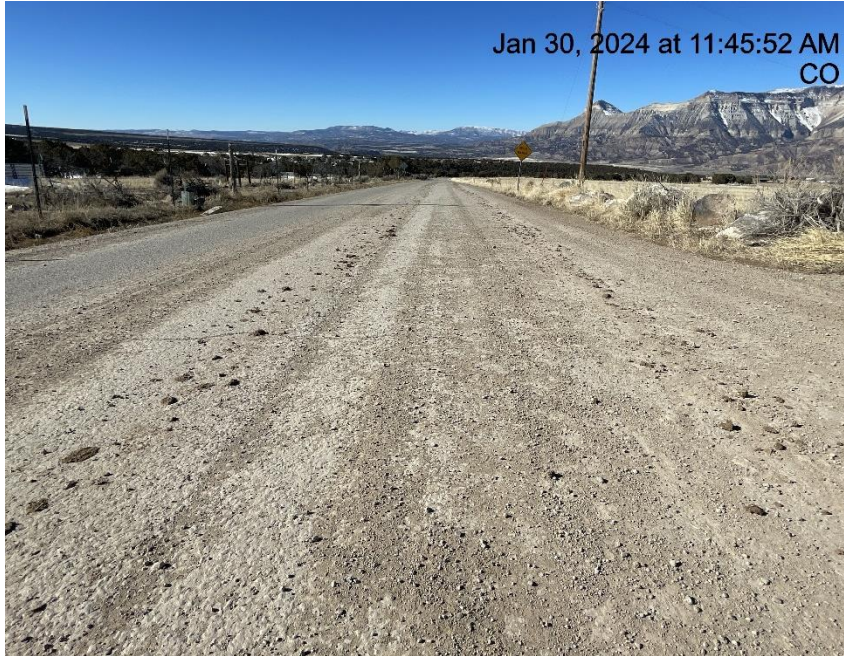
Photo # 4836 Insufficient tracking BMP's/tracking off location & onto to CR 306 (Spring Creek RD)

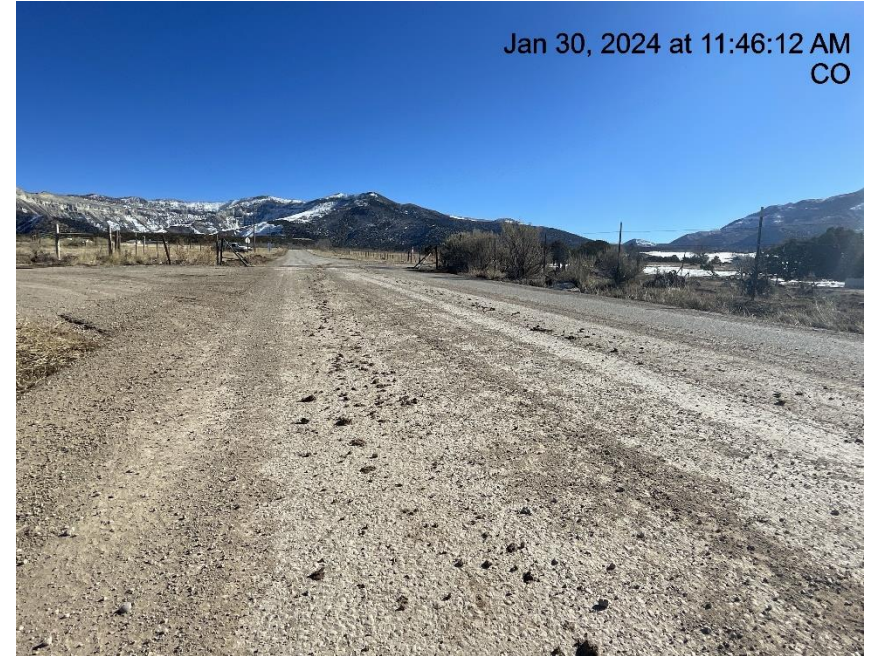
Photo # 4837 Insufficient tracking BMP's/tracking off location & onto to CR 306 (Spring Creek RD)

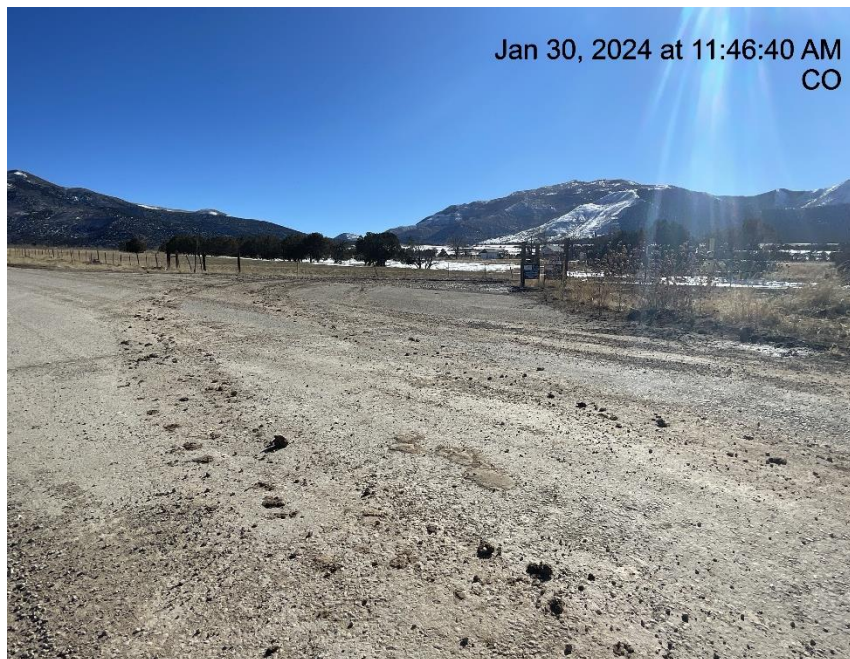
Photo # 4838 Insufficient tracking BMP's/tracking off location & onto to CR 306 (Spring Creek RD)

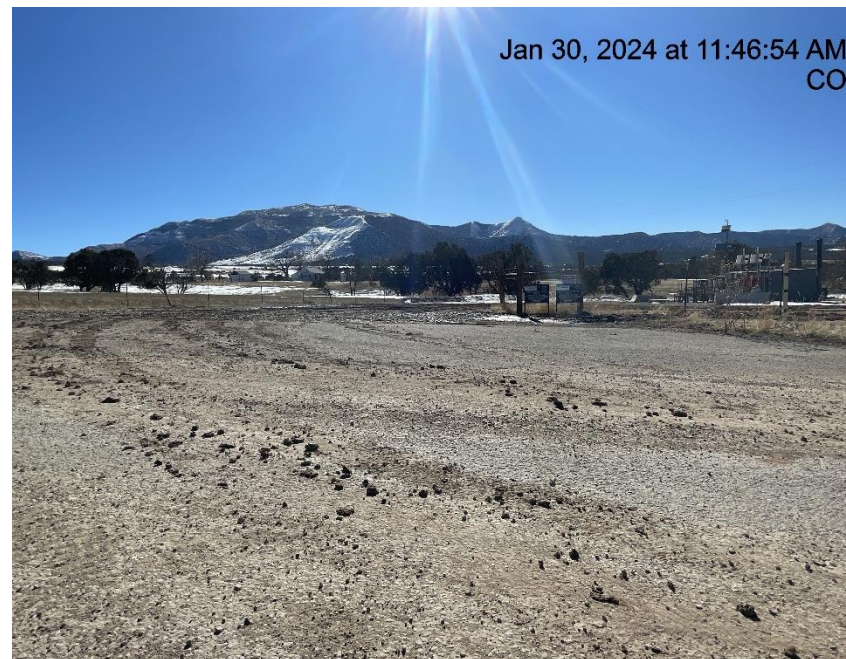
Photo # 4839 Insufficient tracking BMP's/tracking off location & onto to CR 306 (Spring Creek RD)

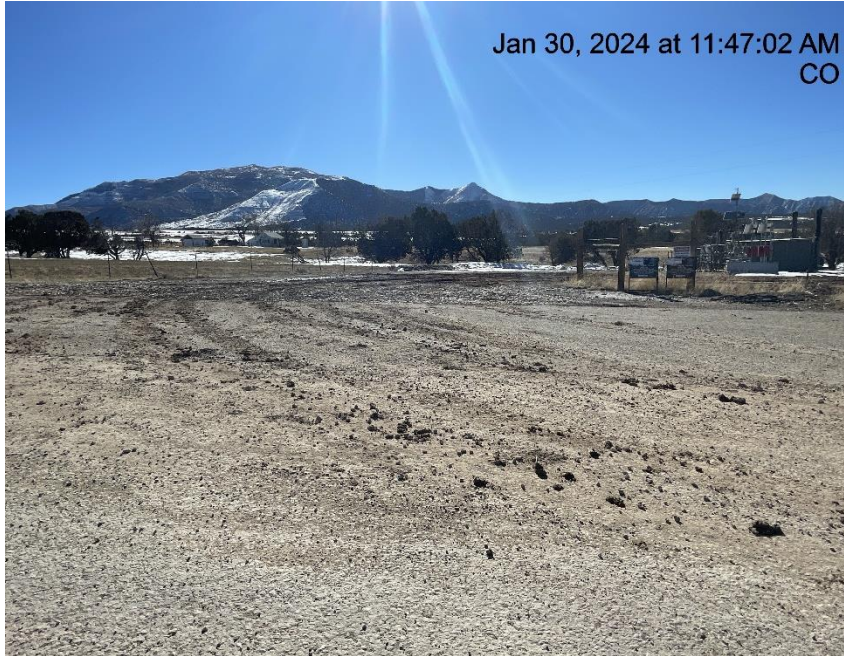
Photo # 4840 Insufficient tracking BMP's/tracking off location & onto to CR 306 (Spring Creek RD)

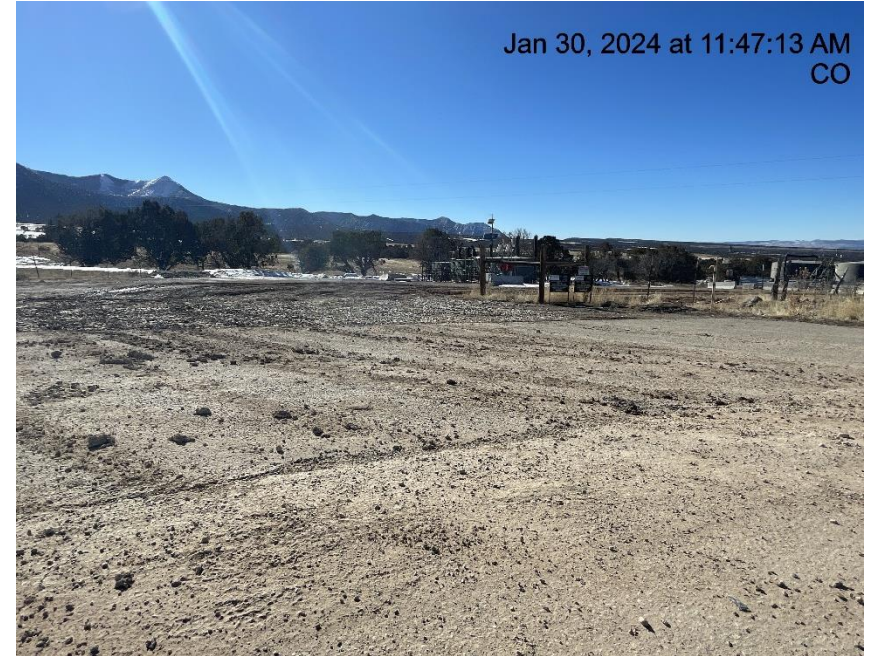
Photo # 4841 Insufficient tracking BMP's/tracking off location & onto to CR 306 (Spring Creek RD)

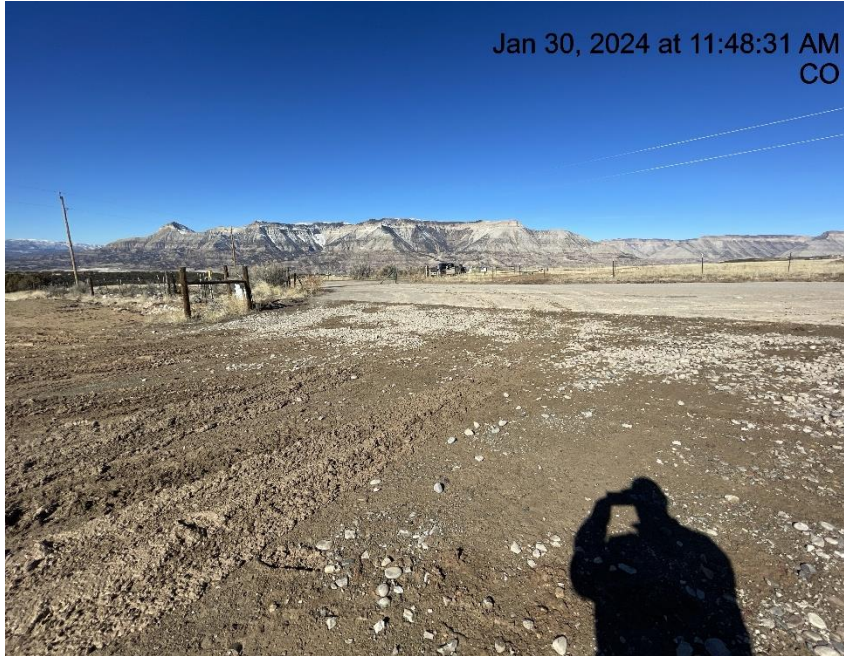
Photo # 4842 Insufficient tracking BMP's/tracking off location & onto to CR 306 (Spring Creek RD)

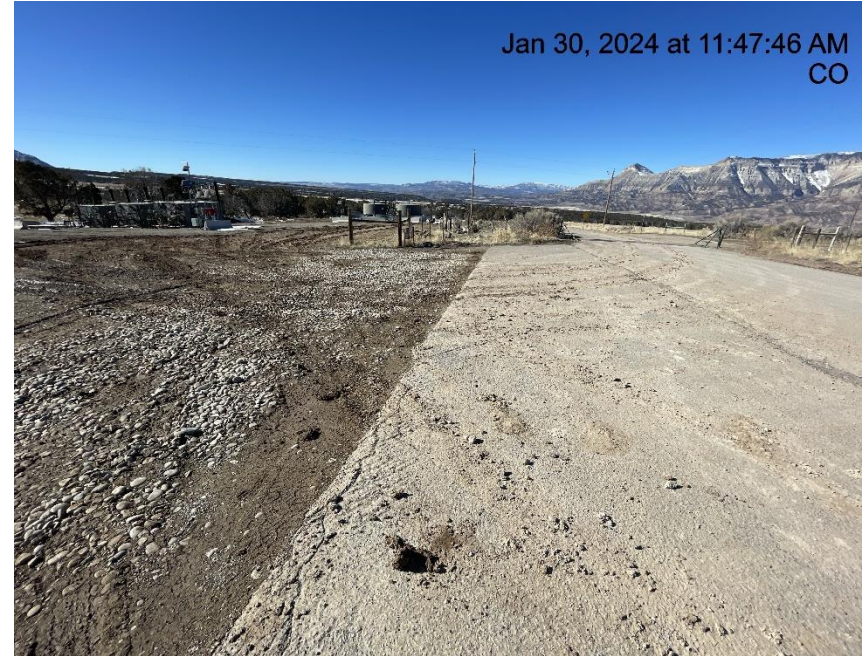
Photo # 4843 Insufficient tracking BMP's/tracking off location & onto to CR 306 (Spring Creek RD)
