## Inspection Photos

Location Name: CAERUS PICEANCE LLC FEDERAL 28-15X (PJ28) Pad

Location #: 334065

**COLORADO**  
Energy & Carbon Management  
Commission  
Department of Natural Resources

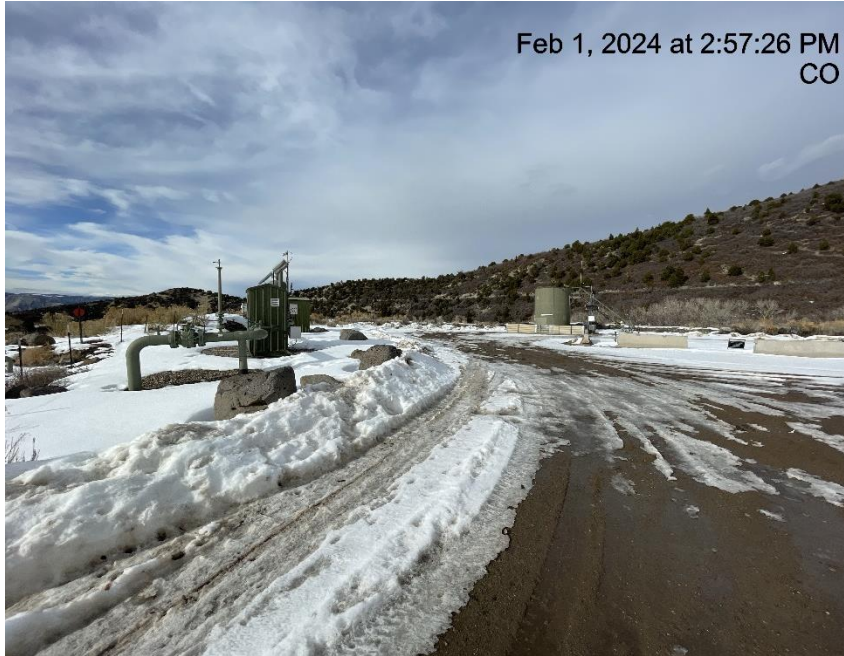
Photo # 5391 From entrance to location

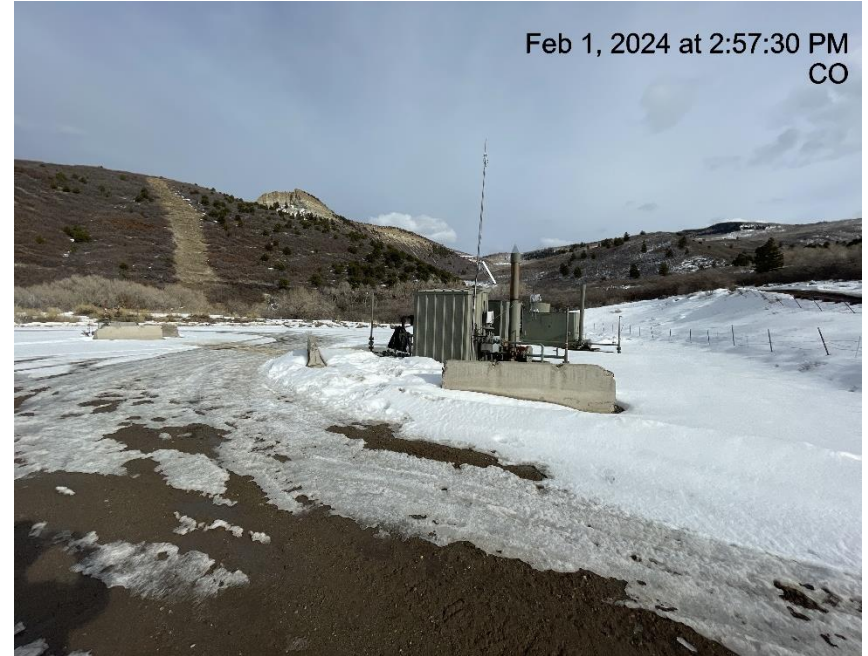
Photo # 5392 From entrance to location

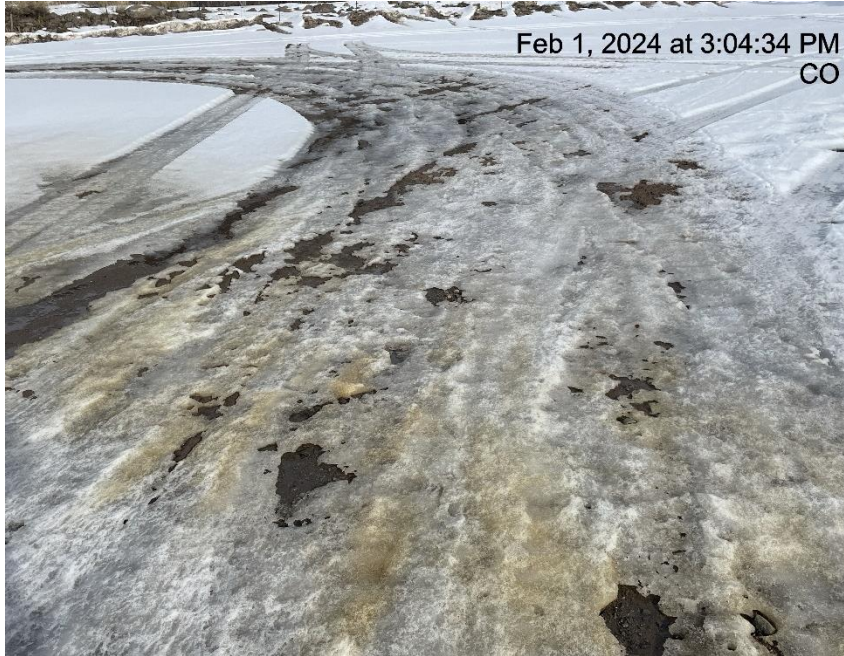
**Photo # 5401 Stained soils & snow**

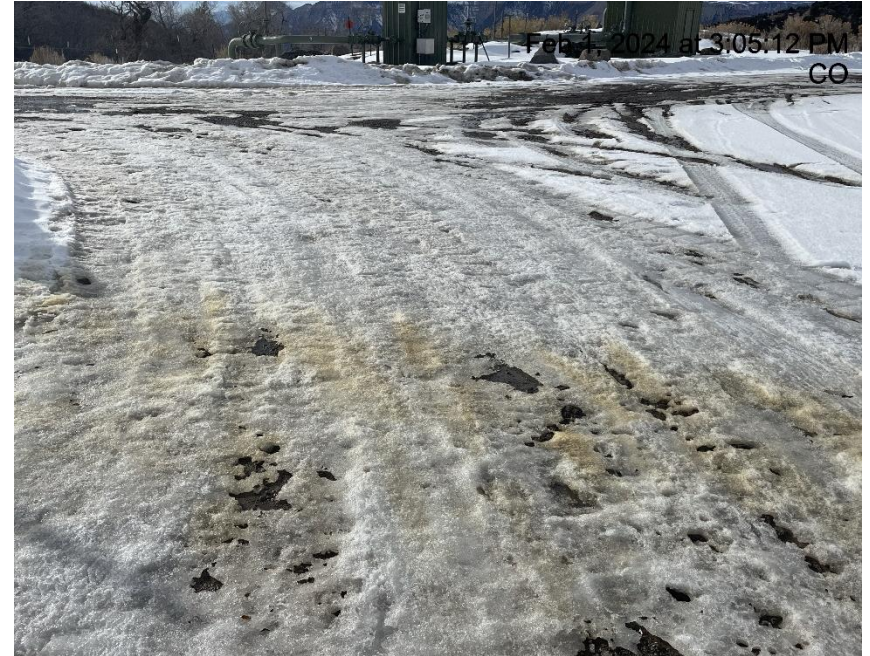
**Photo # 5402 Stained soils & snow**

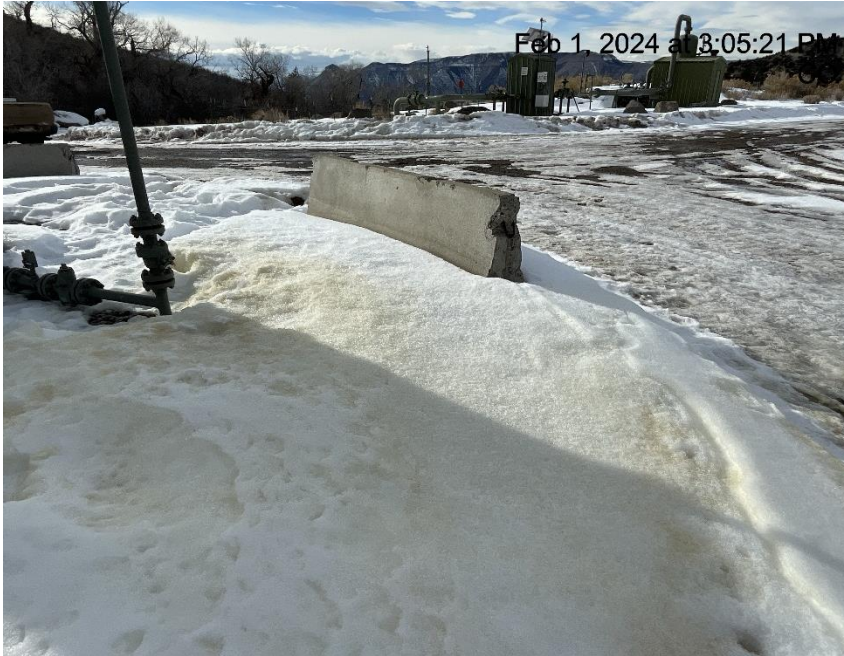
Photo # 5403 Staining in snow

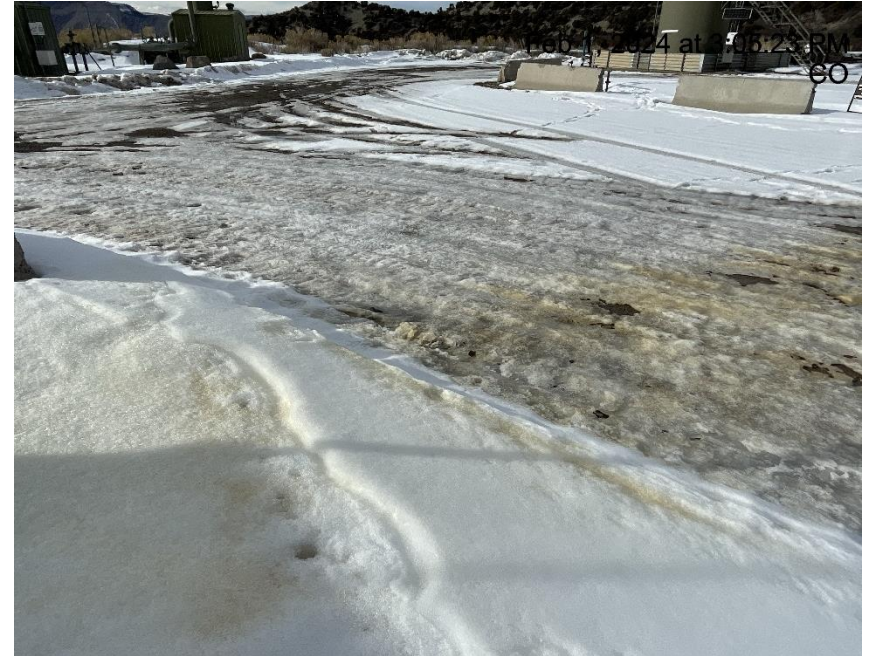
Photo # 5404 Stained soils & snow

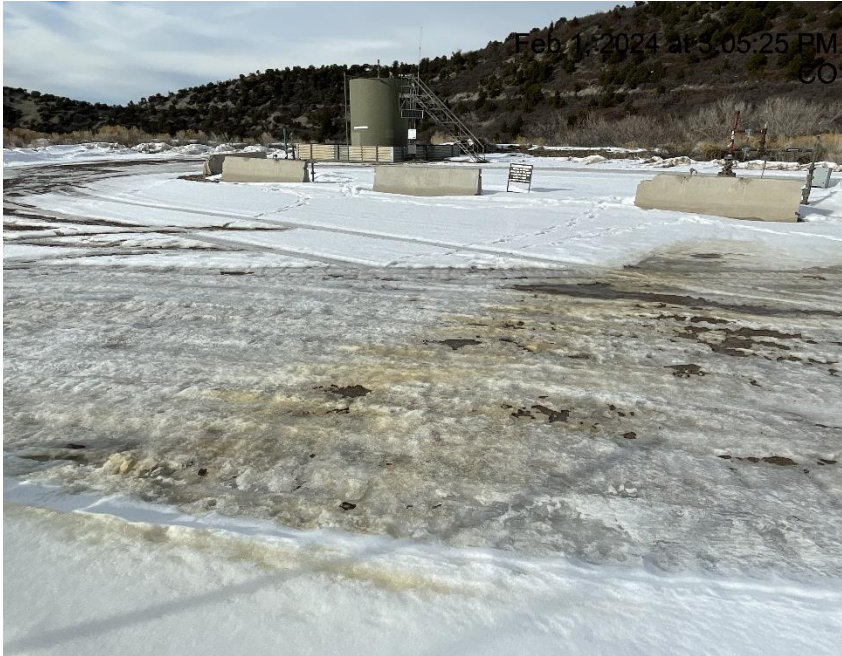
Photo # 5405 Stained soils & snow

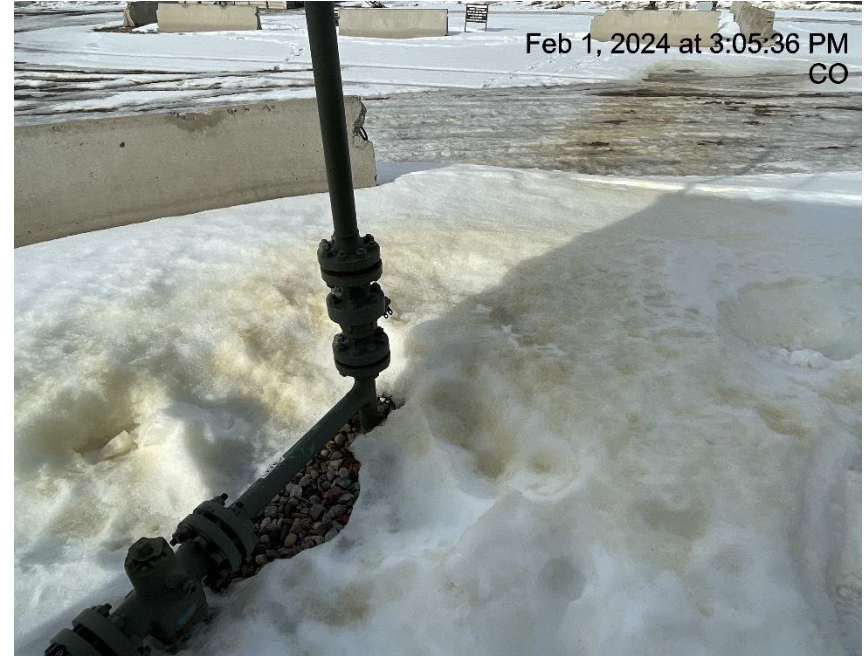
Photo # 5406 Stained soils & snow

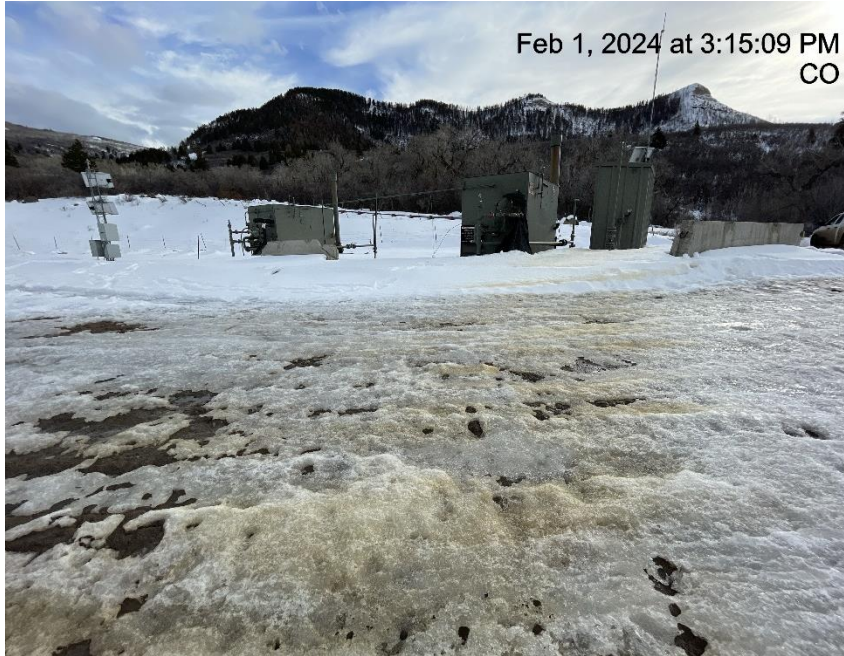
**Photo # 5407 Stained soils & snow**

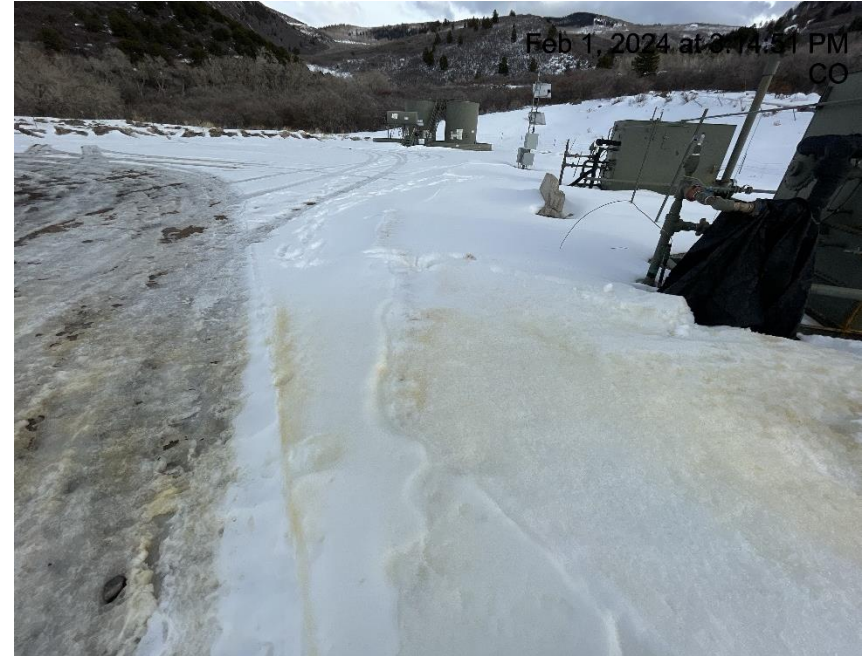
**Photo # 5408 Stained soils & snow**

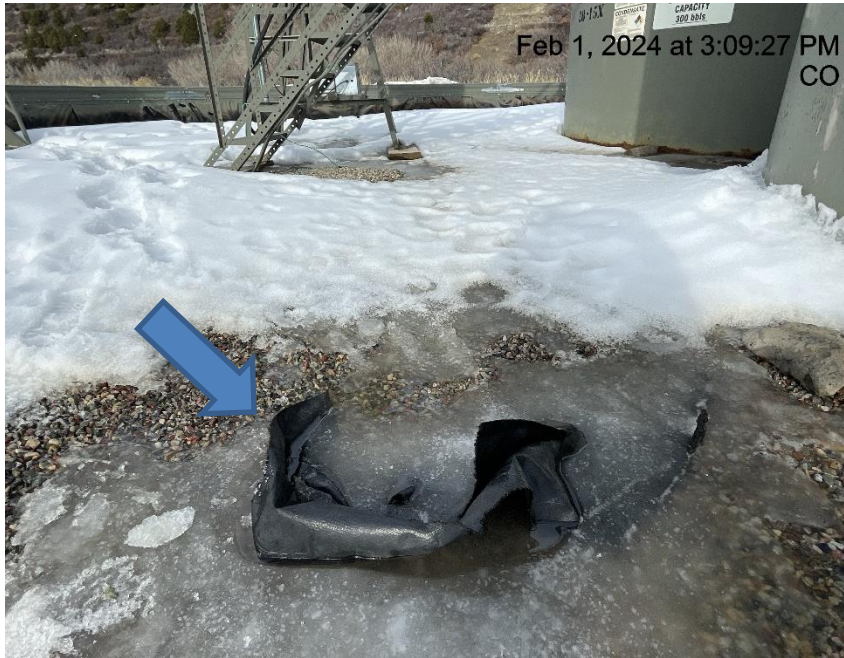
Photo # 5409 Possible tear in base of secondary containment liner

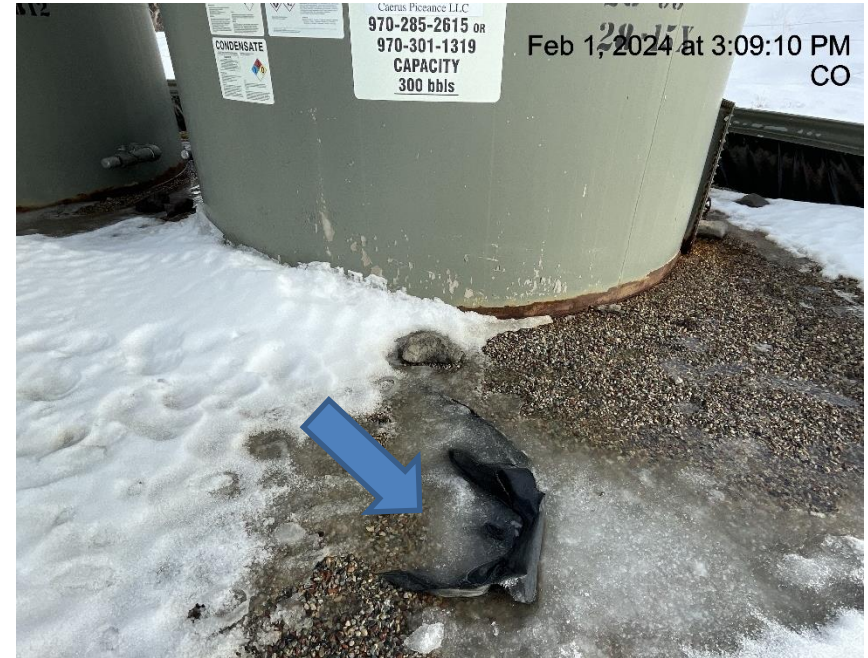
Photo # 5410 Possible tear in base of secondary containment liner
