Storm Water Management and Erosion control
Location Name: CAERUS PICEANCE LLC FEDERAL 20-10 (PN20) Pad
Location ID: 334682

**Location Overview: Location is within High
Priority/Density/Black Bear Habitat areas. Location is in close
proximity to Rule 411a Surface Water External Buffer.**

Section/Township/Range: 20 7S95W

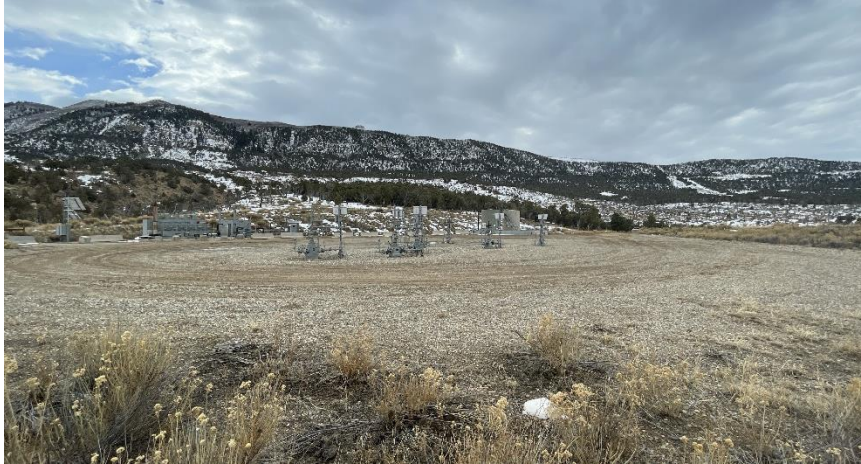
North West corner of location.

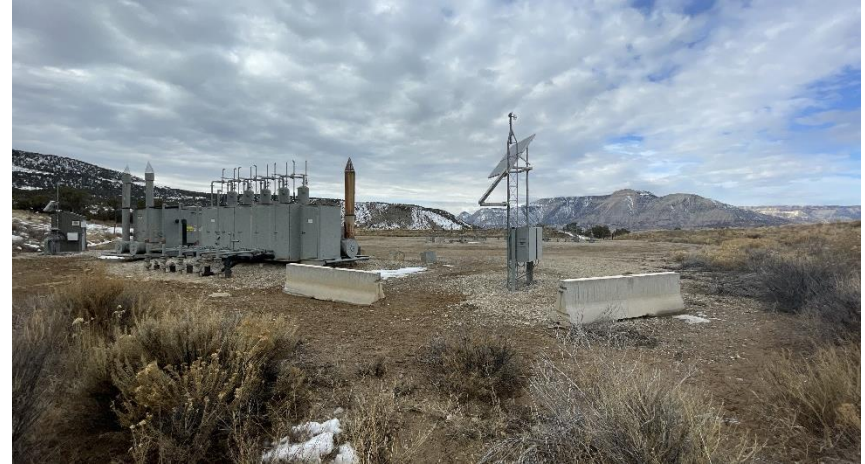
North East corner of location.

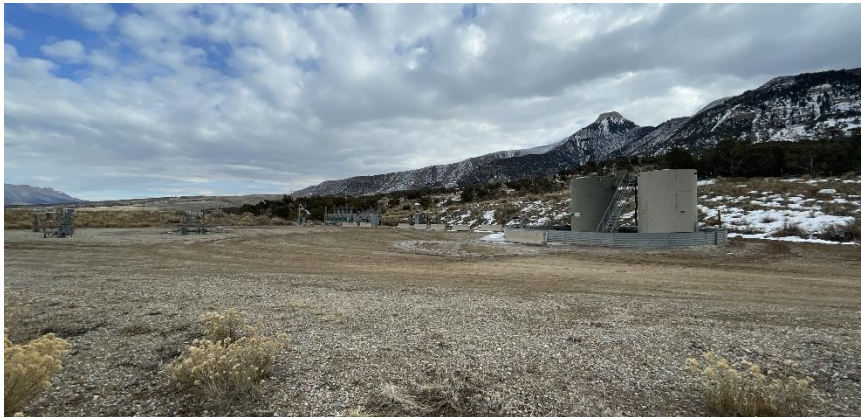
South West corner of location.

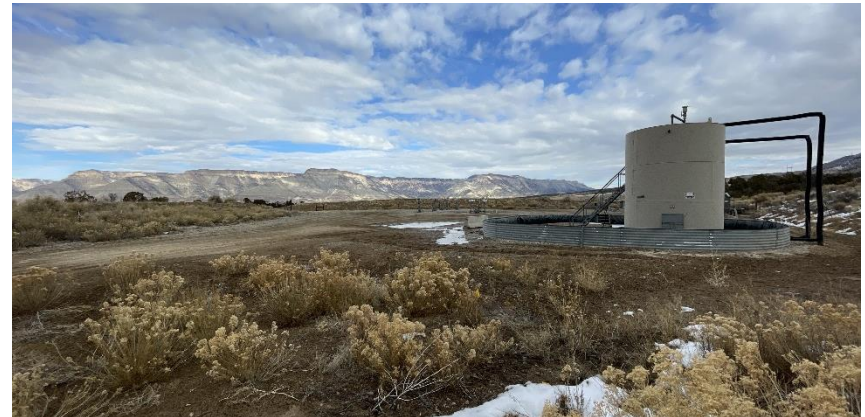
South East corner of location.

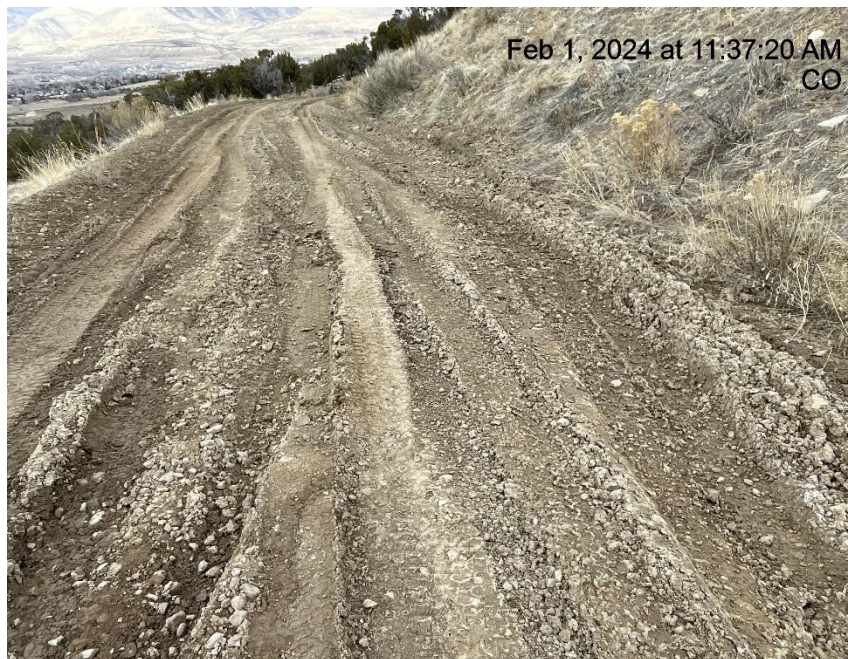
Photo # 5000 Lack of stabilization/compaction/insufficient BMP's on lease road

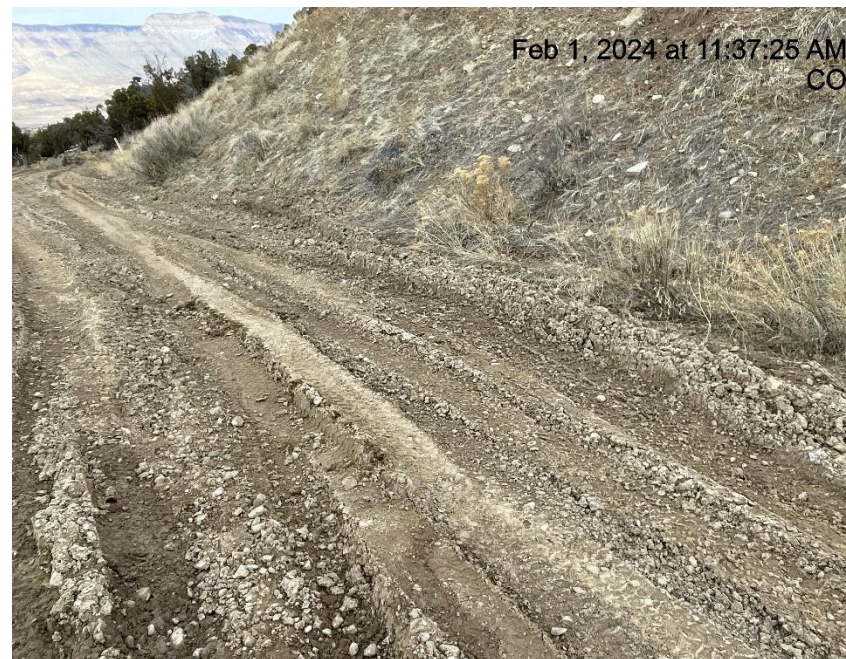
Photo # 5001 Lack of stabilization/compaction/insufficient BMP's on lease road

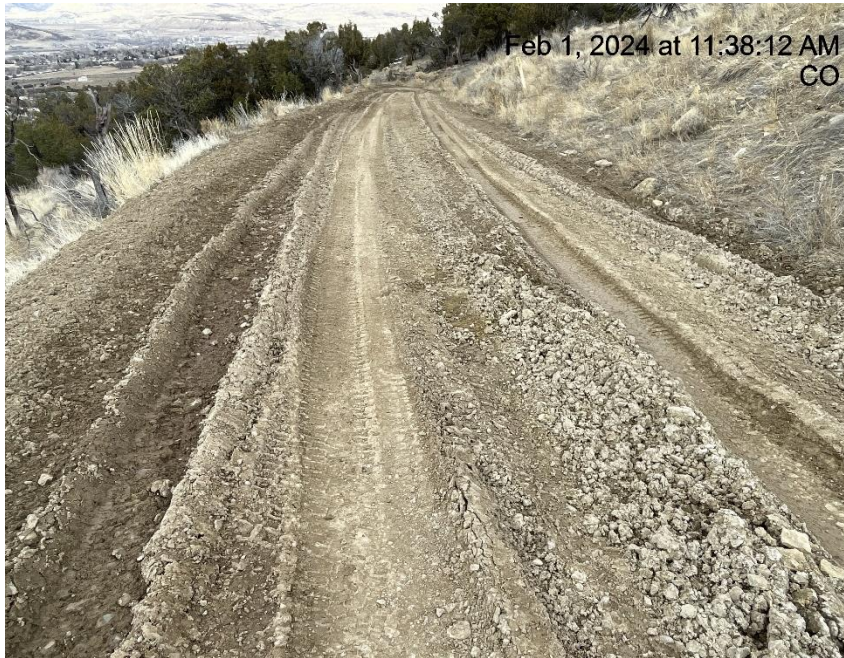
Photo # 5002 Lack of stabilization/compaction/insufficient BMP's on lease road

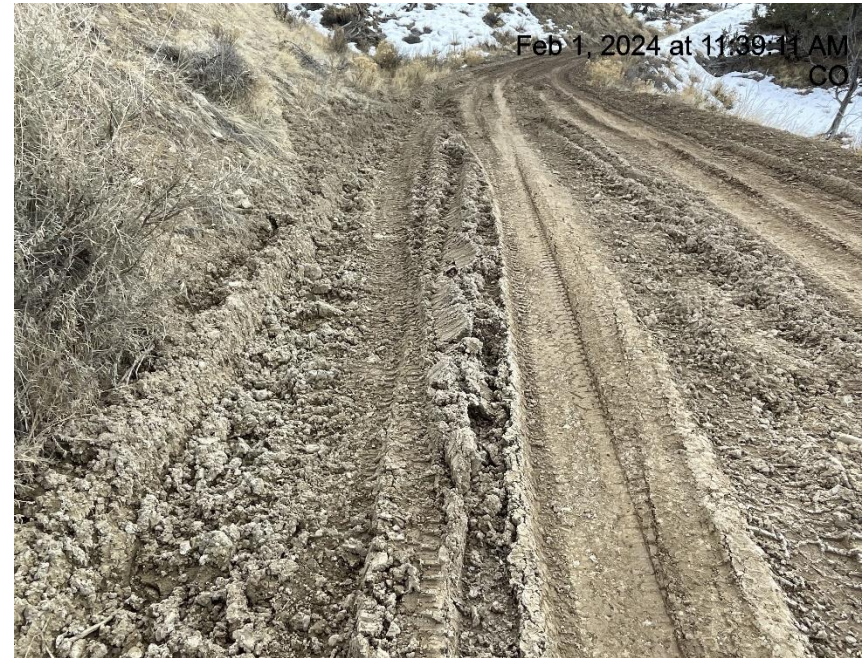
Photo # 5003 Lack of stabilization/compaction/insufficient BMP's on lease road

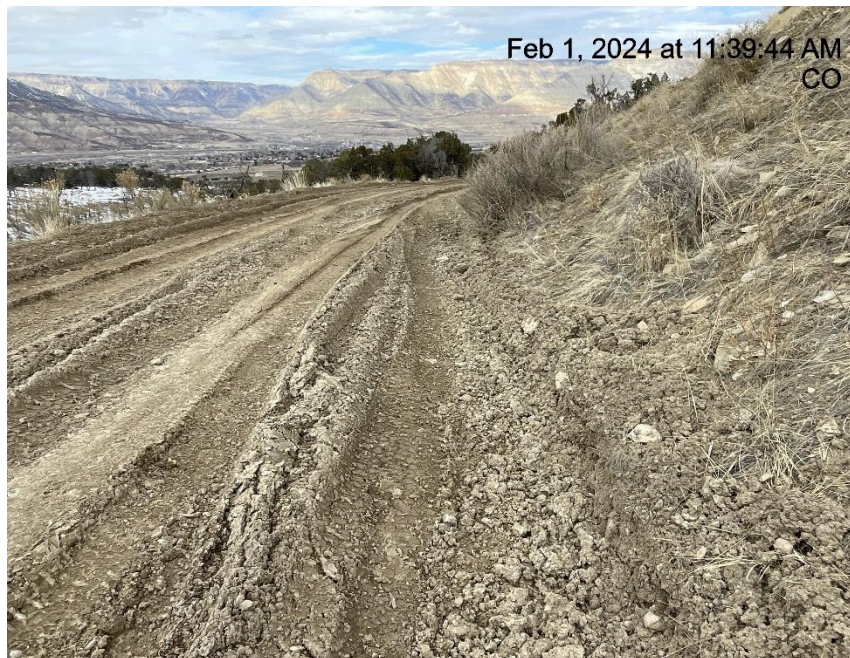
Photo # 5004 Lack of stabilization/compaction/insufficient BMP's on lease road

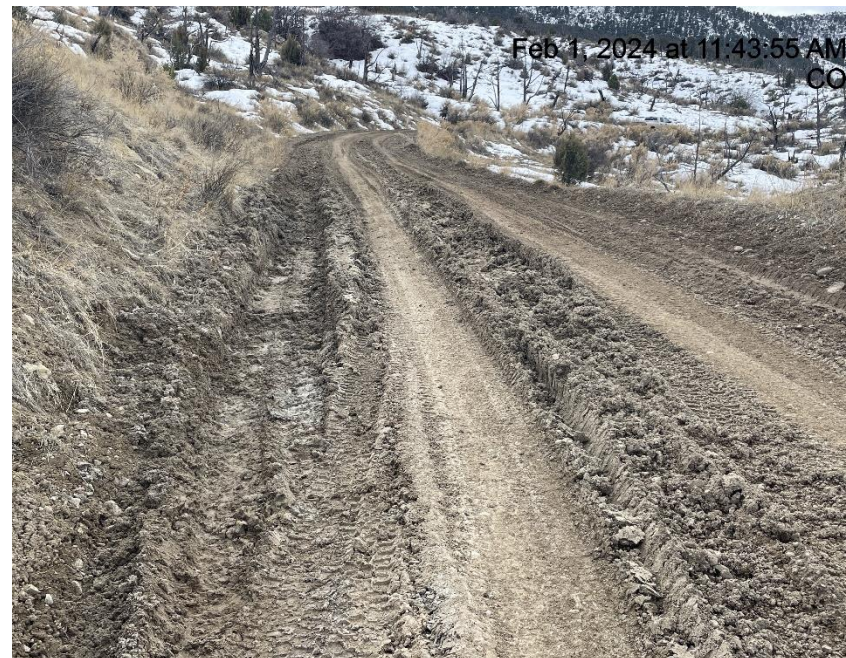
Photo # 5005 Lack of stabilization/compaction/insufficient BMP's on lease road

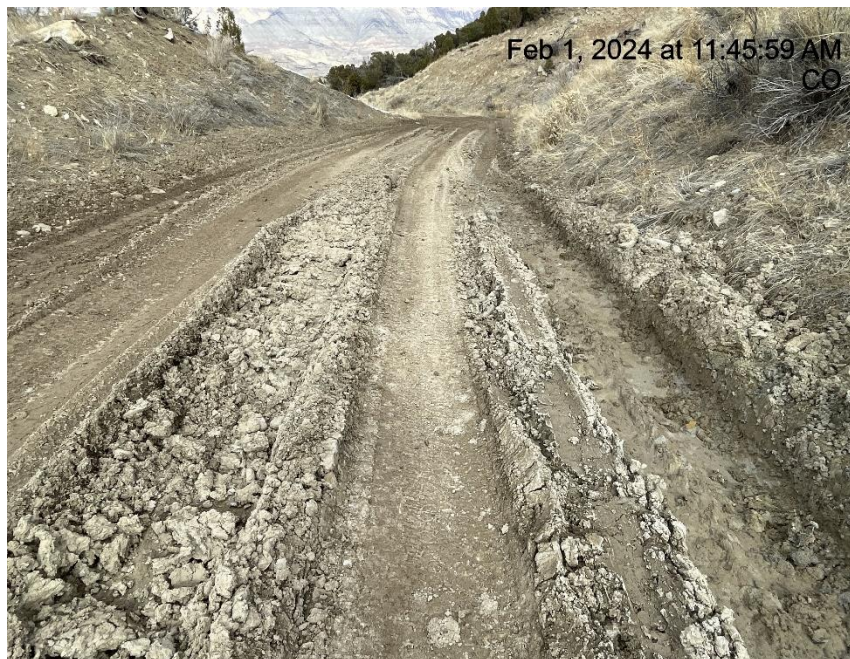
Photo # 5006 Lack of stabilization/compaction/insufficient BMP's on lease road

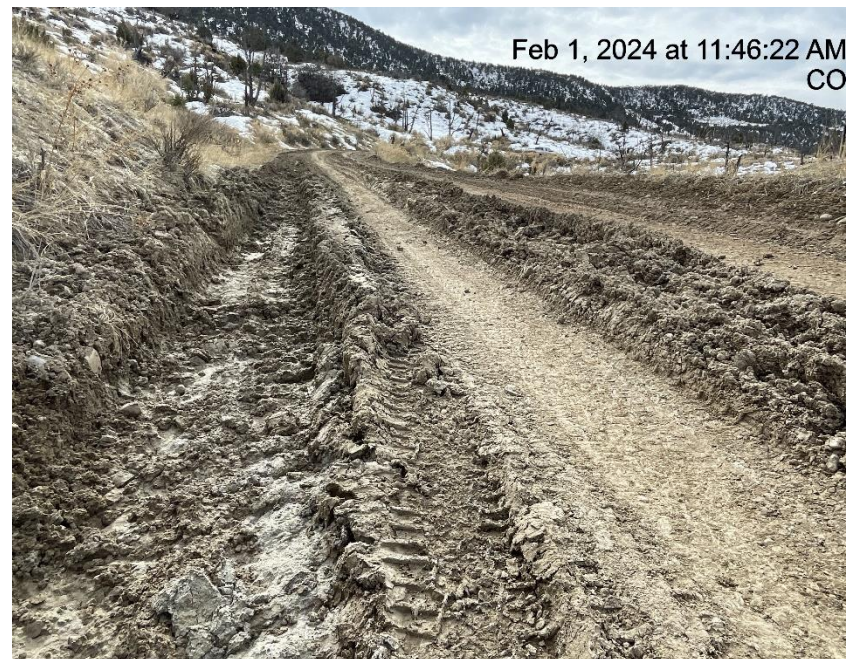
Photo # 5007 Lack of stabilization/compaction/insufficient BMP's on lease road

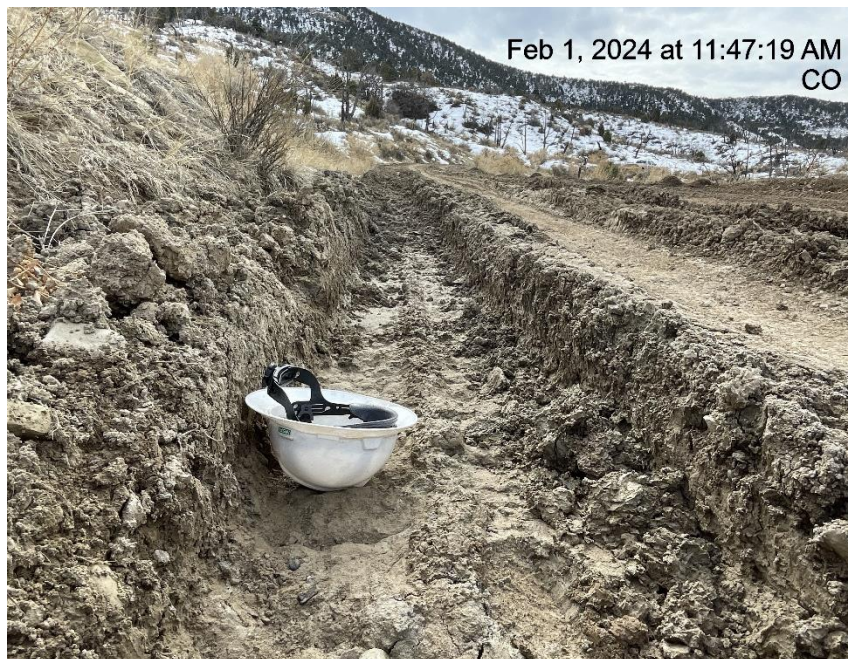
Photo # 5008 Lack of stabilization/compaction/insufficient BMP's on lease road

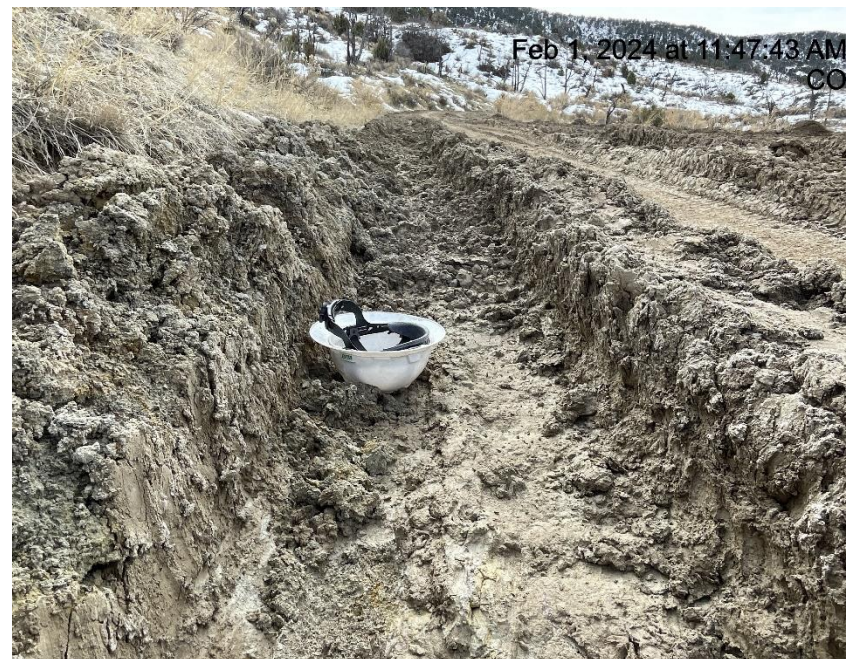
Photo # 5009 Lack of stabilization/compaction/insufficient BMP's on lease road

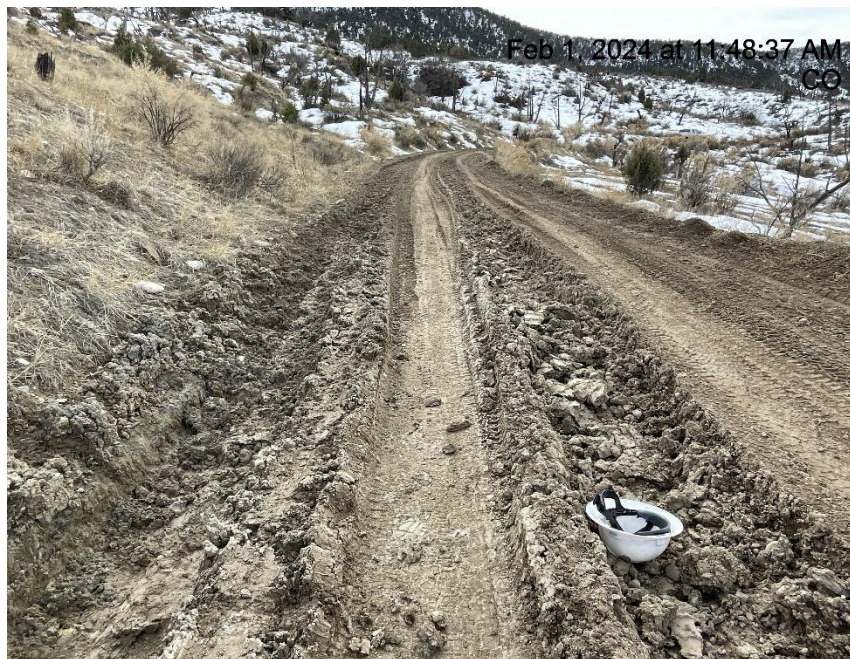
Photo # 5010 Lack of stabilization/compaction/insufficient BMP's on lease road

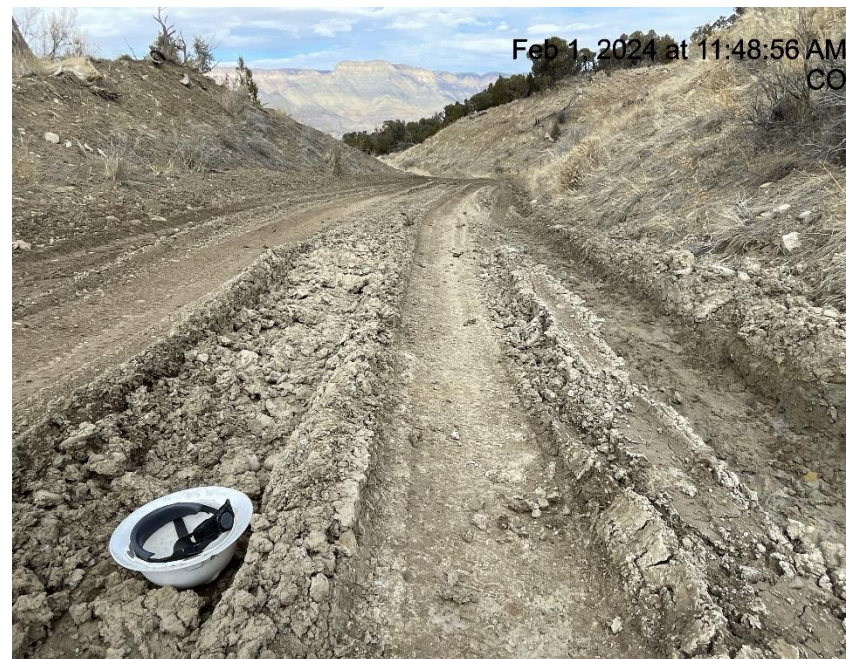
Photo # 5011 Lack of stabilization/compaction/insufficient BMP's on lease road

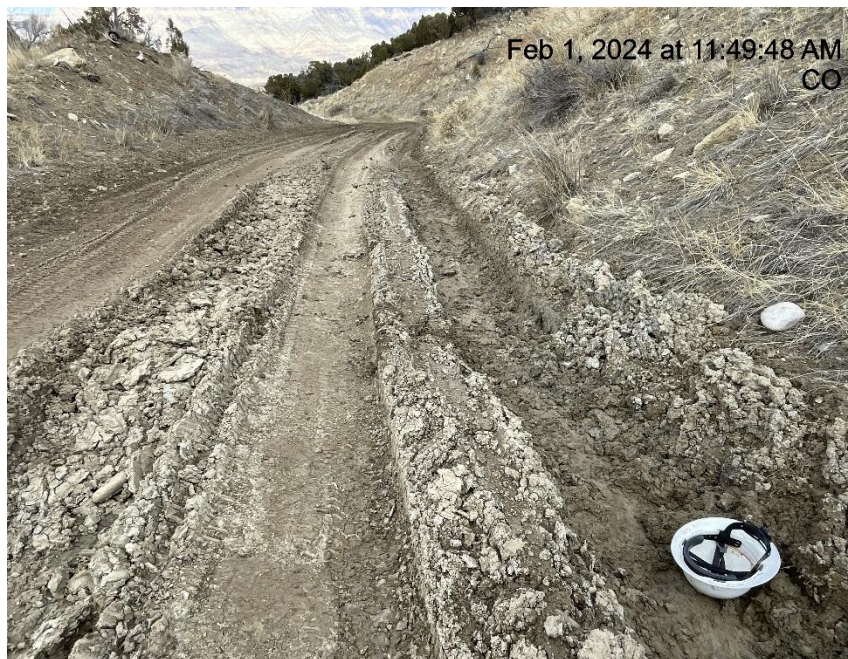
Photo # 5012 Lack of stabilization/compaction/insufficient BMP's on lease road

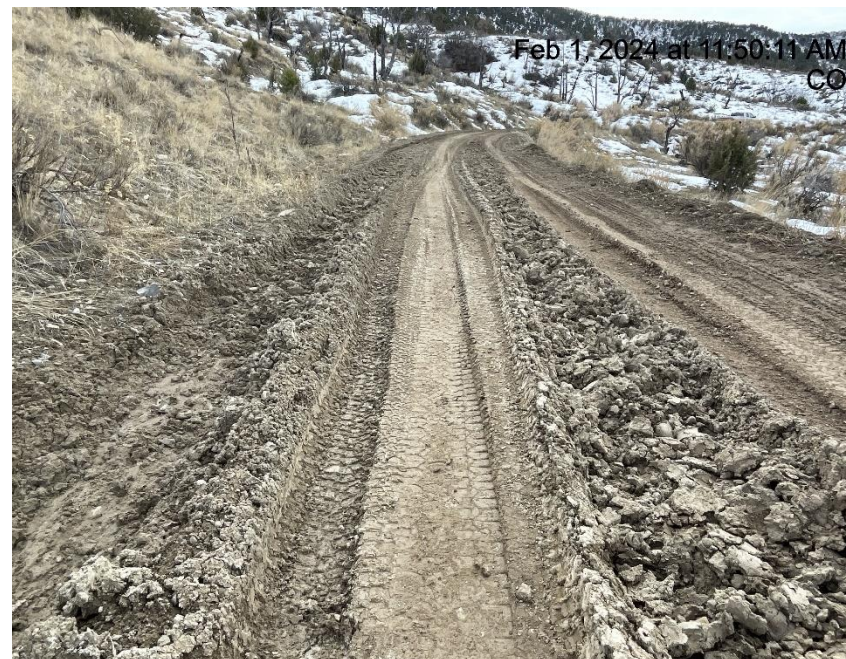
Photo # 5013 Lack of stabilization/compaction/insufficient BMP's on lease road

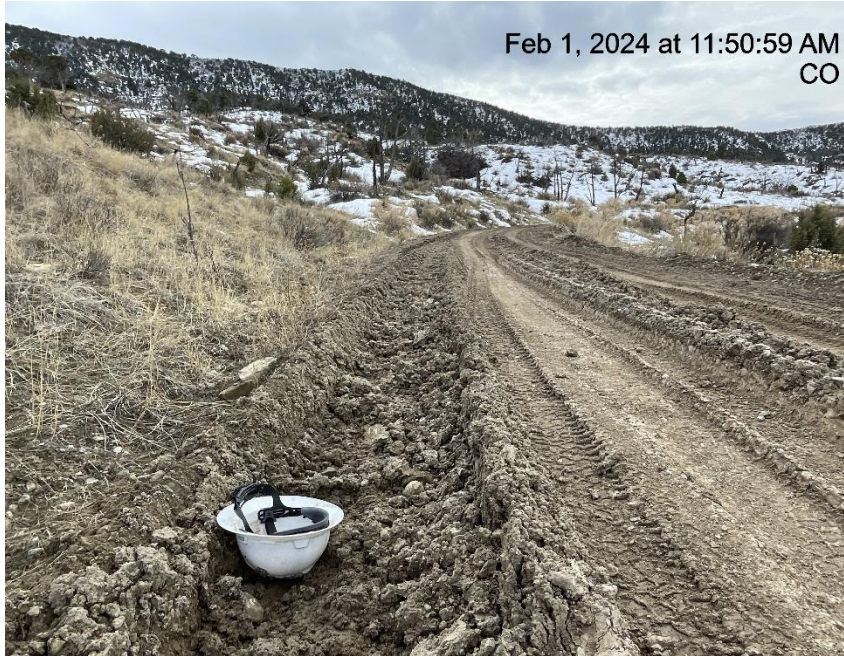
Photo # 5014 Lack of stabilization/compaction/insufficient BMP's on lease road

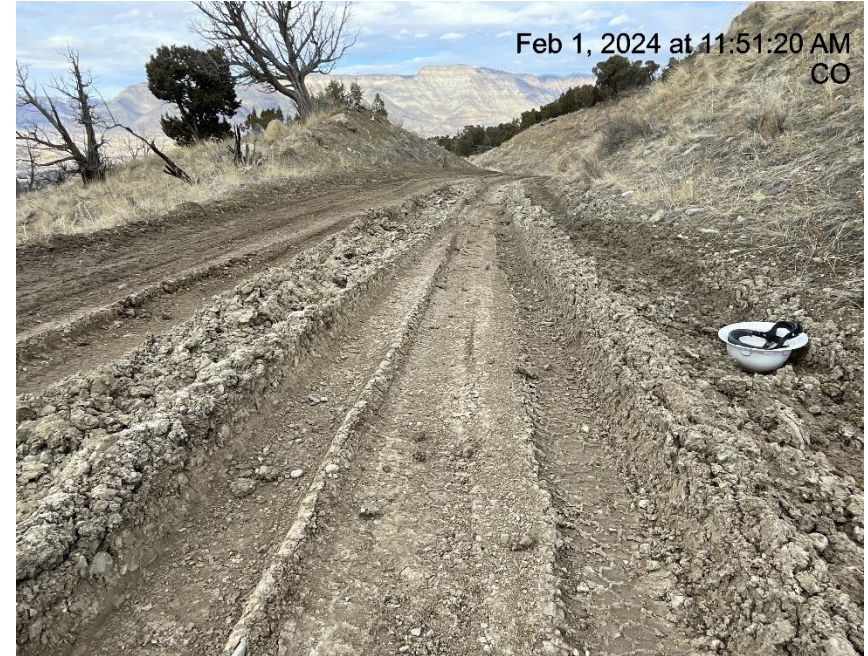
Photo # 5015 Lack of stabilization/compaction/insufficient BMP's on lease road

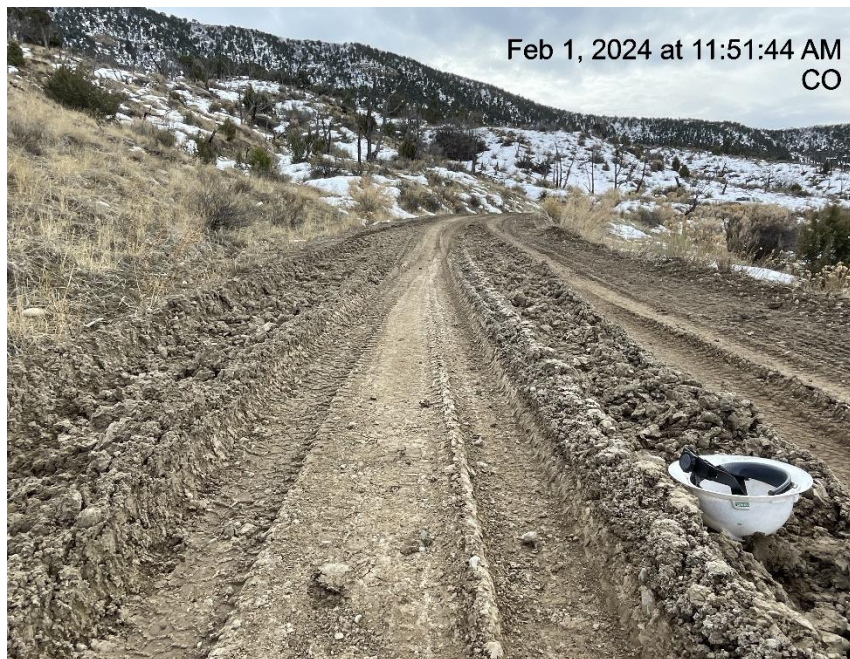
Photo # 5016 Lack of stabilization/compaction/insufficient BMP's on lease road

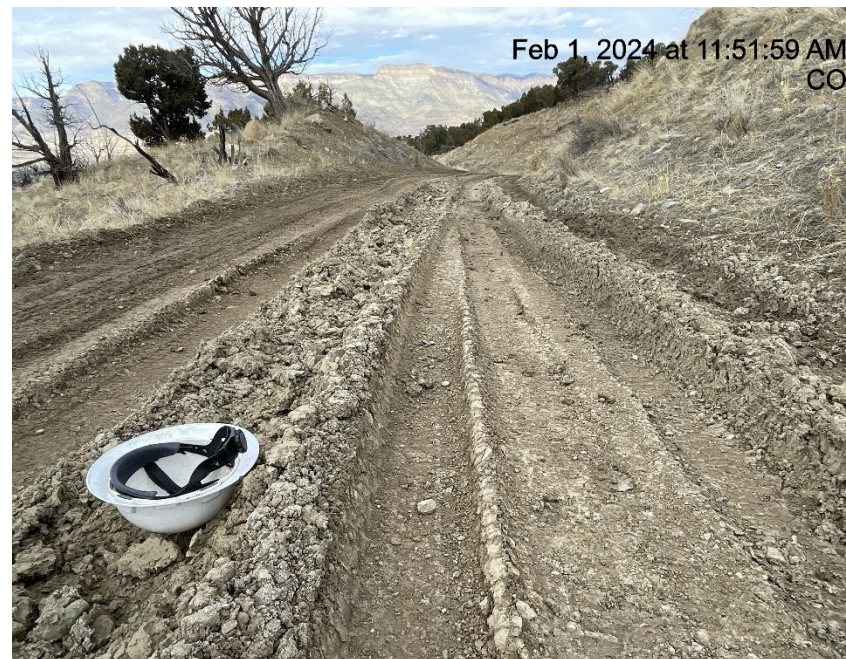
Photo # 5017 Lack of stabilization/compaction/insufficient BMP's on lease road

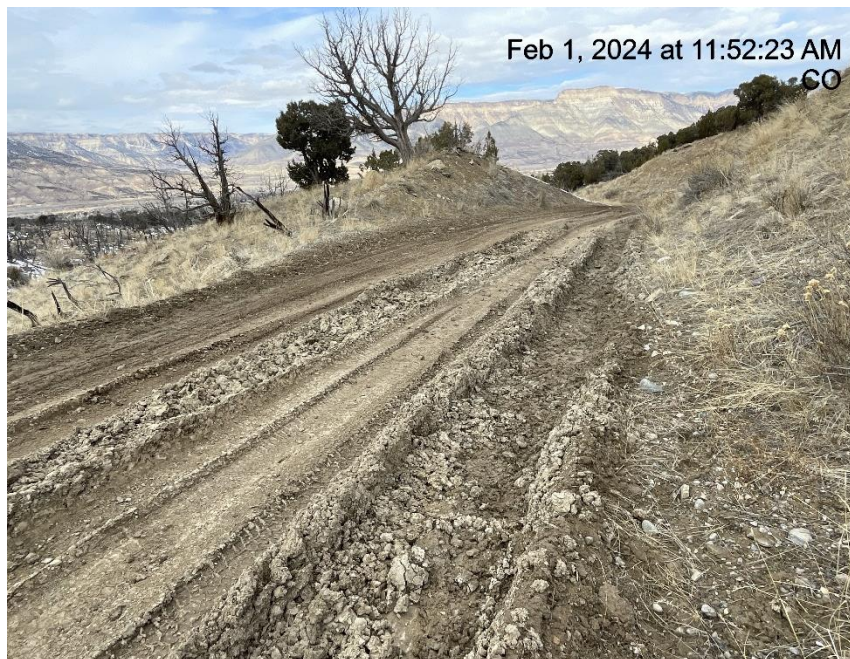
Photo # 5018 Lack of stabilization/compaction/insufficient BMP's on lease road

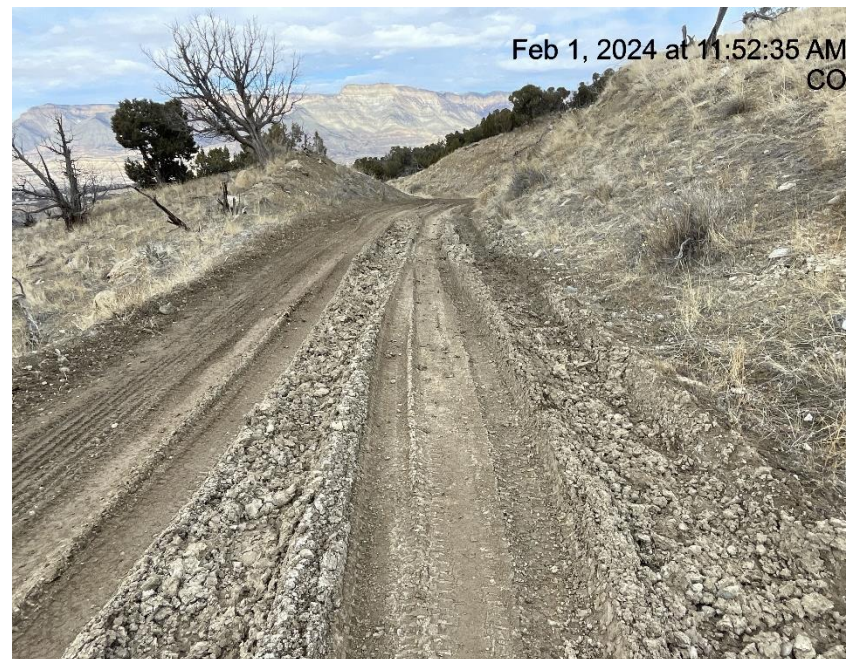
Photo # 5019 Lack of stabilization/compaction/insufficient BMP's on lease road

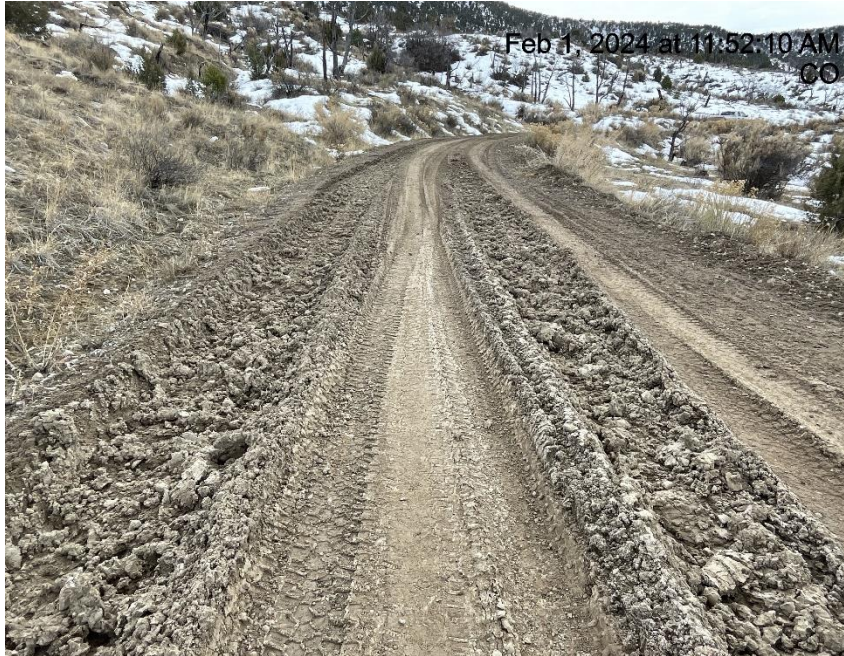
Photo # 5020 Lack of stabilization/compaction/insufficient BMP's on lease road

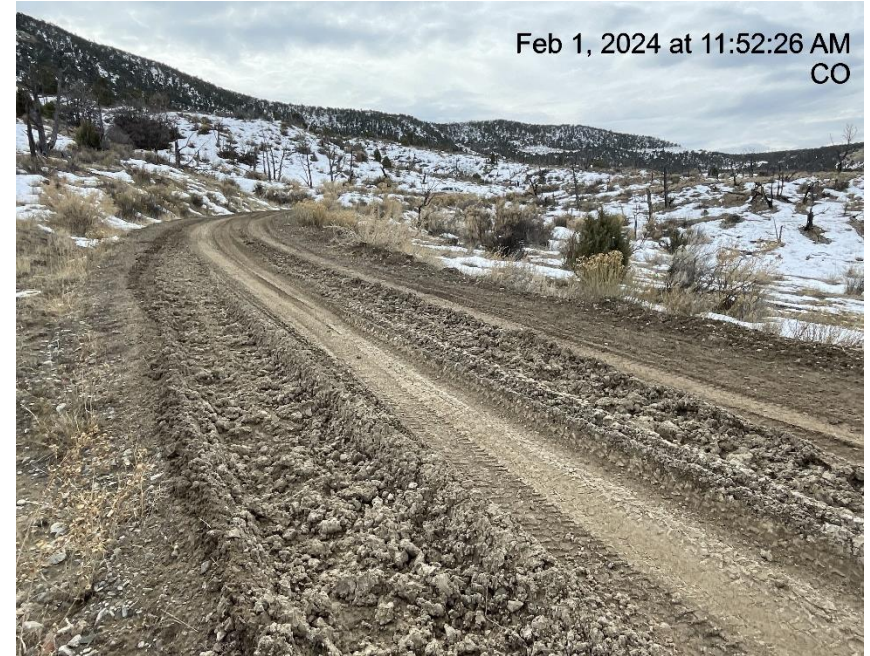
Photo # 5021 Lack of stabilization/compaction/insufficient BMP's on lease road

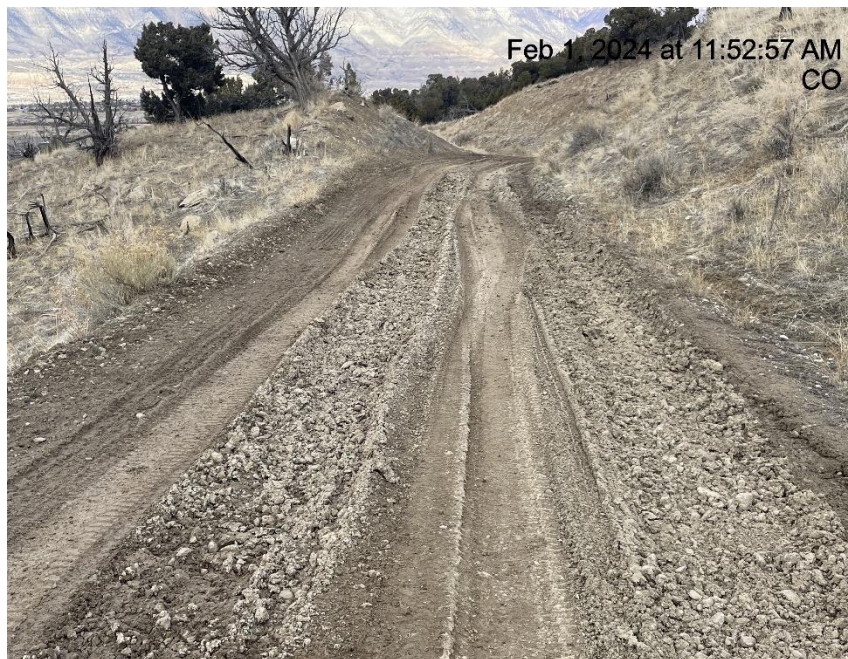
Photo # 5022 Lack of stabilization/compaction/insufficient BMP's on lease road

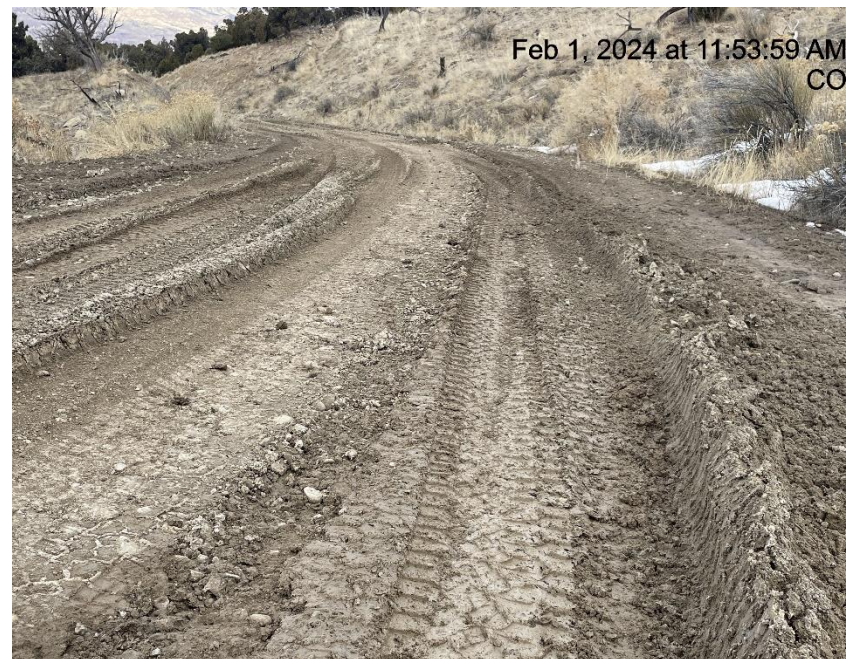
Photo # 5023 Lack of stabilization/compaction/insufficient BMP's on lease road
