Inspection Photos
Location Name: CAERUS PICEANCE LLC FEDERAL 20-10 (PN20) Pad
Location ID: 334682

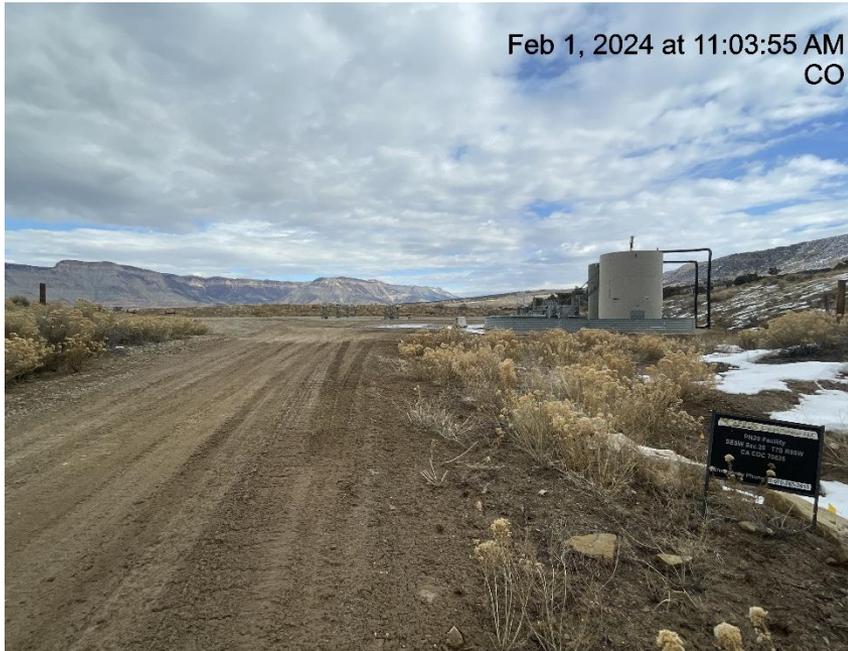
Photo # 4988 From entrance to location

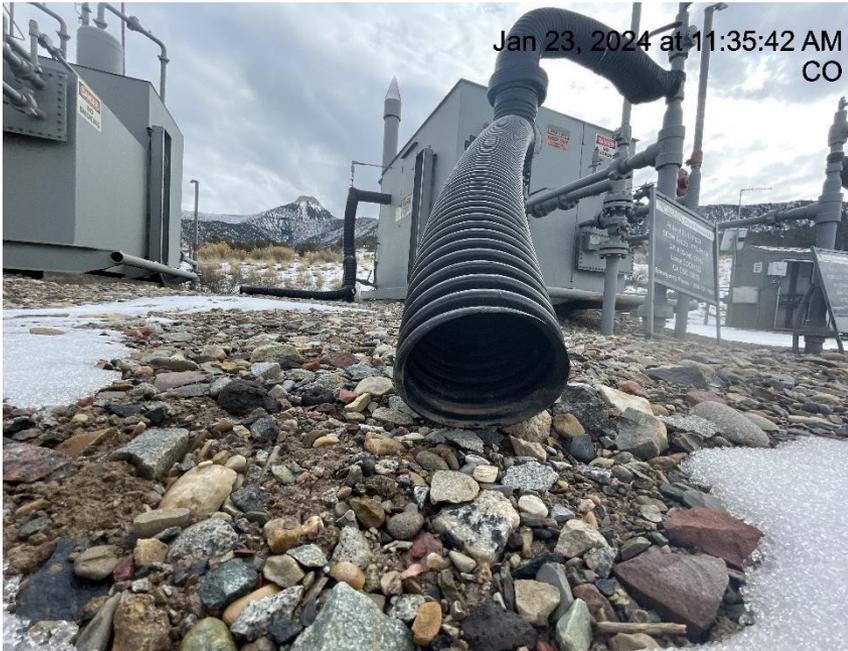
Photo # 3518 From inspection 708902869 conducted on 01/23/2024 Flowline heating insulation open ended/ wildlife hazard/available for entry by wildlife

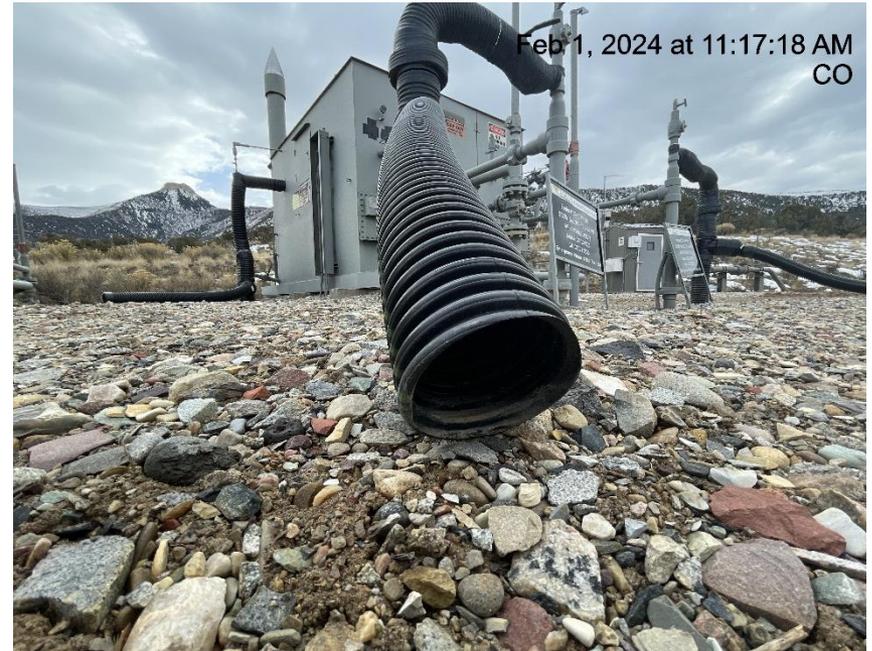
Photo # 4994 Flowline heating insulation open ended /wildlife hazard/available for entry by wildlife

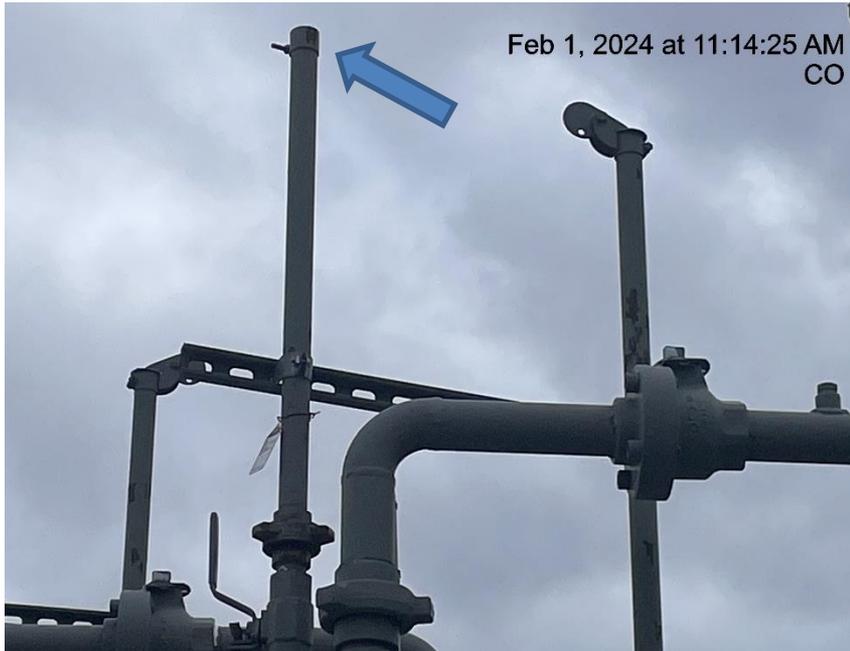
Photo # 4995 Rupture disc vent line lacks cap

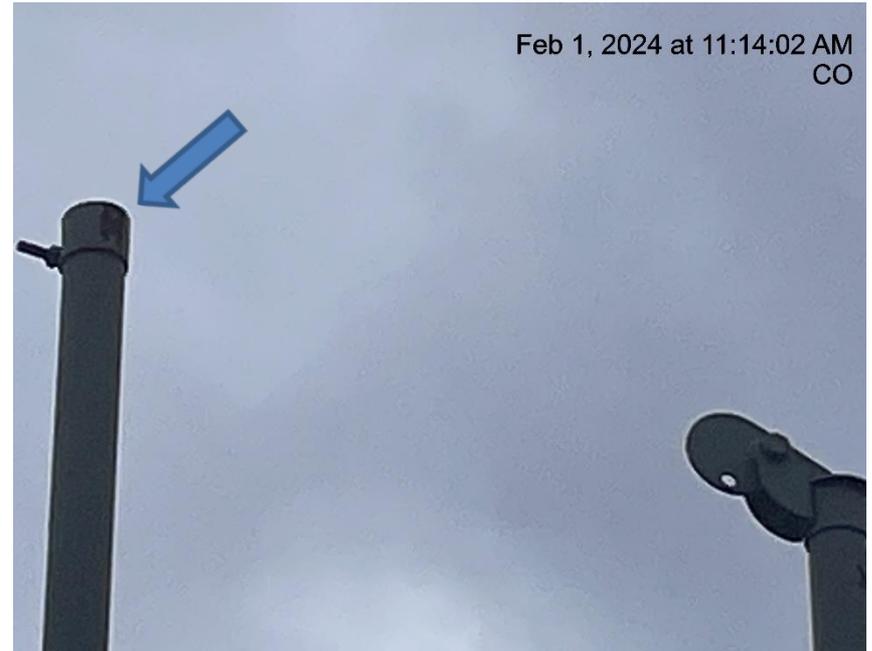
Photo # 4996 Rupture disc vent line lacks cap

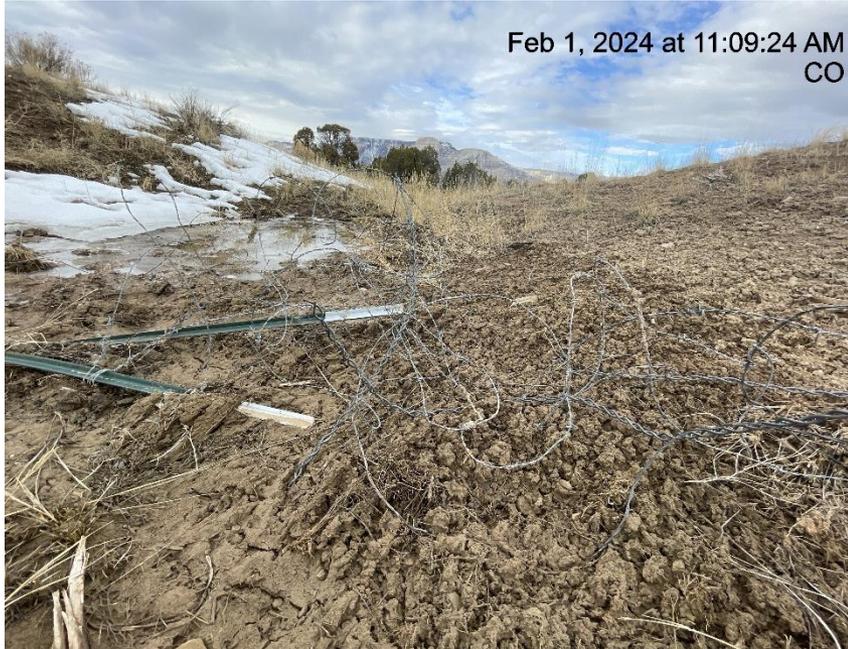
**Photo # 4997 Barbed wire laying on ground/wildlife hazard
(N/NW area on edge of location)**

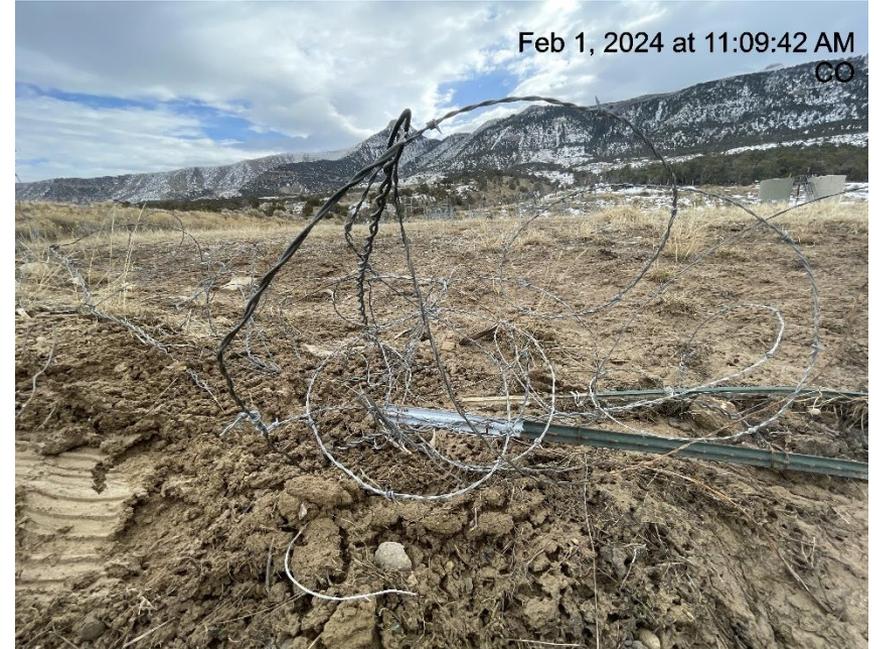
**Photo # 4998 Barbed wire laying on ground/wildlife hazard
(N/NW area on edge of location)**
