Inspection Photos

Operator: CAERUS PICEANCE LLC #10456

Location ID: 335793

Inspection Doc: 696205596

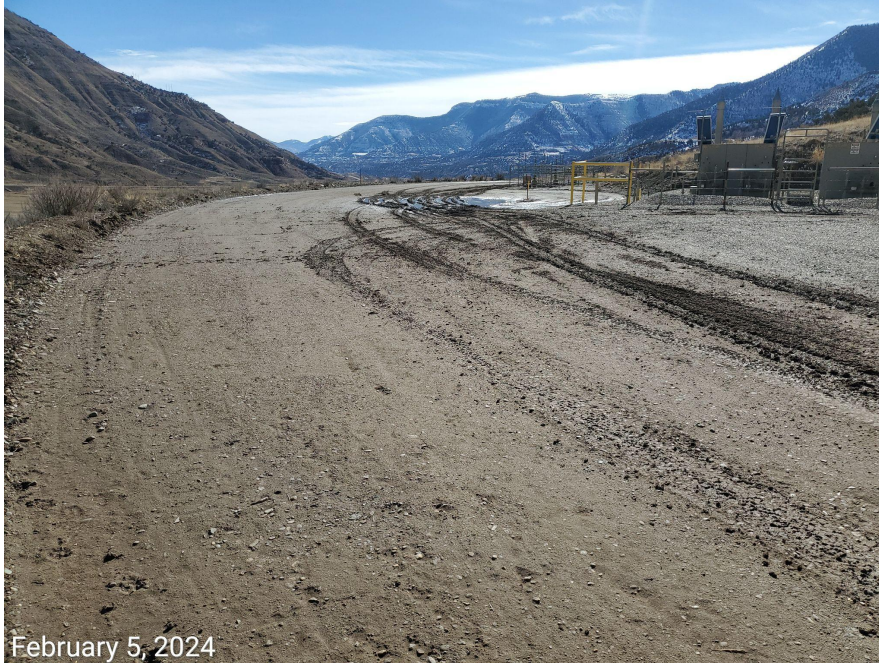
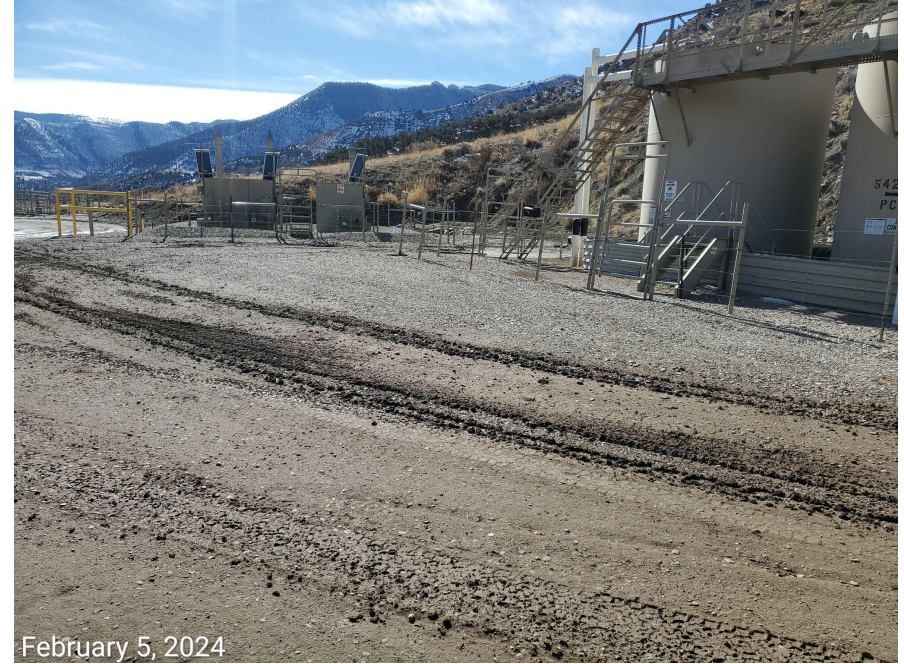
Photo 1: Photos 1-2 taken from the east end of the Location. Photos provide an overview of the Location from south, southwest, northwest to north.

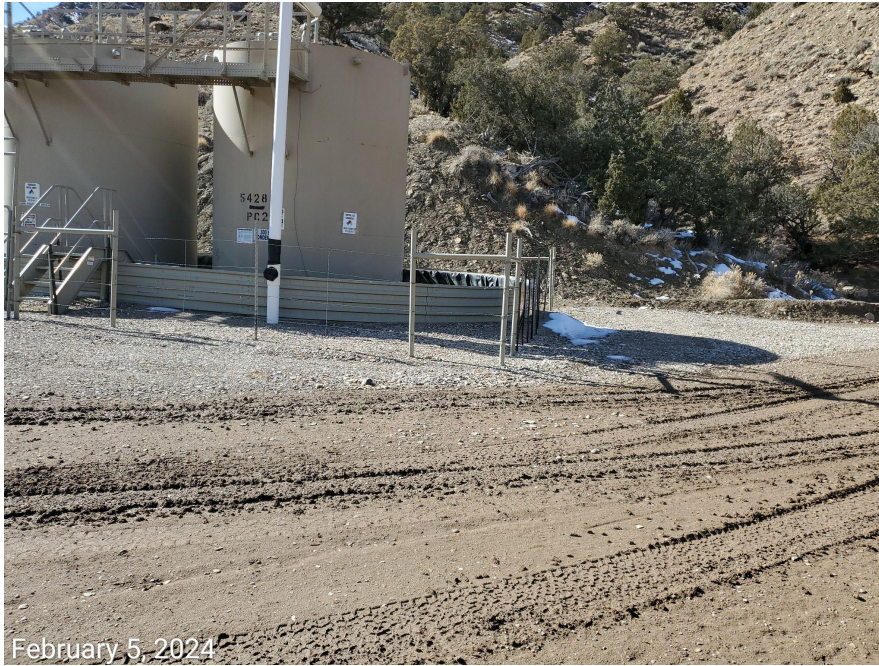
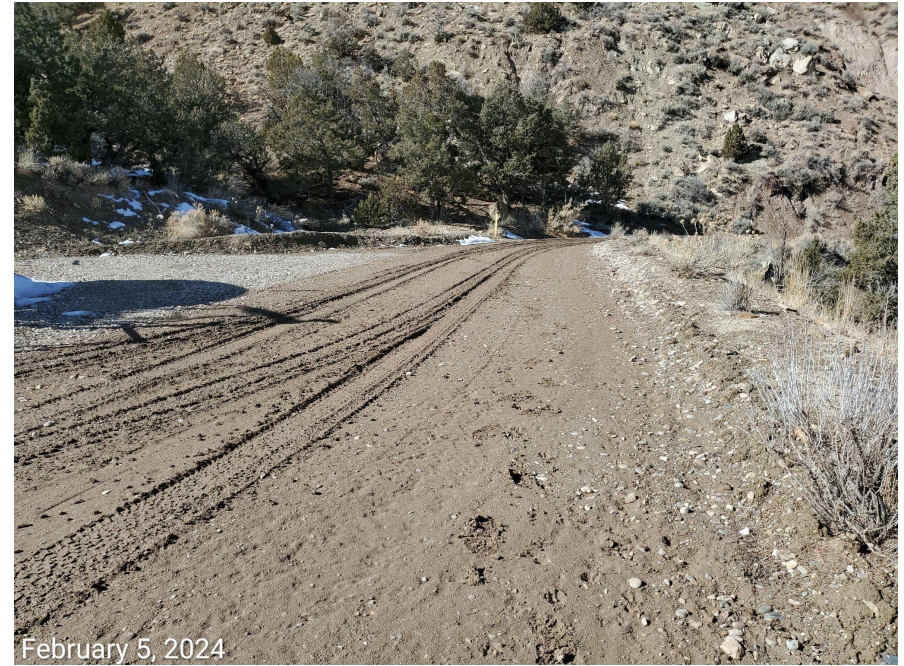
Photo 2: See comments under photo 1.

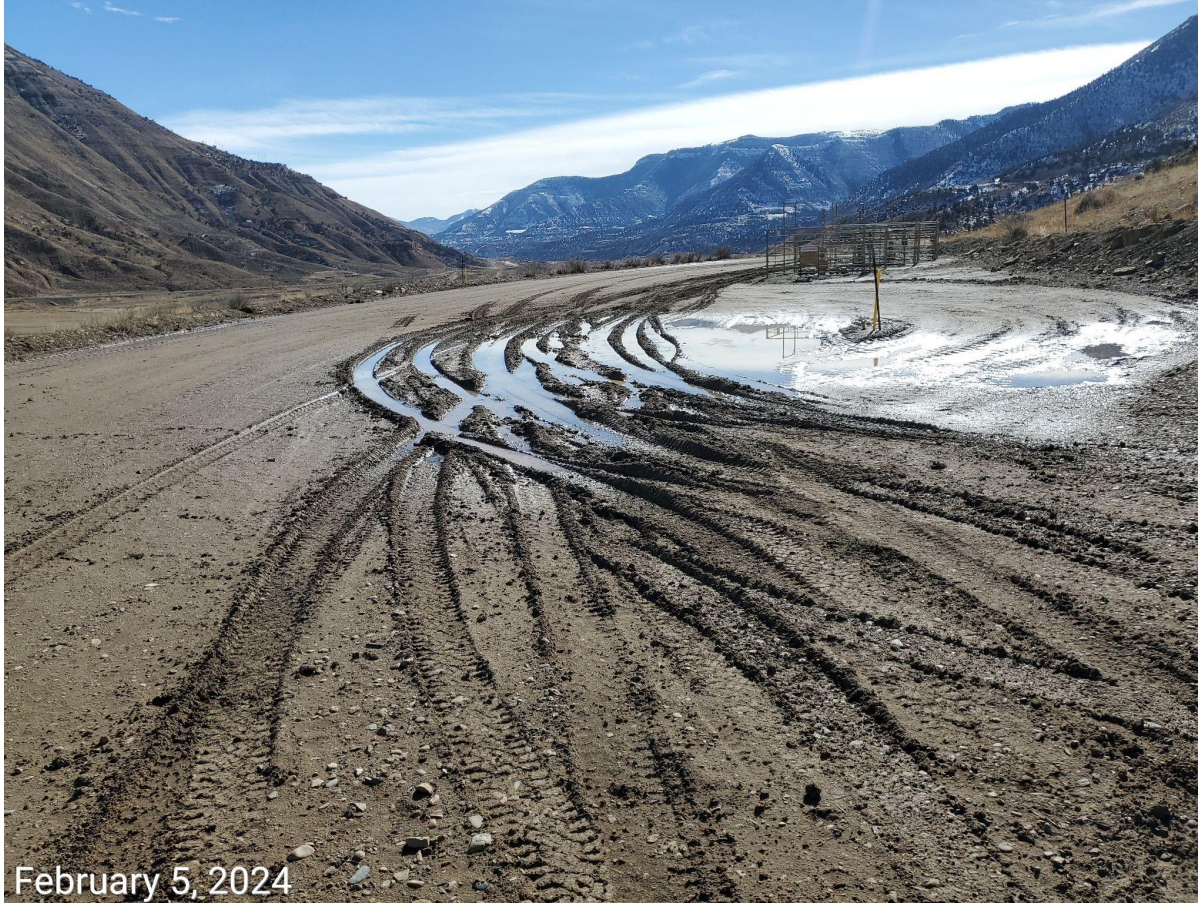
Photo 3: Photo example showing the WPS lacks stabilization; BMPs to stabilize the WPS, as well as to minimize erosion, degradation and sediment transport missing or insufficient; tracking/rutting observed.

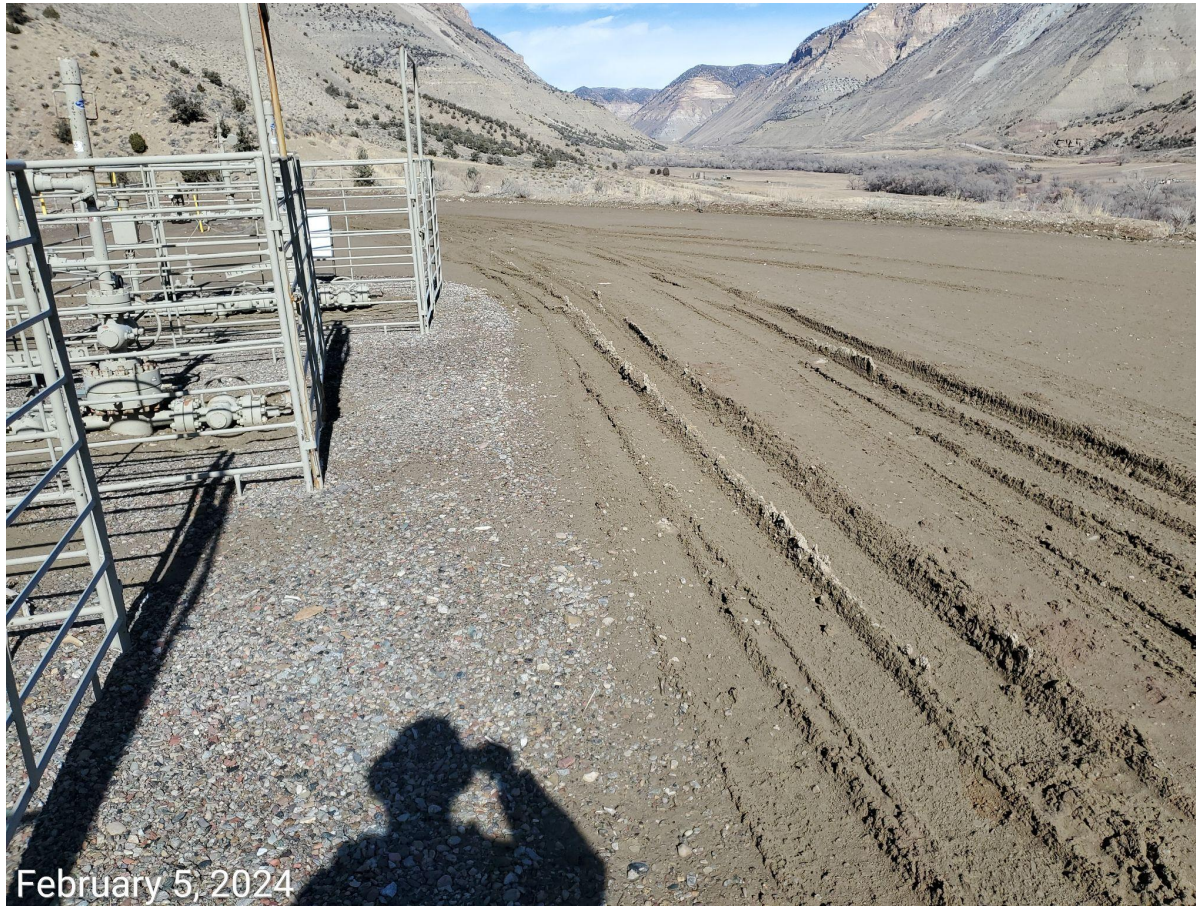
Photo 4: Photo example showing the WPS lacks stabilization; BMPs to stabilize the WPS, as well as to minimize erosion, degradation and sediment transport missing or insufficient; tracking/rutting observed.

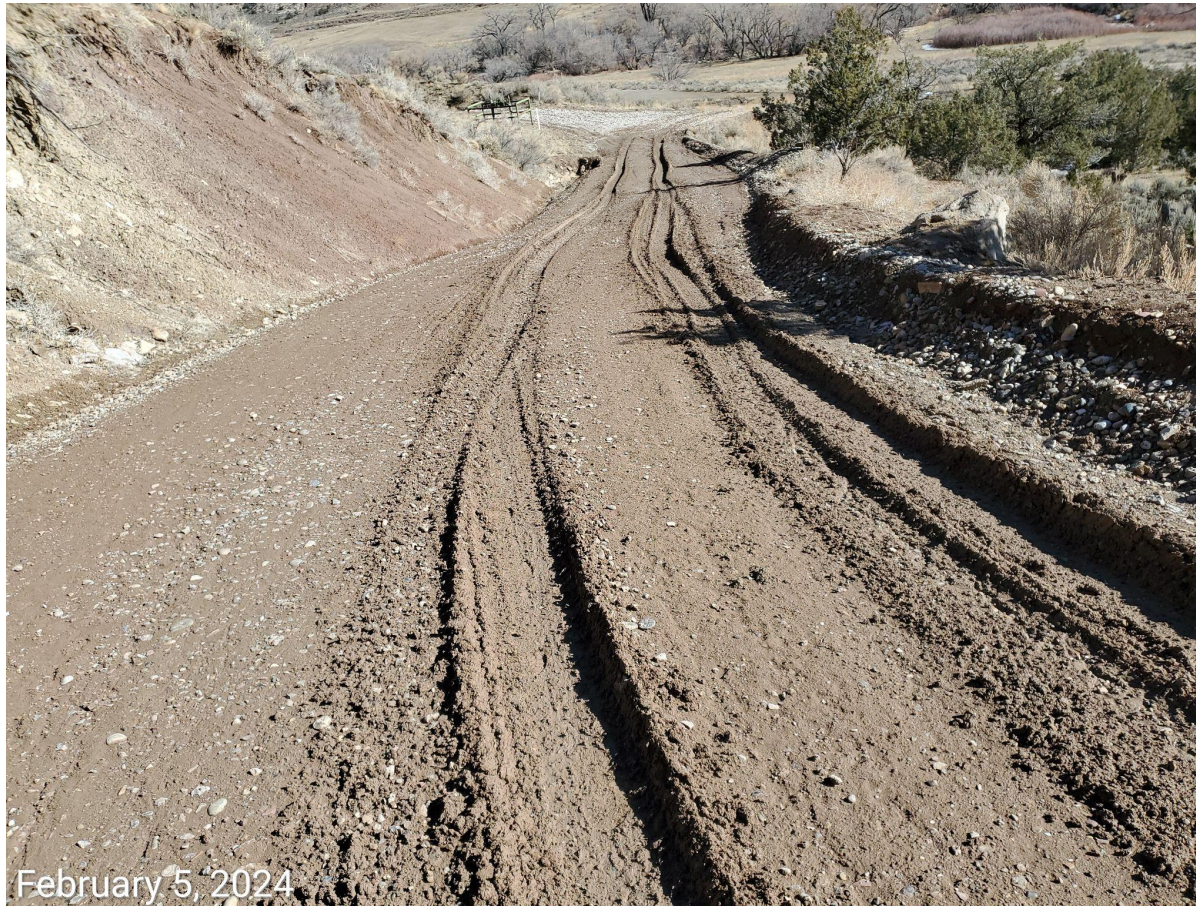
Photo 5: Photo example showing the access road lacks stabilization; BMPs to stabilize, as well as to minimize erosion, degradation and sediment transport missing or insufficient; tracking/rutting observed.

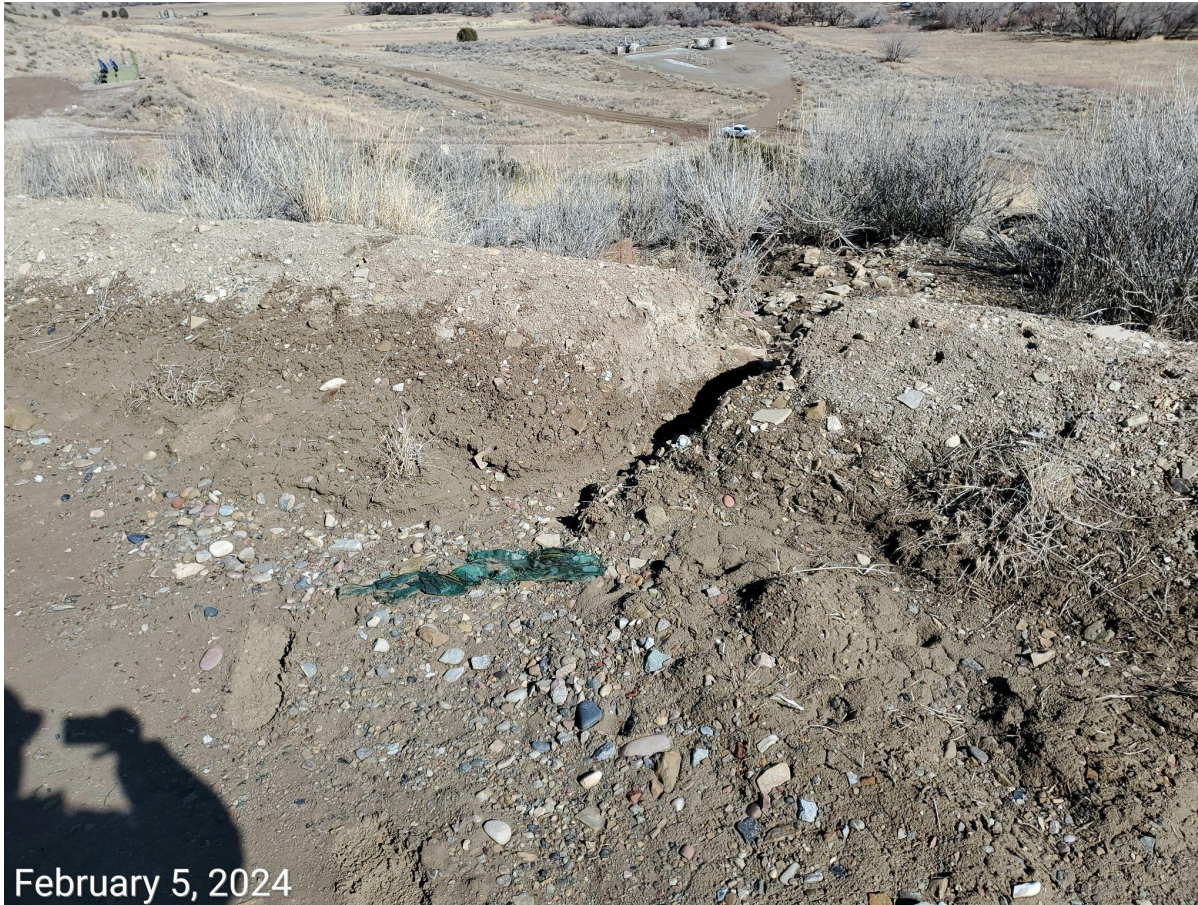
Photo 6: Photos taken from the northeast end of the WPS. Photo shows the berm along the perimeter of the pad is no longer in proper functioning condition; stormwater runoff from the pad has resulted in erosion, degradation and off-site sediment transport.

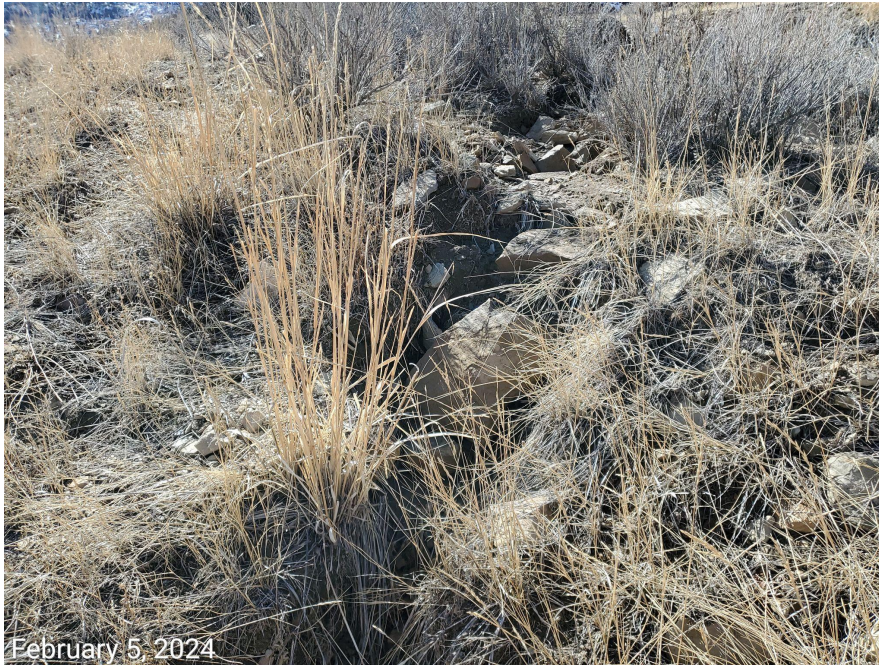
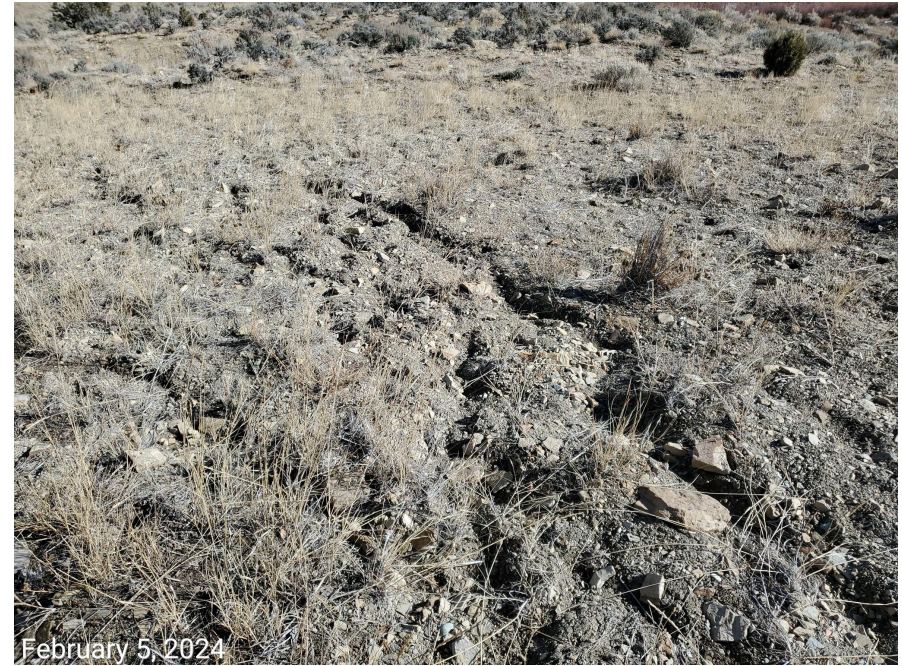
Photo 7: Continue from photo 6. Photos examples showing erosion/degradation due to stormwater runoff from the WPS.

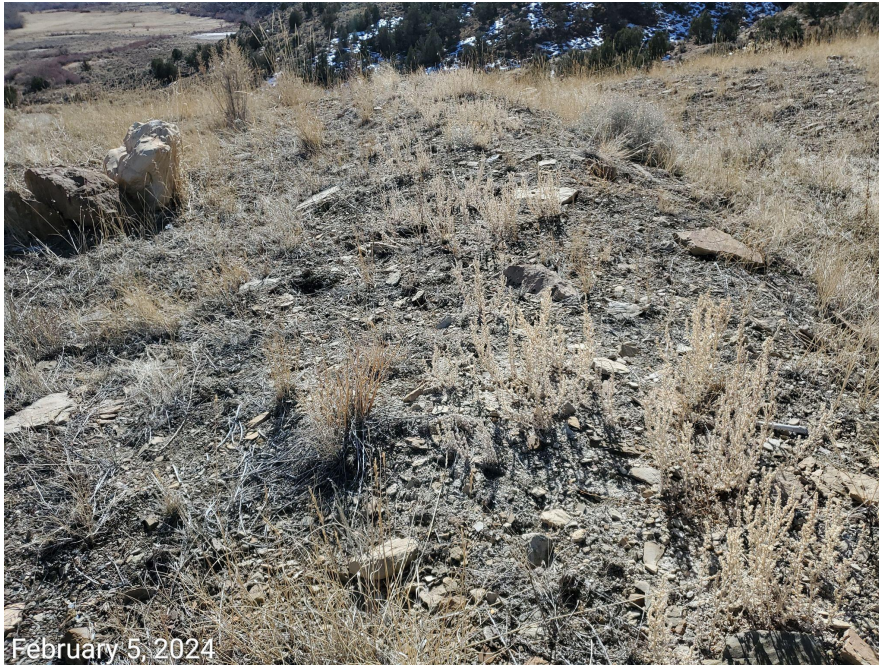
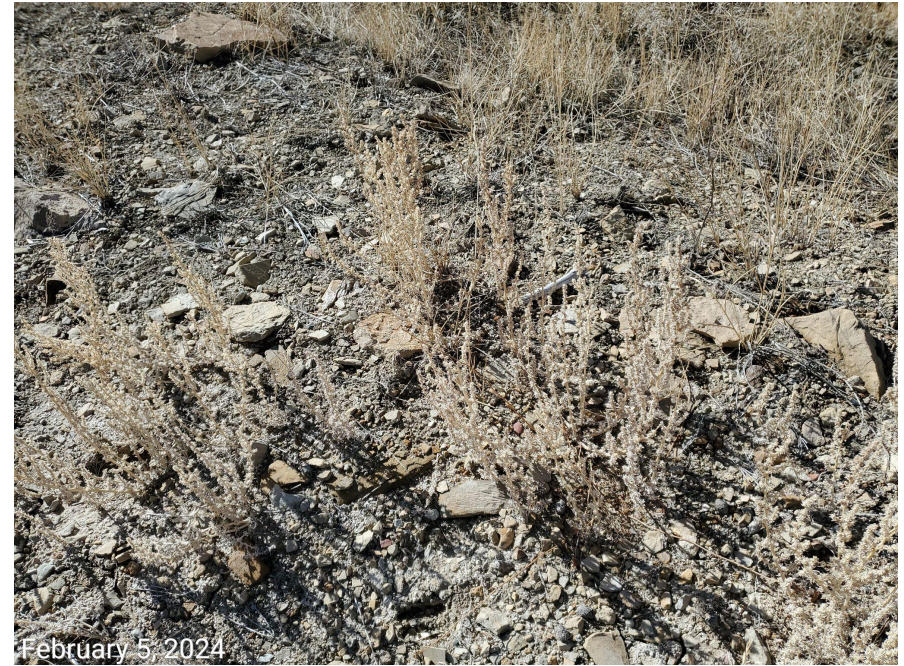
Photo 8: Photos taken from the south end of the Location. Photo shows halogeton established on the Location.

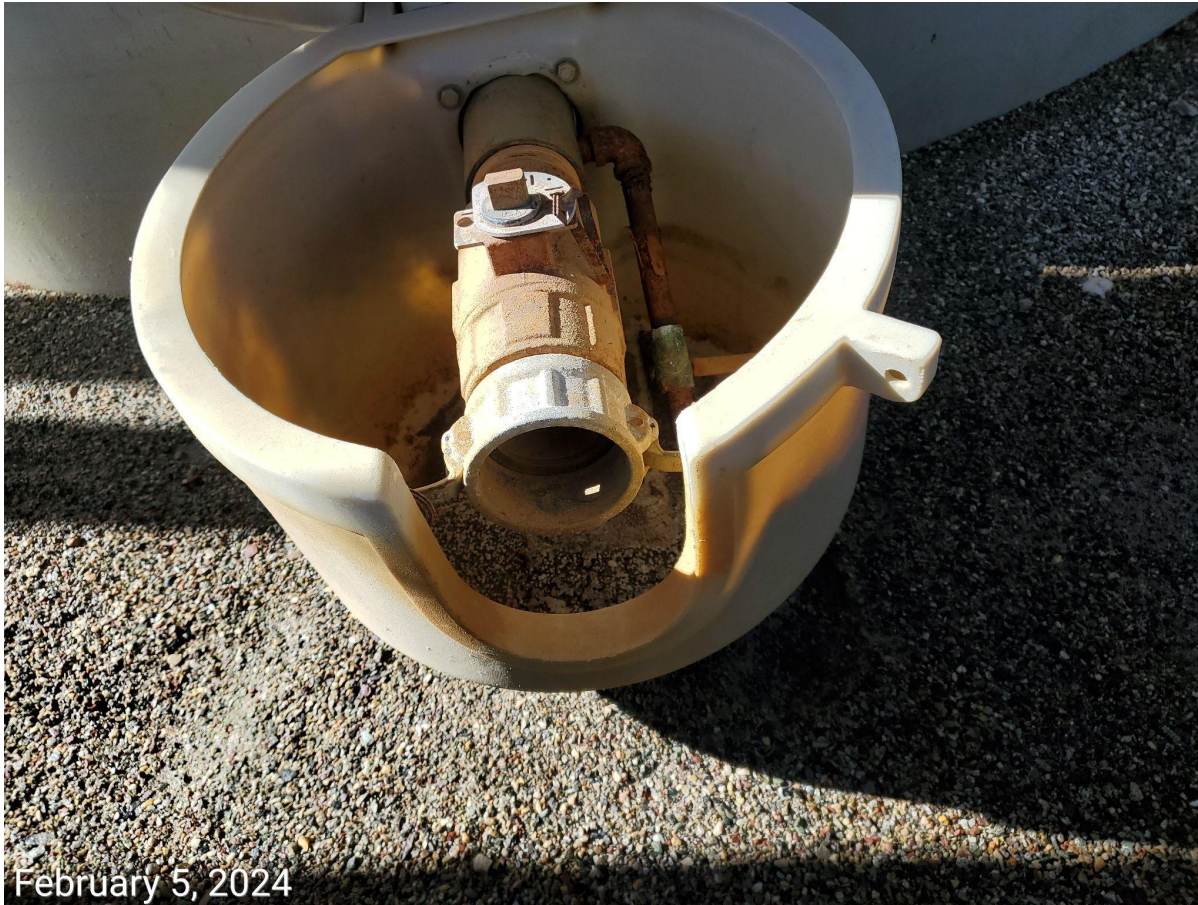
Photo 9: Lines at tanks lack cap/plug.
