Location
: 465486

COLORADO
Energy & Carbon Management
Commission
Department of Natural Resources

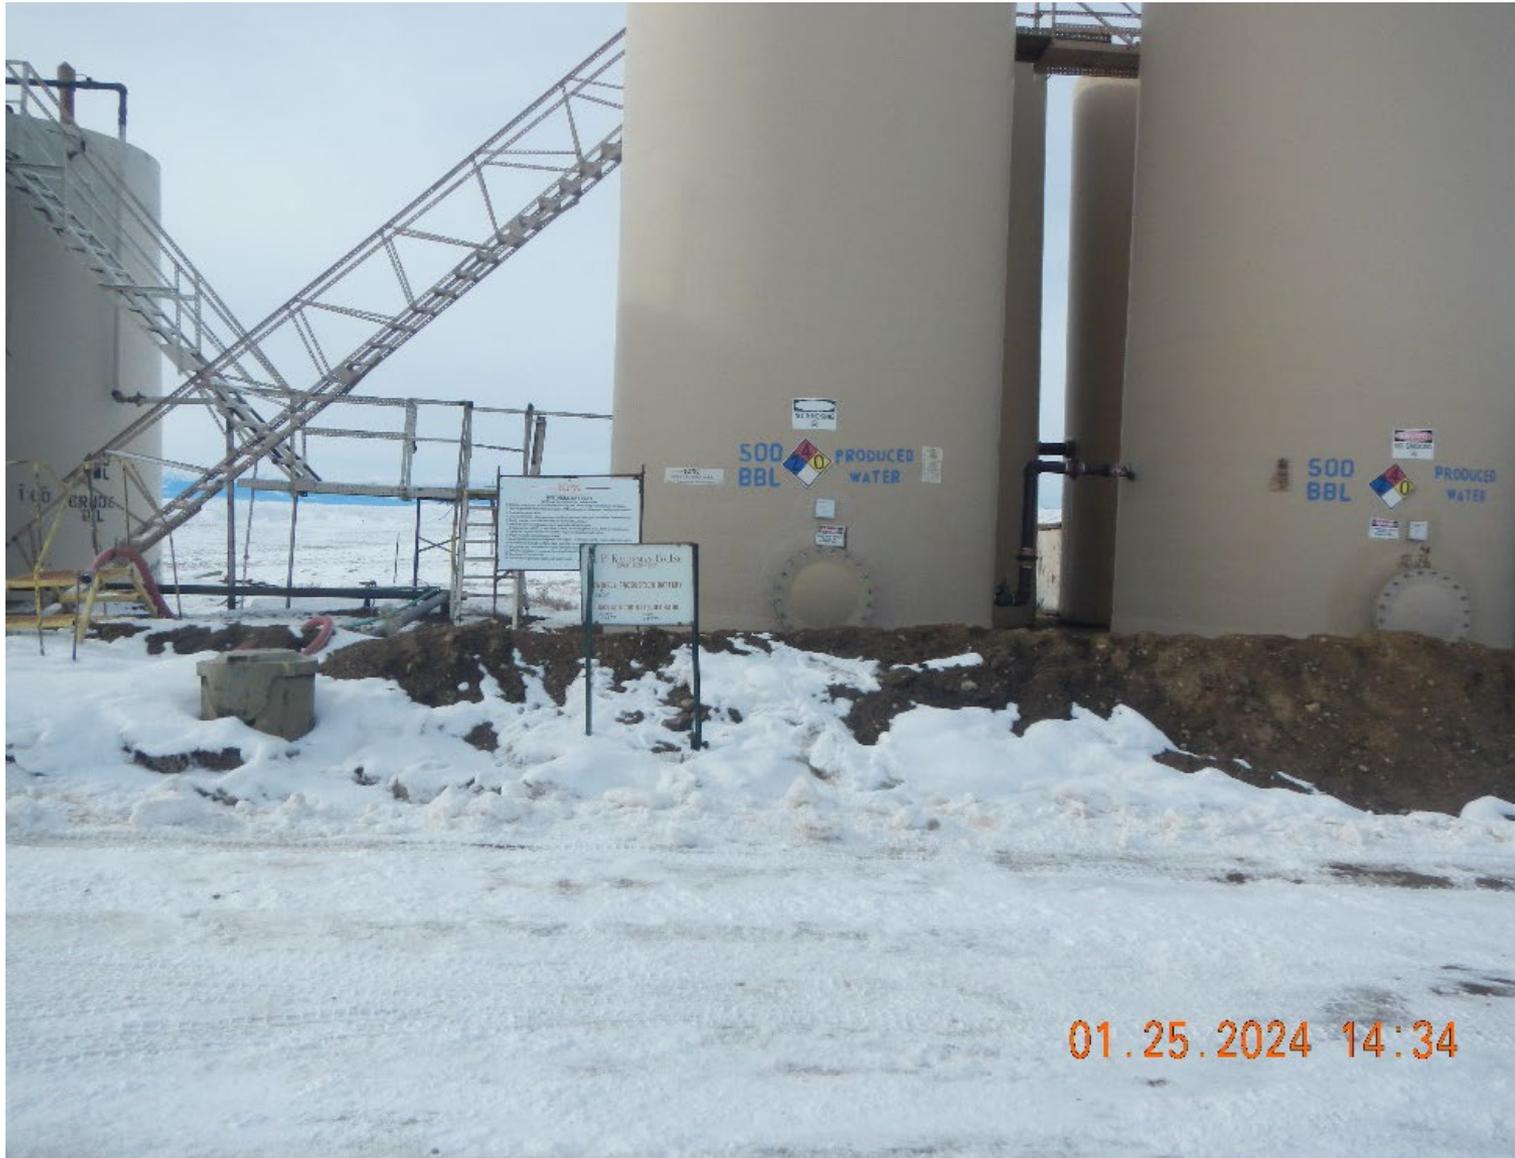
Photo #1 Tank battery at Dwinell

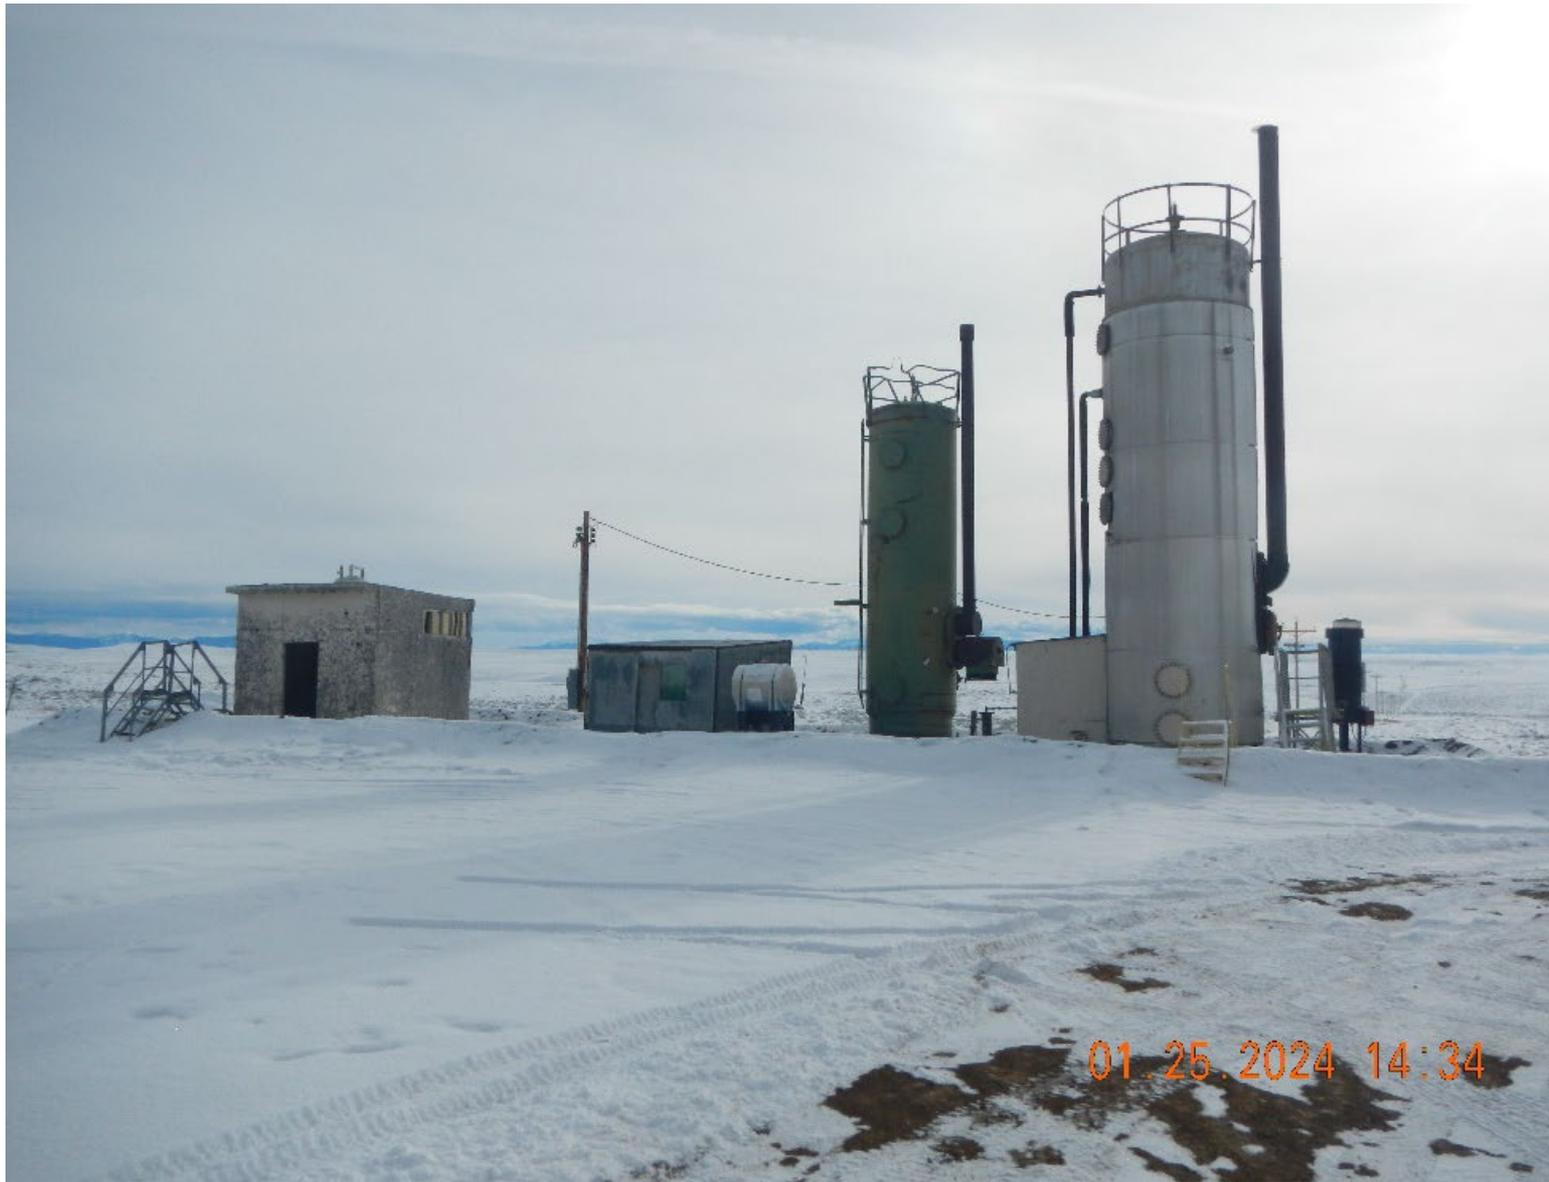
Photo #2 treaters and combustor. This Containment area is south of the main tank battery.

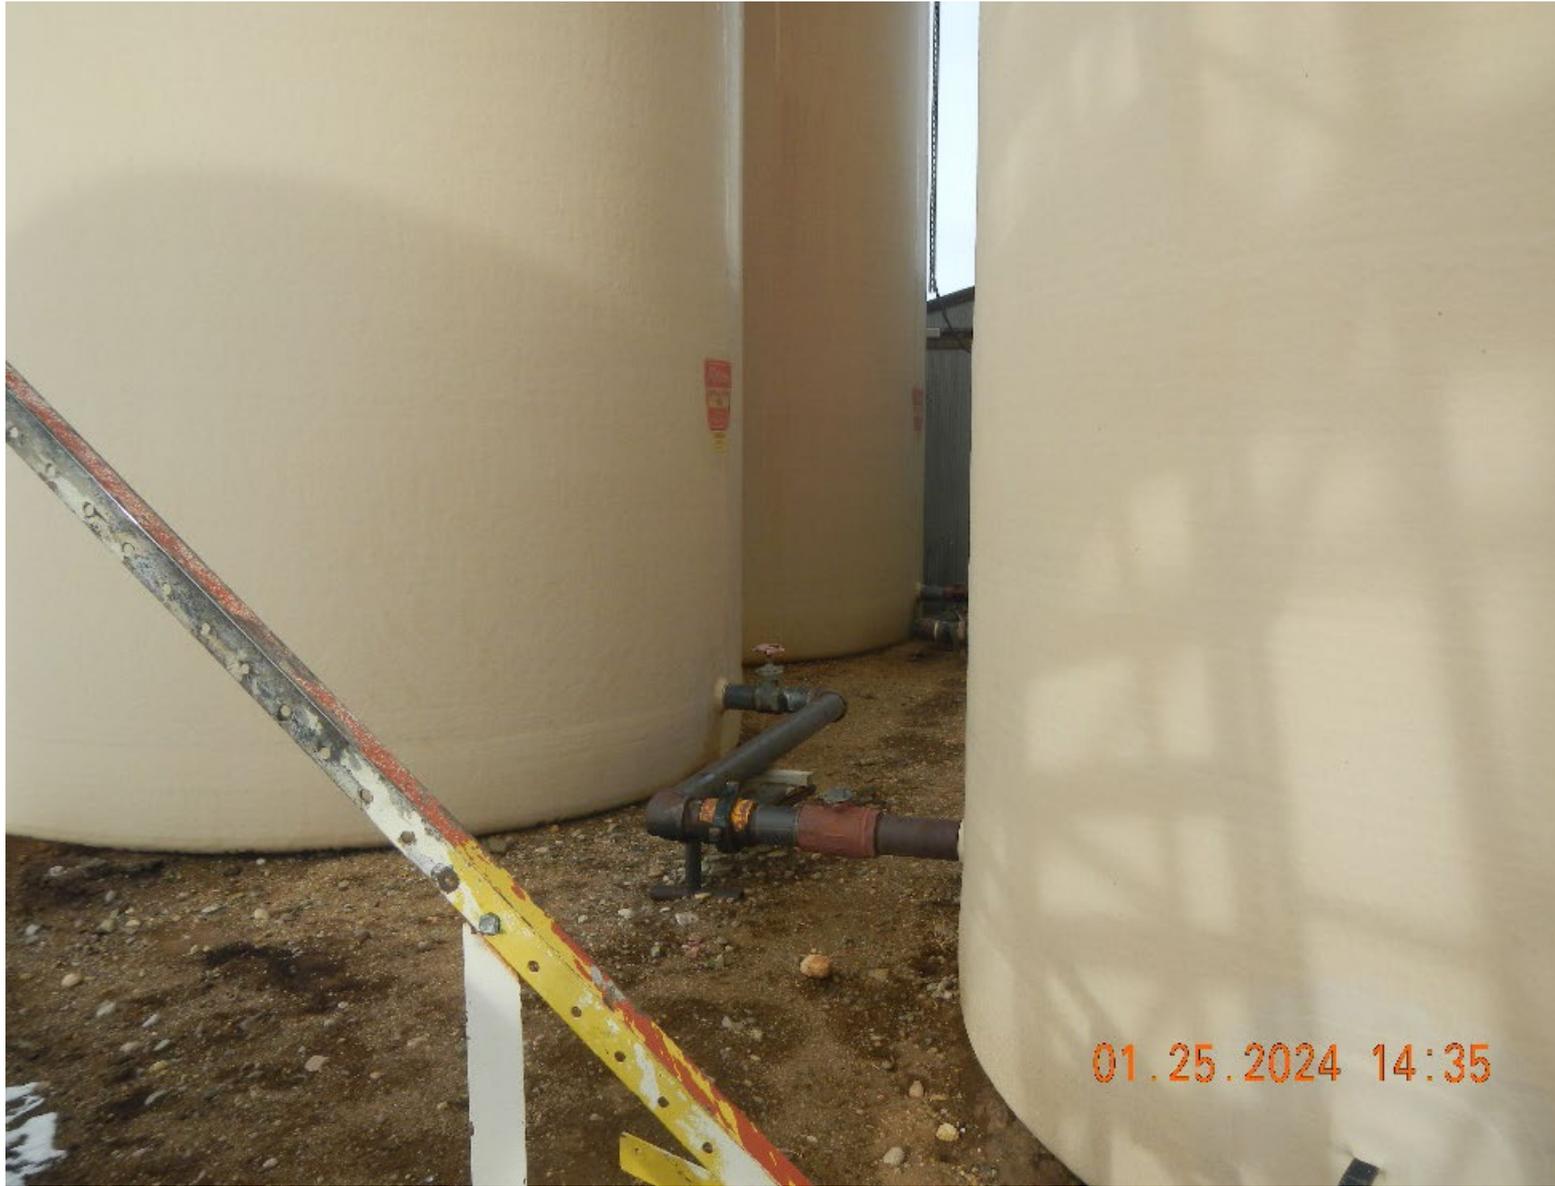
Photo #3 Water tanks in main tank battery.

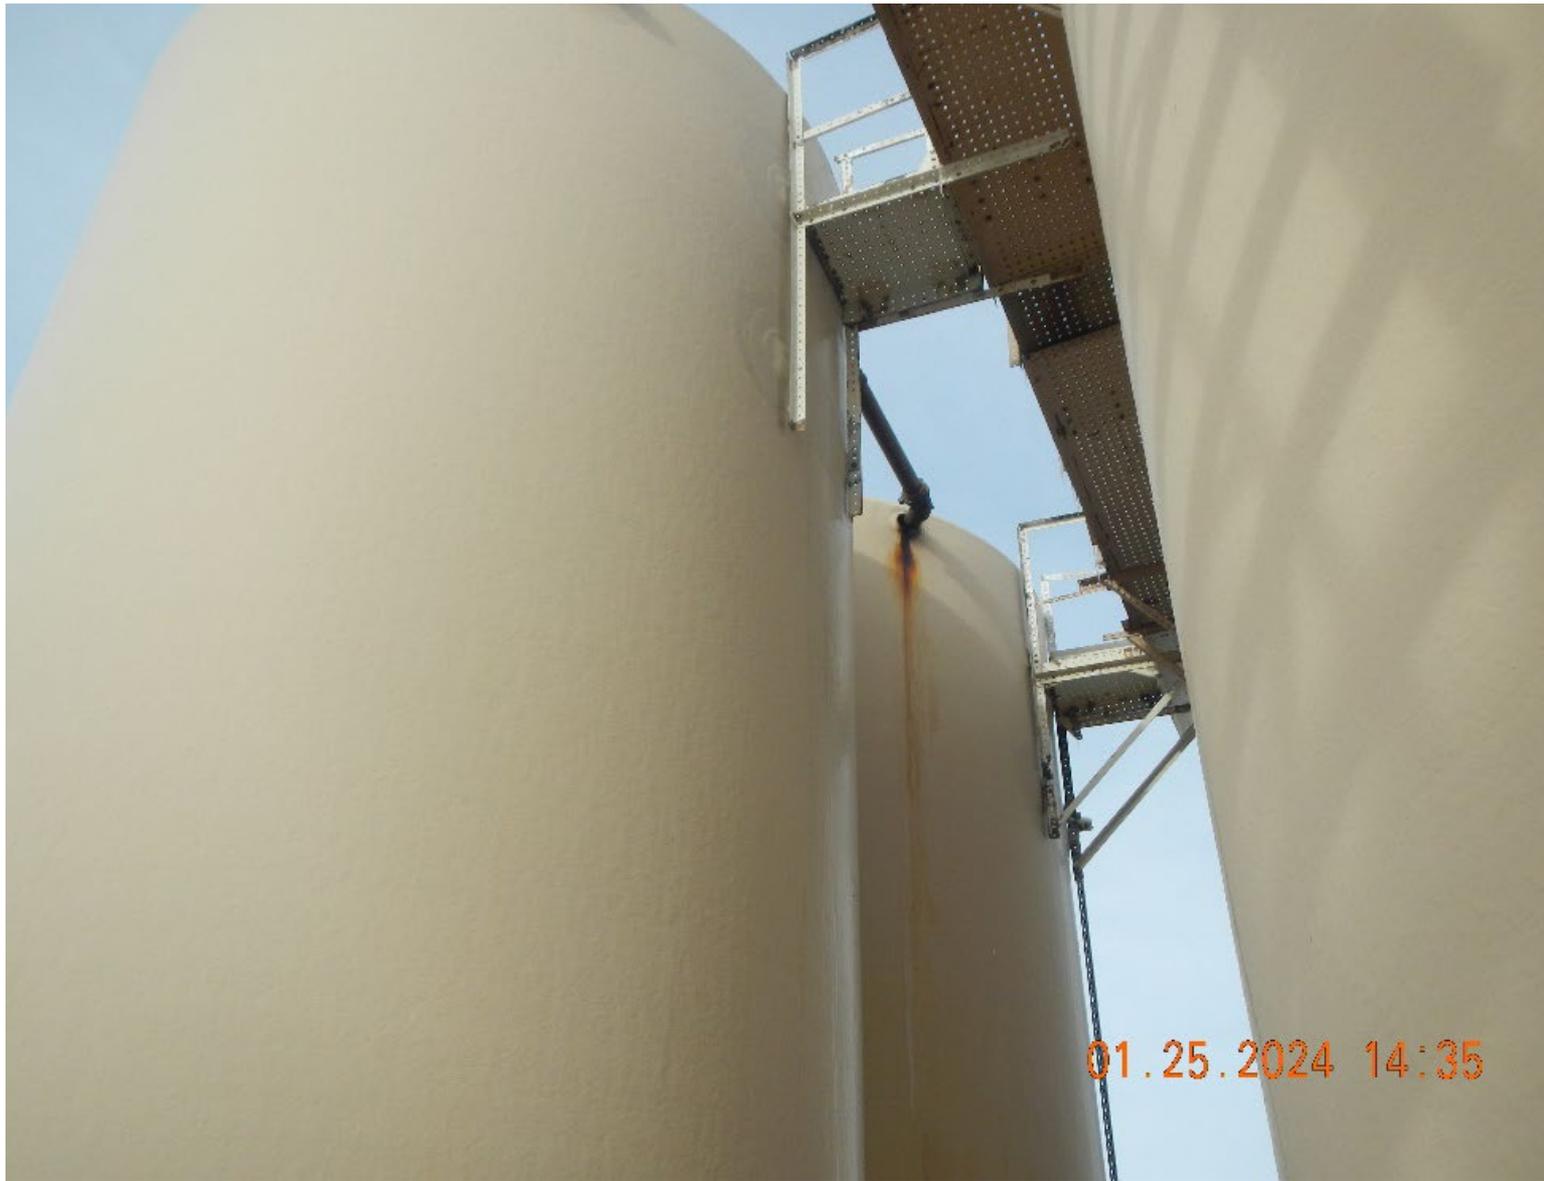
Photo #4 looking up at water tanks. Tank at back left of photo is the north-western most tank in the tank battery. Note the piping on the top of the tank is not seated or connected.

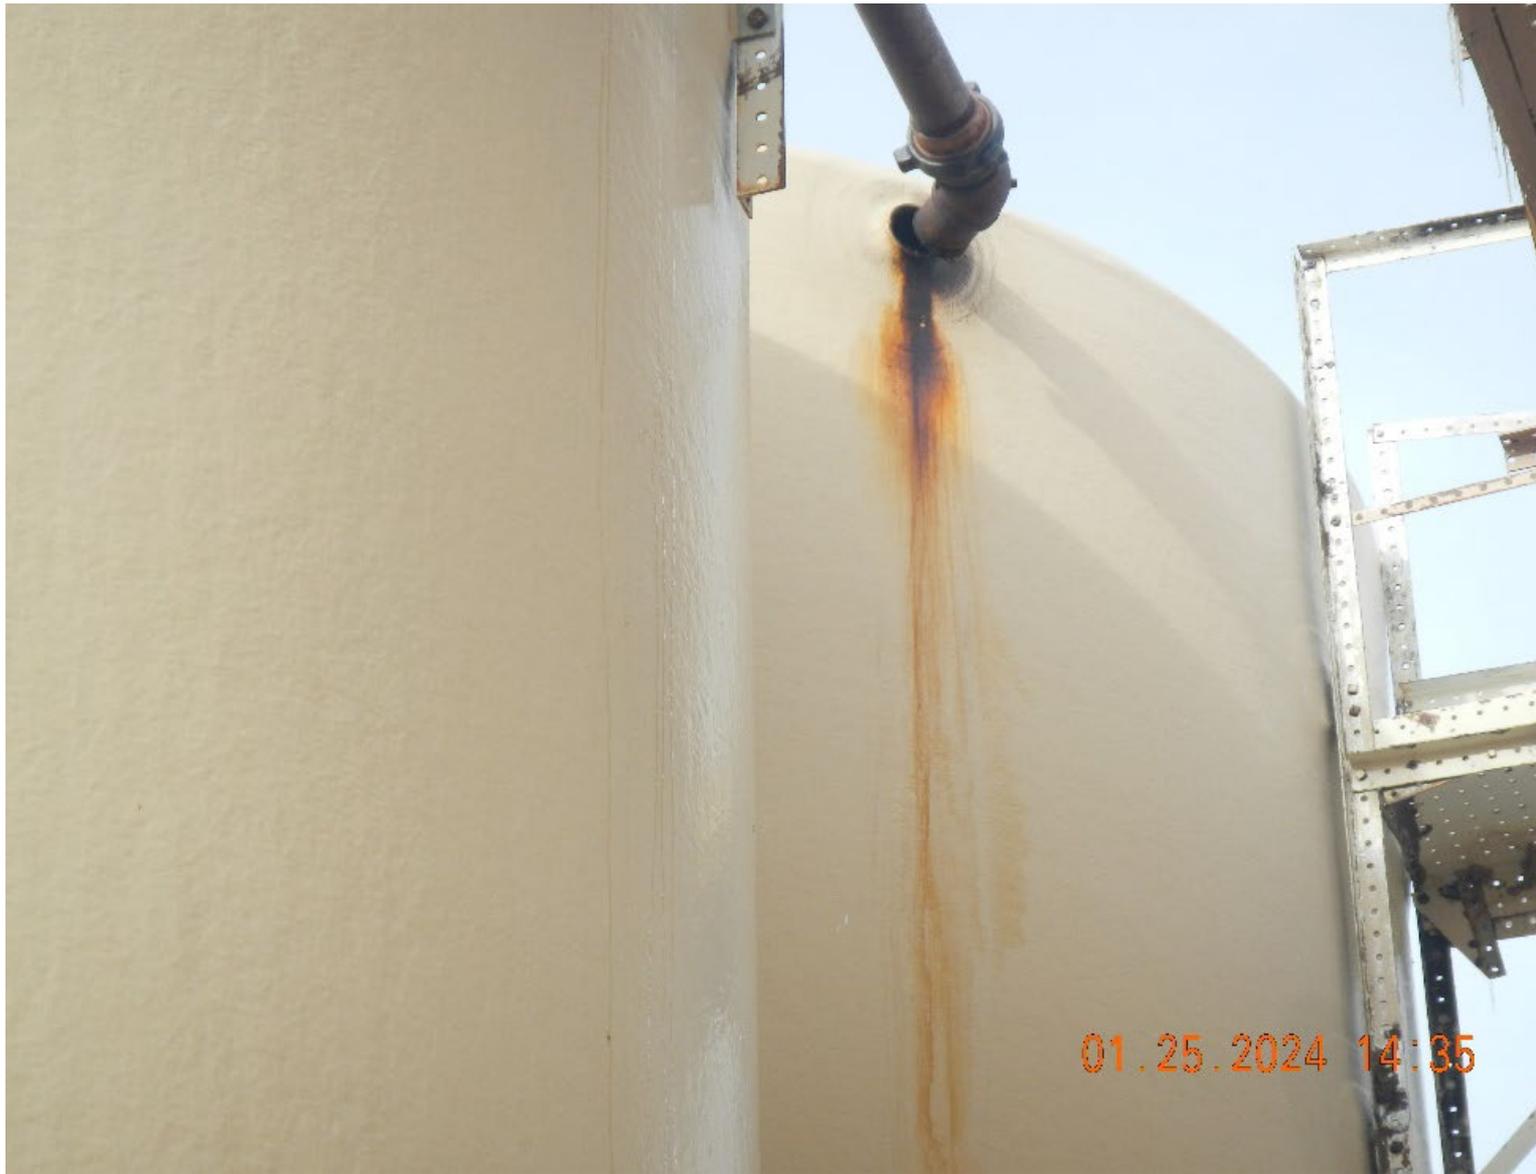
Photo #5 looking up at water tanks. Tank at back left of photo is the north-western most tank in the tank battery. Note the piping on the top of the tank is not seated or connected.

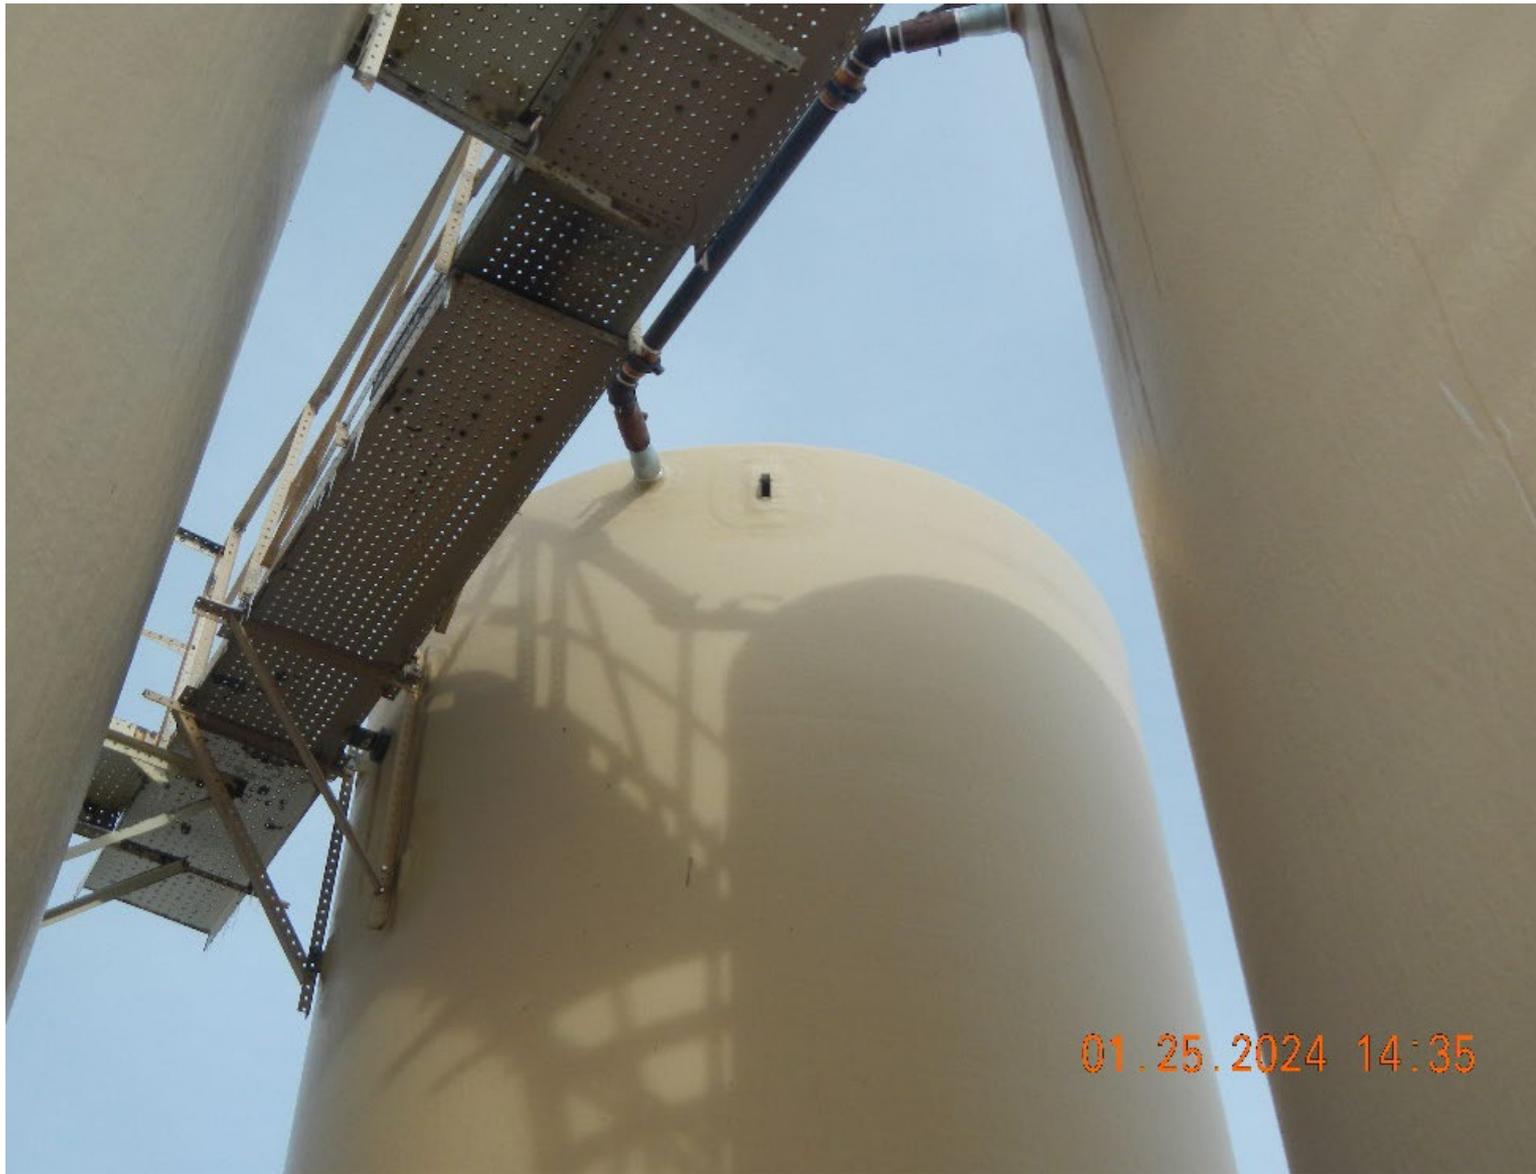
Photo #6 looking at the north eastern most tank at center of
photo.

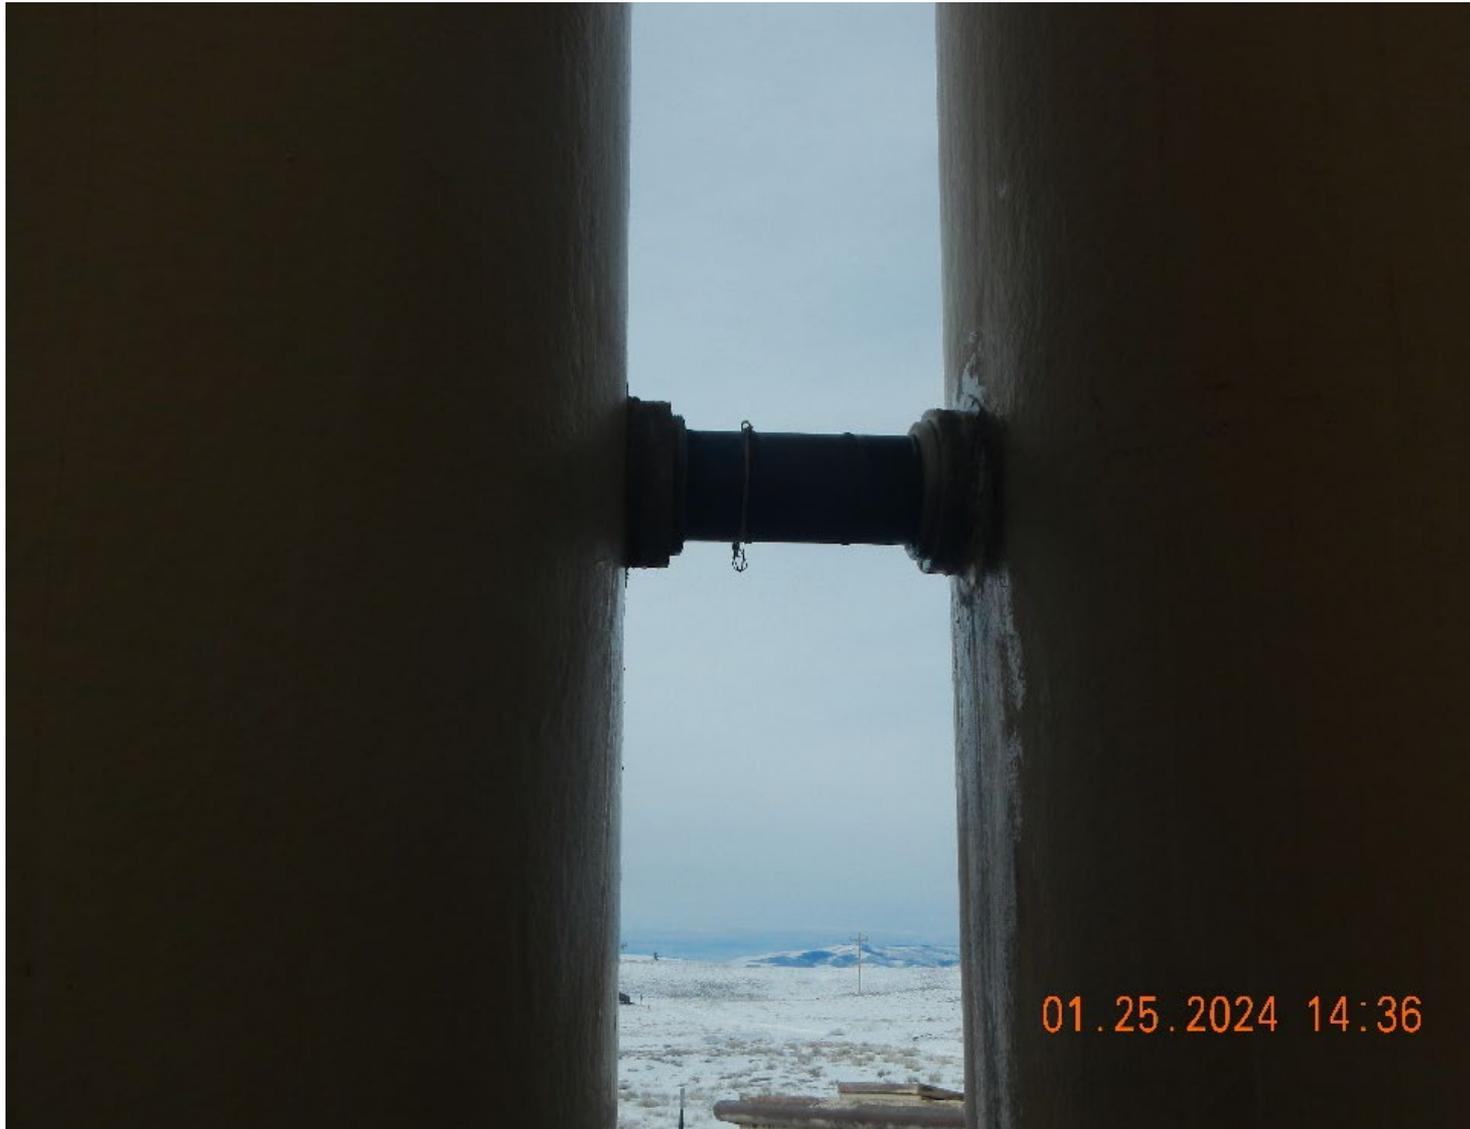
Photo #8 This is the connection that was observed in inspection #714300014. From that inspection, “an on-going release at the approximate 4” manifold going from tank to tank on the two (2) westerly 500 bb”. The repair appears to be adequate, there was no dripping or ongoing release, the apparent “wetness” in photo is repair adhesive

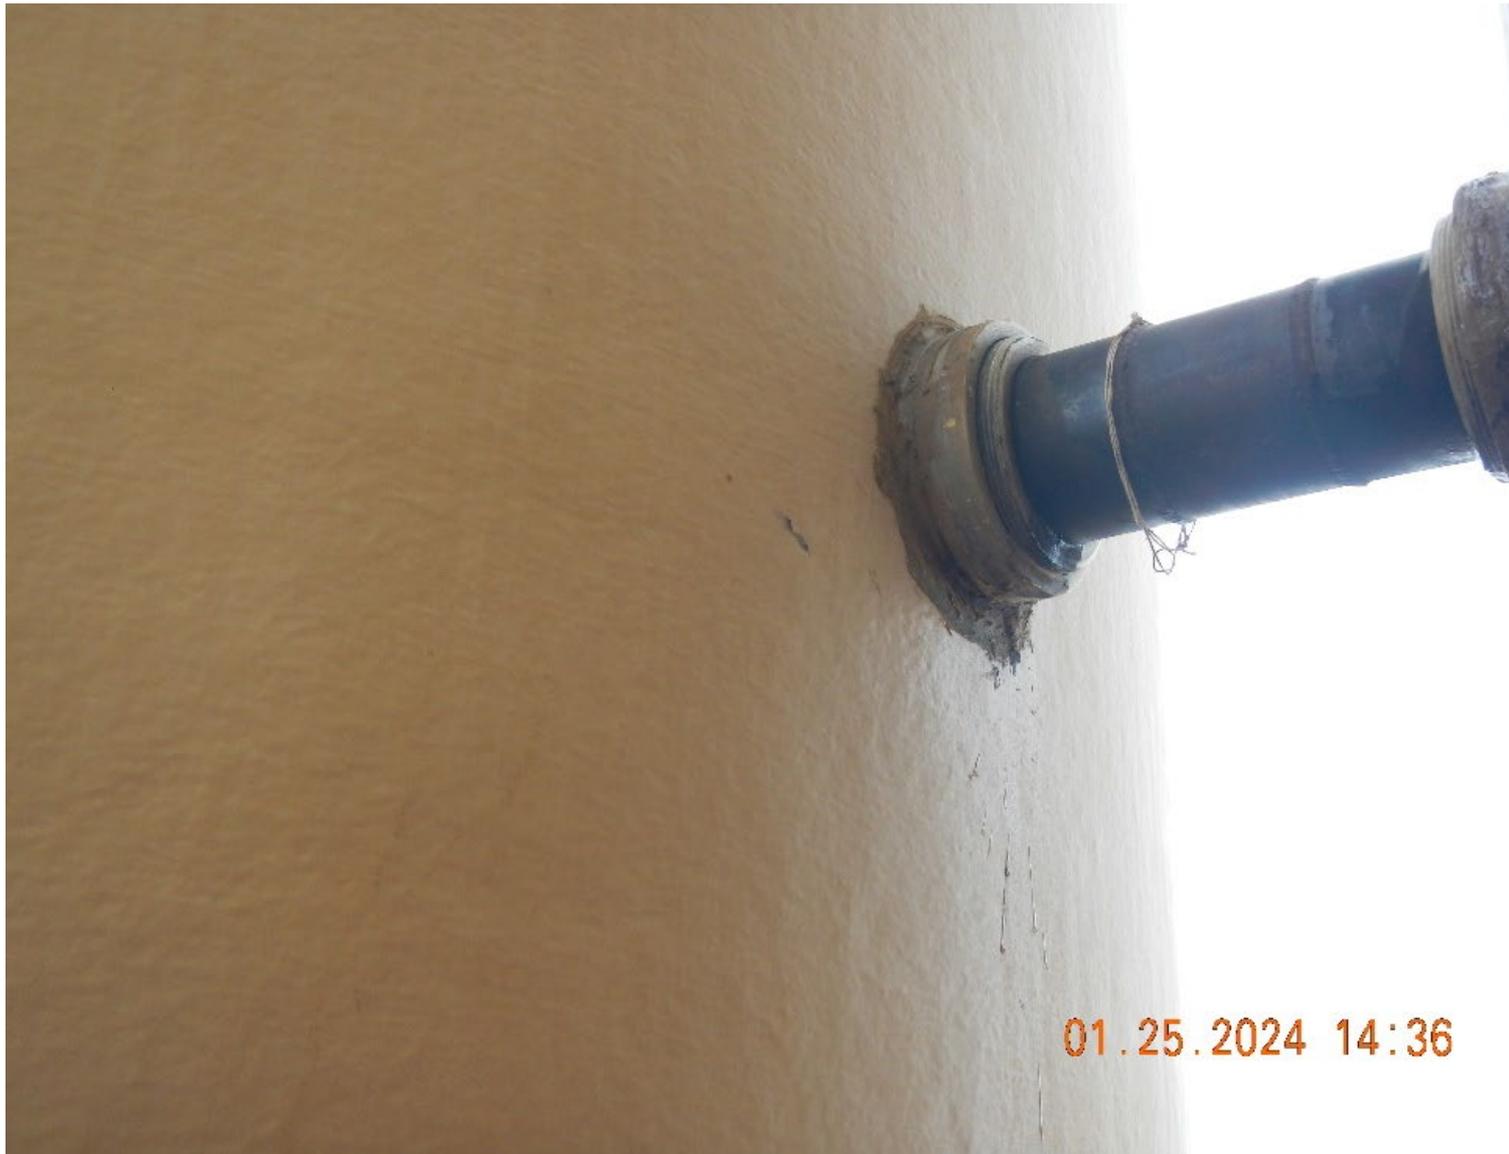
Photo #9 This is the connection that was observed in inspection #714300014. From that inspection, "an ongoing release at the approximate 4" manifold going from tank to tank on the two (2) westerly 500 bbs". The repair appears to be adequate, there was no dripping or ongoing release.

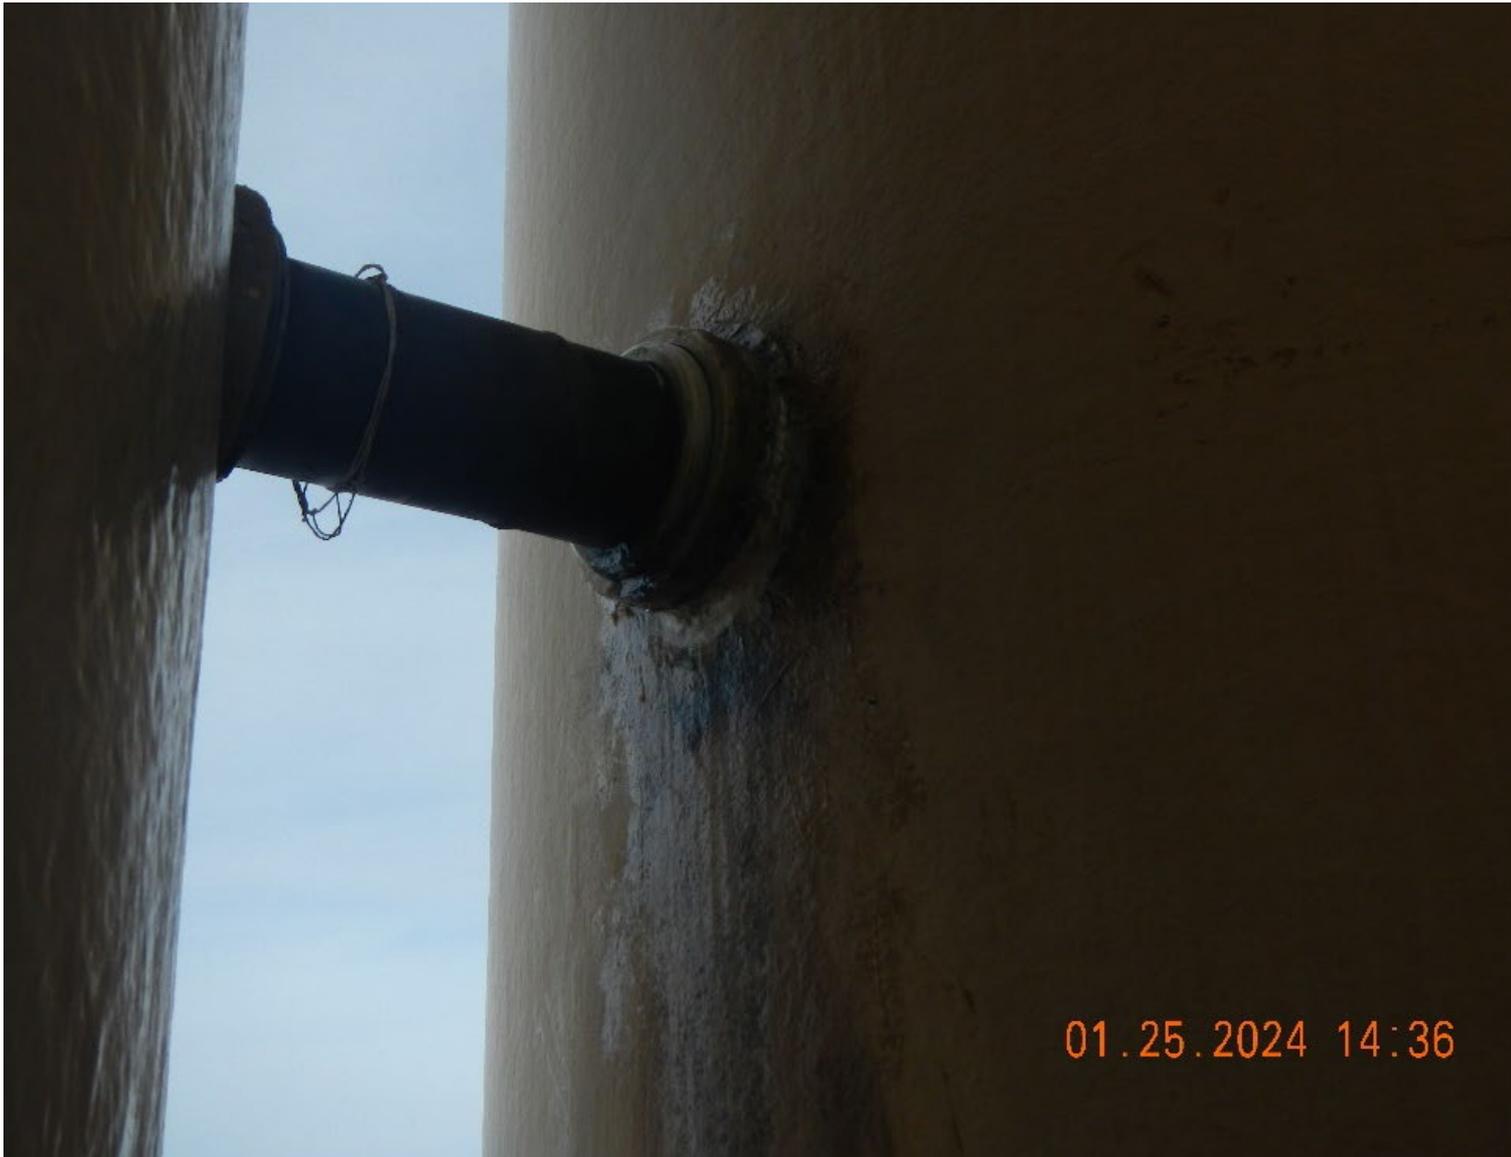
Photo #8 This is the connection that was observed in inspection #714300014. From that inspection, “an on-going release at the approximate 4” manifold going from tank to tank on the two (2) westerly 500 bb”. The repair appears to be adequate, there was no dripping or ongoing release, the apparent “wetness” in photo is repair adhesive

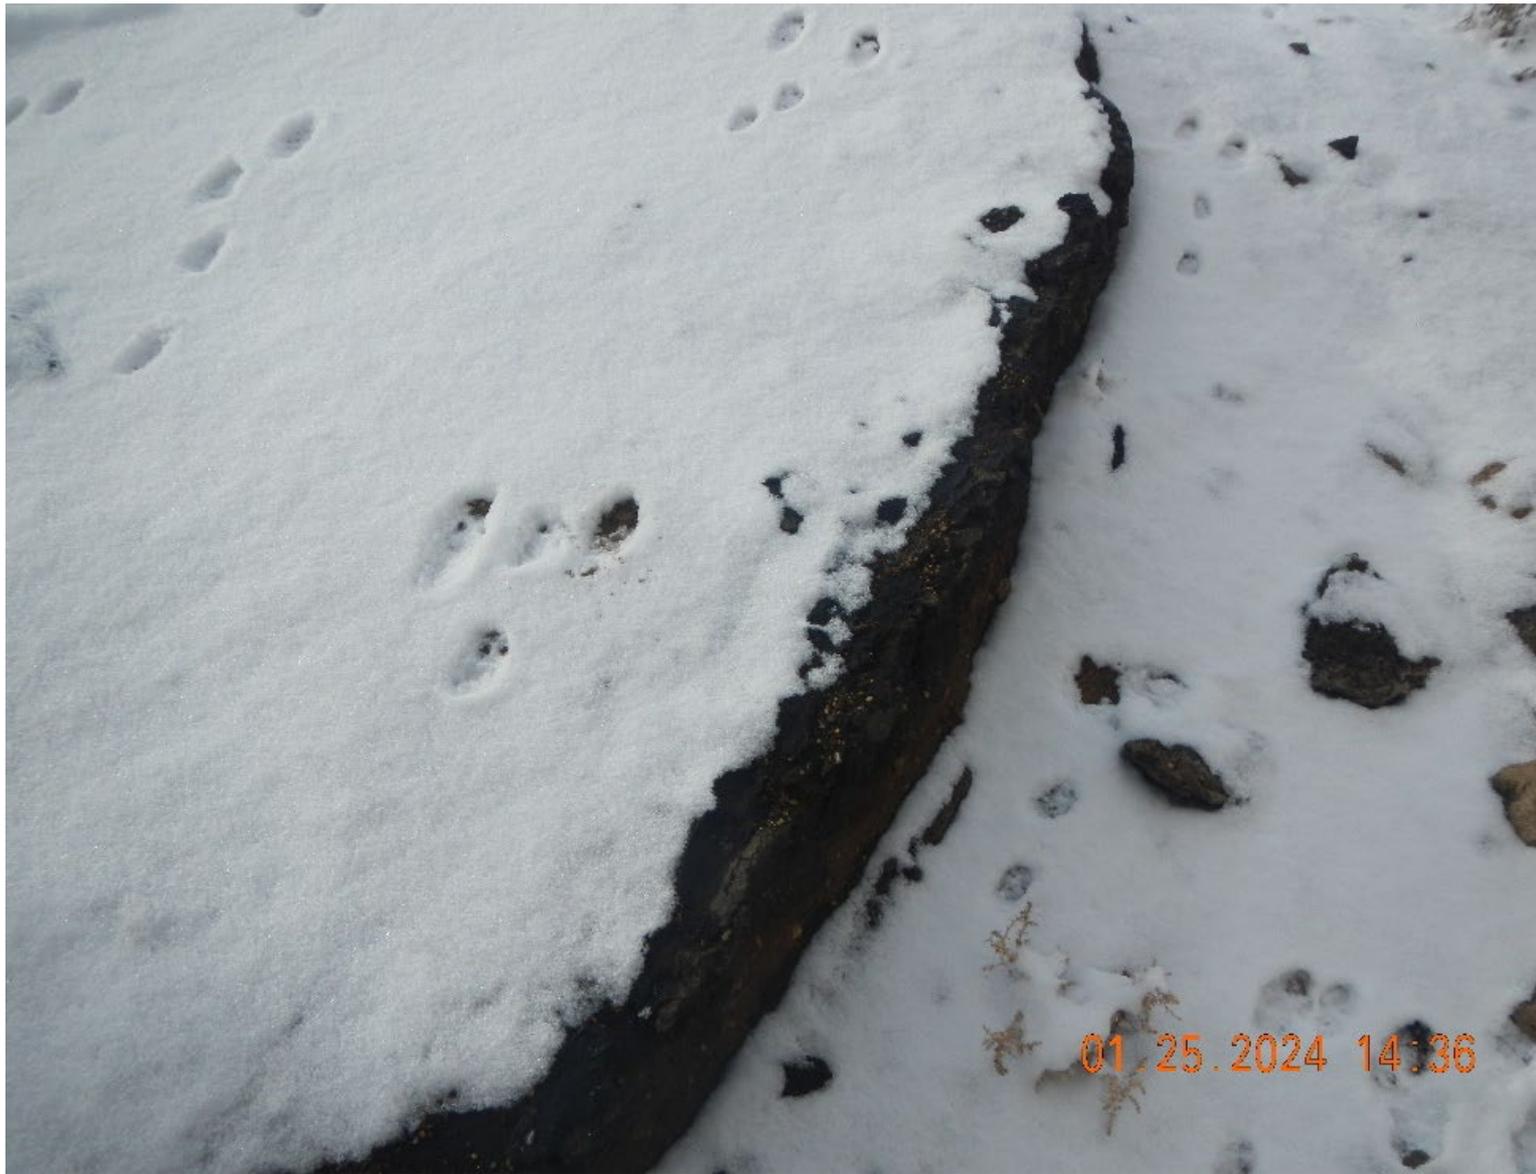
**Photo #11 apparent hydrocarbon staining inside of tank
battery, bunny tracks from Jackrabbit.**

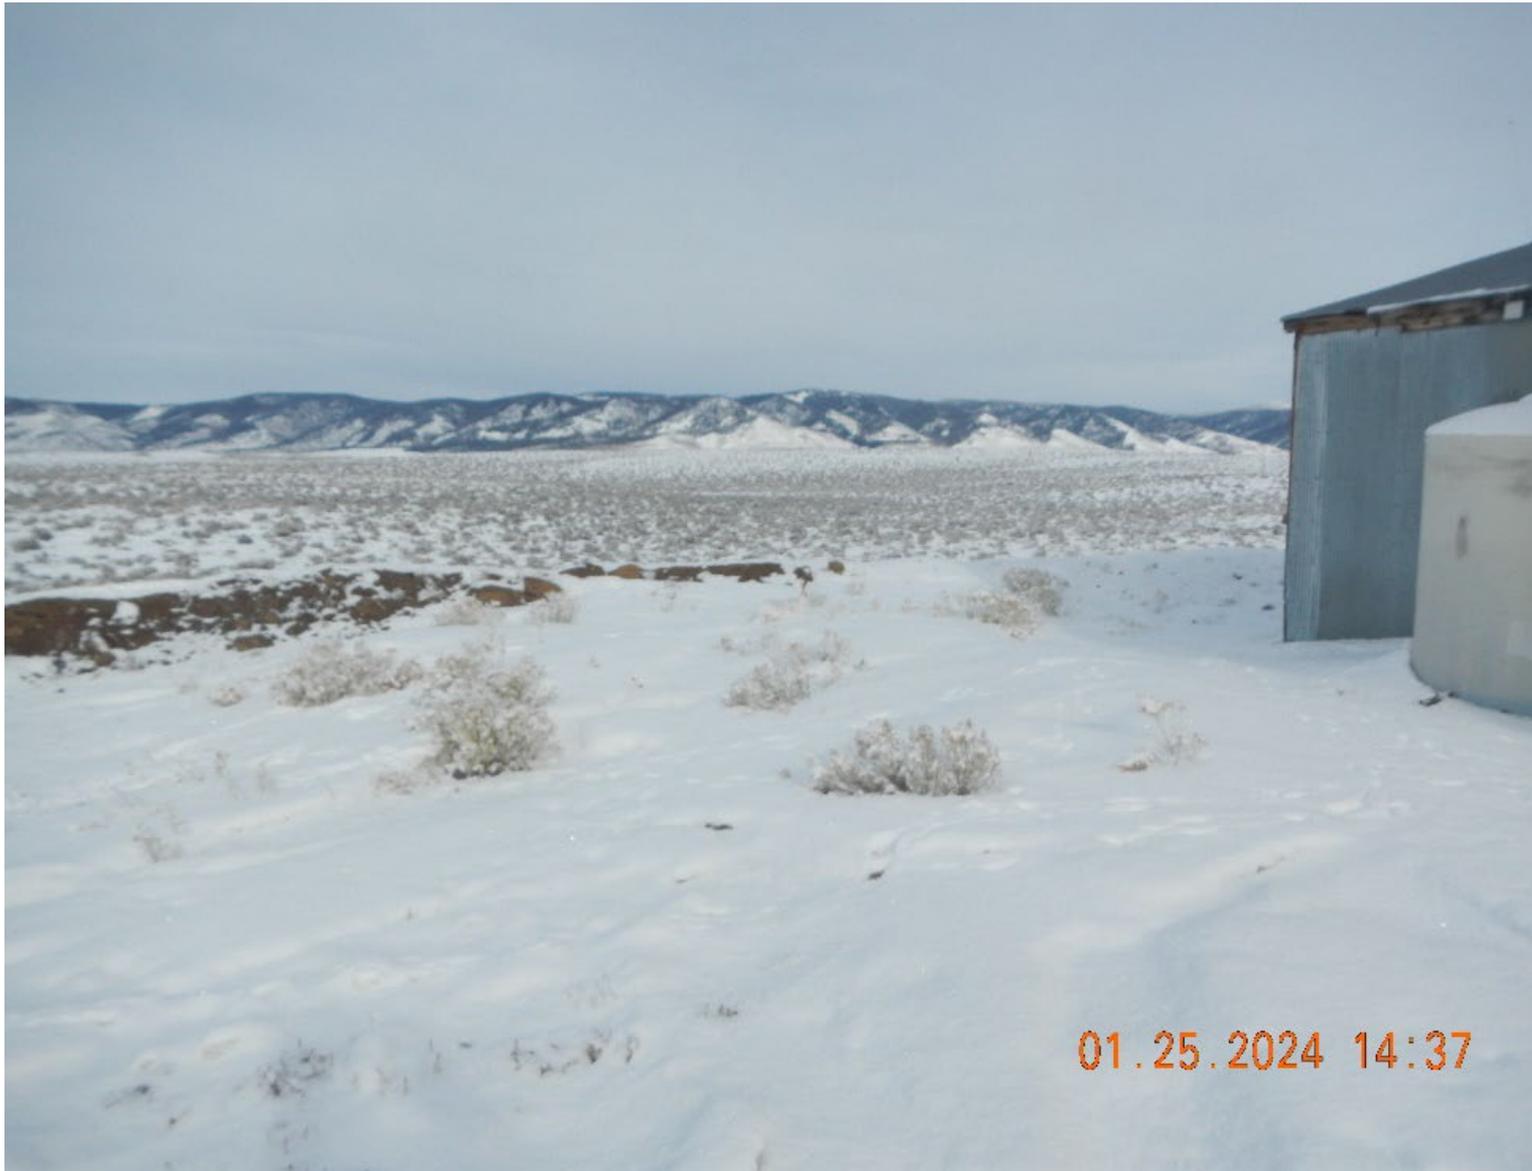
Photo #12 looking north-north east shed on right is north of
tanks.

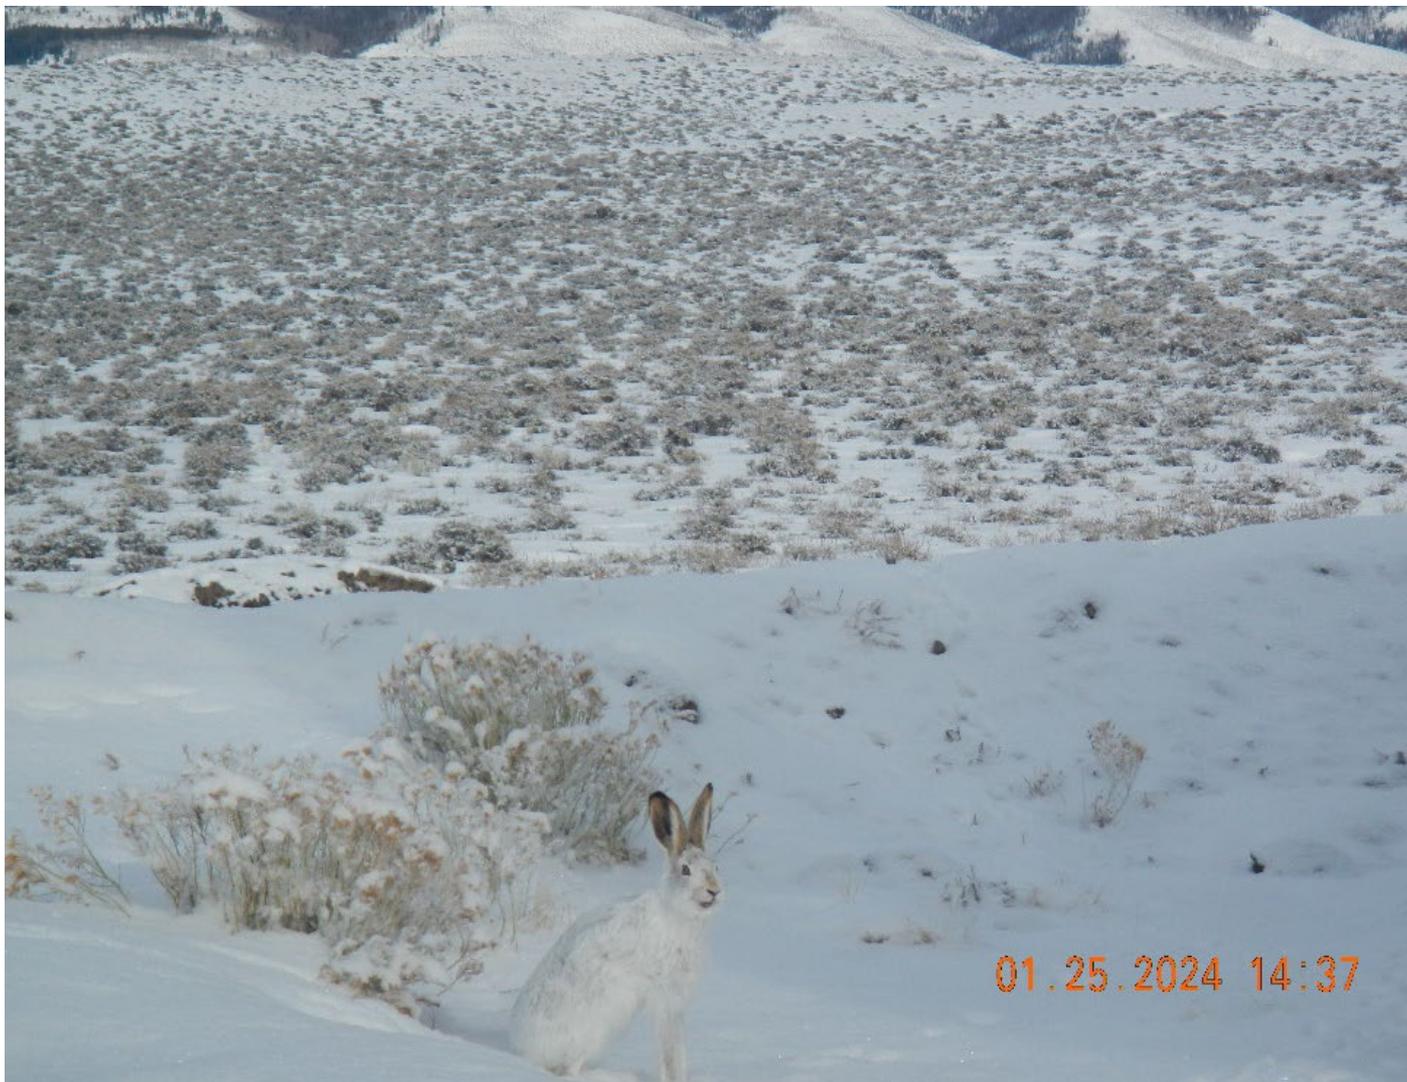
Photo #14 Jackrabbit inside tank battery.

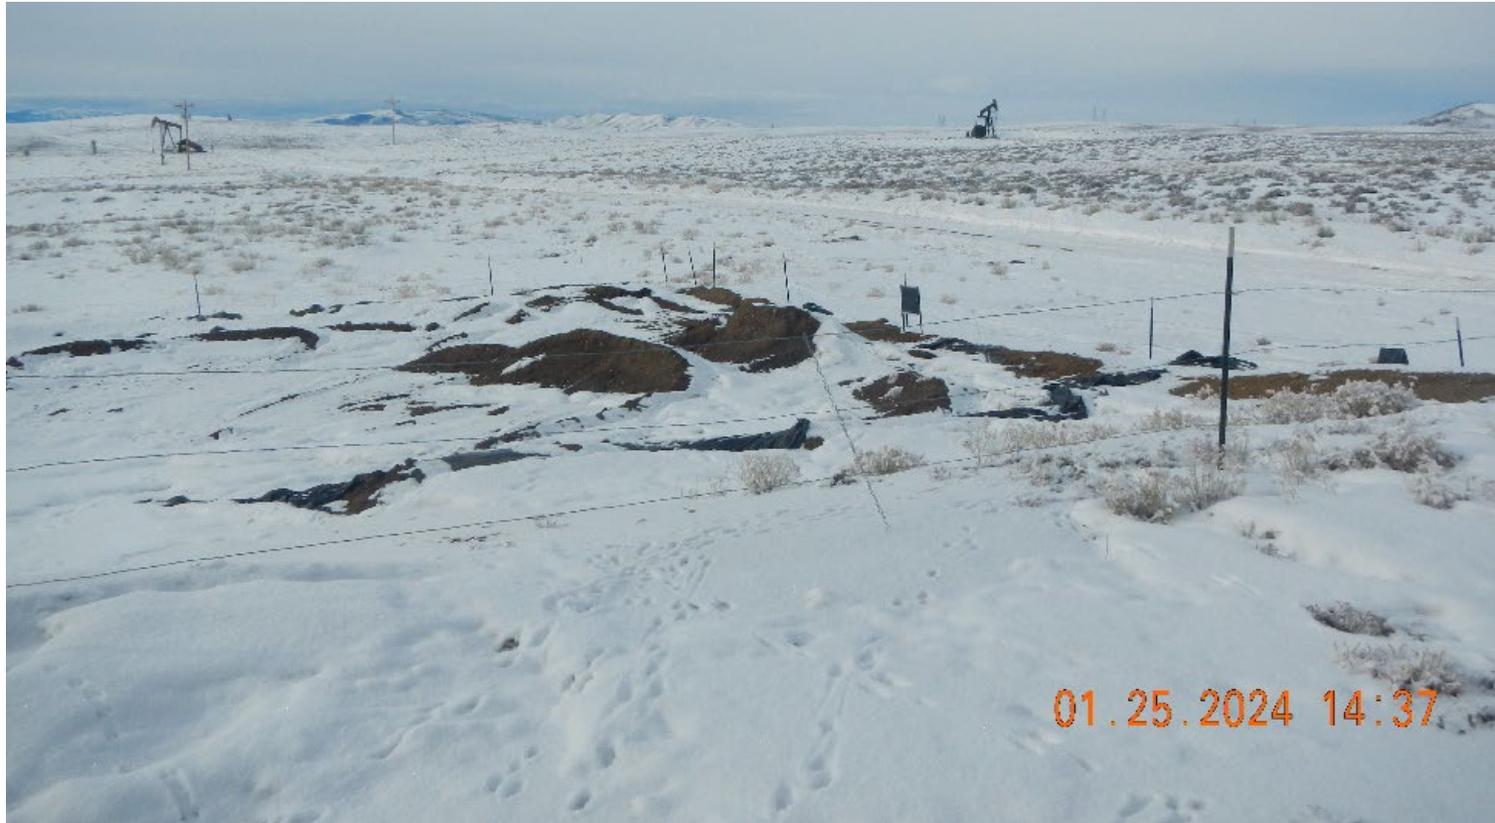
Photo #15 photo taken inside tank battery looking at stockpiled soil in the lower tier of tank battery.
