Location
: 465486

COLORADO
Energy & Carbon Management
Commission
Department of Natural Resources

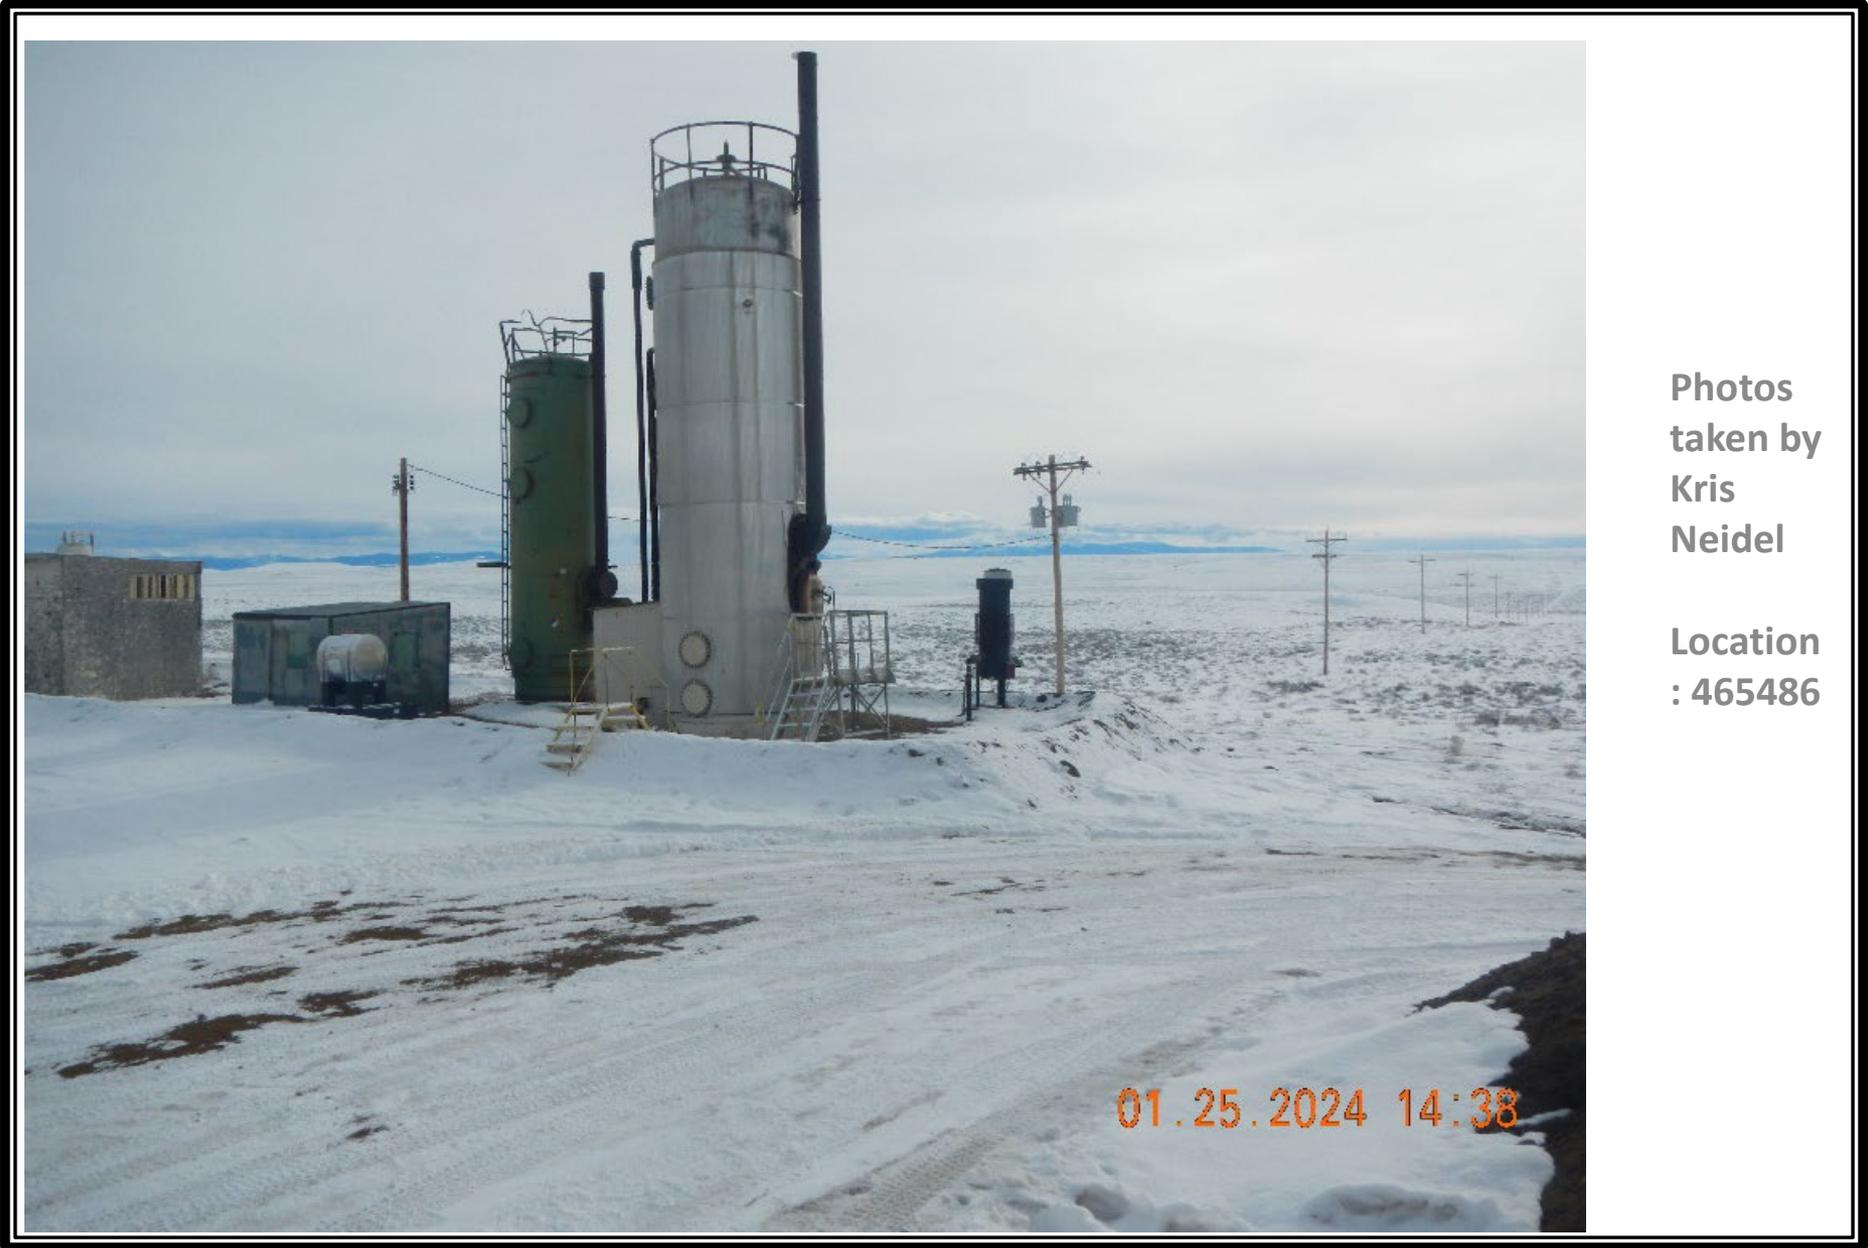
Photo #17 Treaters inside soil containment. The combustor was burning at the time of inspection.

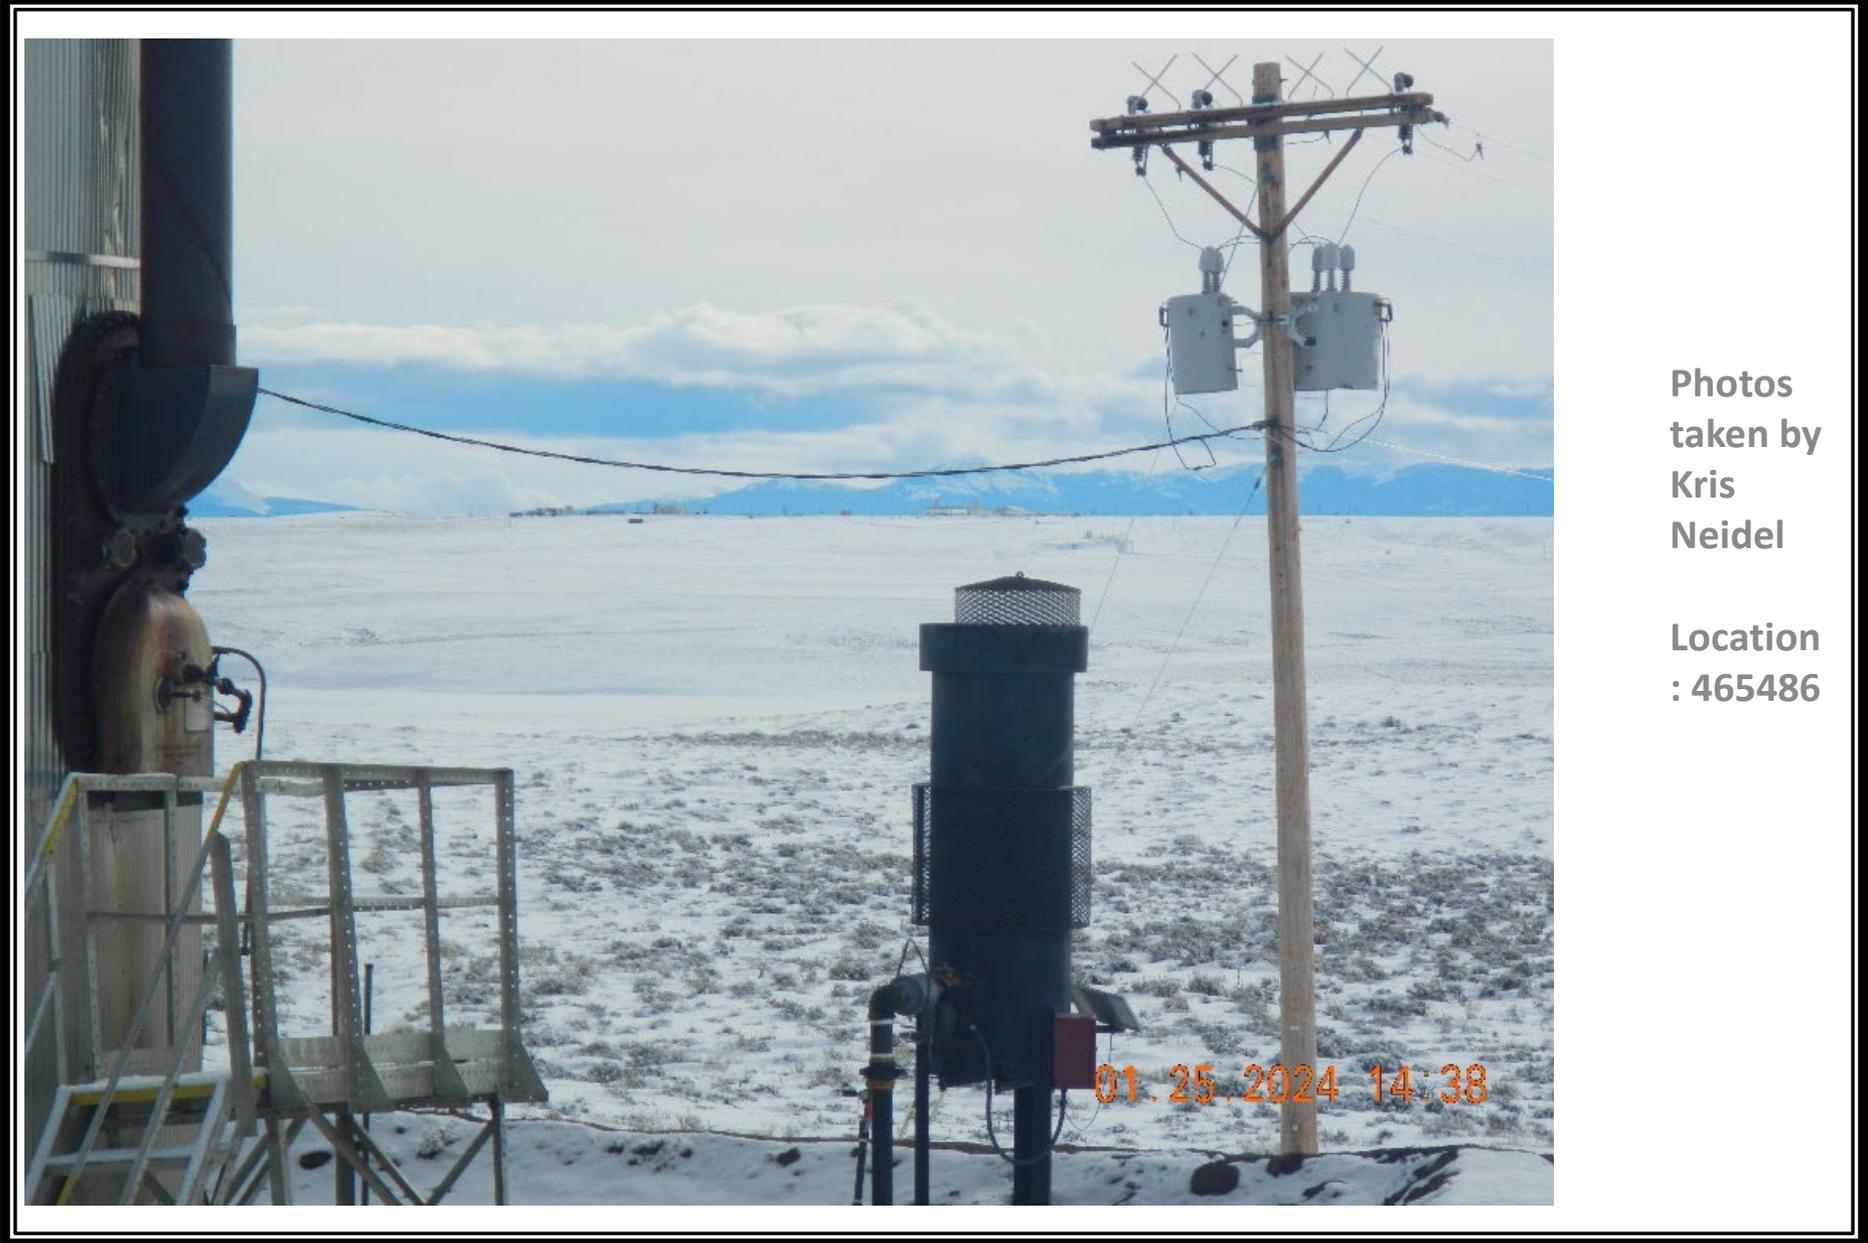
Photo #18 Combustor, the photo was attempting to capture the heat signature coming off the bustor, it does not show in photo, inspector can attest that the combustor was burning gas at the time of inspection.
