**Storm Water Management and Erosion control**  
**Location Name: CAERUS PICEANCE LLC HILL (E16) Pad**  
**Location ID: 334915**

**Section/Township/Range: 16 7S92W**

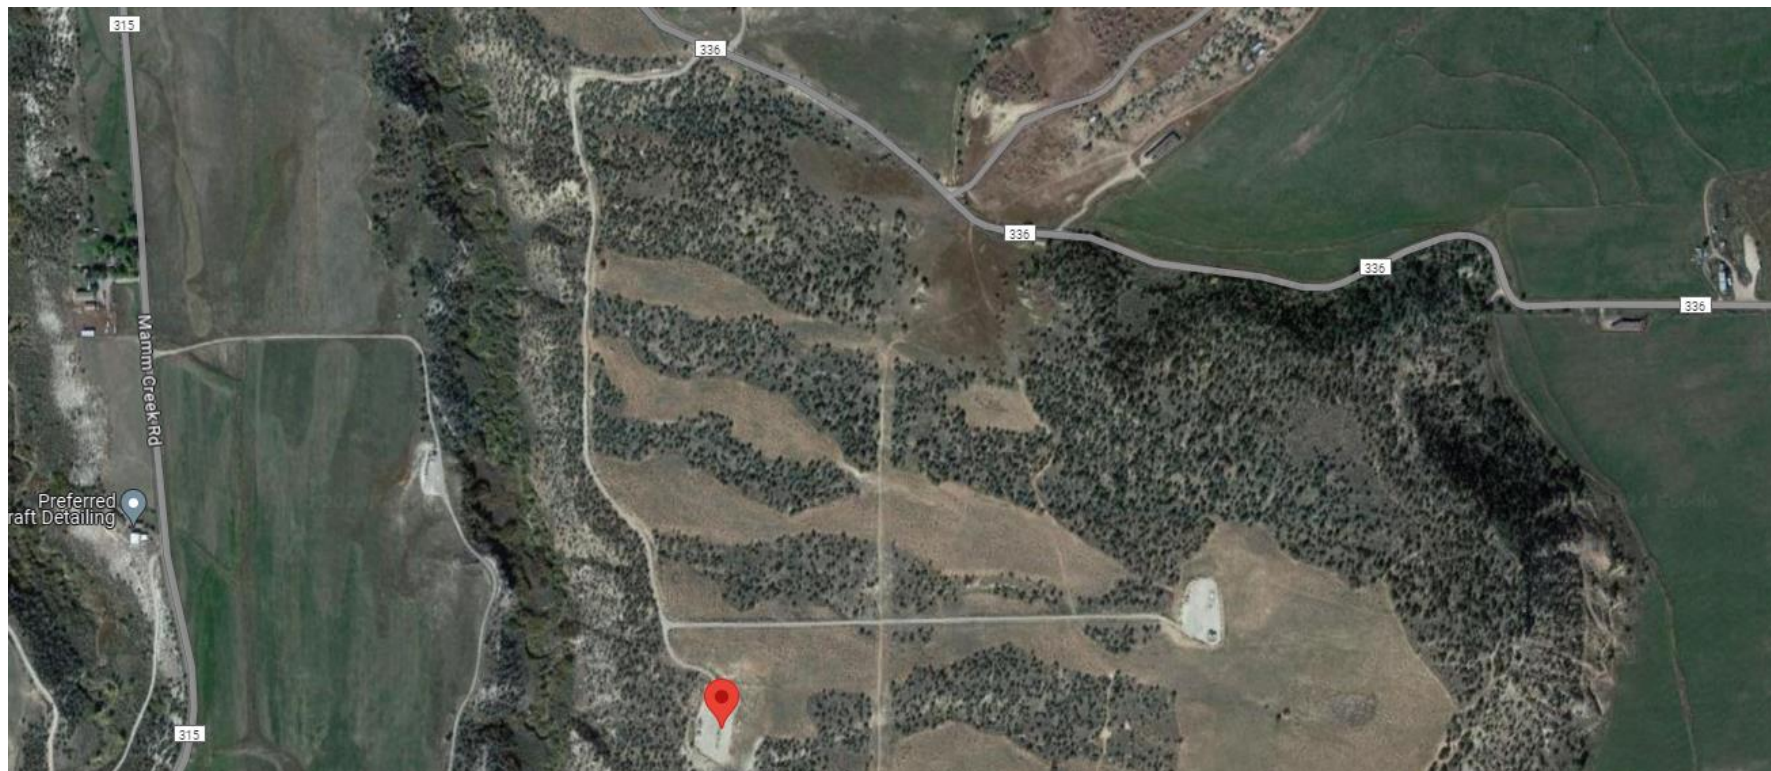
**Location Overview: Location is within High  
Priority/Density/Black Bear Habitat areas & in close proximity  
to NSO Habitat area. Location is approximately 205 yards  
from East Mamm Creek.**

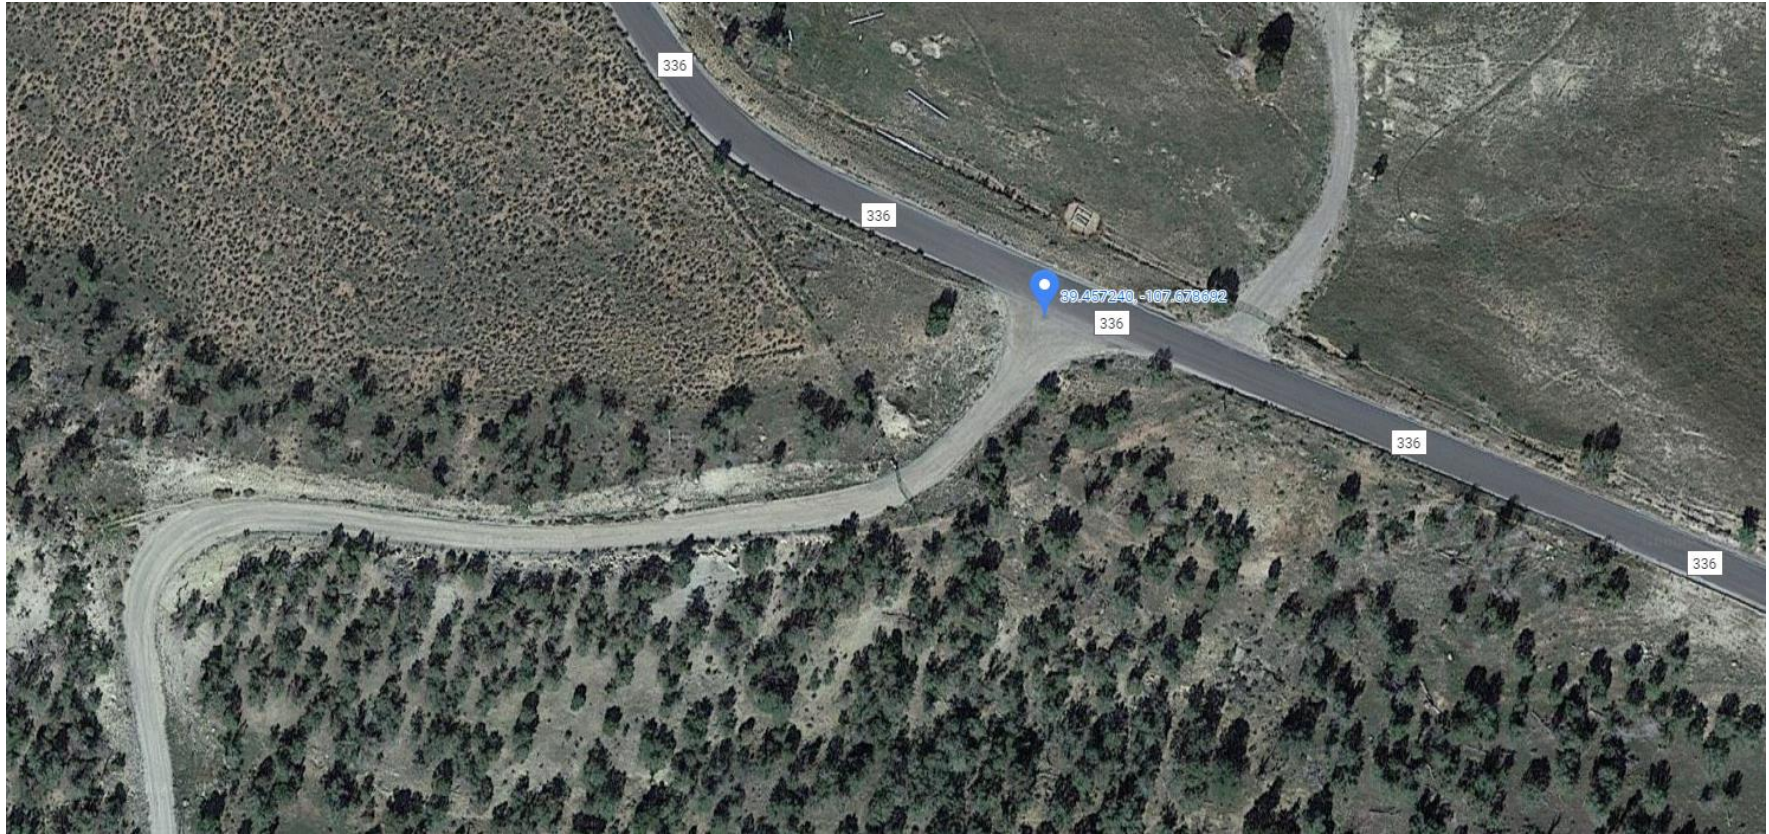
**Overview of intersection of CR 336 (Jenkins Cutoff) & lease road.**

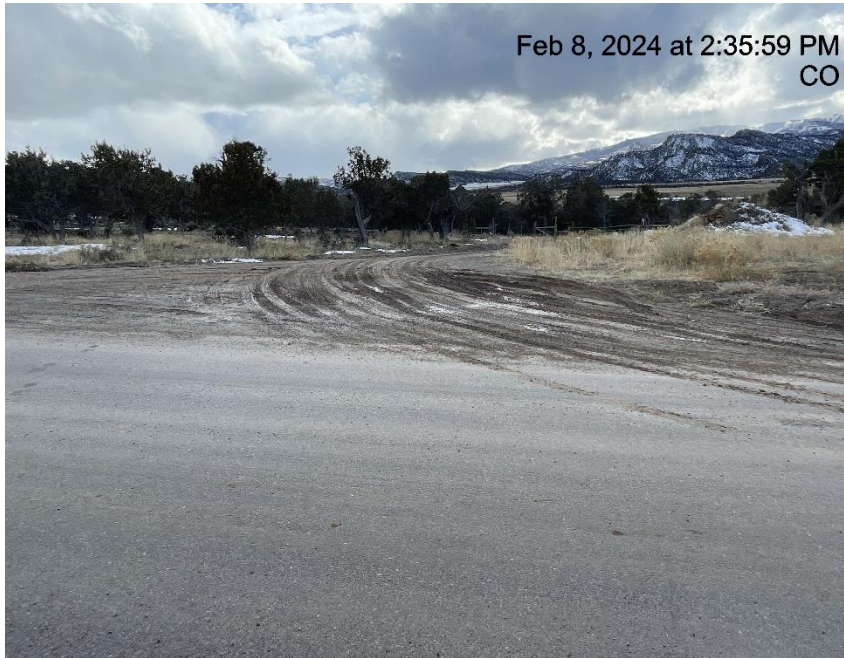
**Photo # 6176 Insufficient tracking BMP's/tracking off lease road & onto CR 336 (Jenkins Cutoff)**

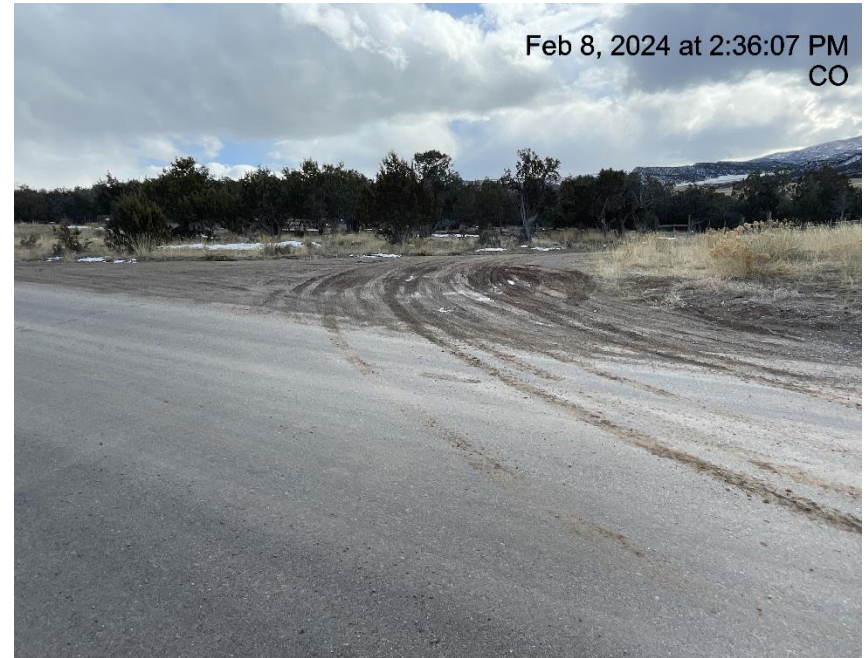
**Photo # 6177 Insufficient tracking BMP's/tracking off lease road & onto CR 336 (Jenkins Cutoff)**

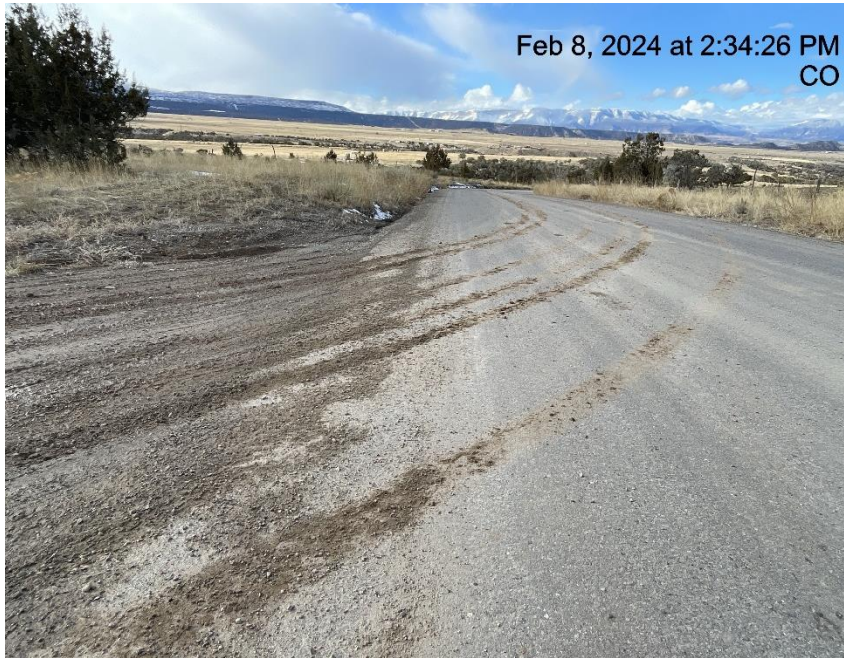
**Photo # 6178 Insufficient tracking BMP's/tracking off lease road & onto CR 336 (Jenkins Cutoff)**

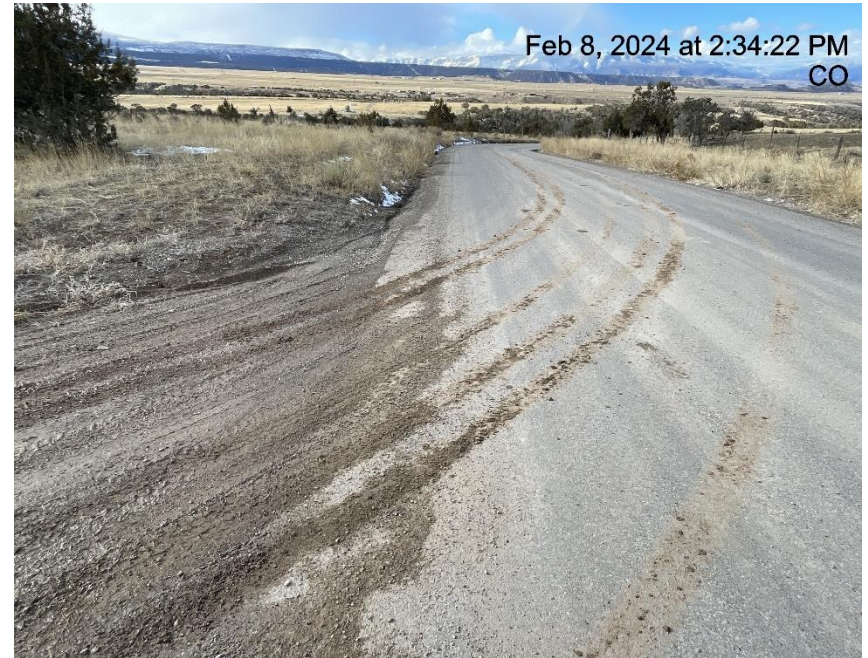
**Photo # 6179 Insufficient tracking BMP's/tracking off lease road & onto CR 336 (Jenkins Cutoff)**

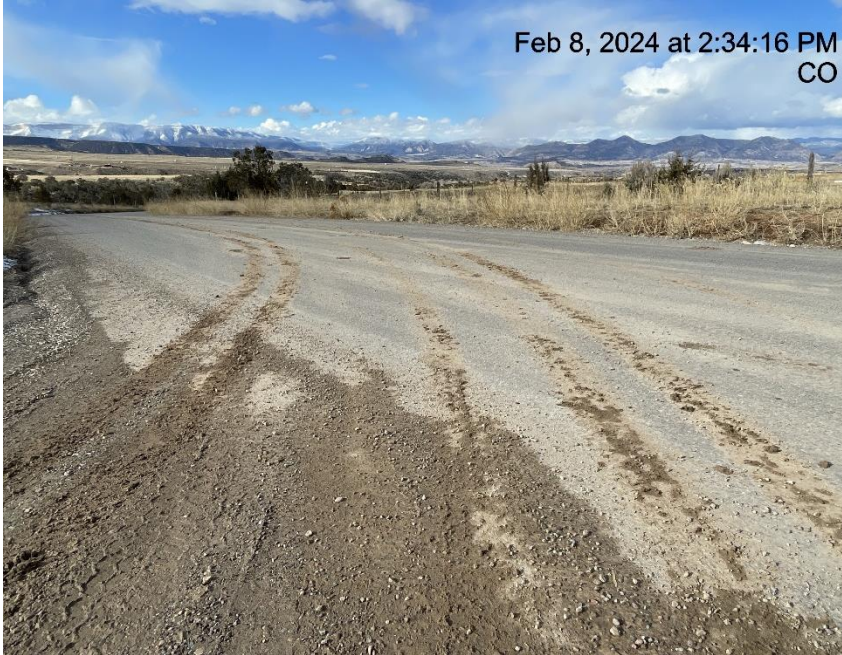
**Photo # 6180 Insufficient tracking BMP's/tracking off lease road & onto CR 336 (Jenkins Cutoff)**

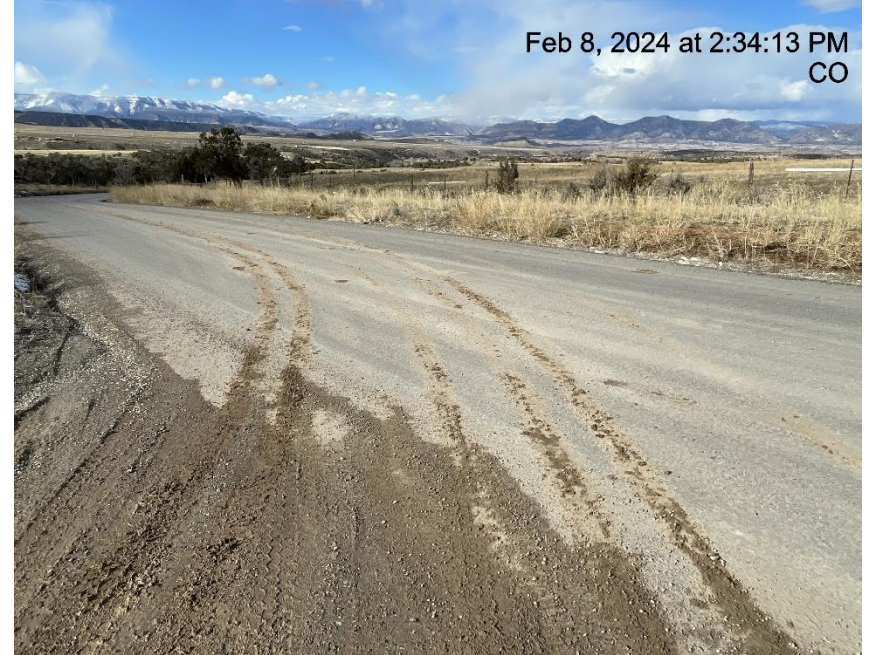
**Photo # 6181 Insufficient tracking BMP's/tracking off lease road & onto CR 336 (Jenkins Cutoff)**

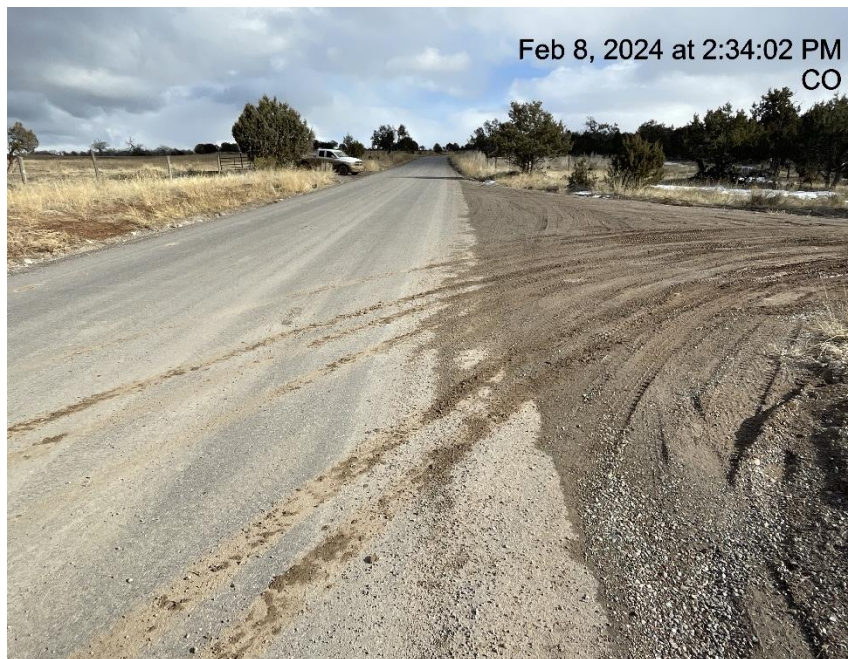
**Photo # 6182 Insufficient tracking BMP's/tracking off lease road & onto CR 336 (Jenkins Cutoff)**

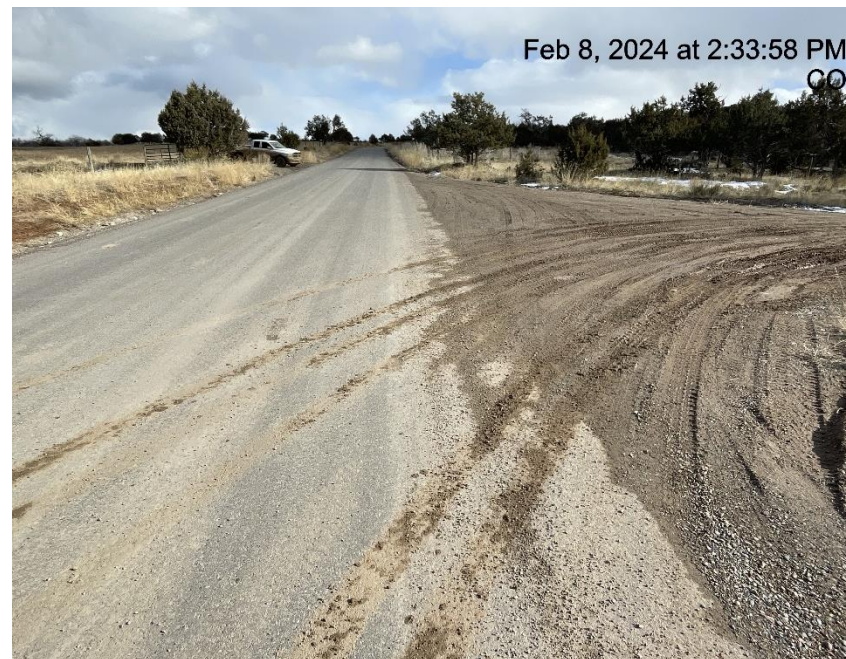
**Photo # 6183 Insufficient tracking BMP's/tracking off lease road & onto CR 336 (Jenkins Cutoff)**

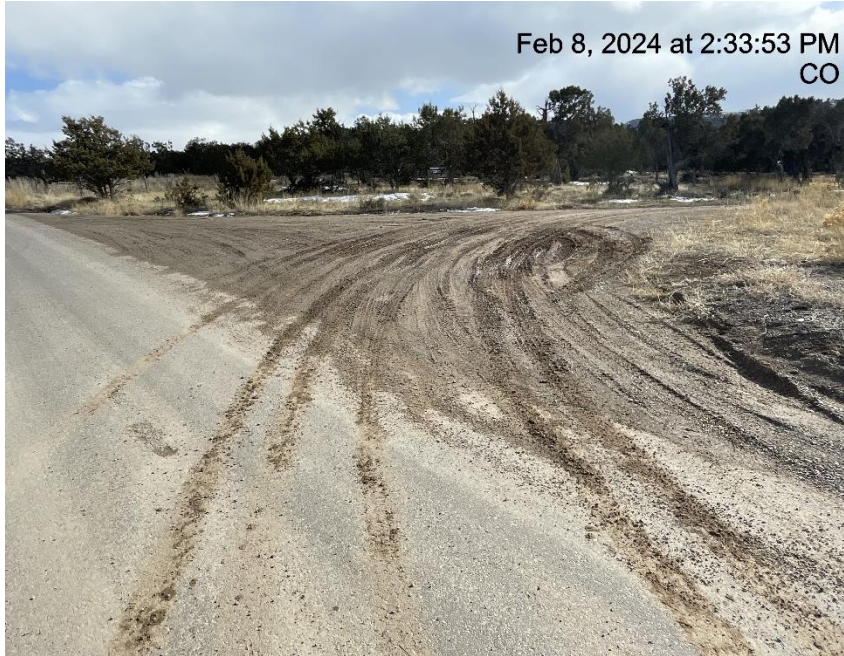
**Photo # 6184 Insufficient tracking BMP's/tracking off lease road & onto CR 336 (Jenkins Cutoff)**

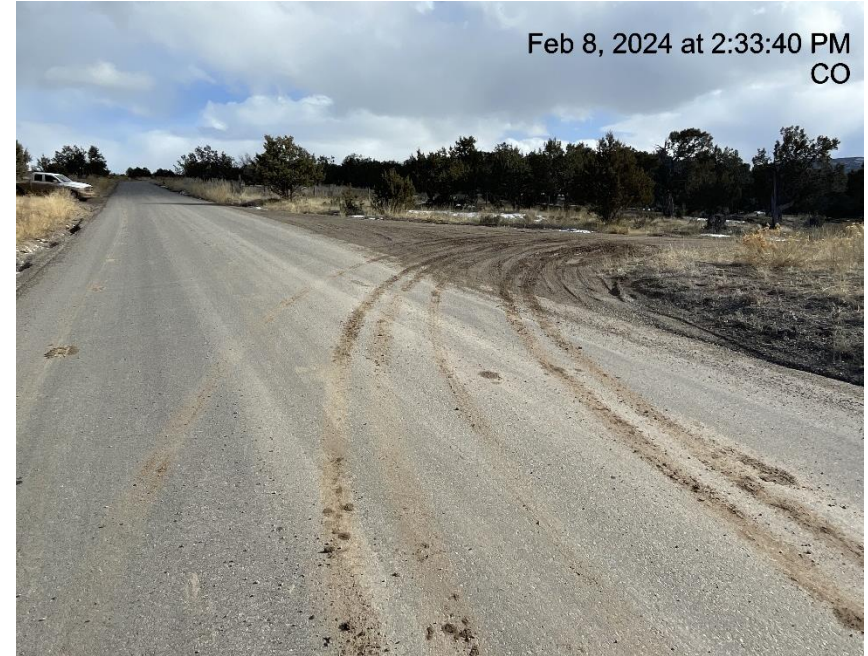
**Photo # 6185 Insufficient tracking BMP's/tracking off lease road & onto CR 336 (Jenkins Cutoff)**

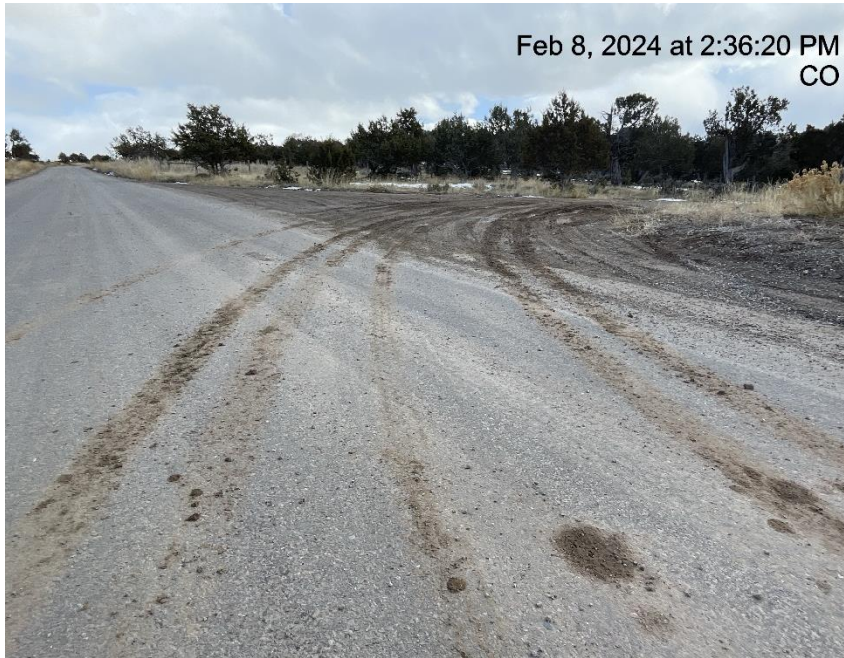
**Photo # 6186 Insufficient tracking BMP's/tracking off lease road & onto CR 336 (Jenkins Cutoff)**

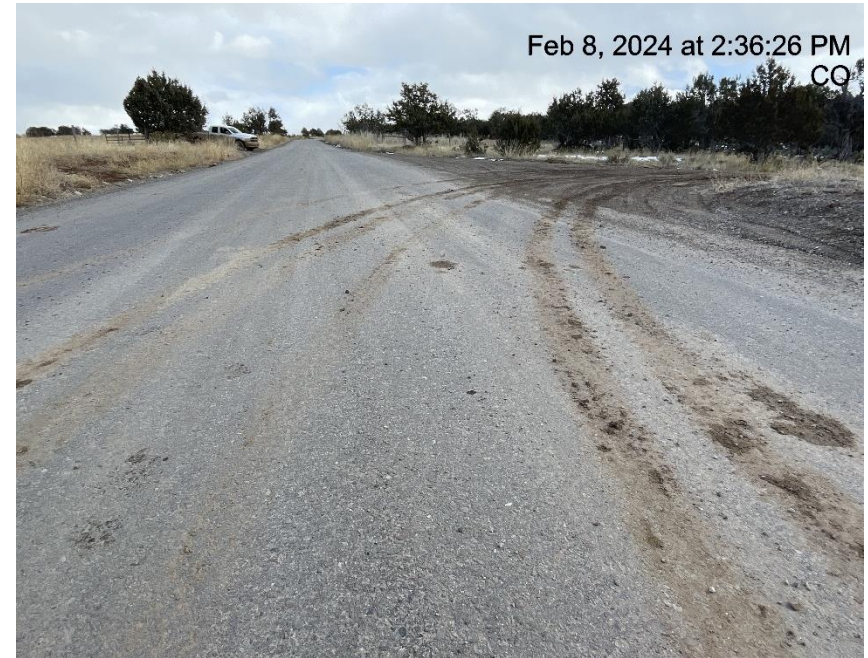
**Photo # 6187 Insufficient tracking BMP's/tracking off lease road & onto CR 336 (Jenkins Cutoff)**

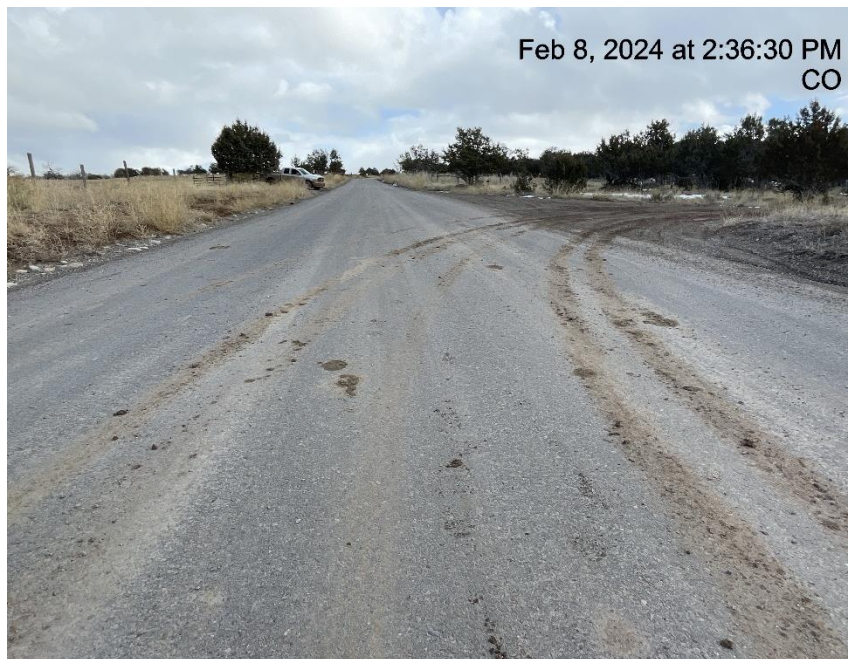
**Photo # 6188 Insufficient tracking BMP's/tracking off lease road & onto CR 336 (Jenkins Cutoff)**

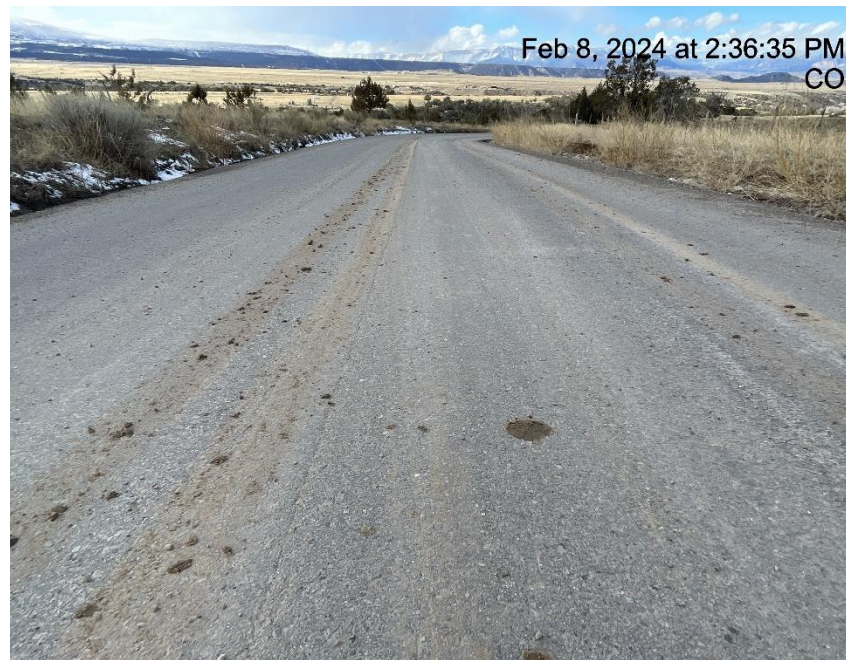
**Photo # 6189 Insufficient tracking BMP's/tracking off lease road & onto CR 336 (Jenkins Cutoff)**

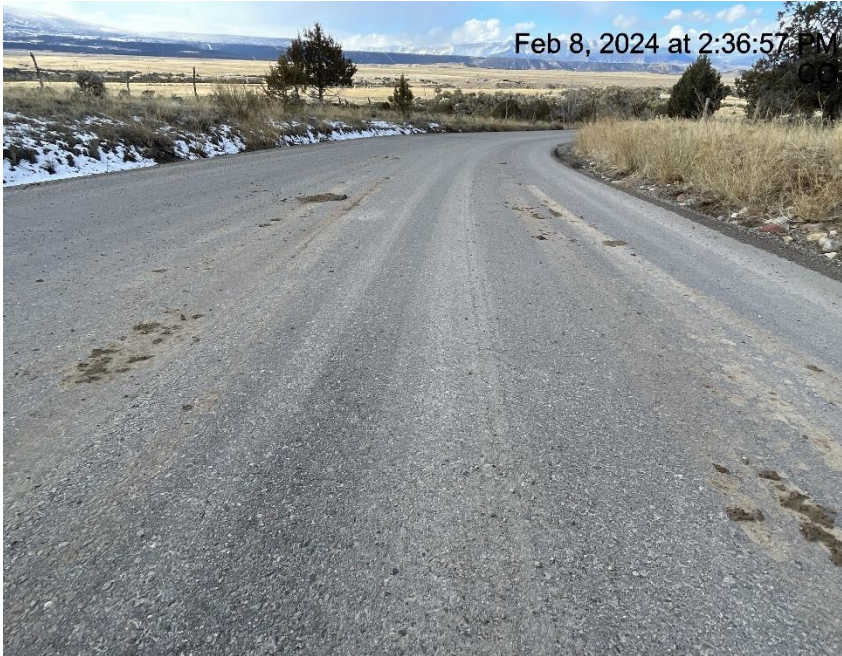
**Photo # 6190 Insufficient tracking BMP's/tracking off lease road & onto CR 336 (Jenkins Cutoff)**

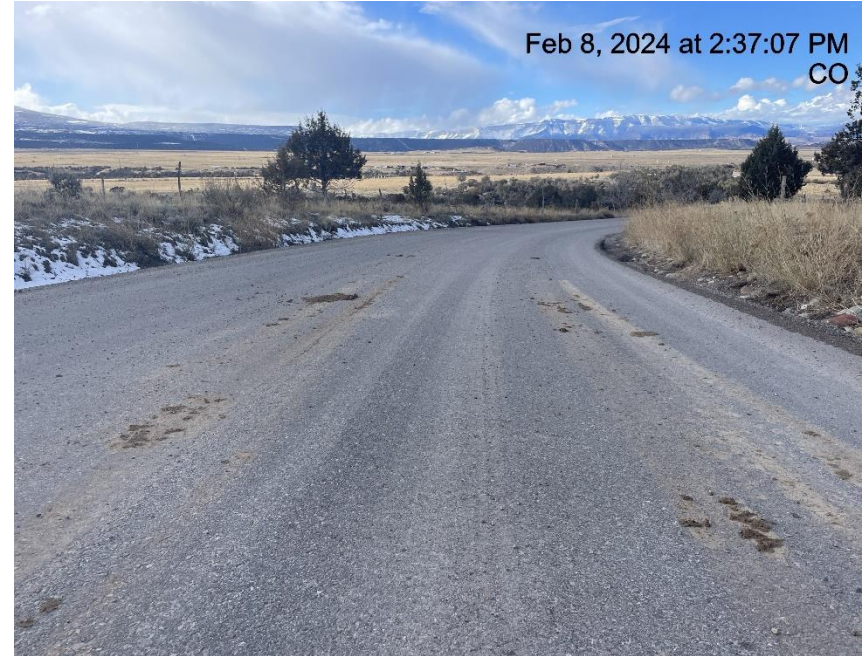
**Photo # 6191 Insufficient tracking BMP's/tracking off lease road & onto CR 336 (Jenkins Cutoff)**

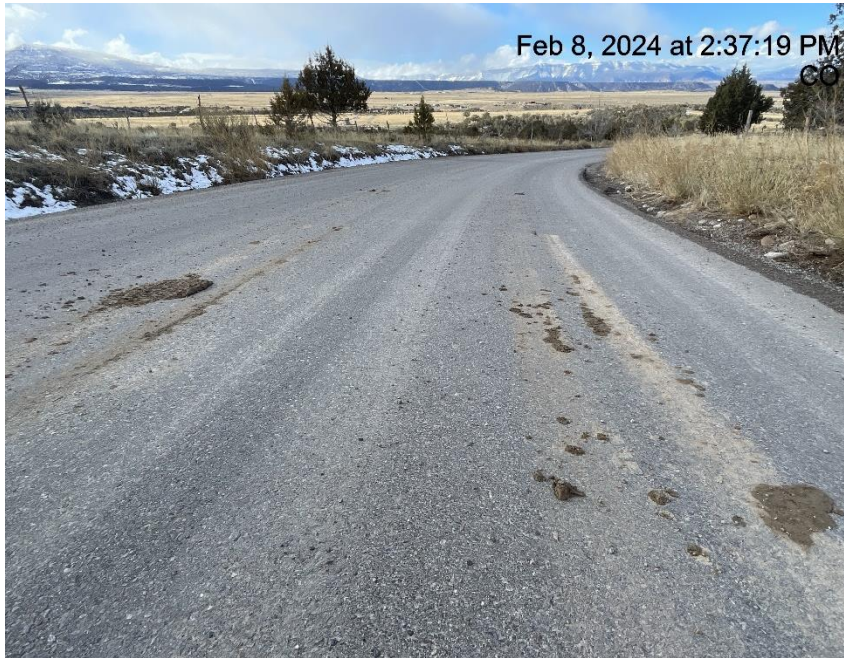
**Photo # 6192 Insufficient tracking BMP's/tracking off lease road & onto CR 336 (Jenkins Cutoff)**

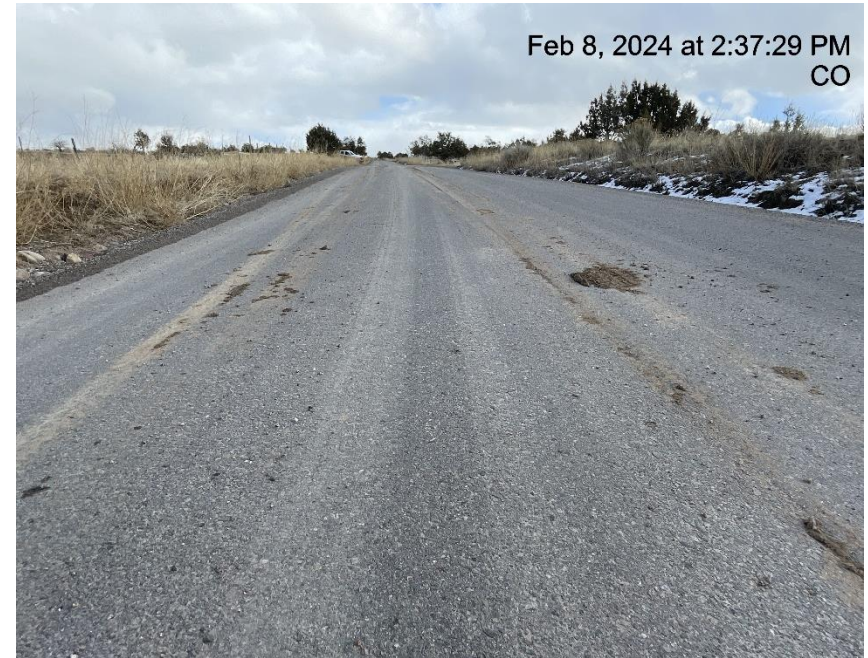
**Photo # 6193 Insufficient tracking BMP's/tracking off lease road & onto CR 336 (Jenkins Cutoff)**

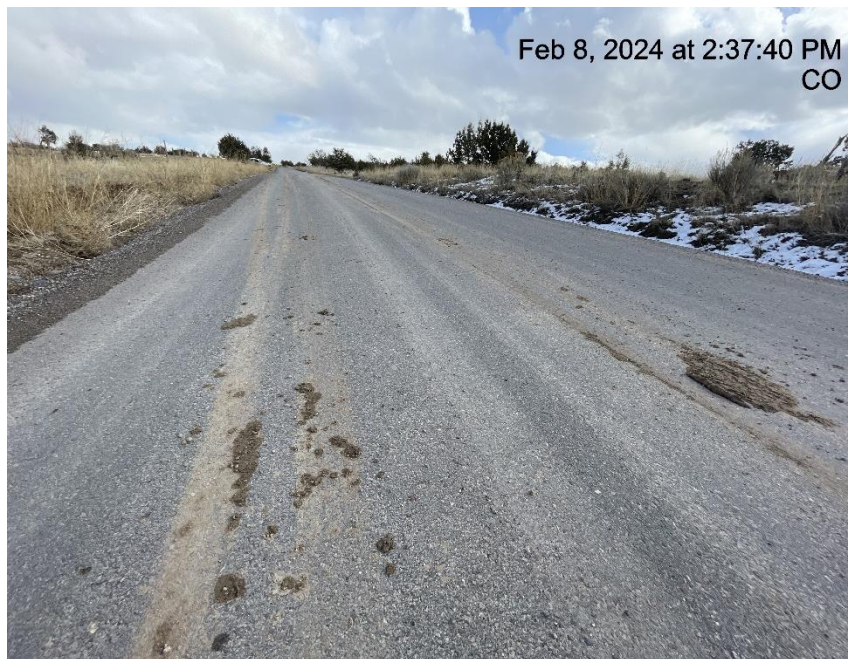
**Photo # 6194 Insufficient tracking BMP's/tracking off lease road & onto CR 336 (Jenkins Cutoff)**
