Inspection Photos

Location Name: CAERUS PICEANCE LLC MAMM CREEK RANCH 29-4 (D29E) Pad

Location #: 334827

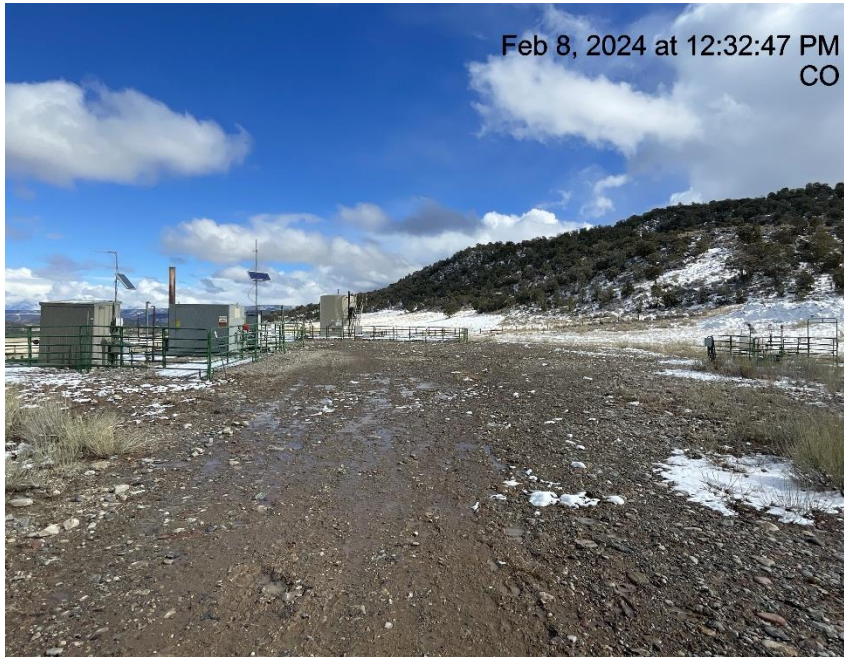
Photo # 6102 From entrance to location

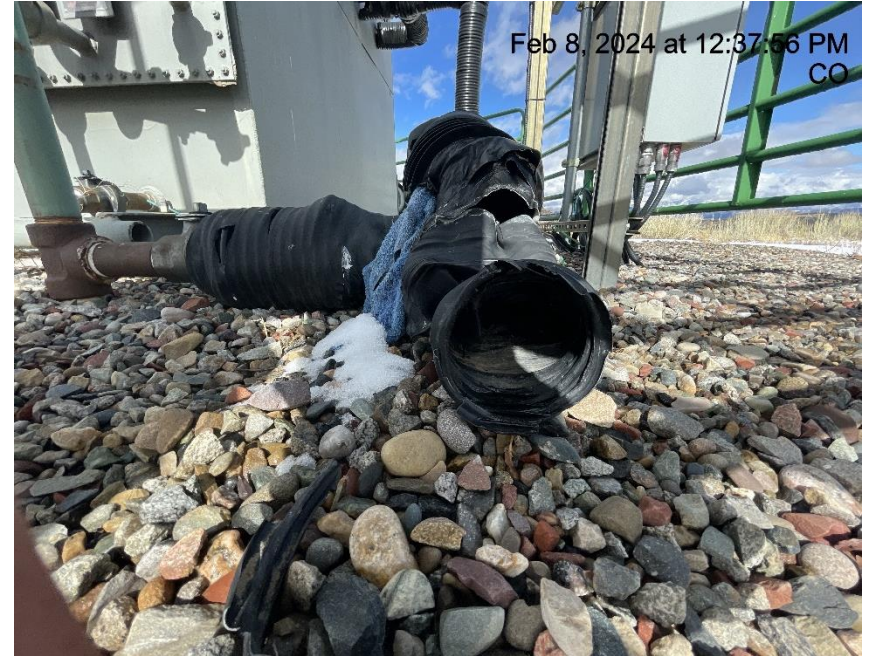
Photo # 6107 Flowline heating insulation open ended/wildlife hazard/available for entry by wildlife
