Inspection Photos

Location Name: TEP ROCKY MOUNTAIN LLC, WILLIAMS-66S96W/33NENE

Location ID: 335435

Date: 2/12/2024

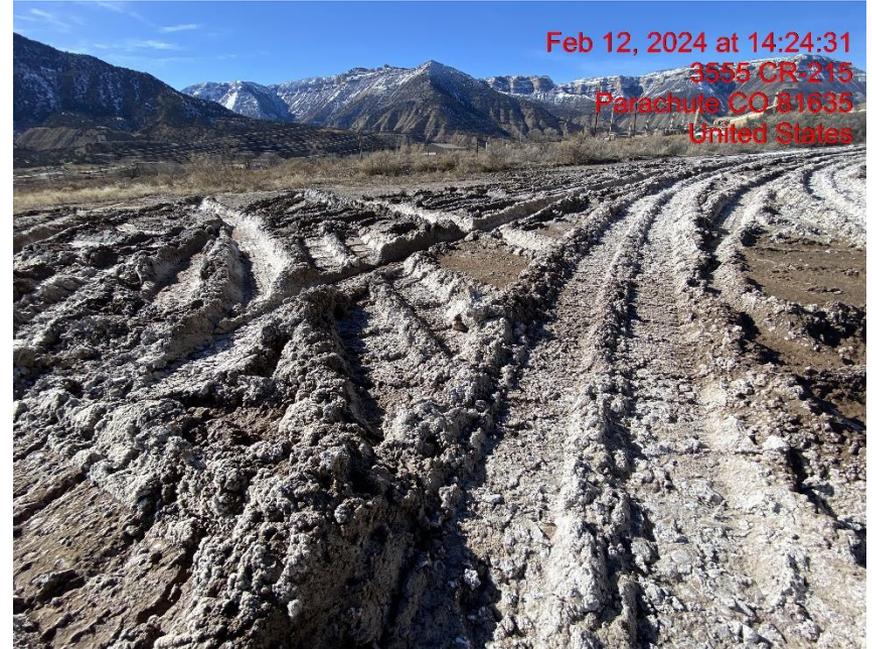
Lack of Stabilization – Photo #09206

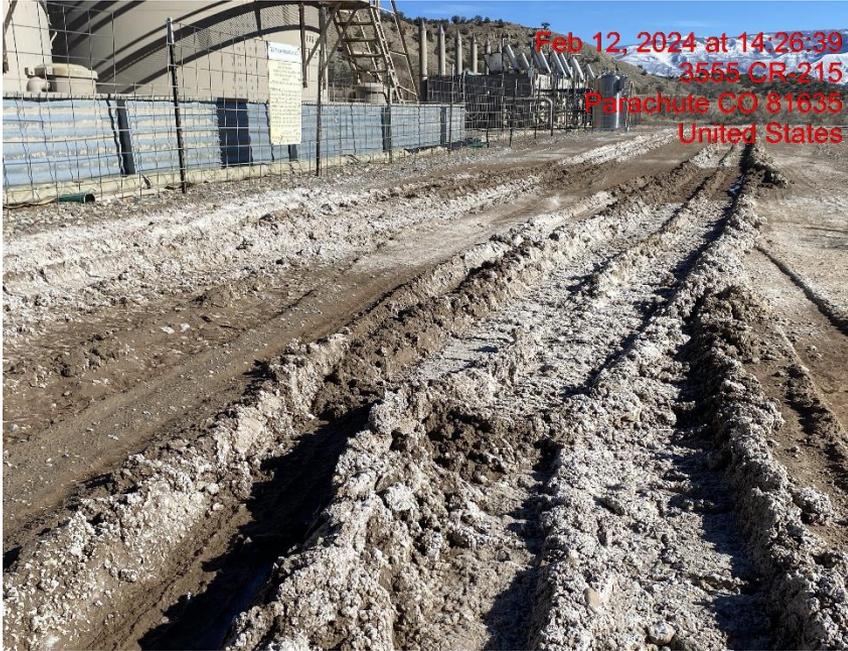
Lack of Stabilization – Photo #09211

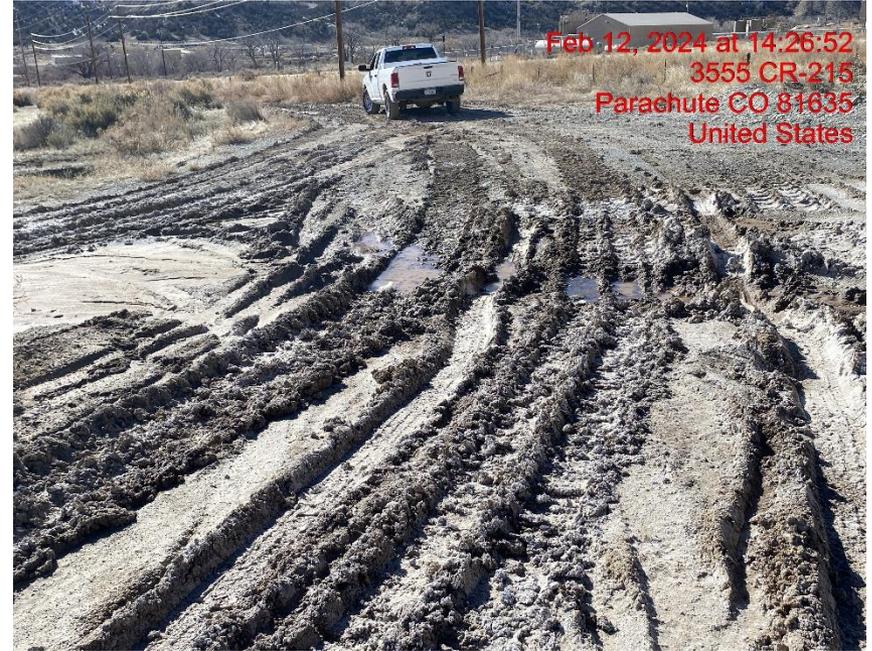
Lack of Stabilization – Photo #09212

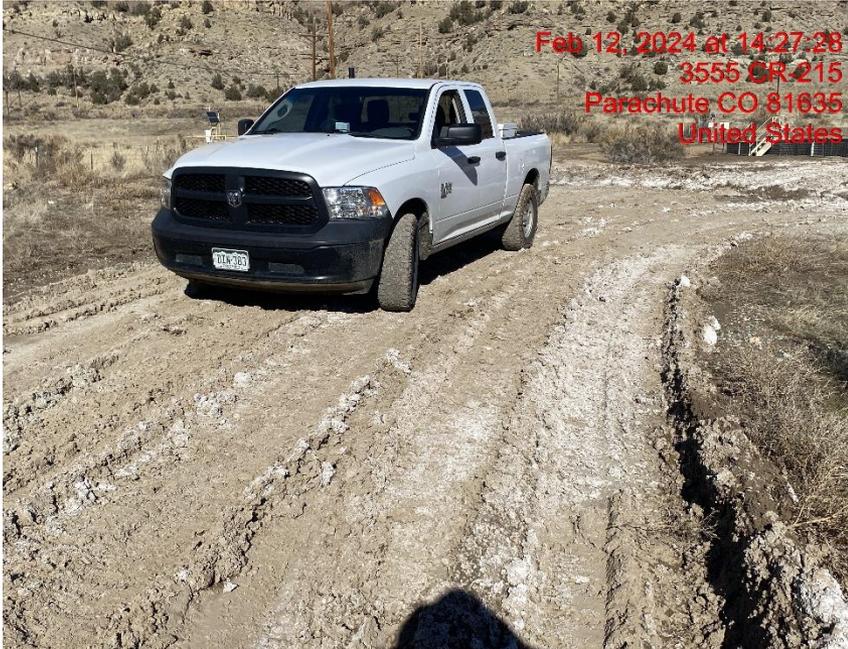
**Insufficient Vehicle Tracking BMPs at Location Entrance/Exit
– Photo #09214**

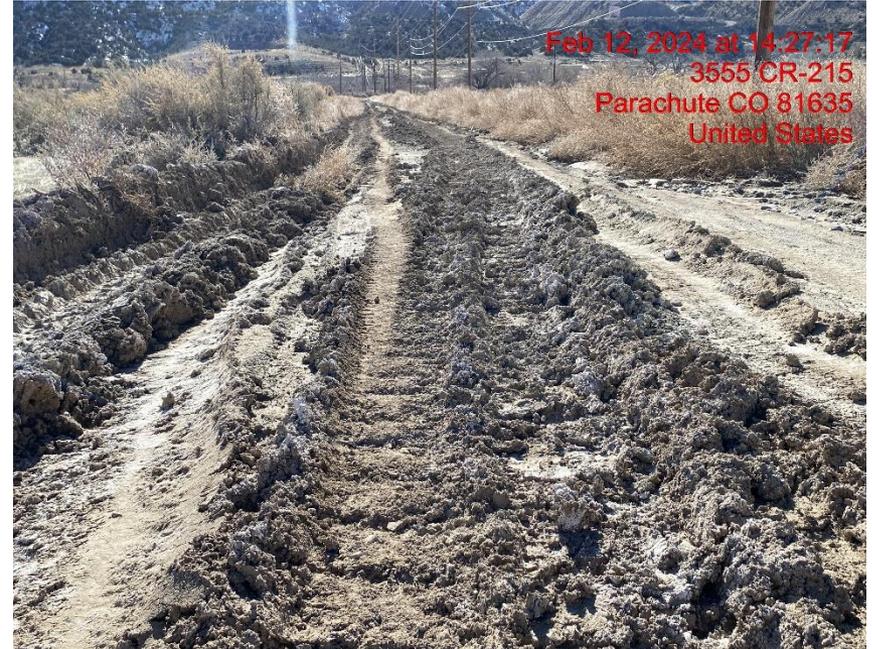
Lease Road Lacks Stabilization – Photo #09213
