Inspection Photos

Location Name: TEP ROCKY MOUNTAIN LLC CLOUGH RWF 44-18 pad

Location ID: 335146

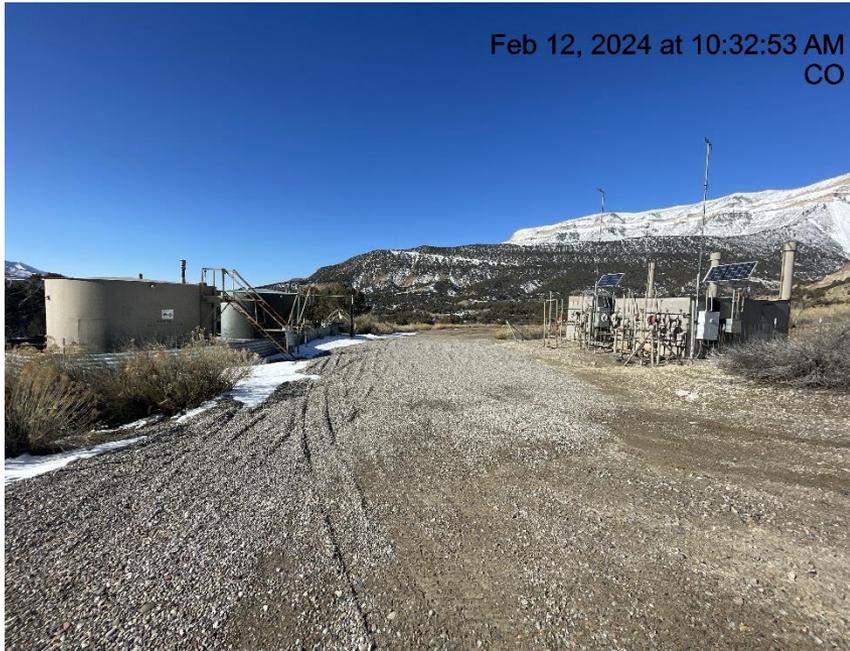
Photo # 6307 From entrance to location

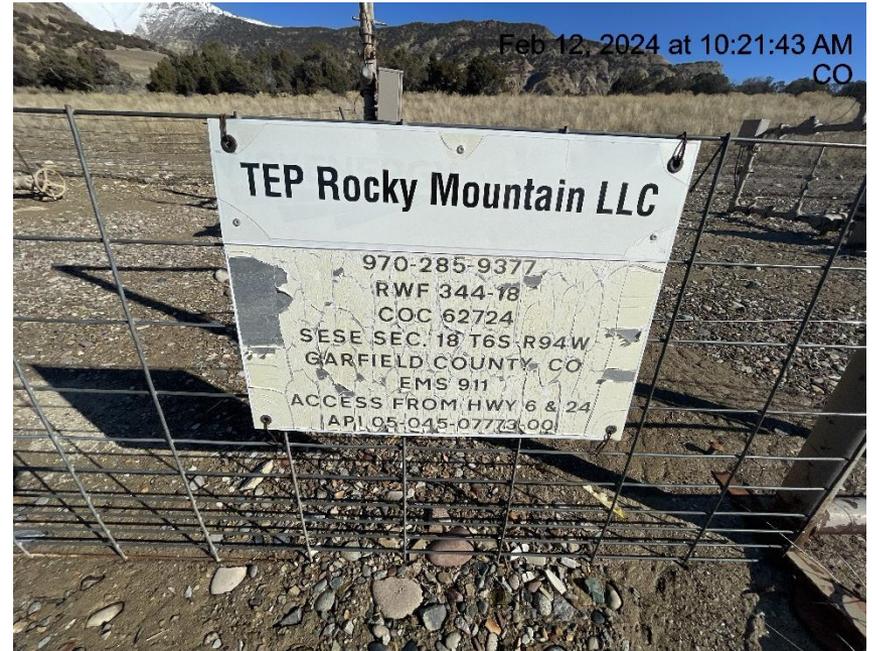
Photo # 6312 Wellhead sign weathered & peeling

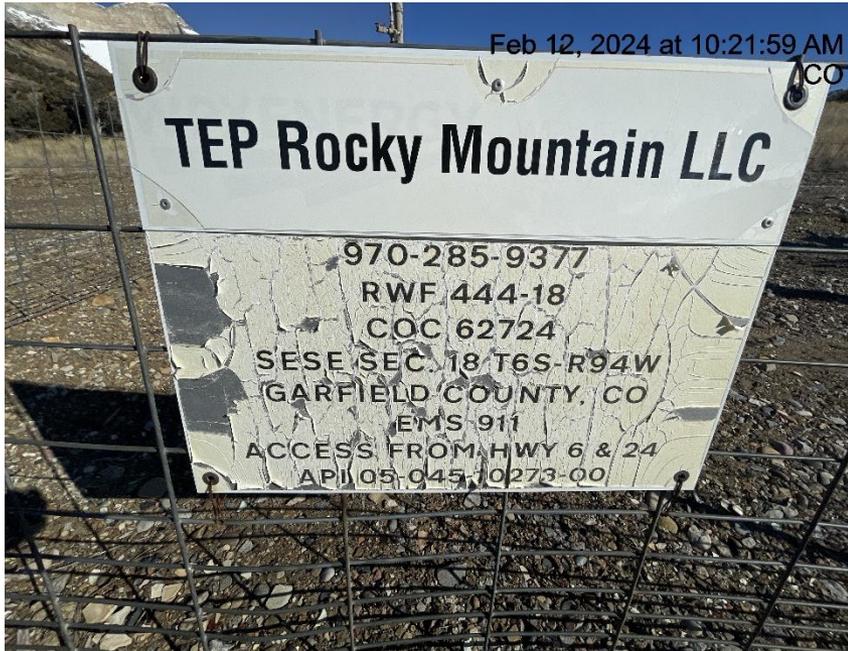
Photo # 6313 Wellhead sign weathered & peeling

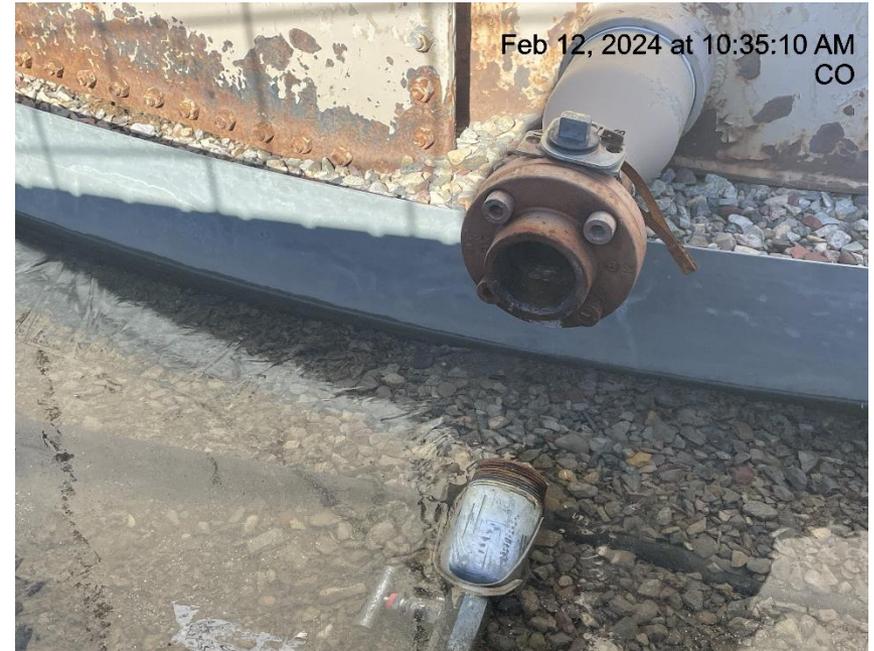
Photo # 6314 Open ended load line
