## Inspection Photos

Location Name: CAERUS PICEANCE LLC GMR 21-8D (H21) Pad

Location #: 335374

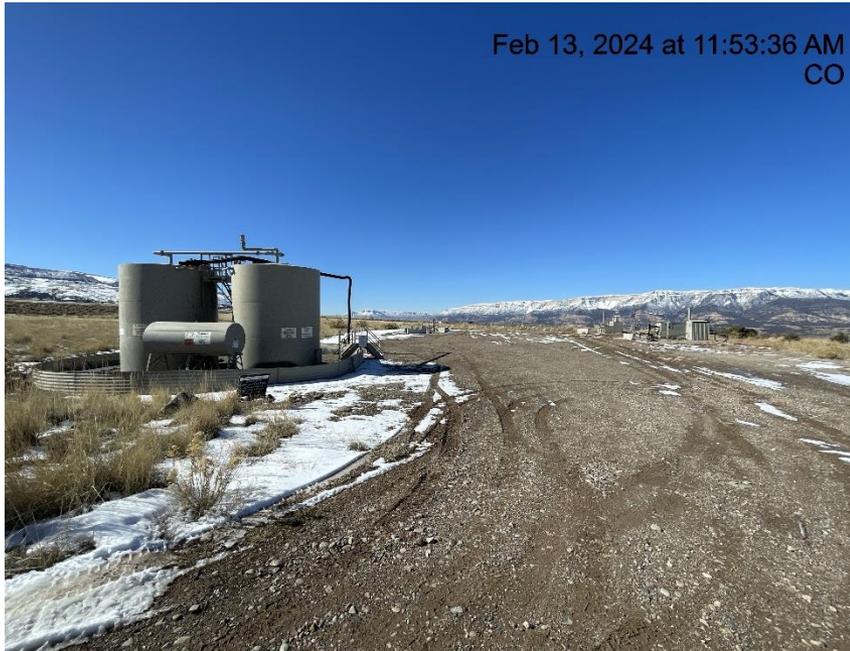
Photo # 6542 From entrance to location

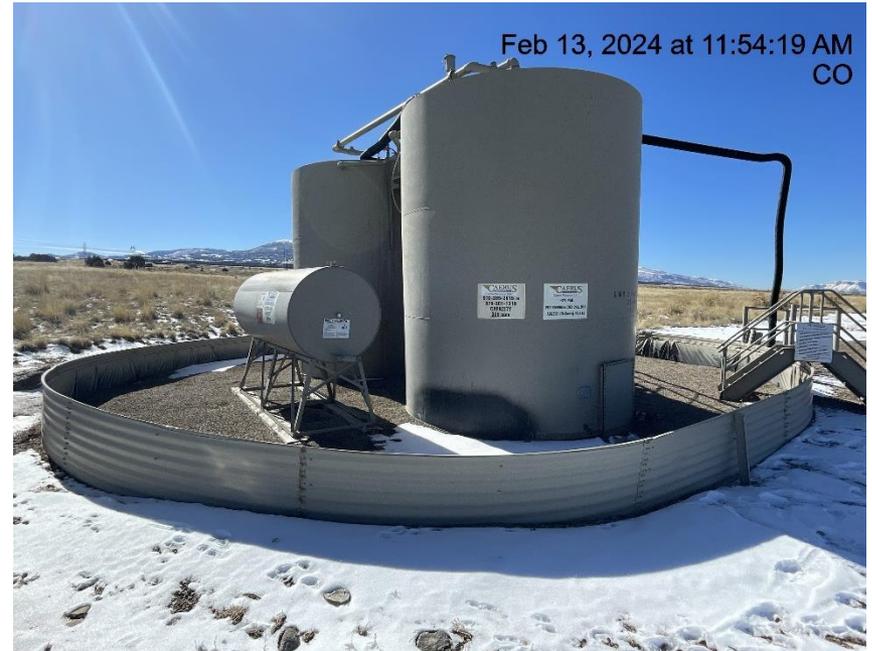
Photo # 6543 Location

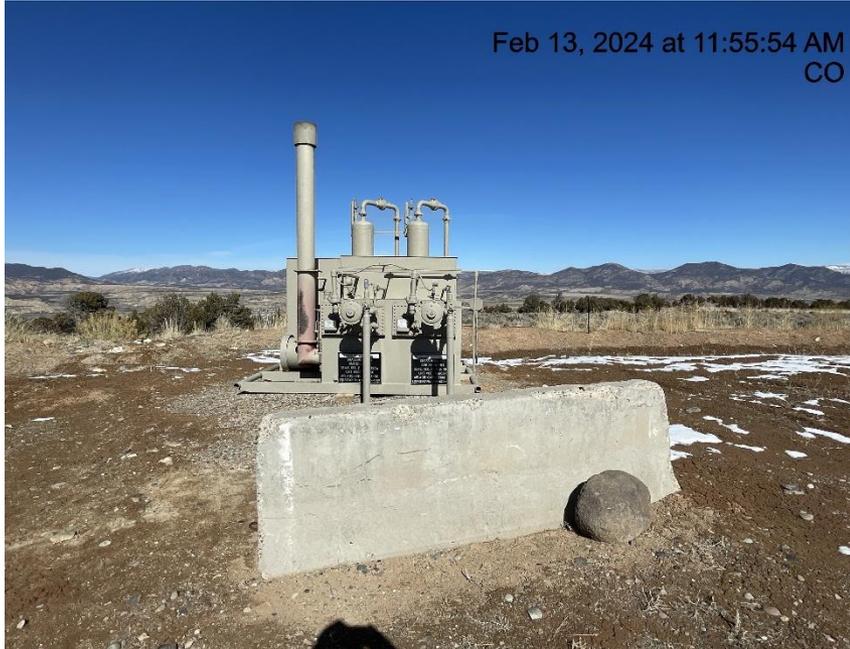
Photo # 6544 Location

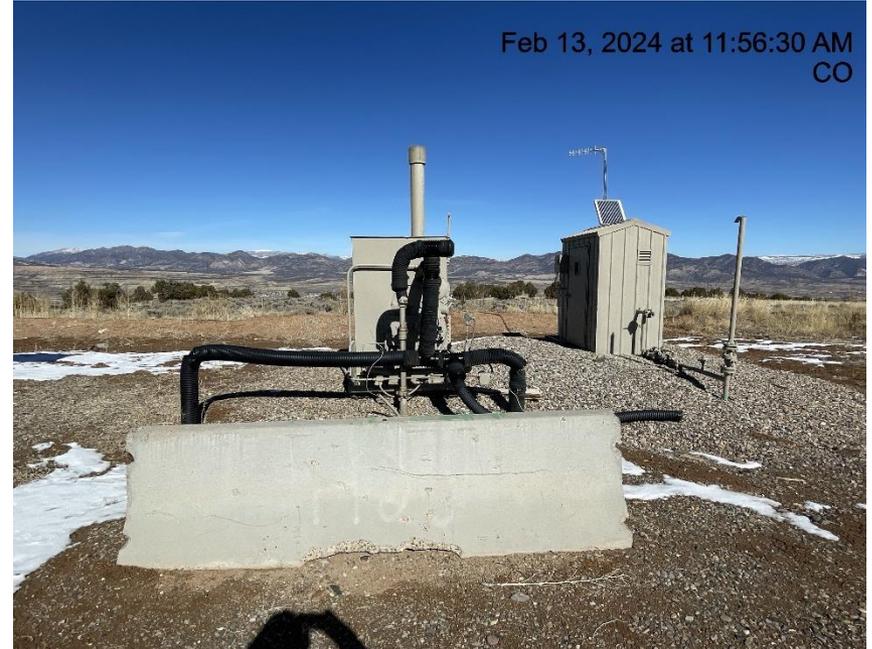
Photo # 6545 Location

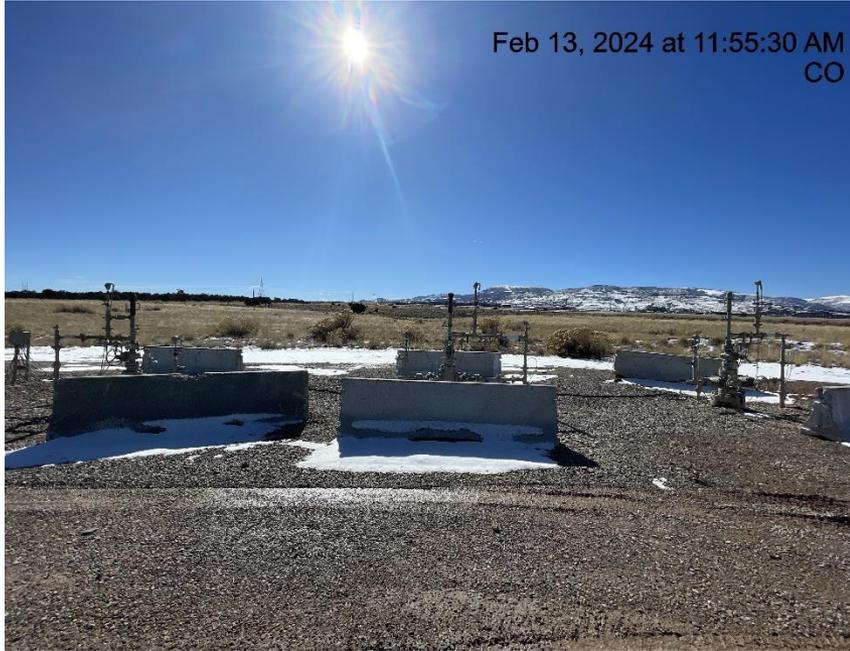
Photo # 6546 Location

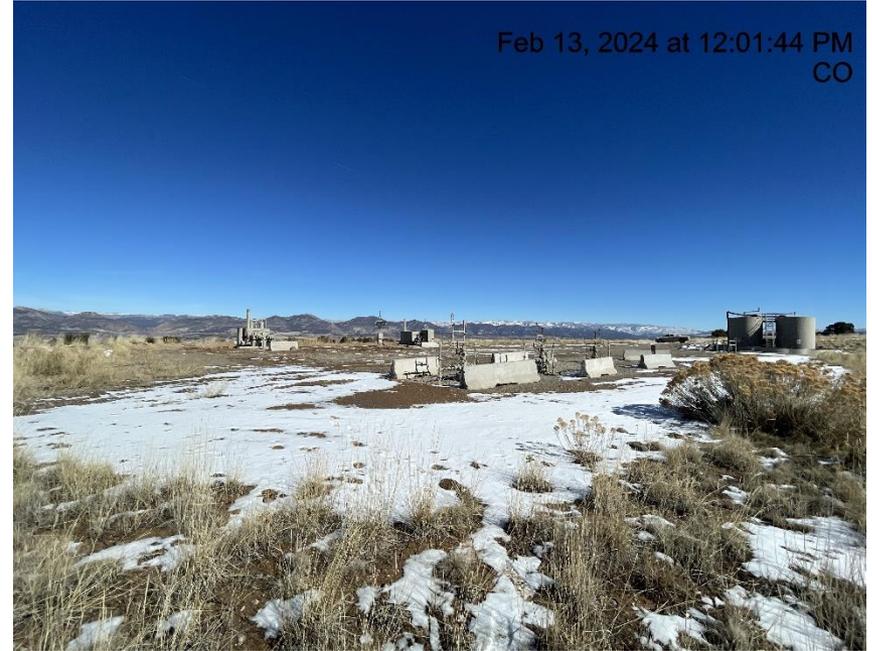
Photo # 6547 Location

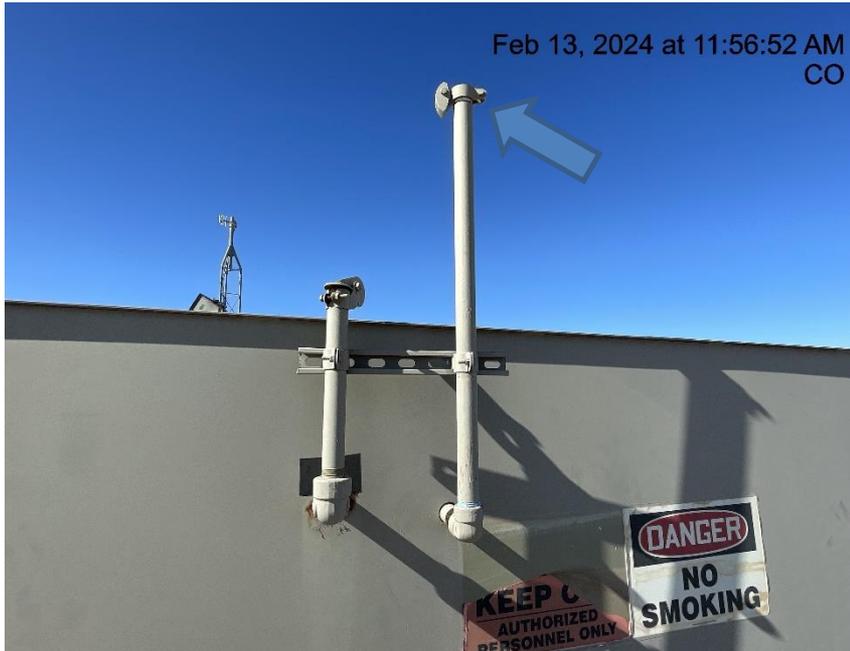
Photo # 6548 PRV vent line lacks cap

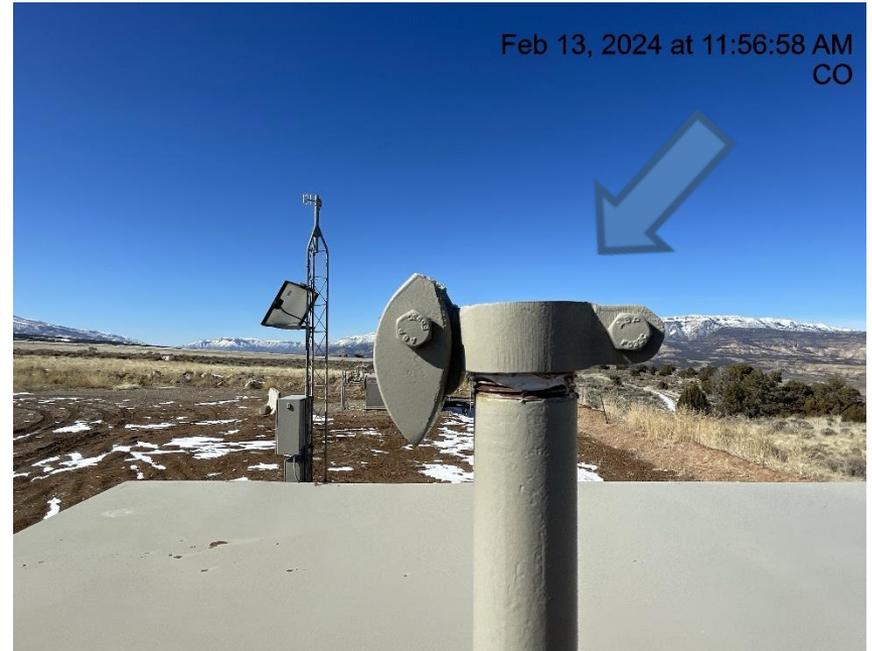
Photo # 6549 PRV vent line lacks cap

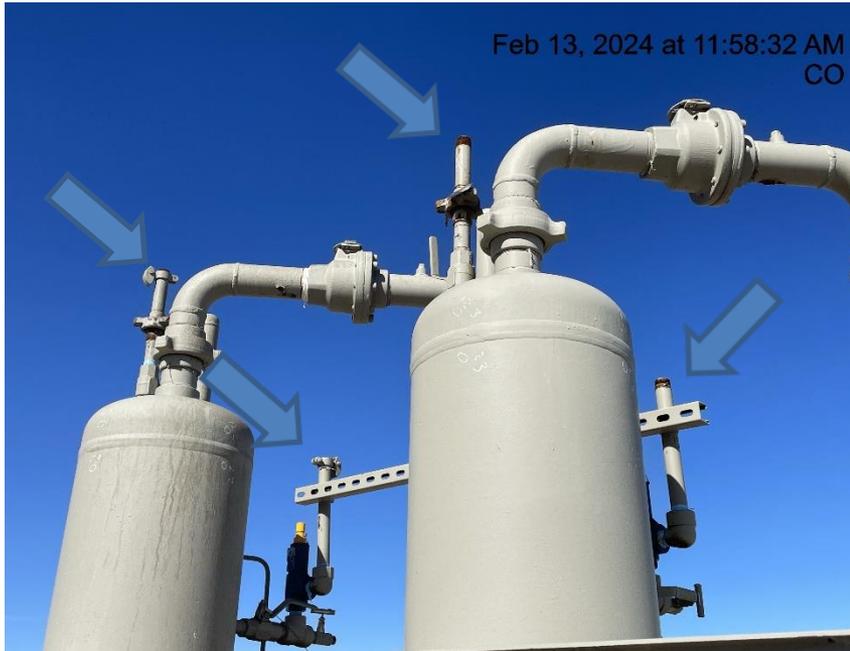
Photo # 6550 PRV & rupture disc vent lines lack caps

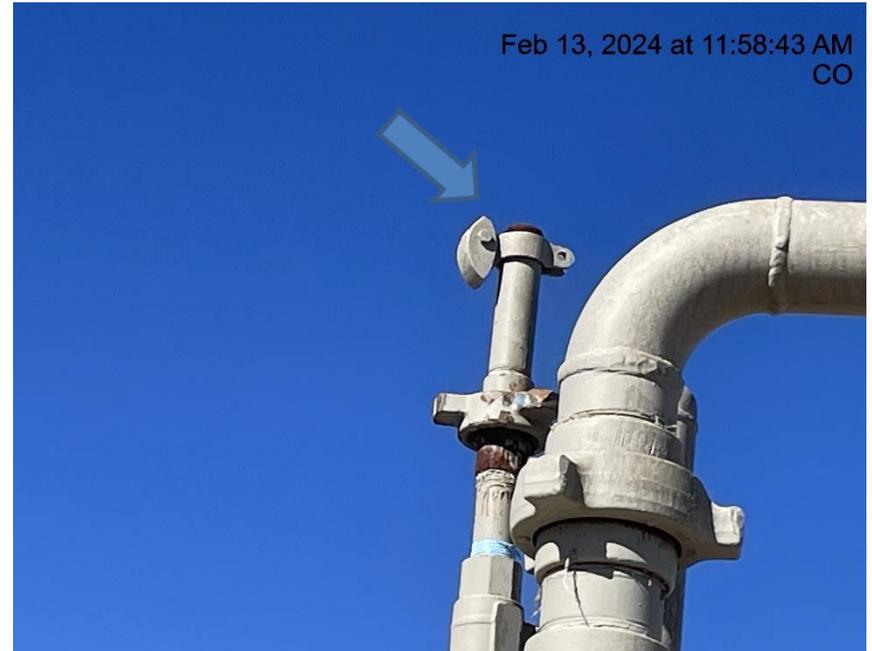
Photo # 6551 Rupture disc vent line lacks cap

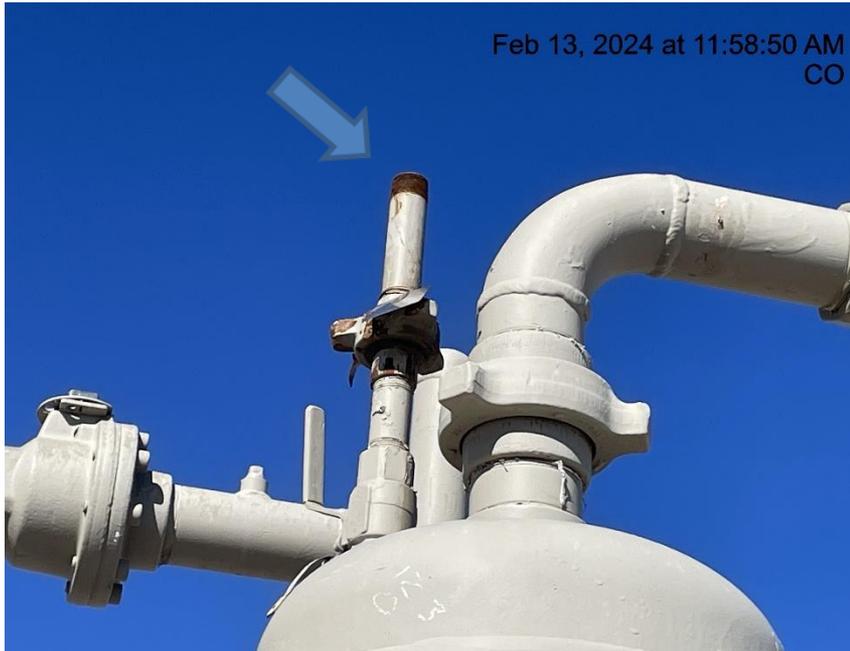
Photo # 6552 Rupture disc vent line lacks cap

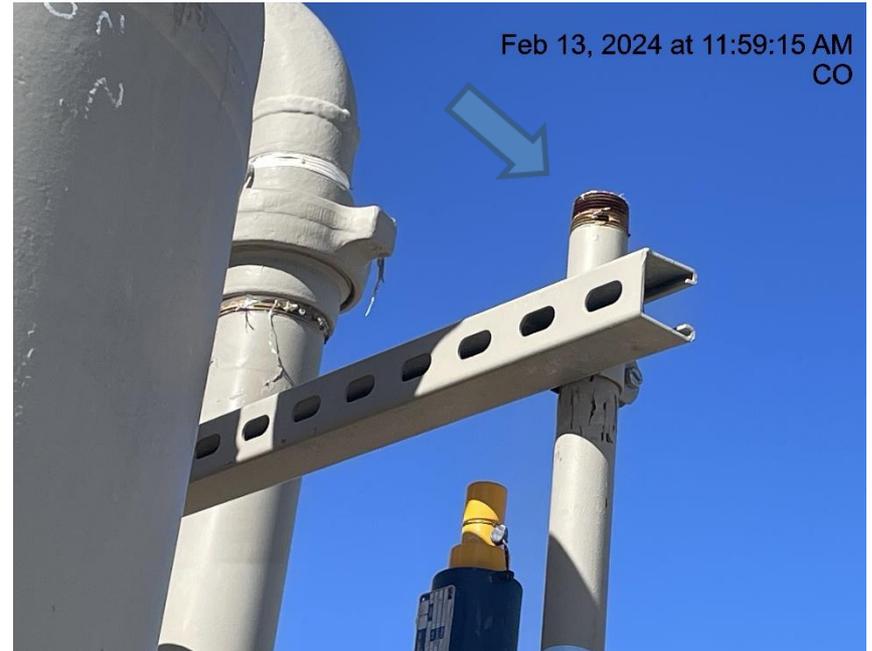
Photo # 6553 PRV vent line lacks cap

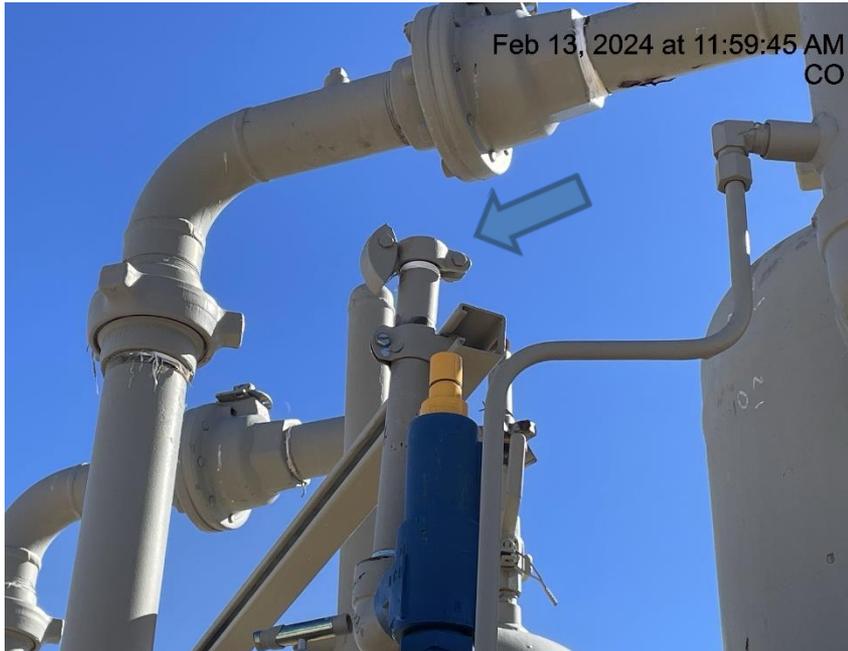
Photo # 6554 PRV vent line lacks cap
