Inspection Photos

Location Name: CAERUS PICEANCE LLC, UNOCAL-66S96W/9SWSW

Location ID: 335687

Date: 2/13/2024

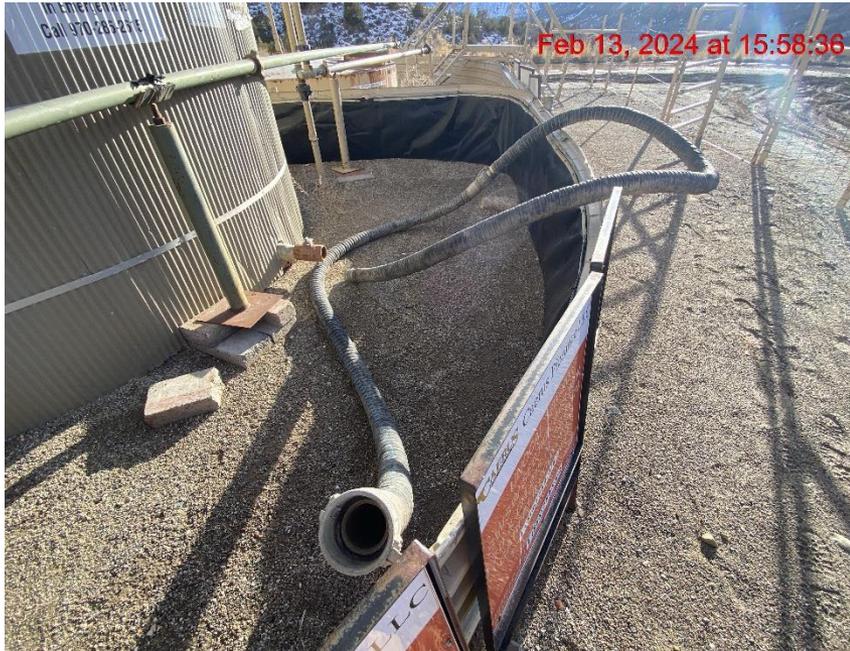
Stored Equipment – Photo #09281

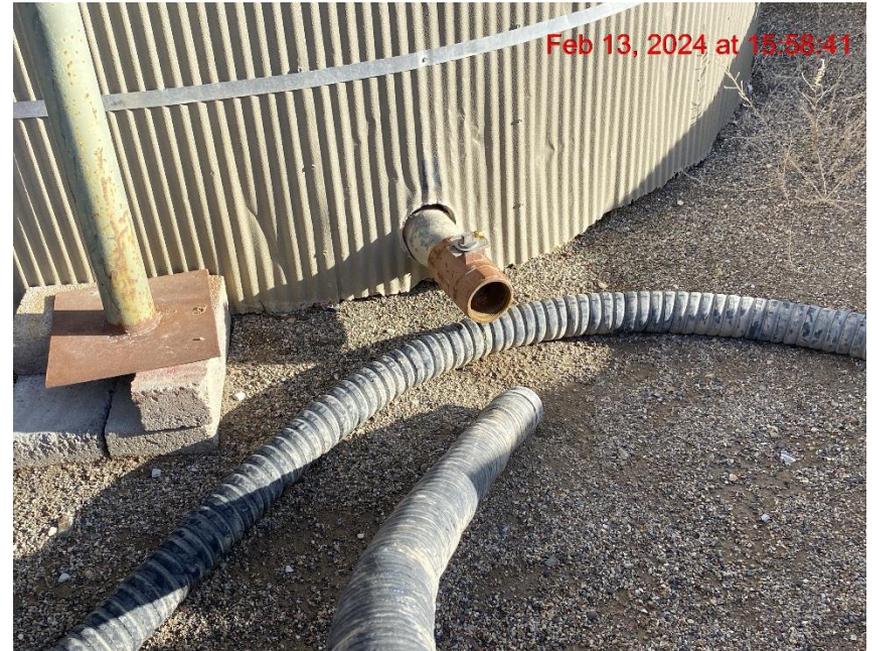
Open-Ended Line – Photo #09282

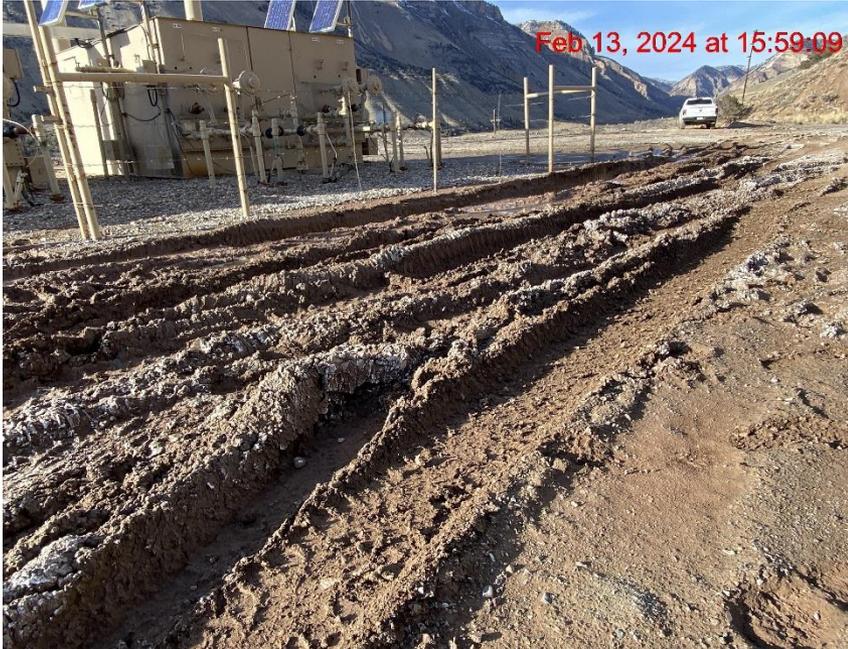
Lack of Stabilization – Photo #09284

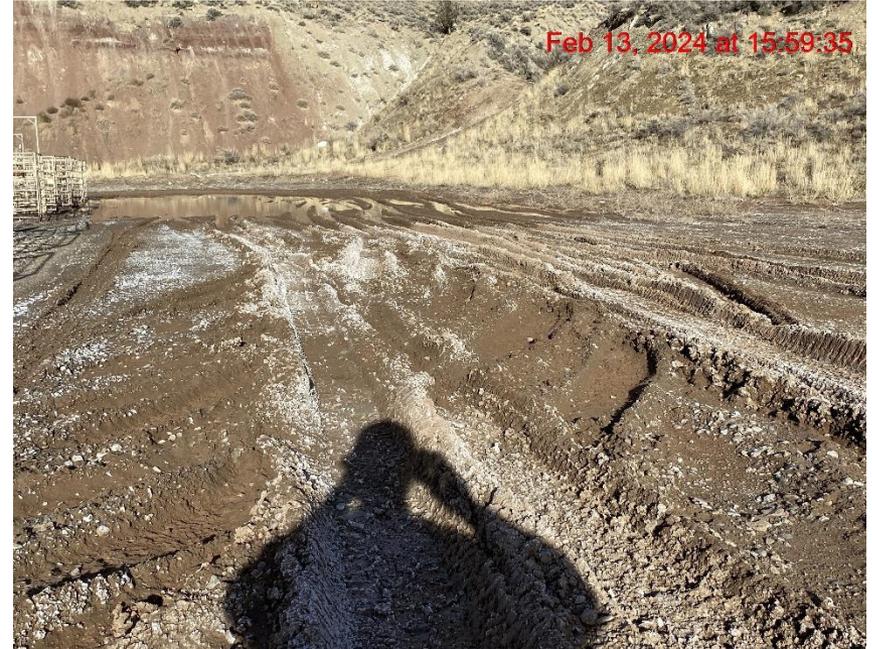
Lack of Stabilization – Photo #09285

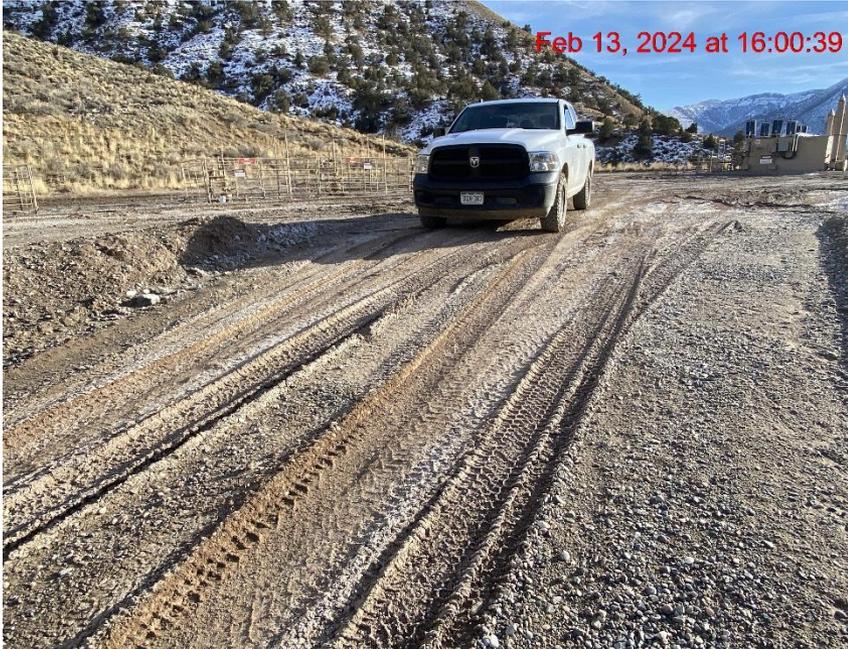
**Insufficient Vehicle Tracking BMPs at Location Entrance/Exit
– Photo #09287**

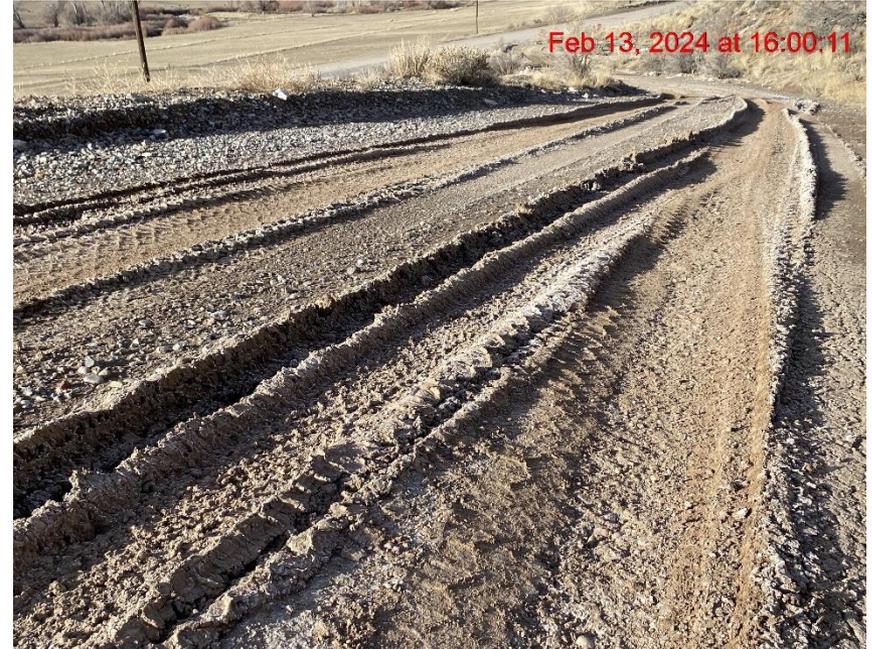
Lack of Stabilization on Lease Road – Photo #09286
