Inspection Photos
Location Name: CAERUS PICEANCE LLC MILLER 11-7 (G11W) Pad
Location #: 334578

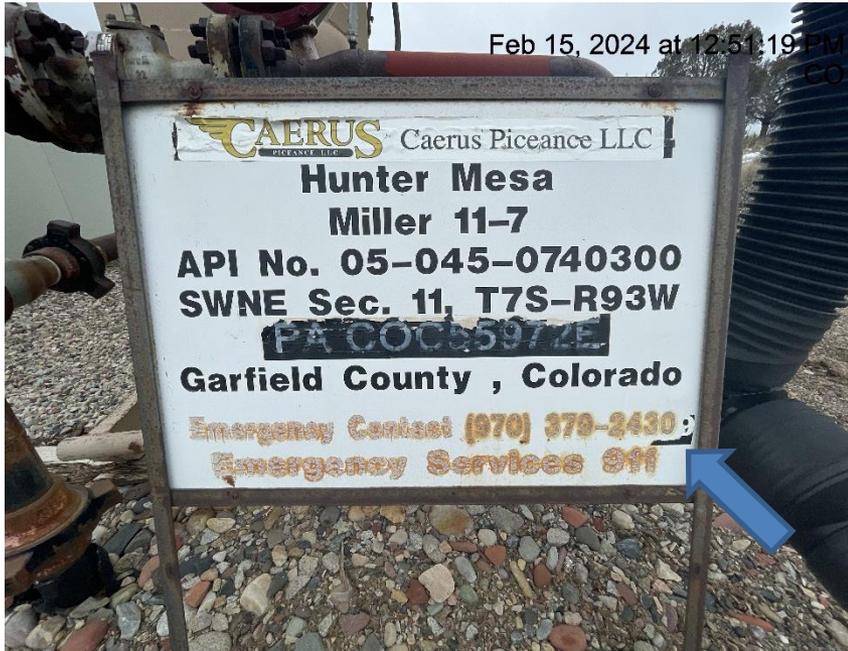
Photo # 6838 Emergency contact # incorrect

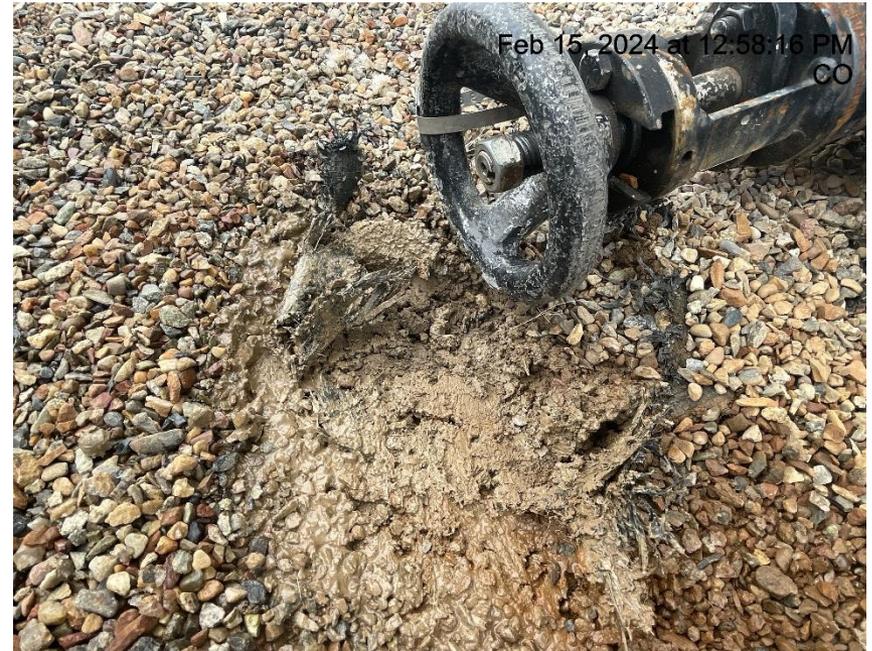
Photo # 6839 Hole in liner/liner needs maintenance

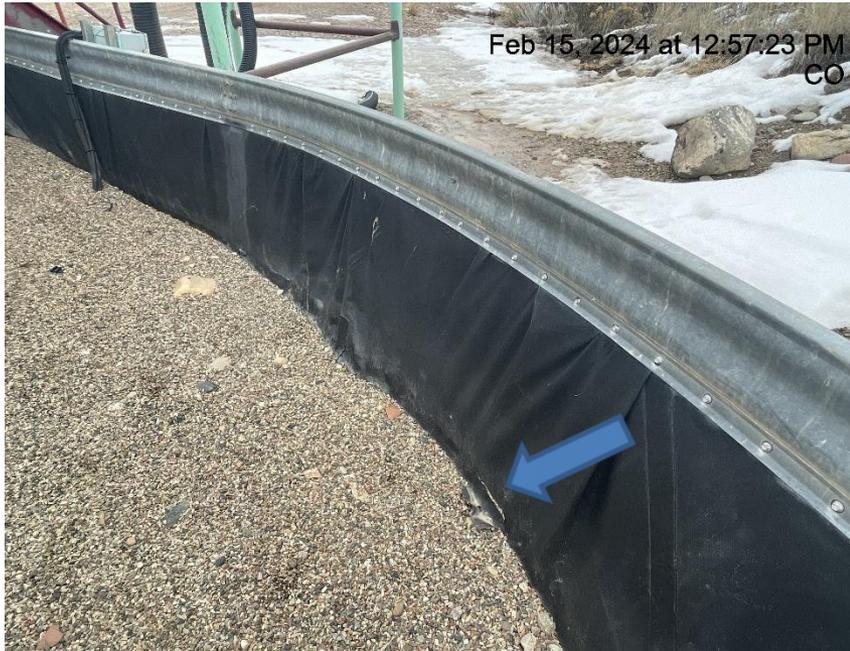
Photo # 6840 Hole in liner/liner needs maintenance

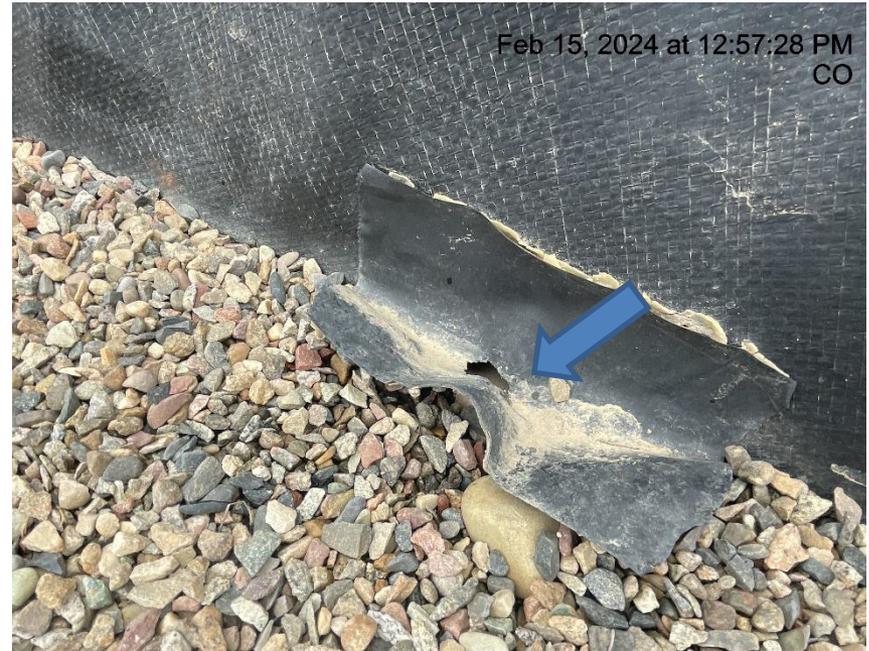
Photo # 6841 Hole in liner/liner needs maintenance

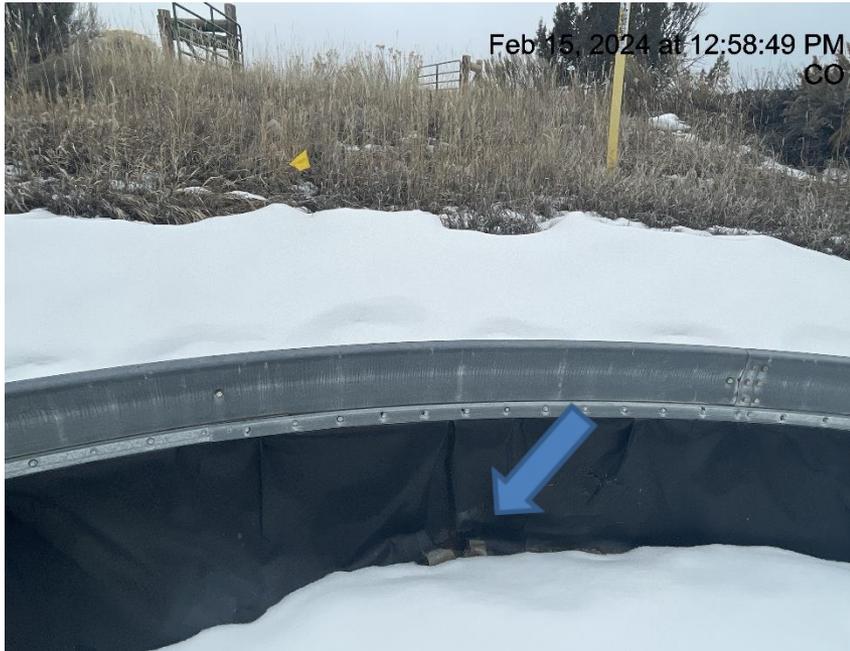
Photo # 6842 Hole in liner/liner needs maintenance

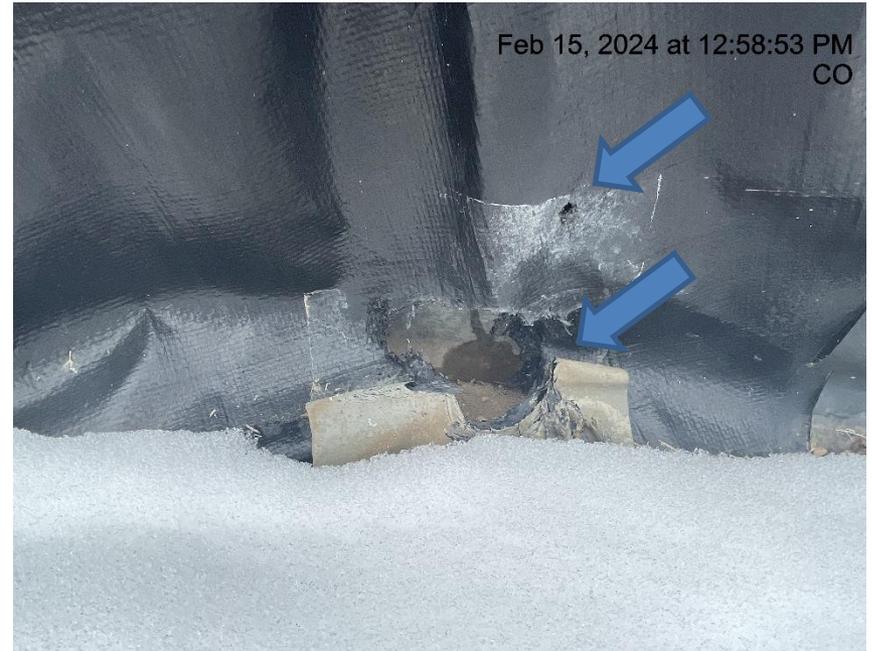
Photo # 6843 Holes in liner/liner needs maintenance

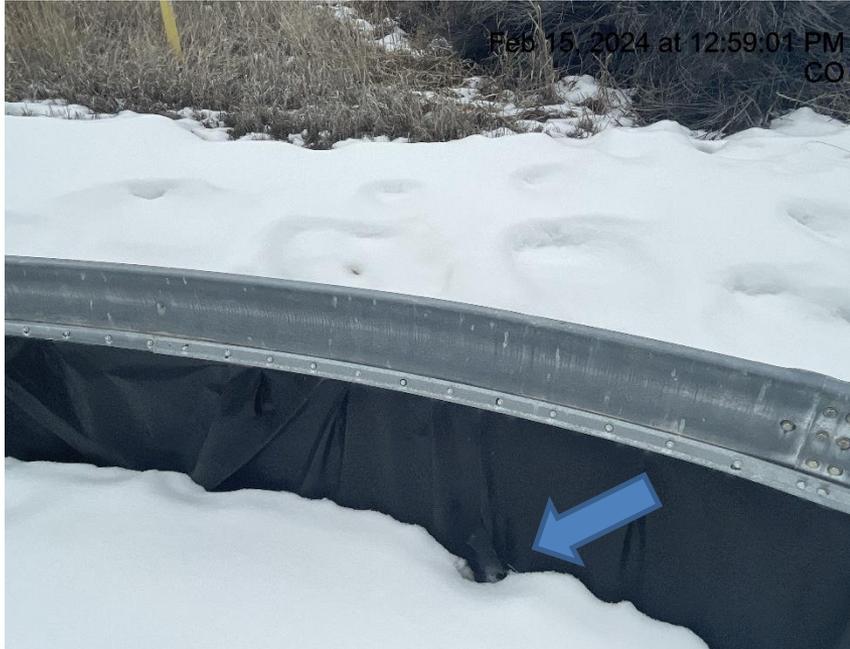
Photo # 6844 Hole in liner/liner needs maintenance

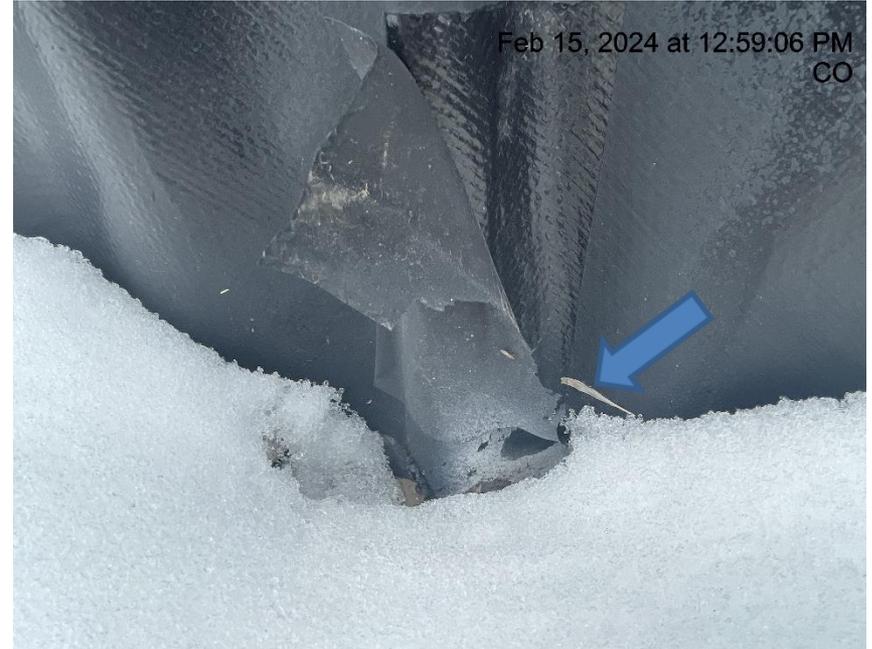
Photo # 6845 Hole in liner/liner needs maintenance

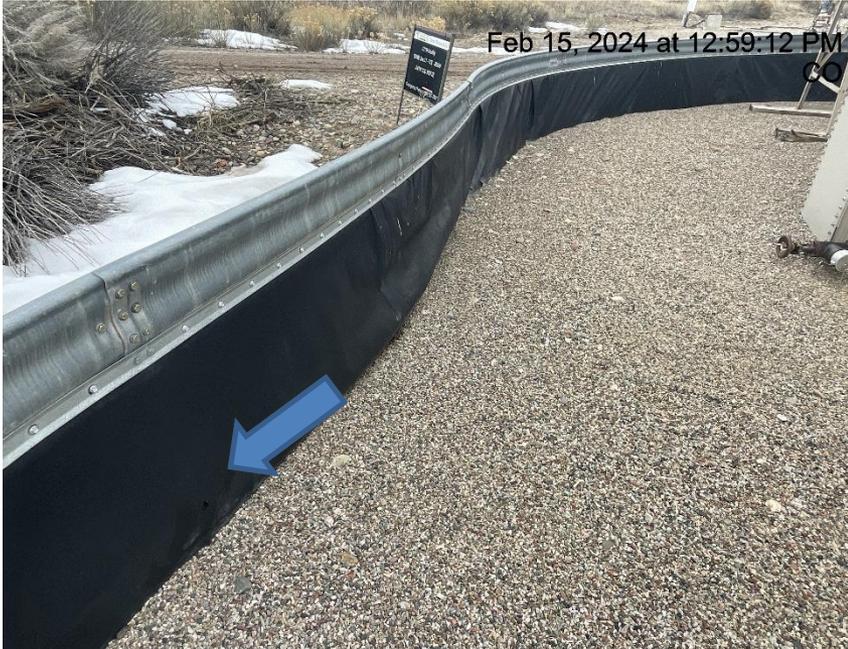
Photo # 6846 Hole in liner/liner needs maintenance

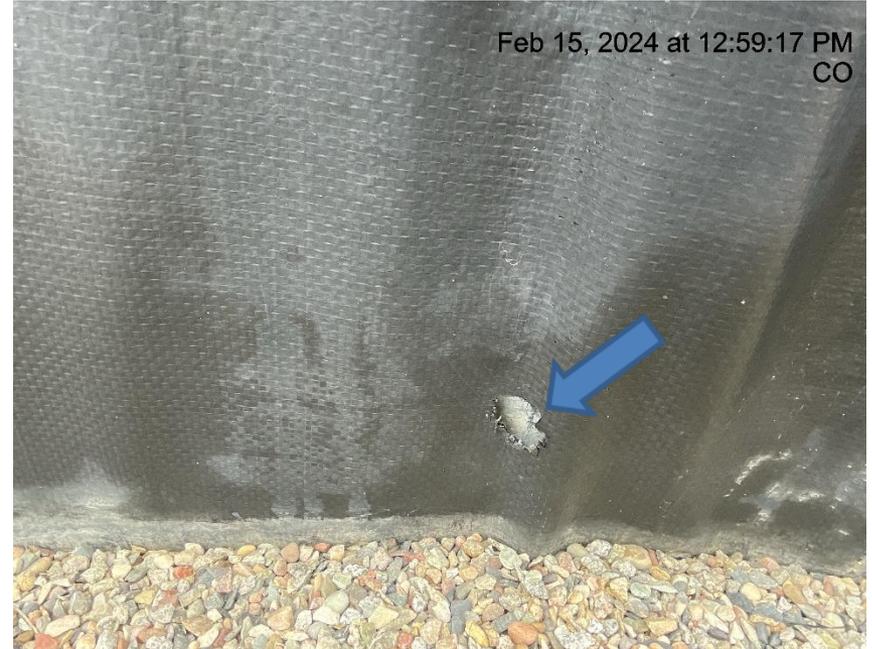
Photo # 6847 Hole in liner/liner needs maintenance

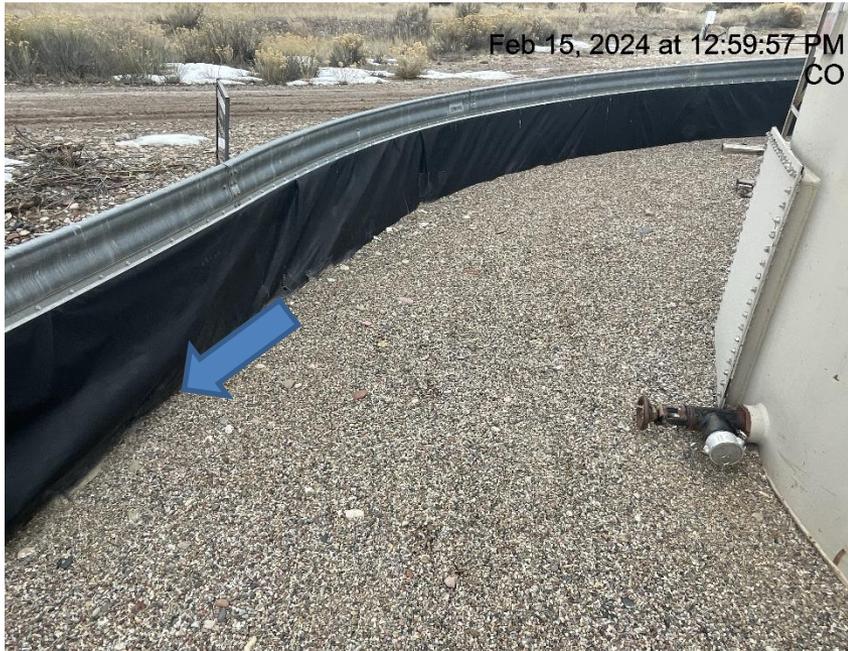
Photo # 6850 Hole in liner/liner needs maintenance

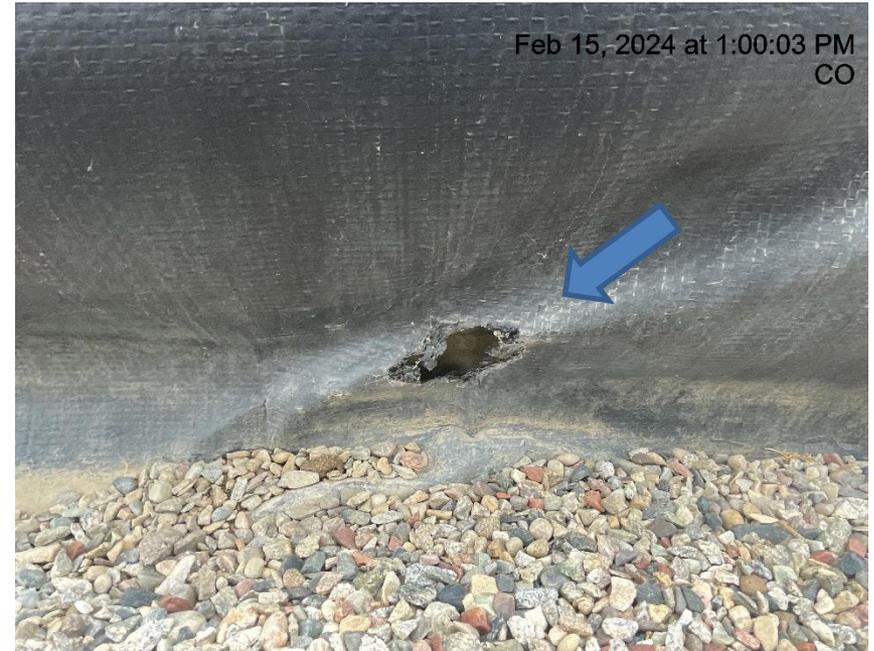
Photo # 6851 Hole in liner/liner needs maintenance
