**Inspection Photos**  
**Location Name: Federal Plover 28-5X**  
**Location ID: 331082**

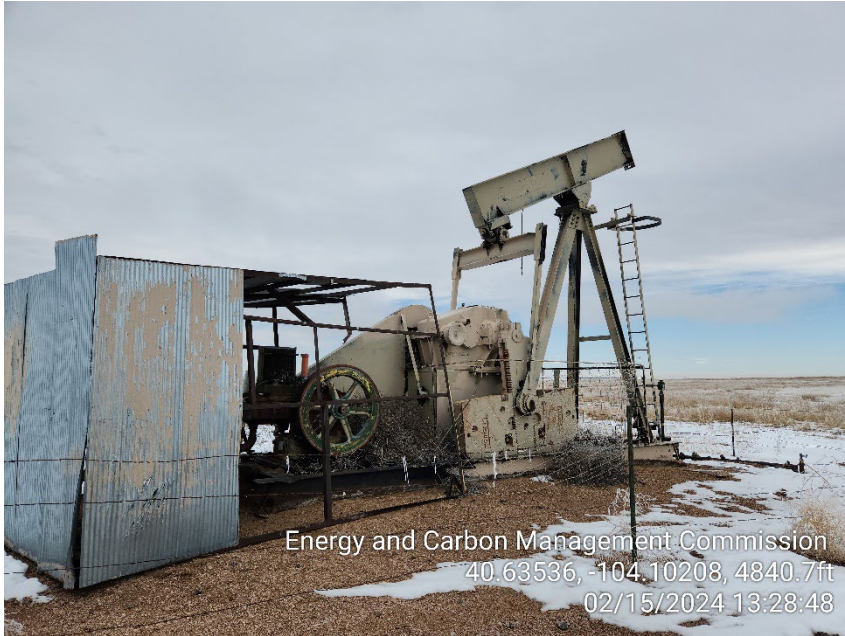
**Photo 1 – Pumping Unit**

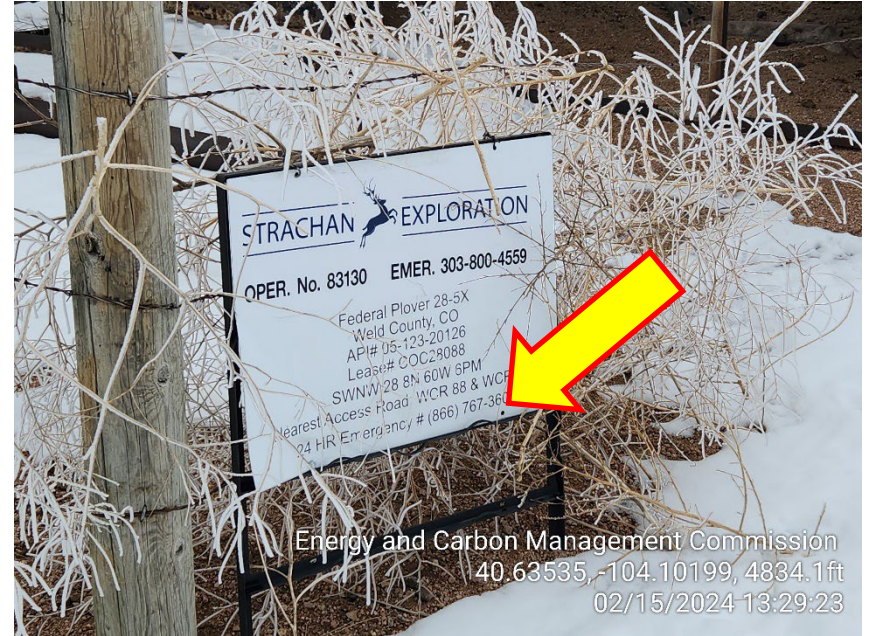
**Photo 2 – 24-Hour Emergency Contact Number from previous Operator is still present**

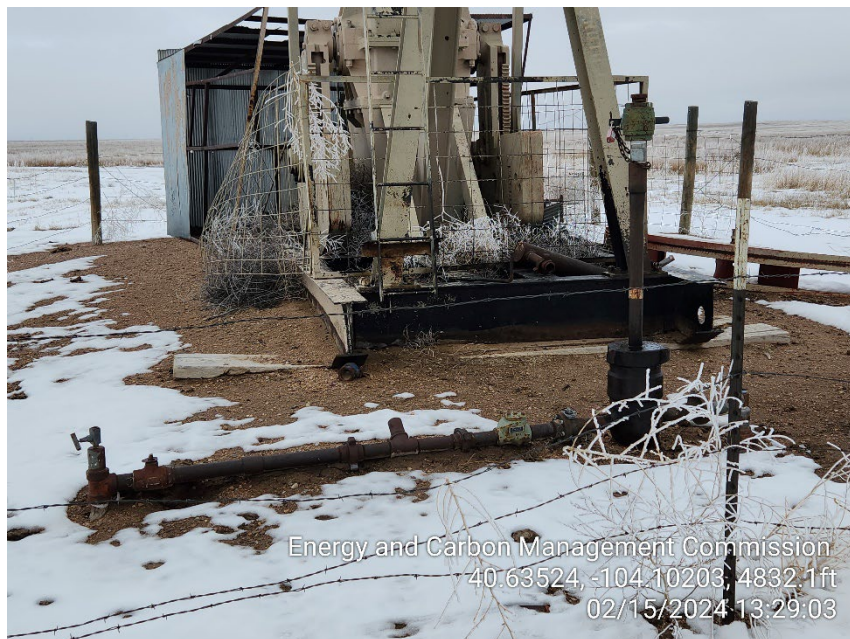
**Photo 3 – Wellhead**

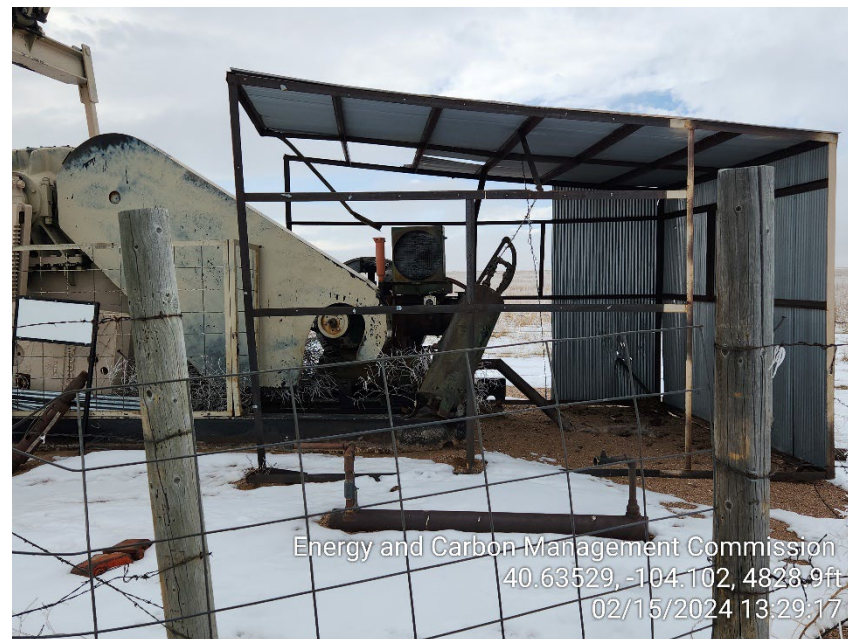
**Photo 4 – Gas Engine**
