Inspection Photos

Location Name: CAERUS PICEANCE LLC, CHEVRON-66S96W/4SWNW

Location ID: 335814

Date: 2/20/2024

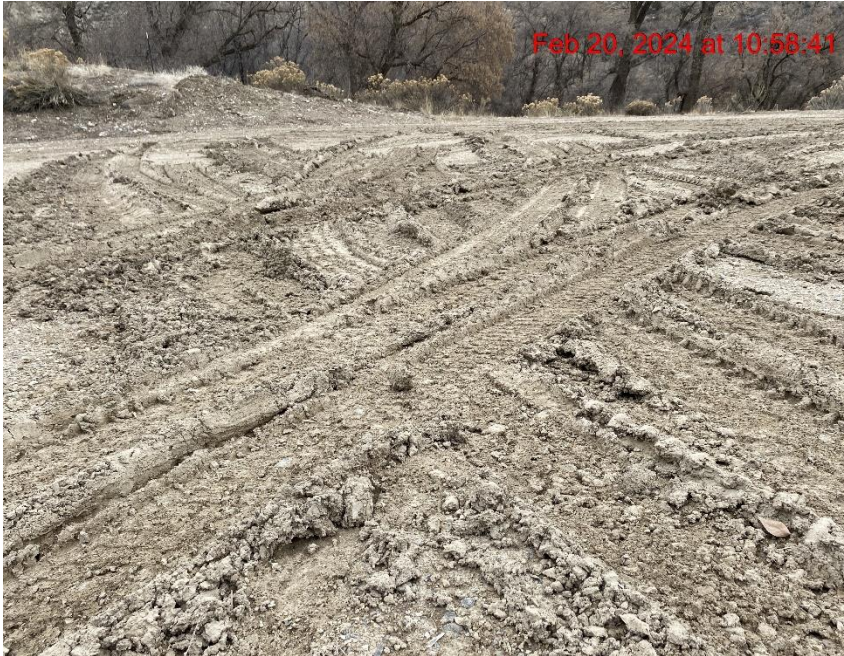
Lack of Stabilization – Photo #09372

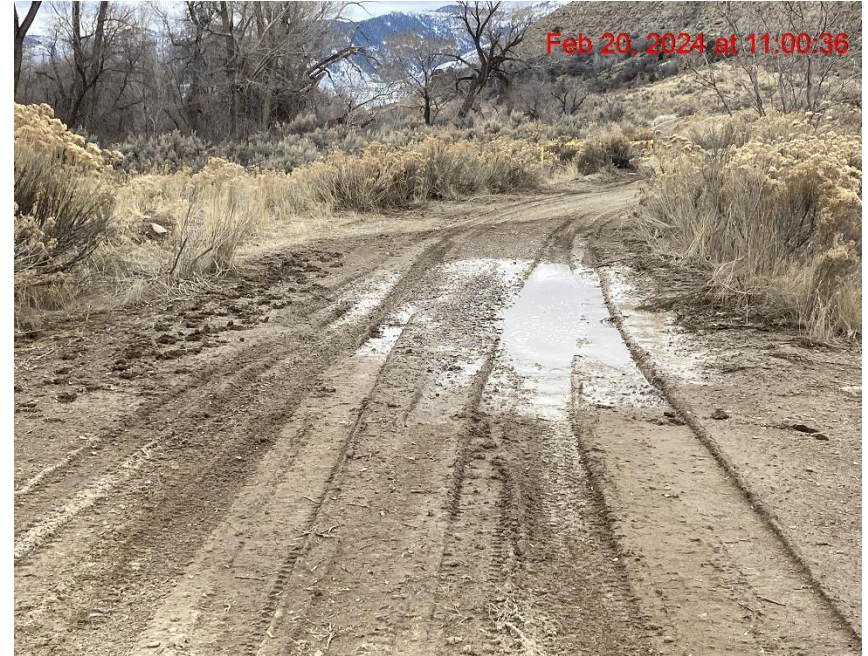
Lack of Stabilization – Photo #09374

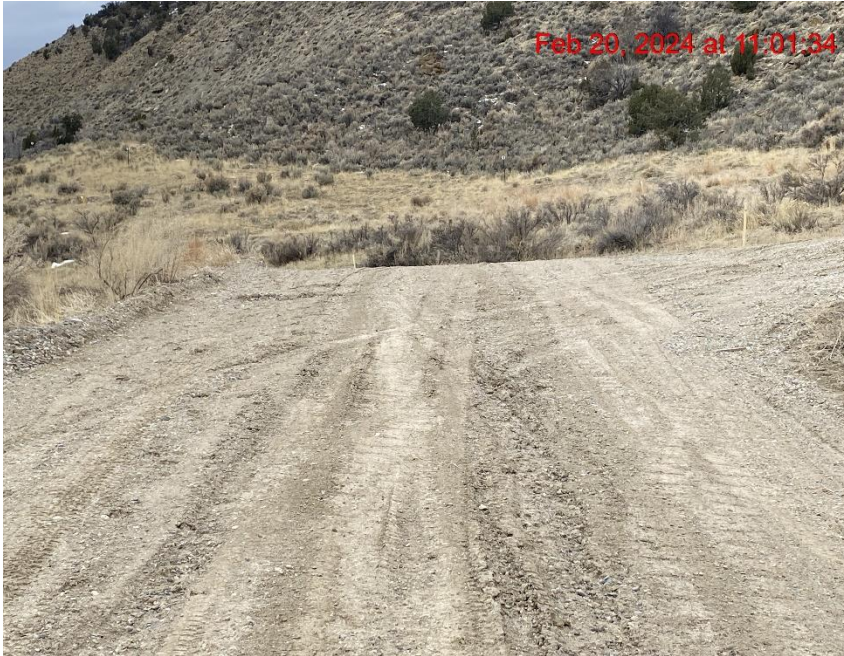
Insufficient Vehicle Tracking BMPs at Location Entrance/Exit
– Photo #09375
