Inspection Photos

Location Name: CAERUS PICEANCE LLC, CHEVRON-66S96W/4SWSW

Location ID: 335566

Date: 2/20/2024

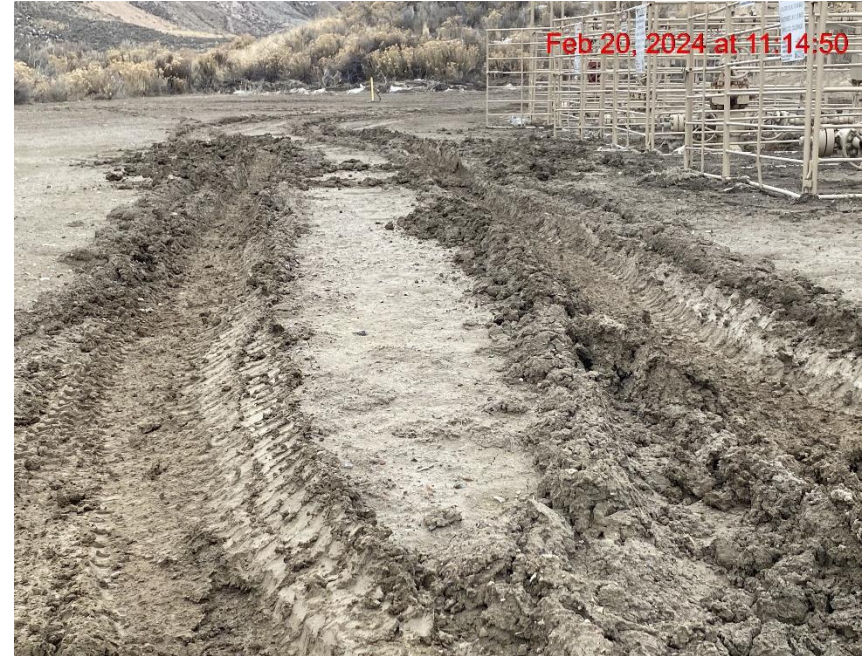
Lack of Stabilization – Photo #09394

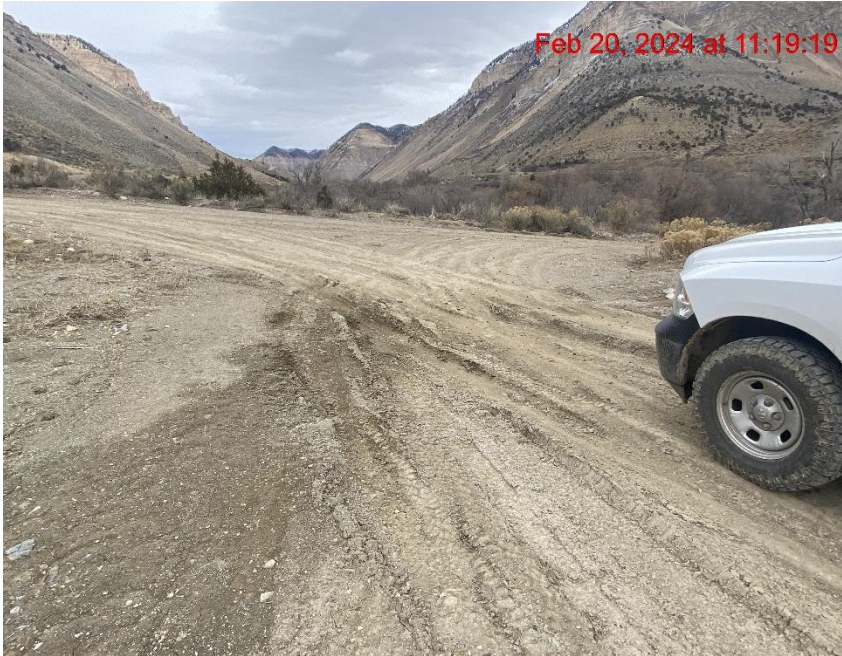
Insufficient Vehicle Tracking BMPs at Location Entrance/Exit
– Photo #09404
