Inspection Photos

Loc: 485654

Operator: BNL (ENTERPRISE) INC

Inspection Date: 2/21/2024

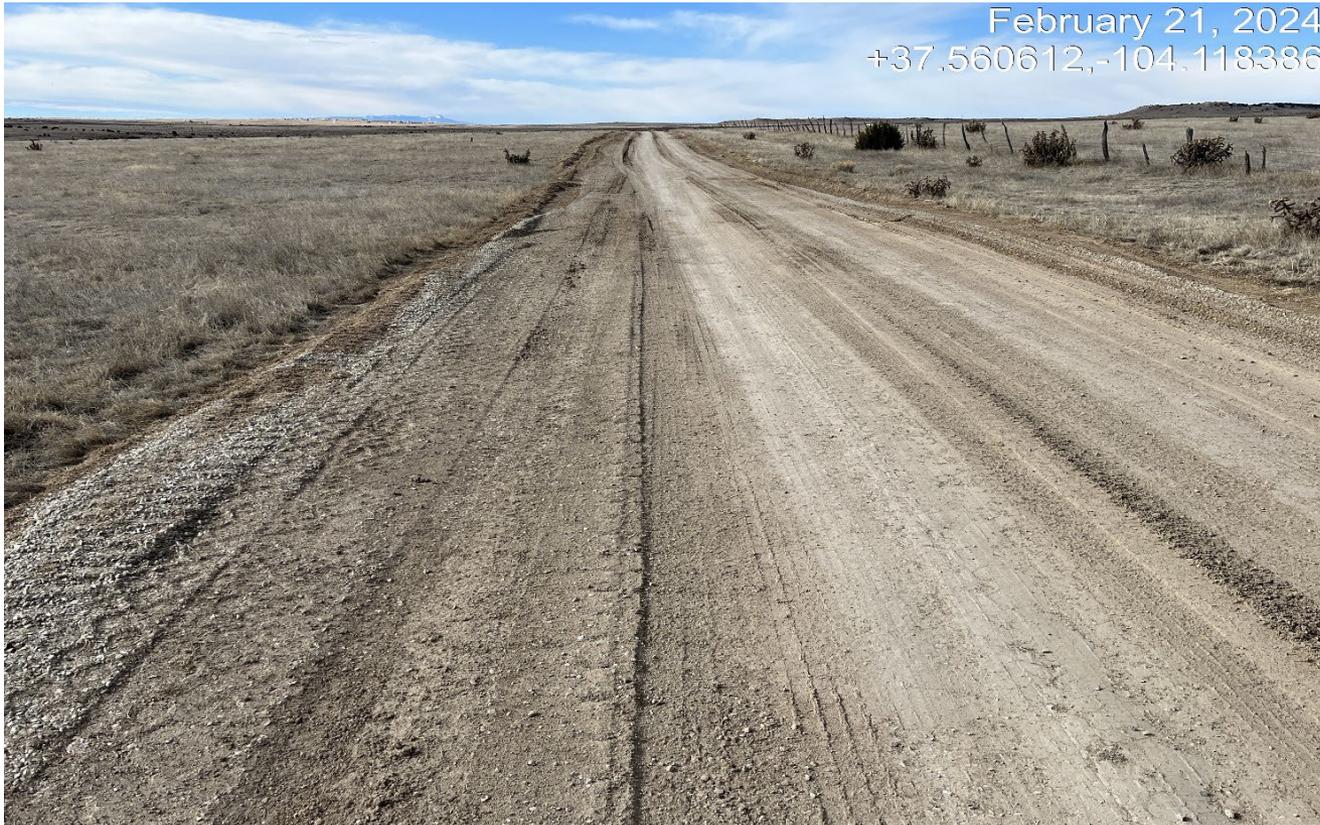
Photo 1. Facing south toward the access road. The sides of the road will need to be reclaimed. The road is not crowned and there are no ditches for stormwater which may become a problem.

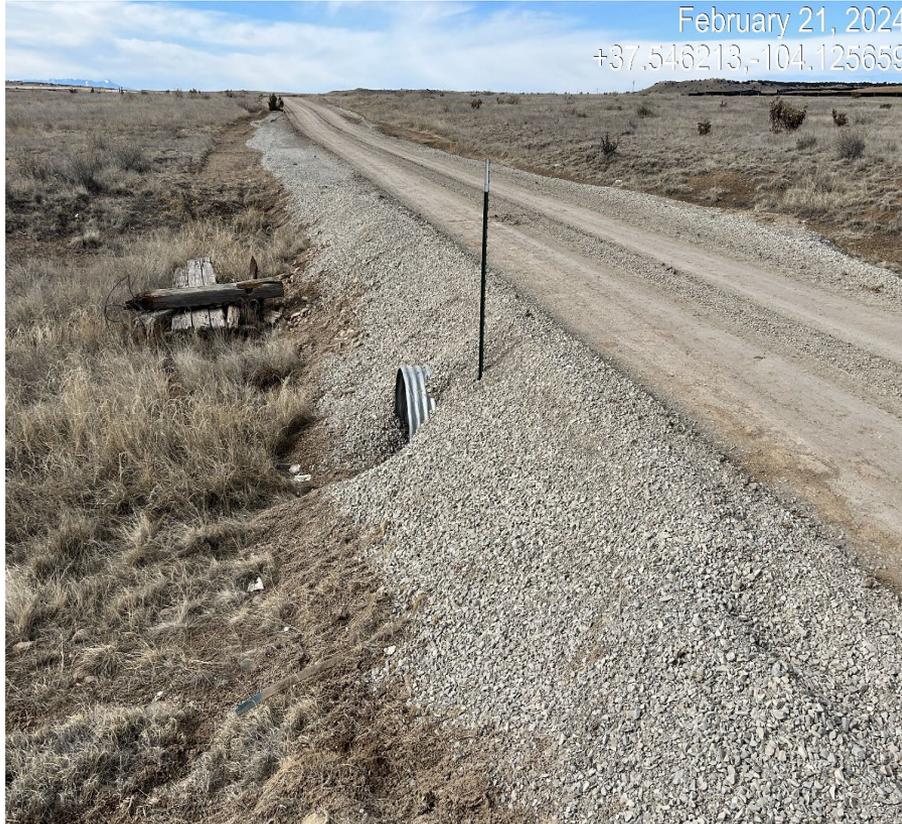
Photo 2. The drainage crossing has a large culvert but there is no outlet protection and loose gravel is falling into the culvert.

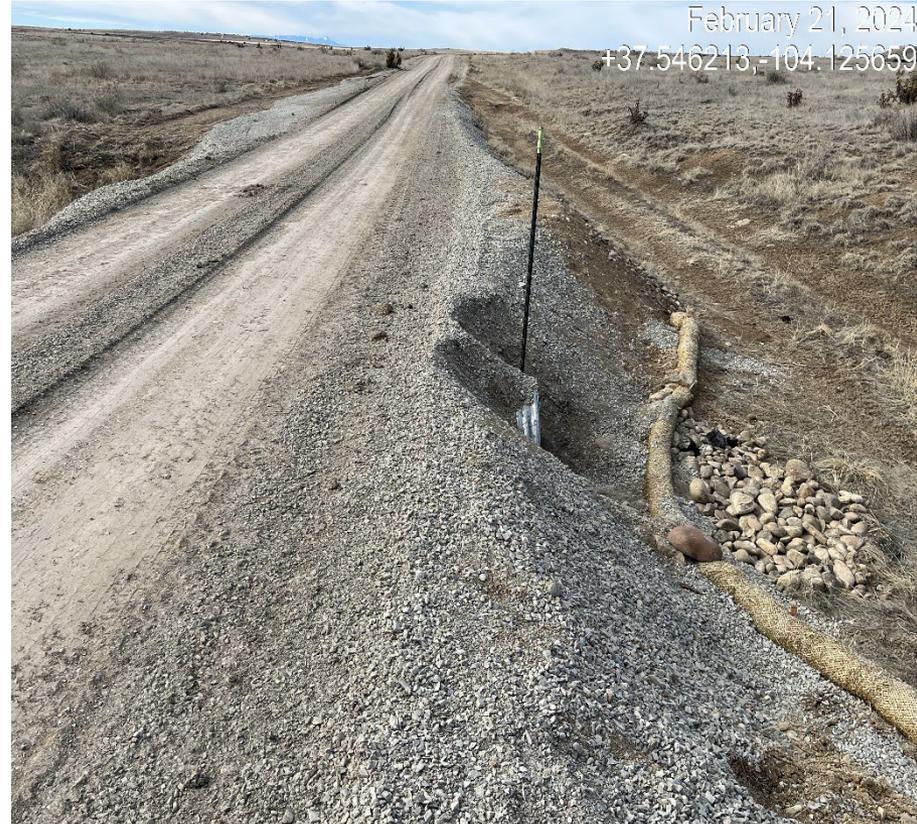
Photo 3. The embankment along the road side at the culvert is not stabilized and loose gravel is falling into the culvert.

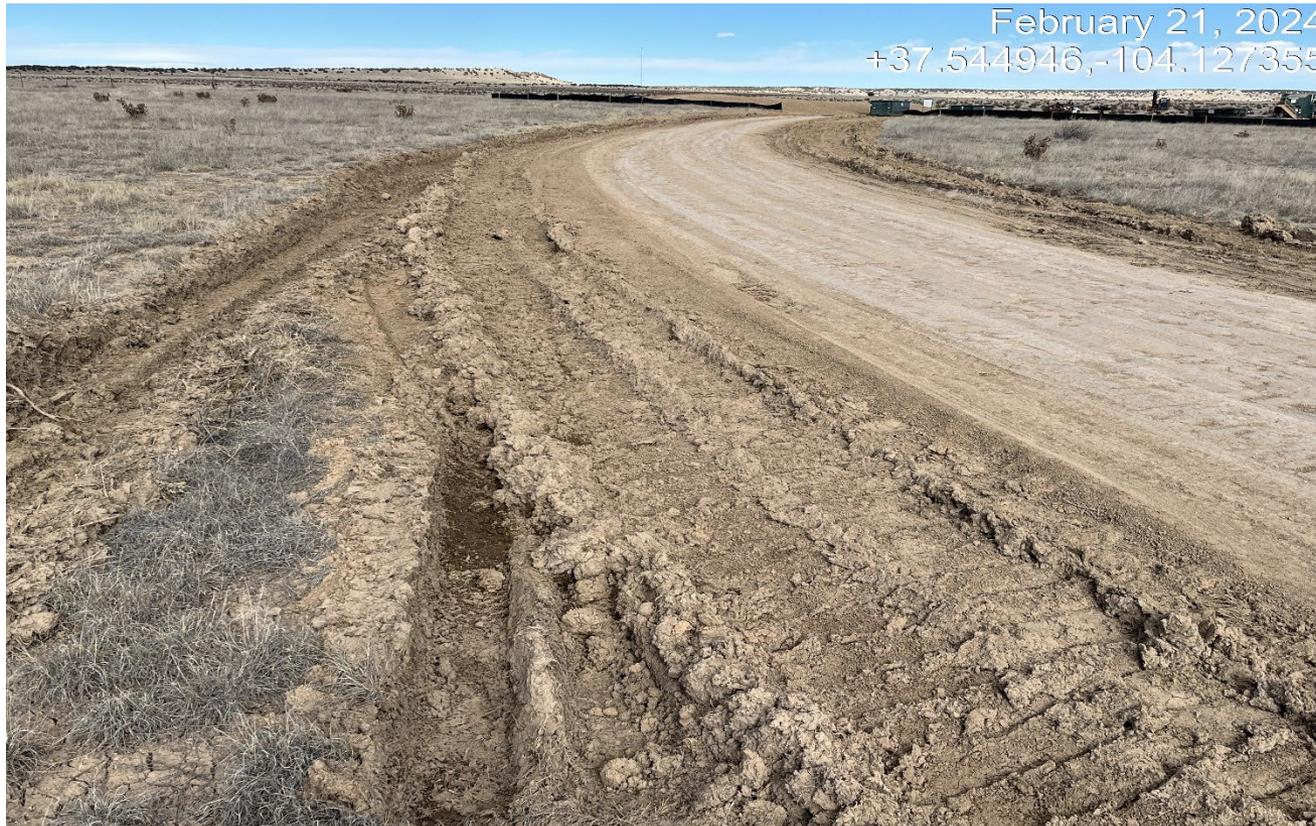
Photo 4. Facing northwest toward the access road. The side of the road needs to be seeded and stabilized and the road needs to be crowned and graveled.

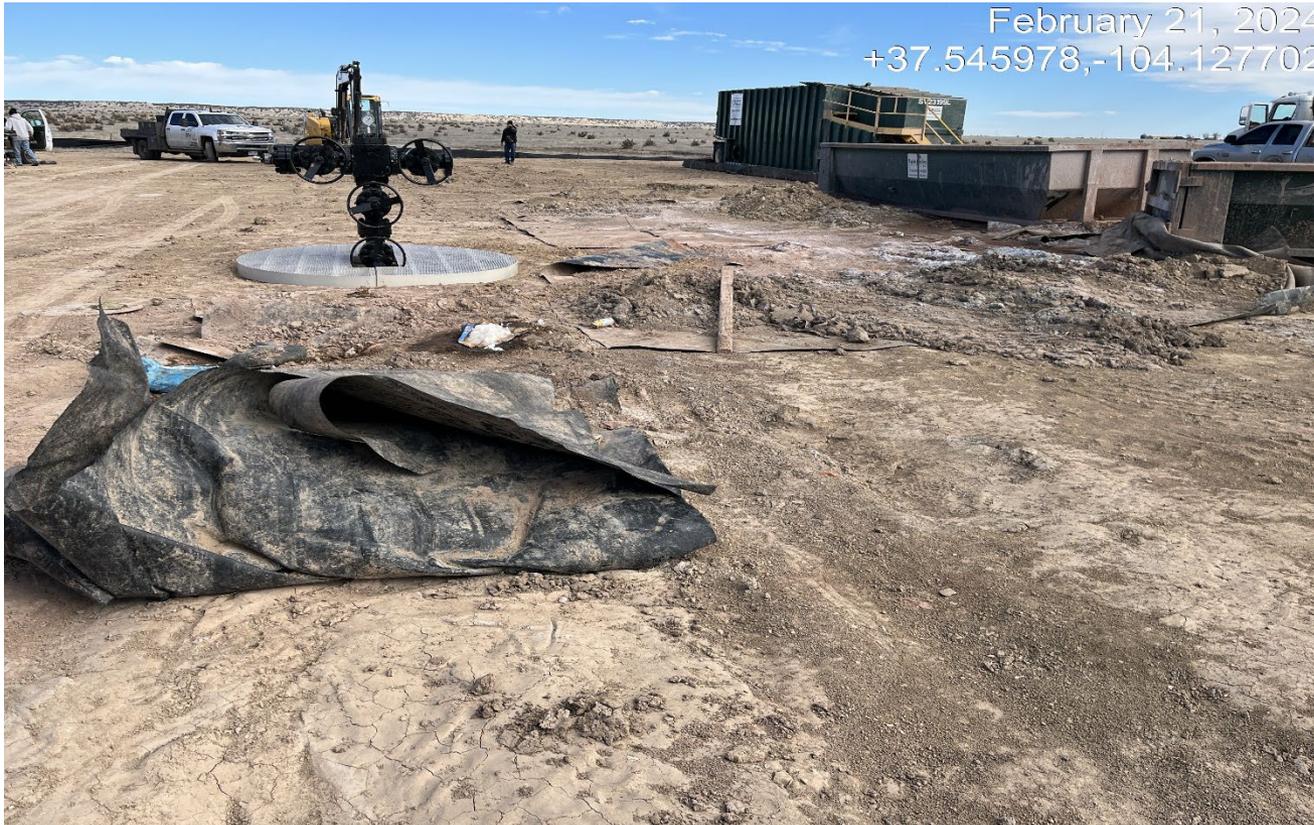
Photo 6. Facing toward the drilled well. The drill cuttings are not properly stored with containment and have spread off the liner.

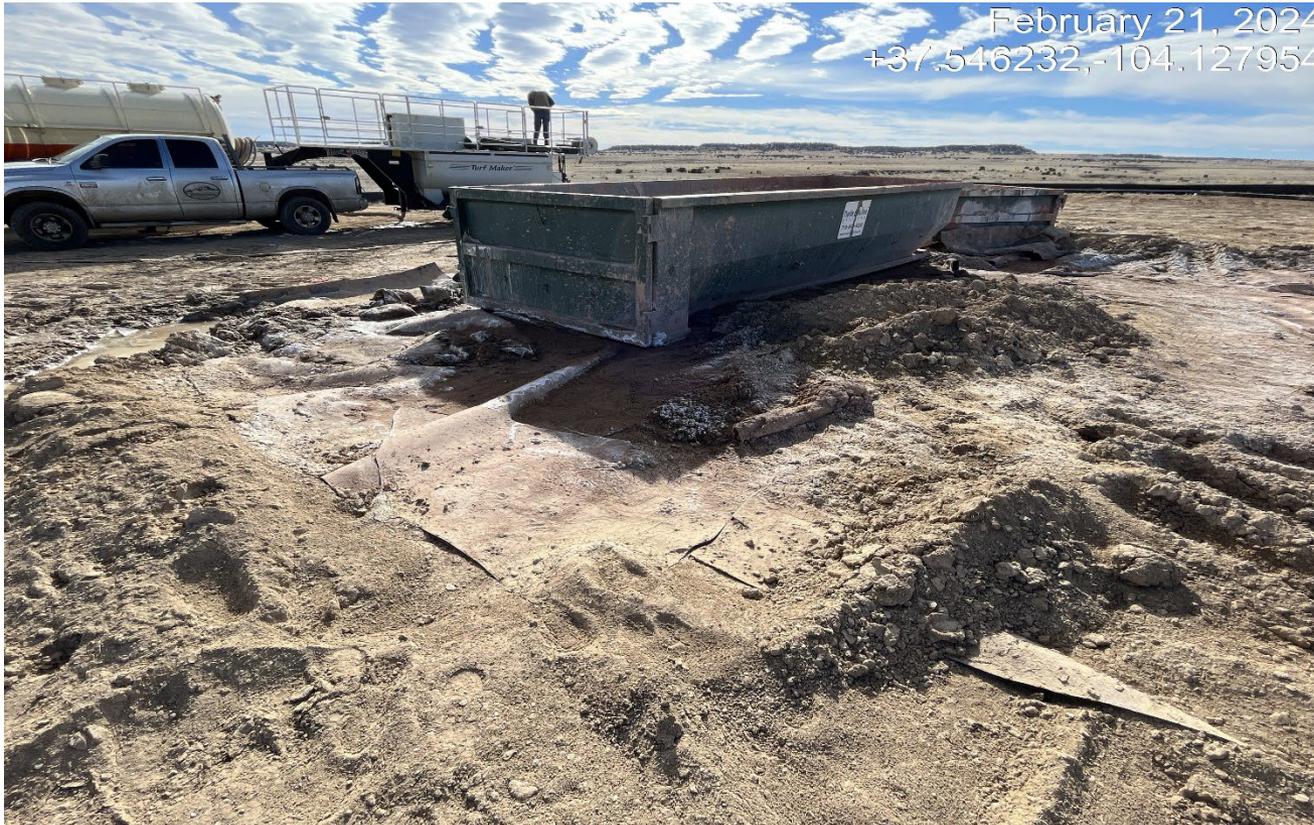
Photo 7. The containers are filled with drill cuttings and appear to be leaking out from the back gate. The drill cuttings are not properly stored with containment and have spread off the liner.

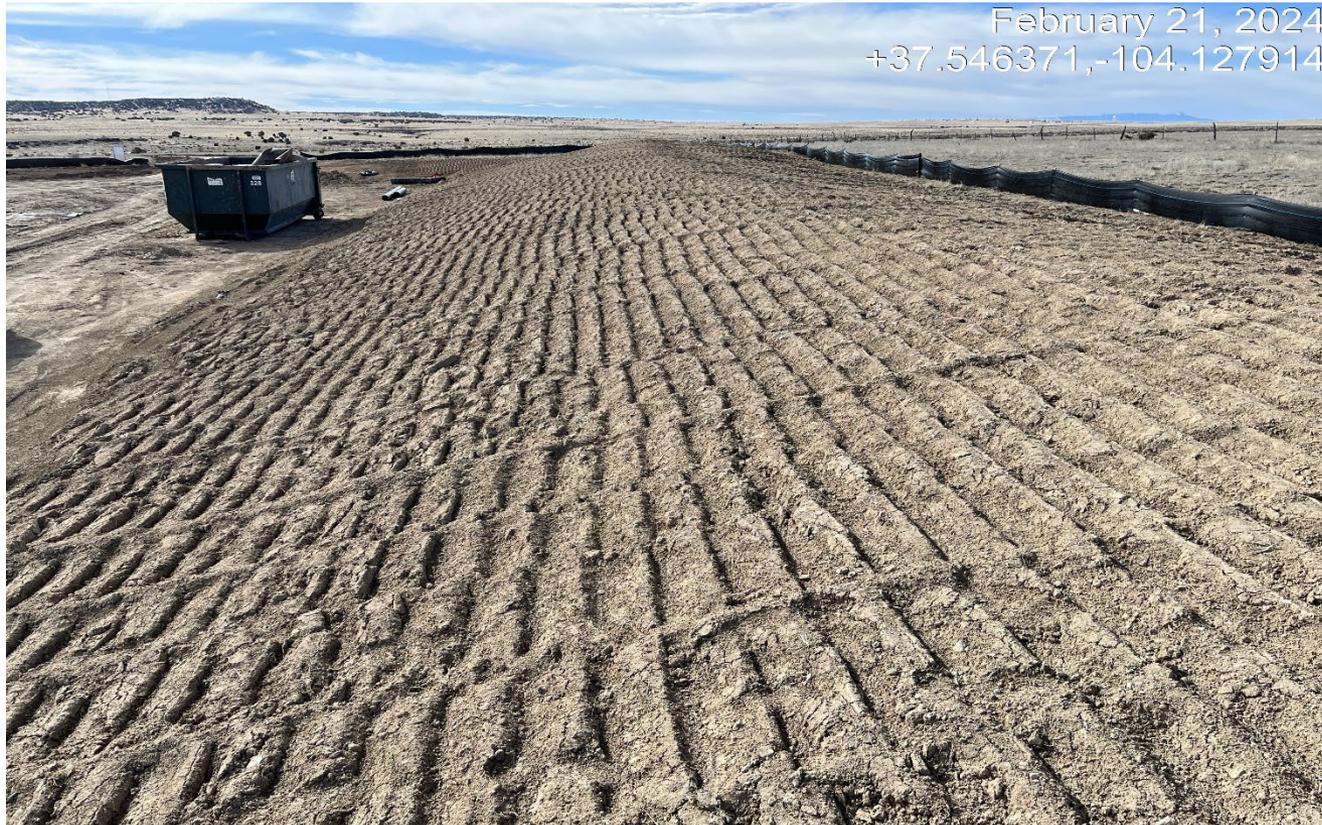
Photo 8. Facing toward the soil stock pile. The stock pile will need to be seeded before the growing season unless it will be re-spread for reclamation before that time.

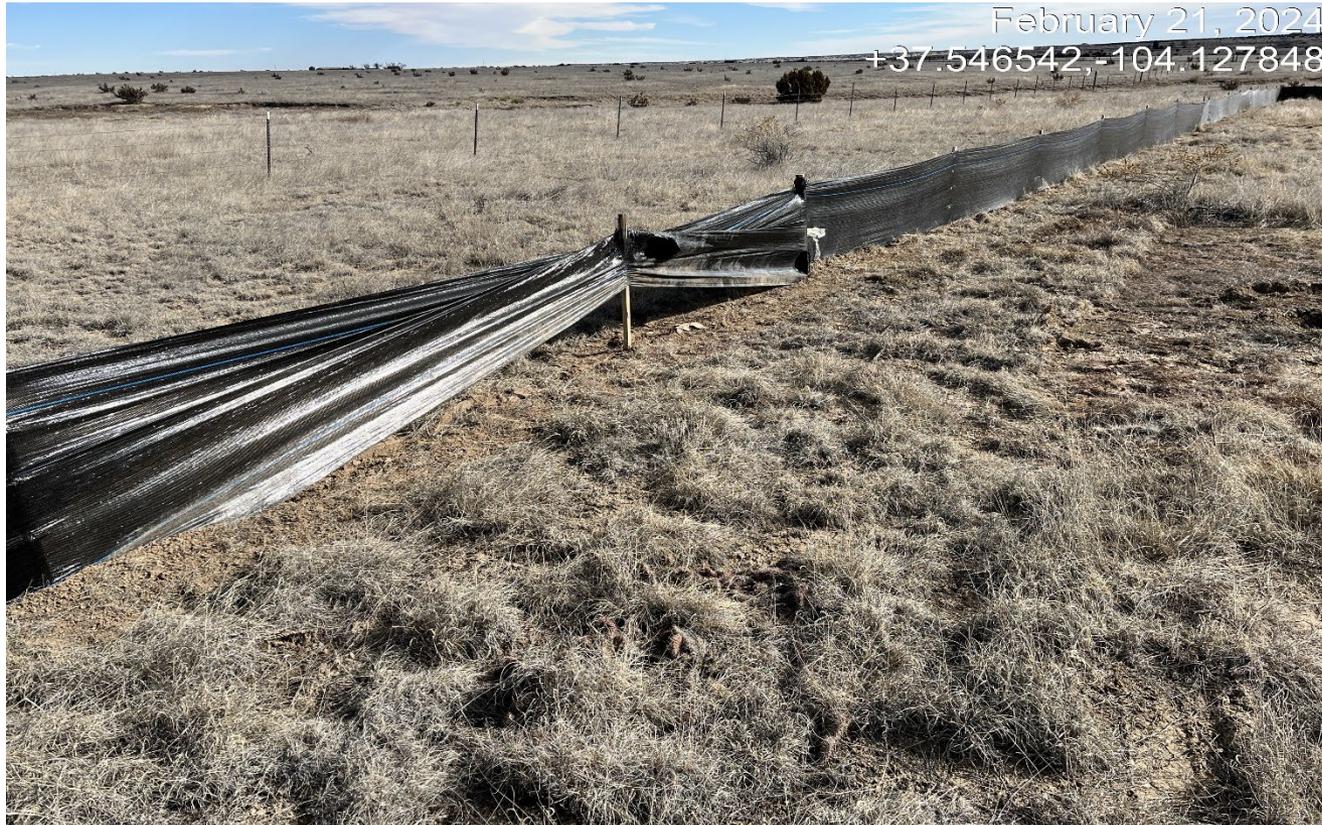
Photo 9. There are several area where the silt fence is not maintained..
